E. BURNSIDE ST.
AT
S.E. & N.E. UNION AVE.

Report of Traffic Conditions

ORE 99E - Hwy. No. 1E - M.P. X1.00 to M.P. X0.80

SIGNALIZATION PLAN N. E. UNION AVE. and N. E. BROADWAY

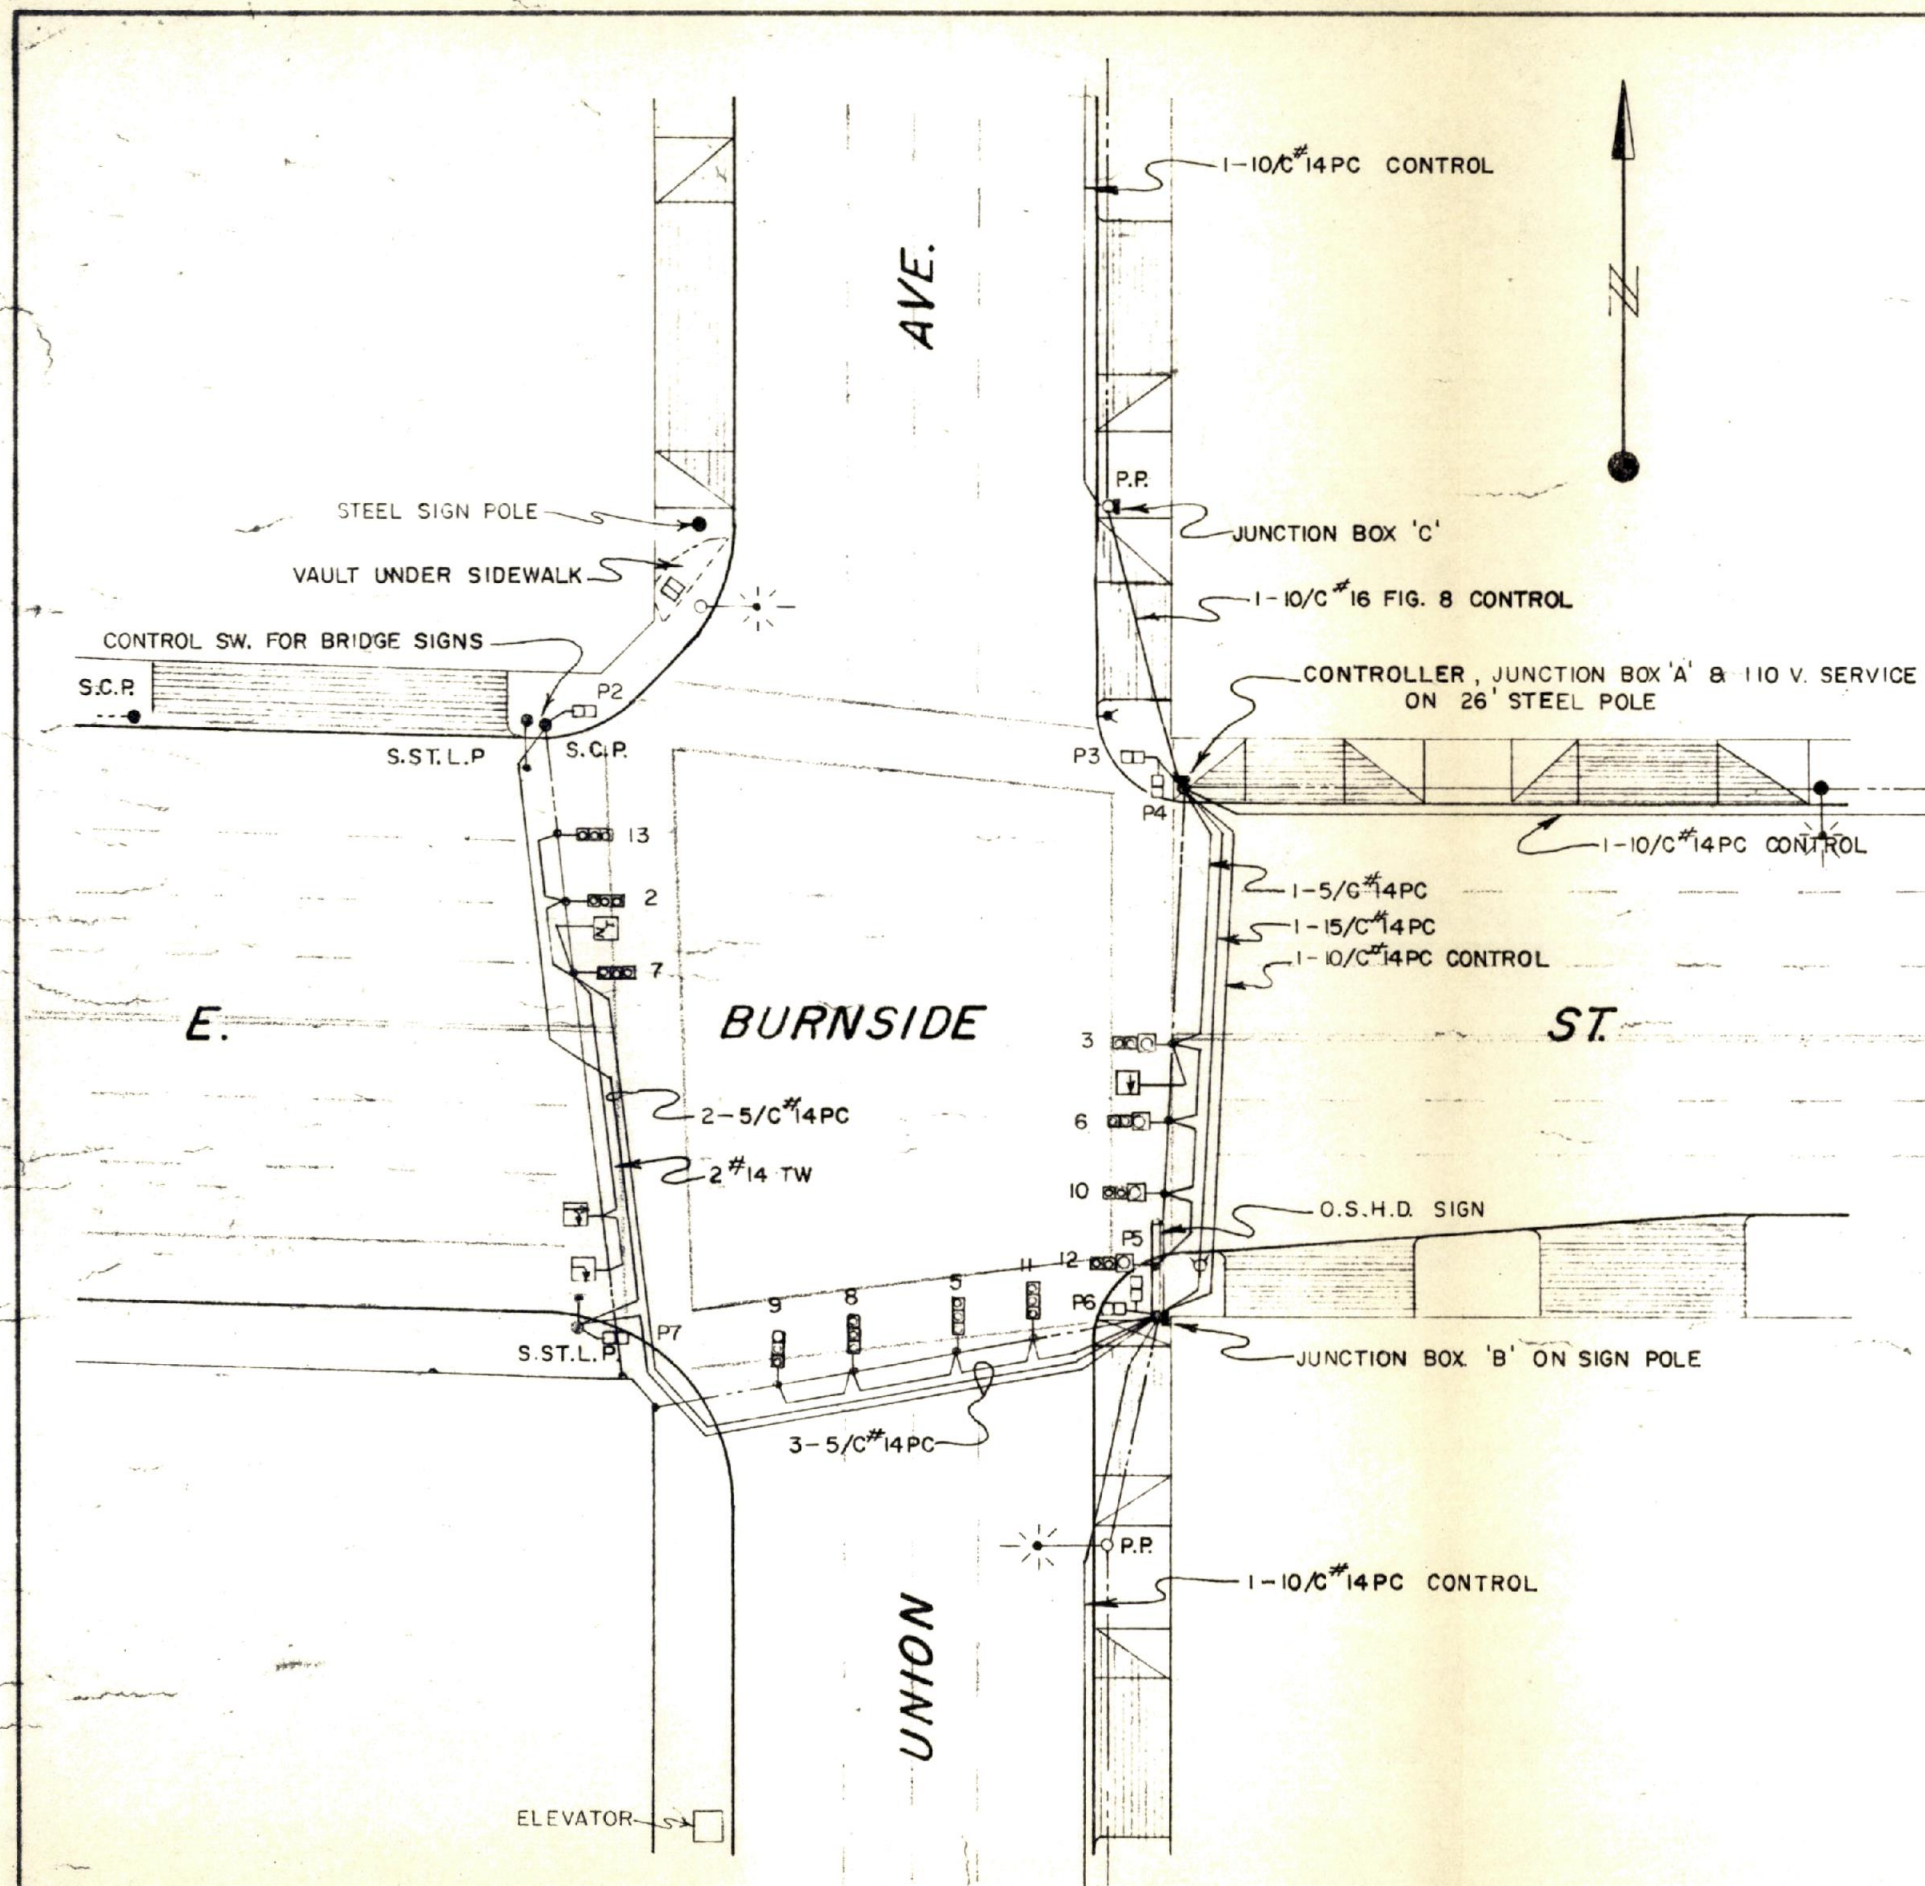
PL-0-001

Reference to these photographs will show that none of the signal heads at the Burnside Street intersection have backboards. Only three of the ten signal heads have 12-inch red lenses - the remainder are the standard 8" size. Because of the wide streets involved, the number of moving traffic lanes, and the heavy traffic, the existing red signal indications are not considered adequate.

As a result of this investigation, it is recommended that backboards be installed on all 10 signal heads at the intersection of Union Avenue and Burnside Street in the City of Portland. It is further recommended that 12-inch red lenses be installed in the seven signal heads which presently have 8-inch red lenses.

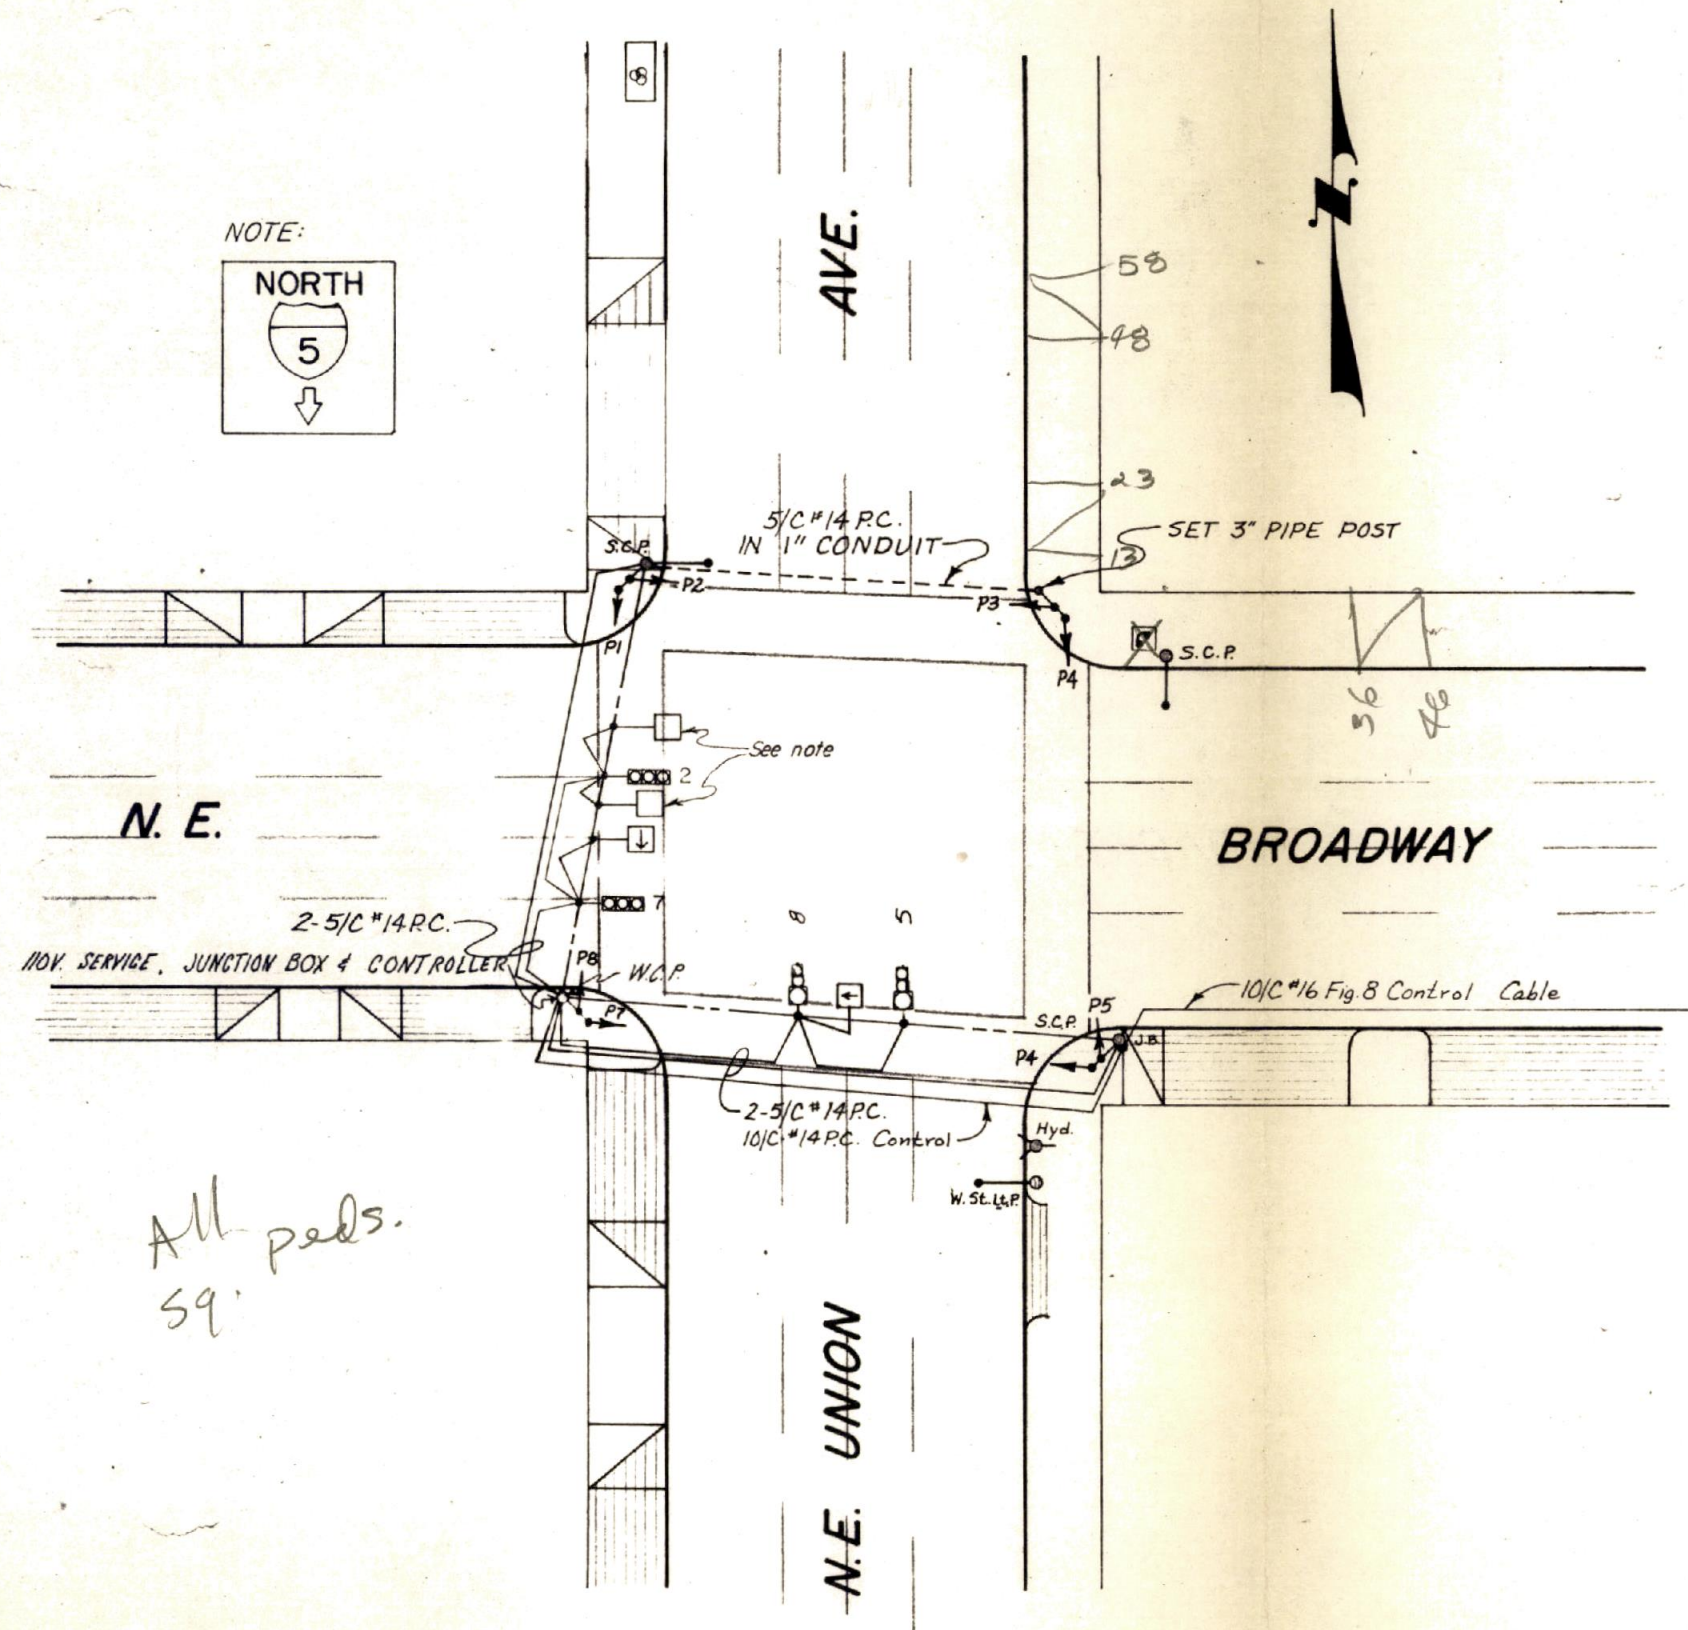
PL-2-076

WOOD POLE ON S.W. CORNER LENS - EXIST. HEADS ARE LOW

- ✓1. Remove both span wire suspended I-5 Trailblazer signs. ?
2. Install one additional signal head and center the existing "One Way" interior illuminated overhead sign over the two right-hand lanes.
3. Install 12" red lenses on all signal heads. *REPLACE 2 & ADD 1*
4. Install backboards on all signal heads.
