## INVENTORY SITE CS1: Buffalo Slough/ Peninsula Canal

### Summary Information

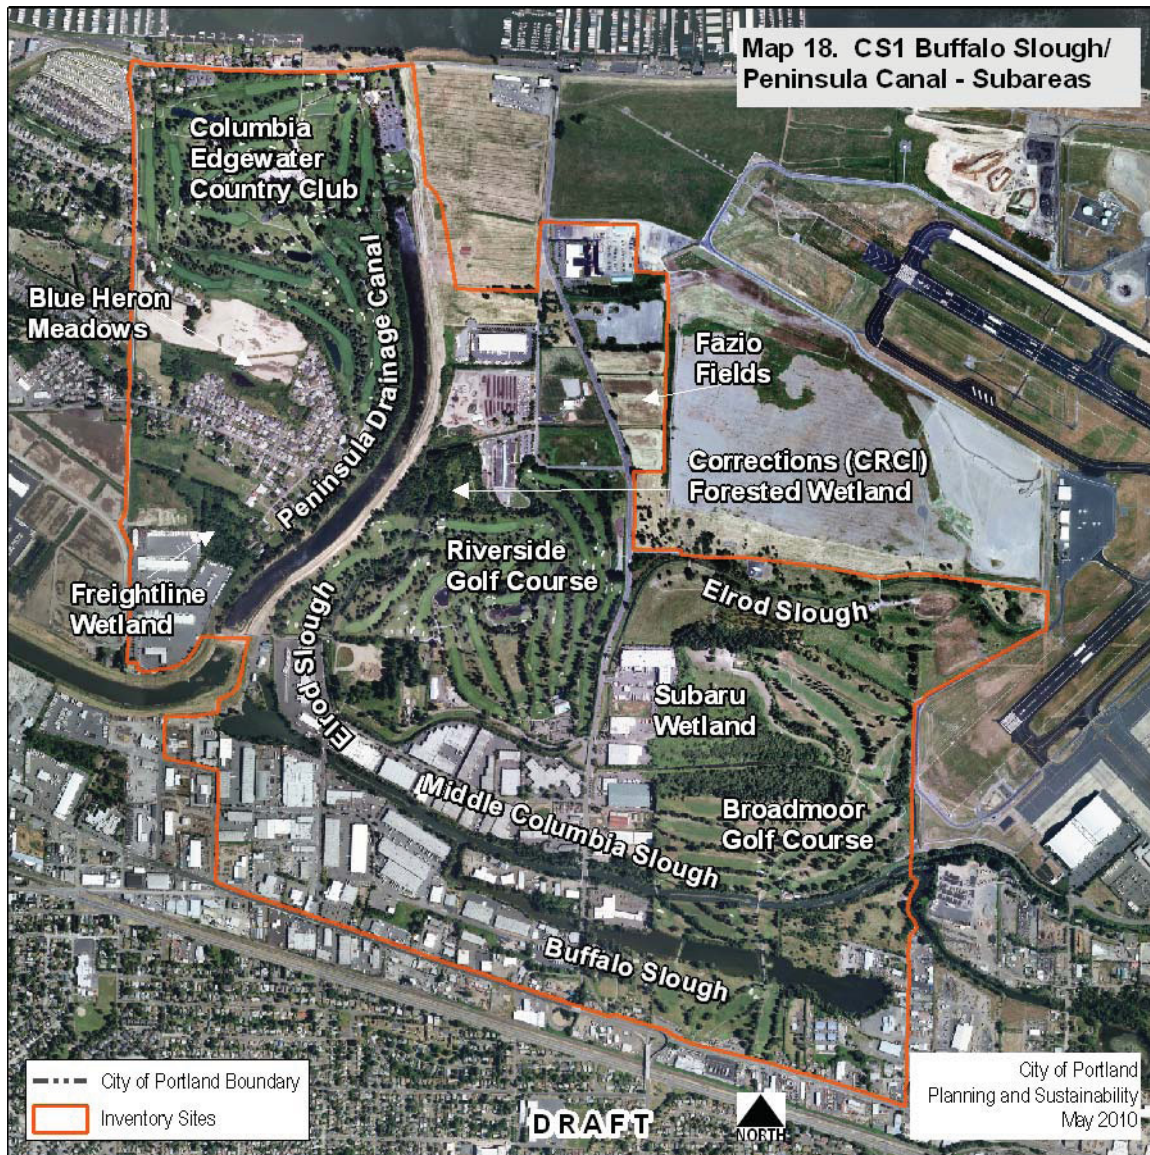
The natural resources are described for sub areas of the inventory site (see Map 18).

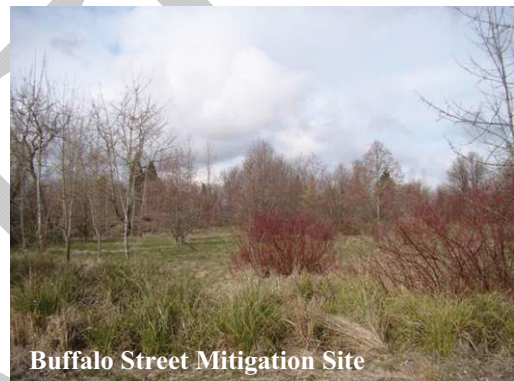
The Port of Portland Buffalo Street Mitigation Site is located between the eastern end of Buffalo Slough and Columbia Slough. In 1994 the Port planted the site with native vegetation. Trees include Oregon ash, black cottonwood, Oregon white oak and Western red cedar. Shrubs included red osier dogwood, Douglas spirea, red alder, black hawthorn, oceanspray, and willow. Ground covers included yarrow, aster, red columbine, slough sedge, rushes and fescues. Since 1994, the site has been managed to reduce invasive species and establish the plantings. Today the site has areas of woodland habitat, open grasses, meadows and wetland. Portions of the uplands provide refugia for amphibian and reptiles. Table 12 is a list of fish and wildlife species observed by Port of Portland staff between 2001 and 2008.

The Port of Portland Buffalo Street Mitigation Site has been designated a Special Habitat Area (CS14) because it meets multiple criteria. The area provides migratory stopover habitat for avian species (M) and it is a wildlife connectivity corridor between Buffalo Slough and the Middle Slough (C).

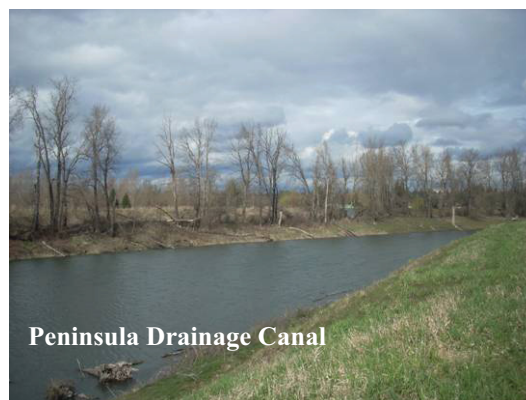
**Peninsula Drainage Canal**

Peninsula Drainage Canal is a roughly 1.5 mile long isolated slough segment. Peninsula Drainage Canal was originally created by the Corps of Engineers in 1921 in an attempt to improve water quality in the Lower Columbia Slough by flushing it with flows from the Columbia River. However, this effort did not succeed because the tidal effect and low gradient of the Lower Slough did not allow enough additional Columbia River flow to improve water quality. Furthermore, the opening to the Columbia River silted in quickly. In 1948, instead of reinforcing the canal levee, the ends of the canal were plugged. Today the Peninsula Drainage Canal acts as a closed system, bound on all sides by levees. Until 1999/2000 the canal was used as watering for livestock resulting in soil compaction and erosion.

The forested area along the northwest bank of the canal is a high quality black cottonwood forest with a Pacific willow and red-osier dogwood understory. Several snags are present and there is some large wood in the channel. An emergent bench exists below the wooded strip including scouring rush and young ash trees. The southwestern bank of the canal is occupied by an open cottonwood forest. Some large snags are present here as well. The understory contains red-osier dogwood, Himalayan blackberry, as well as some English ivy and reed canary grass. The east side of the canal is almost completely reed canary grass with a few swamp roses.

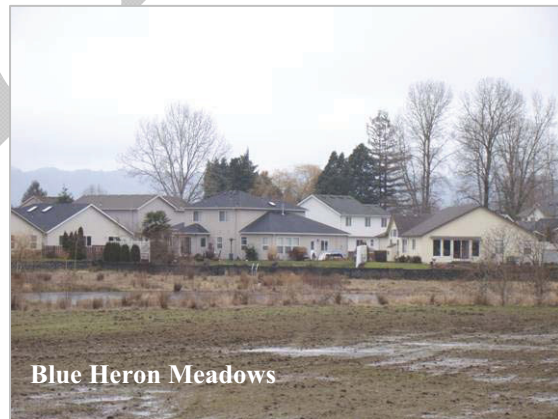
In 1999/2000 much of the agricultural uses ended and residential development began around the wetlands. Blue Heron Meadows wetland was established as an open space tract. Stormwater from the residential development is treated in bioswales and then discharged to the wetland.

The eastern side of the wetland is woodland consisting black cottonwood/red alder and shrubland containing red-osier dogwood, Douglas spiraea, willow, cattails, and common rush. Areas identified as shrubland contain a mixture of species including Douglas spiraea, red-osier dogwood, and willow. Several species of wetland emergents are found around the pond edges.

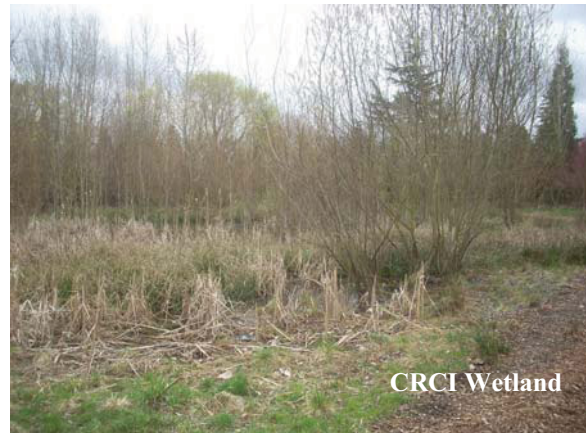
CRCI Wetland

The forested area is composed primarily of black cottonwood, red alder, and Oregon ash, including several large, well established trees. Snowberry and Douglas spiraea are the main understory shrub species along with a small amount of the following weedy species: Himalayan blackberry, English ivy, spurge laurel, and English holly. The eastern edge of the area is primarily red alder with some grand fir.

The interior of this site supports a dense, native shrubland, a somewhat rare occurrence in the slough. Species present include: Nootka rose, swamp rose, red-osier dogwood, Douglas spiraea, tall Oregon grape, and blue and red elderberry. Notably, there are some especially large red-osier dogwood stands on site. Reed canary grass, teasel, and poison hemlock are the most common weed species.

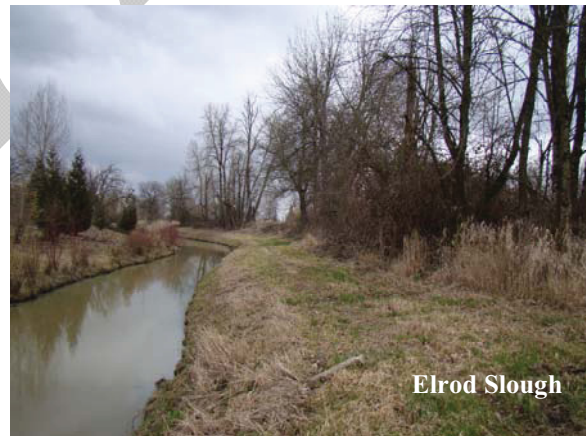
Elrod Slough drains areas north of Broadmoor Golf Course and west and south of Riverside Golf Course. It connects with Subaru Wetlands, Port of Portland mitigation sites, the forested wetland on property owned by the Oregon Department of Corrections and drainageways to the north. The dominant tree species along Elrod Slough are black cottonwood and mixed conifer-hardwood trees. Elrod Slough, as well as Riverside Golf Course, are within the flood area and can provide flood storage during large storm events. Elrod Slough is actively maintained for flow conveyance by the Multnomah County Drainage District. Maintenance includes riparian vegetation removal within 25 feet of the waterway and removal of in-water large structure woody debris. Elrod Slough flows to MCDD pump station #2 where it is pumped into the Slough.
