# **Sam Jackson Park Road**

**Landslide Mitigation**

**July – August 2011**

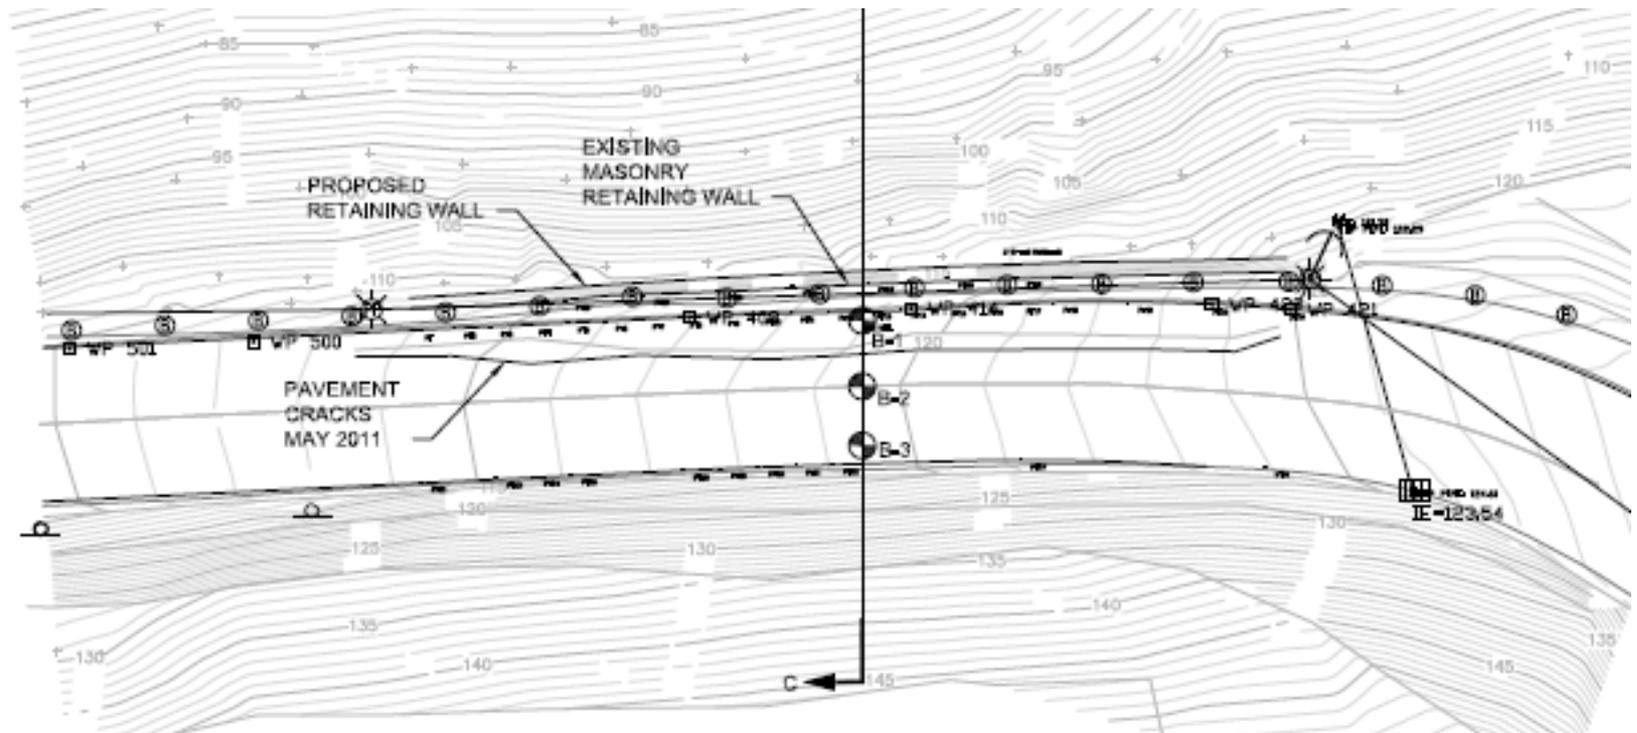
# Crack in SJP Roadway

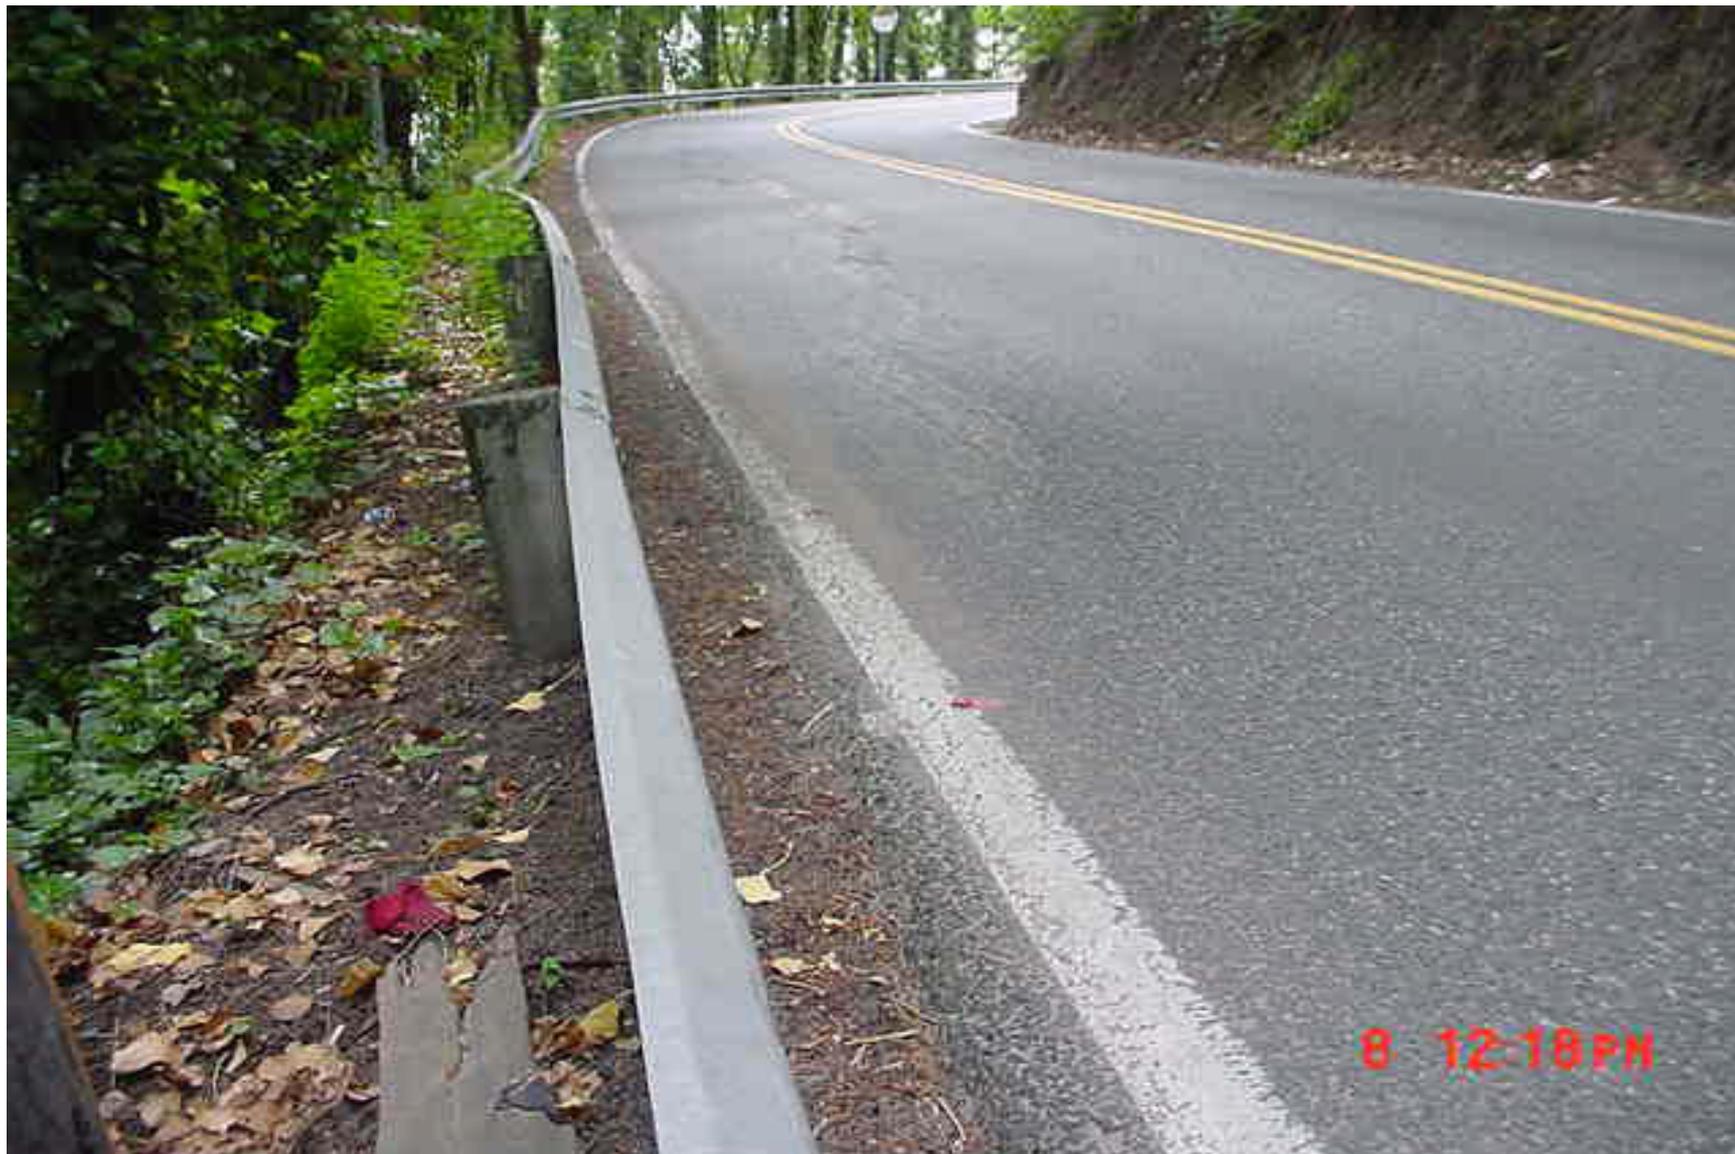
# 2006 Roadway View – slight crack

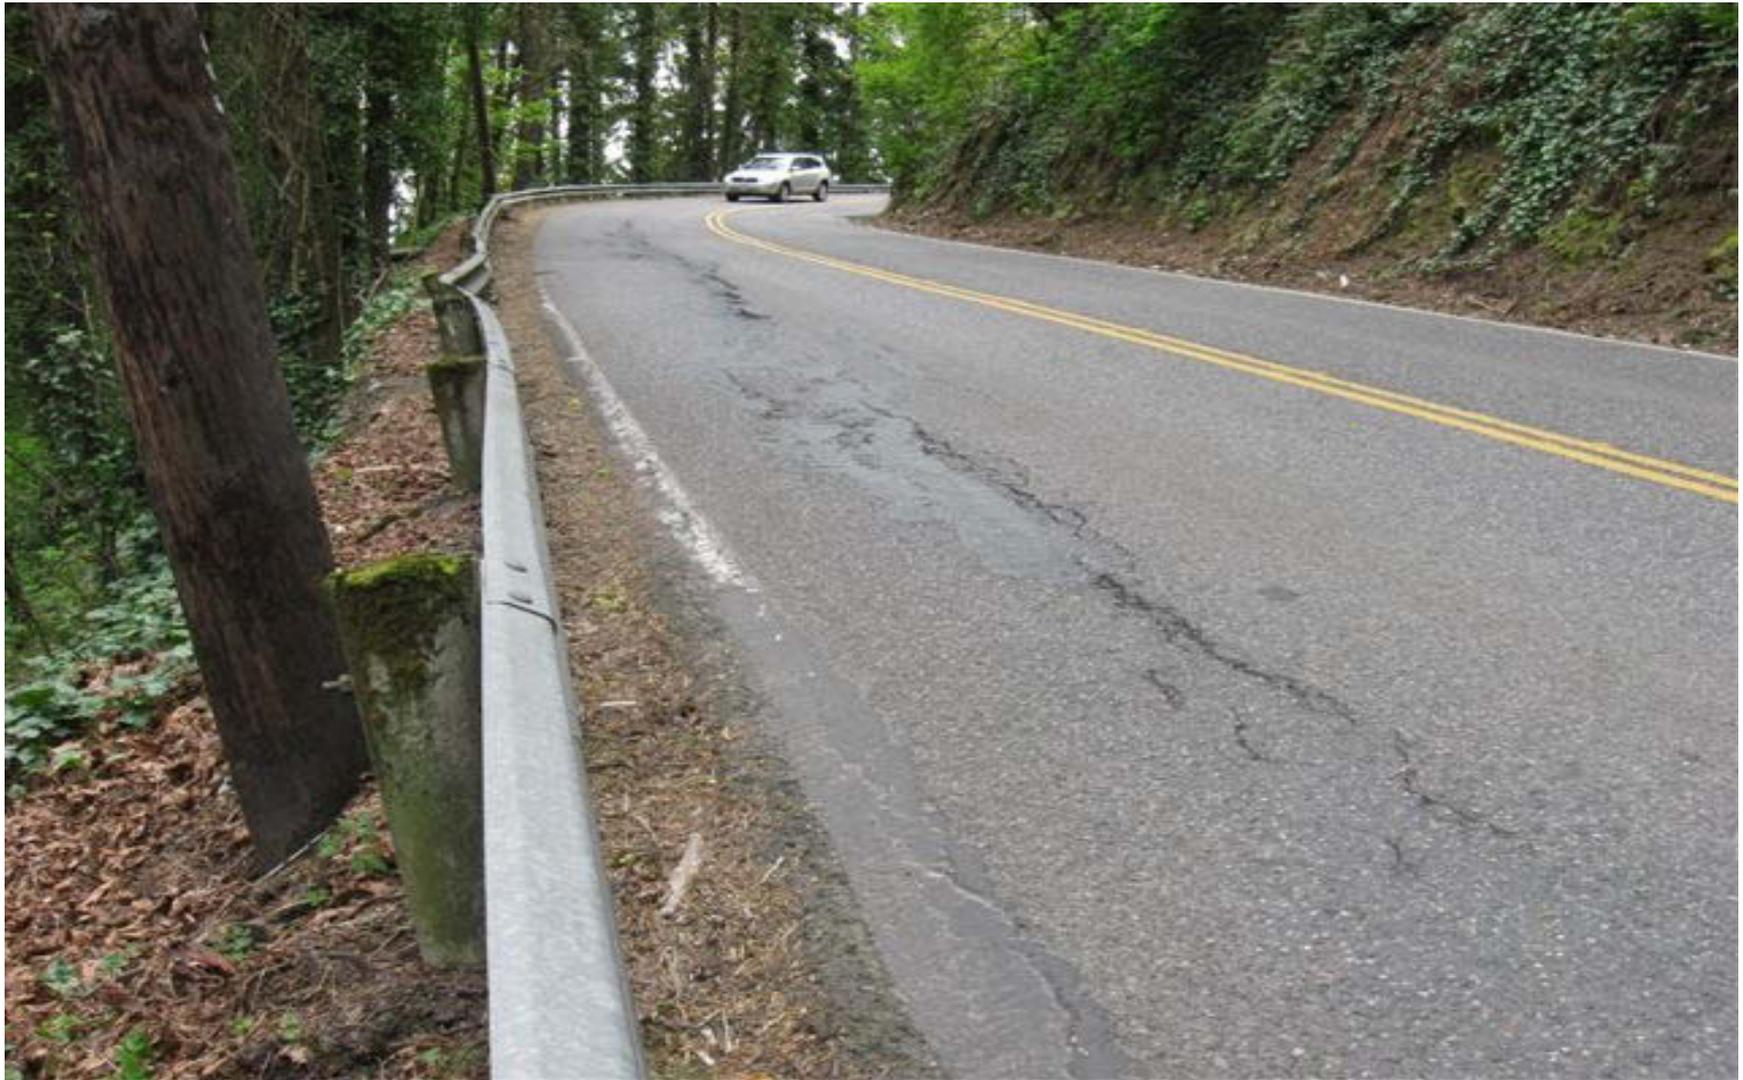
# 2011 Roadway View – significant crack

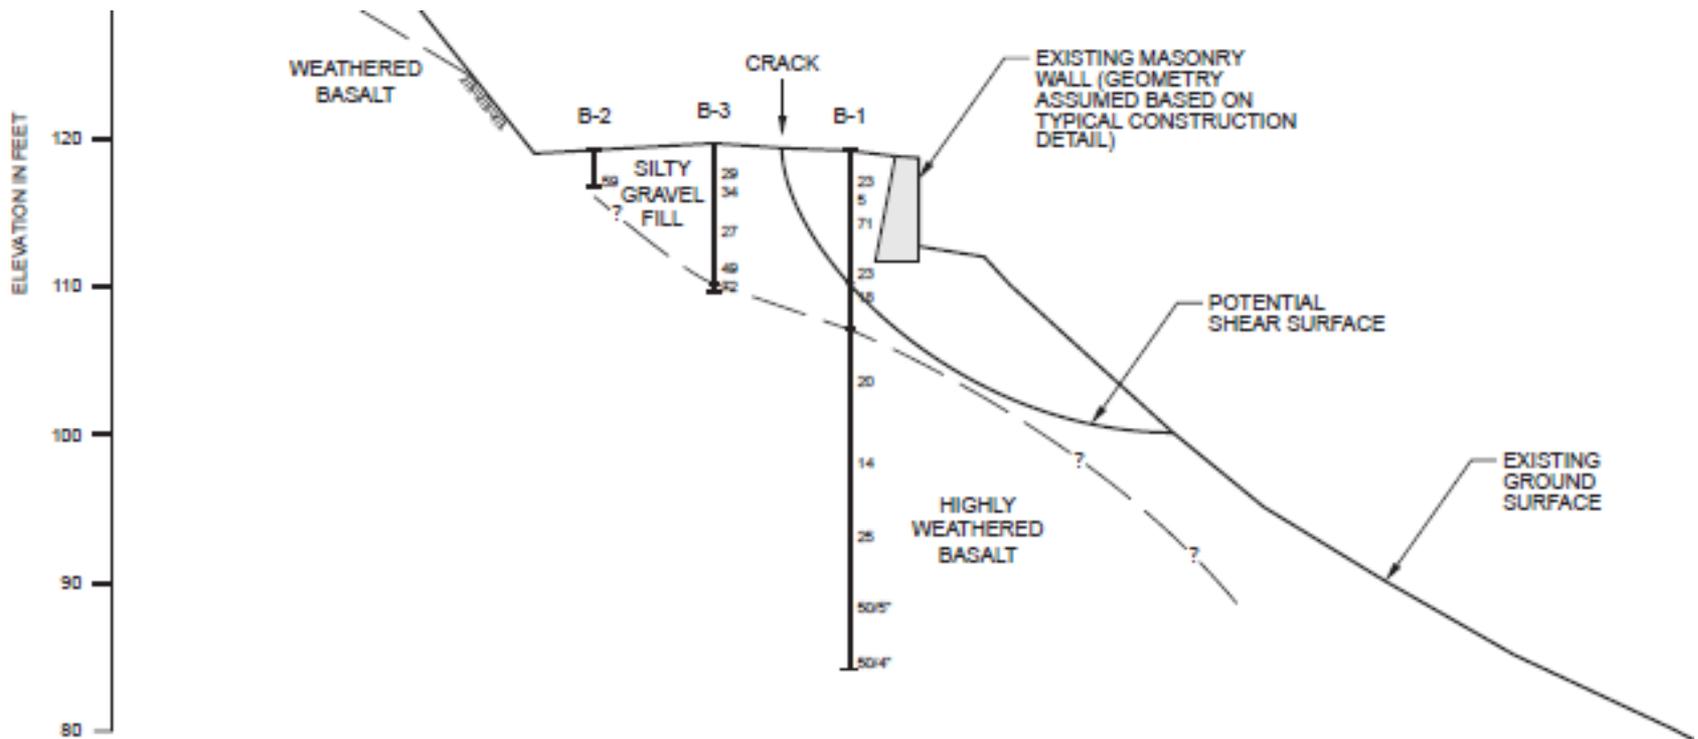
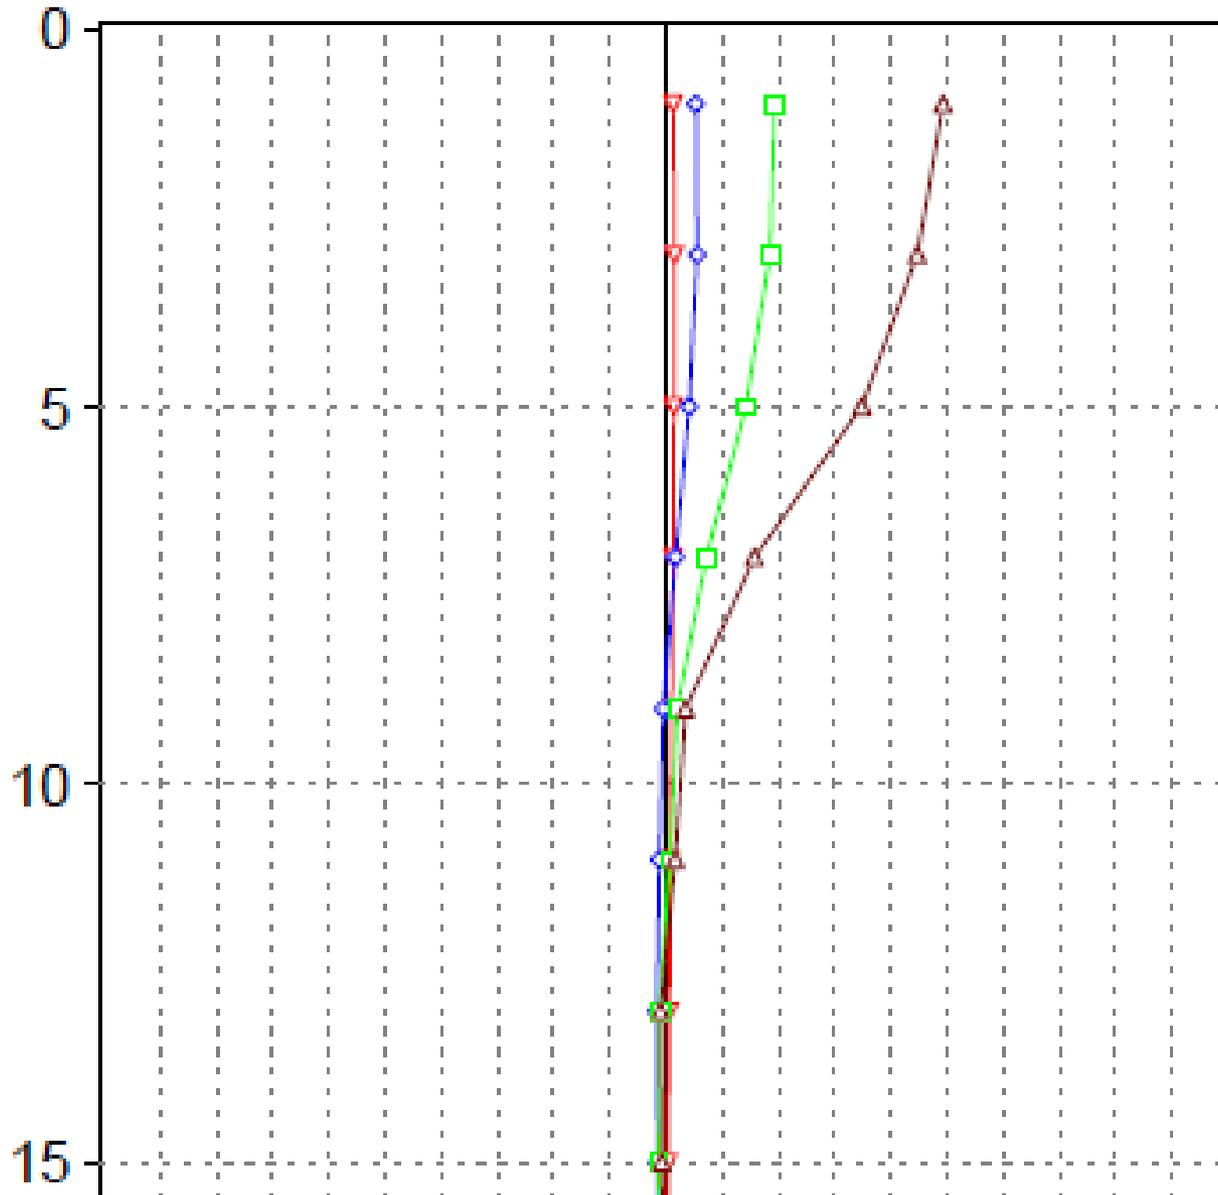
# Landslide Slip Failure

**Soil  
Movement  
Below  
Roadway:**

**November**

**December**

**February**

**April**

**Half Inch  
movement in  
Spring 2011**

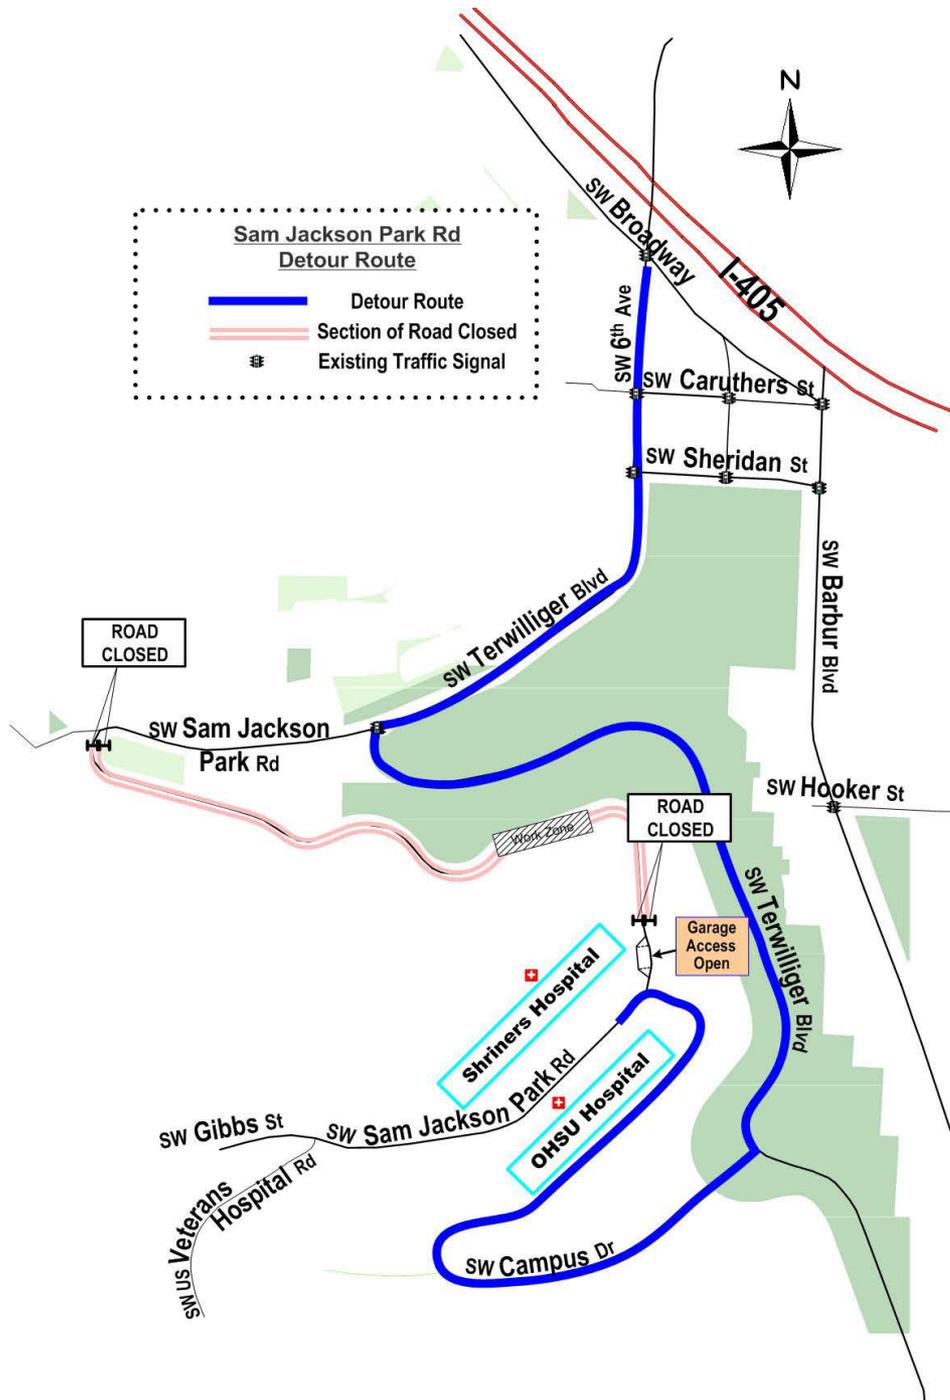
# Detour Plan

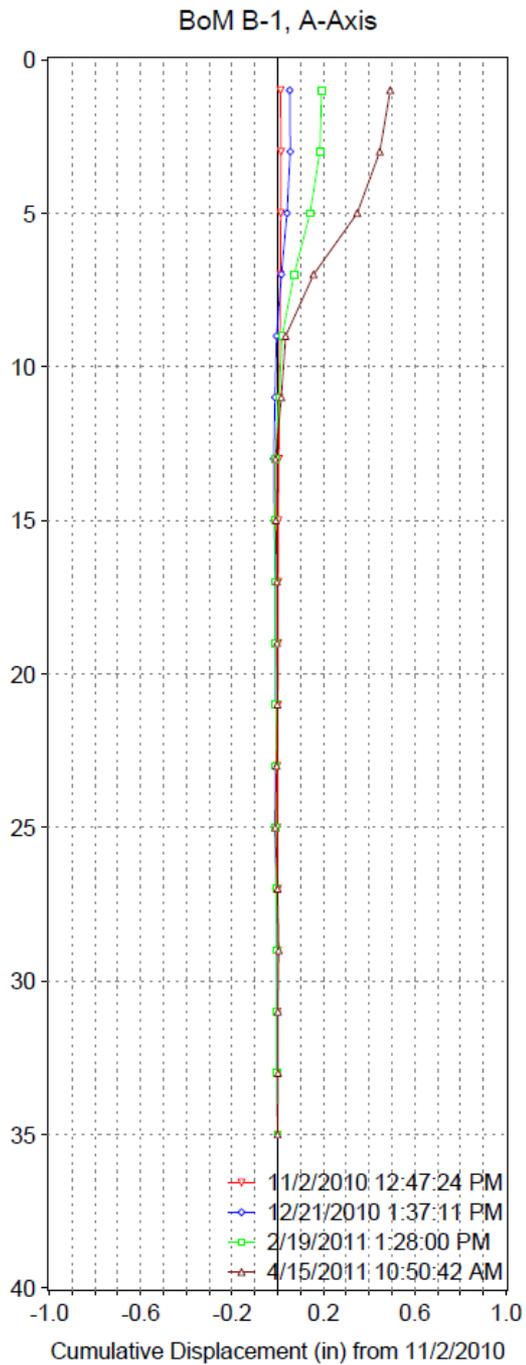
**Soil Lateral  
Movement**

**Nov – April 2011**
