Central City Potential Swimming Beach Sites Study

PORTLAND OR | OCTOBER 5, 2016

Mayer/Reed, Inc.

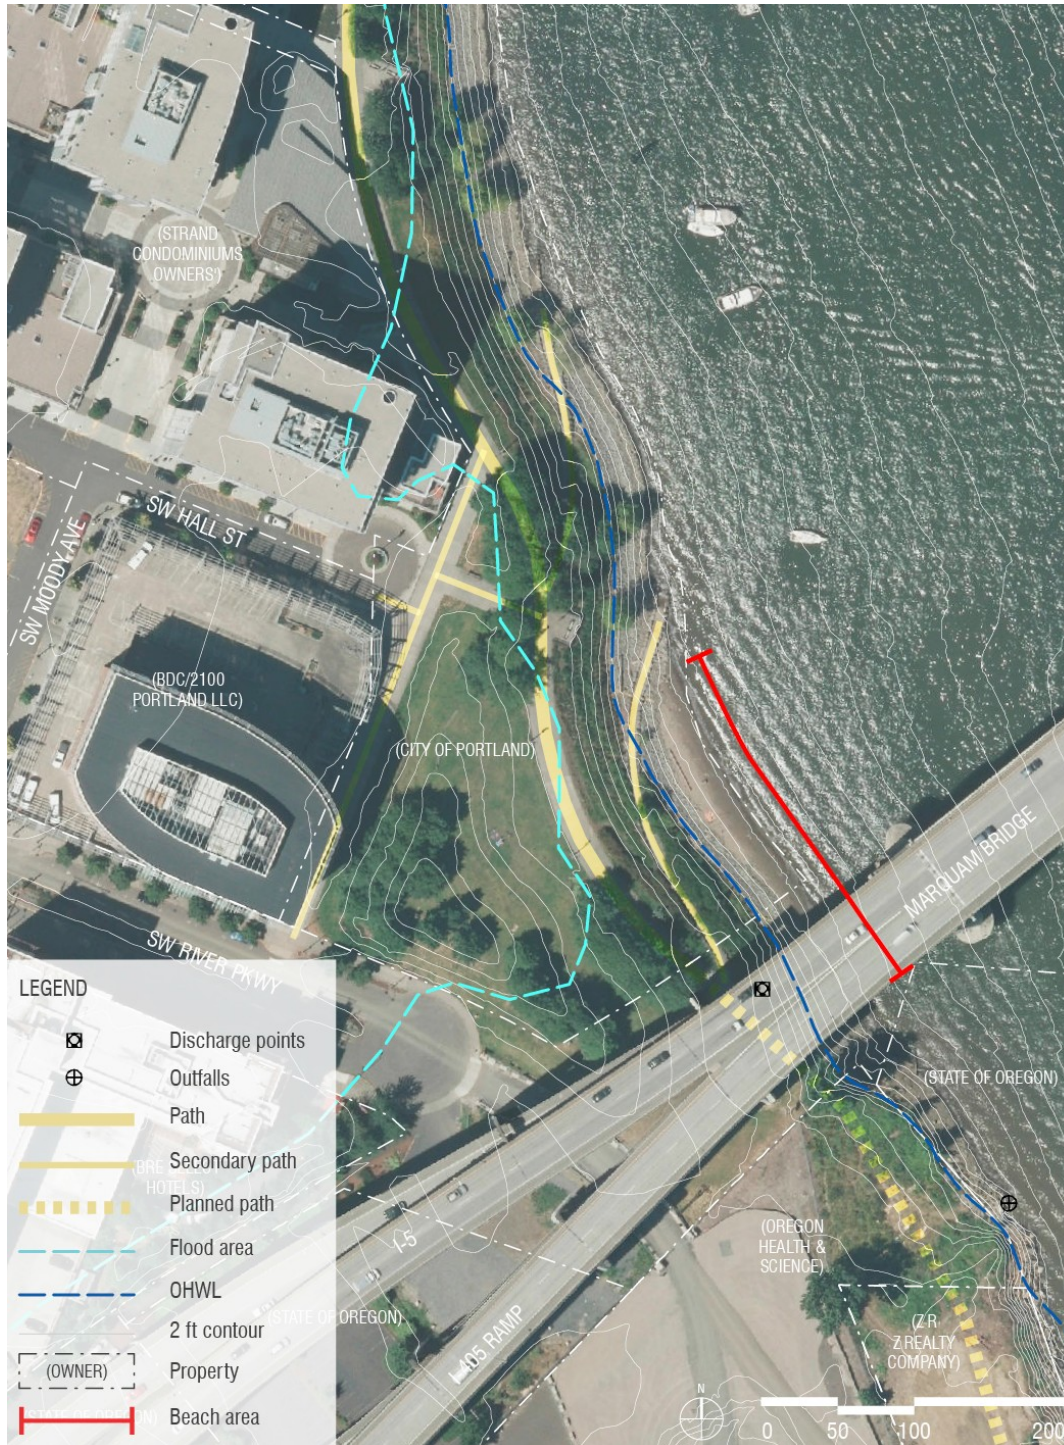
Located under the Marquam Bridge on the river’s west side is a site unofficially termed “Poetry at the Beach.” This public property at the current terminus of the Willamette Greenway Trail has an improved viewpoint overlooking the river and two paved pathways down to the water. Cleared of riprap, the southern path provides access to a naturally-occurring sandy beach. Approximately 15 ft. of riprap and 45 ft. of steep riparian planting zone separate the beach from the trail.

* Flood Area is based on 100-year flood line

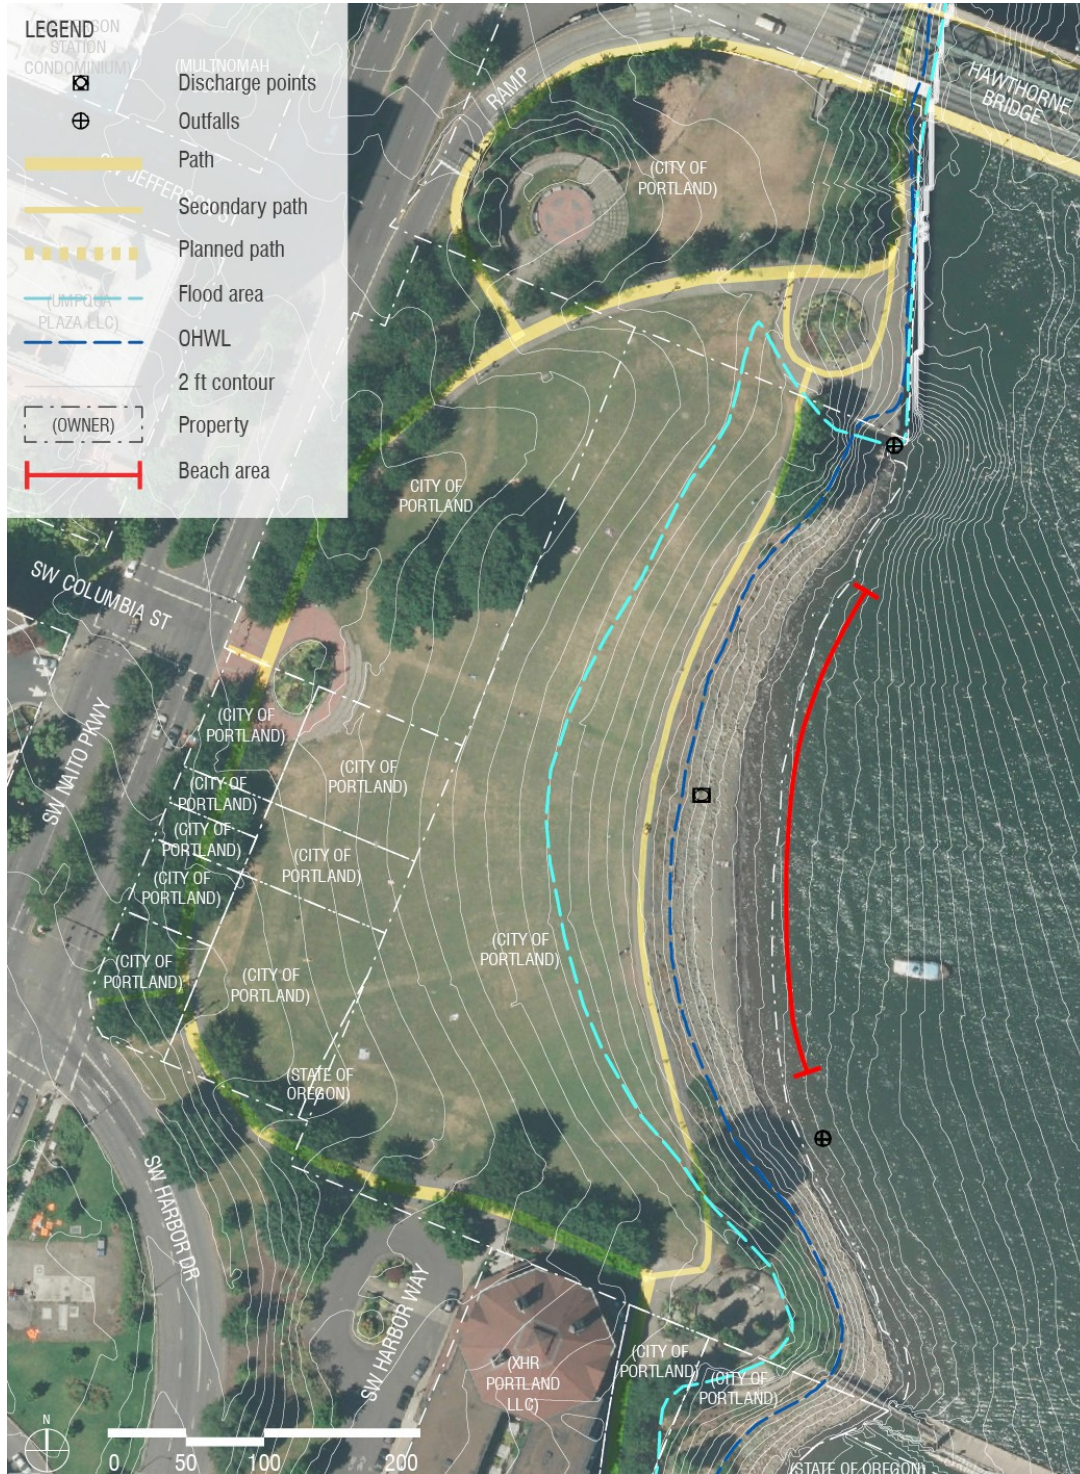
This site is located within Governor Tom McCall Waterfront Park south of the Hawthorne bridge. Access to the beach is provided by an existing eroded pathway at the top of the bank. A large sloping lawn extends west of the waterfront and hosts many events during the summer months. Observation points overlook the river at the north and the south ends.

* Flood Area is based on 1996 flood line

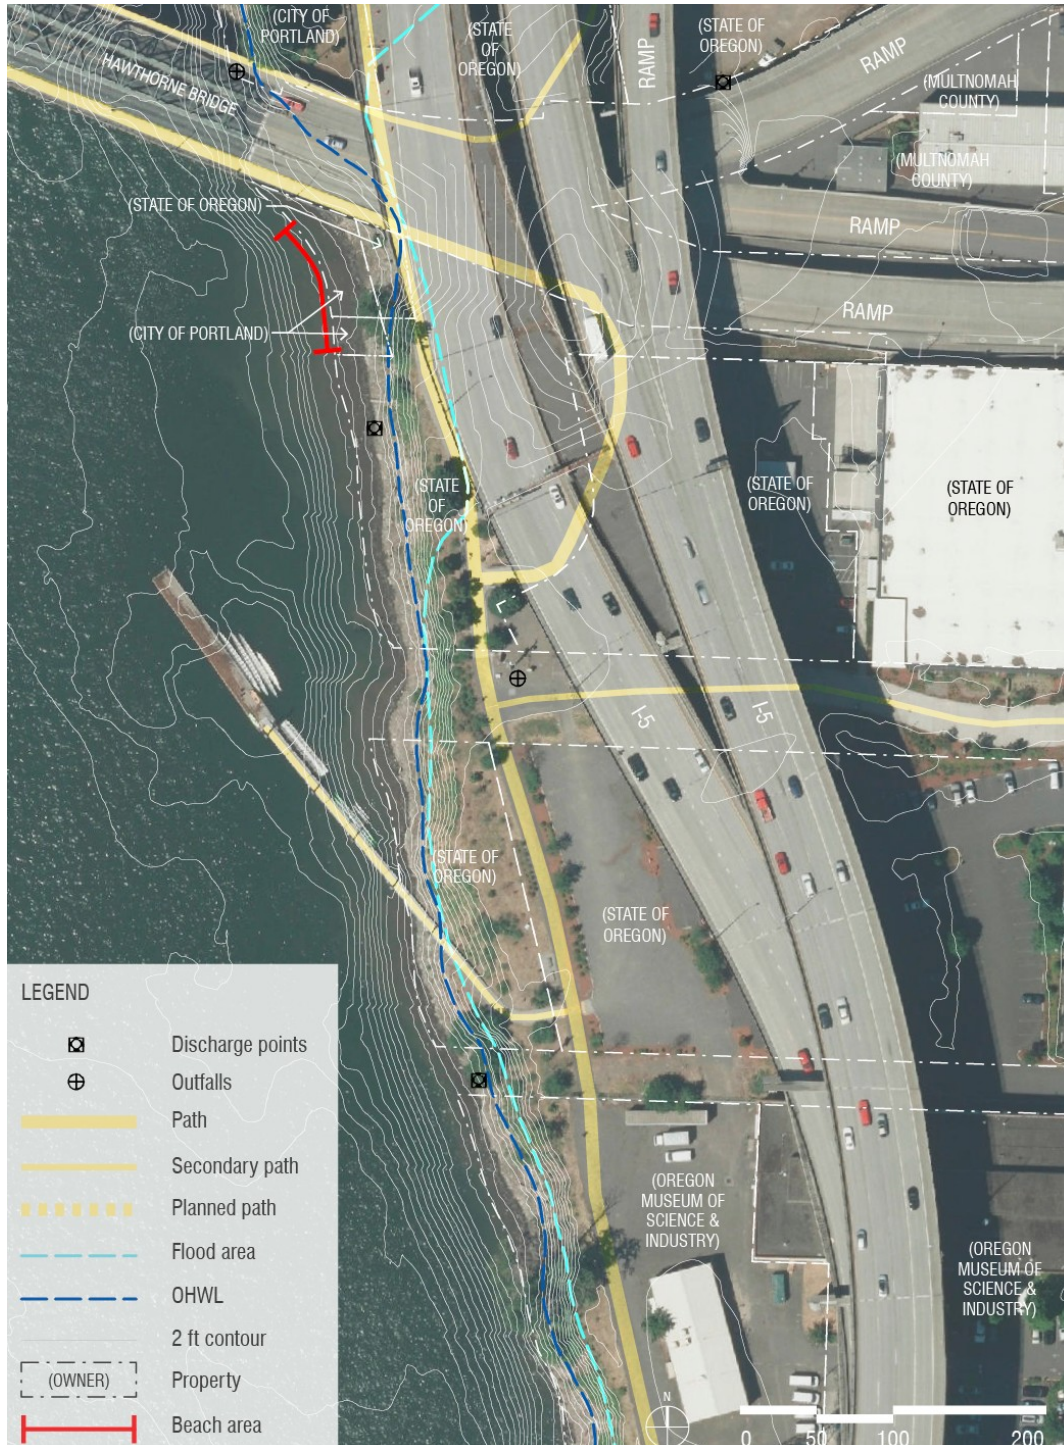
This site is located on the east side of the river at the south end of the Hawthorne Bridge next to the Vera Katz Eastbank Esplanade. Access is possible over an unimproved steep dirt slope down to the water beneath the bridge. The well-used Holman Dock to the south is intended for light water craft, kayakers and crew teams but has become a popular hangout for sun bathers and swimmers on hot summer days resulting in a conflict of uses.

* Flood Area is based on 1996 flood line

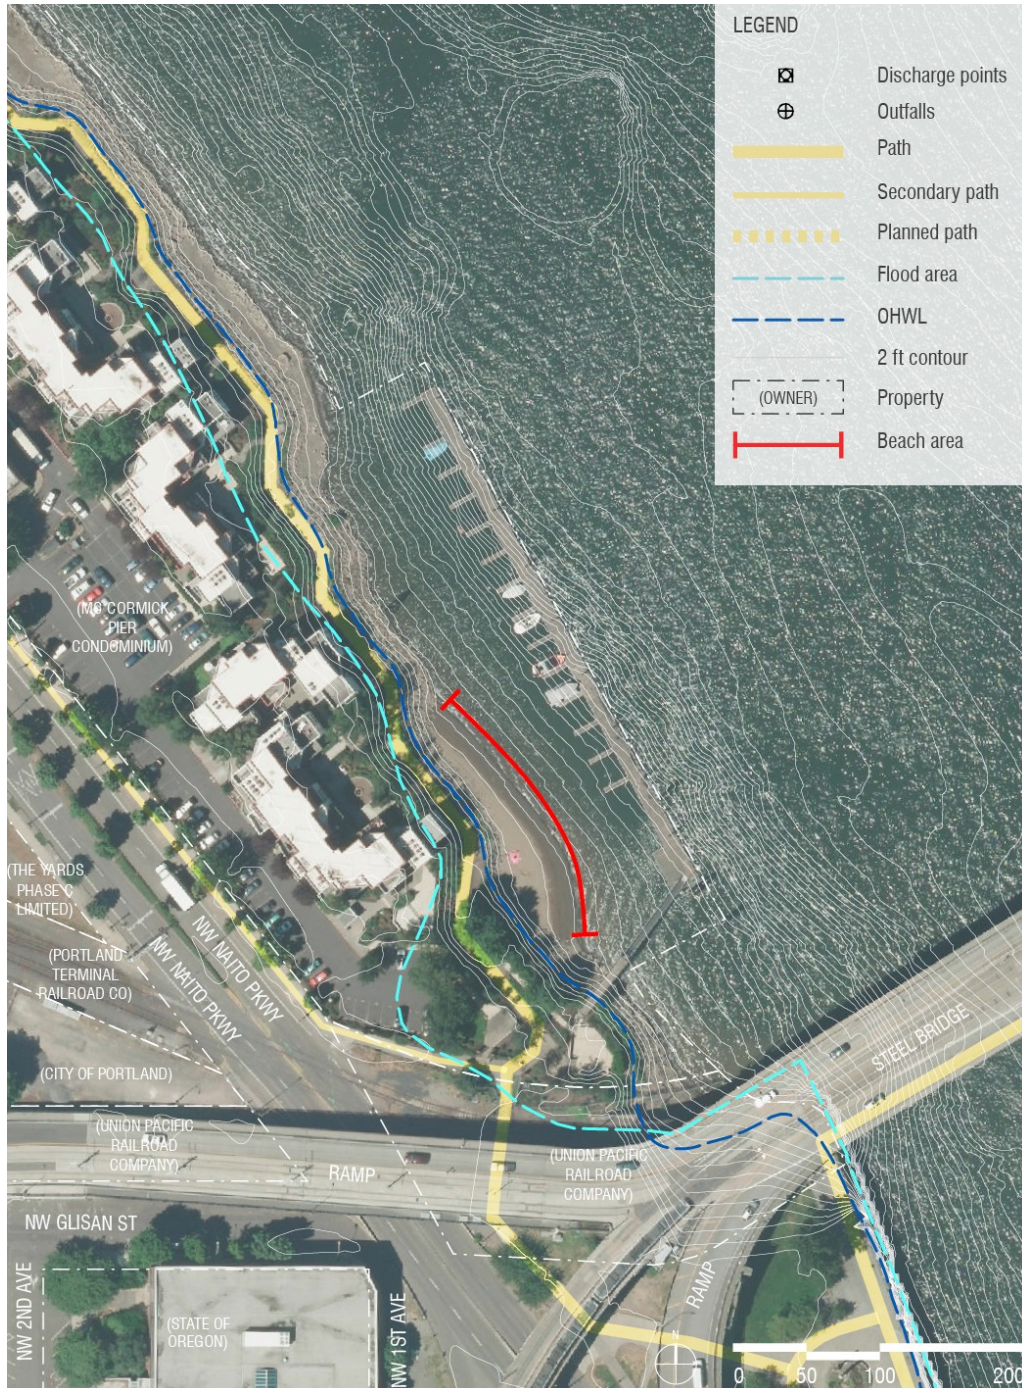
An existing unimproved beach is located north of the Steel Bridge on the river's west side. The beach and the surrounding area are privately owned by the McCormick Pier Condominiums. A segment of the Willamette Greenway Trail is located on an easement through the private property. Approximately 15 ft. of riprap separates the beach from the trail. A rough, steep desire path to the beach has been cleared of riprap. A gated pier for private boat parking is northeast of the beach.

* Flood Area is based on 1996 flood line

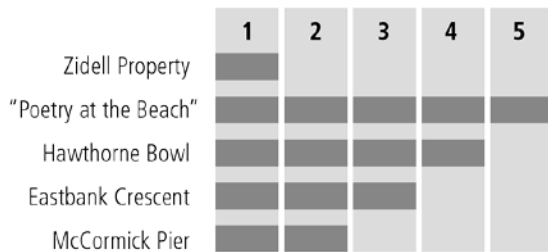
Gradual Bank Slopes for Wading Ranking Diagram

Recommended Standards for Bathing Beaches note that for depths up to 4 ft., the slope should not exceed 1:5, and at greater depths, should not exceed 1:3. River sites that meet these requirements in all conditions is unrealistic. When the 4 ft. depth at low water is combined with the seasonal water variation of at least 16 ft., the horizontal area needed to meet the requirement is between 60 ft. and 100 ft. of uniform beach. Beaches on the Willamette do not generally have a uniform slope over the entire section due to seasonal water variations. This particular criterion includes some subjective and generalized interpretations.

Zidell Property	This site is currently used for launching new barges on a rail system. The bargeway ramp shallowly slopes to prevent damage to the barge, and the rails extend into water several feet deep. However, the slope drops off quickly at this point because the current in the main river has not allowed filling to occur. Filling into the river to eliminate this drop off is possible; however, a large volume of material may be required to achieve an acceptable underwater slope. It would also require sufficient underwater armor of riprap or other material to resist continual erosion. Cutting back the shoreline to create a shallower submerged slope is possible, however it could potentially affect the brownfield sediment cap issues (see Site Remediation, page 25).
"Poetry at the Beach"	While not specifically designed for public access, this beach has slowly formed ideal underwater conditions of a moderately gentle beach entering the river with generally flattened slope. This allows entry to the water and wading into deeper water over a sandy bottom.

Hawthorne Bowl	The slope and depth in the river appear to be generally favorable to wading and the gradient generally gets flatter as one enters the water. However, at some point, the riverbed does fall away into much deeper water.
Eastbank Crescent	A limited area of shallow underwater riverbed exists adjacent to the site; however, these grades will be extensively changed by a future brownfield sediment capping project. These changes to the underwater contours could significantly impact the existing wading conditions. Selection of the cap material will impact the walking

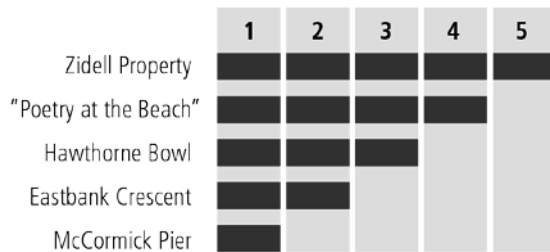
Limited User Conflicts Ranking Diagram

If the beach was to be made accessible to the public, the main user conflict at the beach is with the private boat dock. This dock parallels the beach and ranges from 45-65 ft. from the average high water elevation of 10 ft. during mid to late summer. This narrow swimming area, although protected from the large navigational channel by the dock, is heavily used by private motorized boats. User conflicts could arise with swimmers as motorized boats head to and from the dock. Keeping swimmers and sun bathers off the private dock could become an issue as well. Additionally, light watercraft launching at this narrow swimming area could present some user conflicts with the motorized boats and with the swimmers.

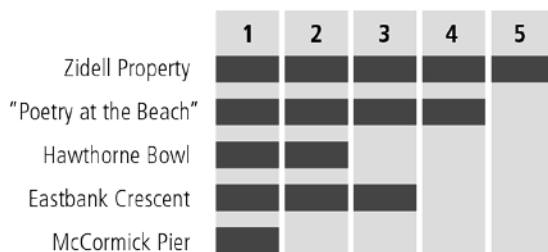
Gentle Beach Slope Ranking Diagram

Zidell Property	The potential beach has a constant slope of approximately 8%.
“Poetry at the Beach”	The existing beach has a constant slope of approximately 8-10%.
Hawthorne Bowl	The existing beach has a constant slope of approximately 10-15%.
Eastbank Crescent	The existing beach slope varies along the water’s edge. The average slope is approximately 10%.
McCormick Pier	The existing beach has a constant slope of approximately 10-15%.

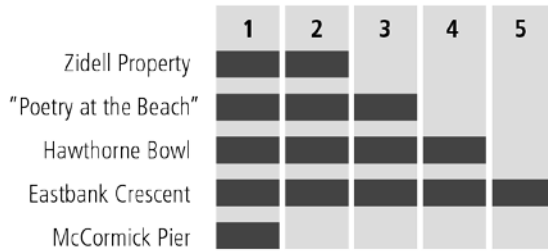
Available Parking / Transportation Ranking Diagram

Residential apartments and condominium units are within close walking distance to the beach along the Willamette Greenway Trail. The residential units are located directly to the west and northwest of the beach with the nearest residential unit approximately 50 ft. away. Additionally, the Old Town/China Town and greater Pearl District areas anticipate more urban residents over time.

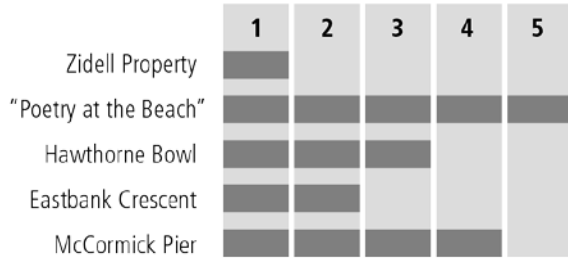
Beach Surface Materials Ranking Diagram

Zidell Property	The existing barge ways are covered by a large gravel cap over existing sediment and rock. This surface is only walkable with footwear. The bargeways are steel beams supported on multiple piling below the surface. The surface will need improvement.
"Poetry at the Beach"	The river sand on the beach was imported from the Columbia River when park improvements were installed in 1999 and are still generally free of debris and rock. This beach has experienced some erosion over the years, but is generally stable. Limited debris has been observed in this area, other than large rocks thrown in by users.
Hawthorne Bowl	This beach is composed of naturally accumulating gravels and some imported fine material that has migrated down from the upper bank protection. Public access was not originally anticipated at this area and riprap was likely placed from the top of slope into the river. Through the years, sands and gravels have accumulated and people have moved and relocated the existing rocks.

Eastbank Crescent	This beach is composed of naturally accumulating gravels and sands. This is likely caused by the slowing of flow by the bridge constriction which allows suspended materials to drop out of transport by the river. Debris and rocks are present below the water surface. These conditions will change with the future PGE contamination cap work. The surface may need imported river sands or fine gravels.

Beach surface material is naturally occurring fine river sand. The sand is barefoot friendly and has accumulated downstream of the bridge constriction. An existing marina likely shields the shore from erosion and encourages sand accumulation. Limited debris has been observed.
