Subject: **Annual CSO and CMOM Report, FY 2017**  
Columbia Boulevard Wastewater Treatment Plant NPDES Permit #101505

# Annual CSO and CMOM Report FY 2017

Required by NPDES Permit #101505  
for CBWTP and CSO Systems

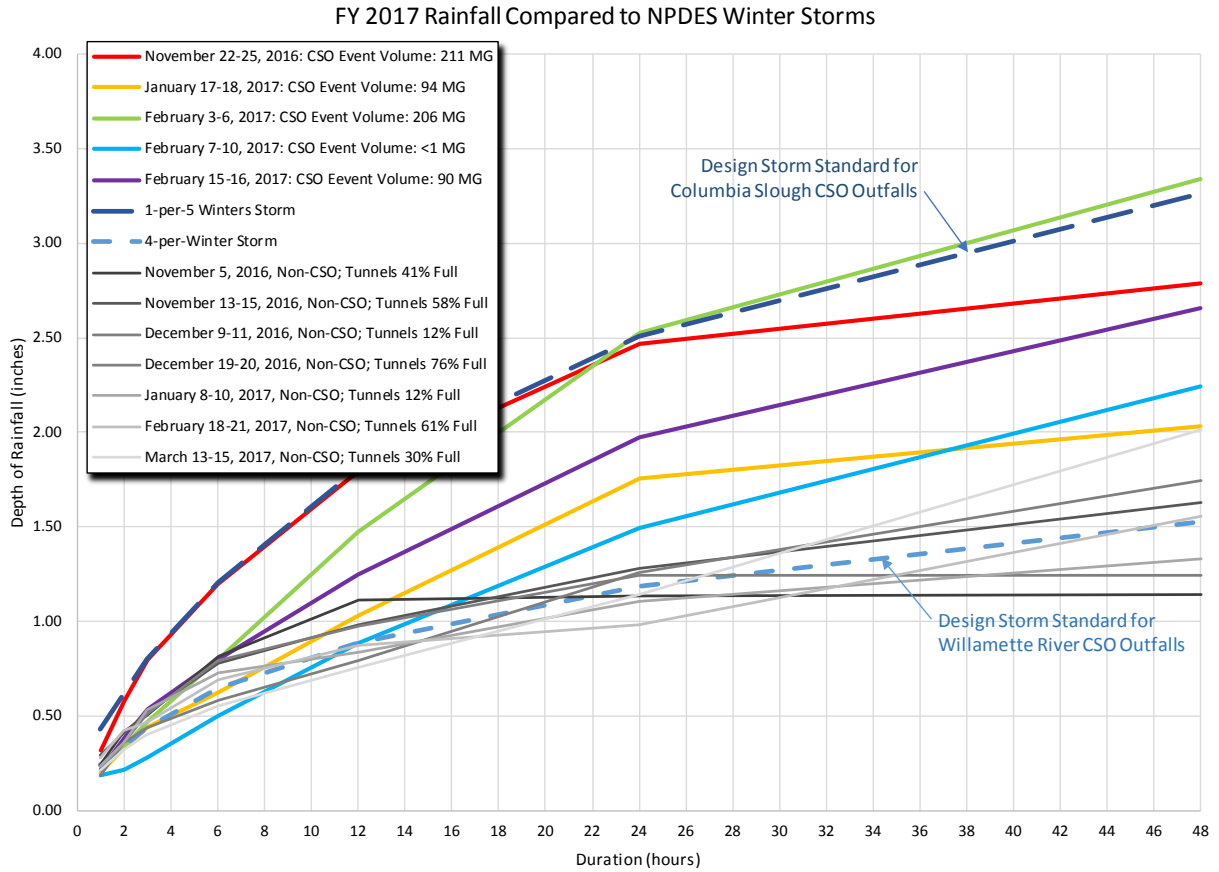
Figure 1 FY 2017 CSO Winter Storms Compared to NPDES Winter Storms

The five winter storms that caused CSO discharges and exceeded the 4-per-winter NPDES Permit thresholds are shown graphically in Figure 1 below. This graph is a “Depth-Duration” chart that displays the maximum depth of rainfall that occurred for the range of storm duration, from 1-hour to 48- hours. The five events that caused CSO to occur are shown with solid colored lines. The five CSO events are compared to the two NPDES Winter Design Storms (4-per-winter and 5-year winter) shown with blue-tinted dashed lines. The seven storms that exceeded the 4-per-winter design storm but did not result in CSOs are shown in gray.

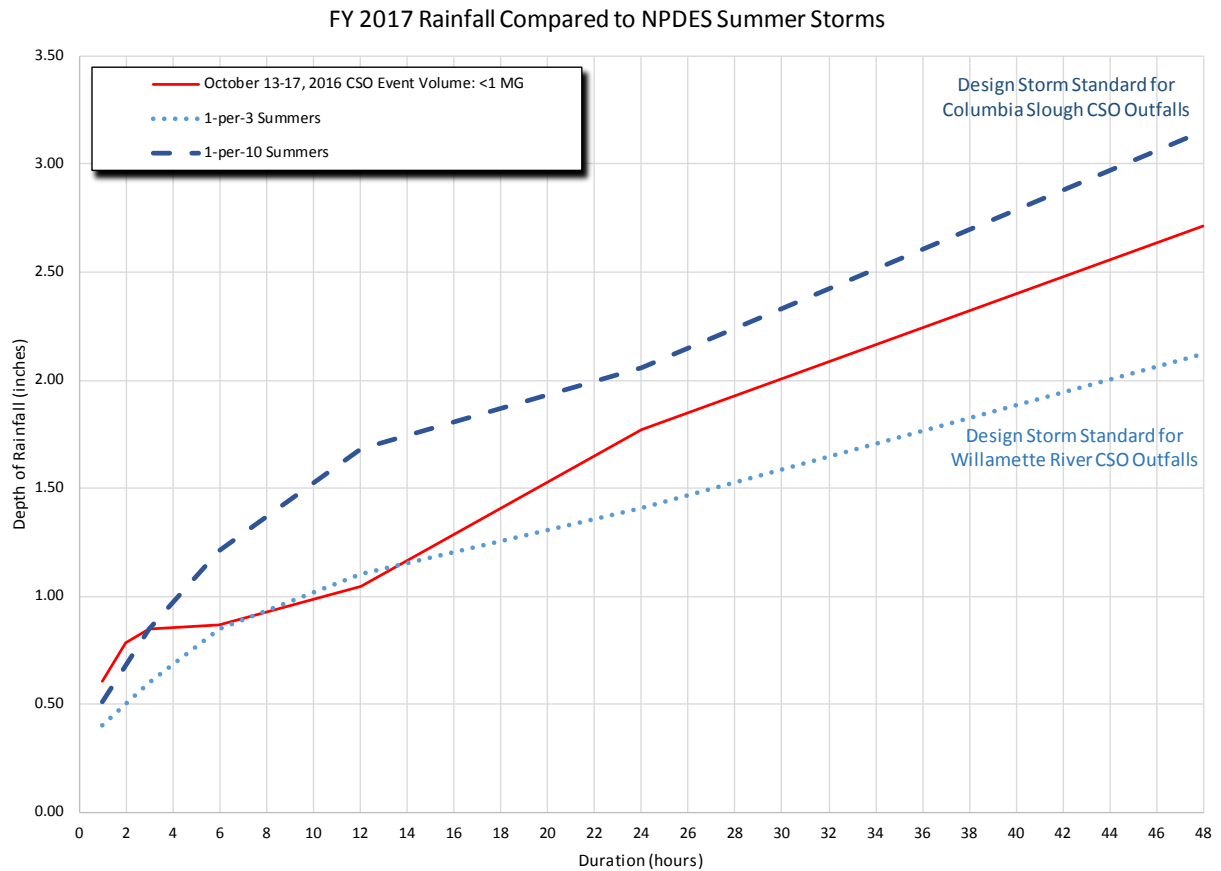
Figure 2 FY 2017 Rainfall Compared to NPDES Summer Storms

Two summer storms exceeded the NPDES Permit 3-year Summer Storm. The October 13-17, 2016, storm is shown graphically in the Depth-Duration chart in Figure 2 below. The event is shown with a red line. The two comparison Summer Design Storms (3-year summer and 10-year summer) are shown with blue-tinted lines. Table 2 provides rainfall details for this event. This storm was a classic atmospheric river winter storm that happened to start at the end of the summer season.

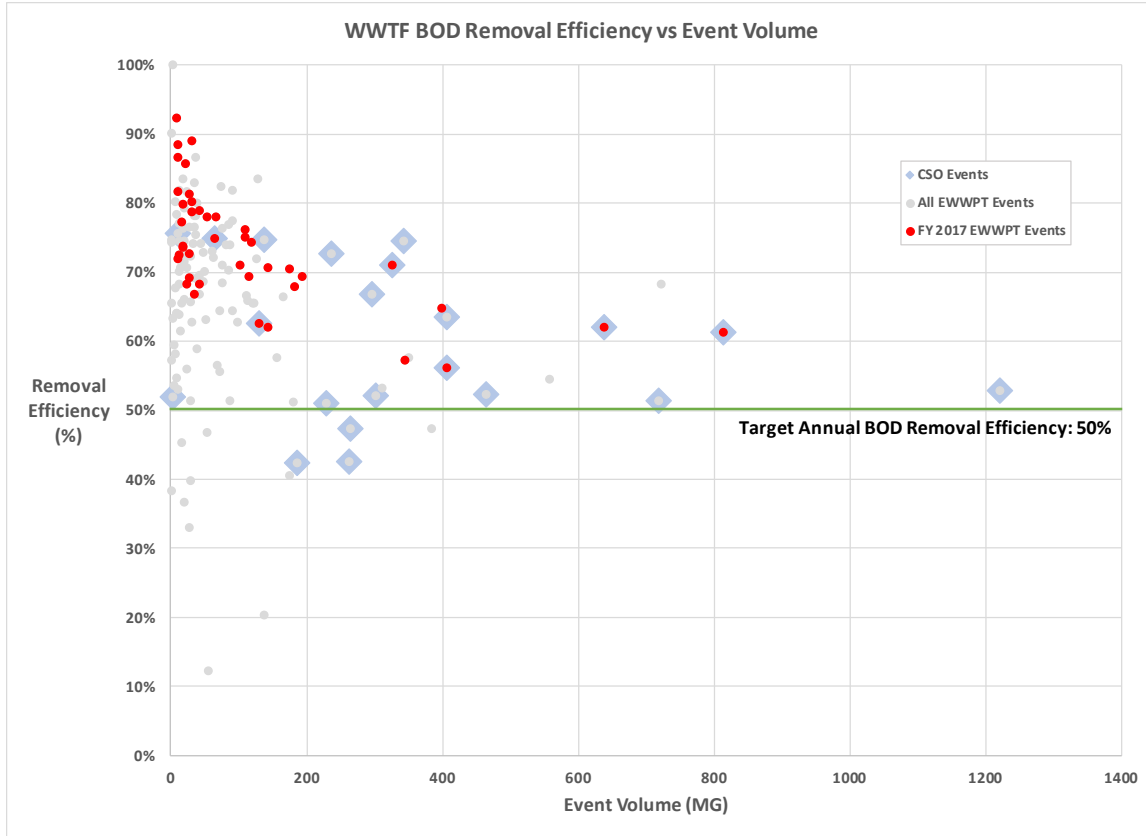
Figure 4 WWTF BOD Removal Efficiency vs. Event Volume

BOD and TSS removal efficiencies compared to event volume are shown in Figure 4 (BOD) and Figure 5 (TSS). Small events tend to have higher BOD and TSS concentrations, and larger volume events have lower concentrations. The CEPT system achieves better than 50% BOD and 70% TSS removal efficiencies on an overall basis. For the first time since CEPT was instituted, all wet weather events this fiscal year placed above the target efficiencies, as seen on the charts.

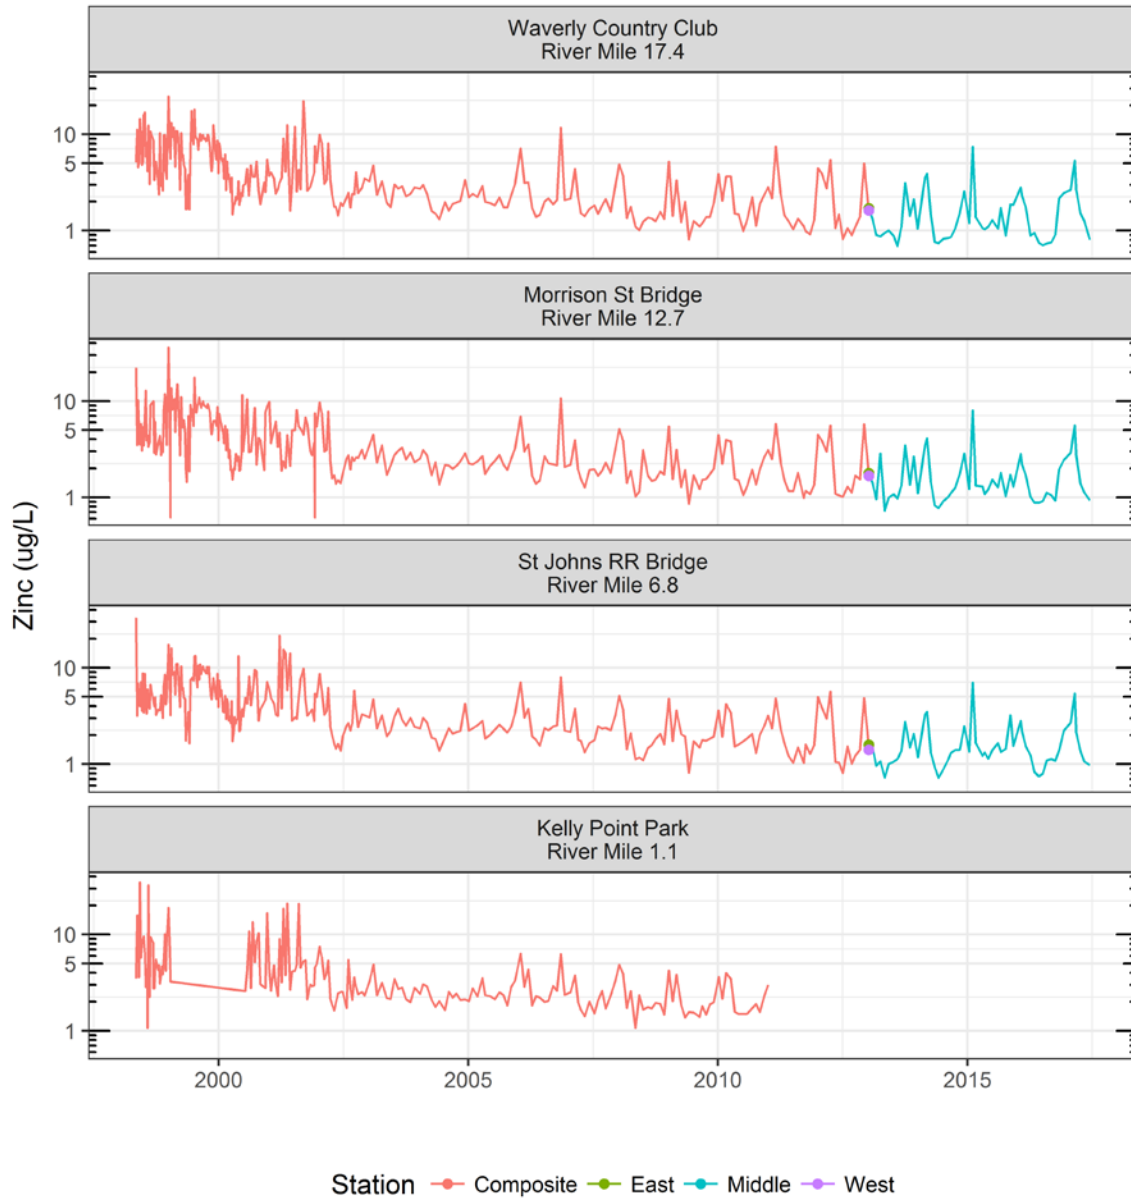
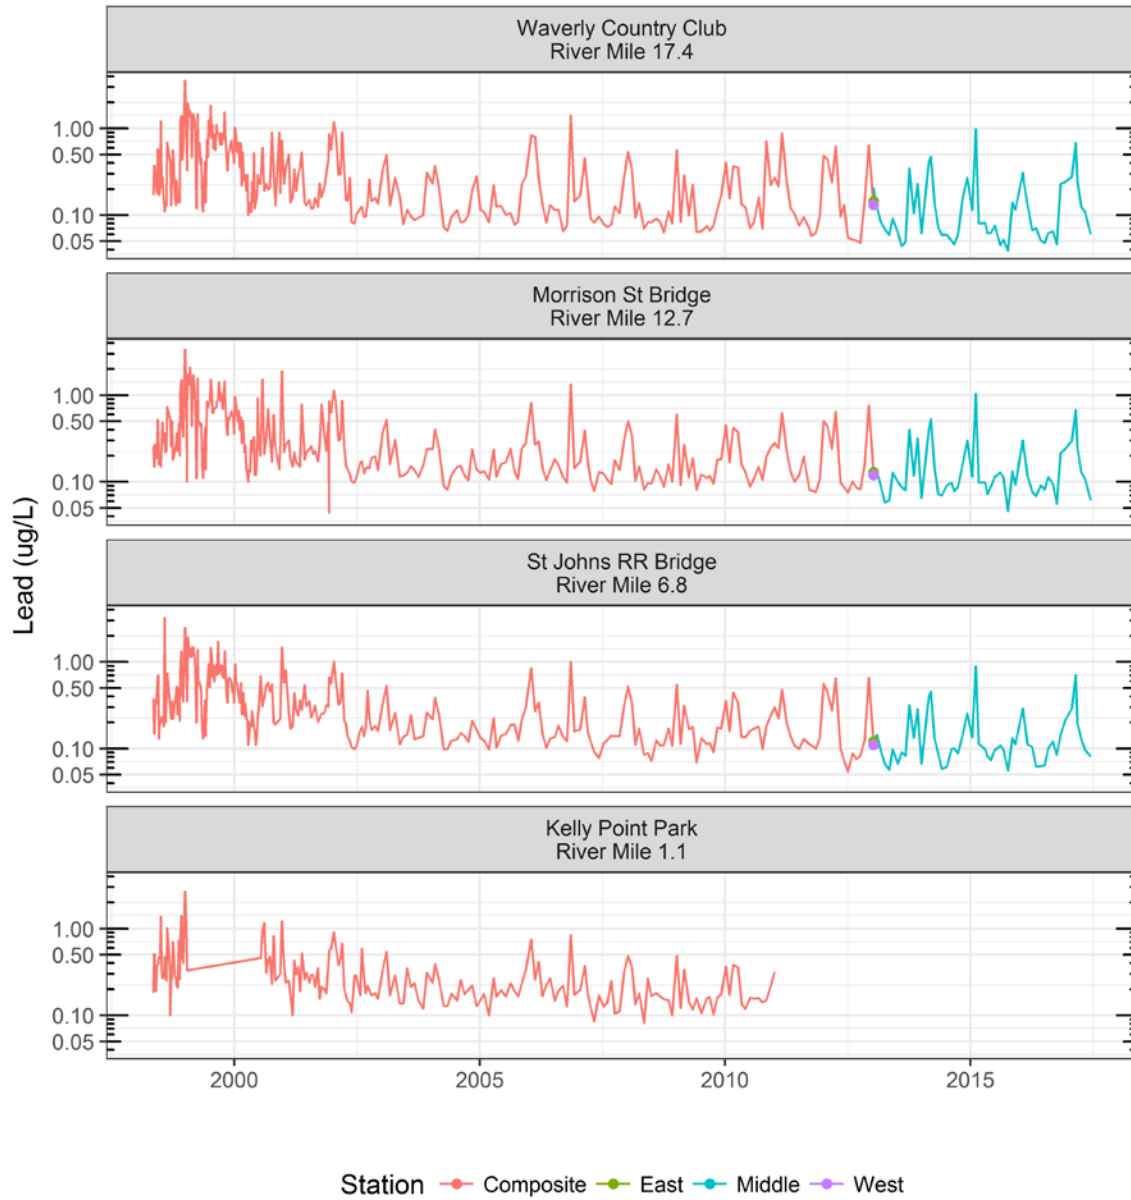
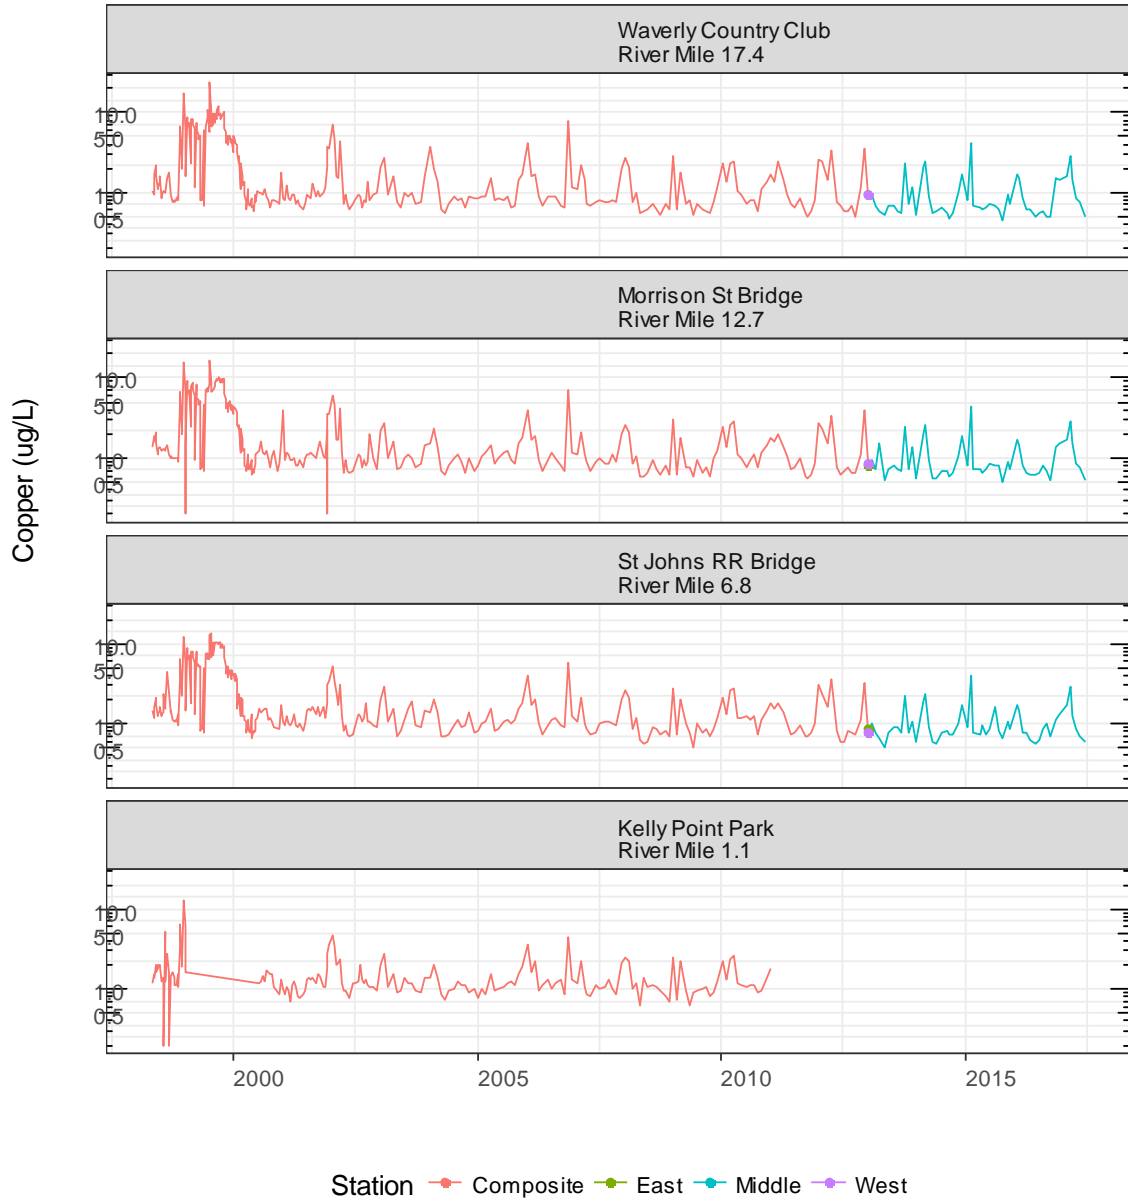
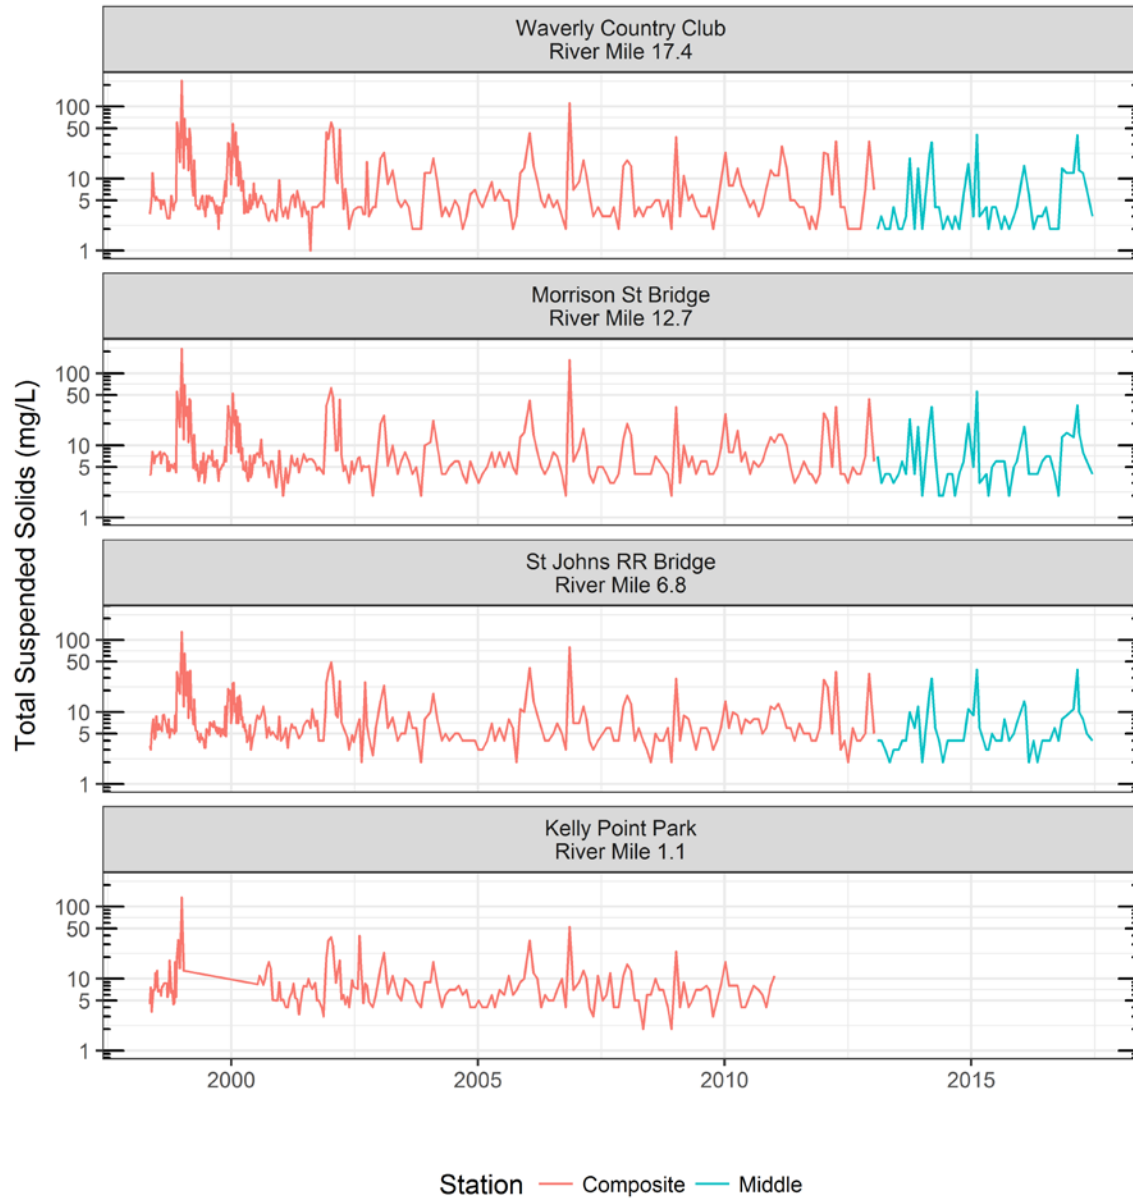
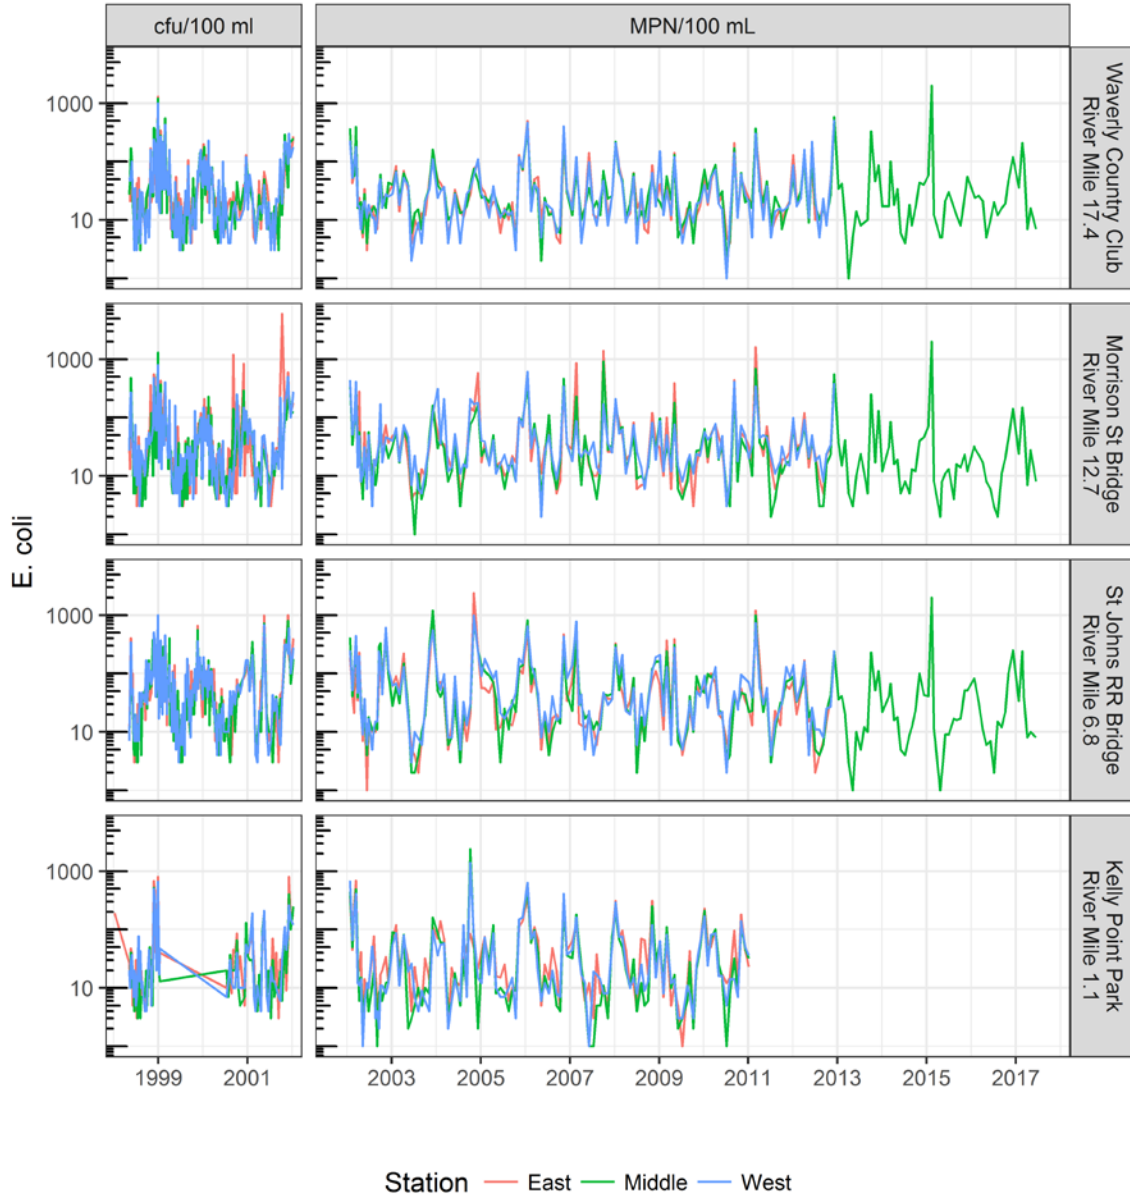
Figure 6 through Figure 10 show the water quality trends along the Portland stretch of the Willamette River for five parameters: zinc, lead, copper, TSS, and *E. coli*. These metals and bacteria parameters are the pollutants of concern for Portland CSO discharges. The sampling results indicate similar performance to FY 2016 and prior.

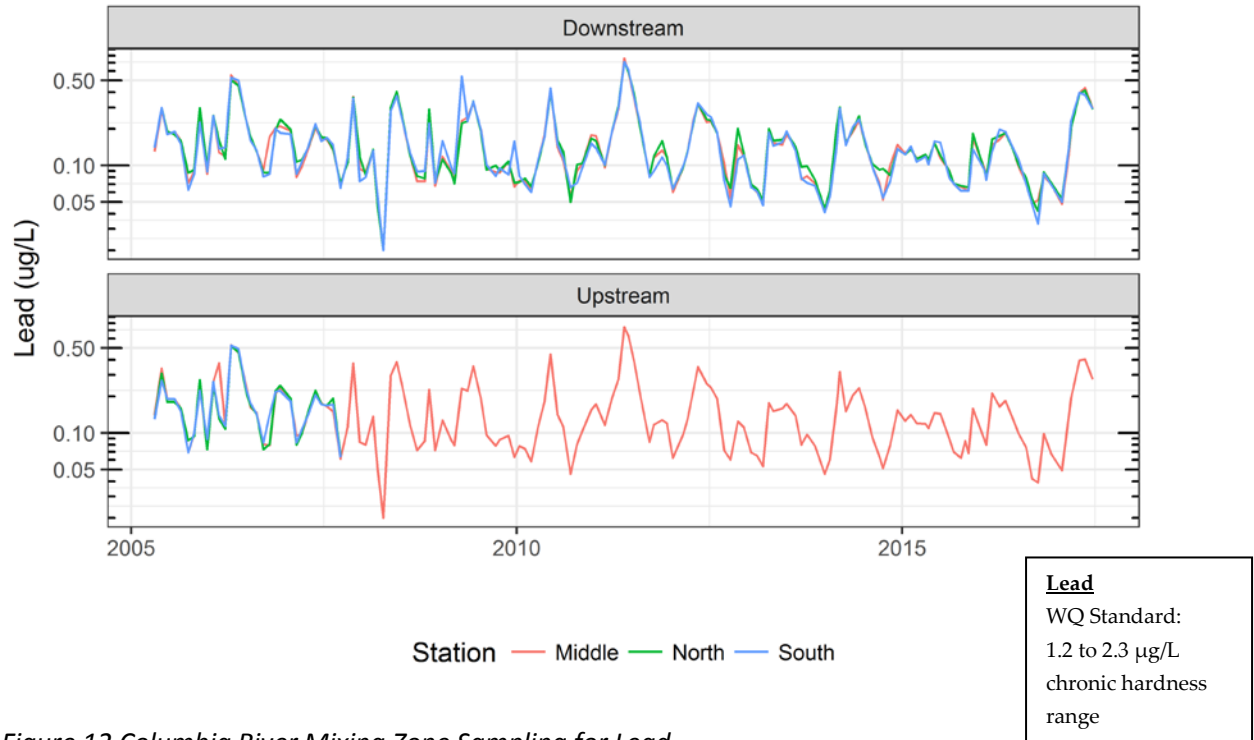
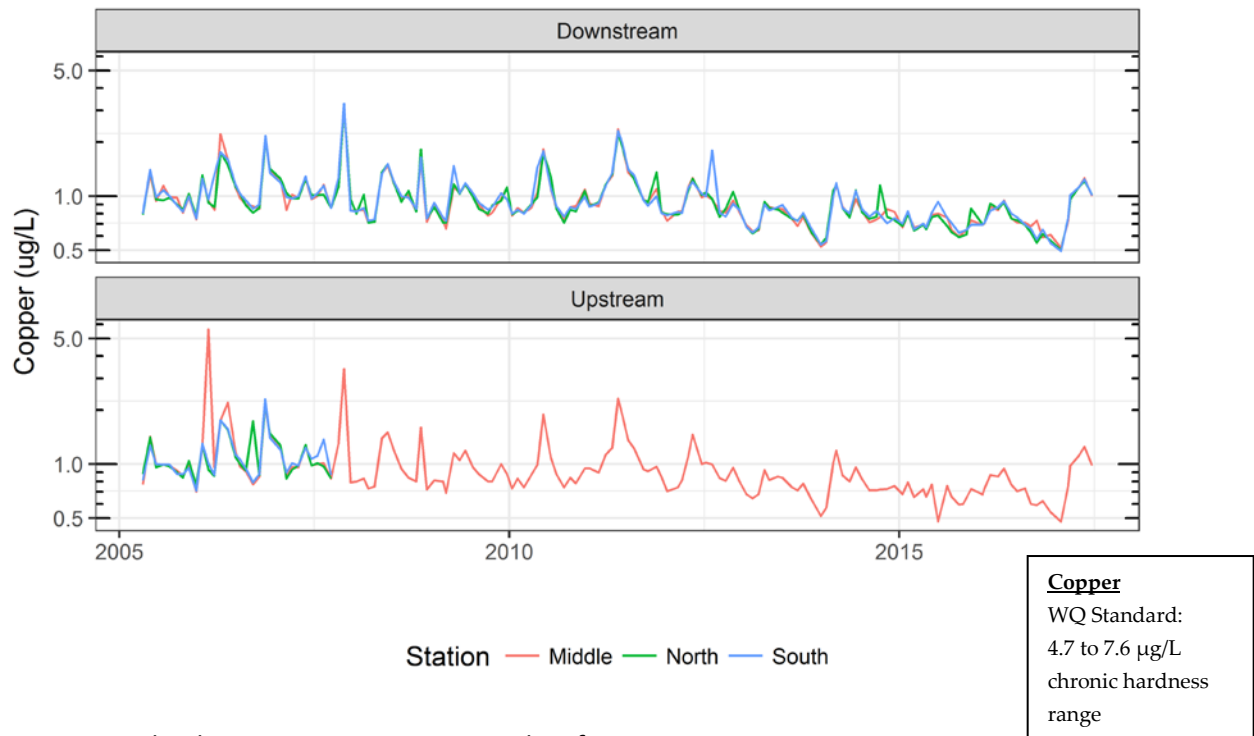
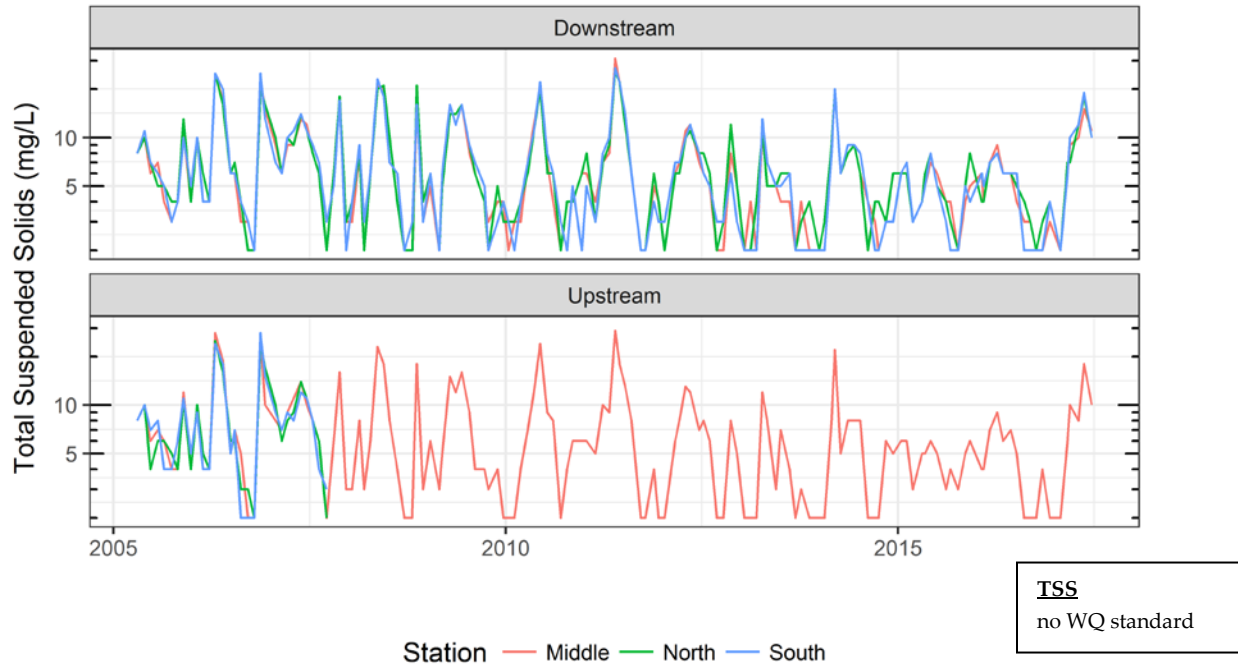
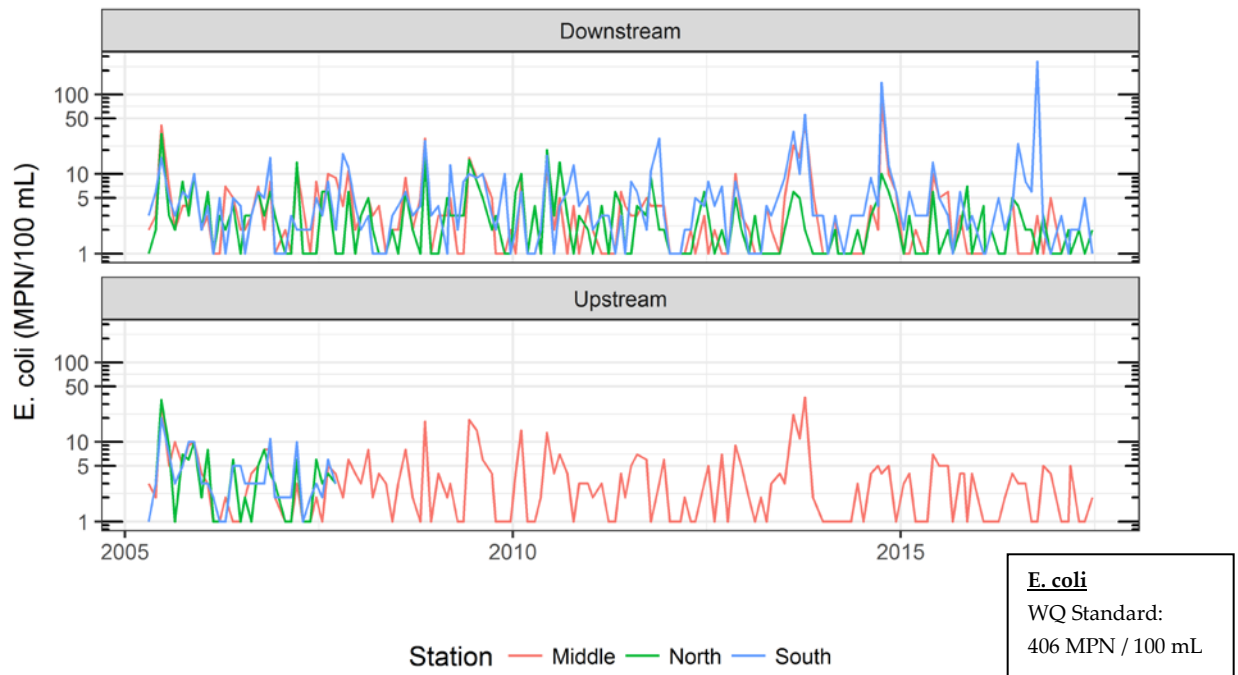
78. The charts show the reasonable range of chronic standards based on the hardness values measured in the river during the sampling period.

All parameters are well within the numeric water quality standards. There is little difference between the upstream and downstream measurements.

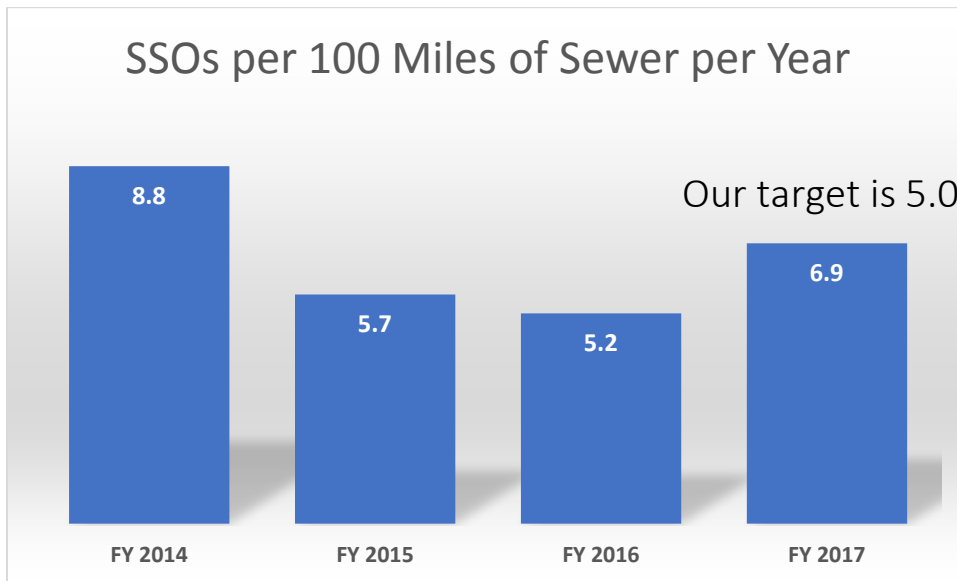
Figure 17 SSOs per Mile of Sewer

As of the end of FY 2017, BES owned and maintained approximately 1,914 miles of main line sanitary and combined sewers, and 683 miles of sewer laterals. The City is typically responsible for maintaining the portion of the service lateral extending from the main sewer to the curb. During FY 2017, the City experienced 180 sewer releases over the 2,597 miles of collection system, which is approximately 6.9 releases per 100 miles of sewer.

Sewer release data is updated by BES SPCR as more complete information becomes available and investigations are conducted, and thus totals in this report reflect current records and may not match previous years' reports and/or monthly discharge monitoring report submittals. A comparison with previous fiscal years is shown in Figure 17.

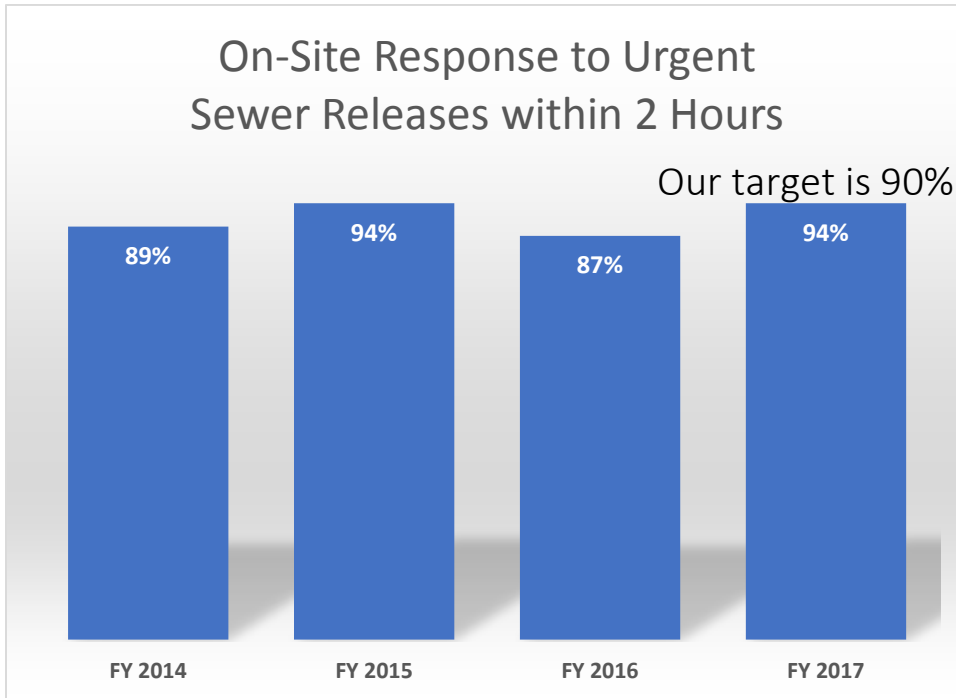
Figure 18 SSO Response Time Comparison

FY 2017	Number of Calls	Percent of Total
Total Urgent Calls Sewer Release Calls		
Urgent Calls with Response Time Less Than 2 Hours	434	94
Urgent Calls with Response Time 2 Hours or More	27	6
Total	461	100

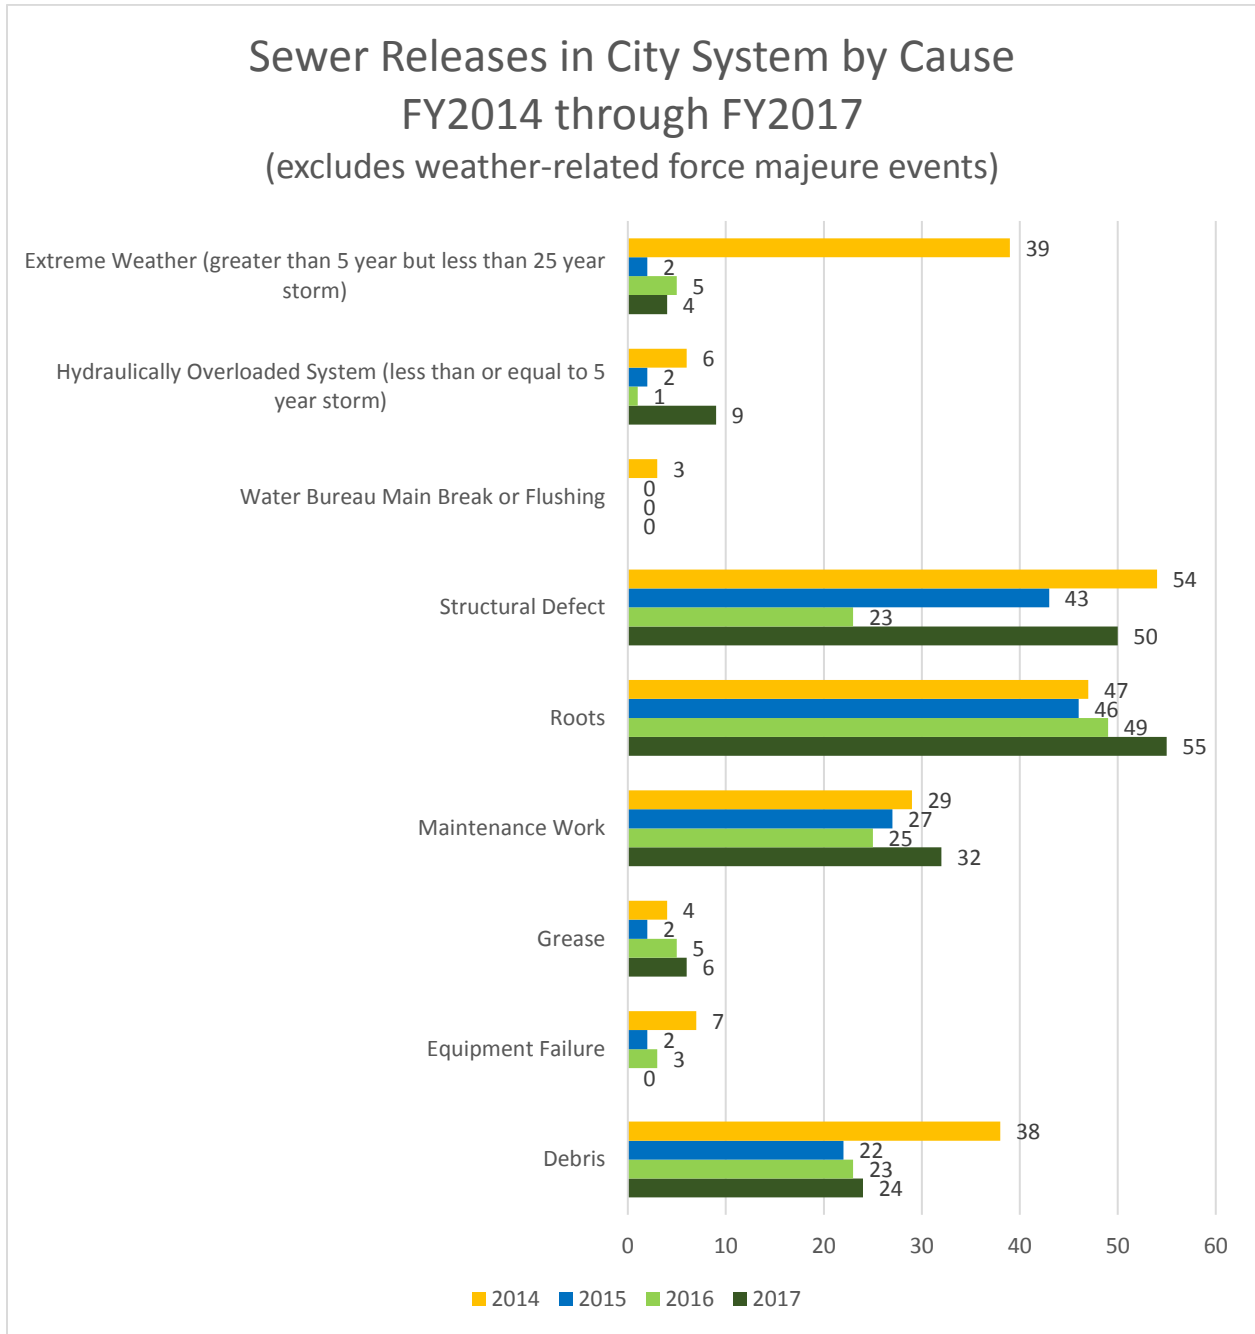
Figure 19 Comparison of Causes of Sewer Releases in FY 2014 through FY 2017

A chart comparing the causes of releases in FY 2014 through FY 2017 is shown in Figure 19. The release data shown are for releases due to problems in the City-maintained portion of the

**Structural Defects.** Releases due to structural defects increased in FY 2017, after trending downward in FY 2015 and 2016. There were 34 releases from structurally defective laterals, 15 from mainline sewers, and one from a manhole in FY 2017. As part of the City’s CIP sewer rehabilitation program, poor condition mainline sewers are identified for repair. The laterals connecting to those pipes are inspected during the design process and included for replacement or rehabilitation if structurally deficient. The risk of releases associated with structural defects should decrease as the large number of sewer repair, rehabilitation, and replacement CIP projects currently in design or under construction are completed.

**Maintenance.** In FY 2017, there were 32 releases associated with maintenance activities, compared to 29 in FY 2014, 27 in FY 2015, and 25 in FY 2016. Sixteen releases were associated with sewer cleaning operations; most of these releases were “bowl water” from toilets and the volume was less than 10 gallons (one of these releases was attributed to a BES contractor jetting a line during a sewer repair project). While precautions are taken to prevent these “blow back” occurrences, some private plumbing systems lack adequate venting and the configuration of some City sewers makes it very challenging for cleaning equipment operators to work in some locations. Special precautions, such as using cleaning nozzles with steeper jet angles and running lower pressures, are taken in areas prone to blow back.

**Debris.** There were 24 releases caused by debris in FY 2017, compared to 38 in FY 2014, 22 in FY 2015, and 23 in FY 2016. Severe winter storm flows typically carry debris into the combined sewer system, and the low number of debris-related releases appears to validate the effectiveness of the City's risk-based approach to sewer cleaning. This risk-based approach includes accelerated frequency of cleaning sewers that have a higher potential for sediment and debris accumulation. Additionally, BES has continued to conduct public outreach to try to minimize sewer backups and releases associated with disposable wipes and similar products.

**Roots.** During FY 2017, of the 55 releases caused by roots, 18 were in sewer mainlines and 37 were in service laterals. To reduce the risk of future root intrusion, City crews installed CIPP liners or excavated and replaced the majority of laterals where releases occurred in FY 2017.

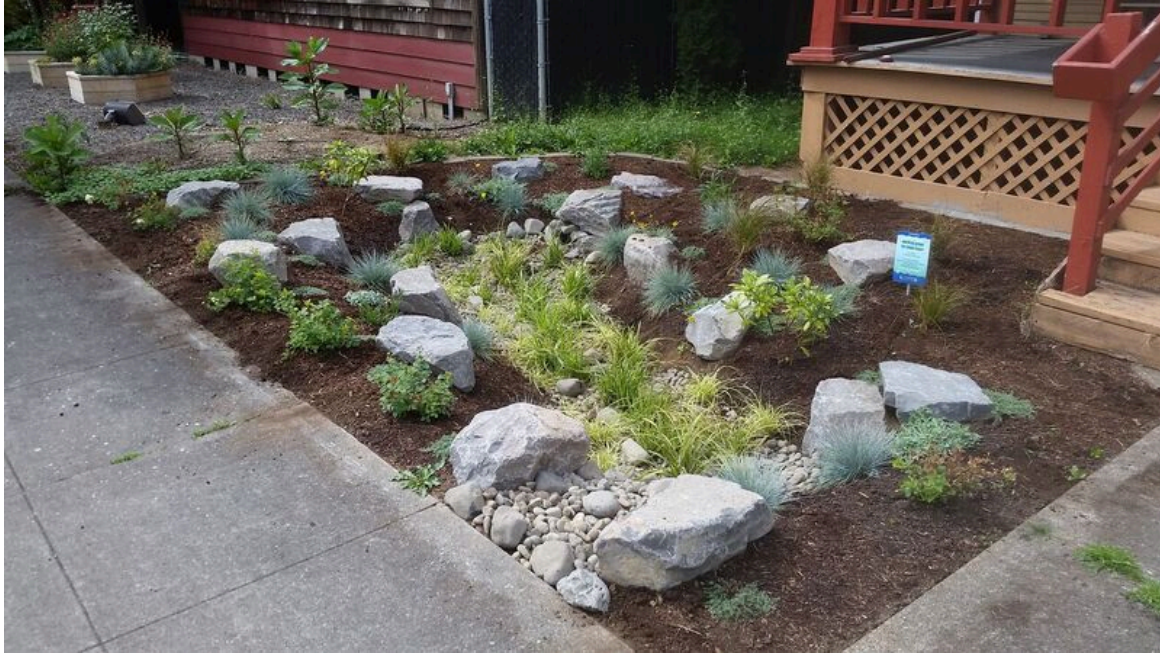
Figure 21 FY 2017 Example Retrofit #1

For FY 2017, 1.8 acres of impervious surfaces were managed by 59 private property stormwater retrofit projects. Two examples of this year's retrofits are shown in Figure 21 and Figure 22 below.
