Annual CSO and CMOM Report FY 2018

Annual CSO and CMOM Report

FY 2018

Required by NPDES Permit #101505
for CBWTP and CSO Systems

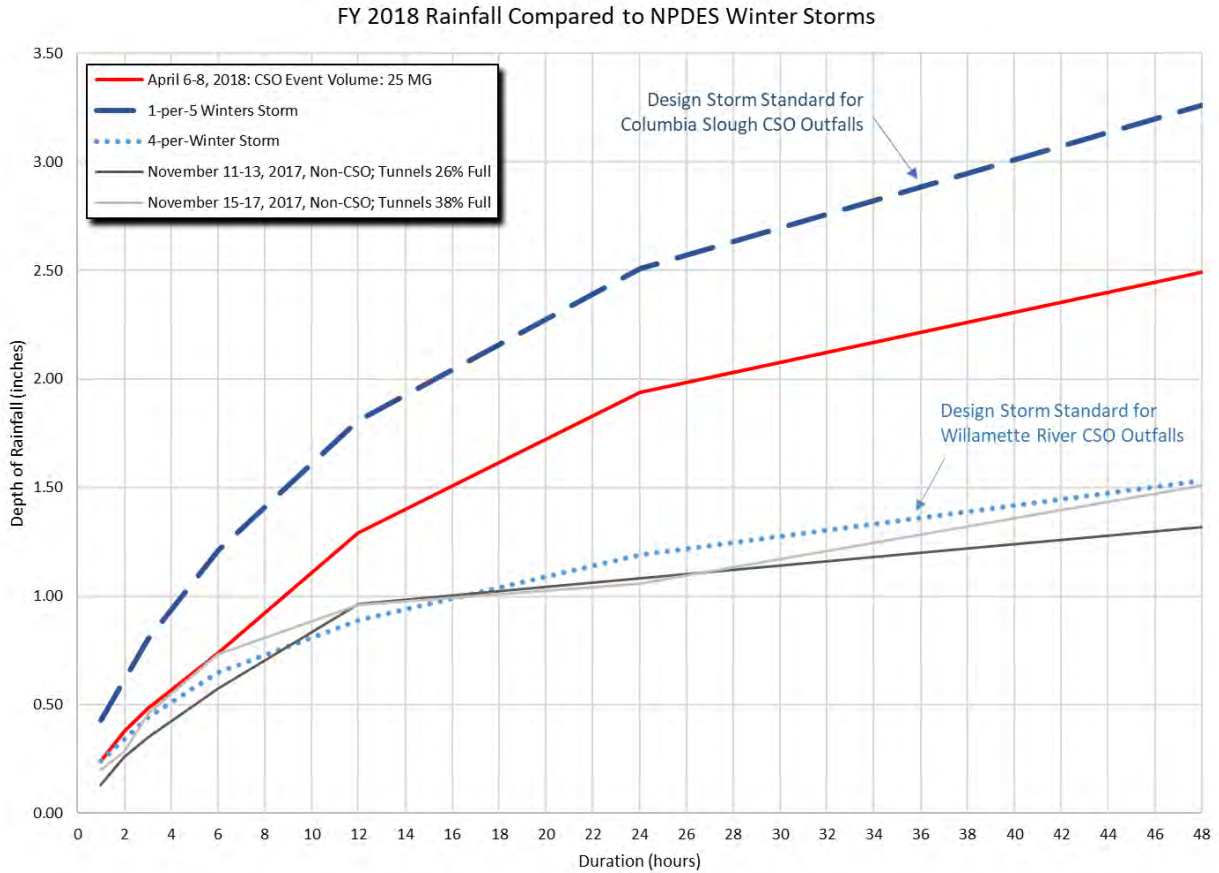
Figure 1 FY 2018 CSO Winter Storms Compared to NPDES Winter Storms

One winter storm exceeded the 4-per-winter NPDES Permit design depths and caused a CSO discharge. That storm is shown graphically in Figure 1 below. This graph is a “Depth-Duration” chart that displays the maximum depth of rainfall that occurred for the range of storm duration, from 1-hour to 48- hours. The event that caused a CSO to occur is shown as a solid red line. The

CSO event is compared to the two NPDES Winter Design Storms (4-per-winter for Willamette River CSO outfalls and 5-year winter for Columbia Slough CSO outfalls) shown with blue-tinted dashed lines. The two storms that exceeded the 4-per-winter design storm but did not result in CSOs are shown in grey. Details for the rainfall for the winter overflow events are provided in Table 1 below.

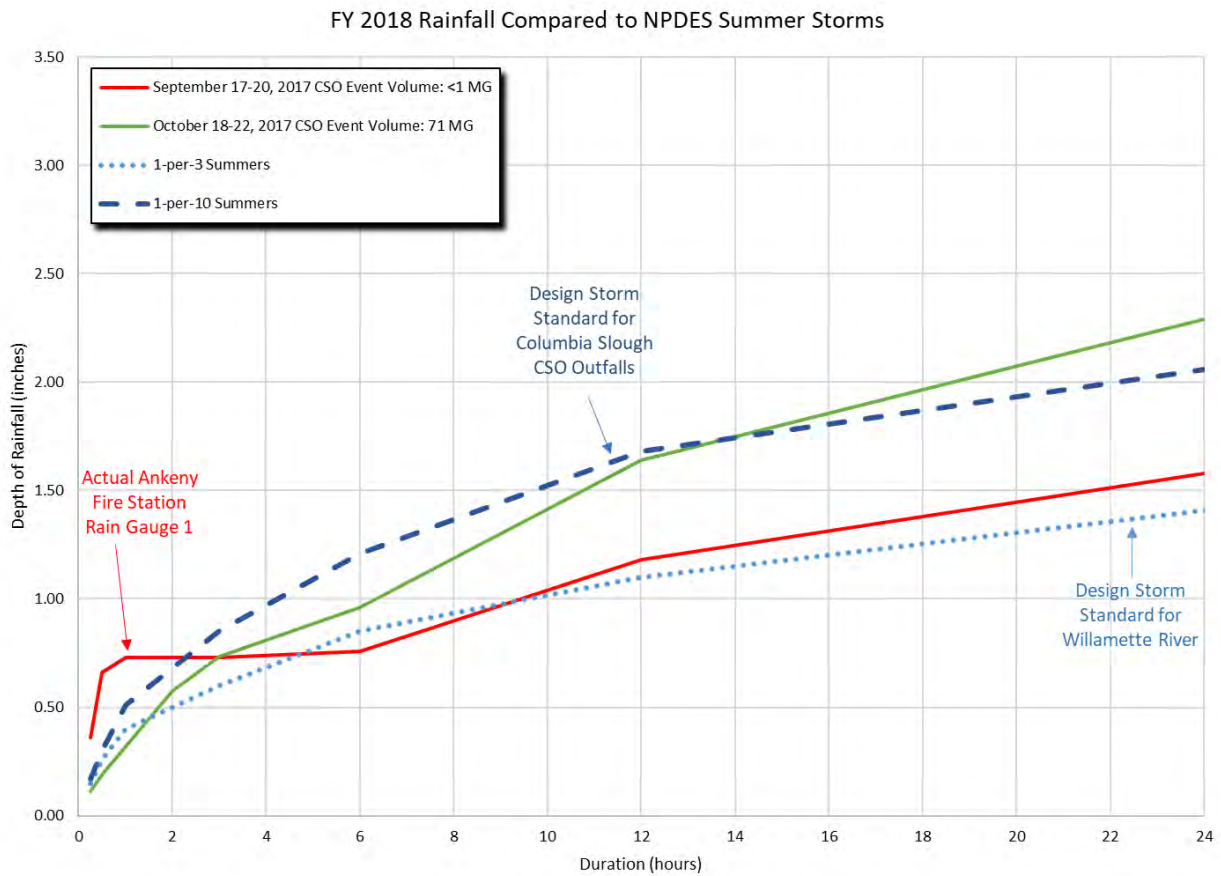
Figure 2 FY 2018 Rainfall Compared to NPDES Summer Storms

Two storms exceeded the NPDES Permit 3-year Summer Storm. The two storms are shown graphically in Figure 2 below. This graph is a “Depth-Duration” chart that displays the maximum depth of rainfall that occurred for the range of storm duration, from 1-hour to 24-hours. The events are shown as solid red and green lines. The two comparison Summer Design Storms (3-year summer for Willamette River CSO outfalls and 10-year summer for Columbia Slough CSO outfalls) are shown with blue-tinted lines. Table 2 provides rainfall details for this event.

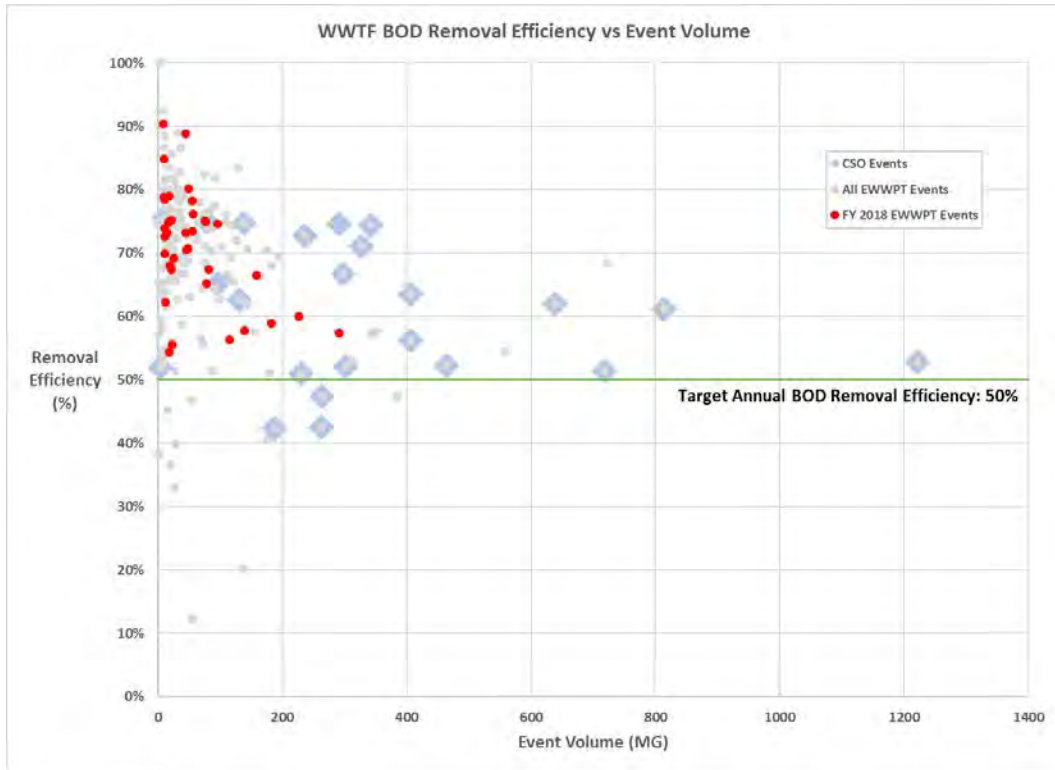
Figure 3 WWTF BOD Removal Efficiency vs. Event Volume

BOD and TSS removal efficiencies compared to event volume are shown in Figure 3 (BOD) and Figure 4 (TSS). Small events tend to have higher BOD and TSS concentrations, and larger volume events have lower concentrations. The CEPT system achieves better than 50% BOD and 70% TSS removal efficiencies on an overall basis. All wet weather events this fiscal year continue to place above the target efficiencies, as seen on the charts.

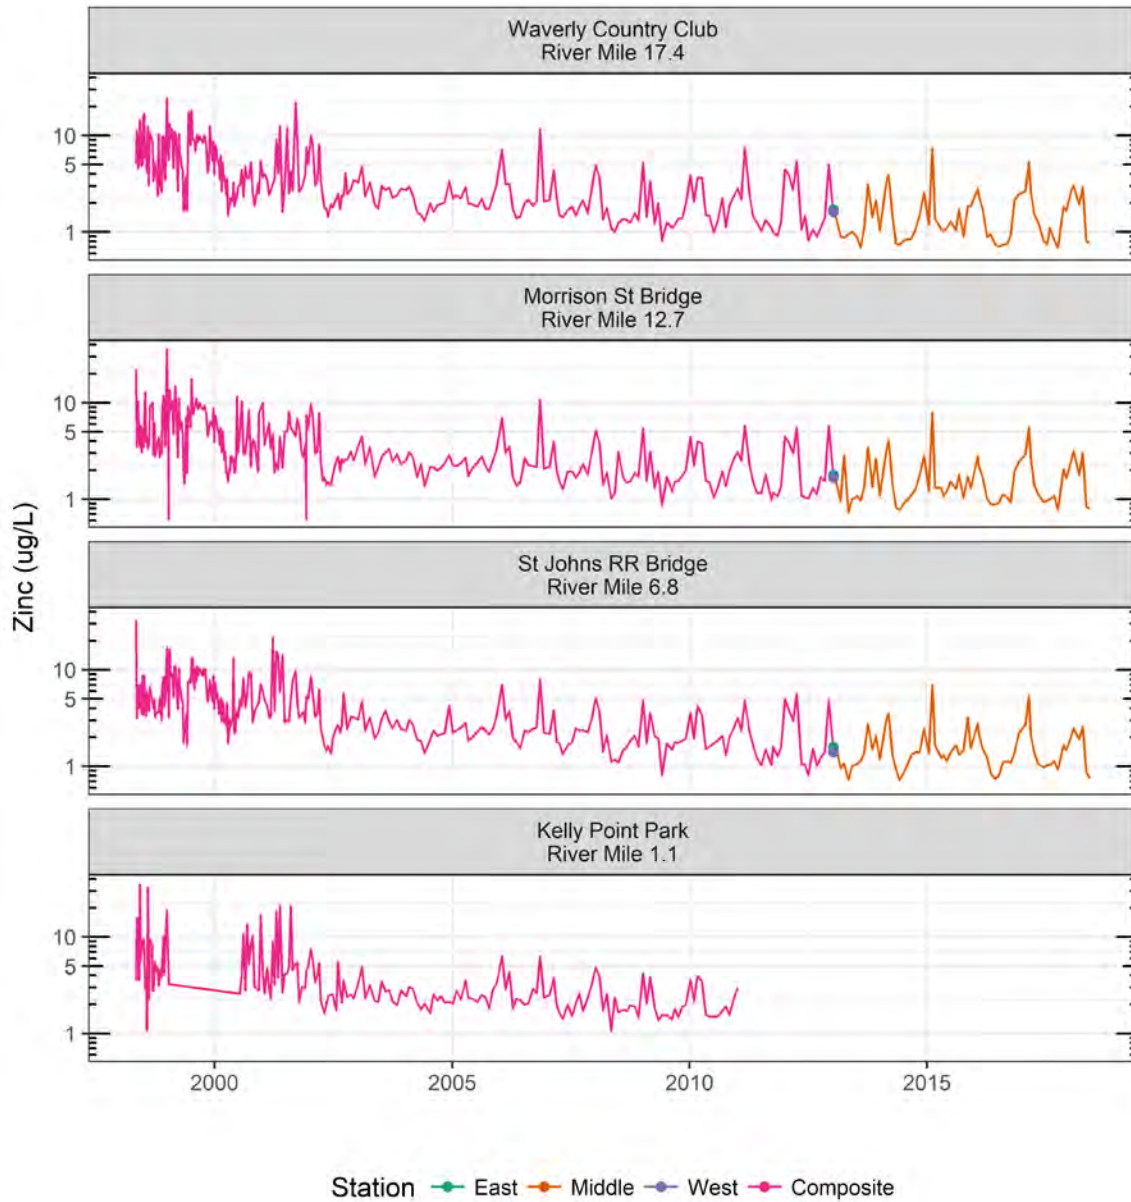
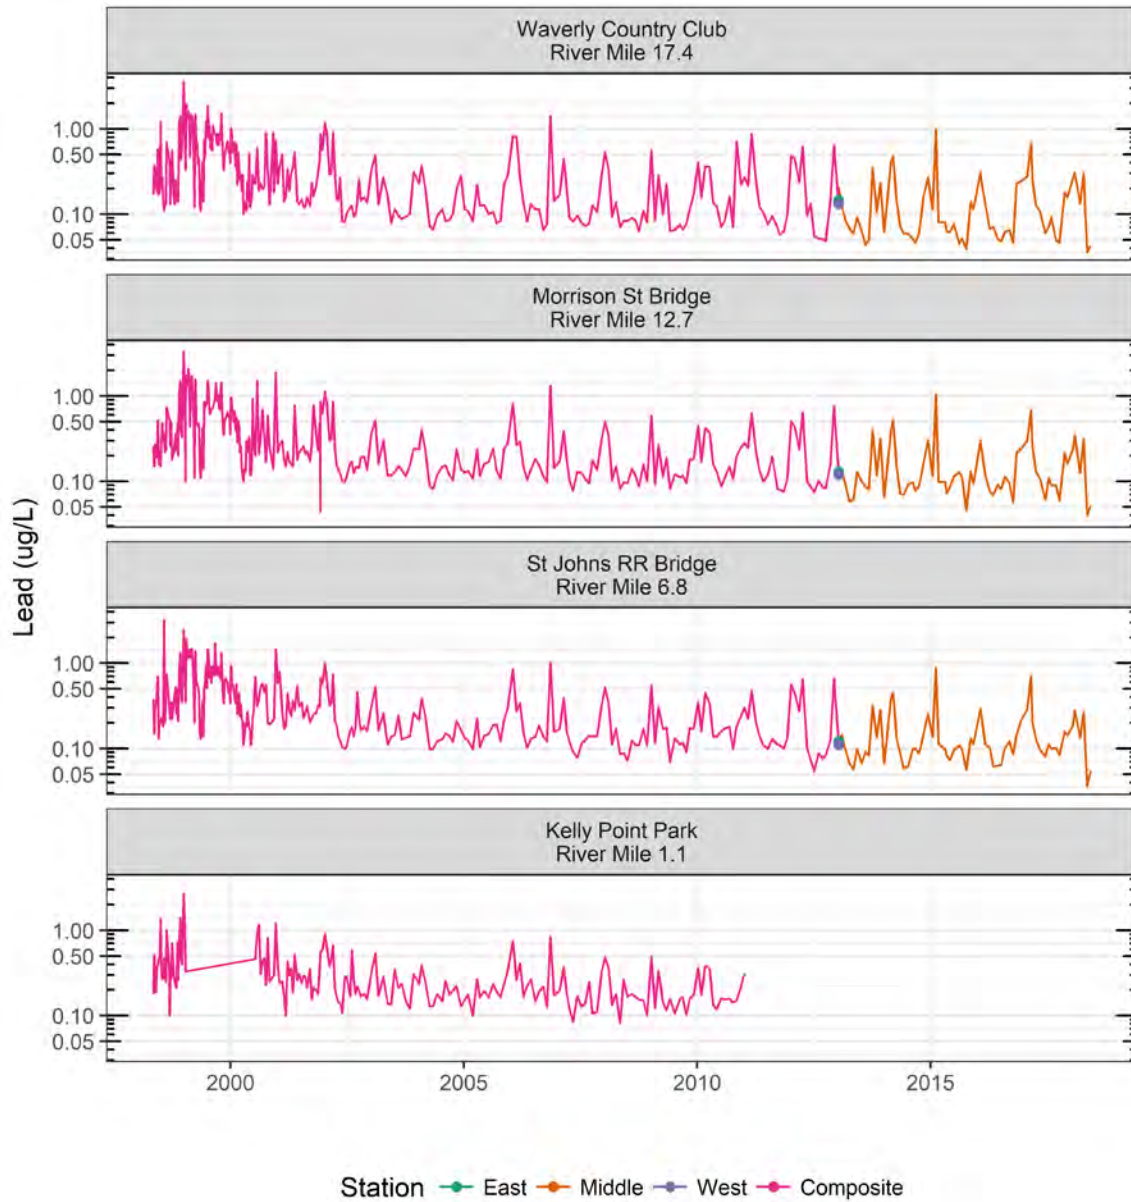
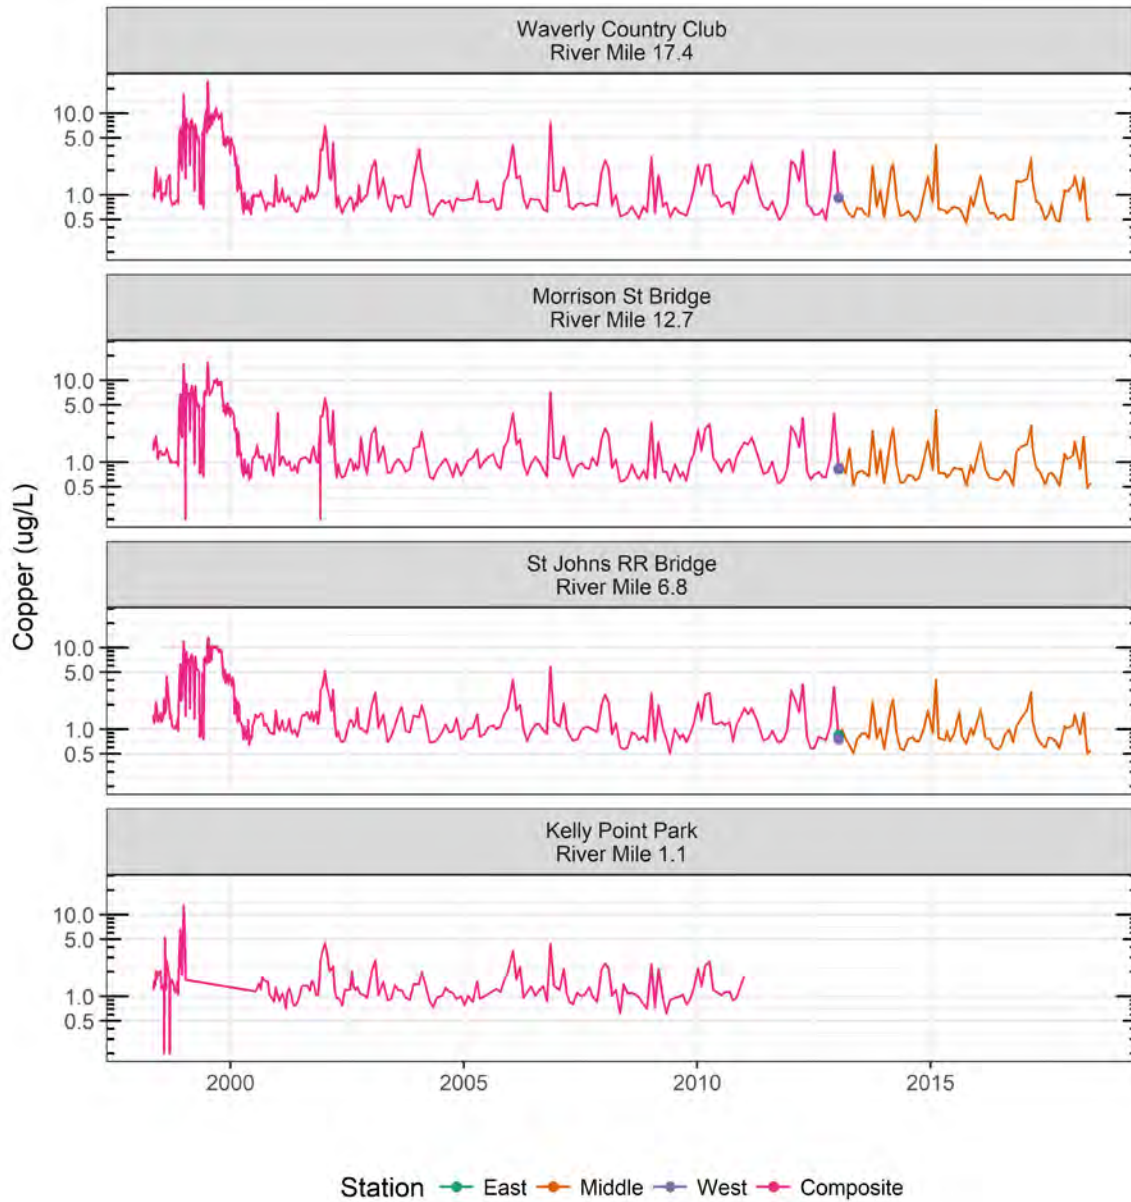
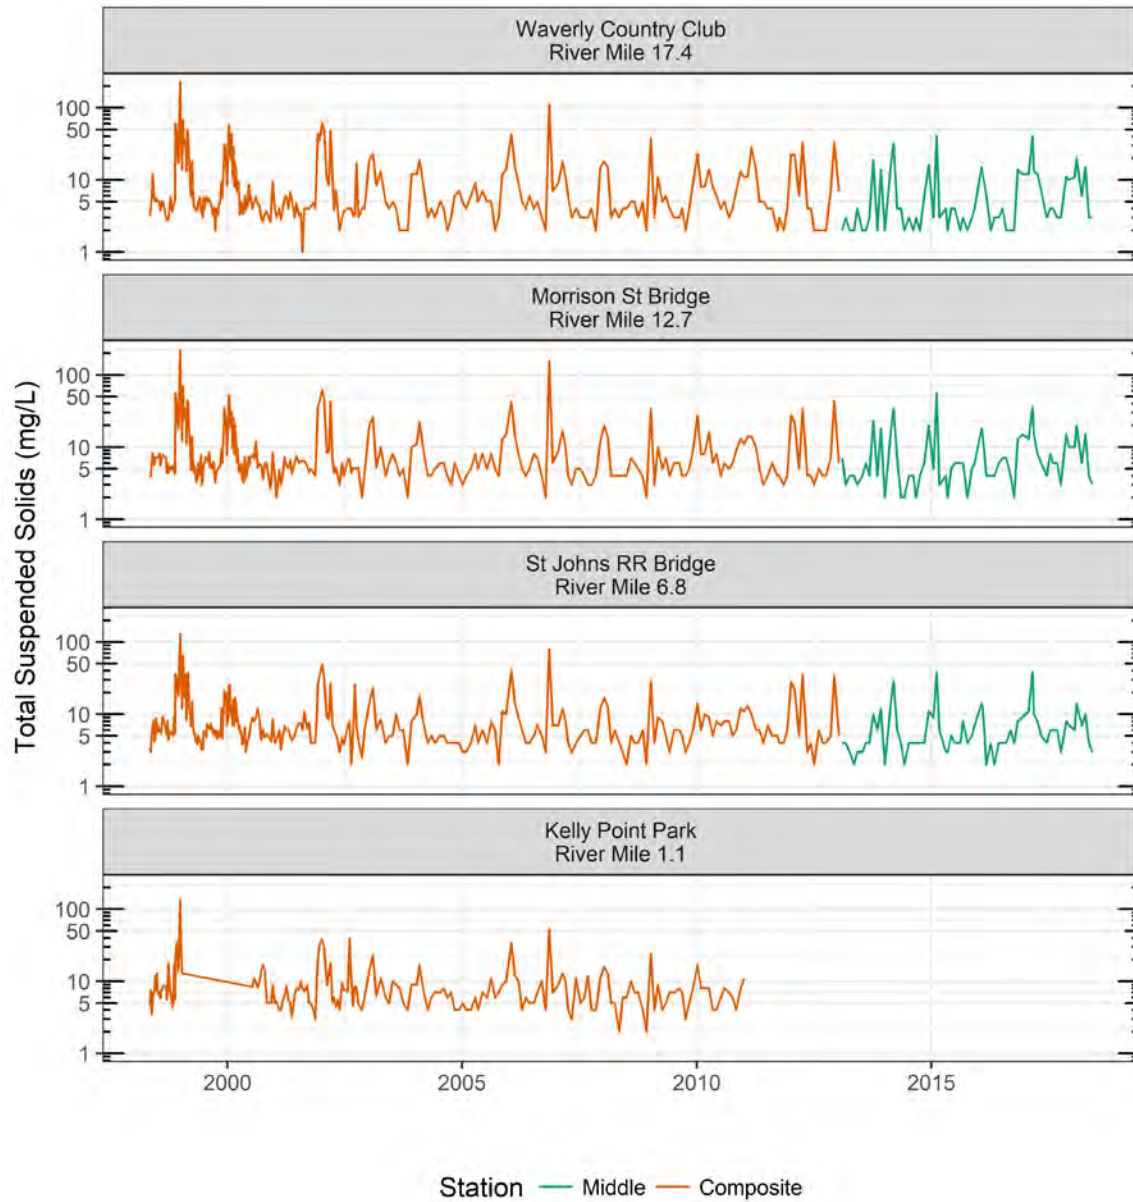
Figure 6 through Figure 10 show the water quality trends along the Portland stretch of the Willamette River for five parameters: zinc, lead, copper, TSS, and *E. coli*. These metals and bacteria parameters are the pollutants of concern for Portland CSO discharges. The sampling results indicate continued similar performance as FY 2017.

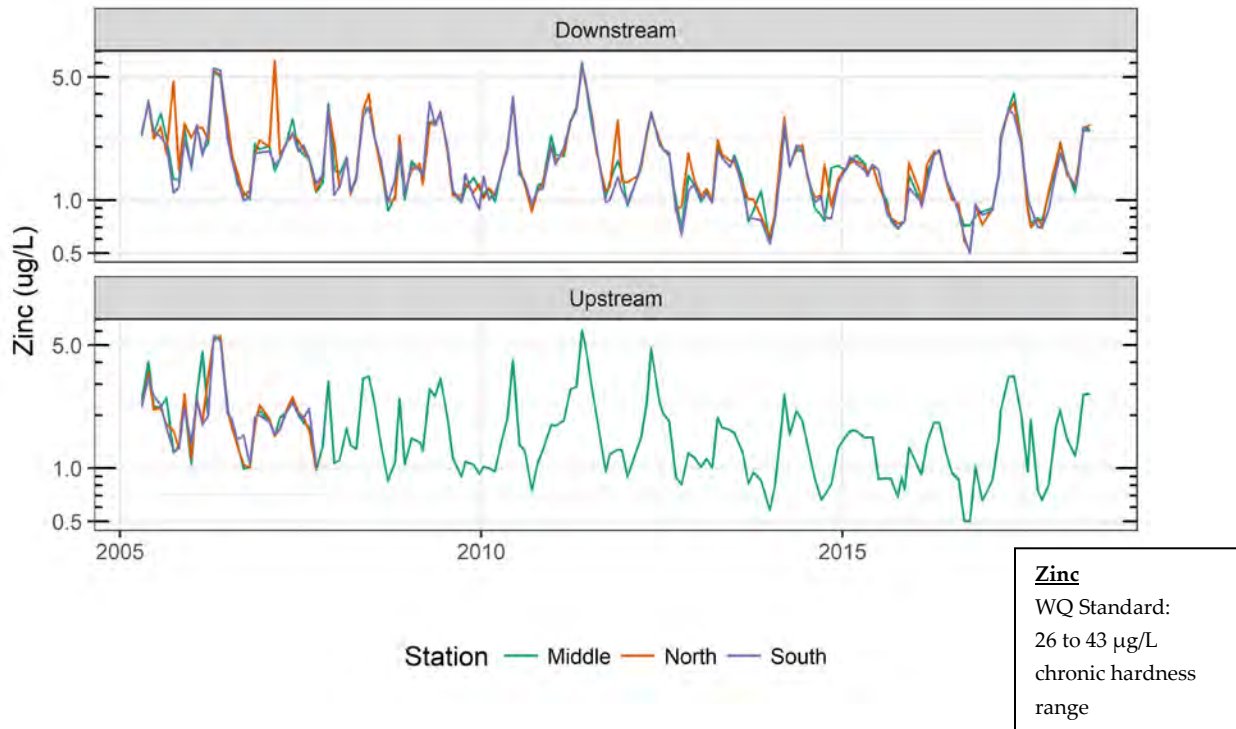
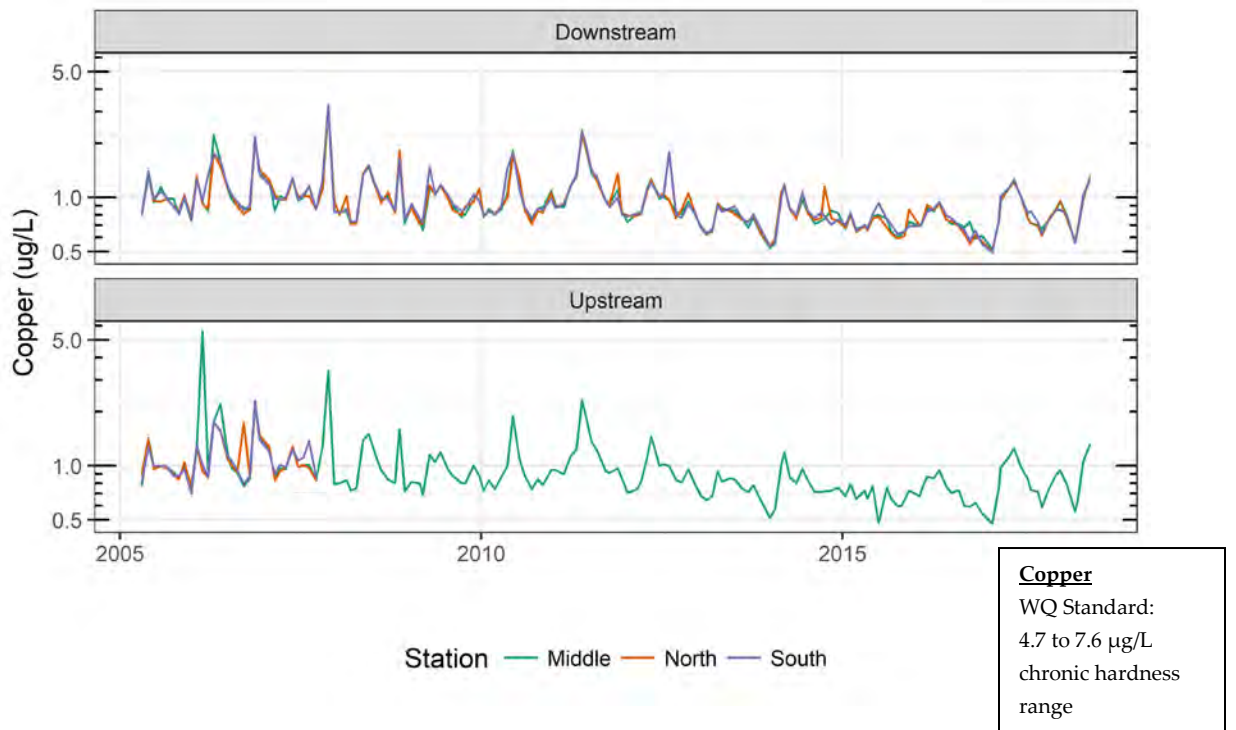
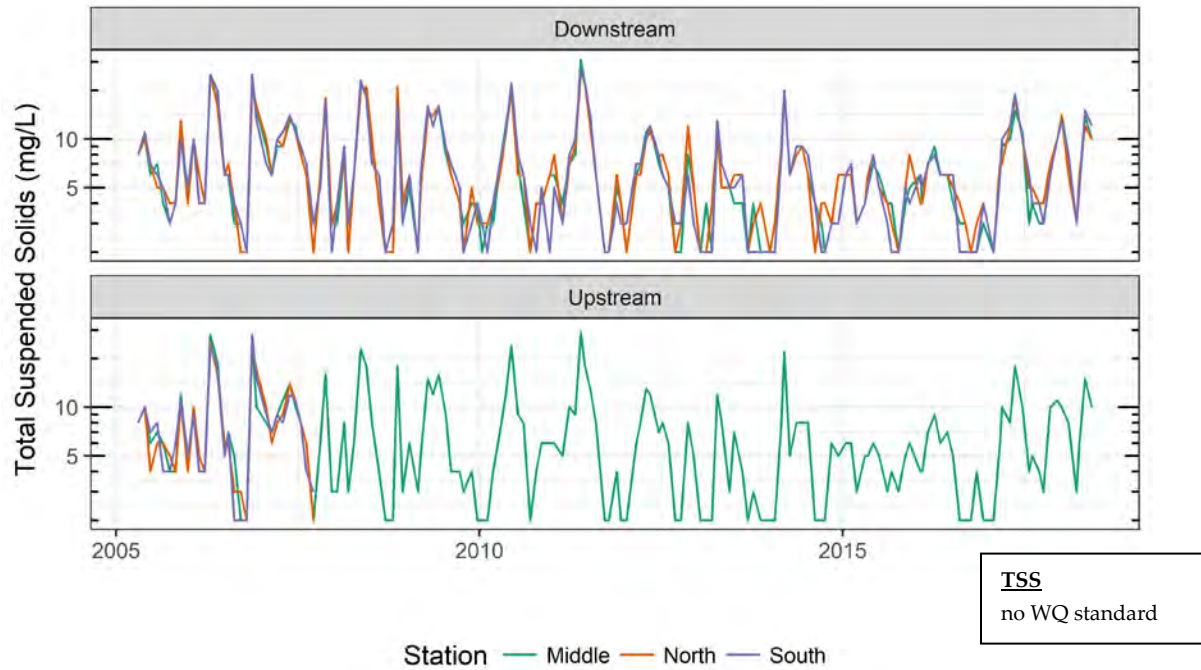
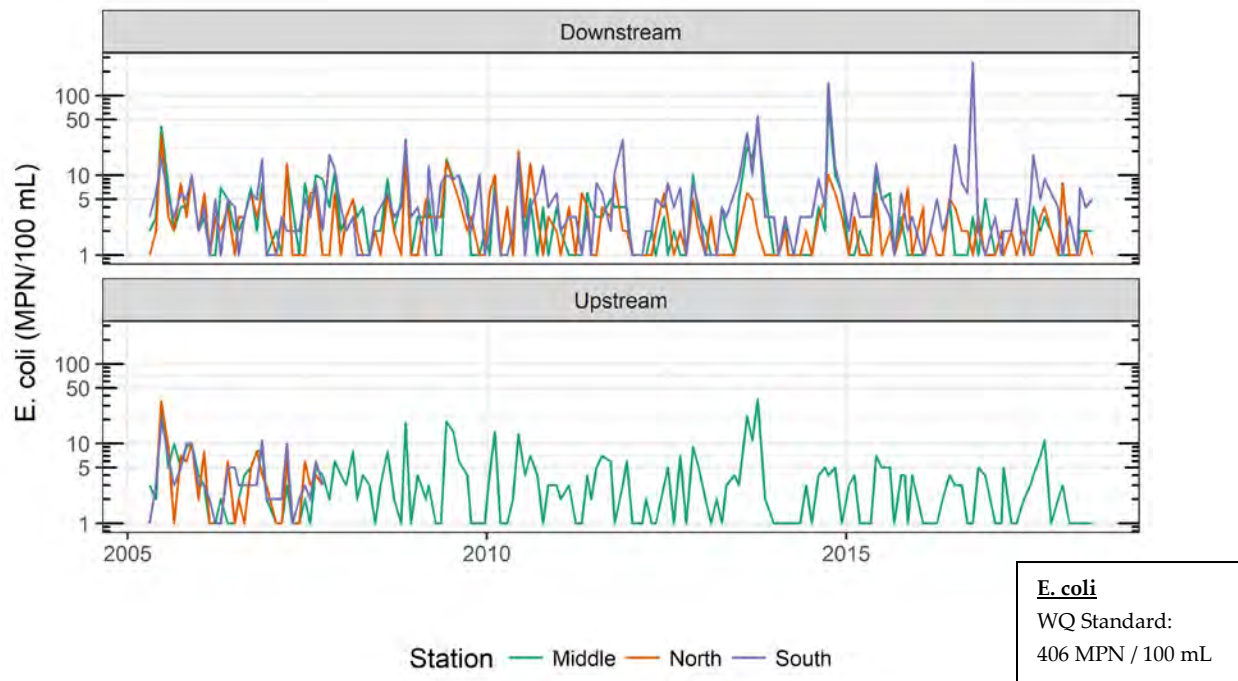
78. The charts show the reasonable range of chronic standards based on the hardness values measured in the river during the sampling period.

All parameters are well below the numeric water quality standards. There is little difference between the upstream and downstream measurements.

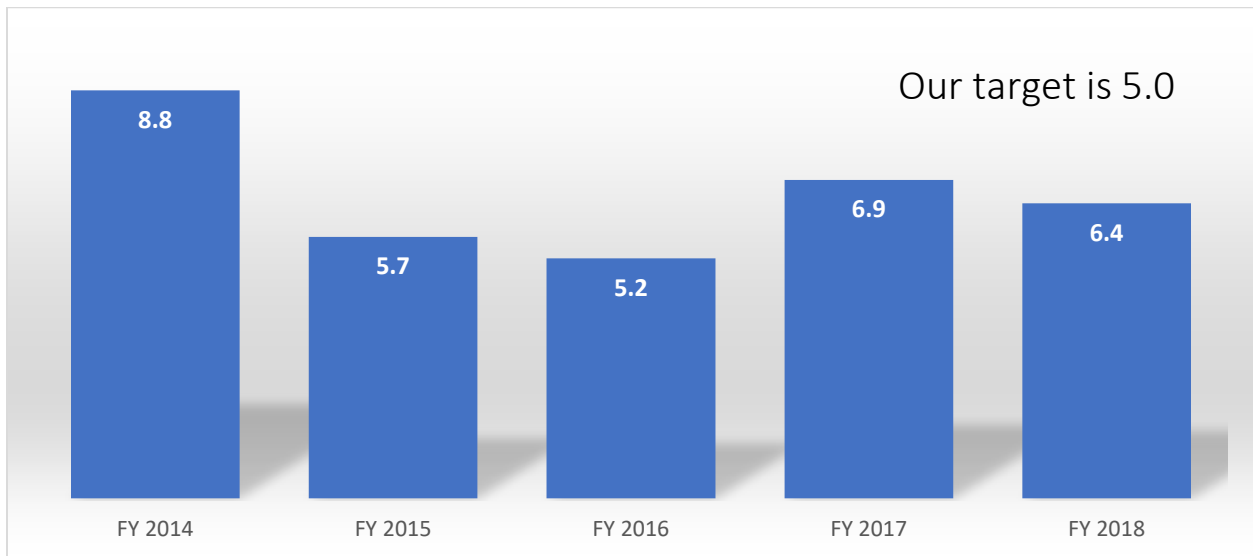
Figure 17 SSOs per 100 Miles of Sewer

As of the end of FY 2018, BES owned and maintained approximately 1,917 miles of main line sanitary and combined sewers, and 712 miles of sewer laterals. The City is typically responsible for maintaining the portion of the service lateral extending from the main sewer to the curb. During FY 2018, the City experienced 168 sewer releases over the 2,629 miles of collection system, which is approximately 6.4 releases per 100 miles of sewer.

Sewer release data is updated by BES SPCR as more complete information becomes available and investigations are conducted, and thus totals in this report reflect current records and may not match previous years' reports and/or monthly discharge monitoring report submittals. A comparison with previous fiscal years is shown in Figure 17.

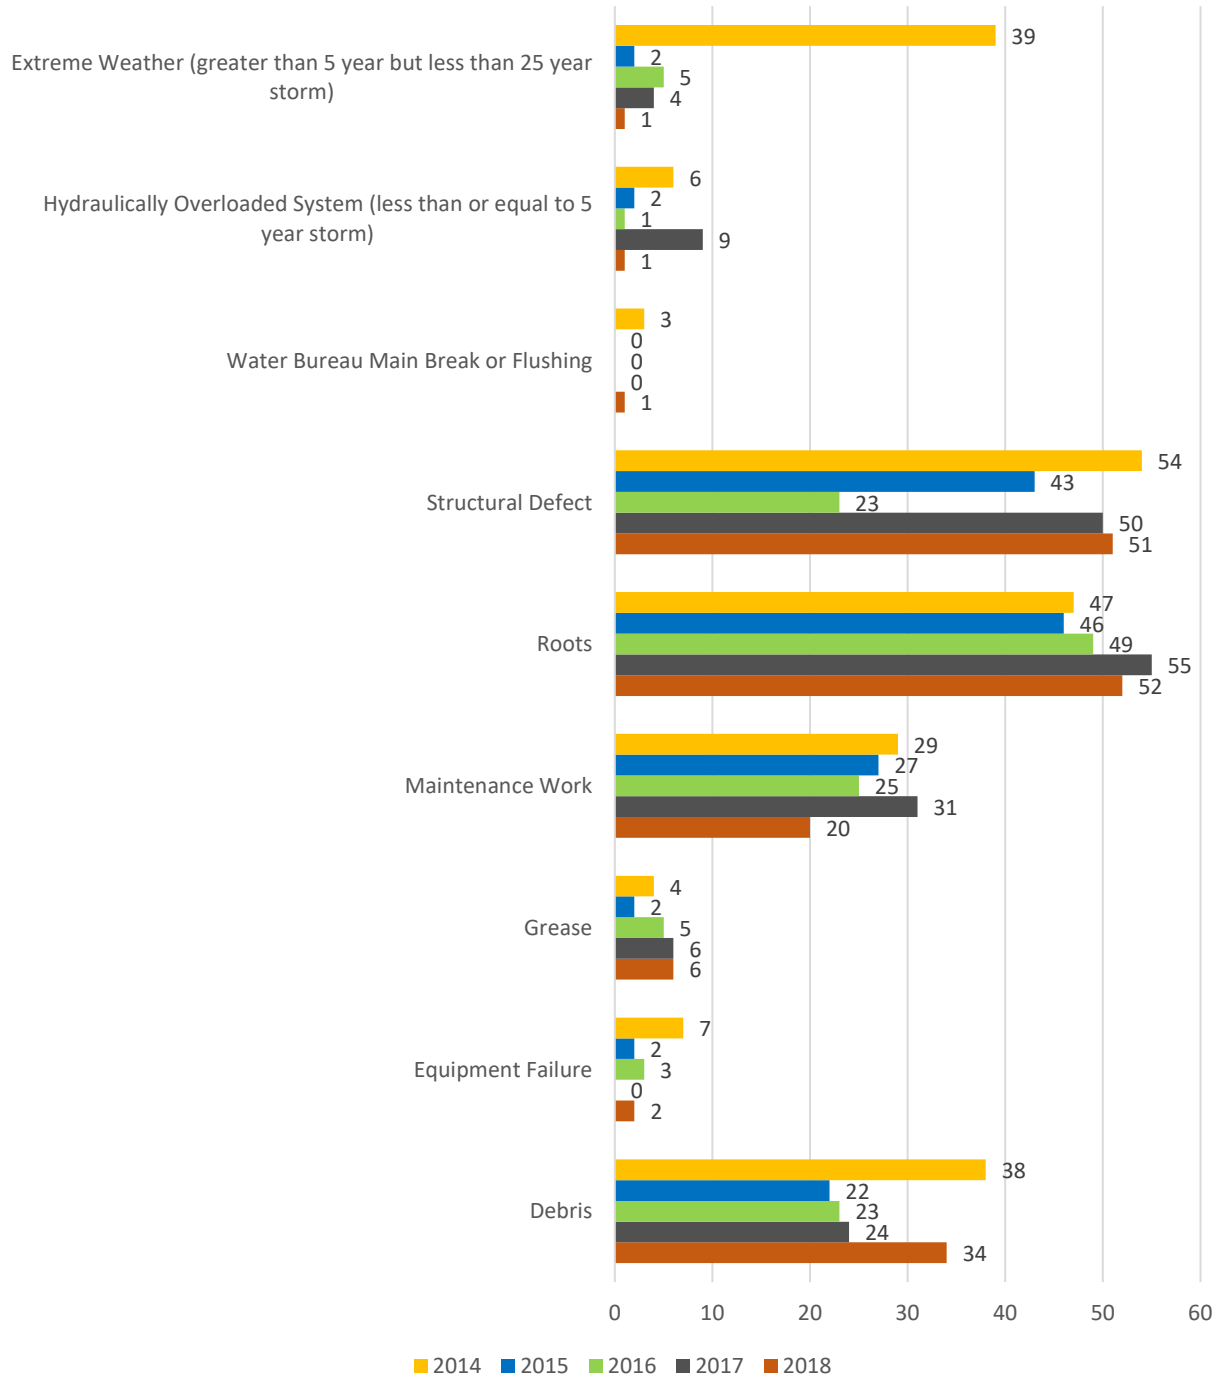
Figure 19 Comparison of Causes of Sewer Releases in FY 2014 through FY 2018

A chart comparing the causes of releases in FY 2014 through FY 2018 is shown in Figure 19. The release data shown are for releases due to problems in the City-maintained portion of the collection system (excluding releases due to causes resulting from problems in privately-owned sewers or laterals). The locations of the sewer releases in FY 2018 are shown on the map in Figure 20.

Sewer Releases in City System by Cause FY2014 through FY2018 (excludes weather-related force majeure events)

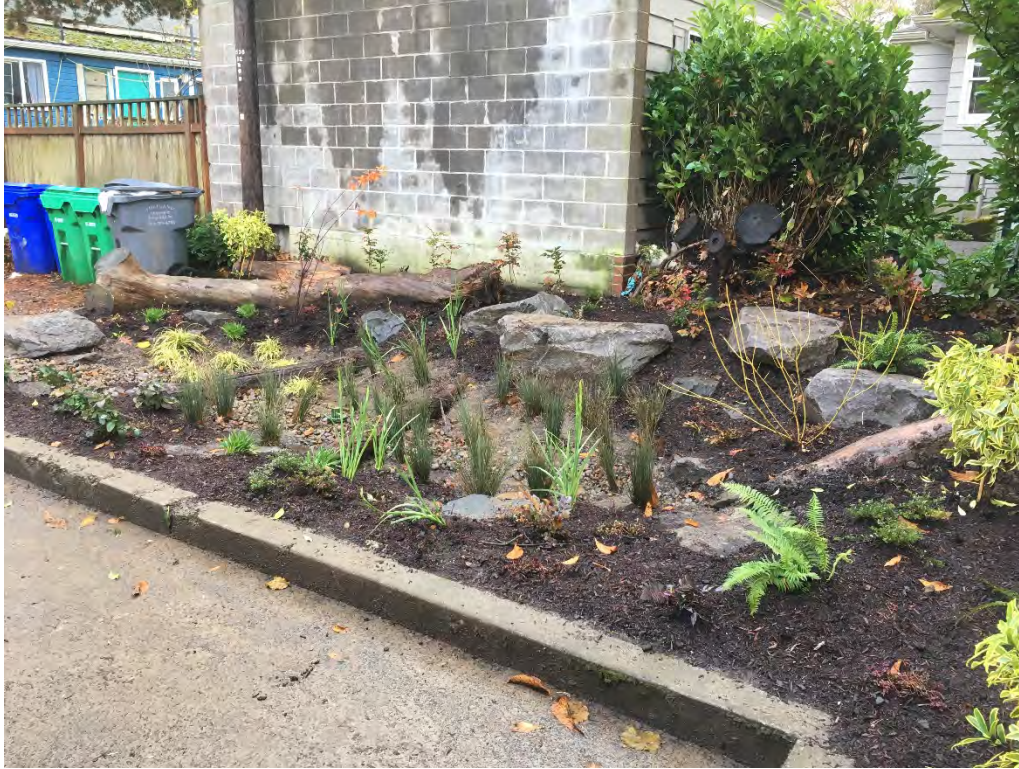
Figure 22 Example Retrofit #1

For FY 2018, 2.4 acres of impervious surfaces were managed by 64 private property stormwater retrofit projects. An area of focus is shown in Figure 21. Three examples of this year's retrofits are shown in Figure 22, Figure 23, and Figure 24 below.
