Subject: **Annual CSO and CMOM Report, FY 2019**  
Columbia Boulevard Wastewater Treatment Plant NPDES Permit #101505

# Annual CSO and CMOM Report FY 2019

REQUIRED BY NPDES PERMIT #101505

**Annual CSO and CMOM Report - FY 2019**  
**September 2019**

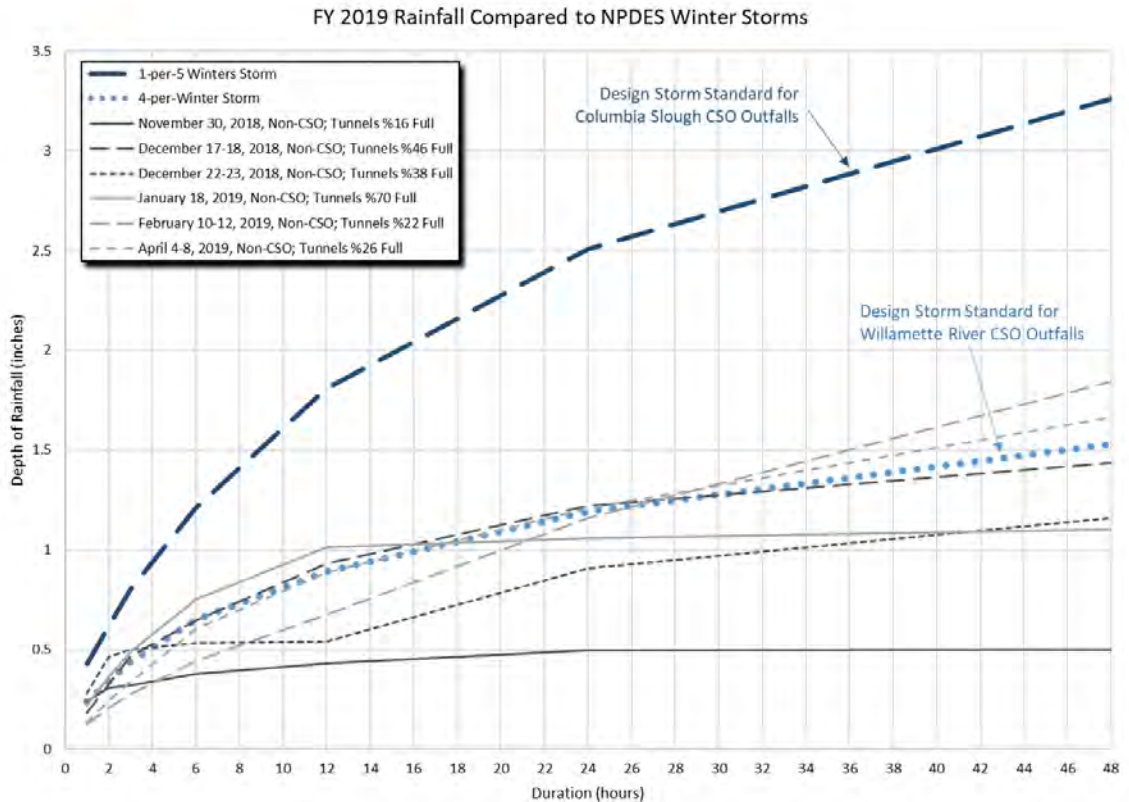
**Figure 1 CSO winter storms compared to NPDES winter storms**

The six storms that exceeded the 4-per-winter NPDES Permit design depths are shown graphically in Figure 1 below. This graph is a “Depth-Duration” chart that displays the maximum depth of rainfall that occurred for the range of storm duration, from 1-hour to 48- hours. The observed rainfall events are compared to the two NPDES Winter Design Storms (4-per-winter and 5-year winter) shown with blue-tinted dashed lines. The six storms that exceeded the 4-per-winter design storm but did not result in CSOs are shown in grey.

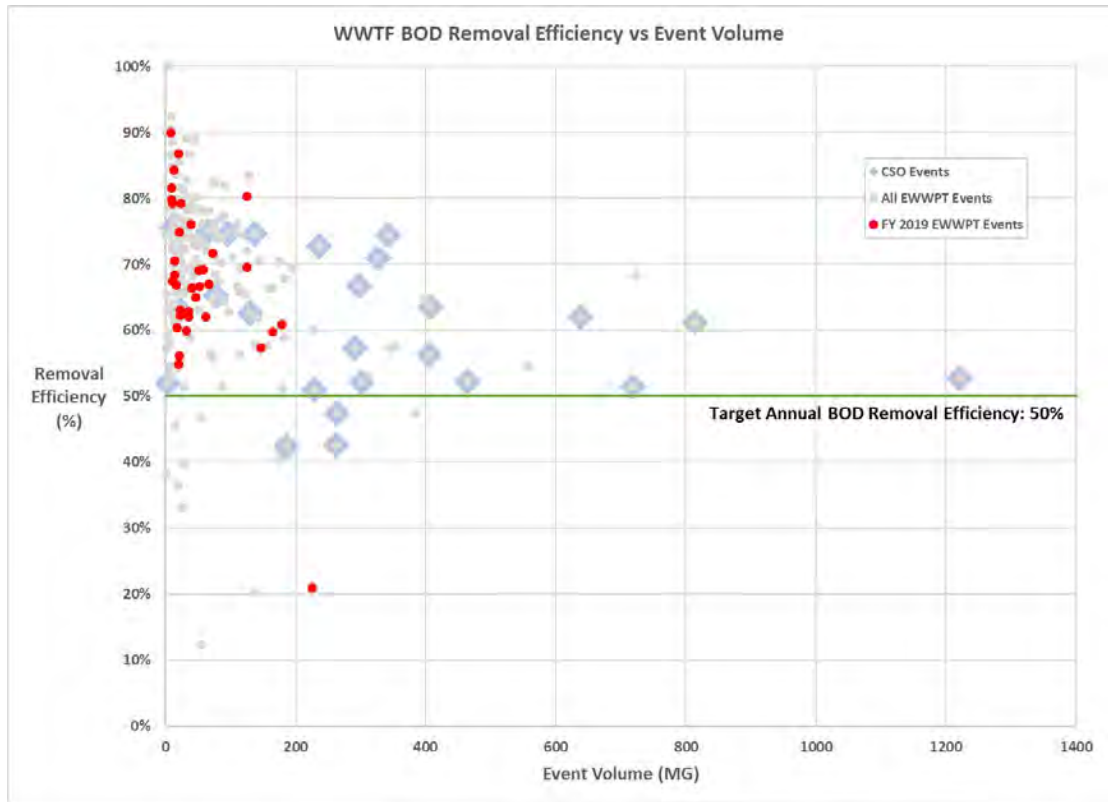
**Figure 3 WWTF BOD removal efficiency vs. event volume**

overall basis. Most wet weather events this fiscal year placed above the target efficiencies, as seen on the charts. These sporadic events with lower efficiencies tend to happen during drier years.

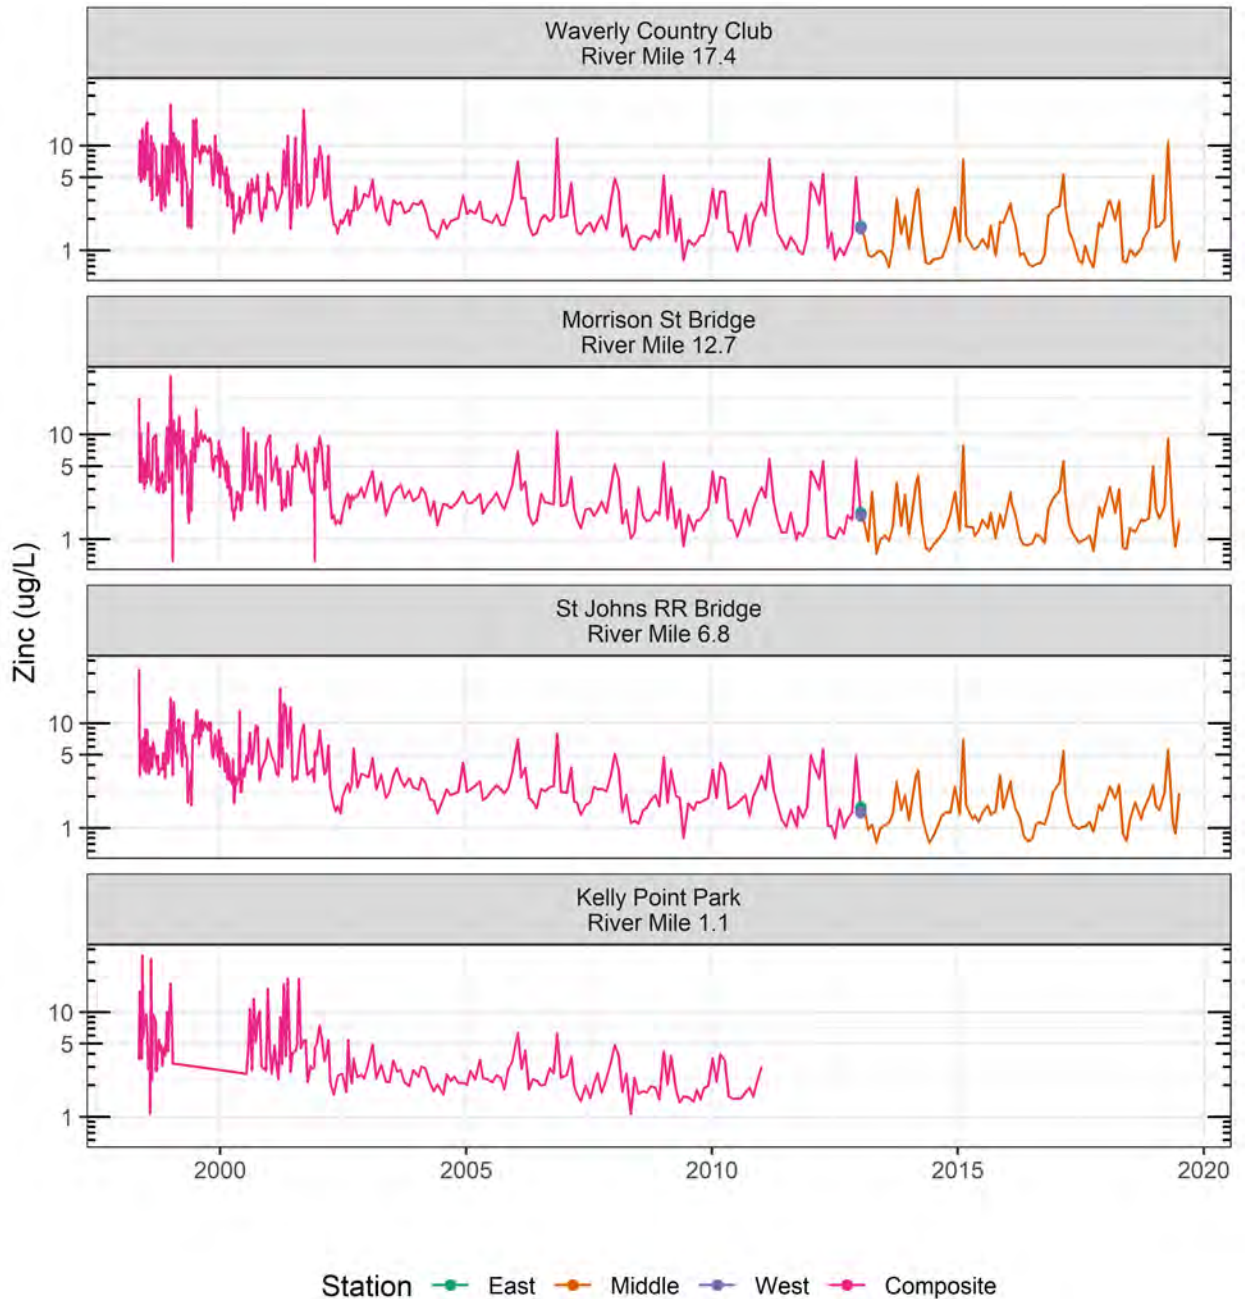
**Figure 5 Willamette River monitoring results for zinc**

metals and bacteria parameters are the pollutants of concern for Portland CSO discharges. The sampling results indicate continued similar performance as FY 2018.

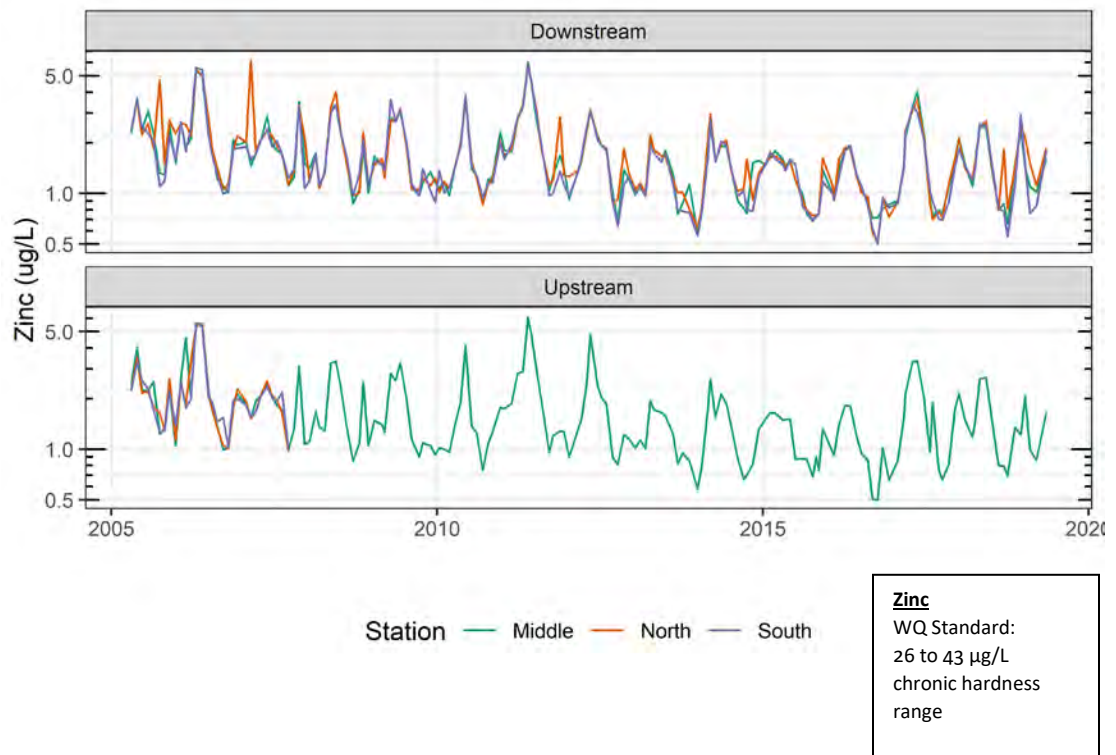
**Figure 10 Columbia River mixing zone sampling for zinc**

Figure 10 through Figure 14 show measurements of the main parameters of interest related to wet weather treatment and the Columbia River: Zinc, Lead, Copper, TSS,

All parameters are well below the numeric water quality standards. There is little difference between the upstream and downstream measurements.

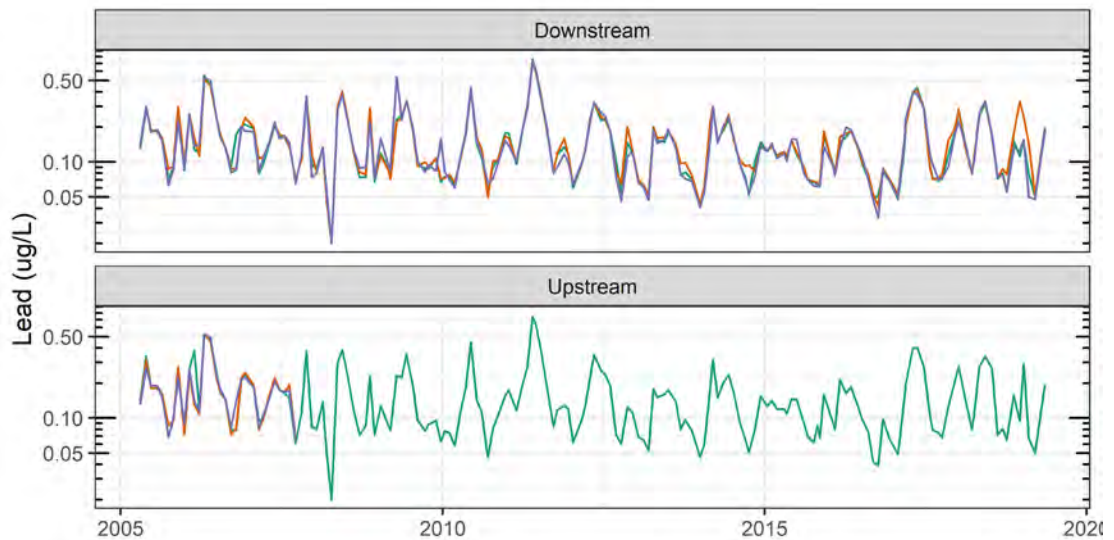
**Figure 11 Columbia River mixing zone sampling for lead**

**Lead**  
 WQ Standard:  
 1.2 to 2.3  $\mu\text{g/L}$   
 chronic hardness  
 range

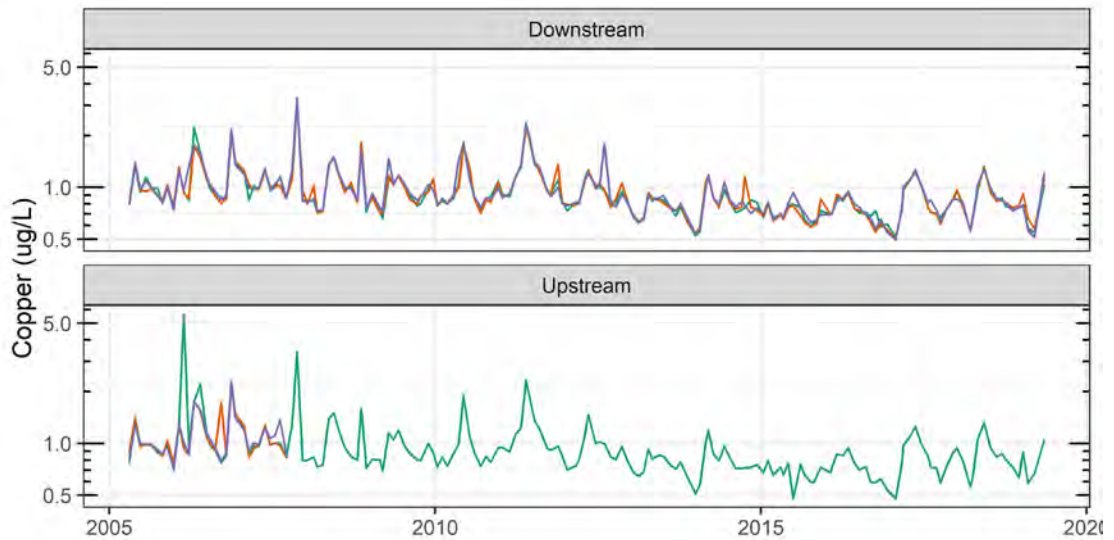
**Figure 12 Columbia River mixing zone sampling for copper**

**Copper**  
 WQ Standard:  
 4.7 to 7.6  $\mu\text{g/L}$   
 chronic hardness  
 range

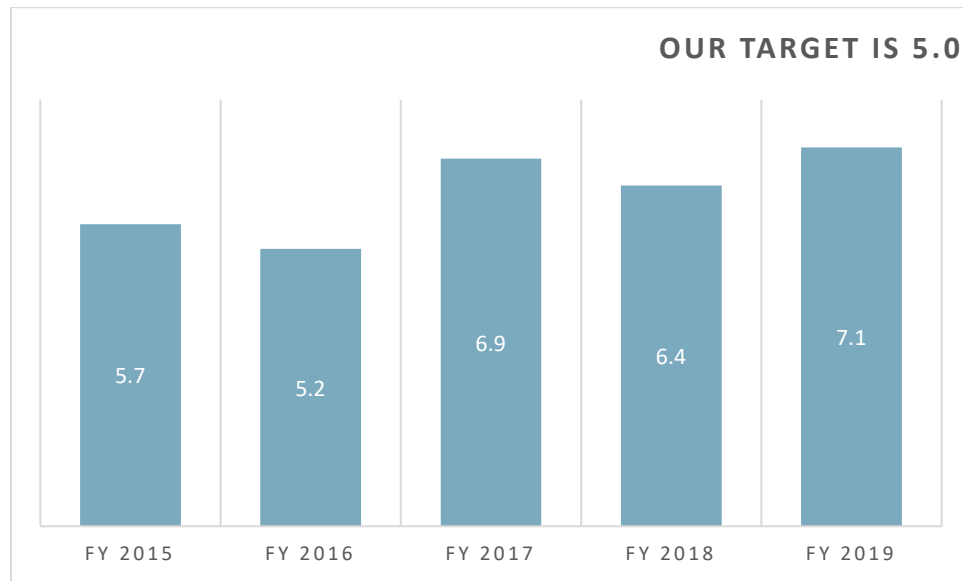
Figure 16 SSOs per 100 miles of sewer

SSOs provide a good measure of the overall effectiveness of maintenance programs for controlling roots, fats, oils, and grease, structural failures, and pump station performance. By tracking SSOs per 100 miles of sewer, BES has a succinct metric for gauging overall success toward minimizing SSOs.

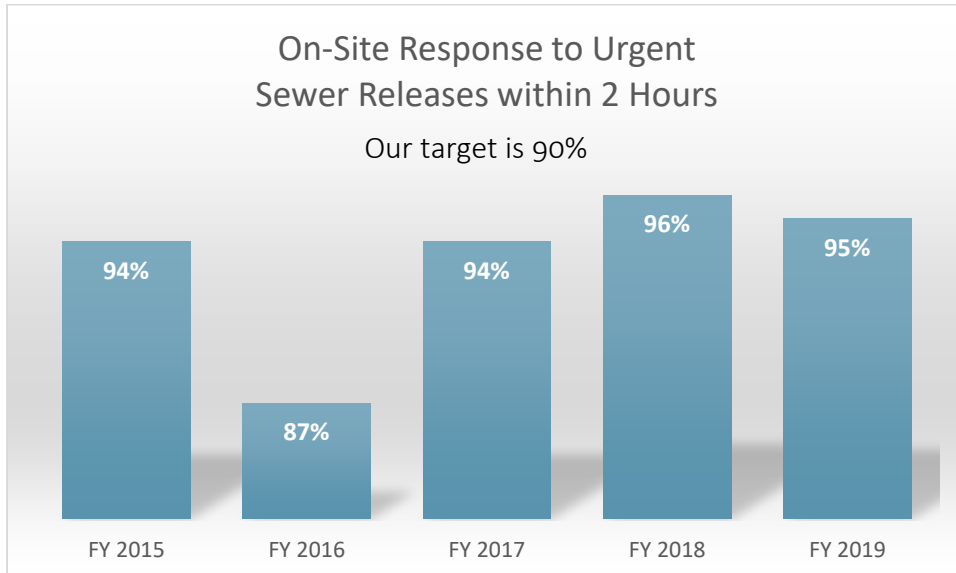
**Figure 17 SSO response time comparison**

FY 2019 Total Urgent Calls Sewer Release Calls	Number of Calls	Percent of Total
Urgent Calls with Response Time Less Than 2 Hours	409	95%
Urgent Calls with Response Time 2 Hours or More	22	5%
Total	431	100%

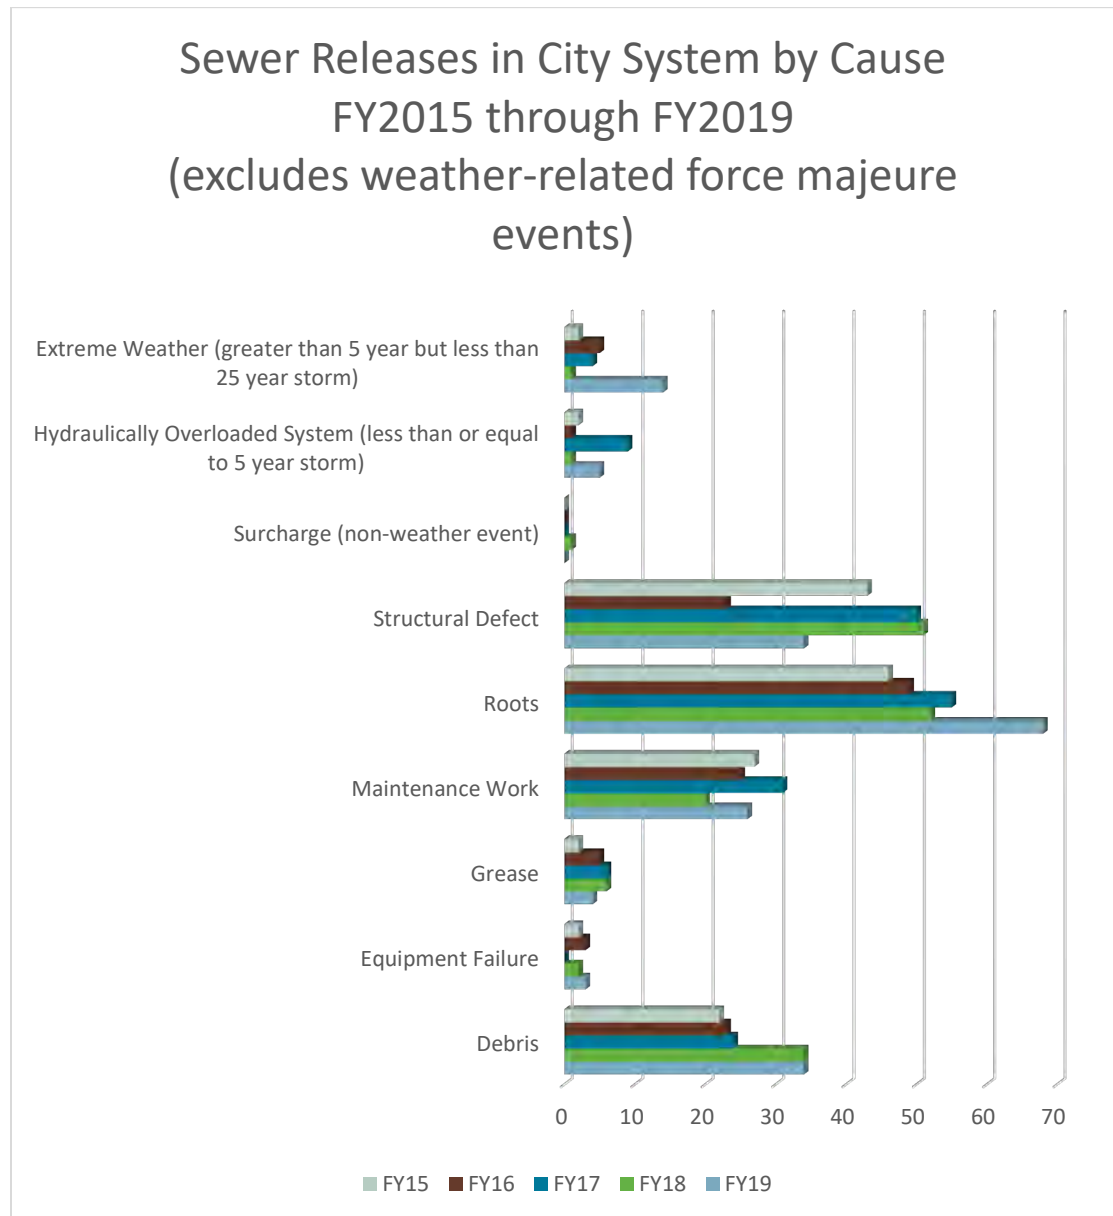
Figure 18 Comparison of causes of sewer releases in FY 2015 through FY 2019

A chart comparing the causes of releases in FY 2015 through FY 2019 is shown in Figure 18. The release data shown are for releases due to problems in the City-maintained portion of the collection system (excluding releases due to causes resulting from problems in privately-owned sewers or laterals). The locations of the sewer releases in FY 2019 are shown on the map in Figure 19.
