MT. ST. HELENS ASH CLEANUP

by Jerry Markesino,  
Street Cleaning Supervisor  
Department of Public Works, Portland, Oregon

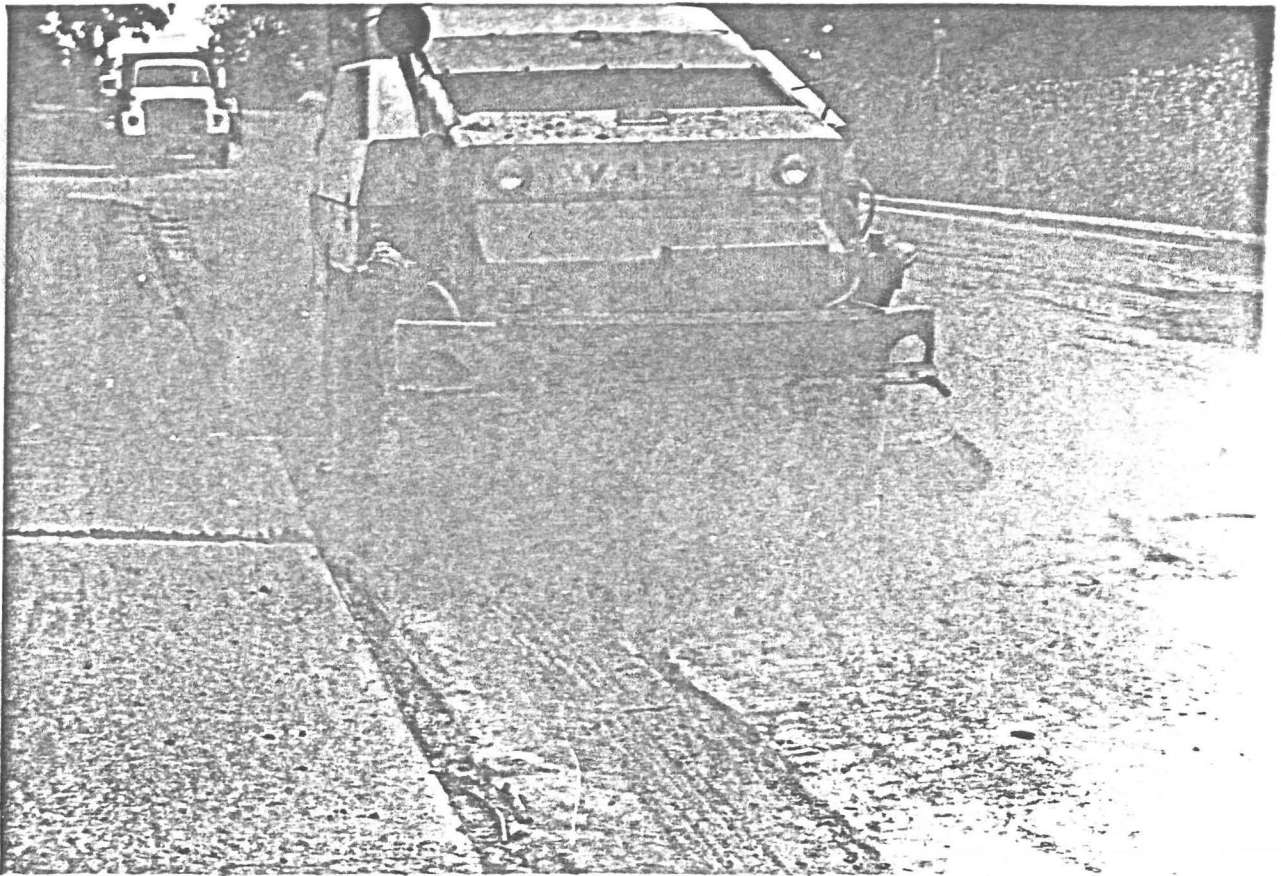
PORTLAND, OREGON

MECHANICAL STREET SWEEPER ATTEMPTS TO COLLECT  
THE ASH MATERIAL FROM THE CURB LANE.

Due to the small particle size of the ash, the street sweeping equipment was only about 50% effective on the first pass. The street cleaning section began a second pass operation which lasted another 6½ weeks. However, even the second cycle failed to totally remove the ash. The actions of traffic and runoff continued to cleanse the pores of the pavement and deposit the ash along the curb. Given time, the ash would mix with normal debris loadings and eventually be removed by future sweeping passes.

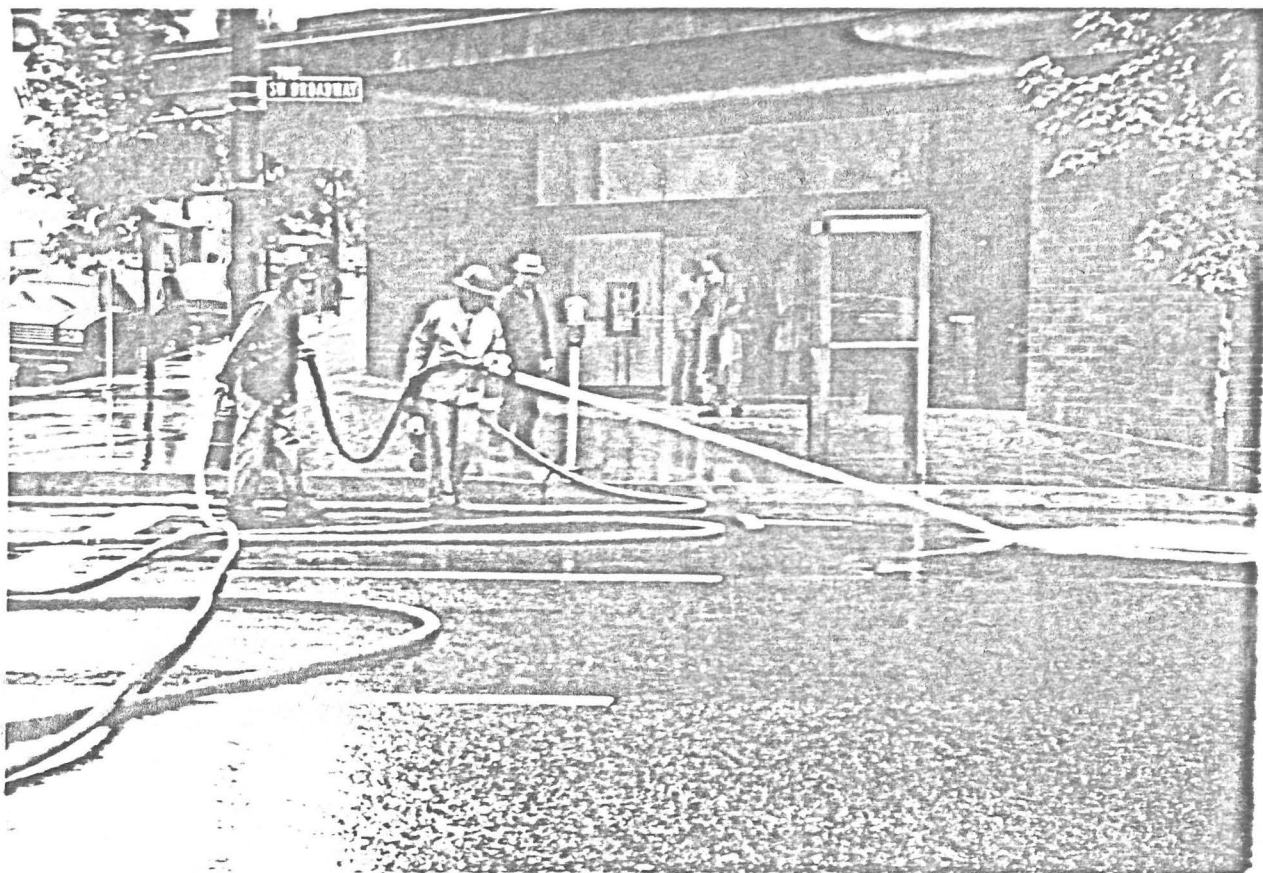
PORTLAND, OREGON

WITHIN 8 HOURS OF THE ASHFALL, HOSE CREWS WERE  
FLUSHING THE CBD AND PARADE ROUTE.

The method of removal involved creating ash trapping dams with sandbags to protect the storm drainage system and then using fire hoses from hydrants and power street flushers to move the ash into the catchment areas. The trapped ash material was then hand loaded into dump trucks for removal. By 9:30 A.M. on Saturday, the ash had been cleared from the parade route and thousands of spectators awaited the beginning of the parade. The festivities ended successfully that afternoon as the city dried out from the one inch

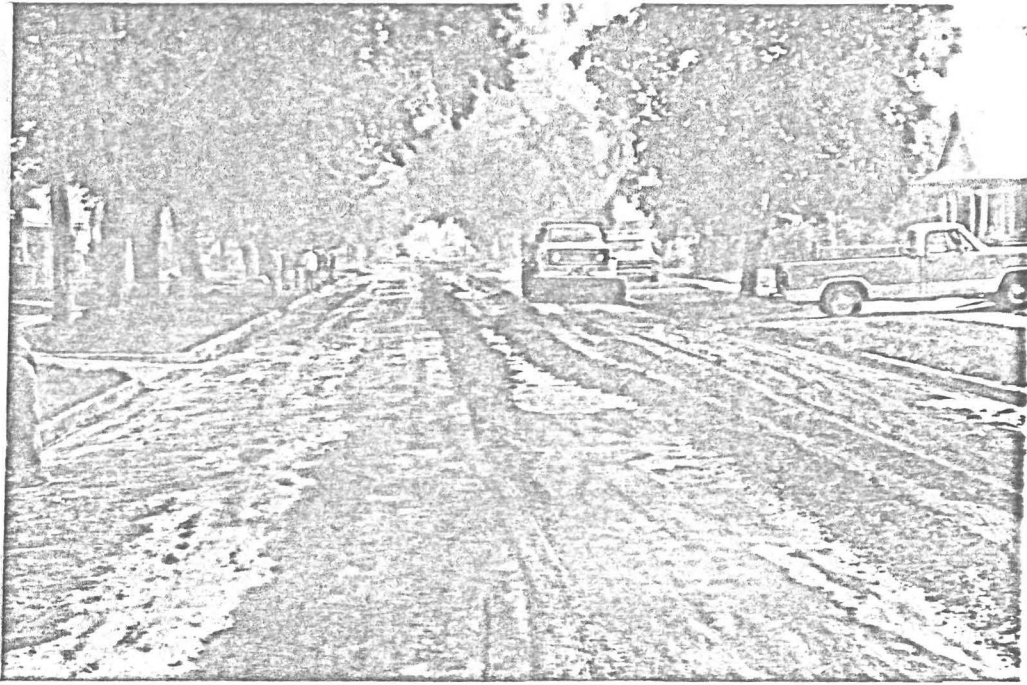
YAKIMA, WASHINGTON

SNOW PLOW TRUCKS WERE USED TO REMOVE THE BULK OF  
THE VOLCANIC ASH BEFORE STREET SWEEPING BEGAN.

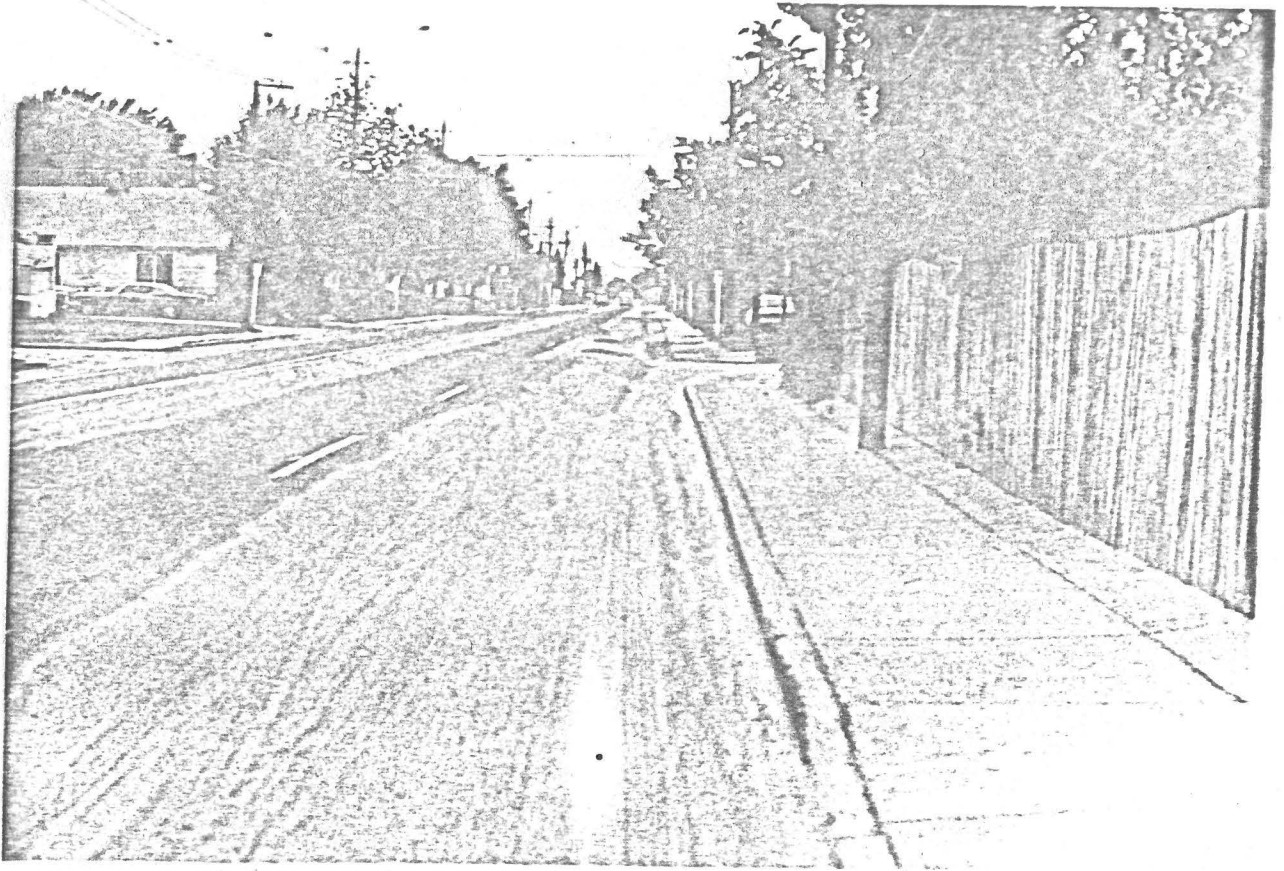
YAKIMA, WASHINGTON

TYPICAL ARTERIAL STREET BEFORE ASH REMOVAL CREWS  
ARRIVED. INDIVIDUAL CREWS WERE REMOVING OVER 1,000 CY  
PER SHIFT.
