### APPEAL SUMMARY

# Softwood Lumber Board **Glulam Connection Fire Test** Summary Report

# PAE Living Building

## Engineering Judgment Report #4

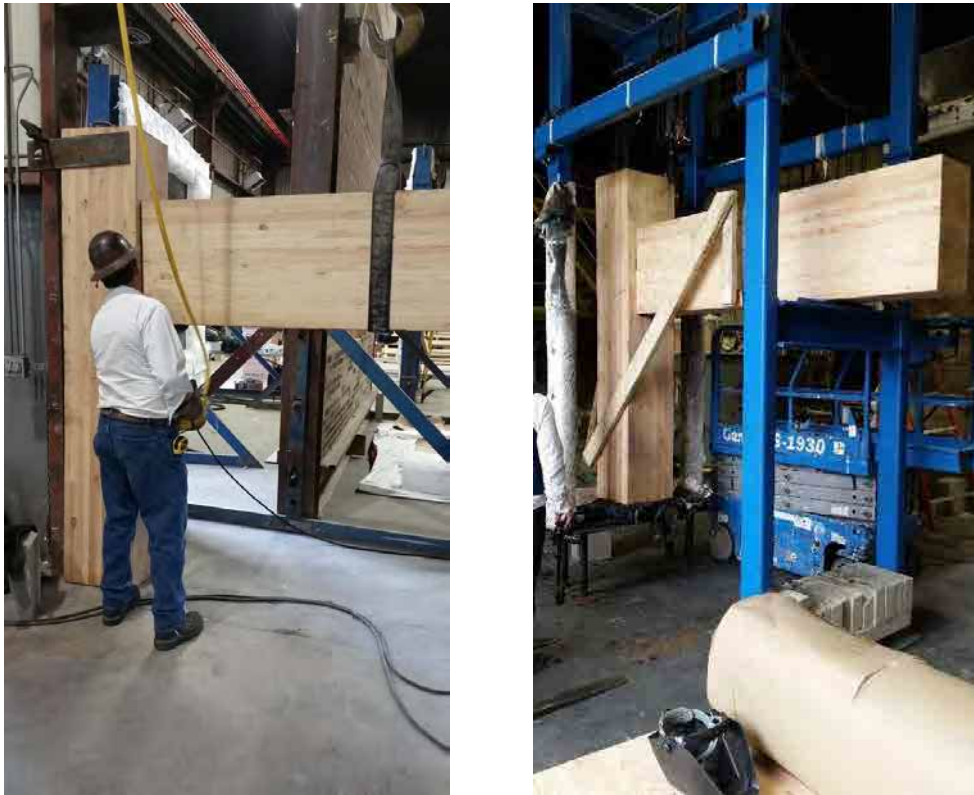
Figure 1 – Test specimen being assembled, before CLT floor is installed

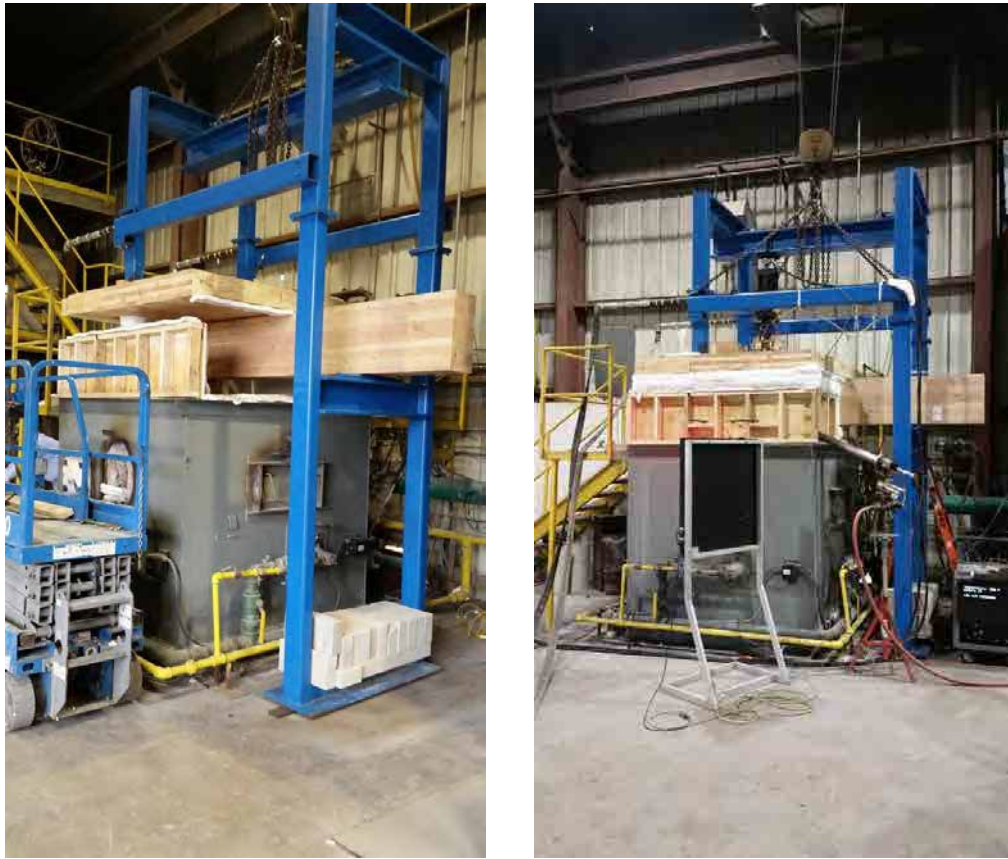
represent actual building conditions. A jack on the frame applies the load direct to the CLT floor, located over the beam end connection. The CLT floor also acts as the lid of the furnace. The applied load was determined from calculations carried out by Arup, based on an assumed structural grid for a typical office building.

Figure 2 – Test specimen in loading frame with CLT floor attached to beam, within upright furnace

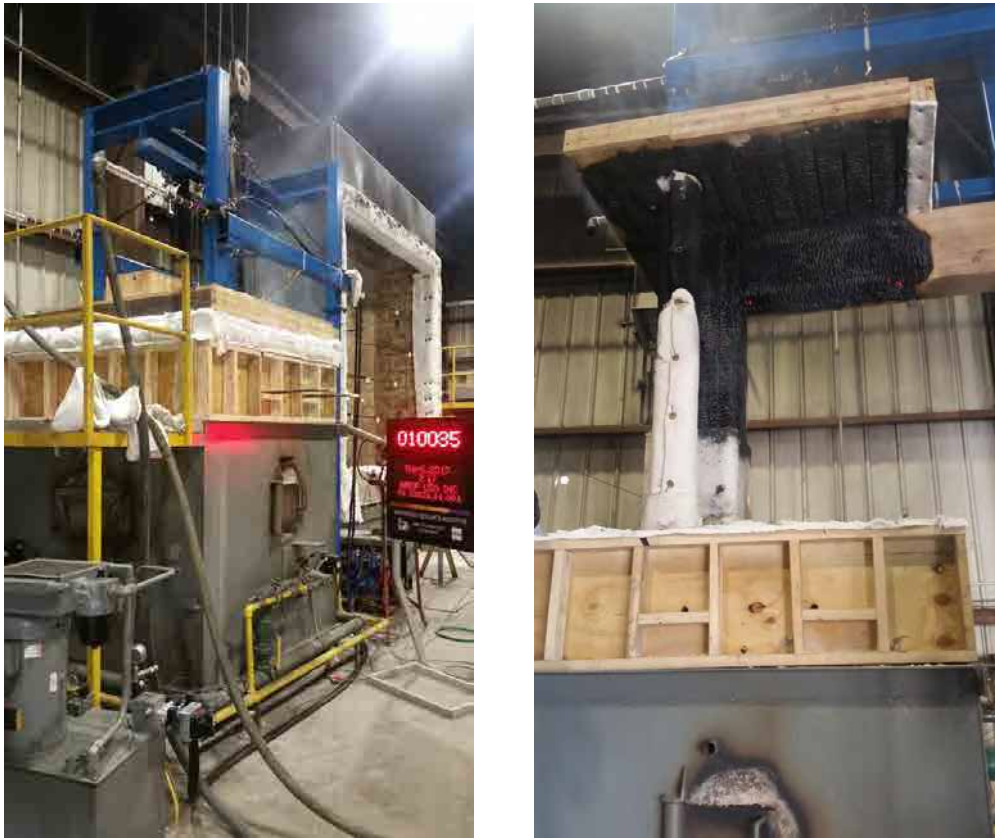
- Column: 16.5" (419mm) x 14.25" (362mm), beam located on 14.25" side
- Beam: 8.75" (222mm) x 18" (457mm) (width x height)
- Applied load at connector: 3,905lbs (17.4kN)
- Connector type: Single Ricon S VS 290x80 (this connector was not at capacity)
- Fire resistance rating achieved was 1hr

Figure 9 - Test 1 at 1hr and being removed from furnace

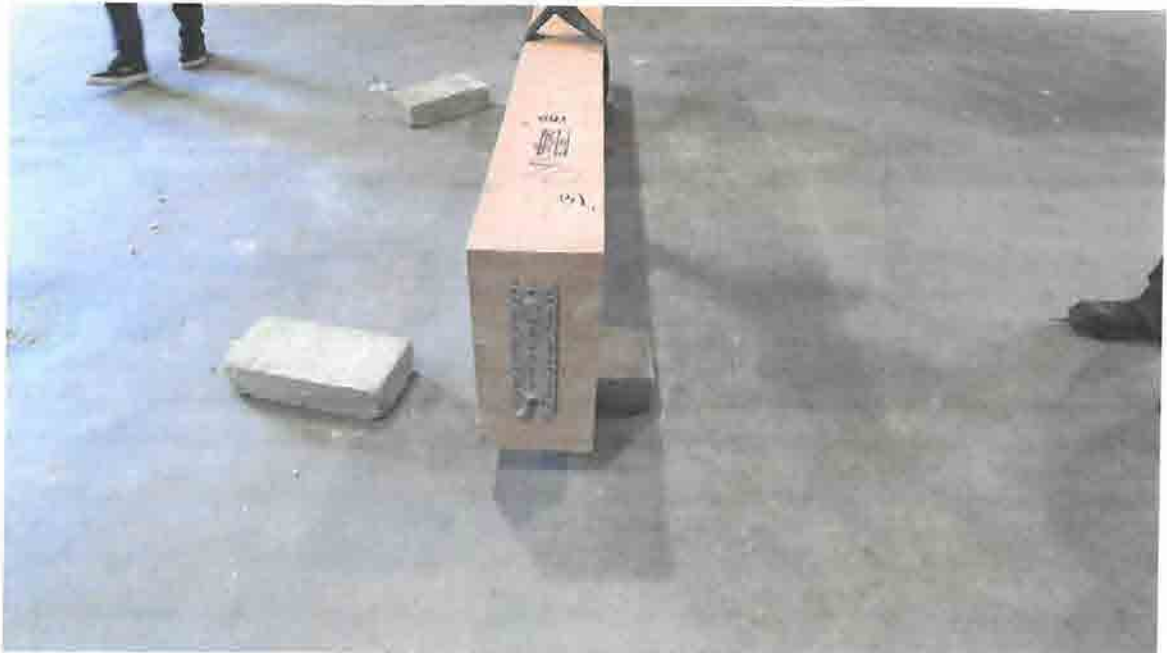
**Figure A-2. Beam Steel Connection Piece.**

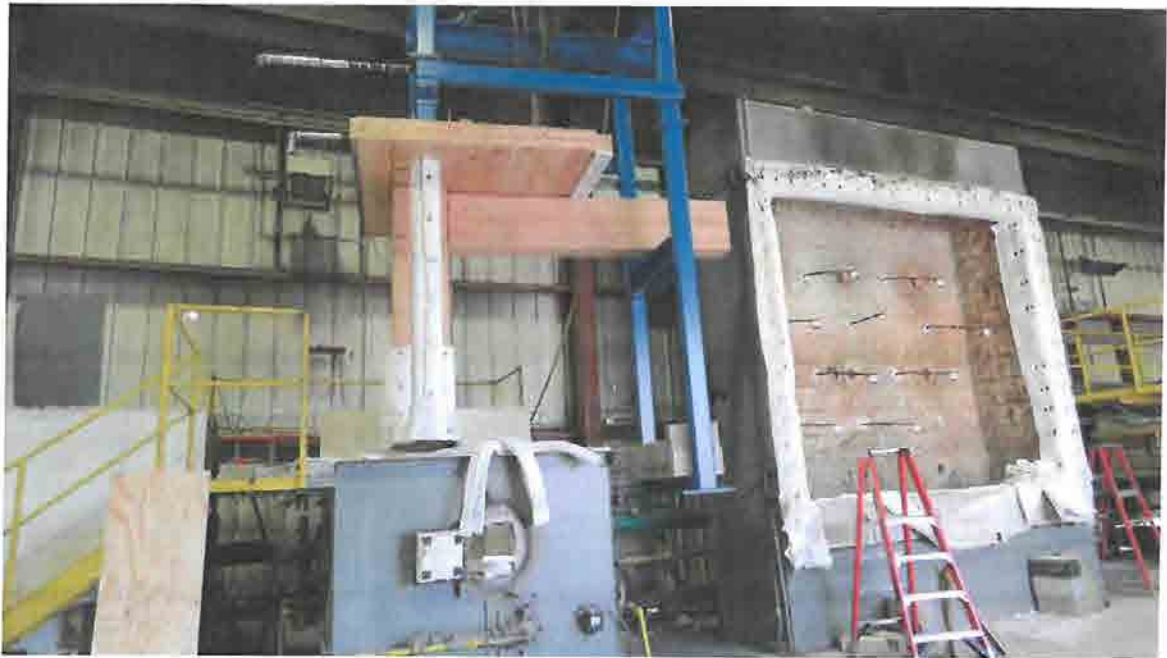
**Figure A-5. Test Article Installed in Self-Reacting Frame.**

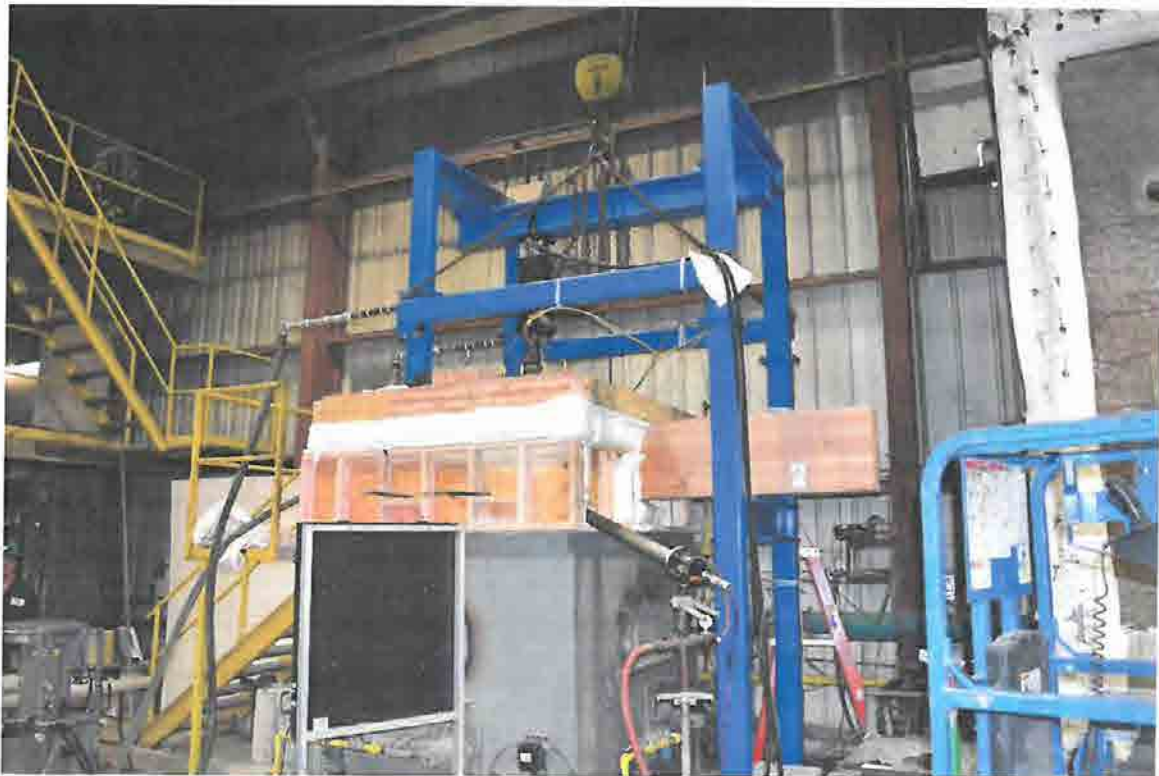
**Figure A-6. Test Assembly Placed Inside Furnace.**

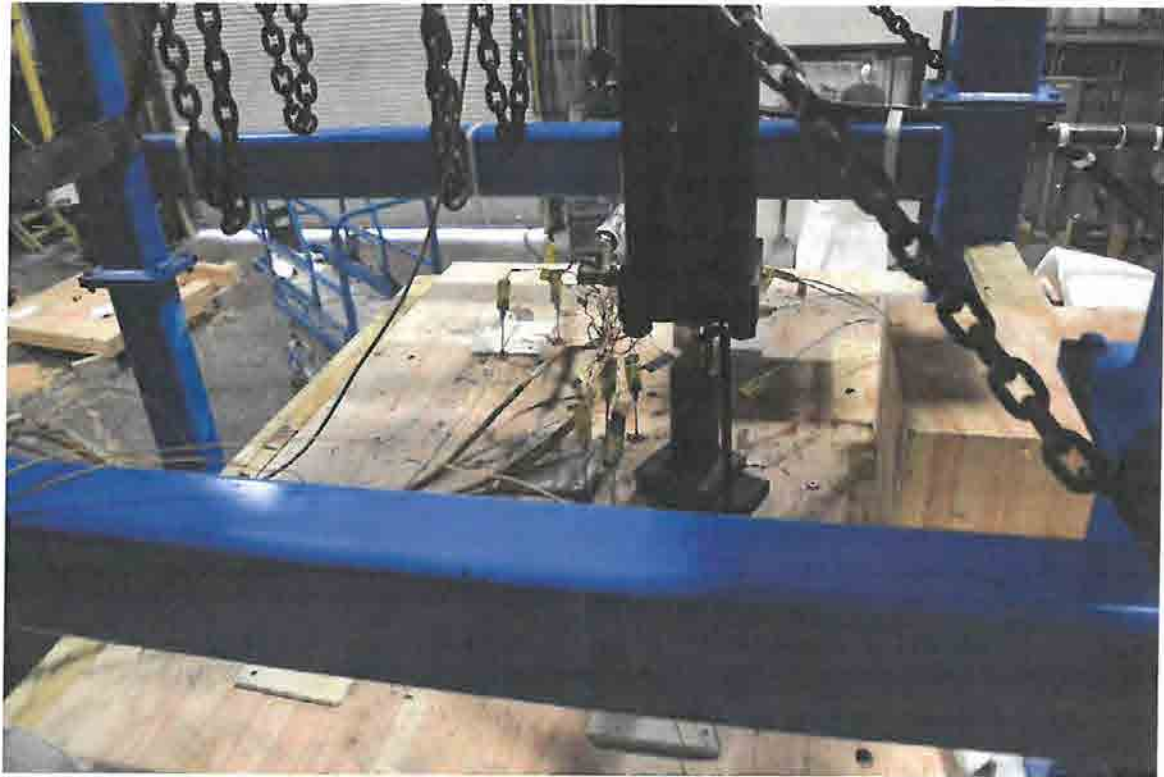
For application of the load a 5 × 6 × 1-in. steel plate was positioned on the top of the CLT panel and the load was applied to the steel plate. Assembly drawings, pictures, details of the test items and self-reacting load frame can be found in Appendix A.

**Figure A-7. Load Application Instrumentation.**

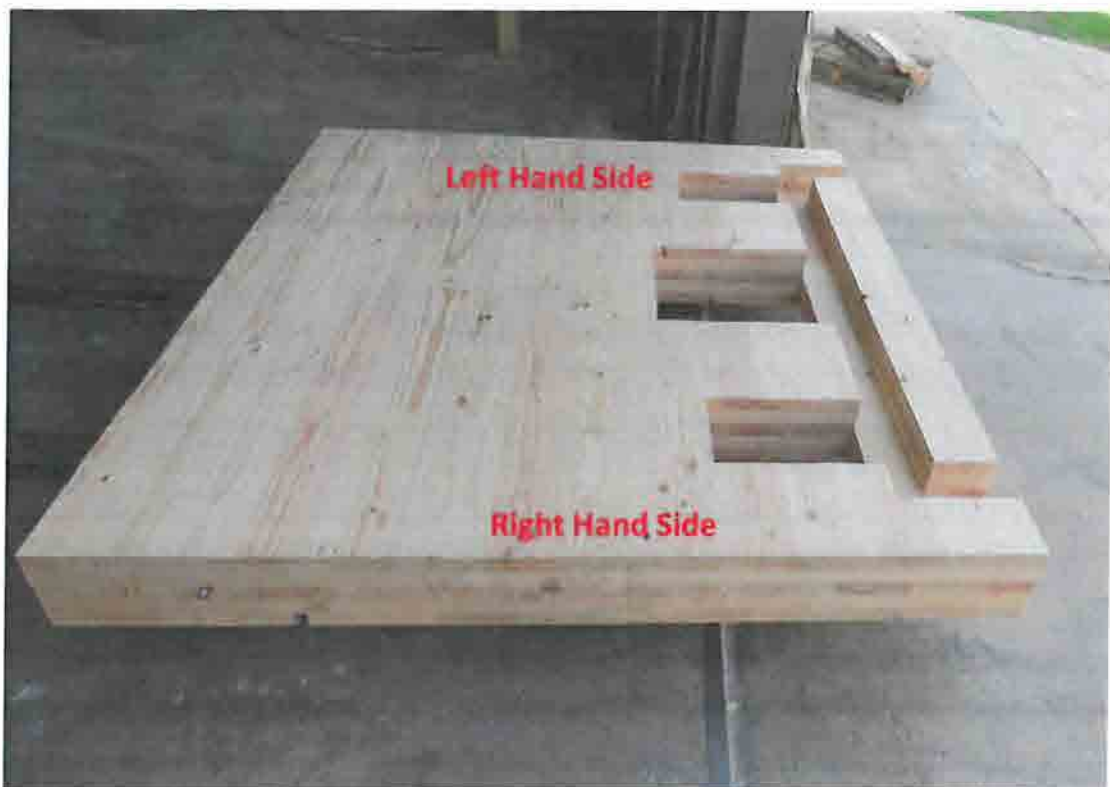
**Figure B-1. CLT Panel Orientation for Thermocouple Installation.**

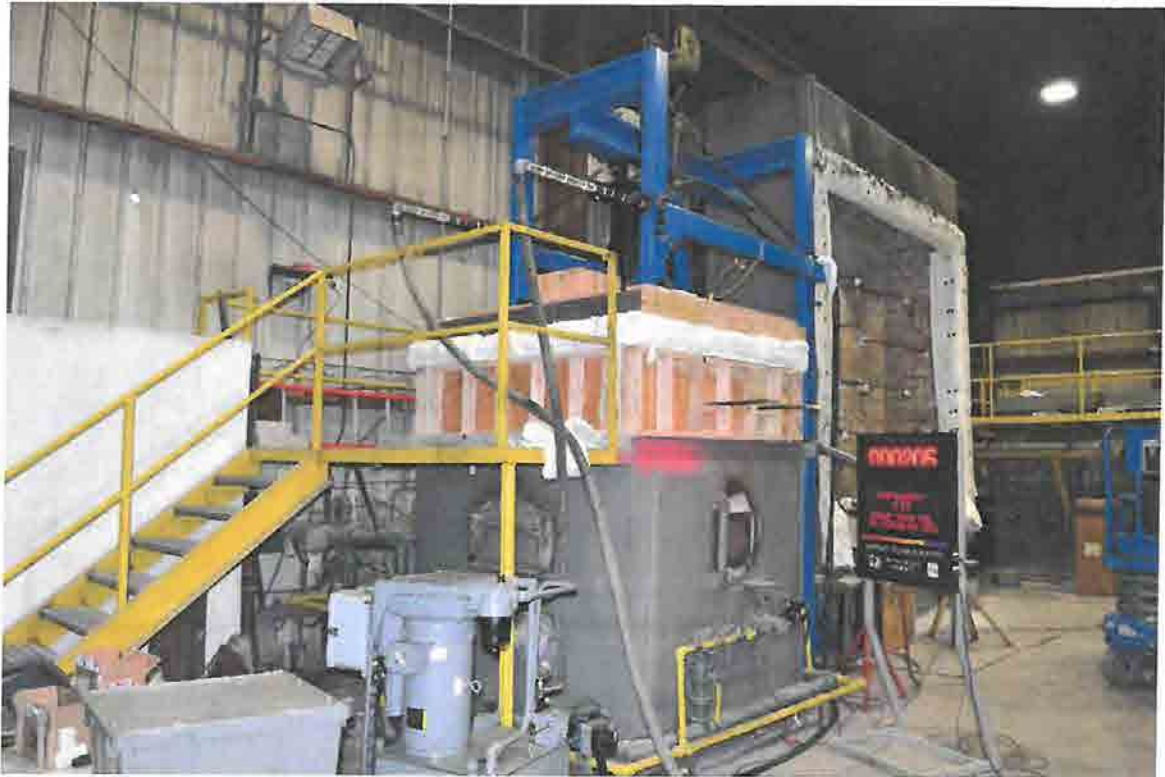
**Figure E-1. View of the Assembly and Applied Load Equipment at 2 min 5 s.**

<b>Time (min:s)</b>	<b>Observation</b>
	Pre-test application of the 4,890 lb.
0:00	Start of test, furnace ignited and data acquisition initiated, deflection measurement is zero before the start of the test.
2:00	Wood has ignited.
4:40	Furnace gas is controlled to idle.
15:00	No issues.
30:00	Slight creep in deflection.
42:40	Load signal lost; signal line damaged by furnace exhaust; repaired with no effects on load.
60:00	Beam continues to hold load.
61:00	Test is terminated.

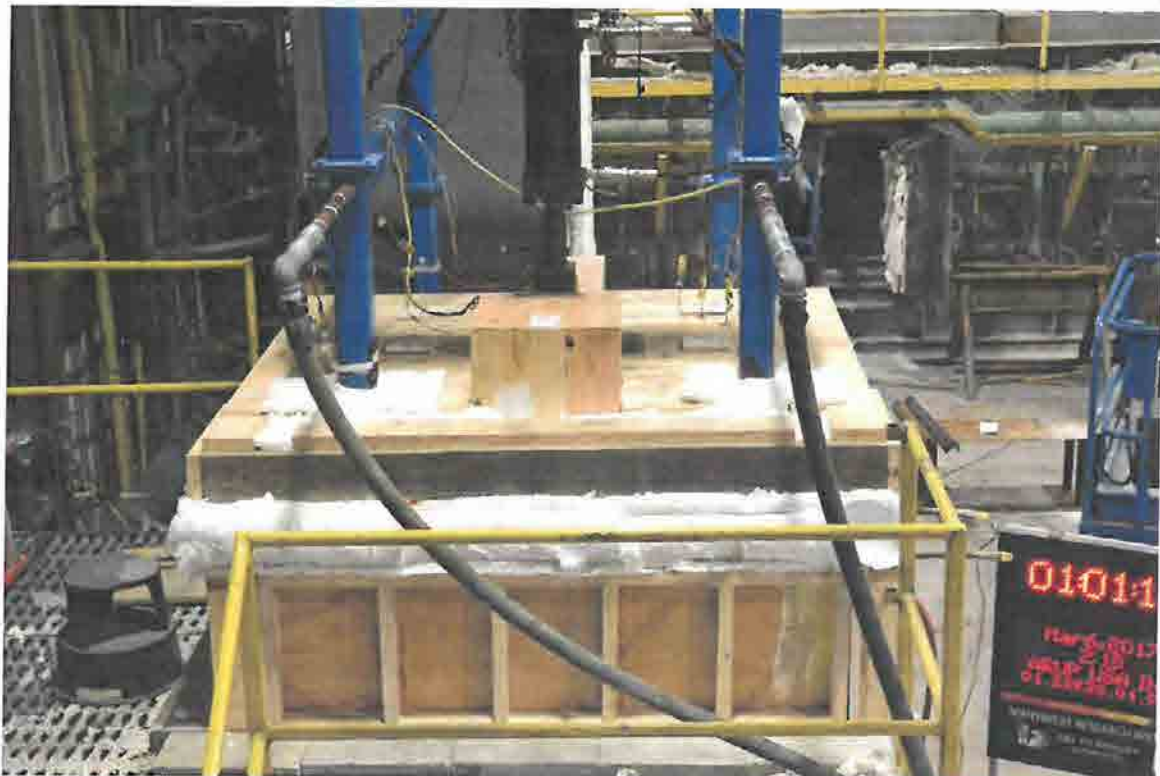
**Figure E-2. View of the Test Assembly at 1 h 1 min.**

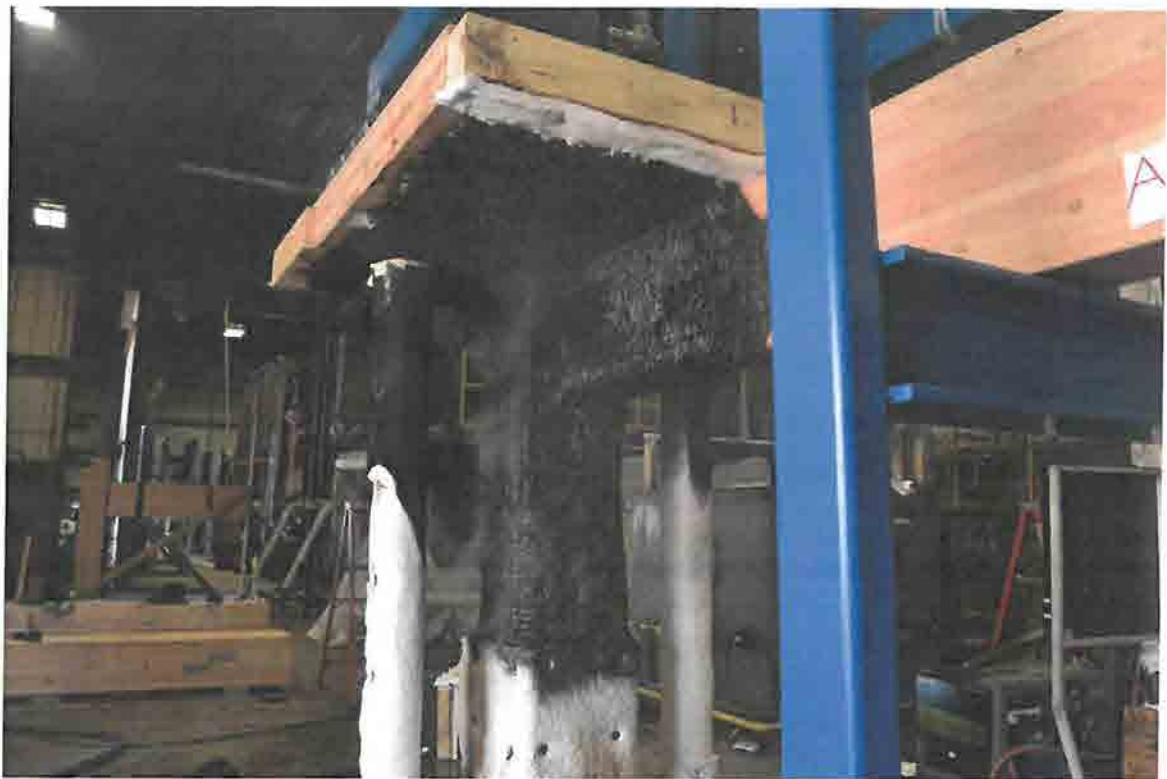
**Figure E-3. View of the Assembly immediately after Testing.**

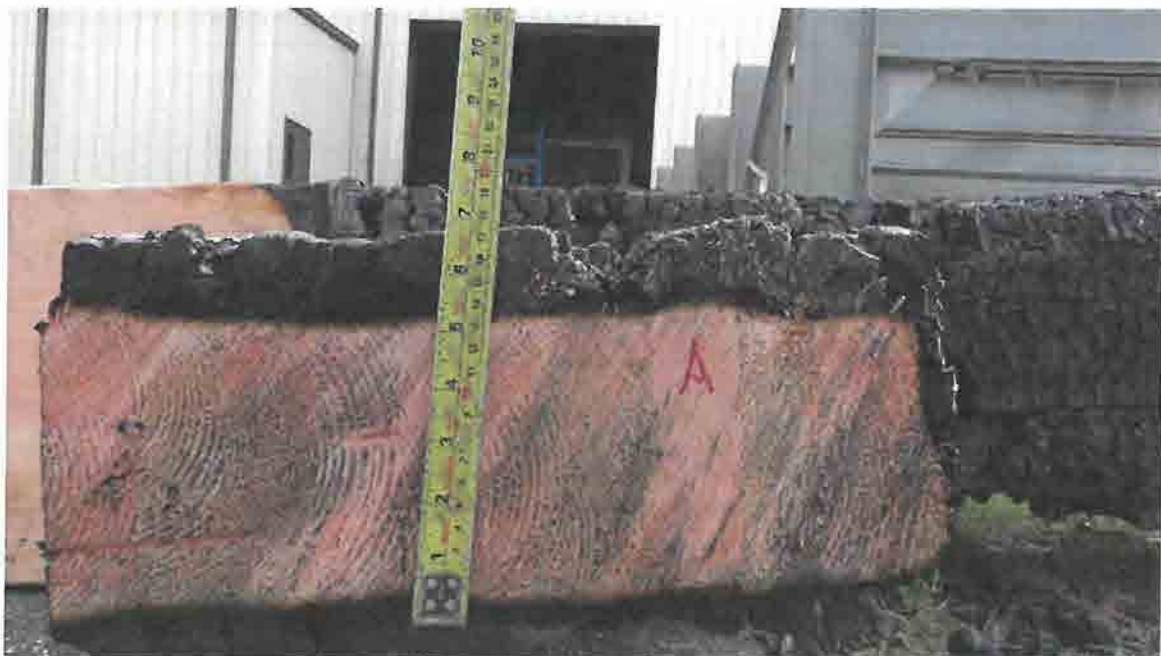
**Figure E-5. Post Test Pictures of the Beam.**

After the tested assembly was removed from the furnace and steel reaction load frame, a chainsaw was used to cut a cross section in the thinnest area of the column and beam. Table 3 provides the measurements of the locations and pictures can be found in Appendix D.

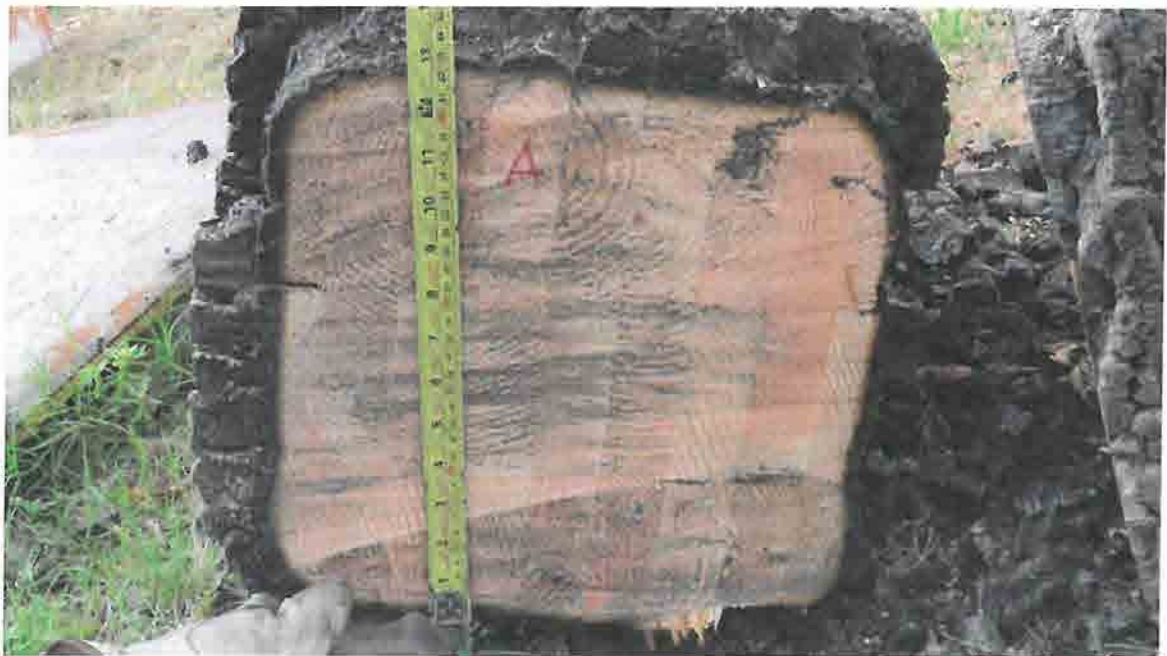
**Figure E-7. Post Test Picture of the Cut Column.**

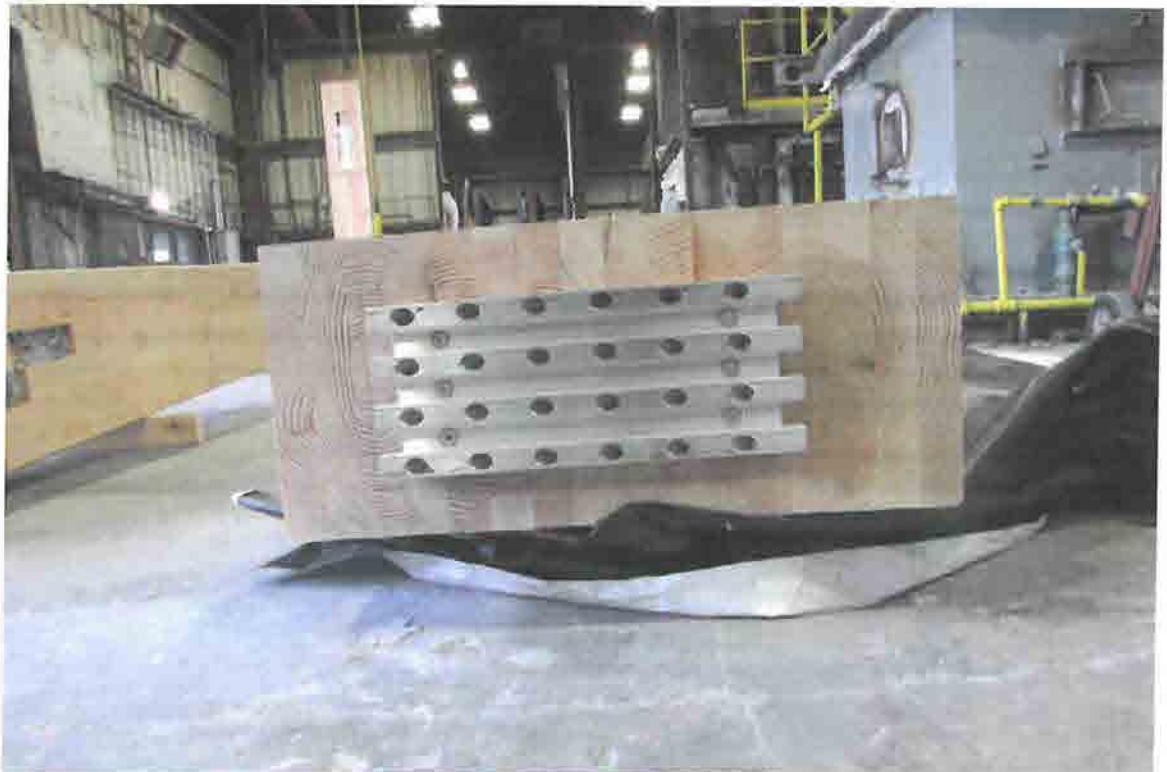
**Figure A-2. Beam Steel Connection Piece.**

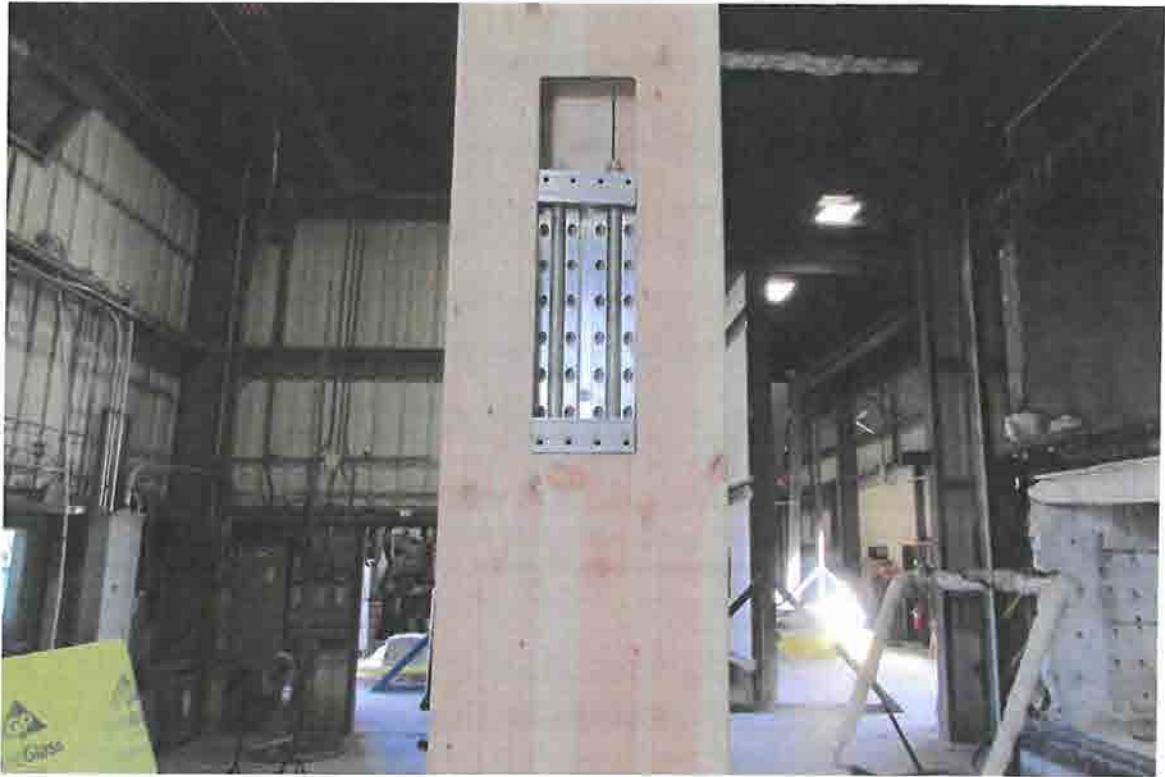
**Figure A-3. Column Steel Connection Piece.**

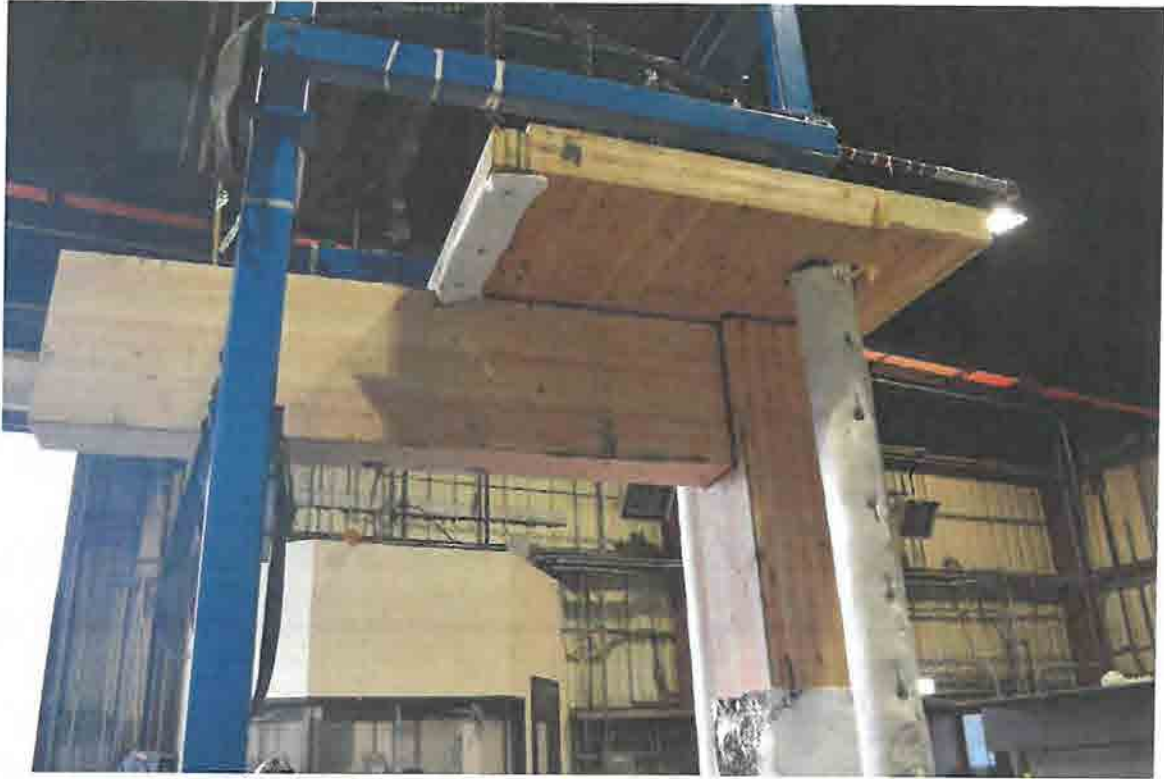
**Figure A-5. Test Article Installed in Self-Reacting Frame.**

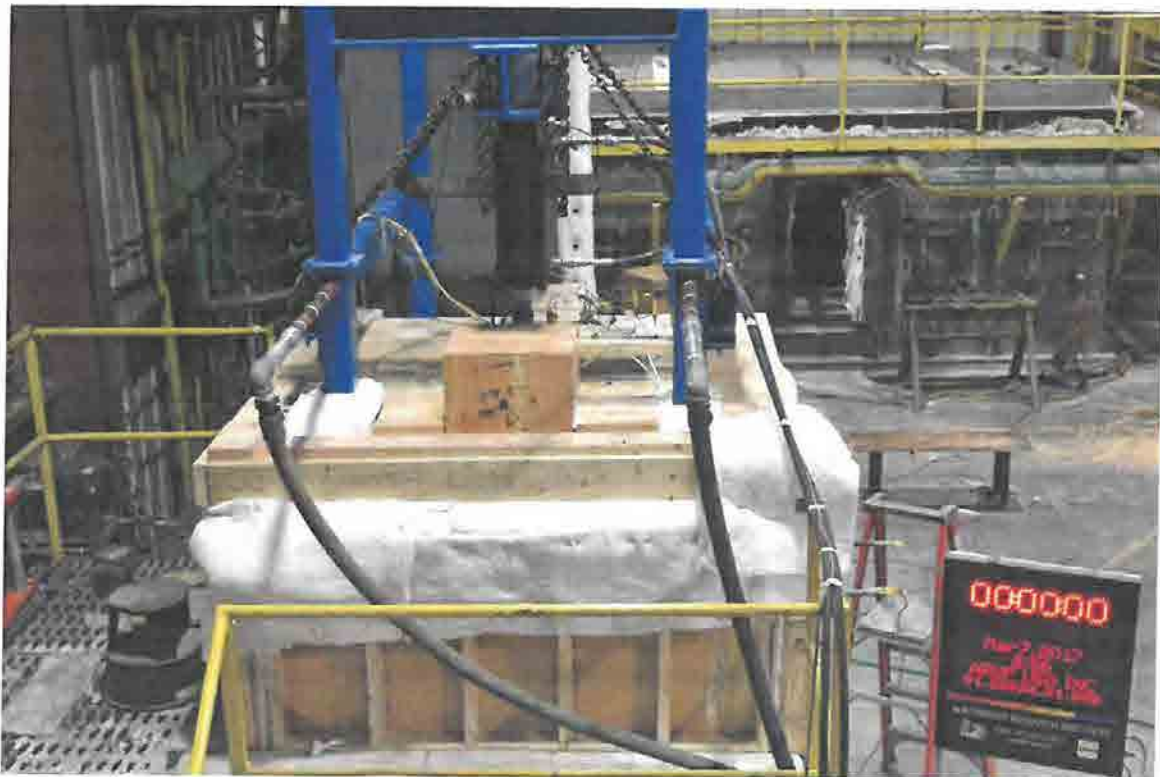
**Figure A-6. Test Assembly Instrumented and Placed Inside Furnace.**

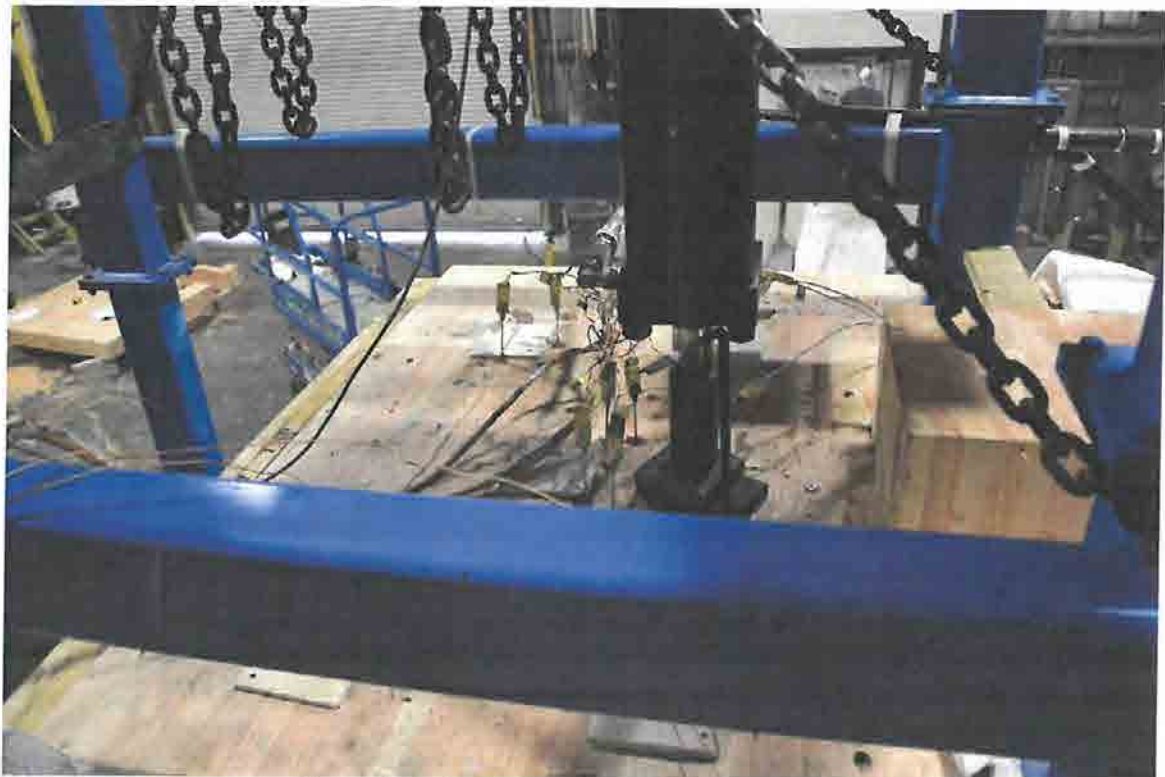
**Figure A-7. Load Application Instrumentation.**

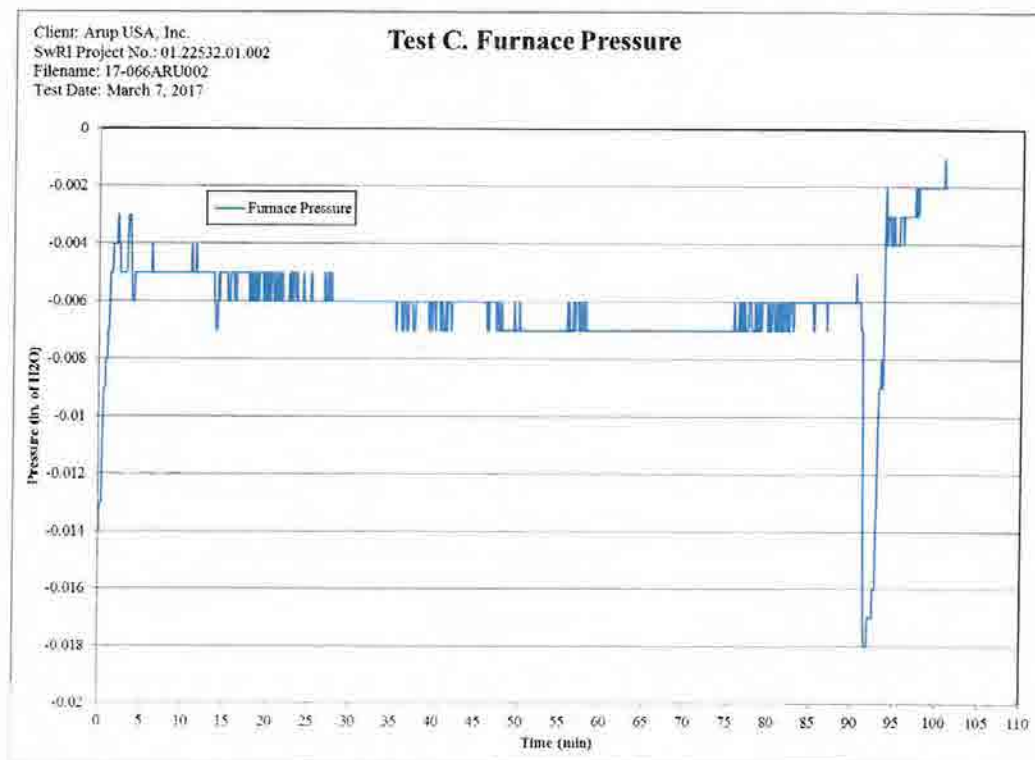
Figure D-6. Test C: Furnace Pressure.

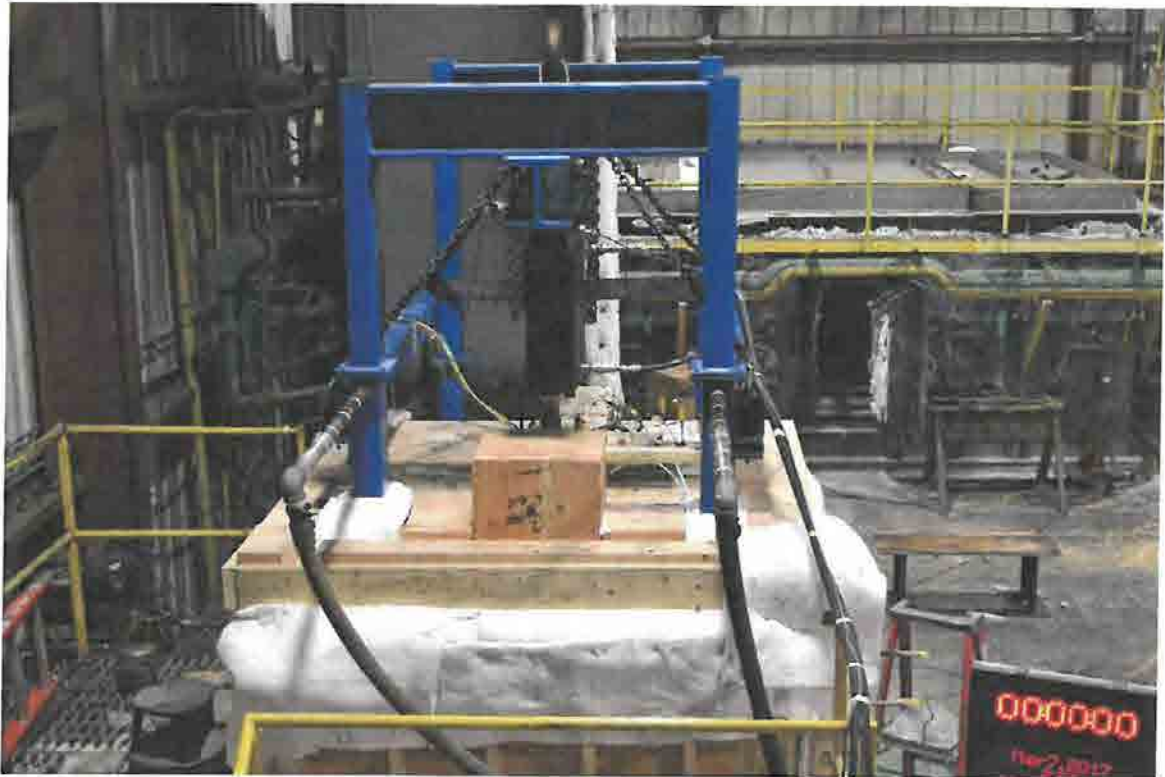
**Figure E-1. View of the Assembly and Applied Load Equipment at Start of Test.**

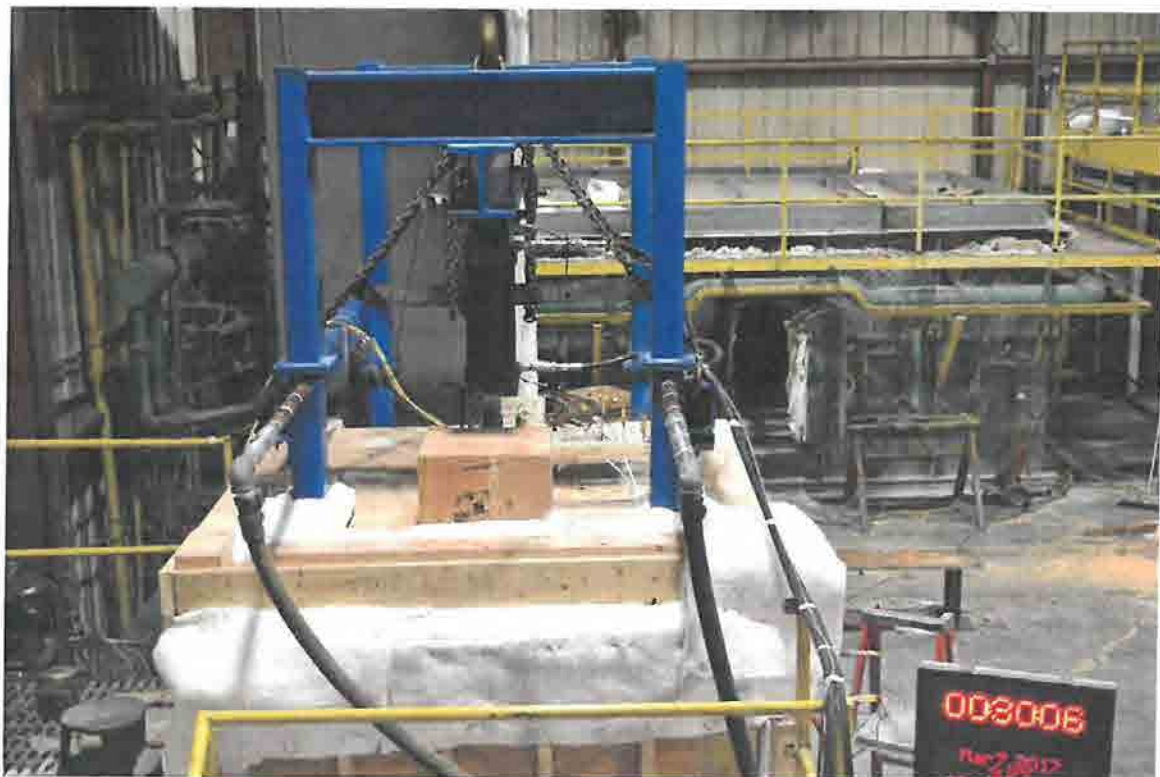
**Figure E-2. View of the Test Assembly at 30 min 6 s.**

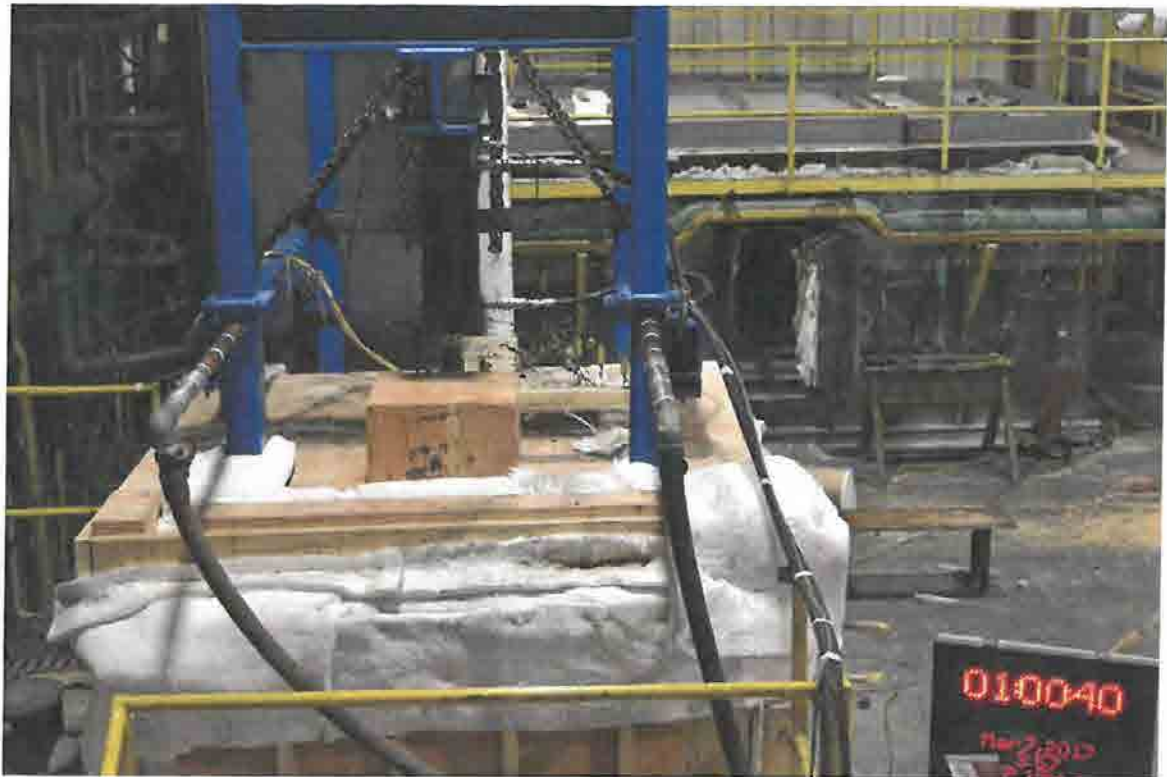
Figure E-3. View of the Test Assembly at 1 h 40 s.

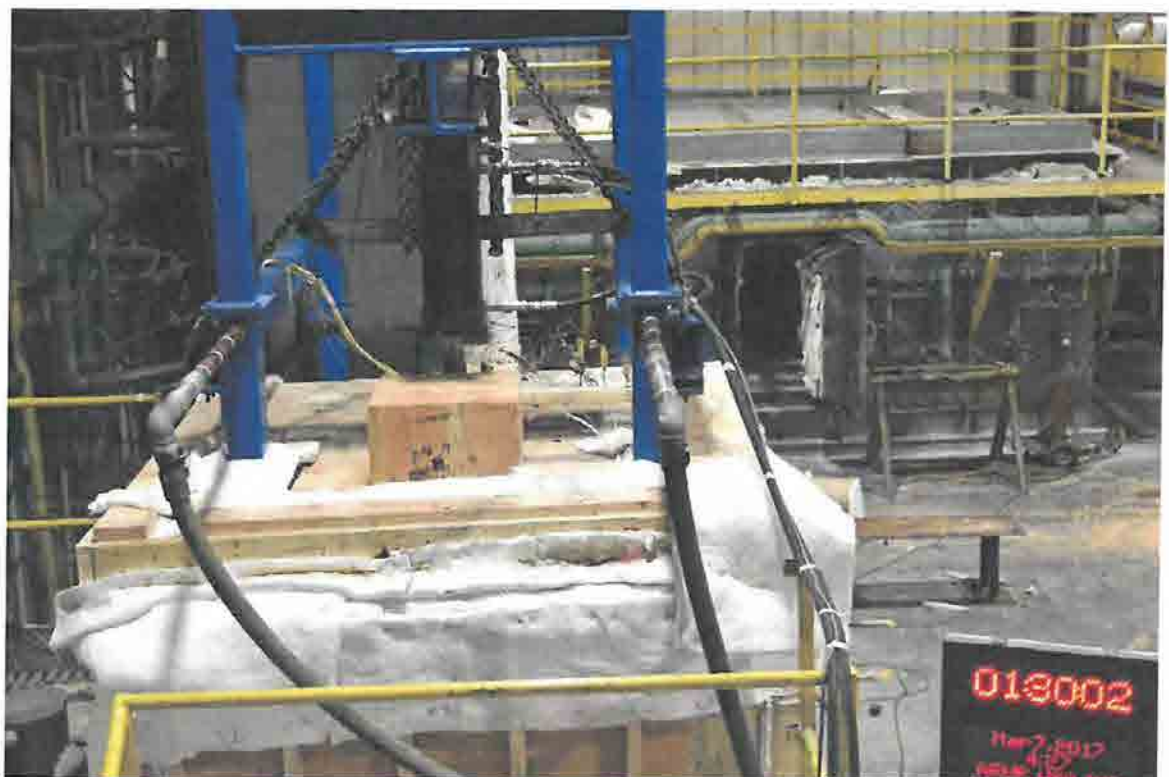
Figure E-4. View of the Test Assembly at 1 h 30 min.

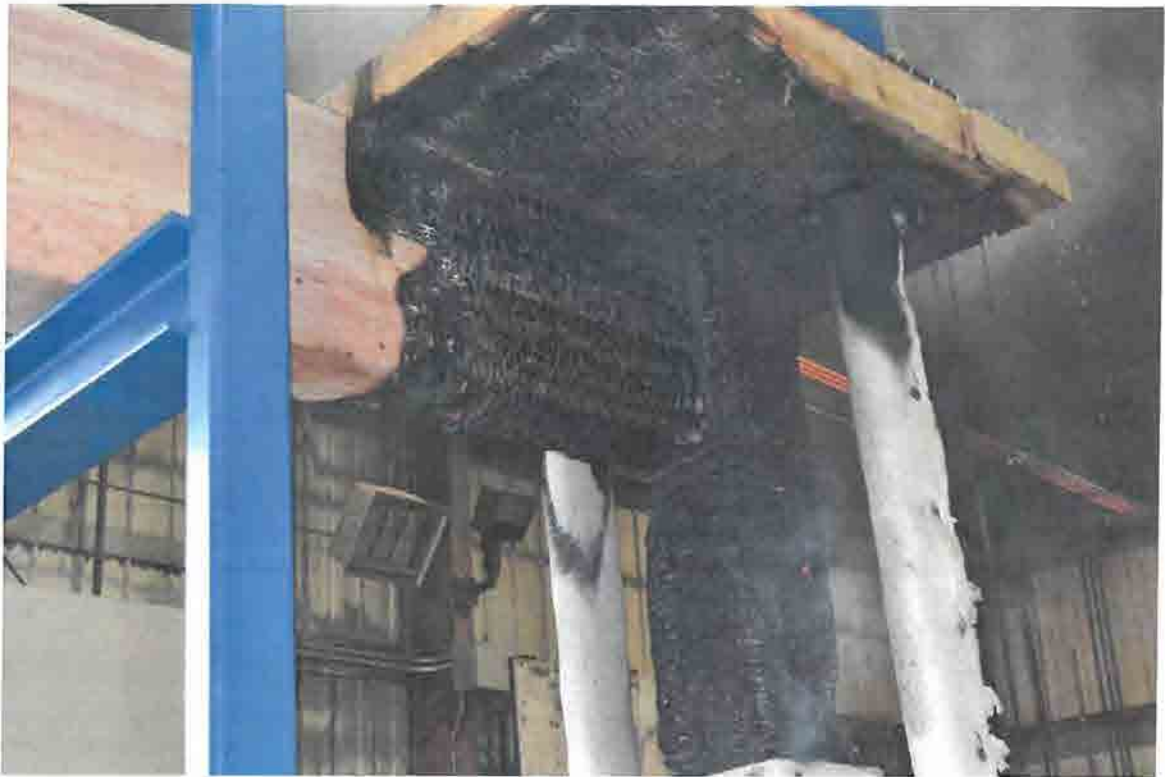
**Figure E-5. View of the Test Assembly Immediately after Testing.**

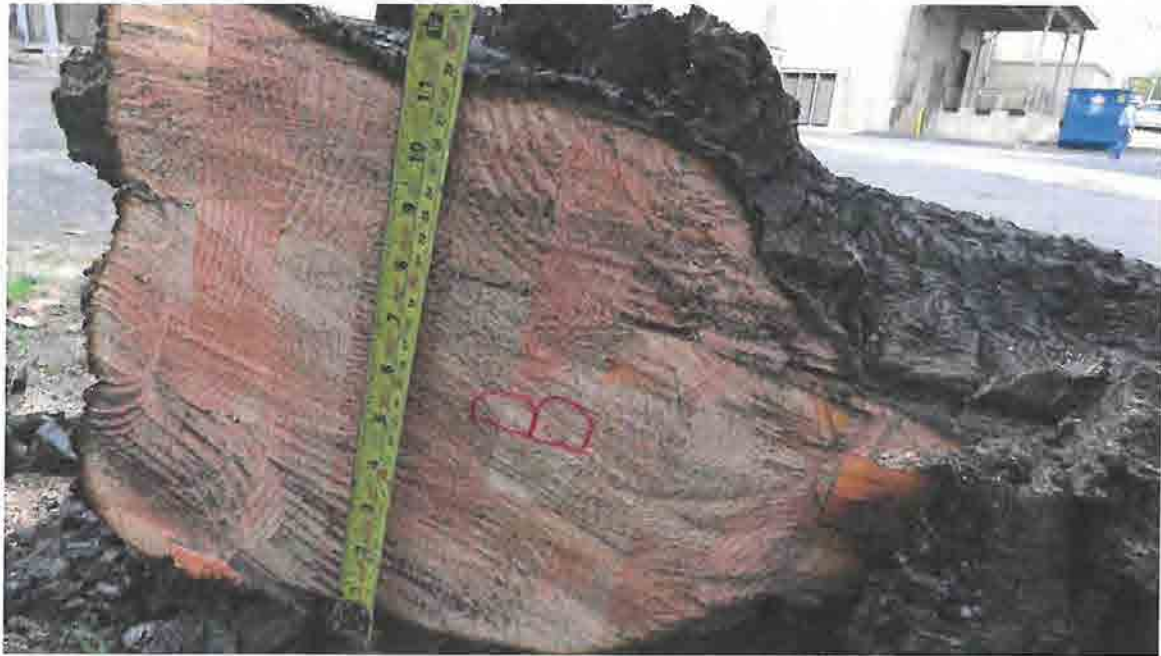
**Figure E-7. Post Test Picture of the Cut Column (Misabeled B, Should be C).**

After the tested assembly was removed from the furnace and steel reaction load frame, a chainsaw was used to cut a cross section in the thinness area of the column and beam. Table 3 provides the measurements of the locations and pictures can be found in Appendix D.

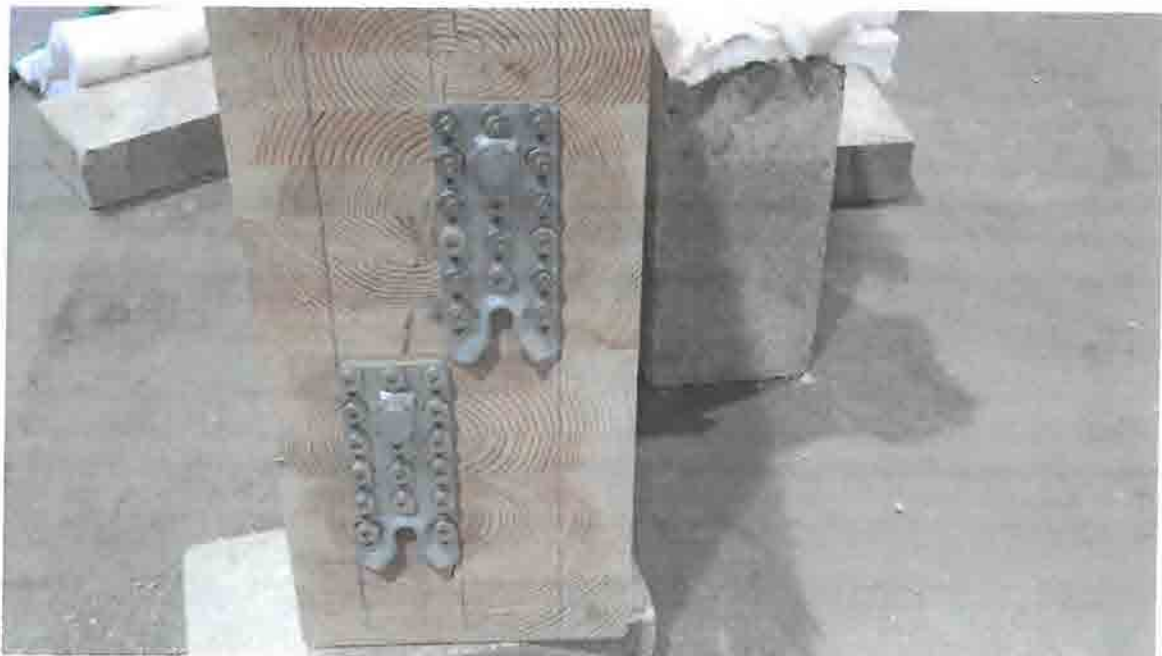
**Figure A-2. Beam Steel Connection Piece.**
