### APPEAL SUMMARY

# Softwood Lumber Board **Glulam Connection Fire Test** Summary Report

# PAE Living Building

## Engineering Judgment Report #4

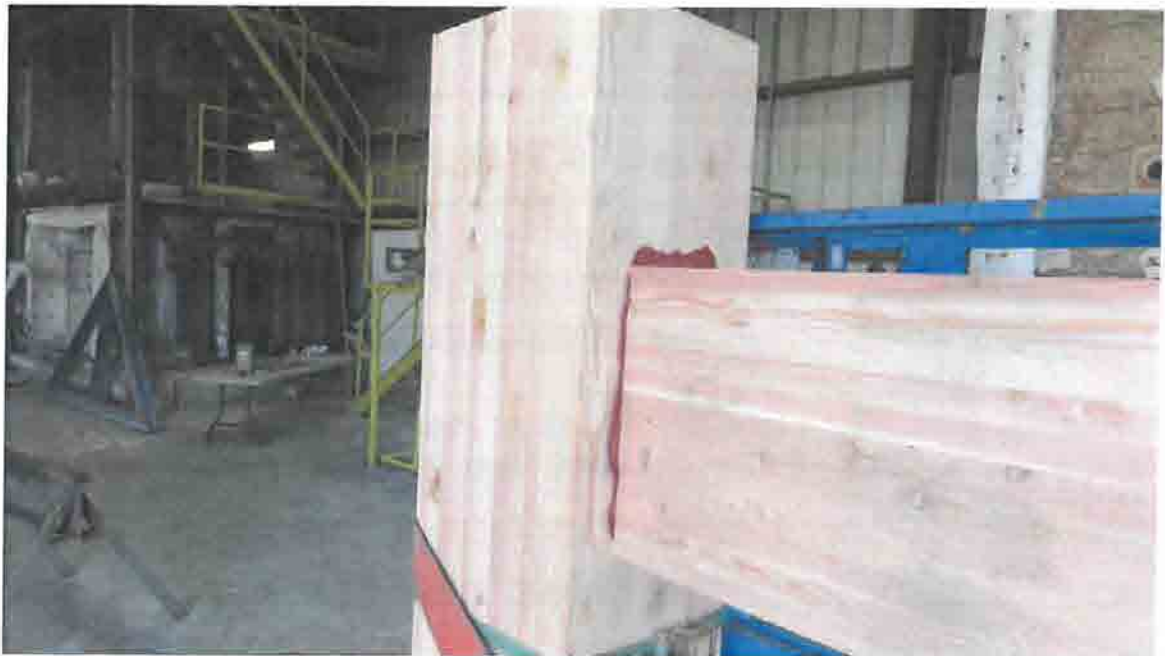
**Figure A-4. Typical Beam and Column Connection.**

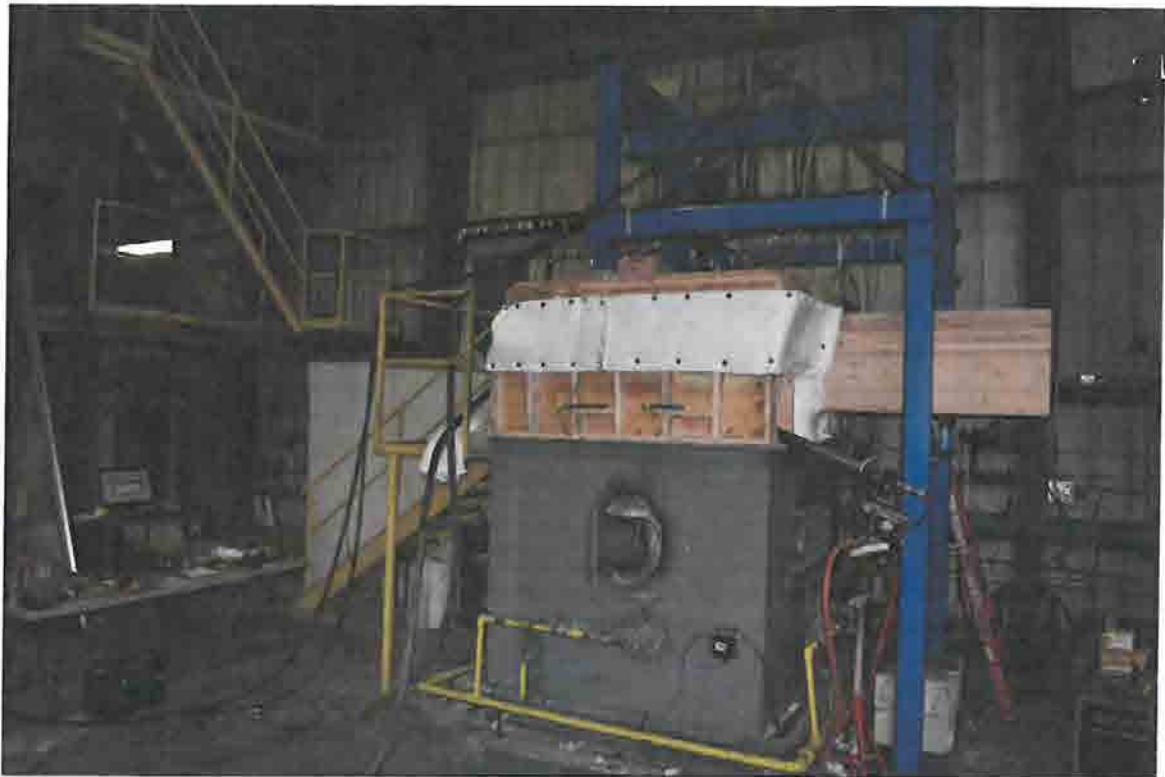
**Figure A-5. Test Assembly Instrumented and Placed Inside Furnace.**

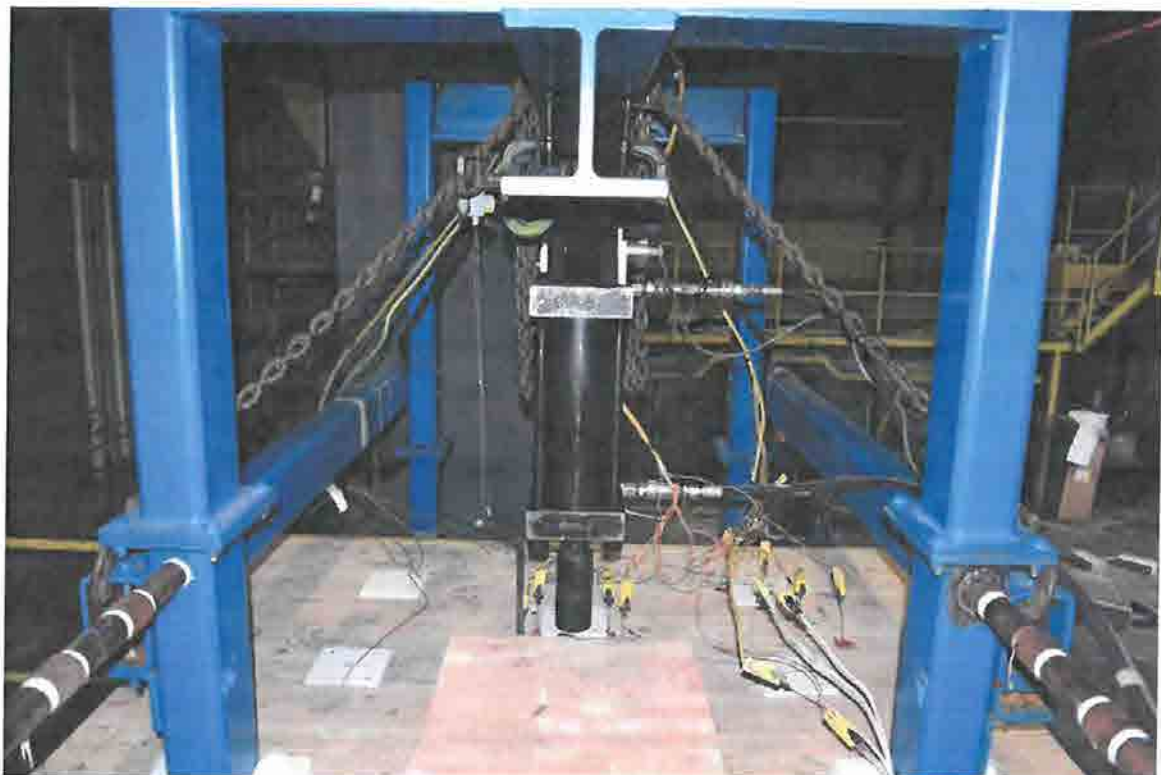
**Figure A-6. Load Application Instrumentation.**

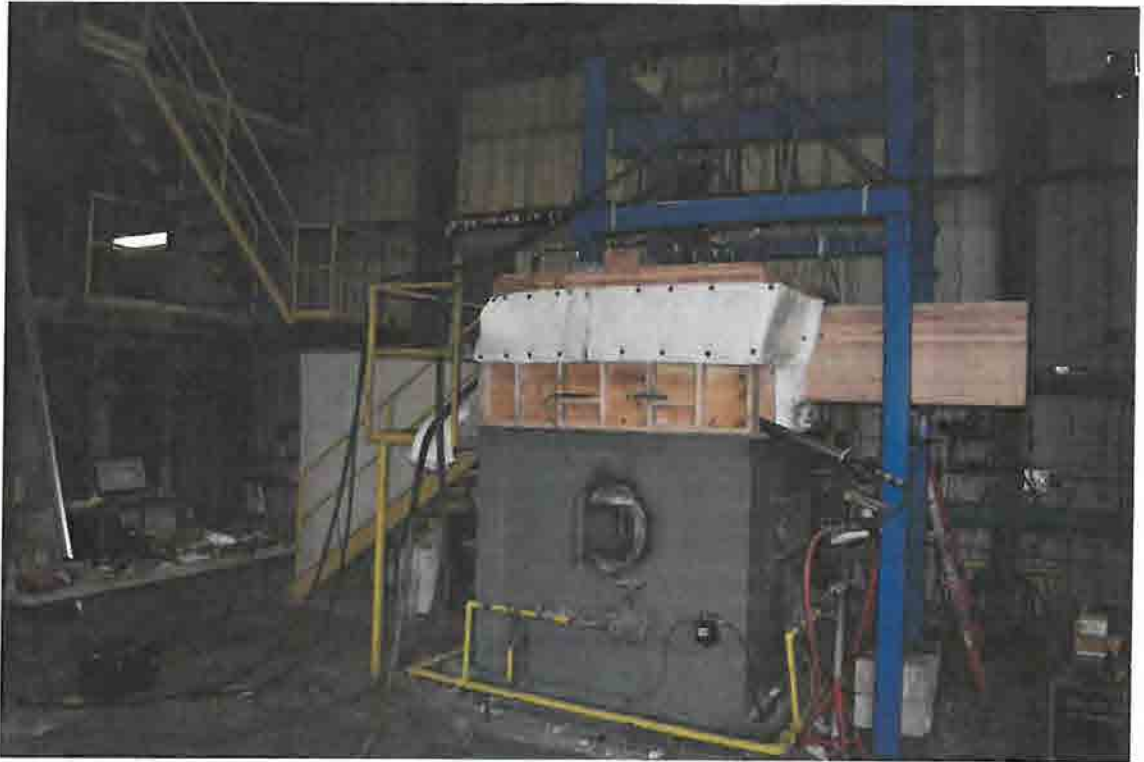
**Figure E-1. View of Test Assembly at Start of Test.**

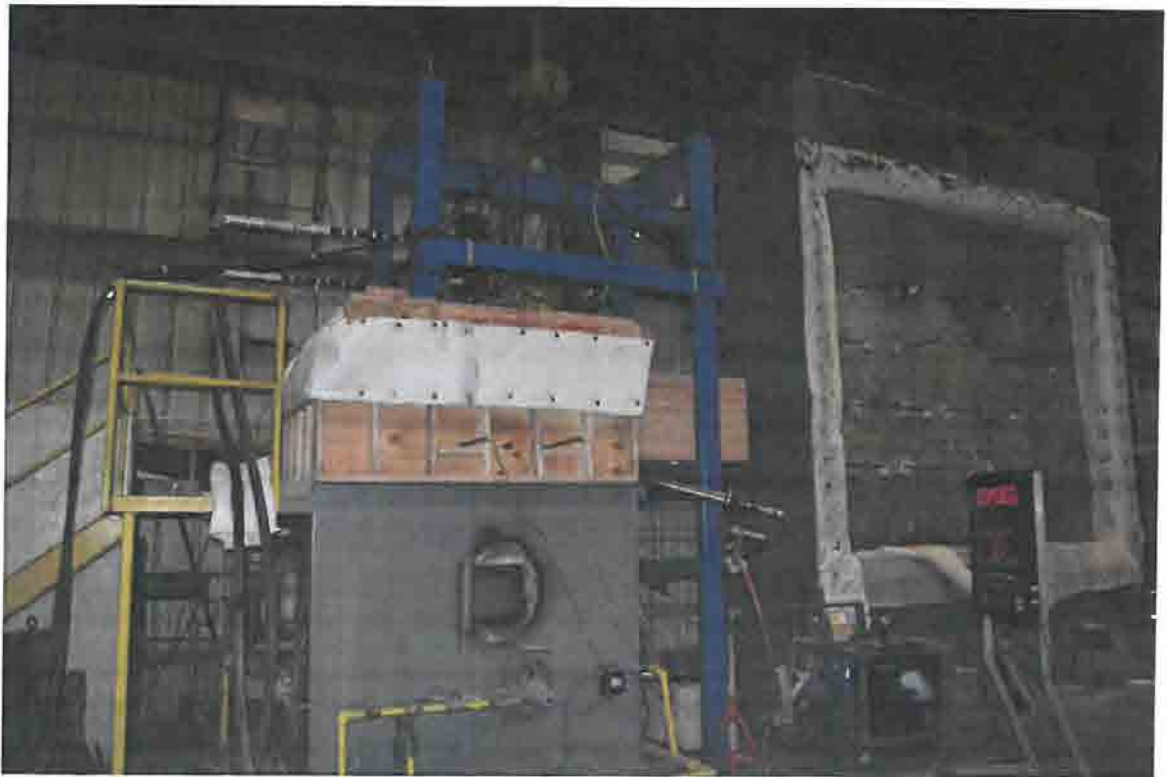
**Figure E-2. View of Test Assembly at 43 min.**

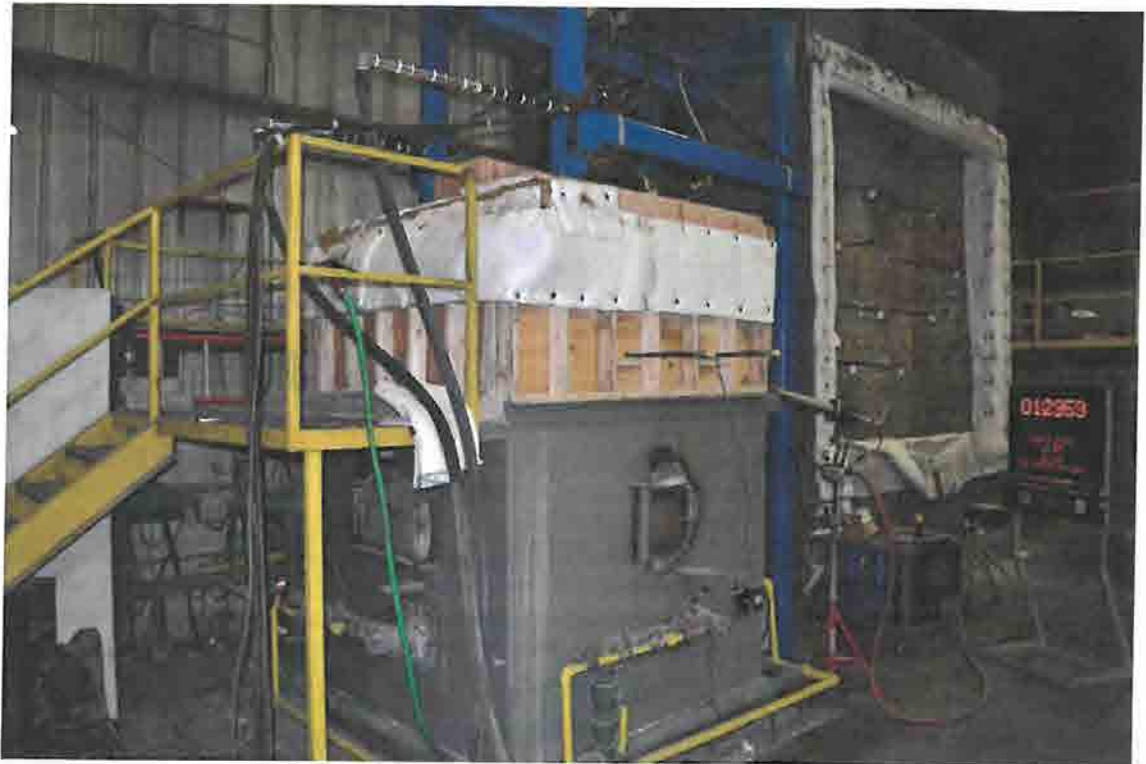
**Figure E-3. View of the Assembly at 1 h 30 min.**

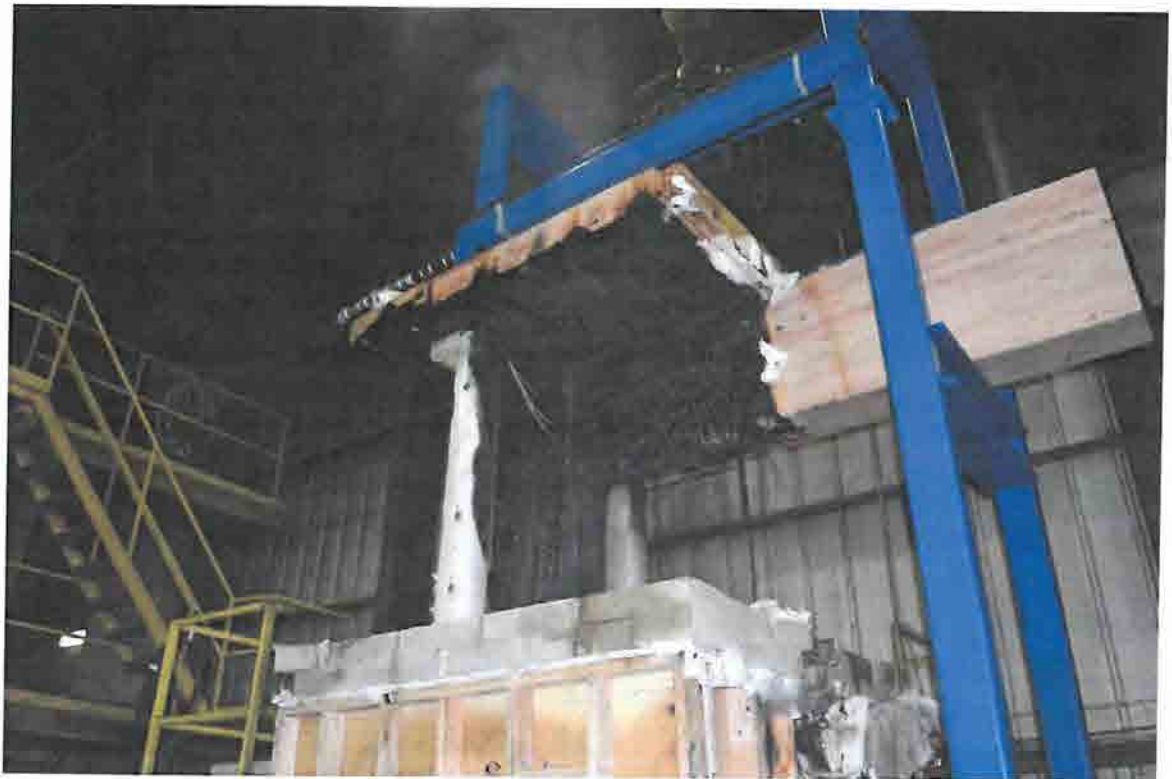
**Figure E-4. View of Connection immediately after Test.**

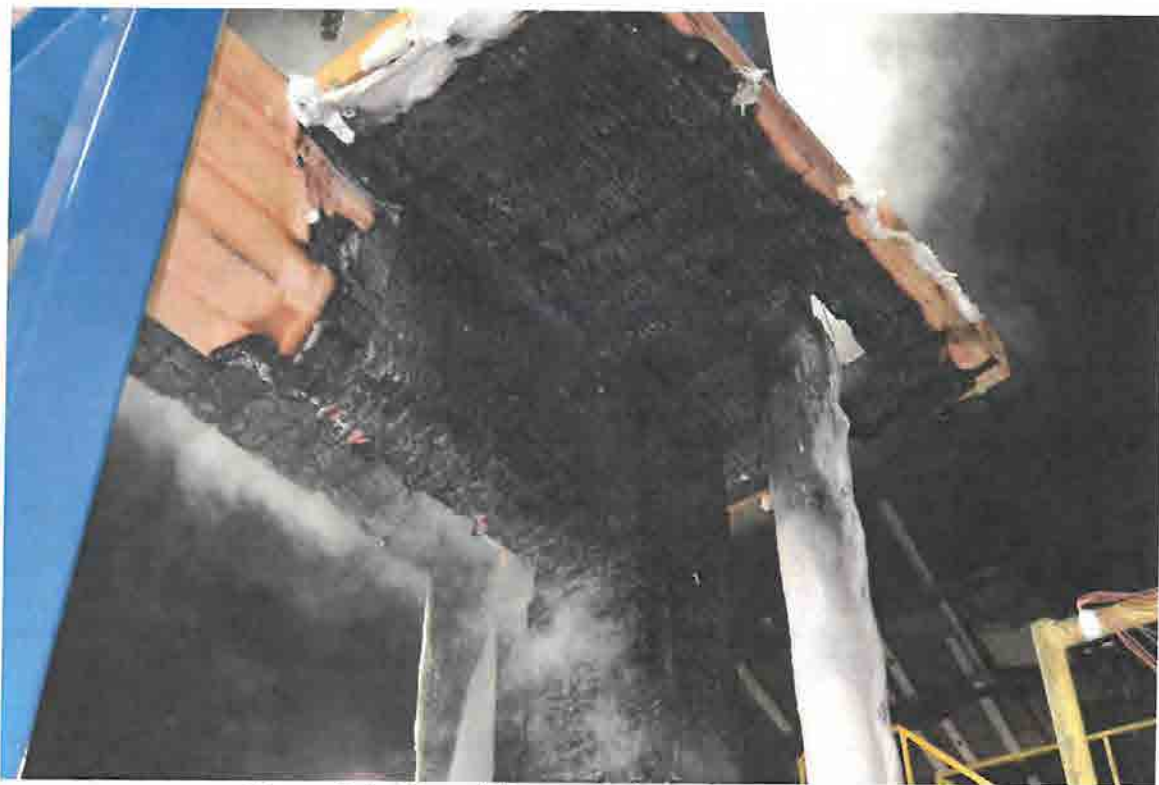
**Figure E-5. View of Connection immediately after Test.**

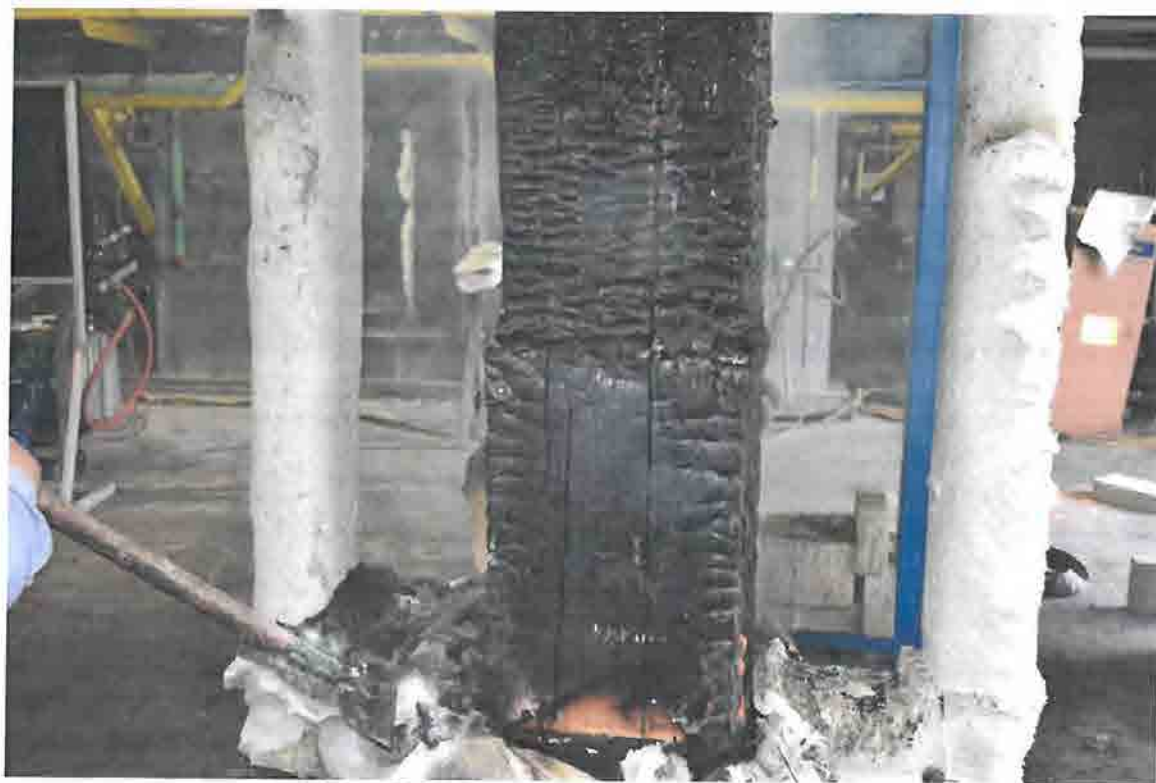
**Figure E-6. Base of Beam after Fire Exposure.**

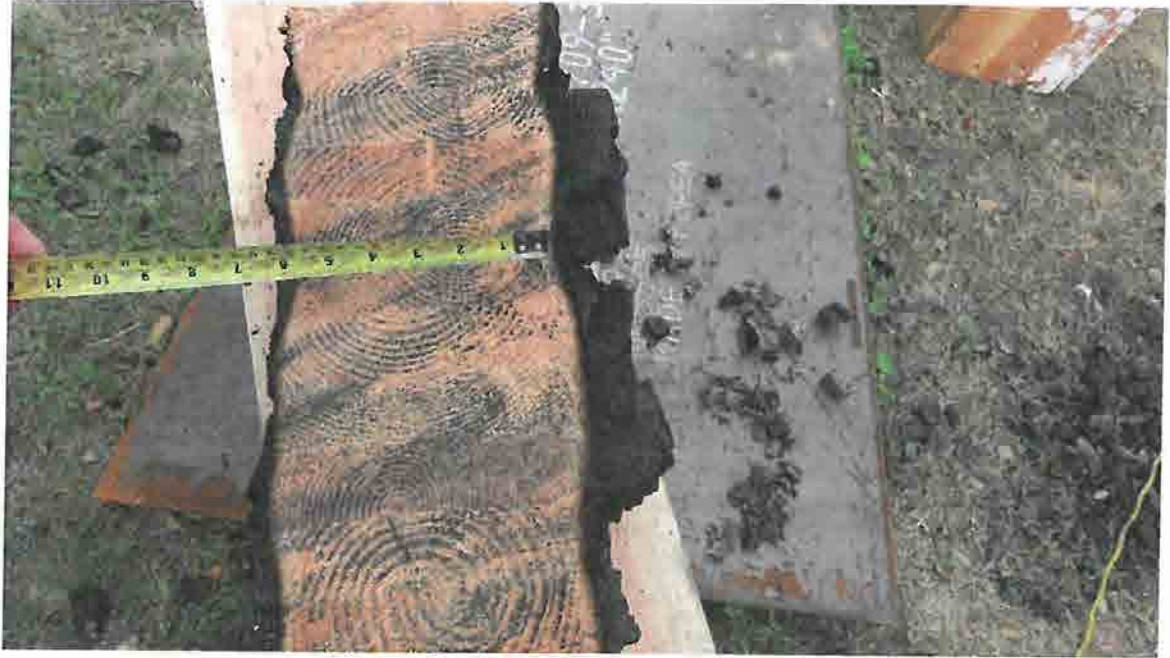
**Figure E-7. Post Test Picture of the Beam.**

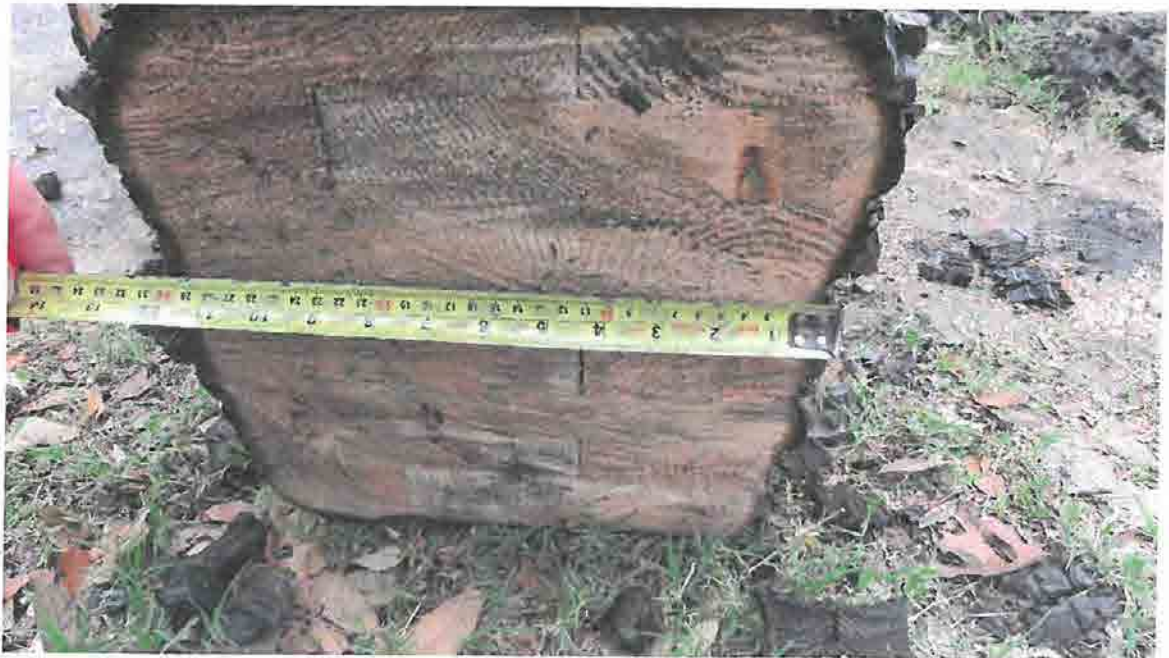
**Figure E-6. Post Test Picture of the Column.**

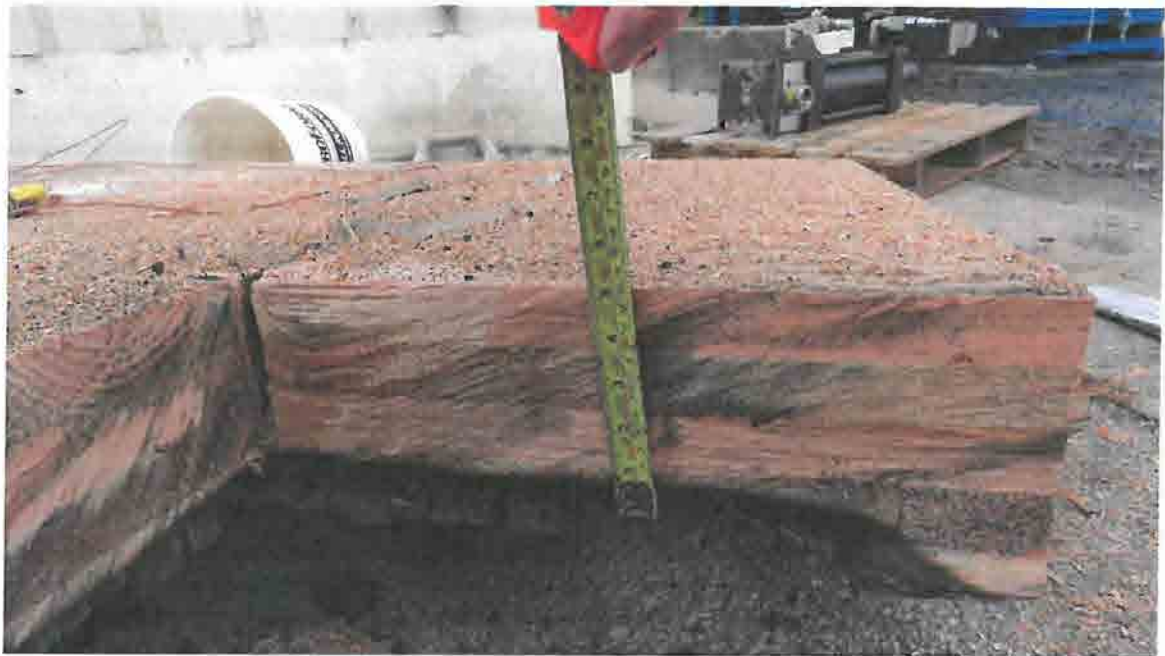
**Figure E-7. Post Test Picture of the CLT Panel.**
