# **Data Evaluation Report**

## **Inline Solids in Basins M-1 and 18**

Prepared for  
**City of Portland**  
**Bureau of Environmental Services**  
**Portland Harbor Source Control Pilot Project**

December 2005

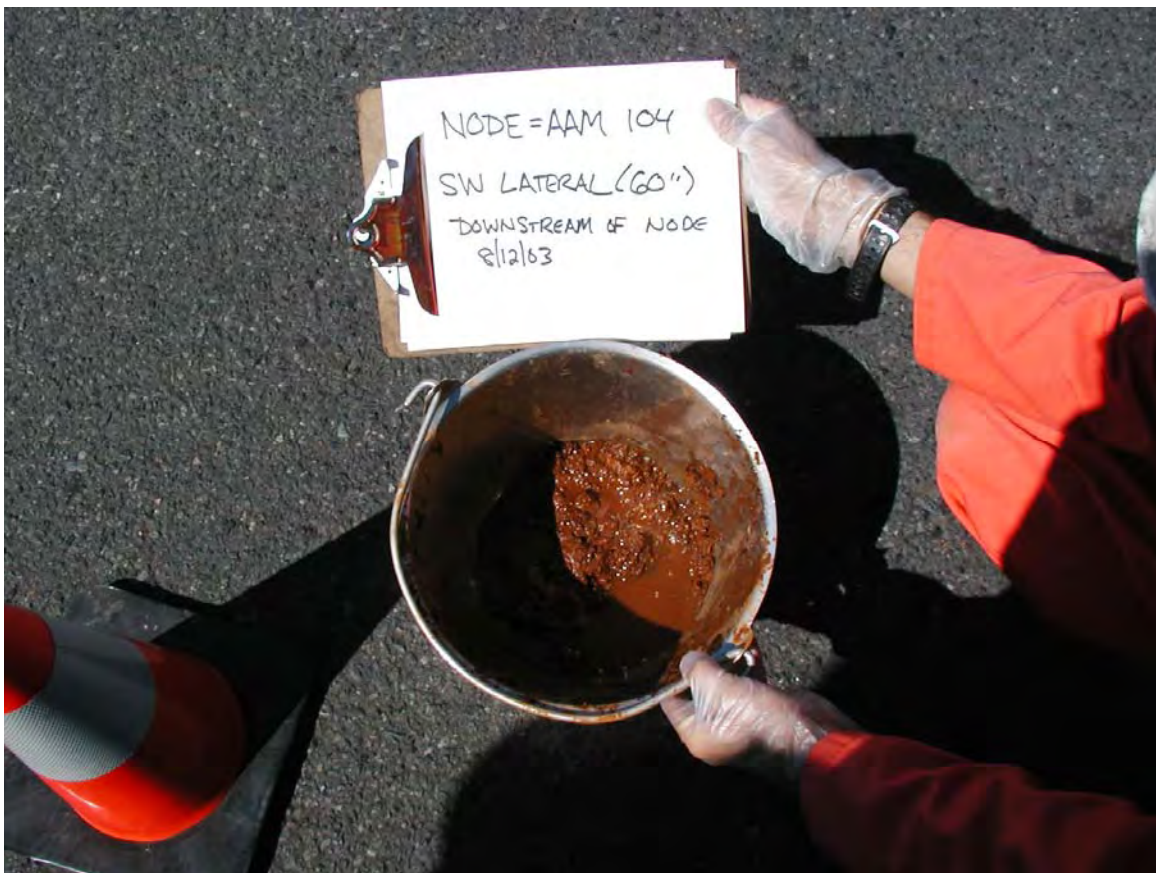
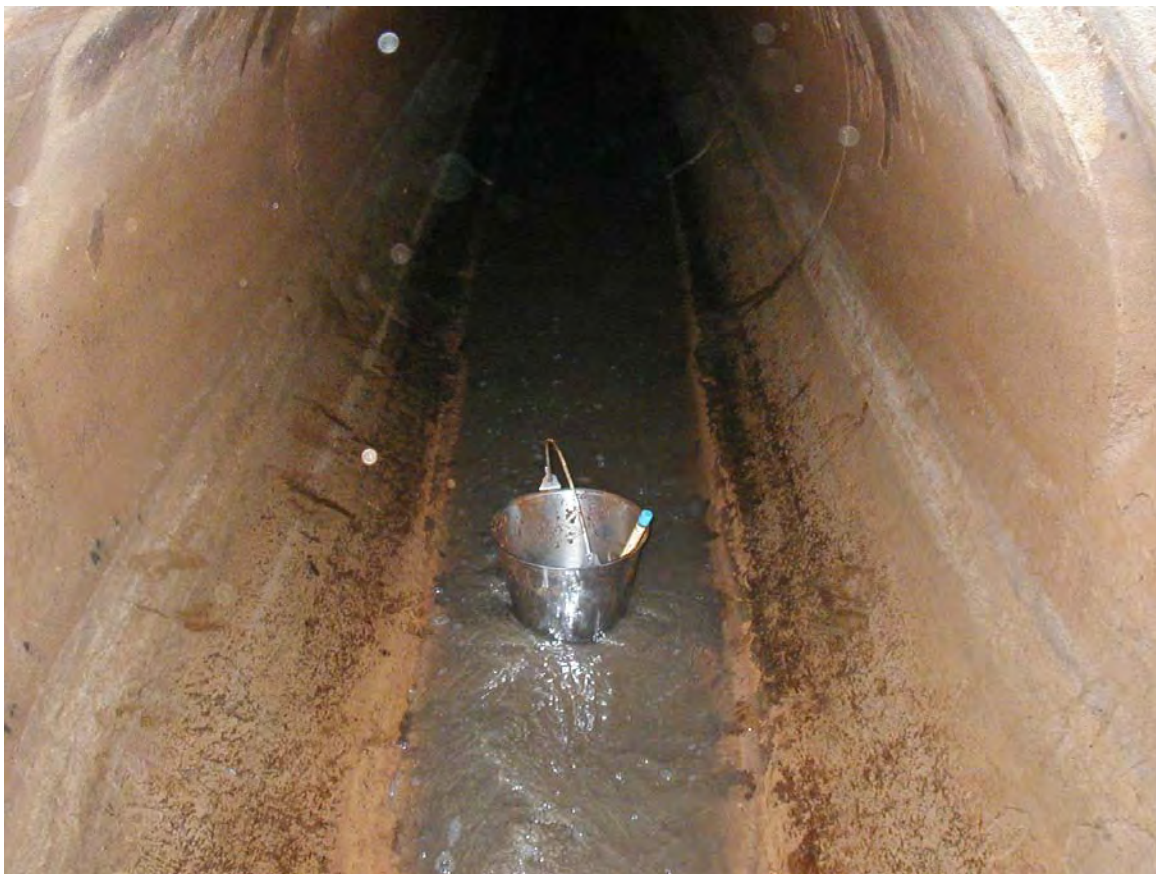
**Photograph 1** — Basin M-1: Sample IL-M1-AAM104-0803-SW

This sample was collected from the downstream (southwest) line exiting manhole AAM104. The sample location is downstream of most of Basin M-1, excluding several properties along the river, among which are Port of Portland Dredge, Fred Devine Diving & Salvage Company, and Foss Environmental. A 0.5-inch-thick layer of orange-brown material was observed in this line and extended about 20 feet downstream of the manhole. No debris, sheen, or odor was noted (see Photographs 1 and 2 in Appendix C).

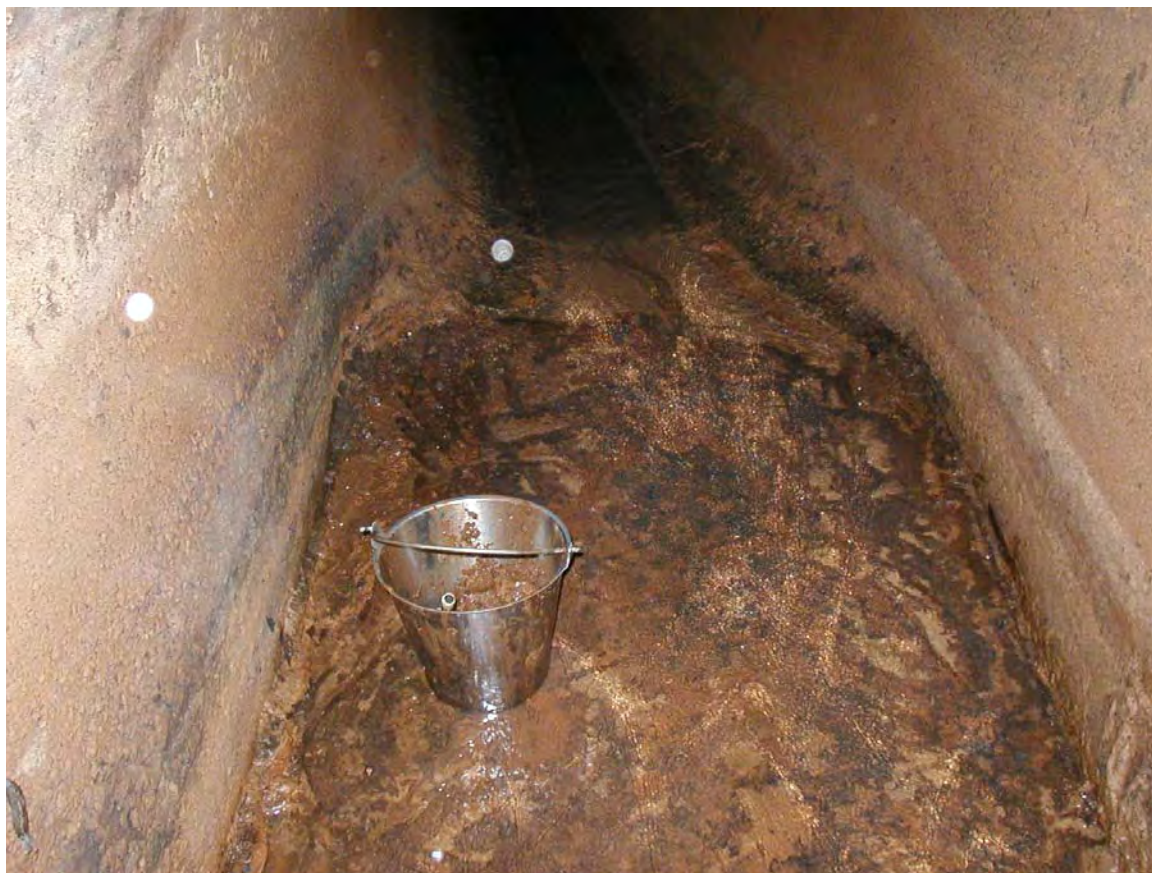
**Photograph 3** — Basin M-1: Sample IL-M1-AAM104-0803-NE

This sample was collected from the upstream (northeast) line entering manhole AAM104. A 0.75-inch-thick layer of orange-brown material was observed in this line and extended 6 feet upstream. A faint discontinuous sheen was observed on the sample during homogenization. No debris or odor was noted (see Photographs 3 and 4 in Appendix C).

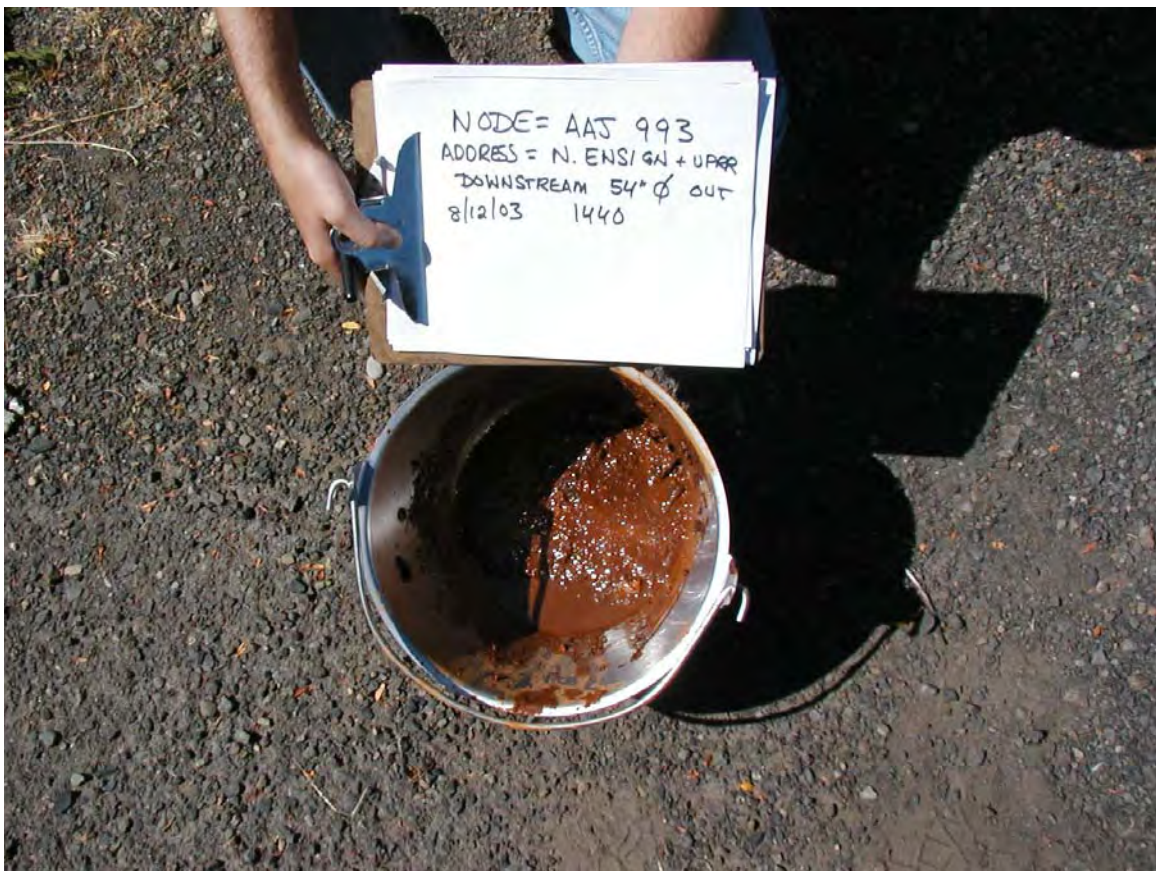
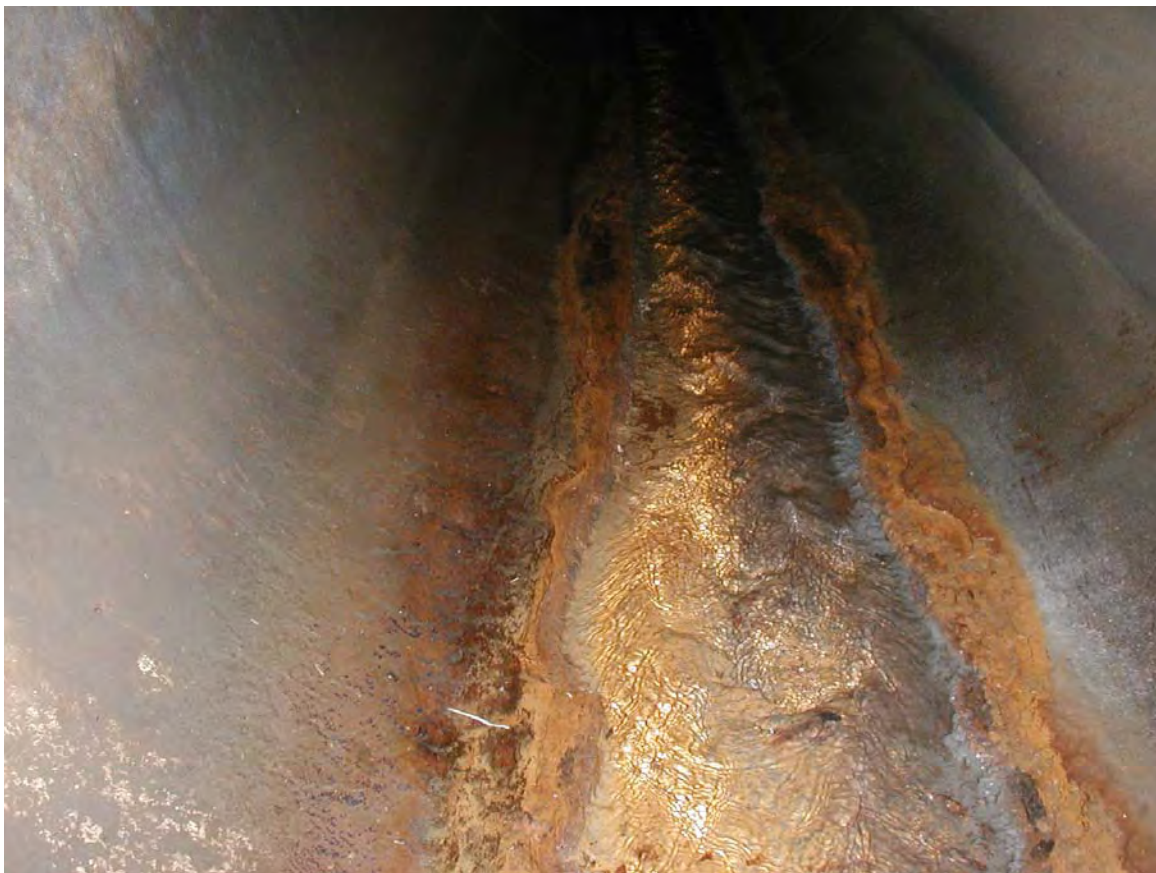
**Photograph 5** — Basin M-1: Sample IL-M1-AAJ933-0803

This sample was collected from the downstream (southwest) line exiting manhole AAJ933. A 1-inch-thick layer of orange-brown material was observed in this line and extended about 10 feet downstream of the manhole. No debris, sheen, or odor was noted (see Photographs 5 and 6 in Appendix C).

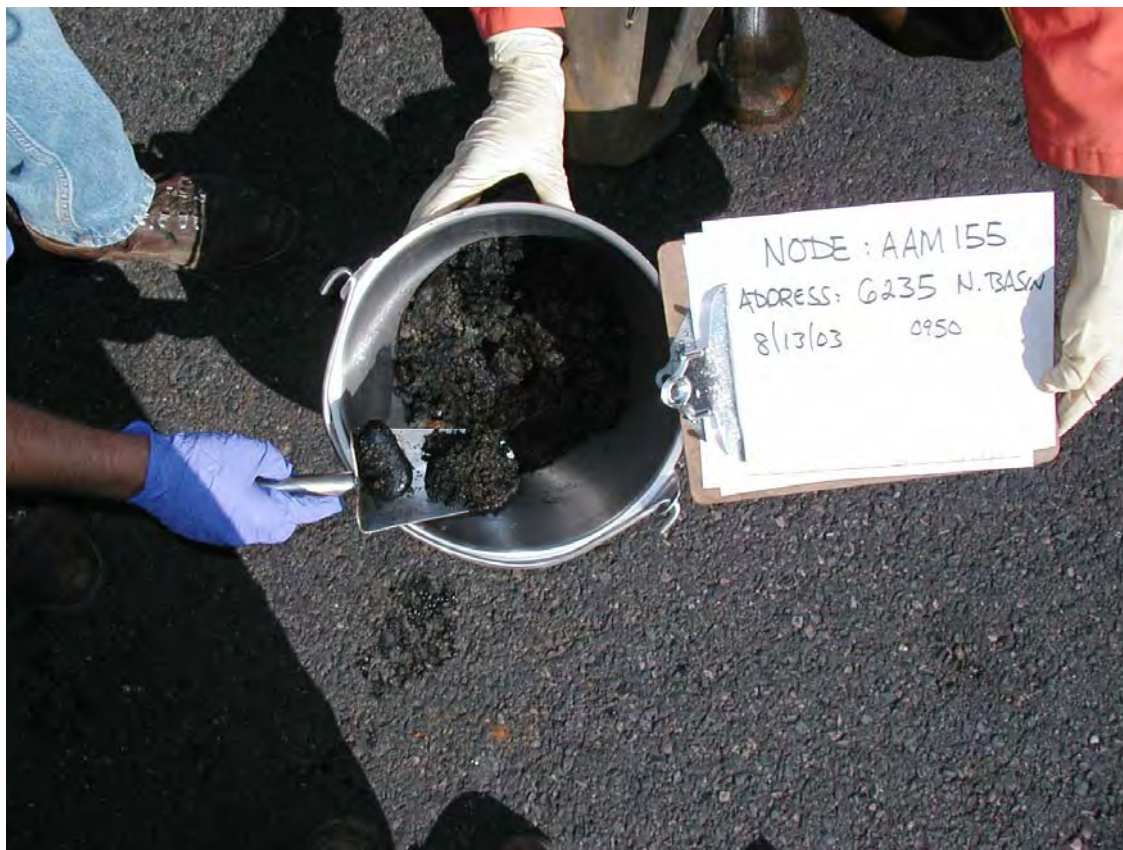
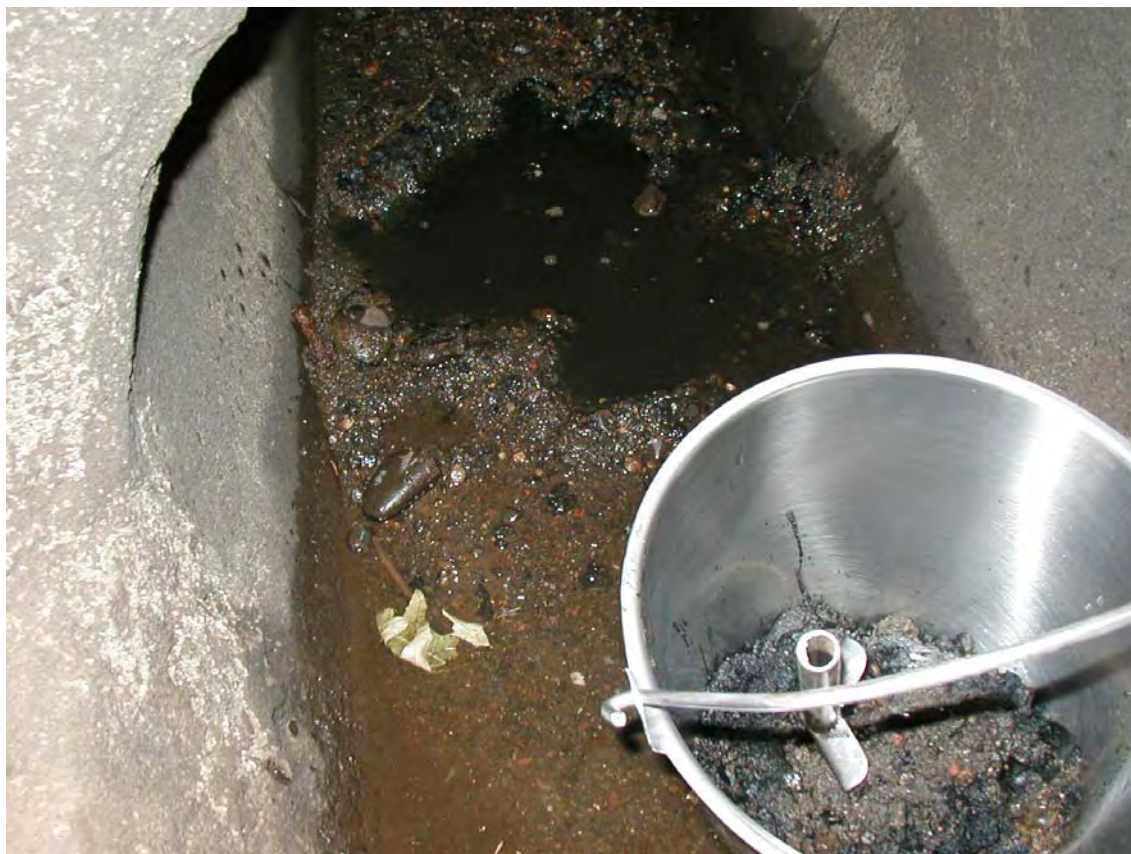
**Photograph 7** – Basin M-1: Sample IL-M1-AAM155-0803

This sample was collected from the downstream (northwest) line exiting manhole AAM155. A 3.5-inch-thick layer of well-graded sand with gravel (well rounded) was observed at this manhole and extended in both the upstream and downstream directions. Two inches of standing water was present at the manhole. The upper inch of the sand was dark brown, while the bottom two inches was black. The sample was collected 0 to 1.5 feet downstream of manhole AAM155 in an area with no standing water. A slight petroleum odor and metal debris (nuts and washers) were observed in the vicinity of the sample location during sample collection; however, no debris or odor was observed in the sample. A light sheen was observed on the sample pore water during sample homogenization (see Photographs 7 and 8 in Appendix C).

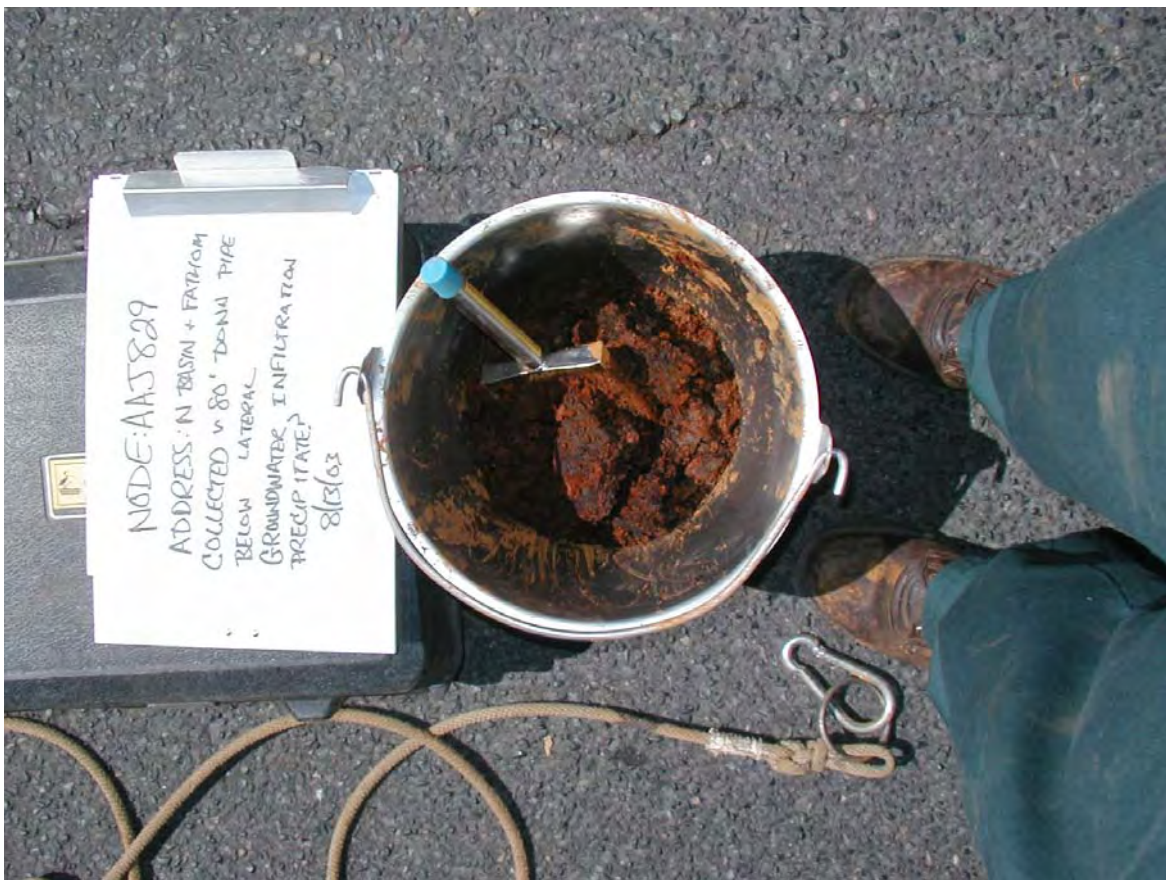
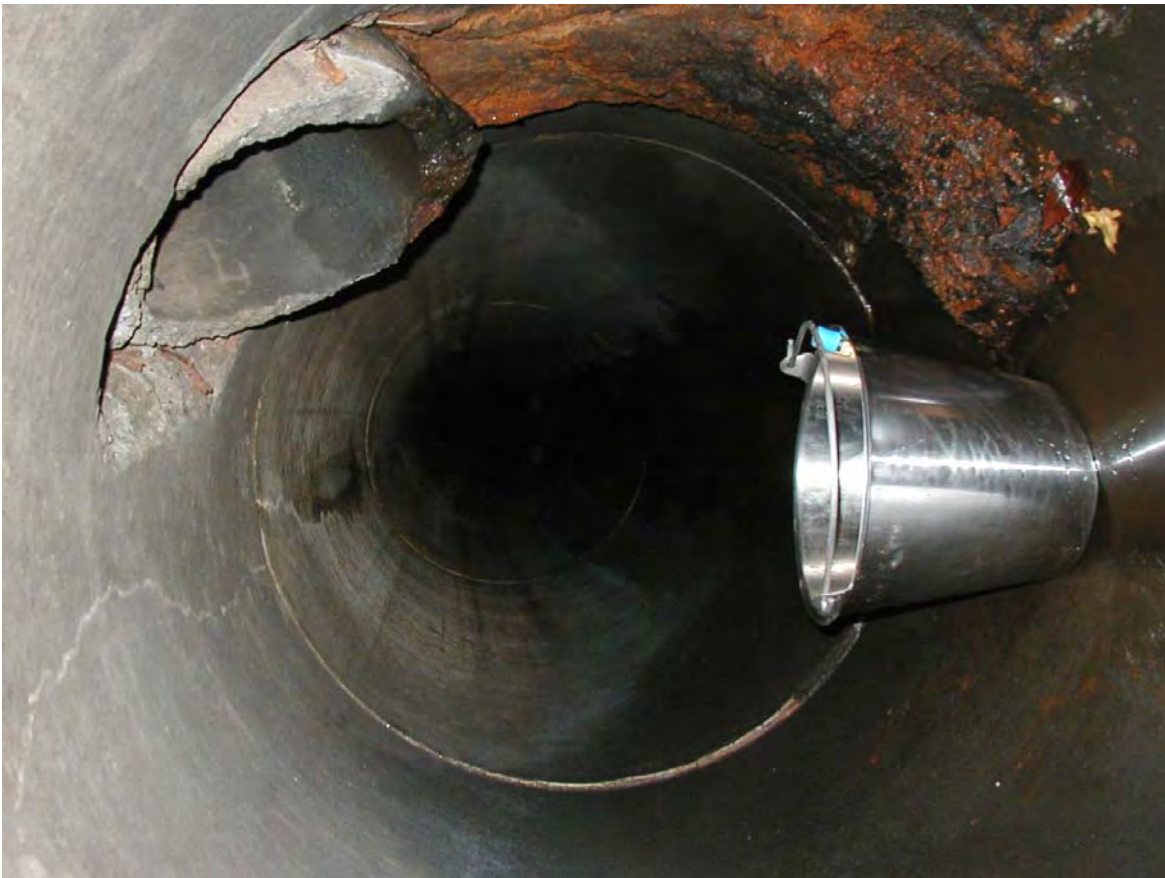
**Photograph 9**— Basin M-1: Sample IL-M1-AAJ829-0803

This sample was collected in the downstream (southeast) line exiting manhole AAJ829 at the base of a small lateral that entered the main line 80 feet downstream (southeast) of the manhole. A 4-inch-thick layer of orange-brown material observed on the sides of the main line appeared to be the result of precipitate deposits from groundwater infiltration at the base of the lateral. No odor, sheen, or debris was observed in the sample (see Photographs 9 and 10 in Appendix C).

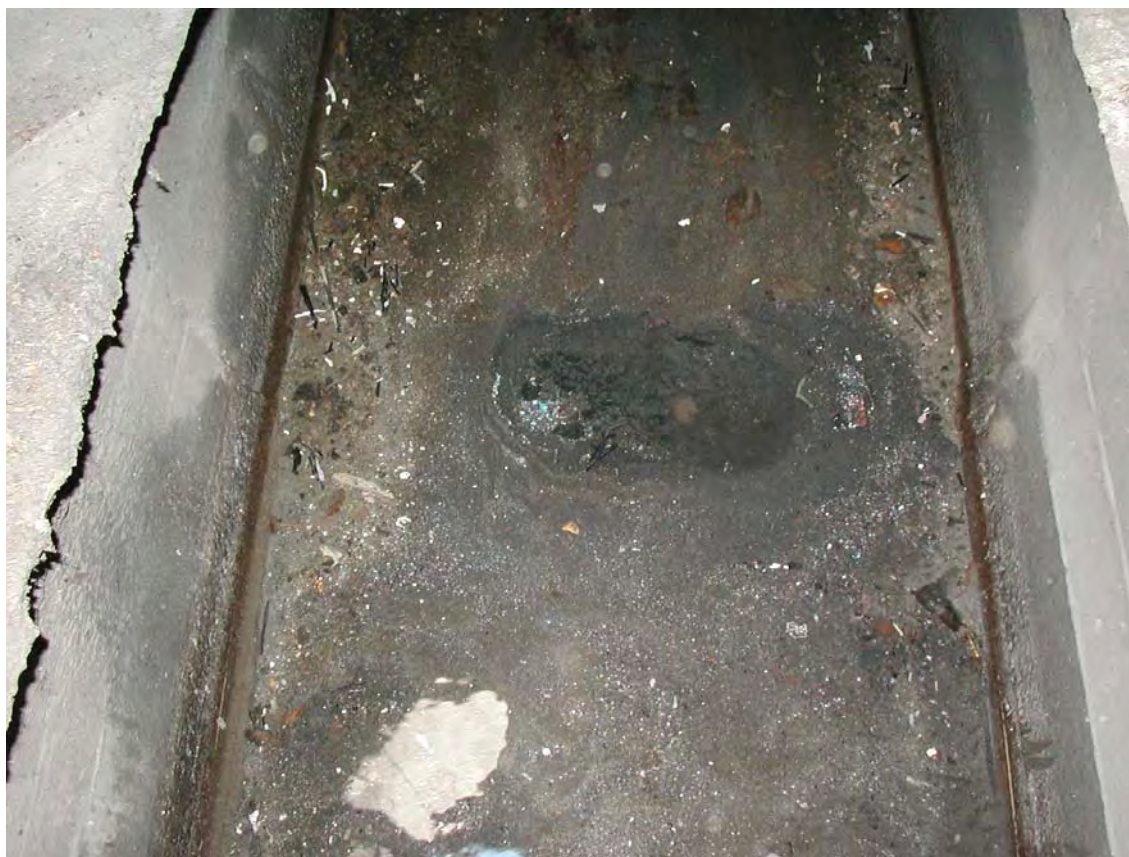
**Photograph 11 – Basin M-1: Sample IL-M1-AAJ831-0803**

These samples were collected at manhole AAJ831. A 6-inch-thick layer of solids was observed at the manhole and extended into the upstream private lateral pipe and down the City storm pipe. The solids consisted of dark gray sand with approximately 1 percent consisting of paint chips. In addition to the paint chips, significant debris was noted in the sand, including small pieces of plastic and metal (washers). During sample collection, a petroleum odor was observed at the manhole and a sheen was observed on the flowing water (see Photographs 11 and 12 in Appendix C).

Because chromium was identified for additional source investigation in Basin M-1, was detected at a concentration above its JSCS toxicity screening value in Subbasin 3, and was detected at concentrations above those observed in river sediments adjacent to the outfall, further evaluation of chromium sources and pathways from Subbasin 3 to the stormwater system is warranted.

Because zinc was identified for additional source investigation, was detected at a concentration above its JSCS toxicity screening value in Subbasin 3, and was detected in Subbasins 2 and 3 at concentrations above those observed in river sediments adjacent to the outfall, further evaluation of zinc sources and pathways from Subbasins 2 and 3 to the stormwater system is warranted.

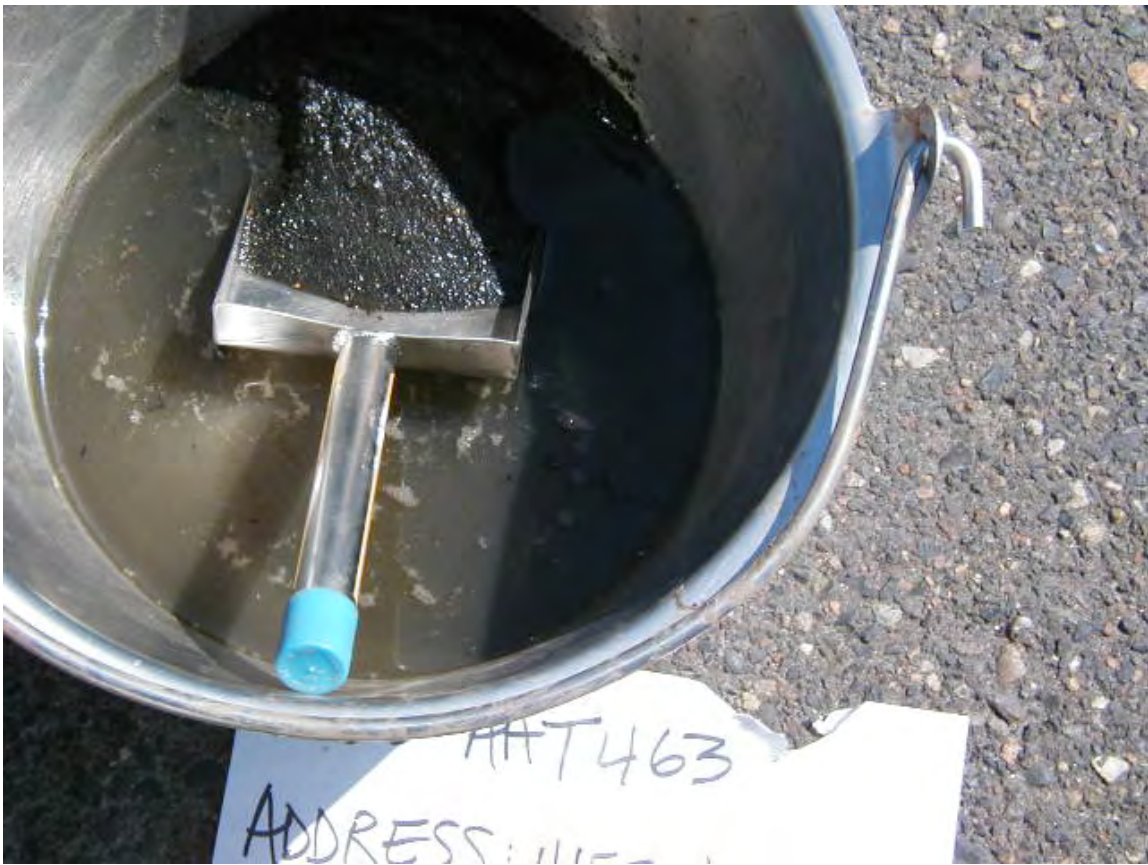
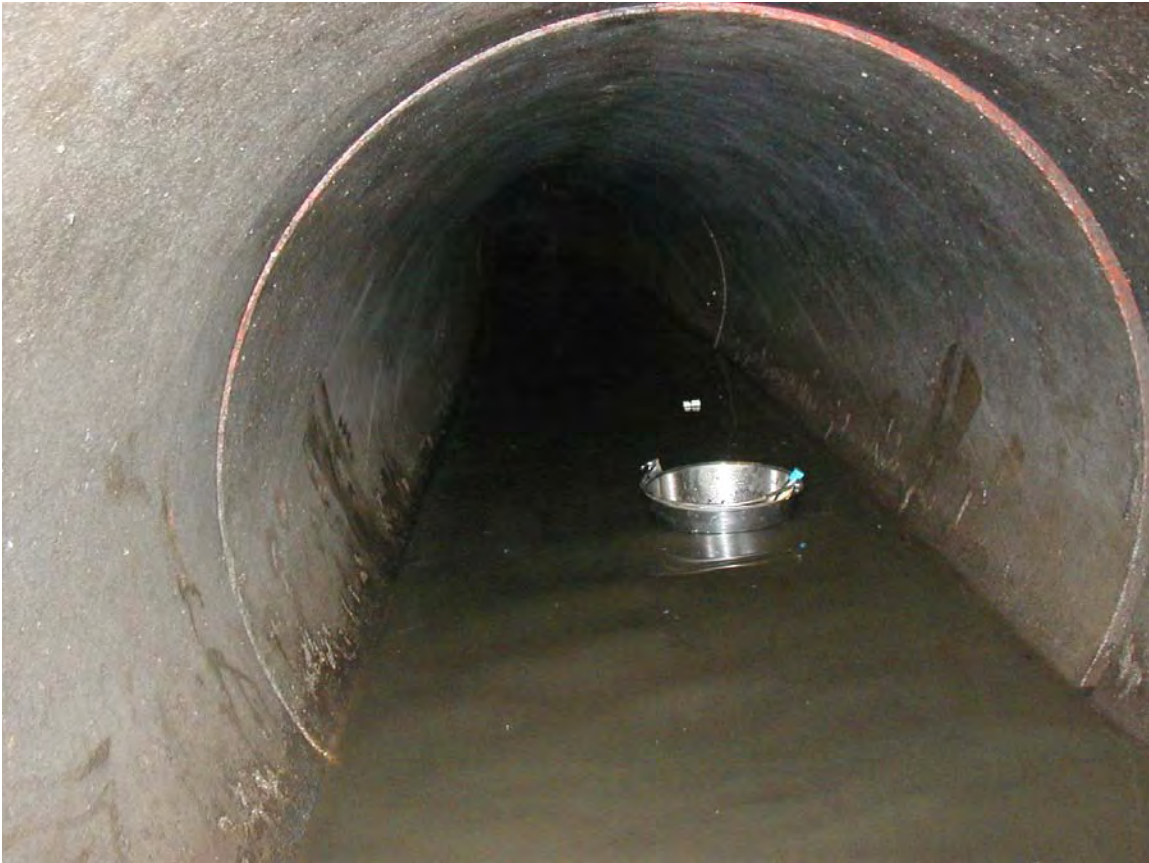
**Photograph 13** – Basin 18: Sample IL-18-AAT463-0803

This sample was collected approximately 30 to 33 feet downstream of manhole AMZ086. A 1- to 2-inch-deep band of gray sand started 10 feet downstream of the manhole and extended at least 100 feet. A light sheen was observed on the sample pore water during homogenization of the sample. A small amount (< 1 percent) of red paint chips was observed in the sample (see Photographs 13 and 14 in Appendix C).

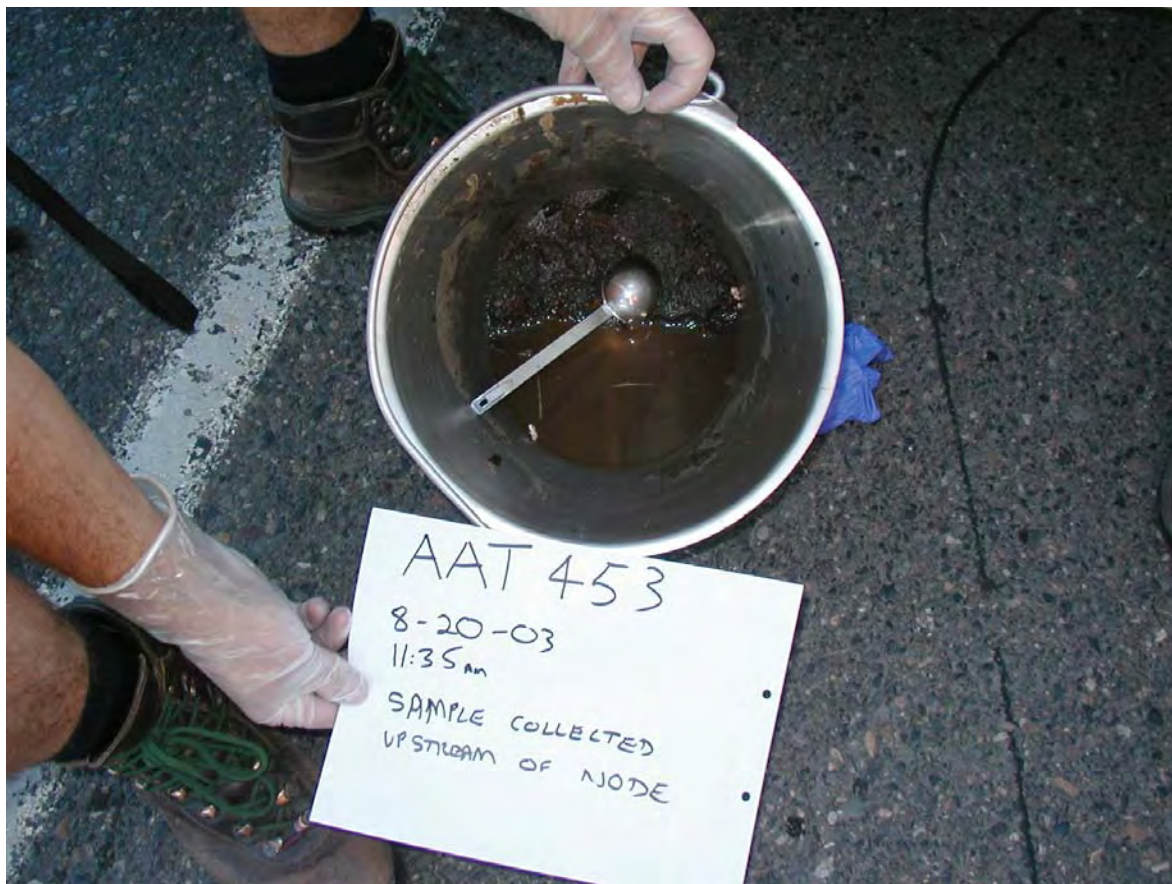
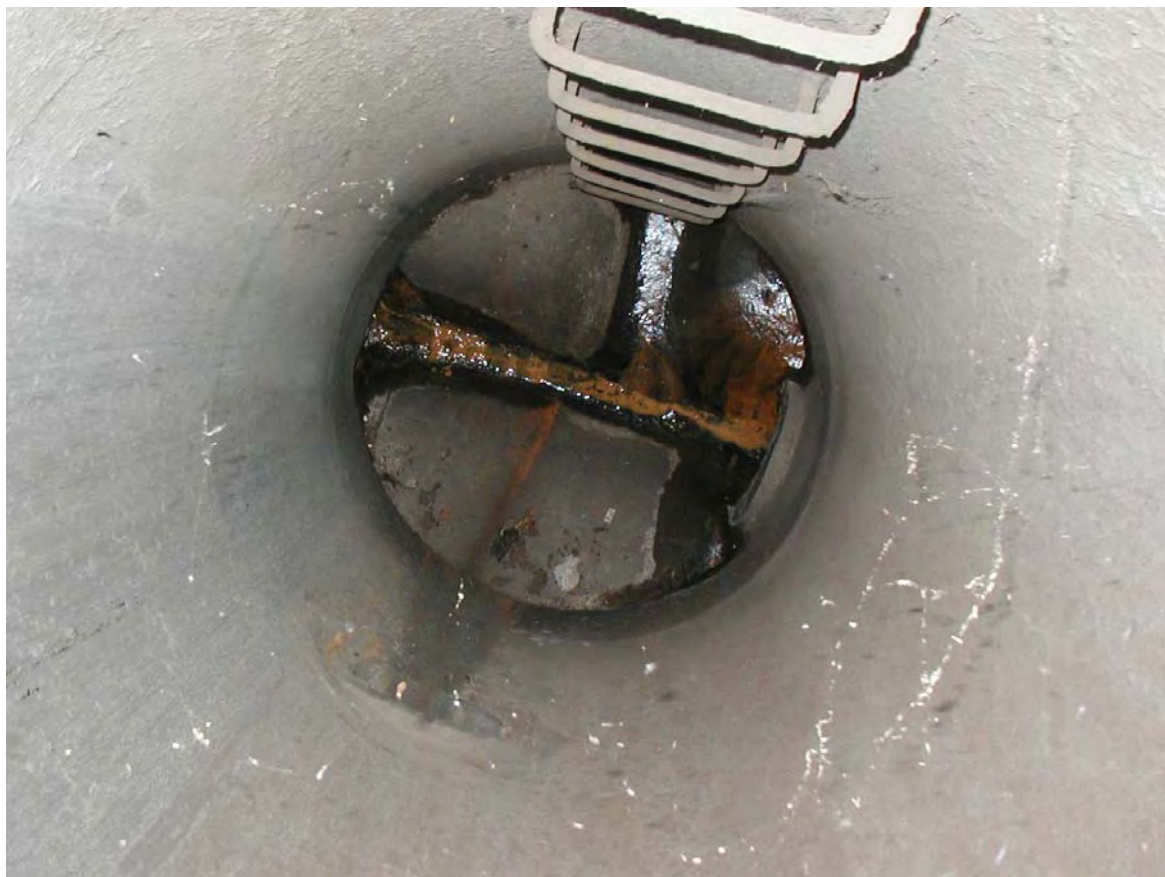
**Photograph 15** – Basin 18: Sample IL-18-AAT453-0803

This sample was collected at manhole AMZ096. A 1-inch-deep band of sand started at the base of the manhole and extended upstream (northwest) about 2 feet. The sample was collected from this deposit. The solids were a gray sand with a minor amount of red and black sand grains. A small amount (< 1 percent) of Styrofoam™ was observed in the sample. No odor or sheen was observed in the sample (see Photographs 15 and 16 in Appendix C).

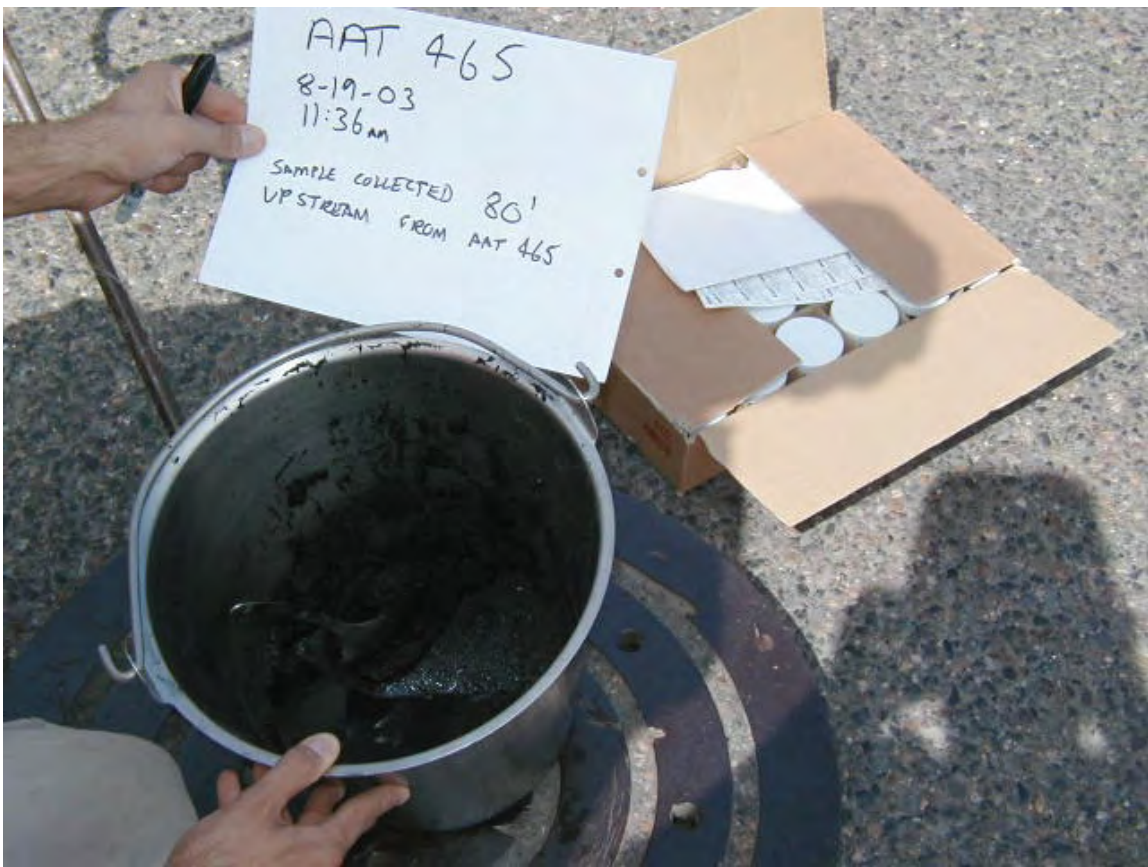
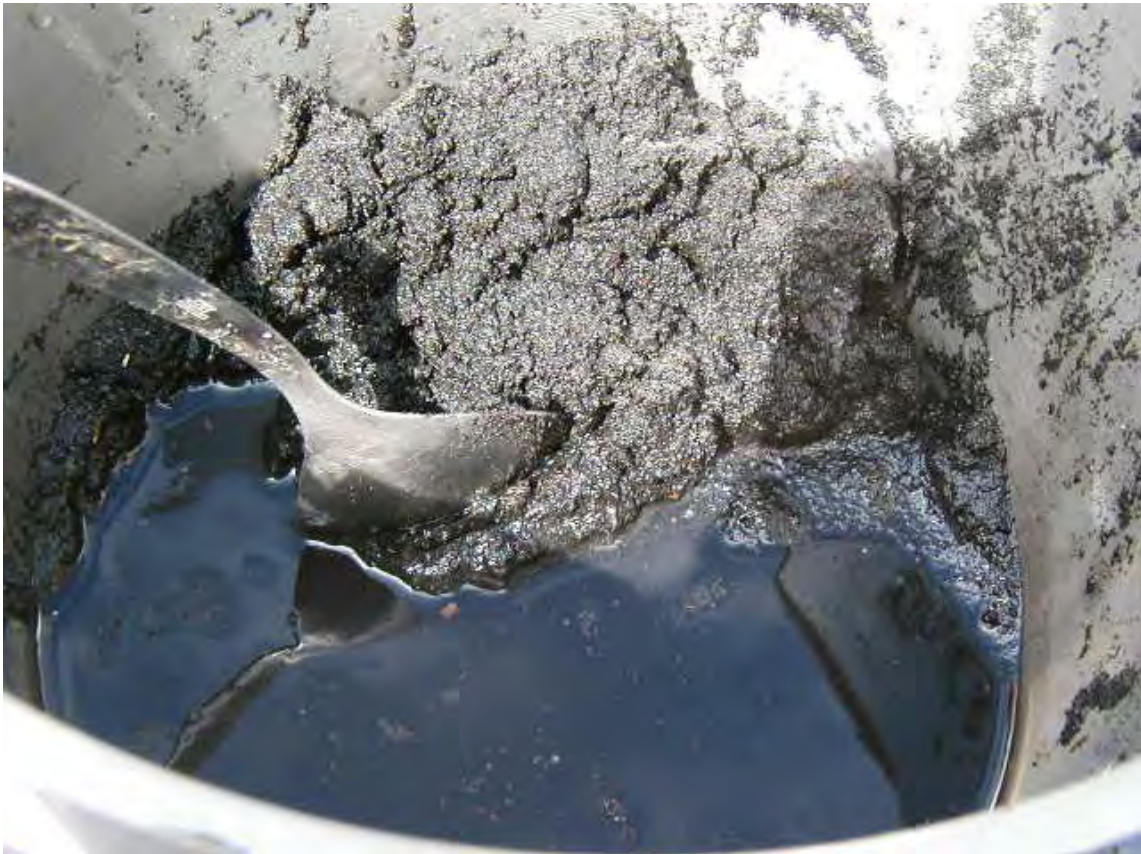
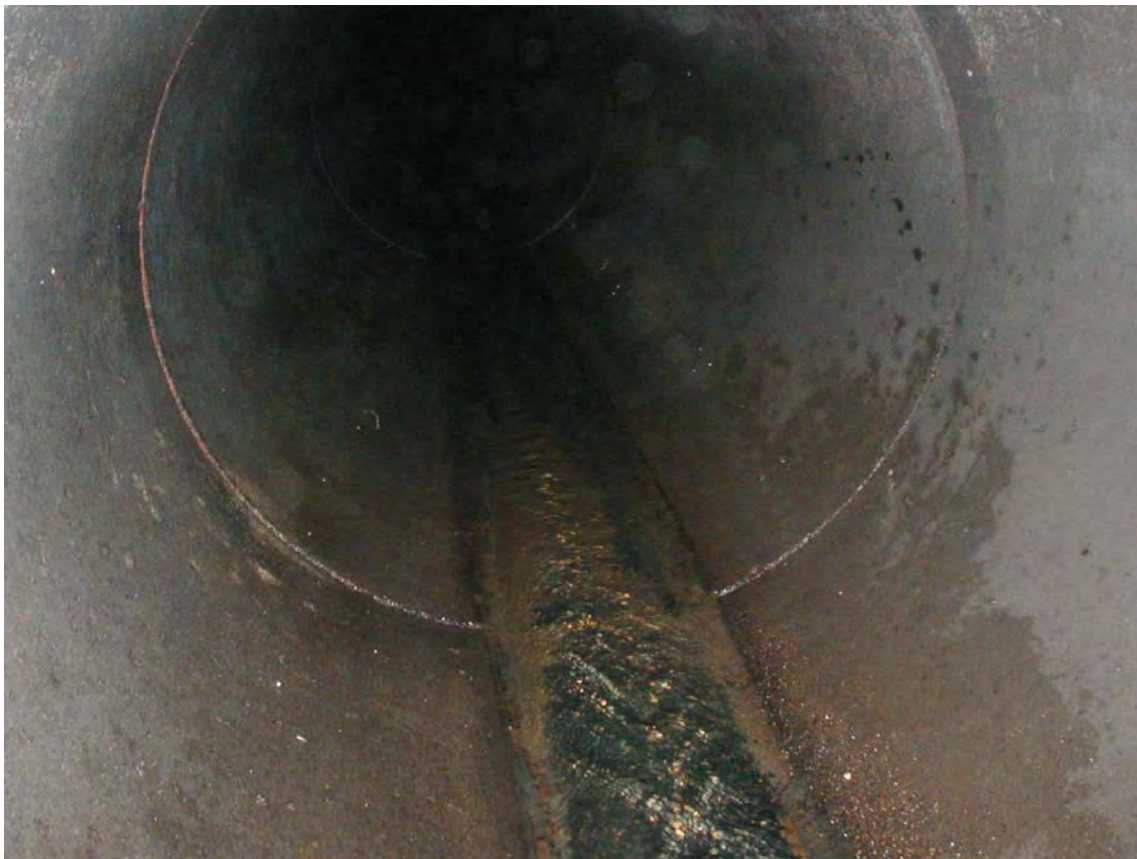
**Photograph 17** – Basin 18: Sample IL-18-AAT465-0803

This sample was collected 50 to 80 feet upstream of manhole AMZ098, from a 0.5-inch-deep band of sand that started 50 feet upstream (southeast) of the manhole and extended 80 feet upstream of the manhole. The solids were black sand with a small amount (< 1 percent) of fine gravel. A minor amount (< 1 percent) of small (1-millimeter-long) metal shavings was observed in the sample. No odor or sheen was noted in the sample (see Photographs 17 through 19 in Appendix C).

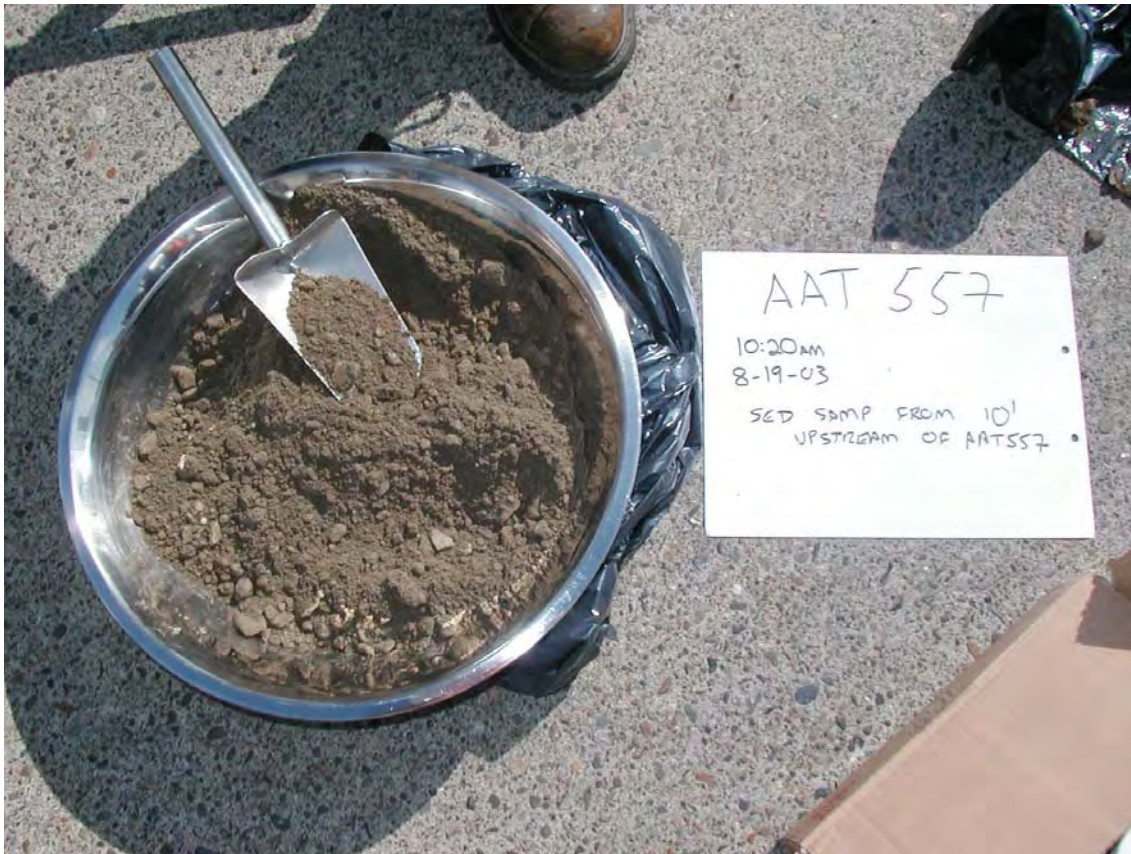
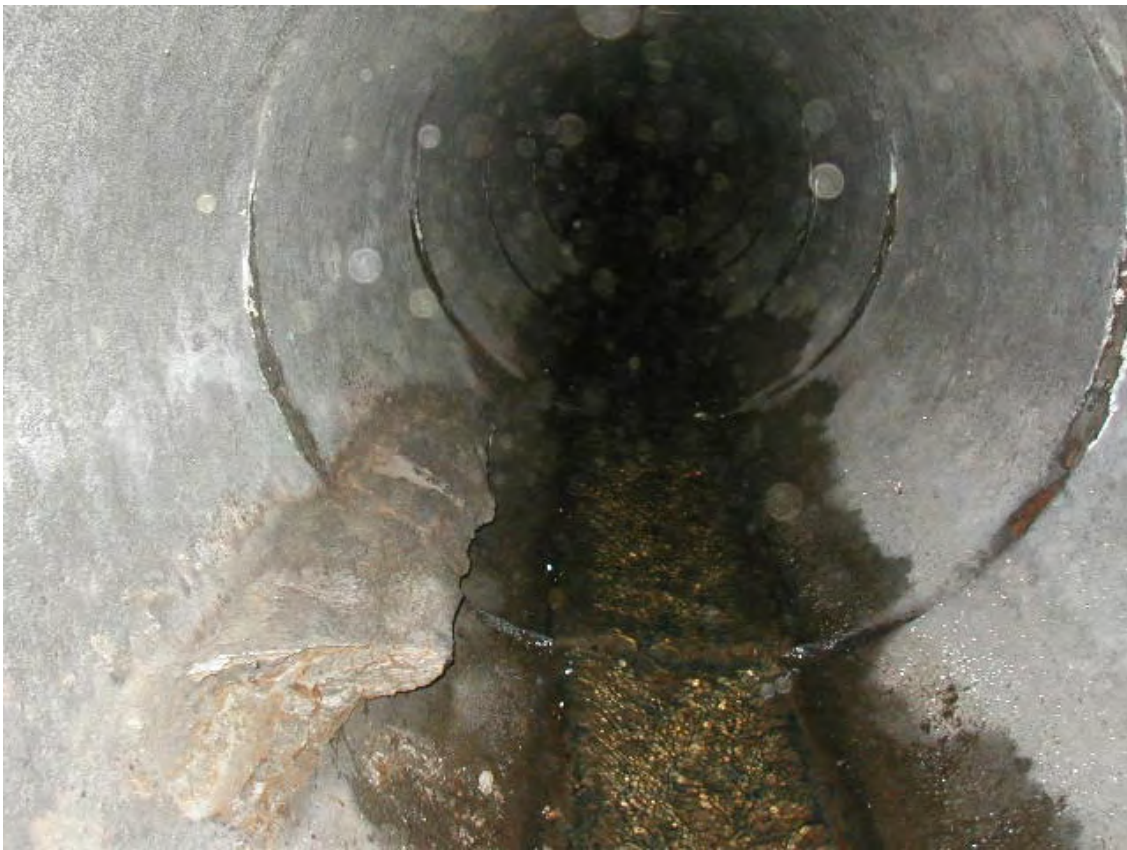
**Photograph 20** – Basin 18: Sample IL-18-AAT557-0803

This sample was collected 10 feet upstream of manhole AAT557. The sample was collected from material forming an accreted silt ledge approximately halfway up the walls of the pipe (see Photograph 21 in Appendix C). The solids were light gray silt with stratified layers of orange, black, and gray. No odor or debris was noted in the sample (see Photographs 20 and 21 in Appendix C).

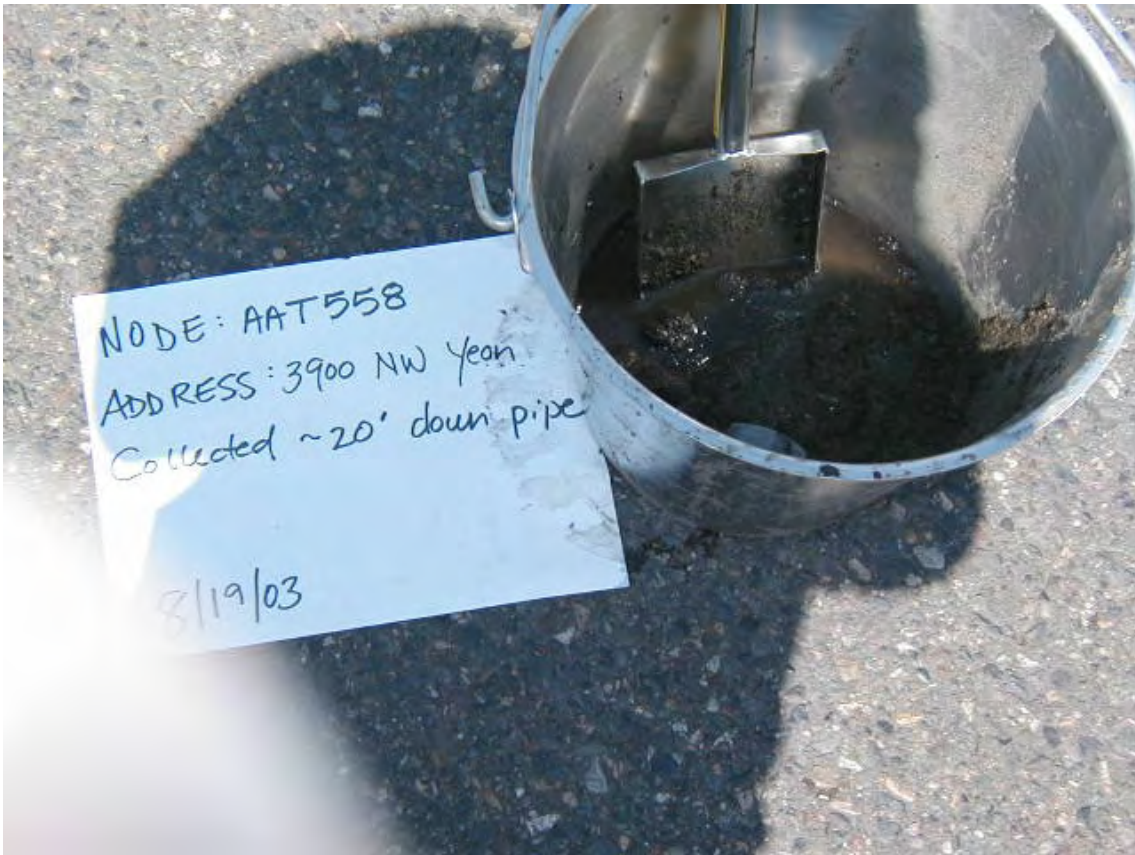
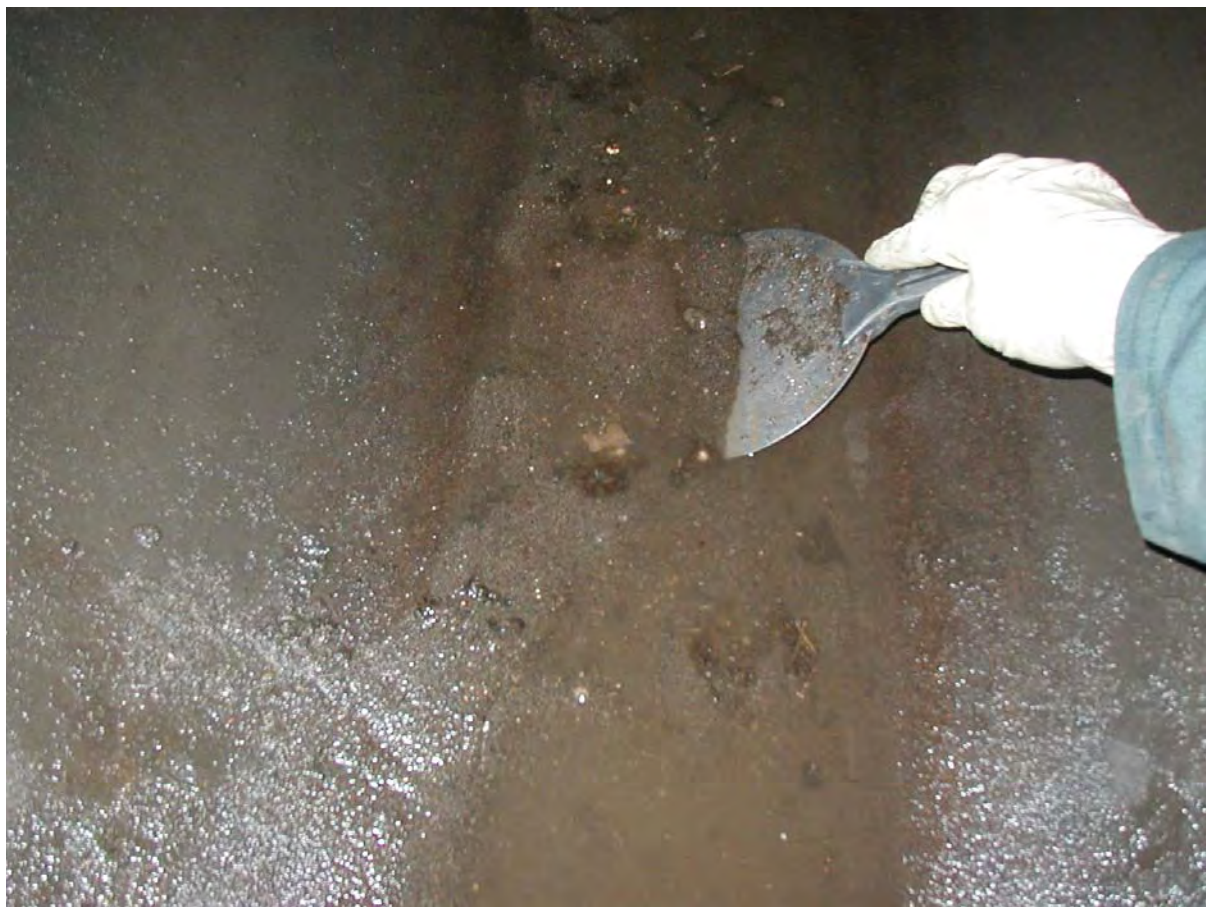
**Photograph 22** – Basin 18: Sample IL-18-AAT558-0803

This sample was collected 20 to 26 feet downstream of manhole AMZ100, from a 1-inch-deep, 6-inch-long band of sand. The solids were black sand with a small amount (< 1 percent) of organic matter (blades of grass and tree twigs). A minor amount (< 1 percent) of green flakes (unknown origin) was present in the sample. No odor or sheen was noted in the sample (see Photographs 22 and 23 in Appendix C).
