TECHNICAL MEMORANDUM No. OF45-1

Outfall Basin 45 Inline Solids Sampling

SUBJECT: Portland Harbor Source Control Investigation

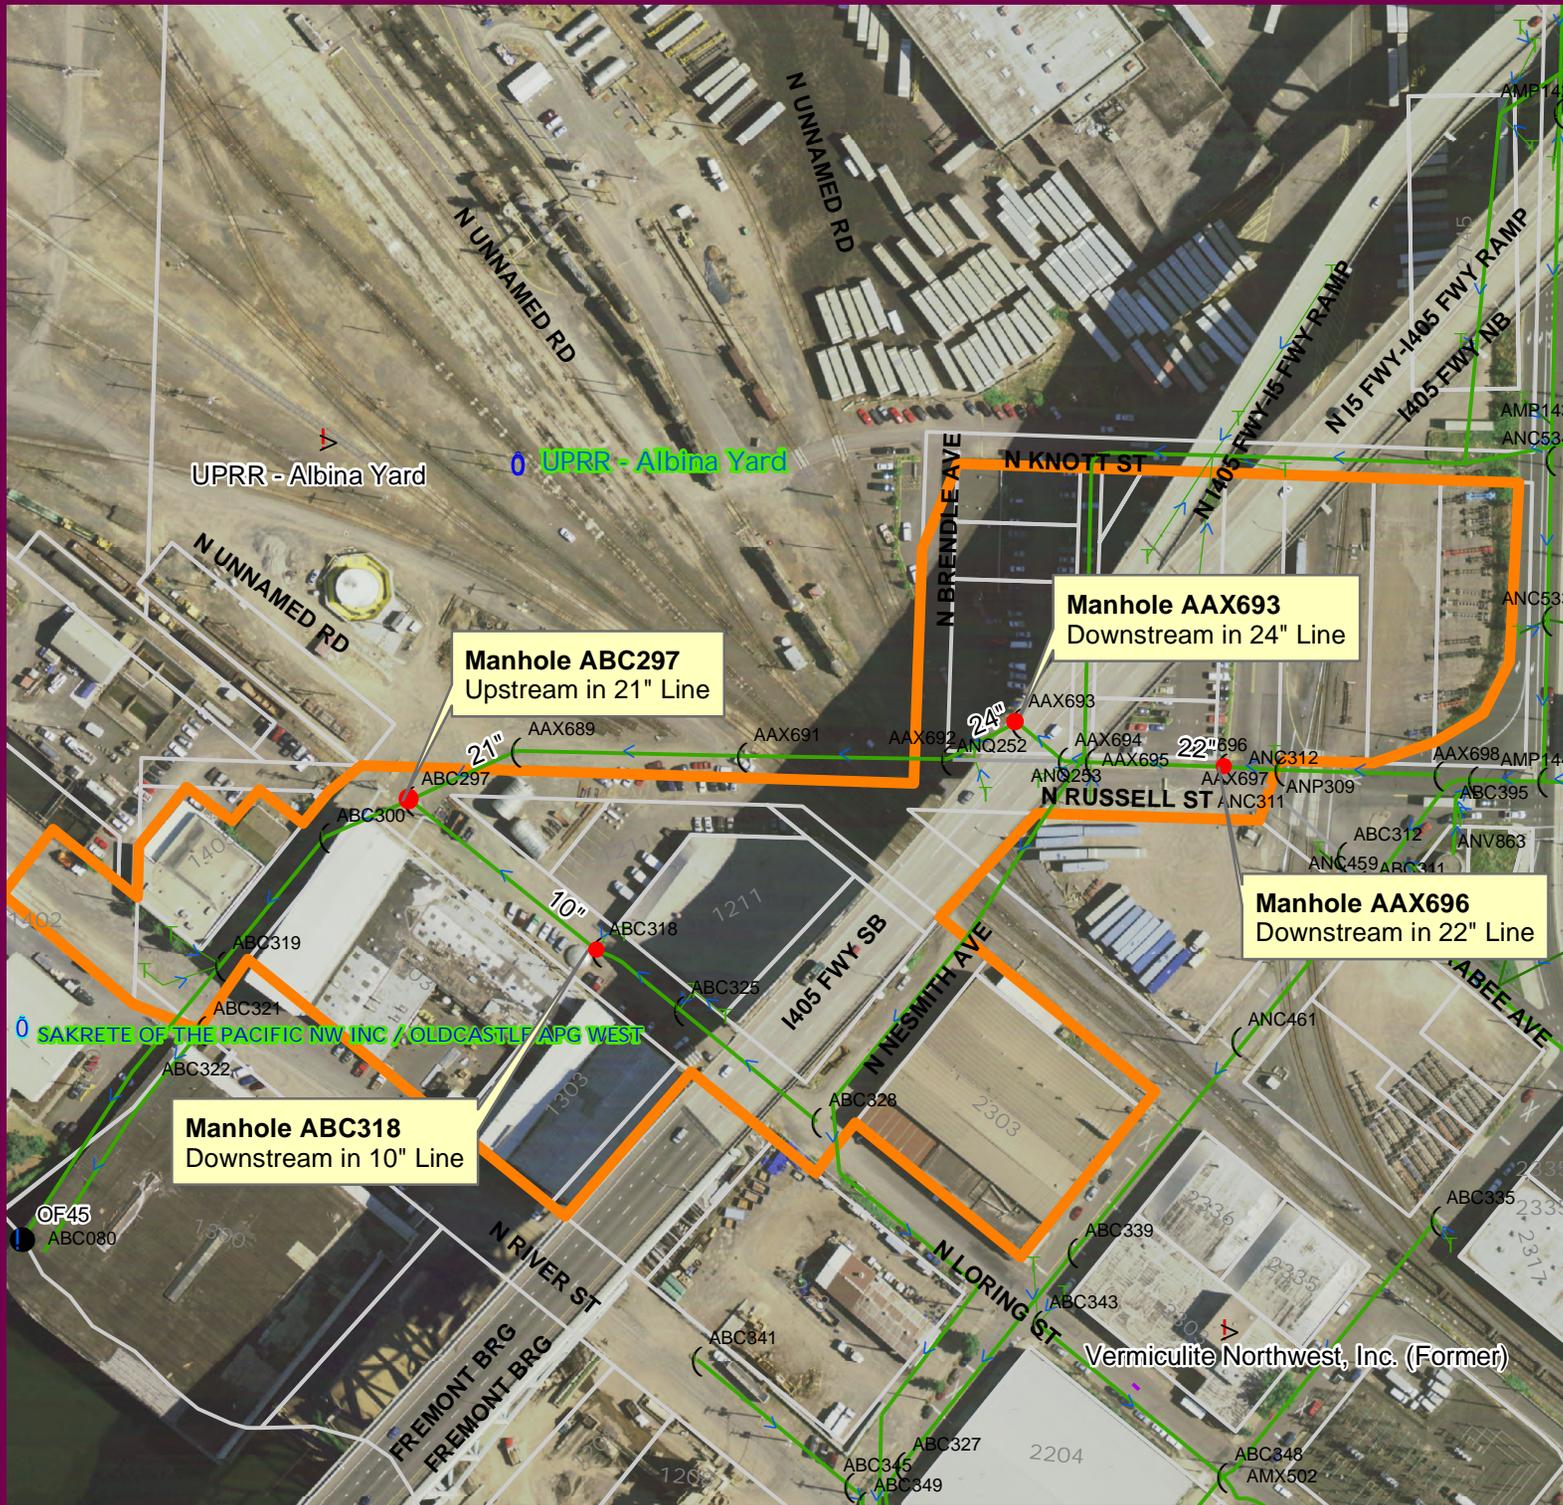
Figure 1
Basin 45
Inline Solids
Sampling Locations

The City coordinated with DEQ regarding this source control investigation before conducting this work. Inline solids were sampled at four locations on June 21, 2007 (see Figure 1). Target sampling locations were selected to represent locations within the two main branches of the system. Final sampling locations were chosen based on inline solids availability.

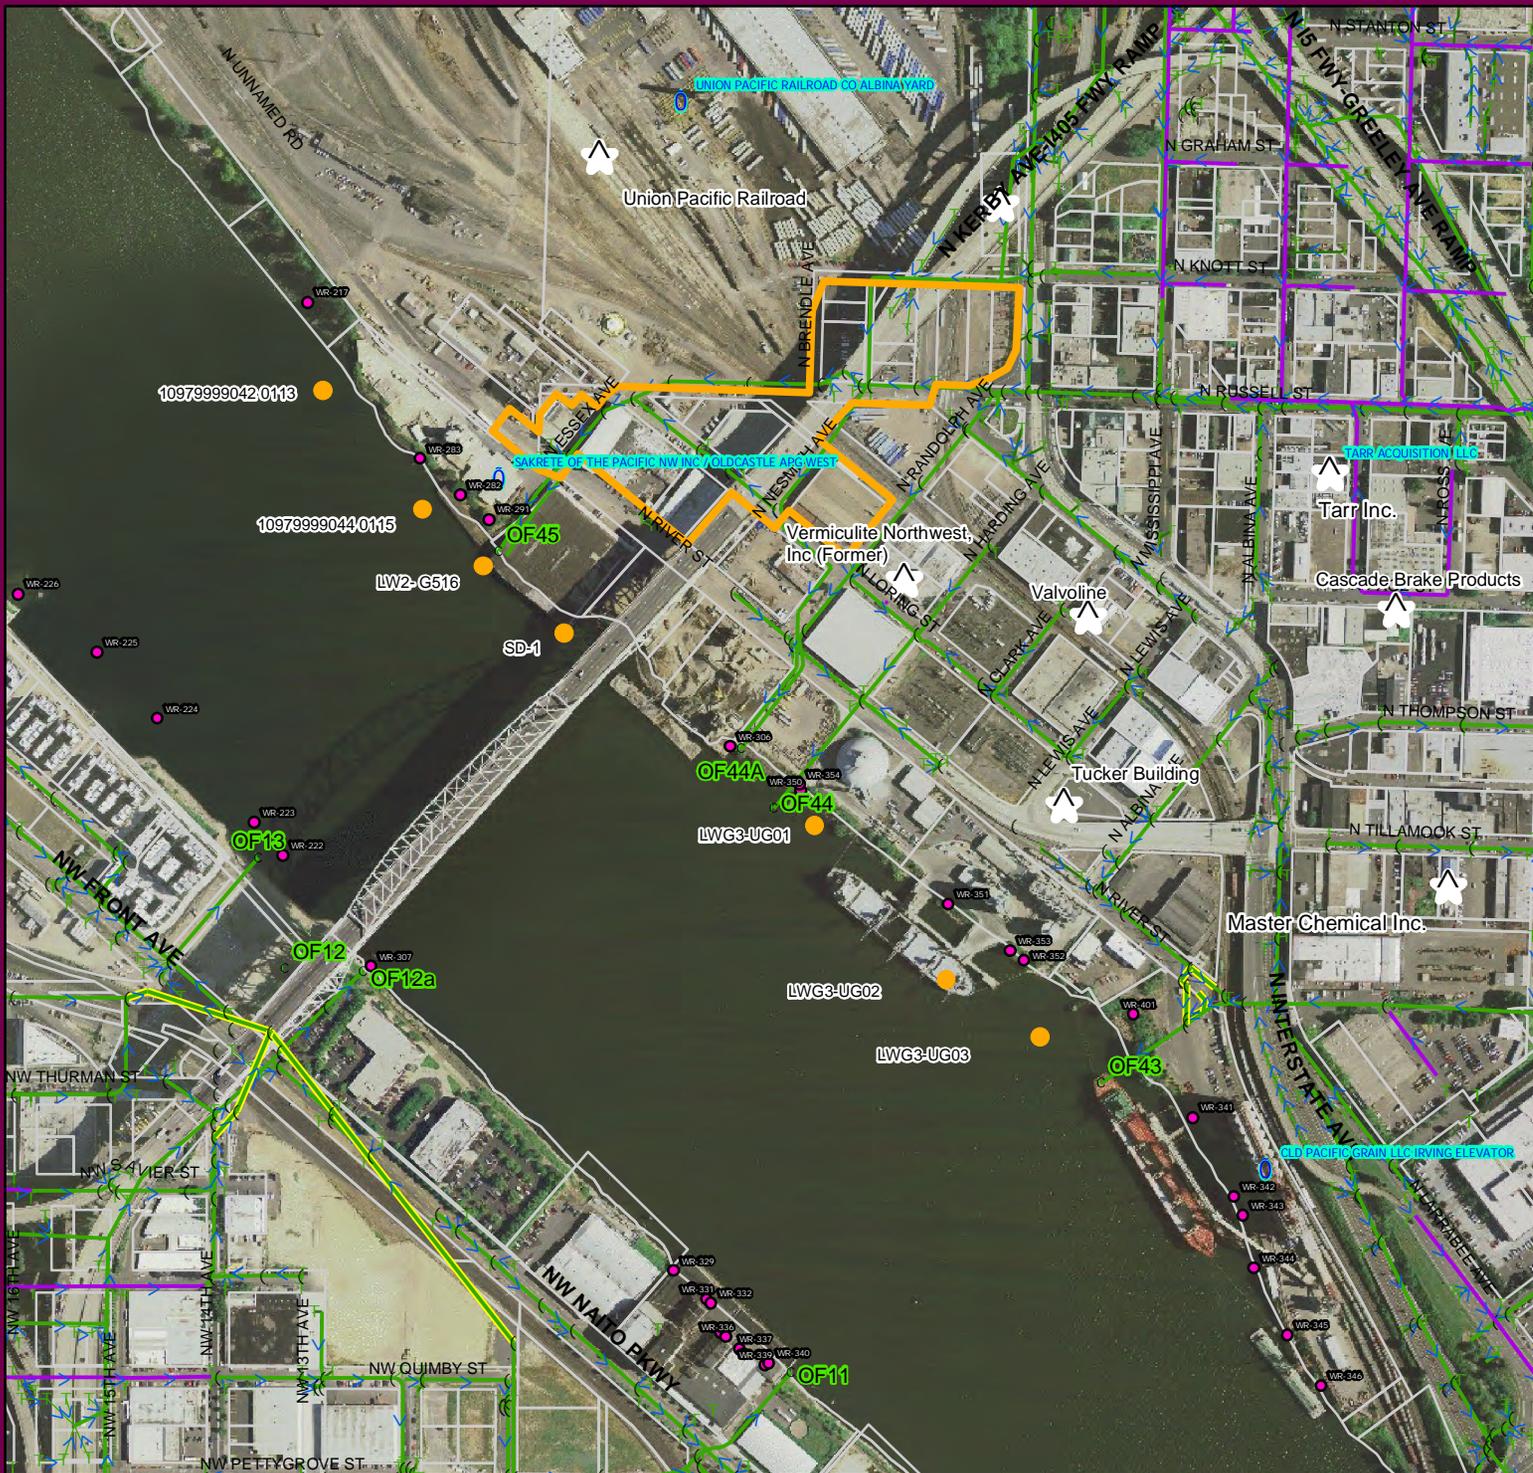
Figure 2
Basin 45
Relevant In-River Sediment
Sample Locations

In-river Sediment Sampling. In-river sediment sampling locations in the vicinity of Outfall 45 are depicted on Figure 2. The LWG collected one shallow sediment sample (LW2-G516) just offshore of Outfall 45 during Round 2 of the Portland Harbor Remedial Investigation in 2004 (Integral, 2005). Sediment samples also have been collected by the LWG and others upriver and downriver from Outfall 45. The results of PCB Aroclor analyses for these samples are presented in the following table. PCBs were detected in river sediment above, at, and below Outfall 45, but were detected at significantly higher concentrations in samples collected upriver of the outfall compared to the samples collected at and downstream of the outfall.

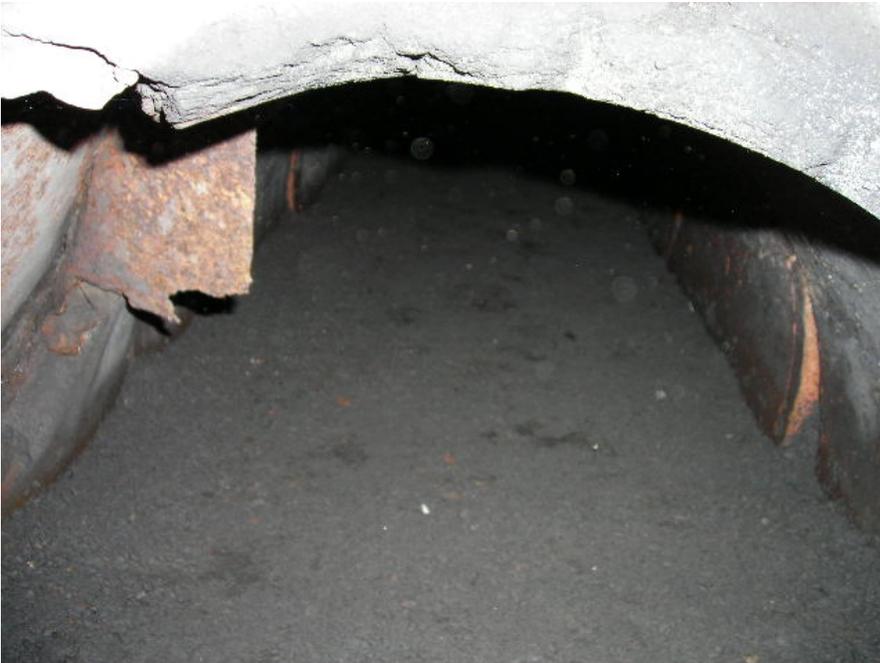
Photo 2 (June 21, 2007). Inline solids were collected from this 22-inch-diameter line discharging to the west from manhole AAX696.

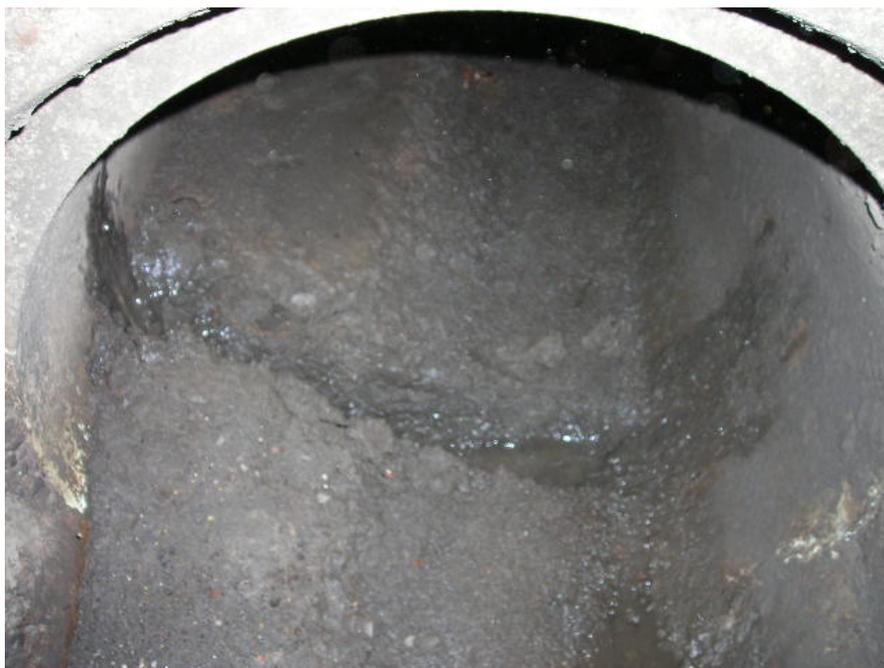
Photo 4 (June 21, 2007). Inline solids were collected from this 24-inch-diameter line discharging to the southwest from manhole AAX693.

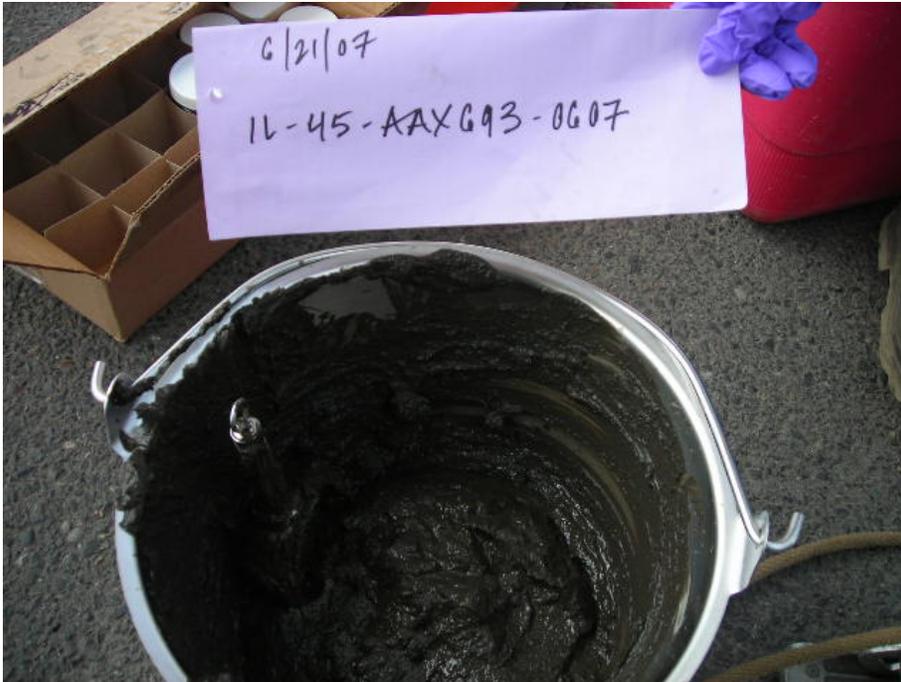
Photo 5 (June 21, 2007). Inline solids collected at manhole AAX693 from the 24-inch-diameter line.

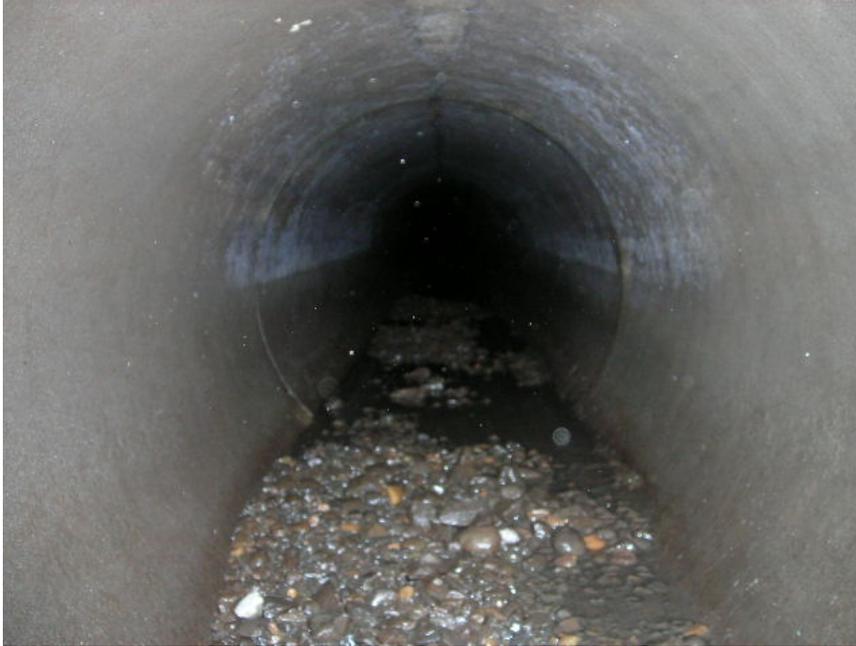
Photo 7 (June 21, 2007). Sample was collected from the 21-inch-diameter line upstream of manhole ABC297.

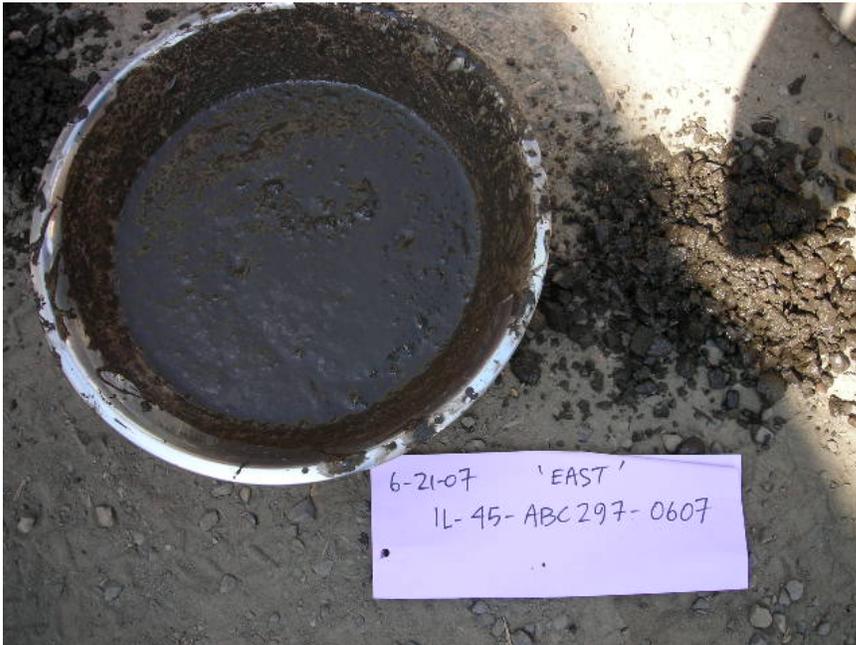
Photo 8 (June 21, 2007). Inline sample collected just upstream of manhole ABC297.

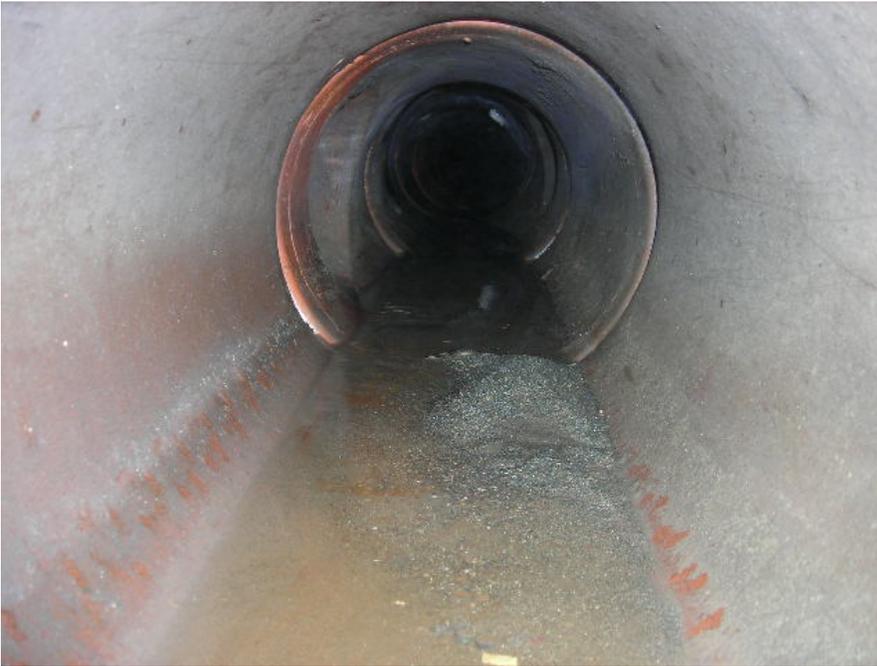
Photo 10 (June 21, 2007). Inline solids sample was collected from the 10-inch-diameter line discharging from manhole ABC318.

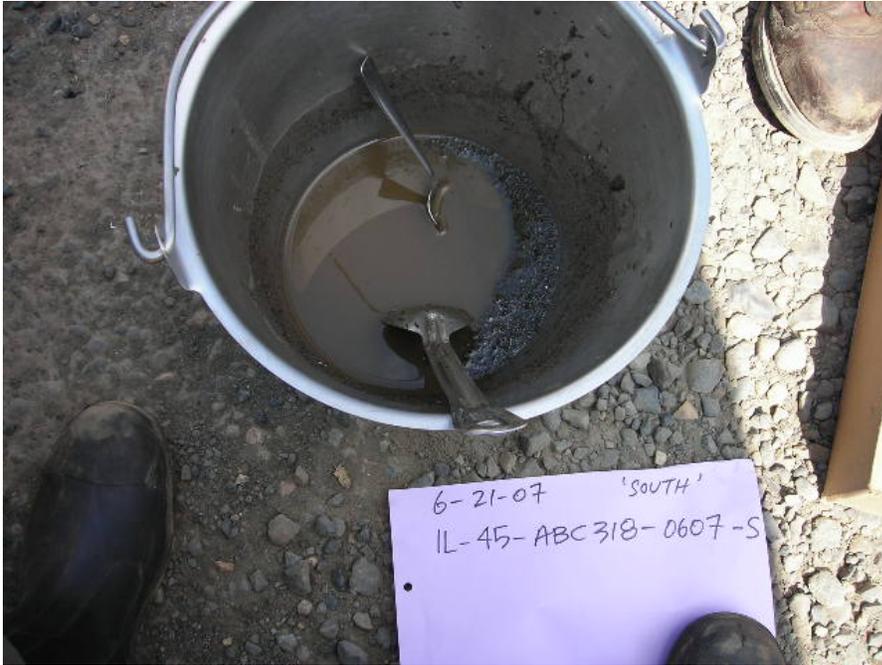
Photo 11 (June 21, 2007). Inline solids sample from just downstream of manhole ABC318.
