TECHNICAL MEMORANDUM No. OF 53A-1

City Outfall Basin 53A Upland Source Control Investigation

SUBJECT: **Dry-Weather Flow and Inline Solids Sampling, City Outfall Basin 53A
Stormwater Conveyance System**

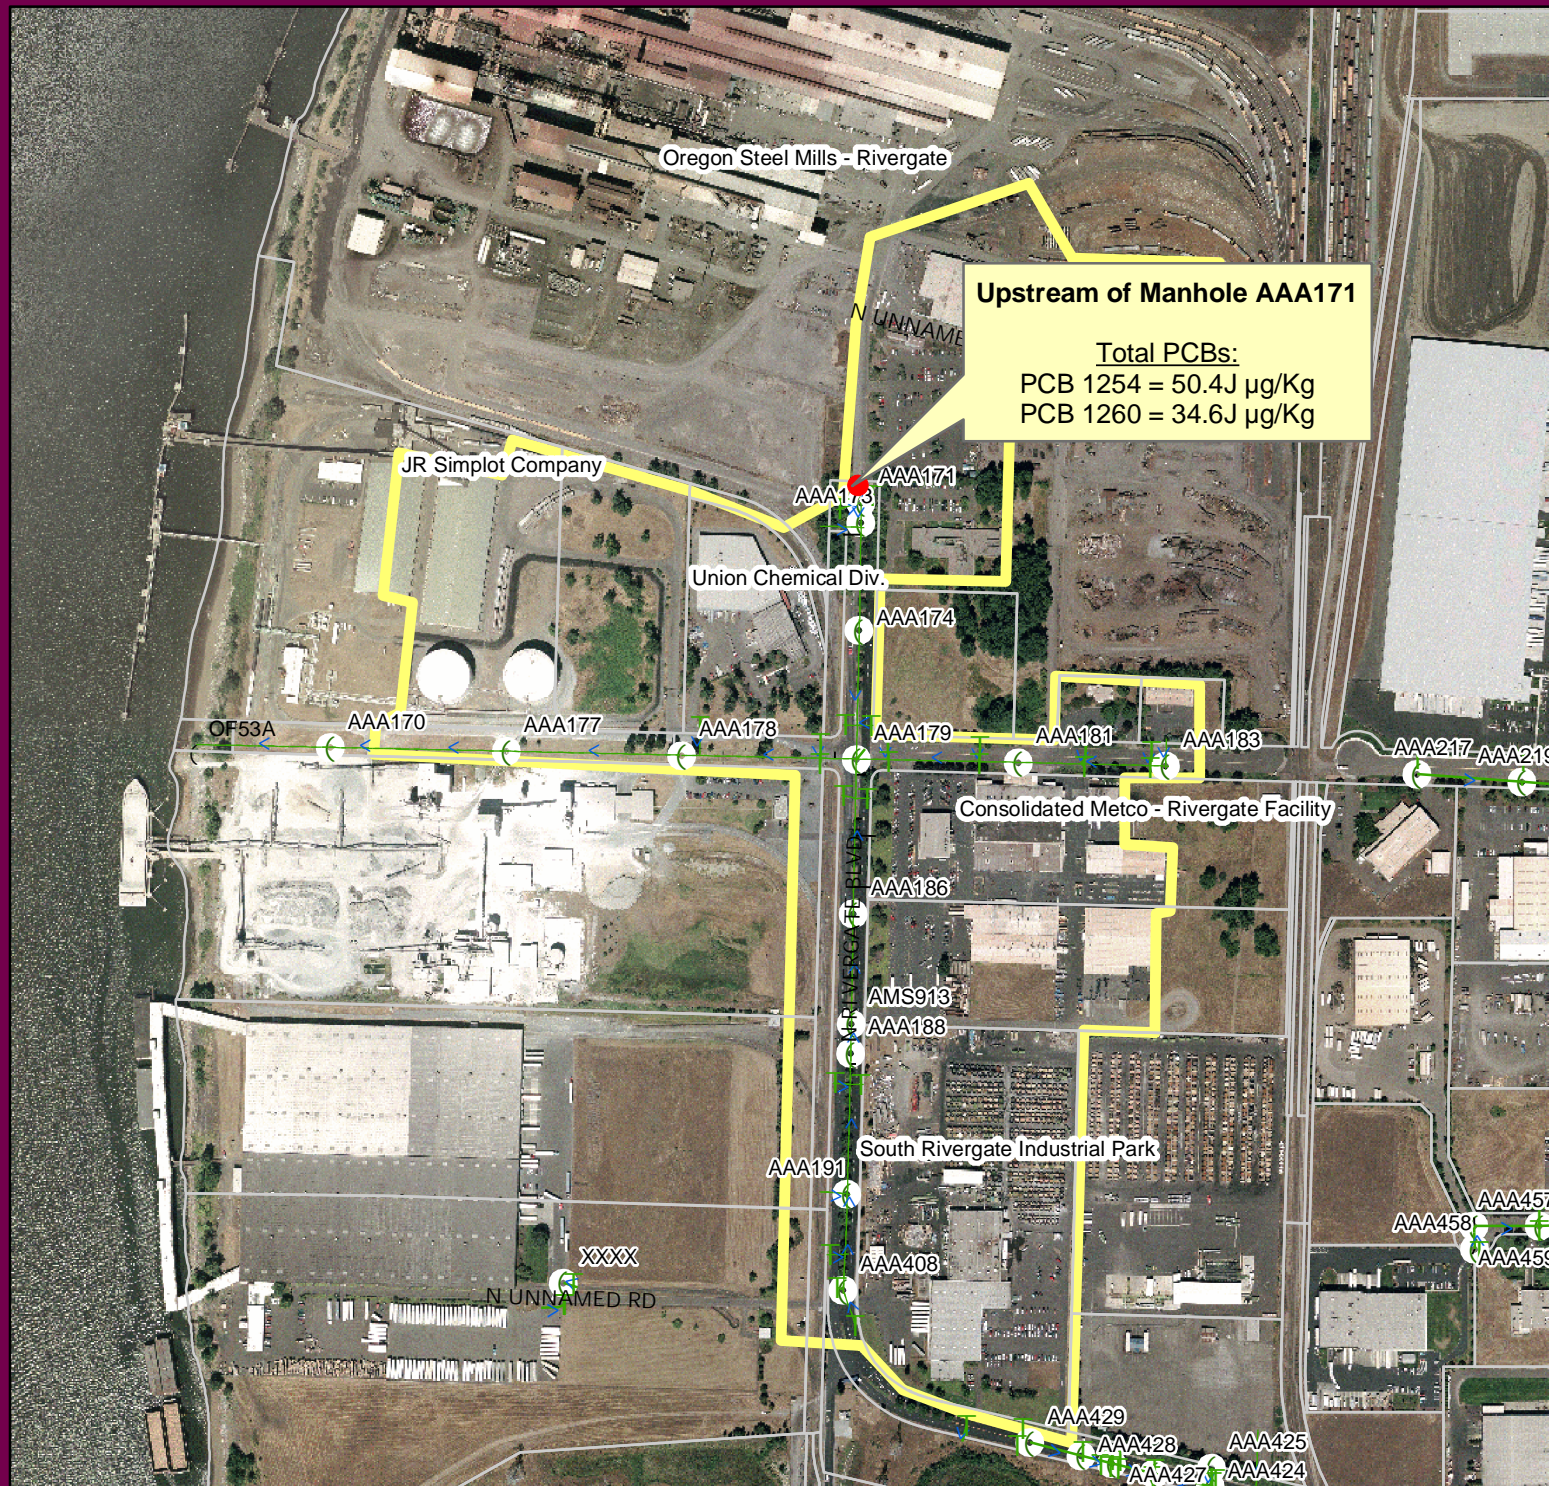
Figure 1
Outfall 53A Inline Solids Sampling
Total PCBs
Sample Date: 6/21/2005

- Two PCB Aroclors, 1254 and 1260, were detected in the inline solids sample; the reported concentration of Aroclor 1254 (50.4 µg/Kg) exceeded the most stringent Portland Harbor Joint Source Control Strategy (JSCS) screening level of 10 µg/Kg (DEQ/EPA, 2005). The concentrations of Aroclor 1260 and total PCBs were less than the most stringent JSCS screening levels.
- Two of the four dry-weather flow samples contained detectable concentrations of total (unfiltered) mercury- at the northern and southern branches of the conveyance system. Mercury was not detected in the sample from the eastern branch, nor from the outfall sample. The detected mercury concentrations were less than the most stringent DEQ/EPA JSCS screening level (0.012 µg/L). The highest concentration of mercury (0.0079 µg/L) was detected in the sample obtained from the northern stormwater line.

Analytical results for the inline solids sample from the OSM lateral indicate that PCBs are being discharged to the City stormwater conveyance on North Rivergate Boulevard. The detected contaminants are consistent with the contaminants of interest (COI) observed at the adjacent DEQ Cleanup site. The City requests that DEQ require OSM to further investigate their site conditions to ascertain the source and migration pathway of PCBs to the City stormwater conveyance system, and to identify appropriate control mechanisms to address this source.

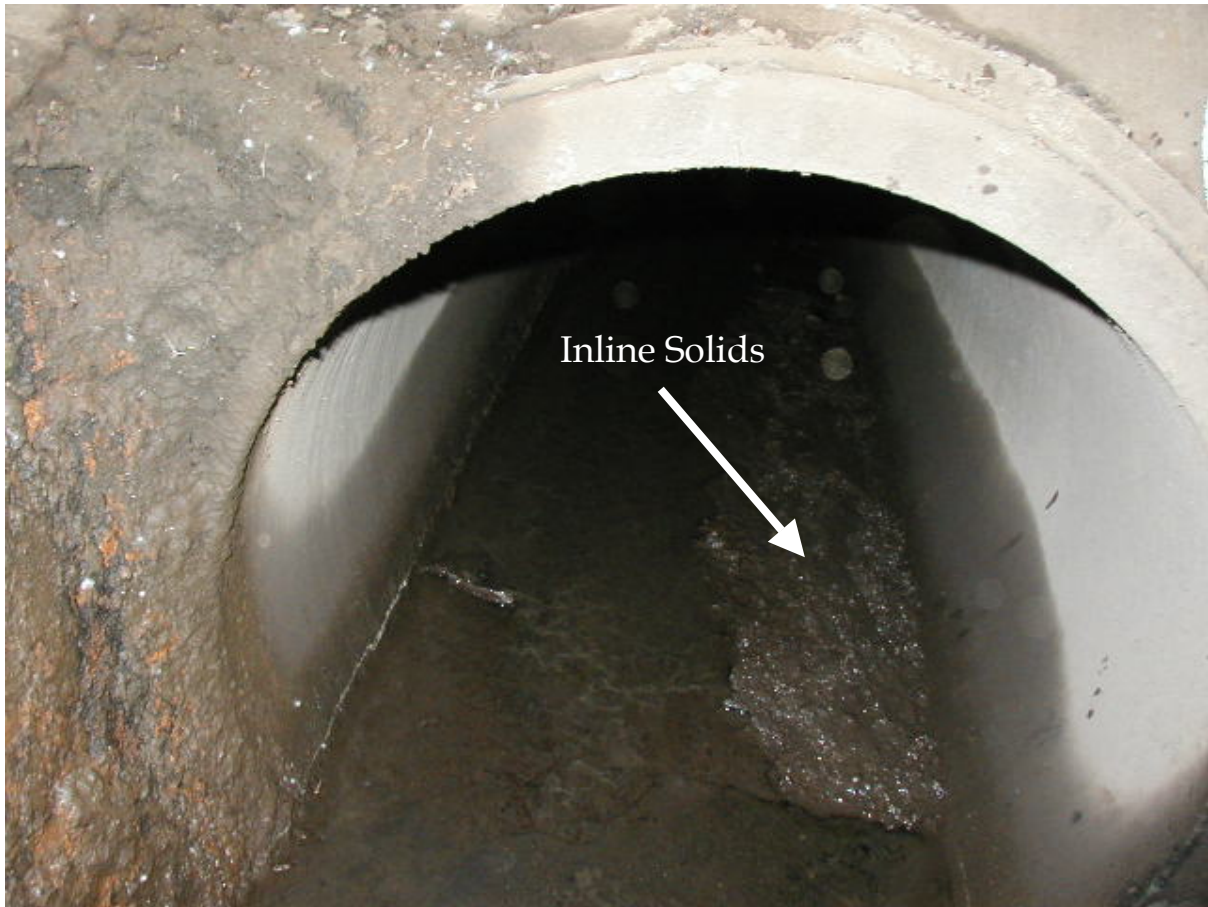
The crew entered manhole AAA171, at the northern end of the stormwater line along North Rivergate Boulevard. The line contained standing water and some cemented fine-grained solids (see Attachment A, Photo 1). These solids were collected from the OSM stormwater lateral line approximately 12 inches upstream of manhole AAA171, using a stainless steel spoon and bowl in accordance with BES Field Operations Standard

Photo 1 (June, 2005). Sampling location for inline solids during June 2005. Sample location was upstream of manhole AAA171 on North Rivergate Boulevard. These fine-grained, cemented solids were collected and analyzed for PCBs.

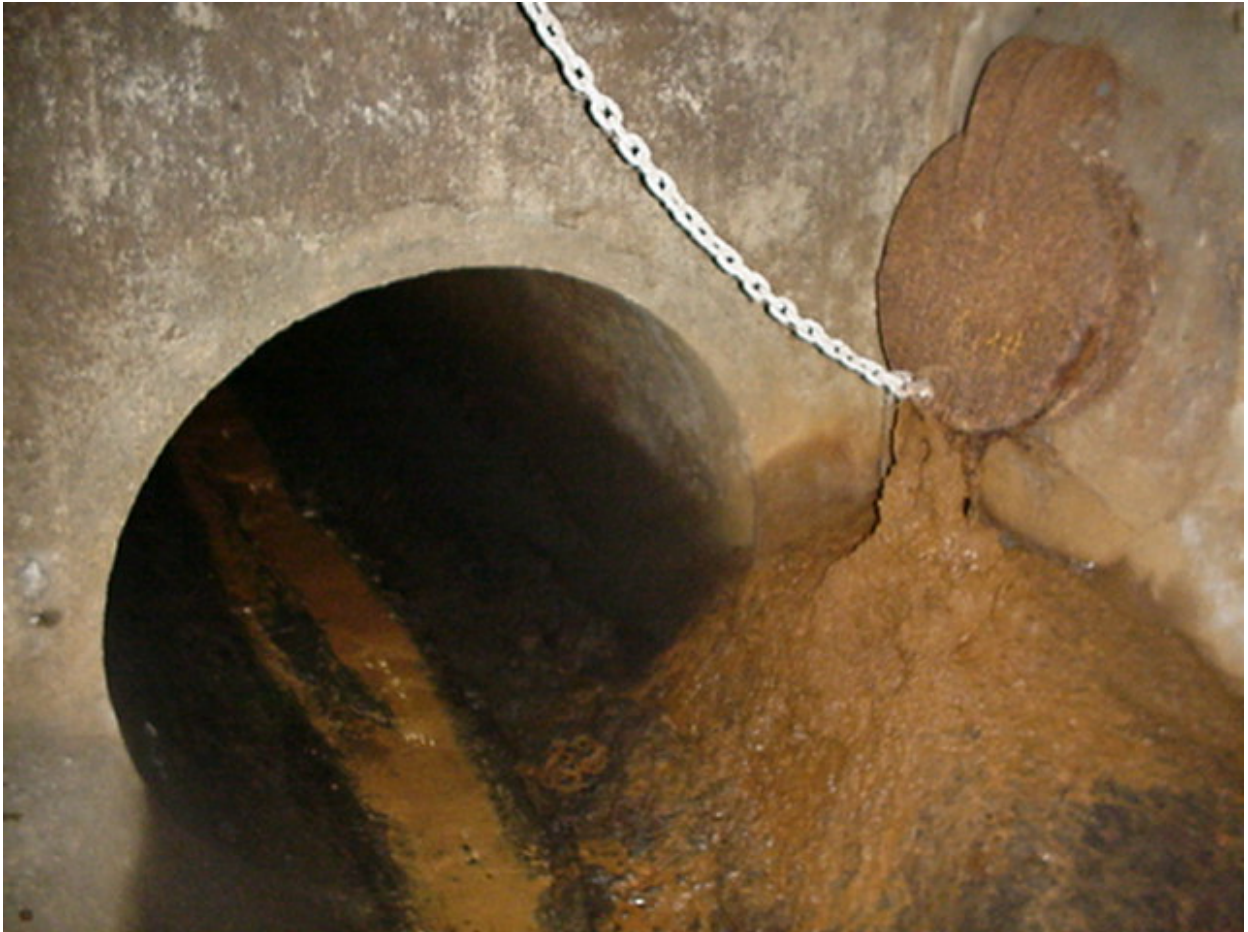
Photo 2 (July, 2005). Incoming line from north, sampled for dry-weather flow at the intersection of North Ramsey Boulevard and North Rivergate Boulevard (node AAA179).

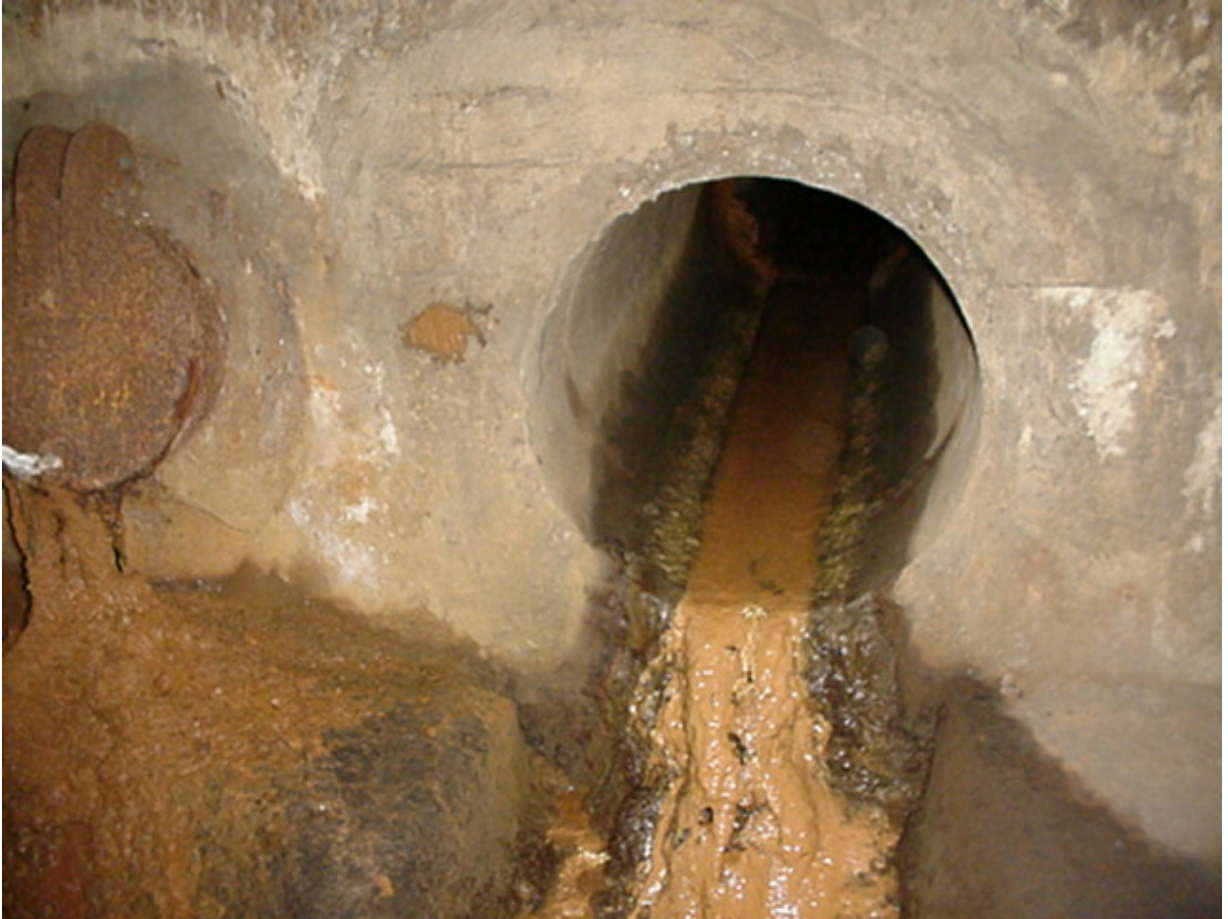
Photo 3 (July, 2005). Incoming line from east, sampled for dry-weather flow at the intersection of North Ramsey Boulevard and North Rivergate Boulevard (node AAA179).

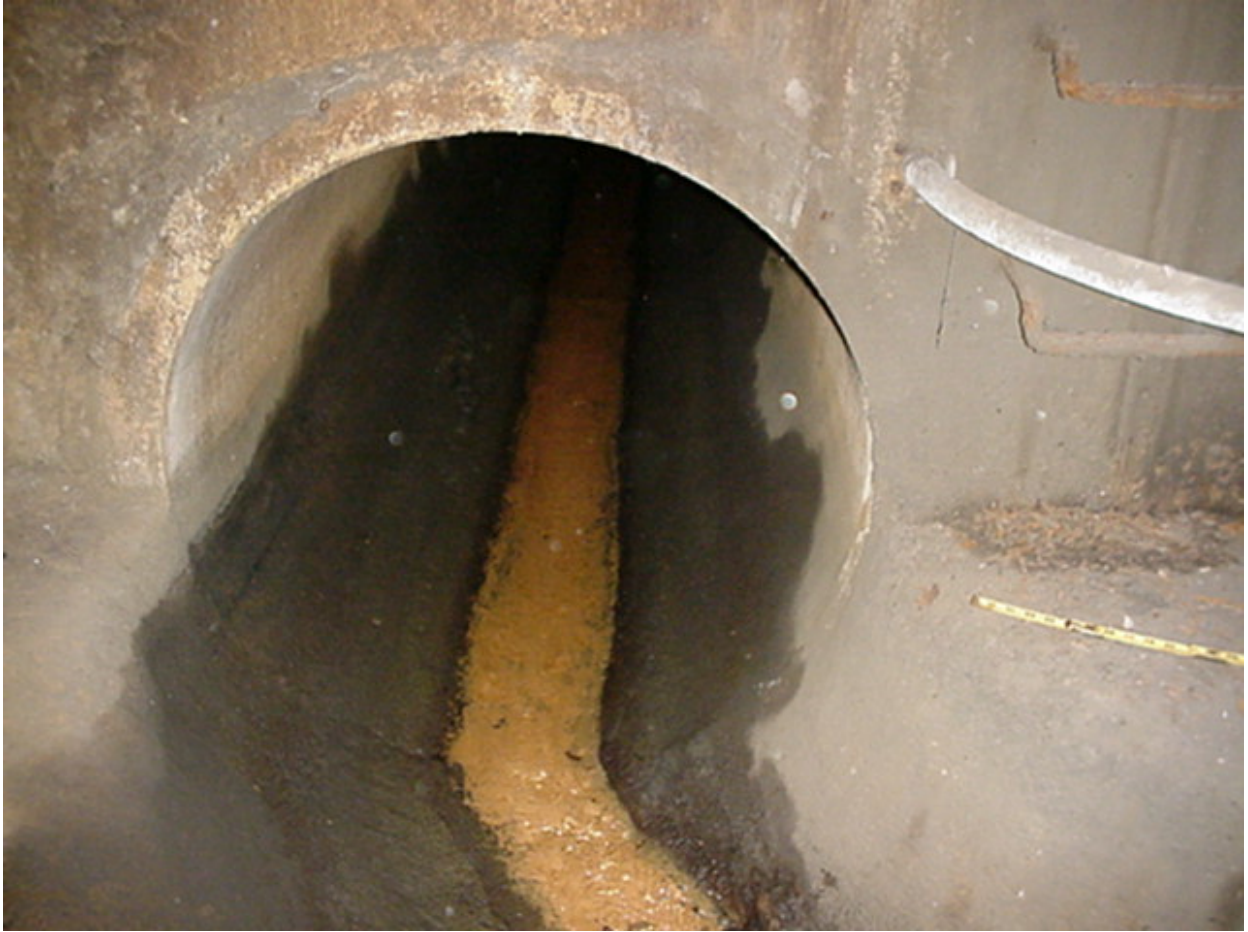
Photo 4 (July, 2005). Incoming line from south, sampled for dry-weather flow at the intersection of North Ramsey Boulevard and North Rivergate Boulevard (node AAA179).
