B.E.S. COLUMBIA BUILDING:
Scope additions and ineffective design oversight
led to substantially higher project costs

October 2014

Office of the City Auditor
Portland, Oregon

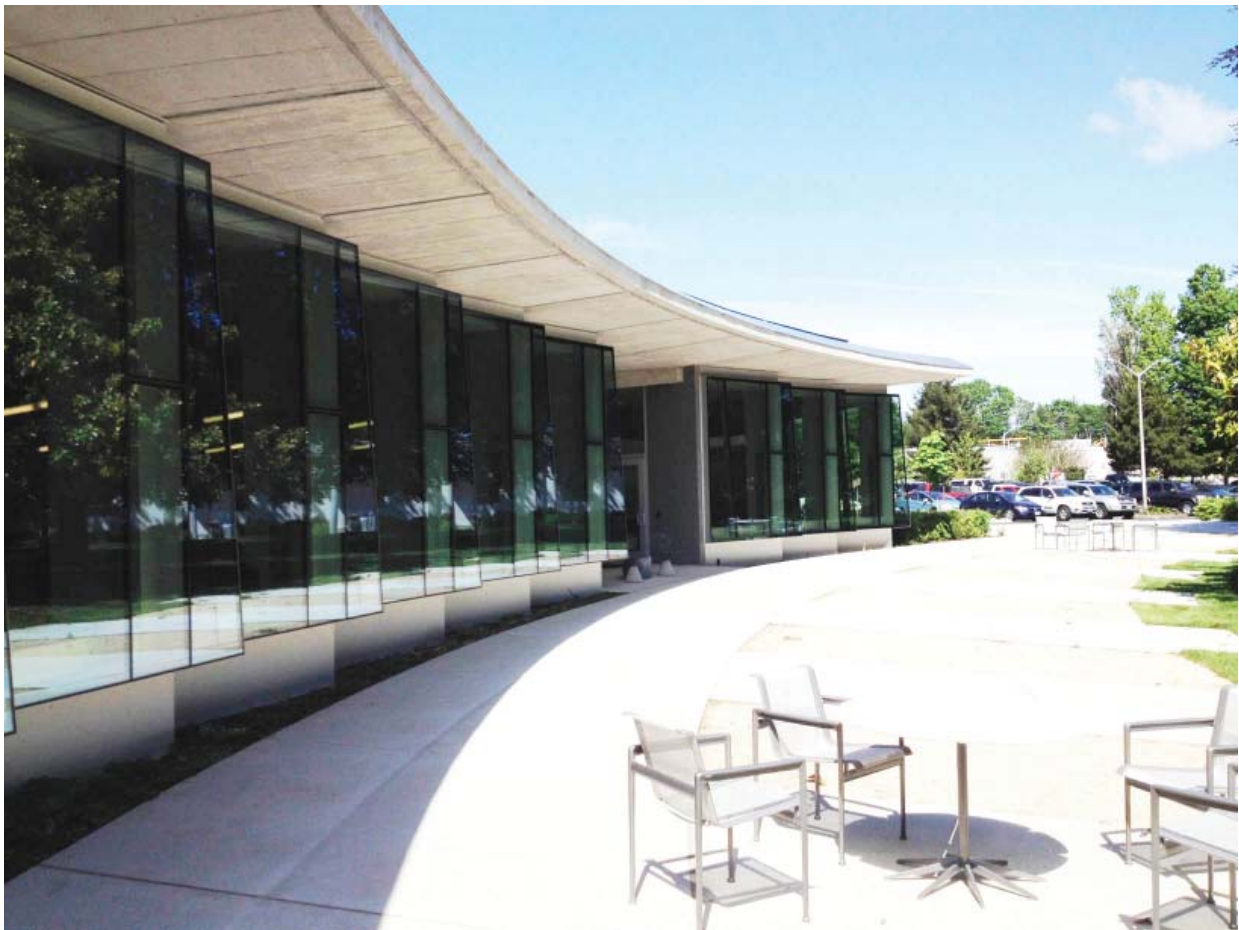
Figure 6 Glass wall on North side of new building

Architects designed a radial-shaped building with tapered structural beams across the ceiling and a complex glass wall, shown in Figure 6.

- Specified windowpane size in the glass wall was not available locally as intended by the architect to meet LEED requirements. A design with smaller panes of glass would have been easier to manufacture and install.

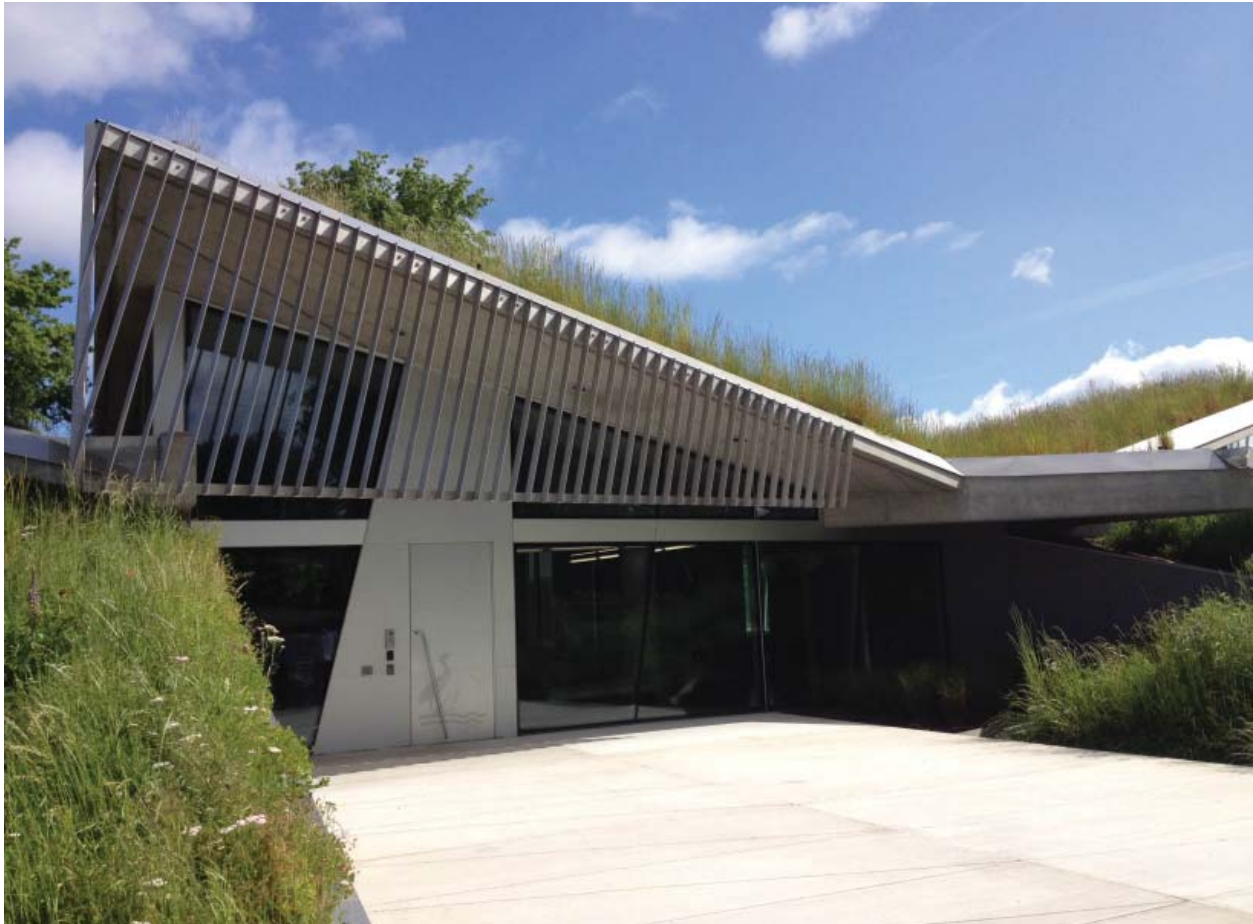
Figure 7 Steep concrete eco-roof, new visitor entrance

Parts of the roof lie at a steep slope of 18 degrees, shown in Figure 7 above the public entrance to the building.

- The warranty on the steep roof required adding soil barriers to prevent wet soil from sliding off. A less-steep roof design may not have needed these additions. Adding the barriers during construction cost the City \$30,000. Other design changes to the eco-roof cost \$80,000.

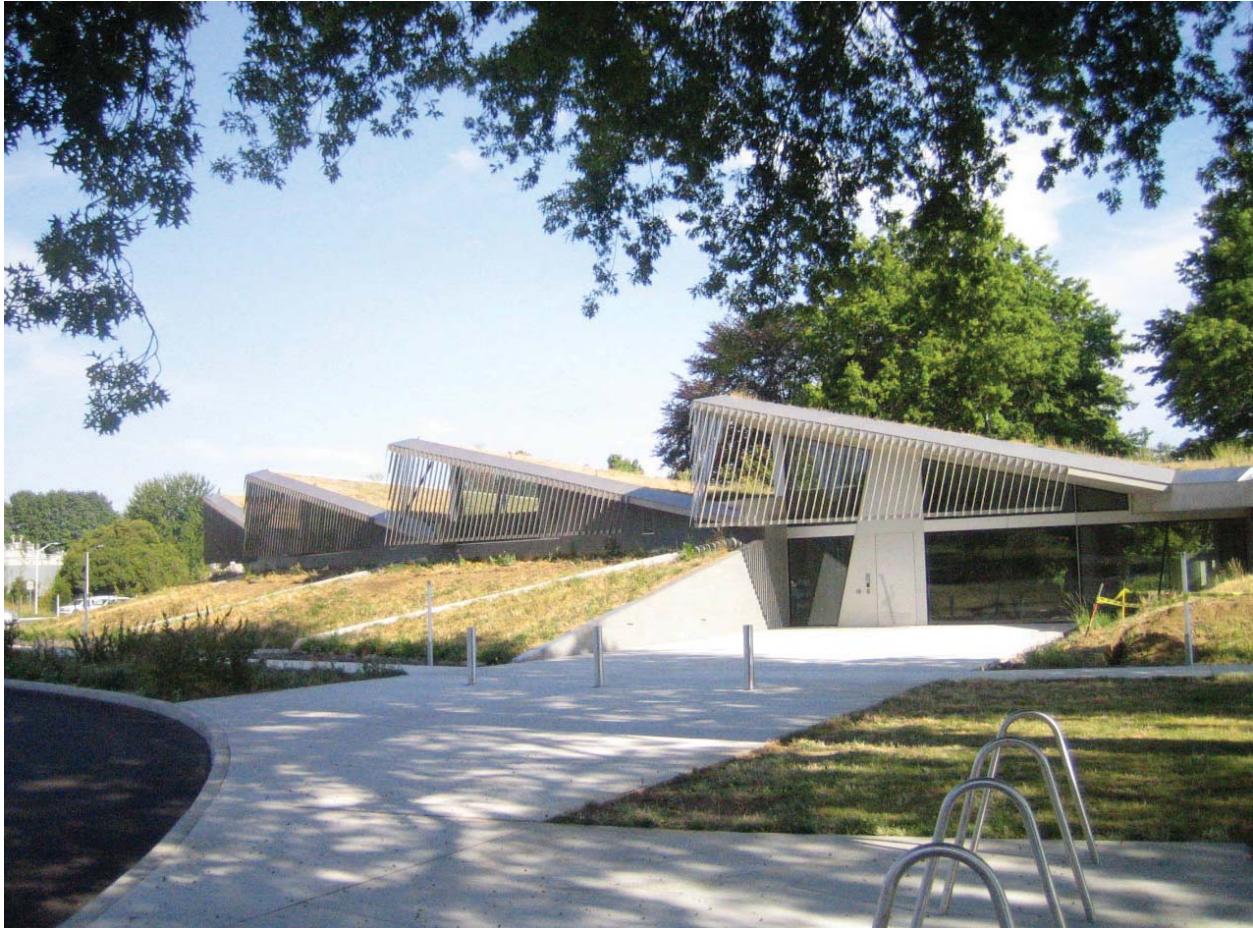
Figure 8 Complex roof with at least 13 planes

Figure 8 shows some of the many different planes, at least 13, that make up the roof. Triangular windows fill the irregular space between some walls and roof. The BES Bureau Leadership Team approved these features.

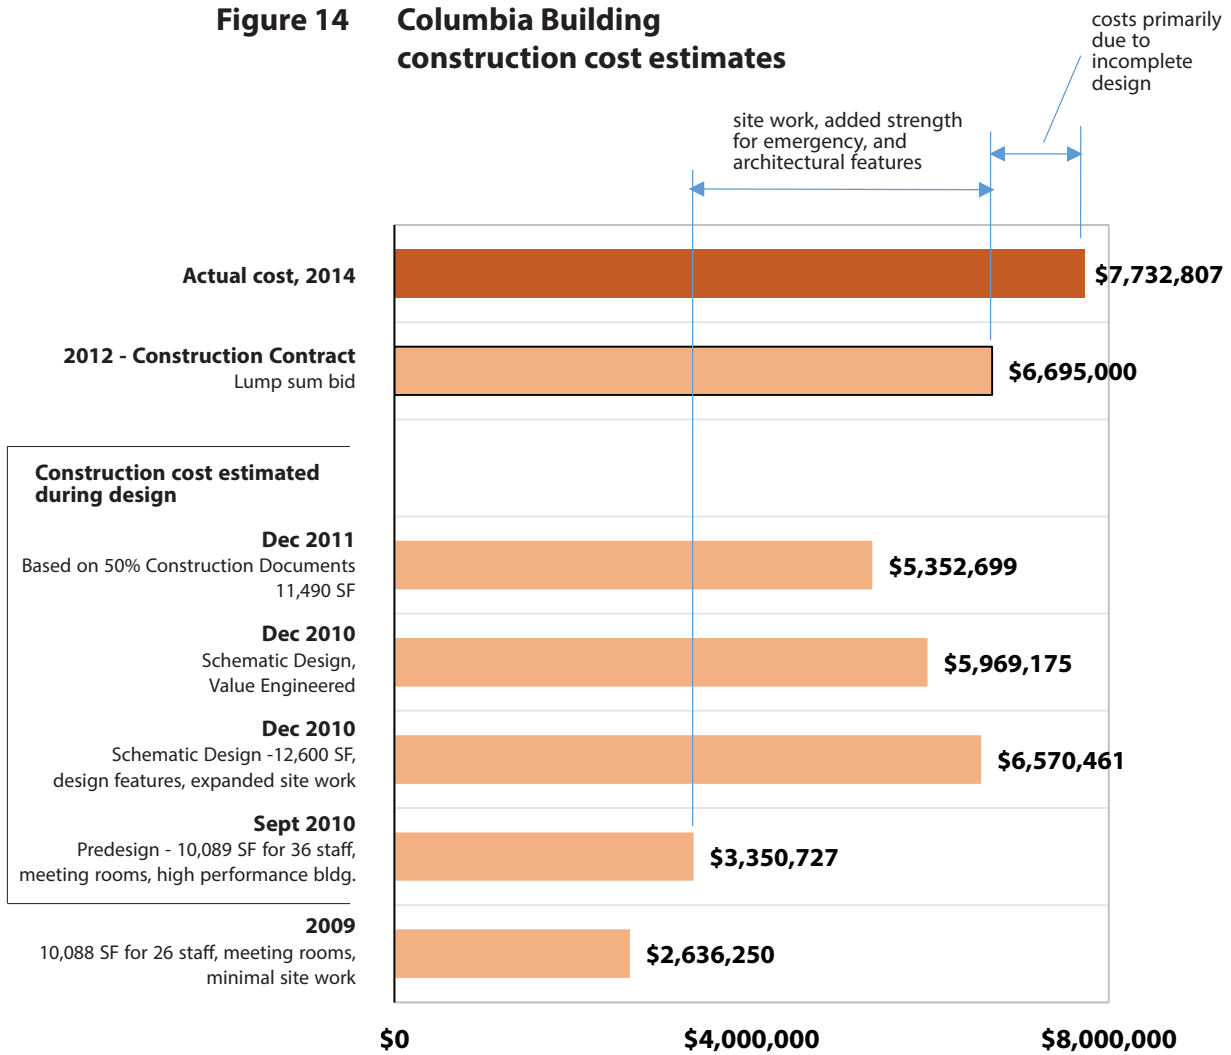
Figure 14 Columbia Building construction cost estimates

Note: Estimates exclude furniture and technology contract costs, design, management, and other BES project costs. Dec 2010 estimates included road construction work performed by another contractor.

Figure 14 shows construction cost estimates prepared during design, compared to the actual bid amount and the final cost including changes during the work.

BES deemed the modified 50 percent construction estimate of \$5,400,000 "optimal," in its communication to Council, although the estimate did not appear to meet the City definition of an optimal estimate, shown in the Appendix. The construction contract bid amount was \$6,695,000 and final construction cost was \$7,732,807 (including the payments to the design contractor).
