2013 Stormwater Management Facility Monitoring Report

Sustainable Stormwater Management Program

December 2013

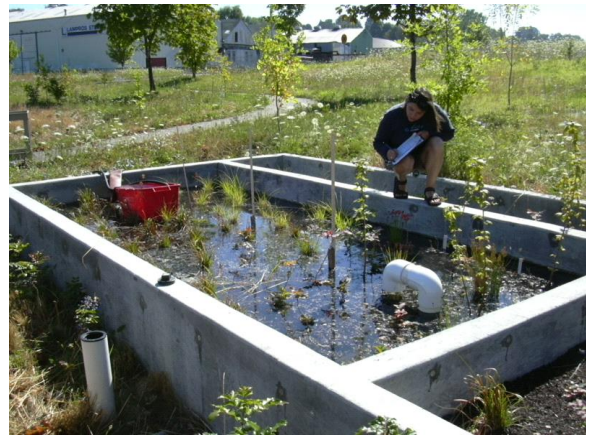
Figure 3-1: Recording drawdown rates at the WPCL Test Planters

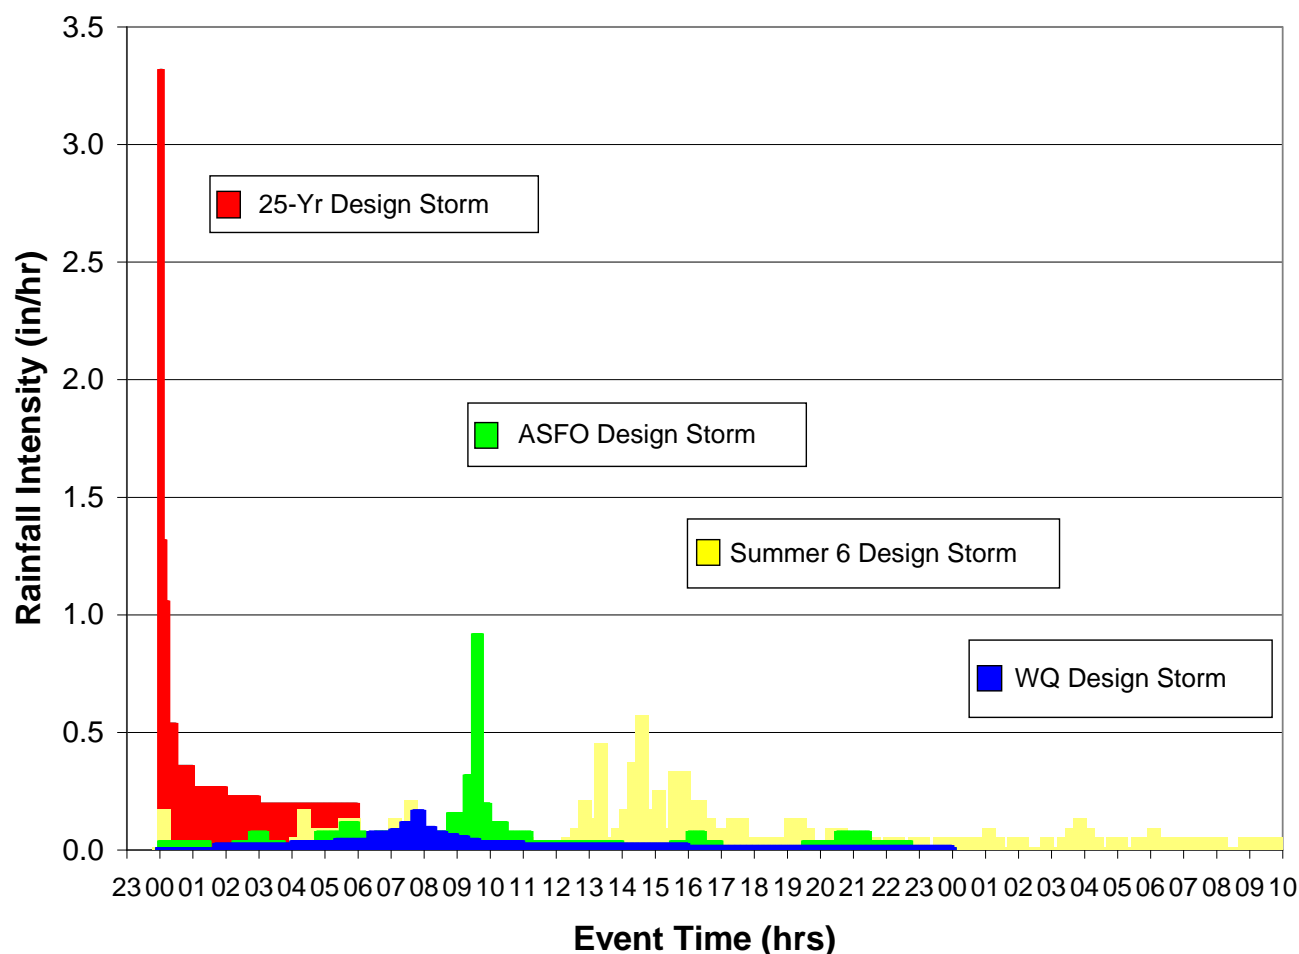
Figure 4-1: Comparison of design storms

Potentially relevant design storms are described in the following sections and compared in *Figure 4-1*.

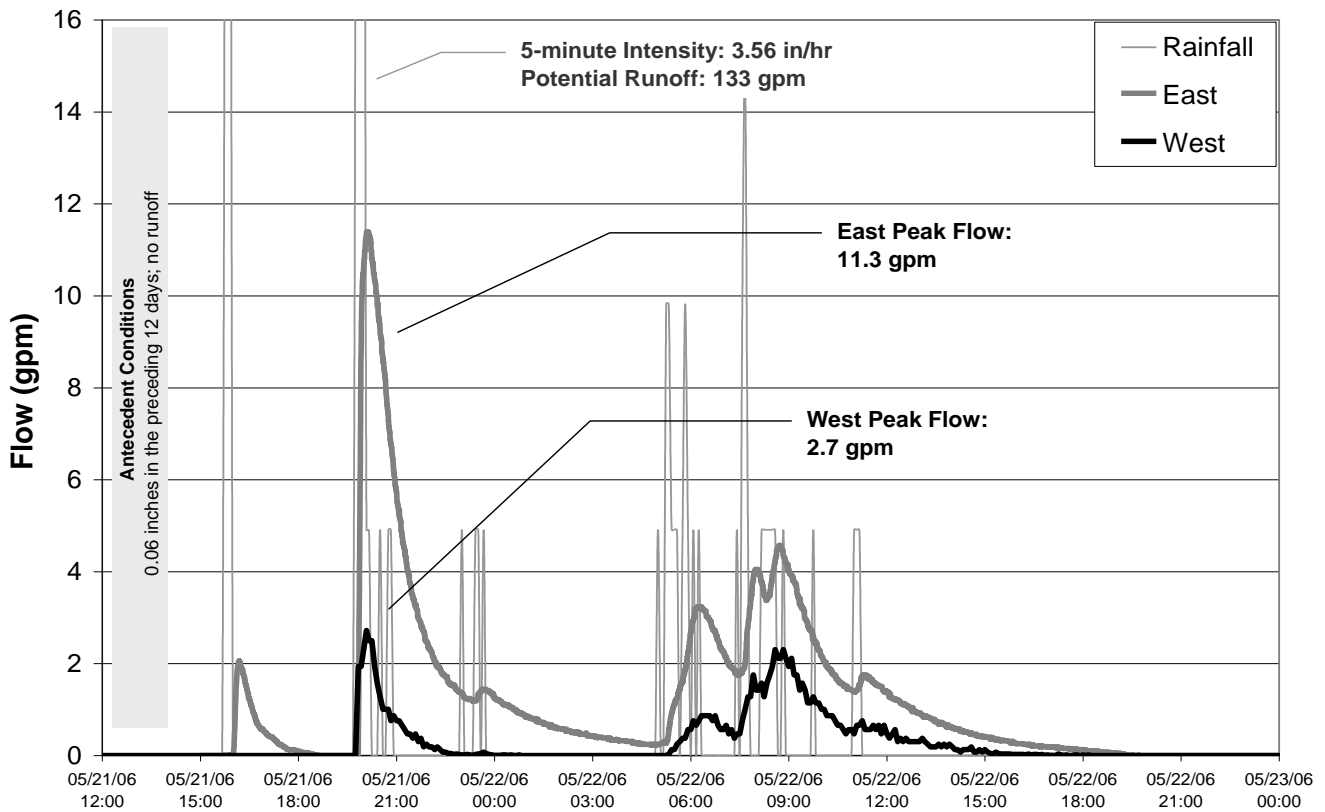
Figure HA-3: Roof runoff for 5/21/2006 event

This event intensity is beyond the 3.32 inches per hour intensity of the 25-Year Design Storm, indicating this ecoroof significantly reduces peak flows for intense rain events.

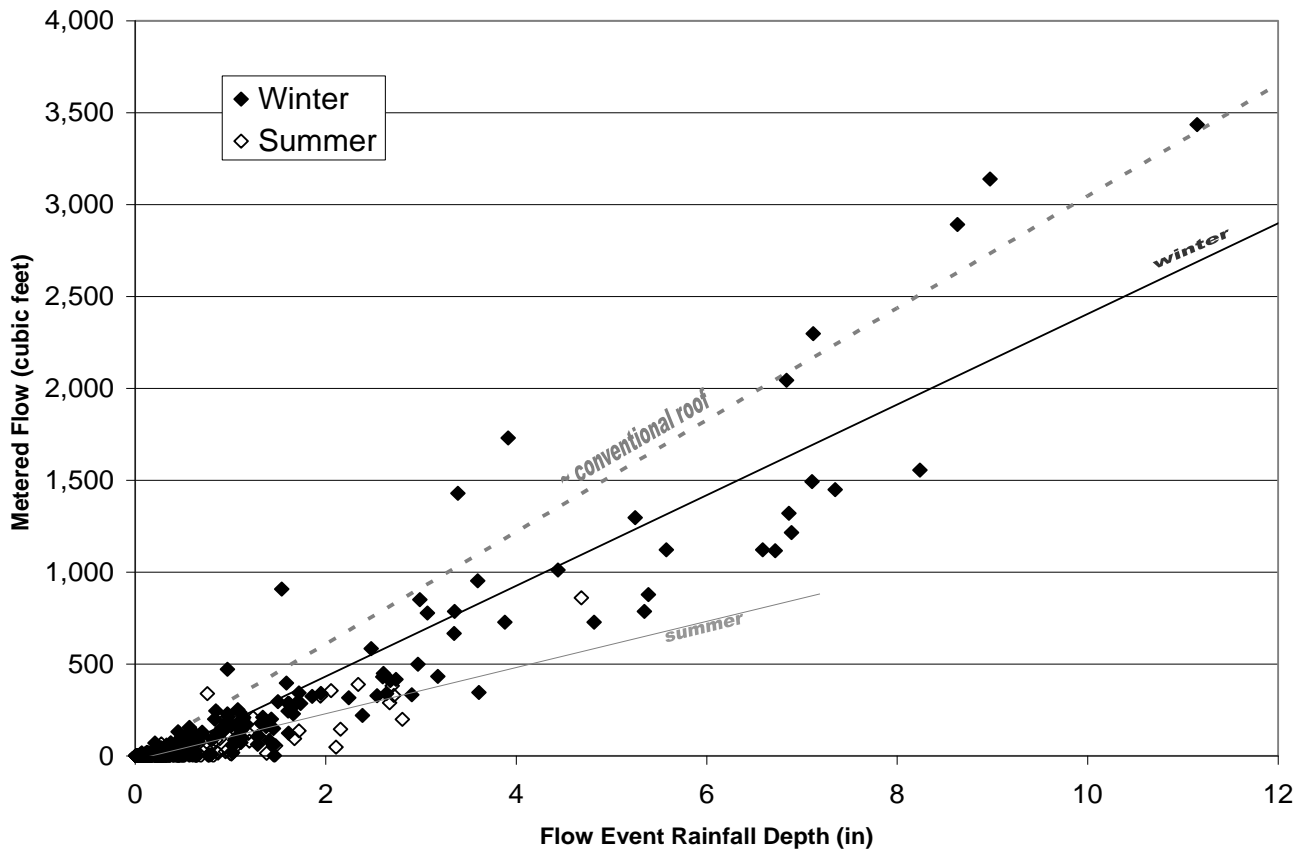
Figure HA-5: Seasonal runoff as a function of total event rainfall, Hamilton – West Side

Looking at individual storm events, it does appear that runoff is strongly related to the rainfall depth of an event (**Figure HA-5**). There is significant scatter, as would be expected from such a dataset with such a variety of storm patterns and antecedent conditions. There are nine events where metered runoff exceeded estimated rainfall. However, given the accuracy of the raingage and the flow meter, this number of outliers seems reasonable. There appear to be separate and well-defined linear trends for the summer and winter seasons.

There have been few events similar to the CSO Design Storms during the monitoring period. Those that occurred during the summer CSO regulatory period (May to October) are presented in **Table HA-5**. It is a small sample of events, but most show substantial retention for the west side, averaging 62% - just about equal to the 63% retention estimated by using the summer trend line in **Figure HA-5**.

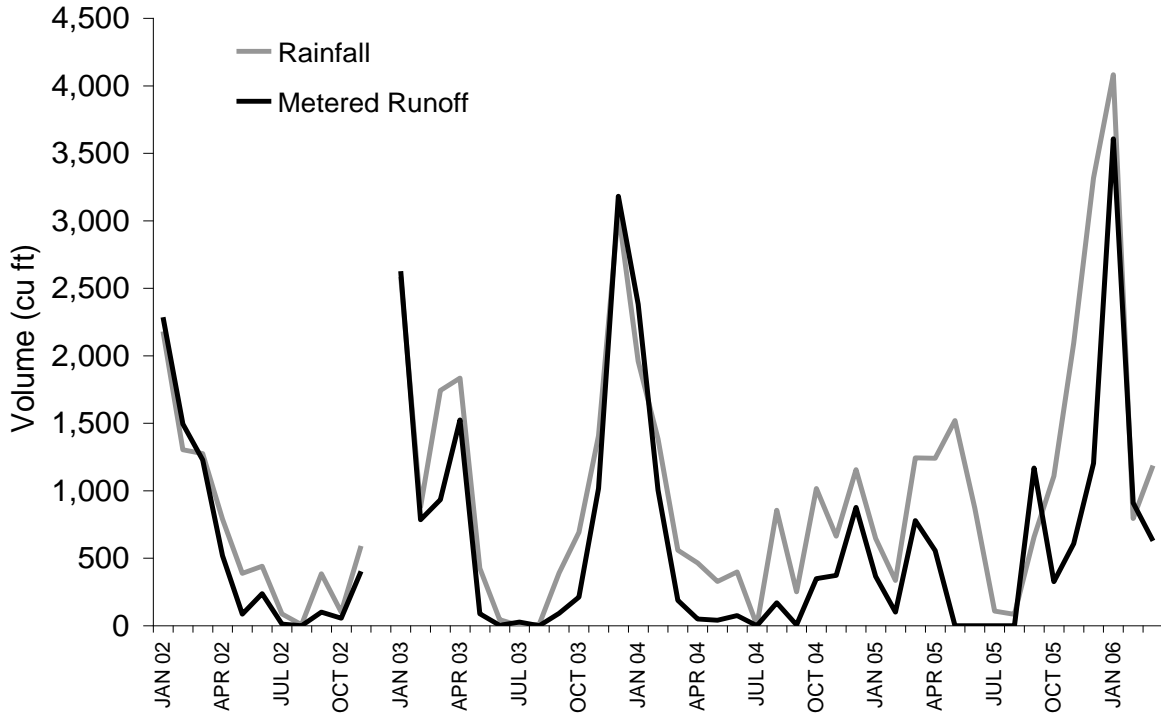
**Figure HA-6: Monthly rainfall and associated runoff retention,
Hamilton Ecoroof – East Side**

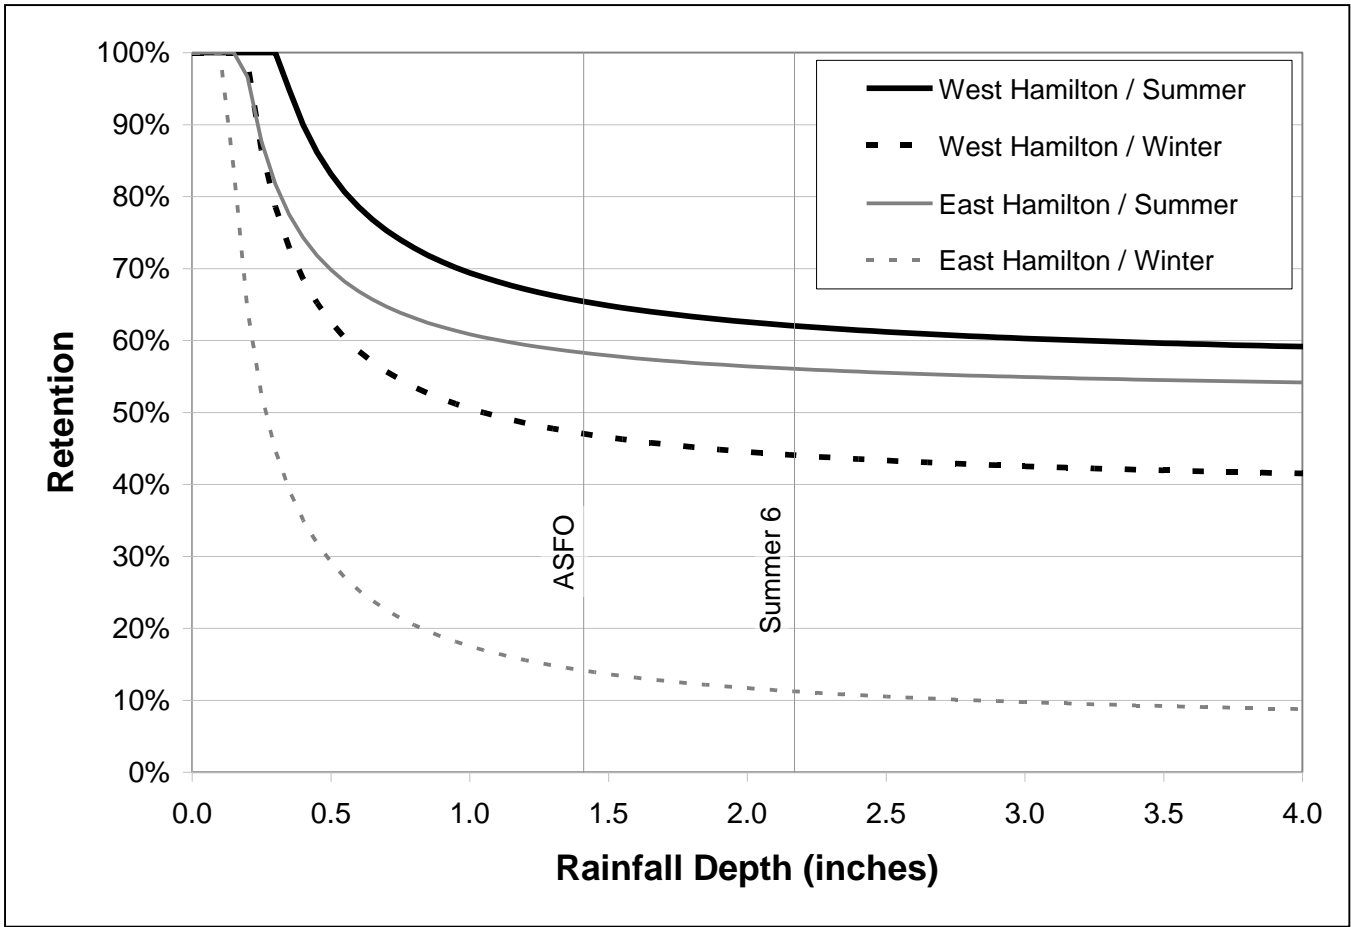
Figure HA-8: Volume retention curves for both sides of Hamilton Ecoroof

The west side soil media is effective and outperforms the east side soil media. Retention can be estimated based upon total event rainfall using the linear trend lines from Figures HA-5 & HA-7. The resulting curves are presented in **Figure HA-8**.

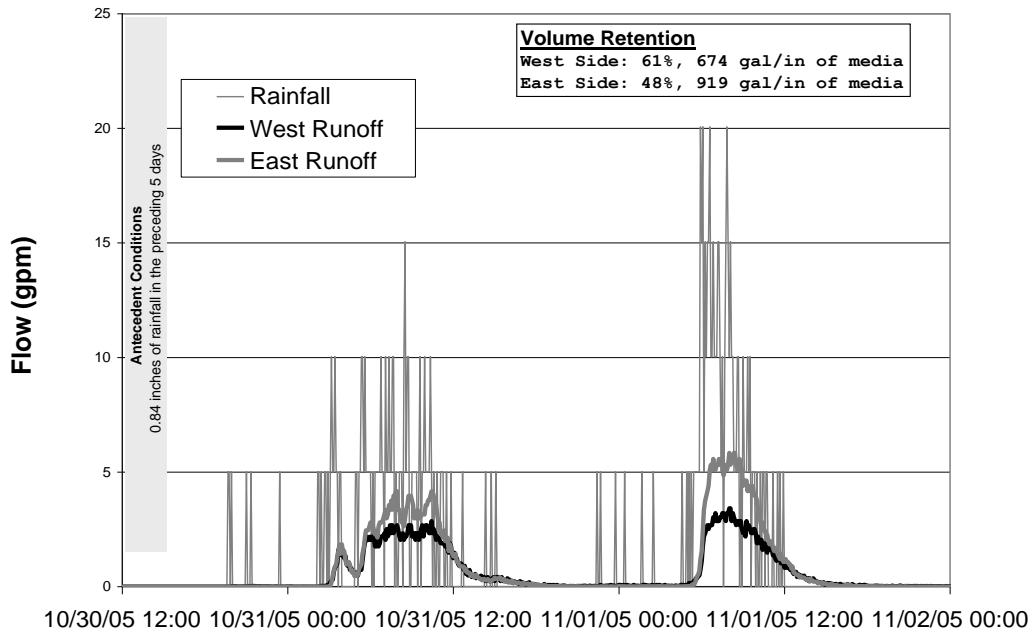
Figure HA-9: Runoff response to an October 2005 event

Figure HA-9 compares the west side and east side response to an October 2005 storm similar in depth to a CSO Design Storm, though not the same pattern.

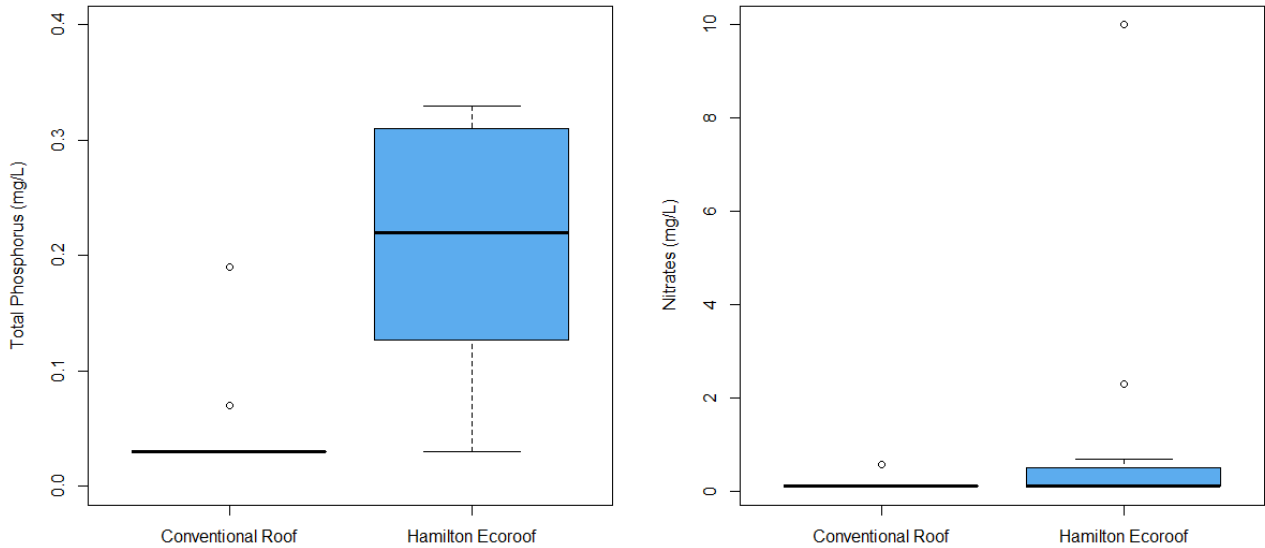
**Figure HA-15: Box Plot of Conventional and Ecoroof Runoff Concentrations
Total Phosphorus (left) and Nitrate (right)**

Conventional runoff showed little or no presence of nutrients (*Table HA-15* and *Figure HA-15*). All nutrients but ammonia are found in greater concentrations in ecoroof runoff. Rainfall at this location has not been shown to contain significant nutrients (Sullivan, 2005). This suggests nutrient runoff is driven mostly by the soil media, vegetation life cycles, and aerial (dry) deposition.

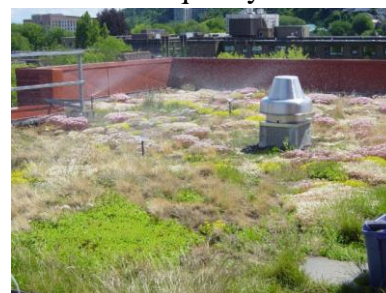
Figure HA-14: Sprinklers on Hamilton Ecoroof

Irrigation is used periodically on the roof, but the soil retains moisture fairly well meaning that daily irrigation is not needed. This reduces irrigation costs and provides a better chance that the roof will have capacity to impact summer storm events.

Periodic irrigation line breaks have been an issue. Inadvertent damage caused by maintenance workers and the activities of residents of the apartment building have been a factor. Because the roof is accessible to residents, debris is routinely present on the roof including food, garbage, beer bottles, and paper.

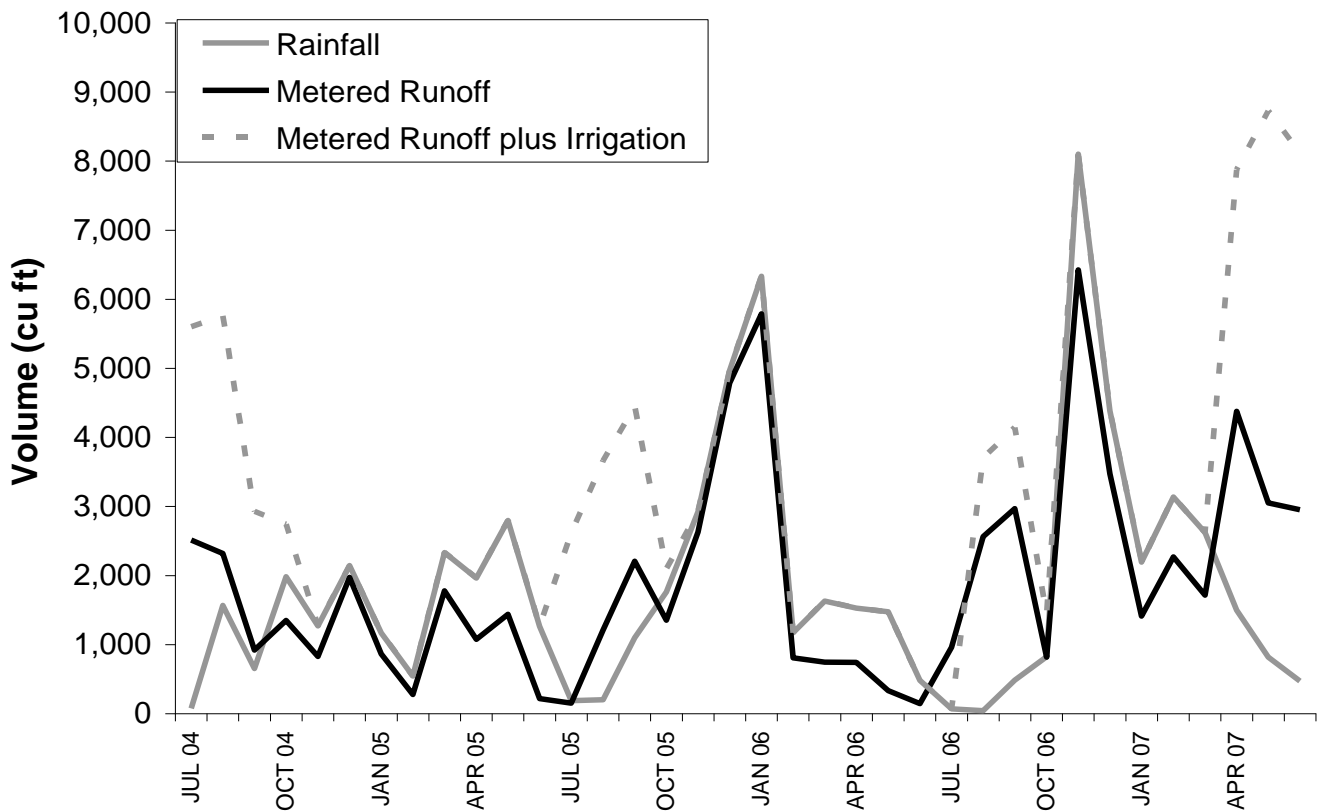
Figure MU-3: Monthly rainfall and runoff retention

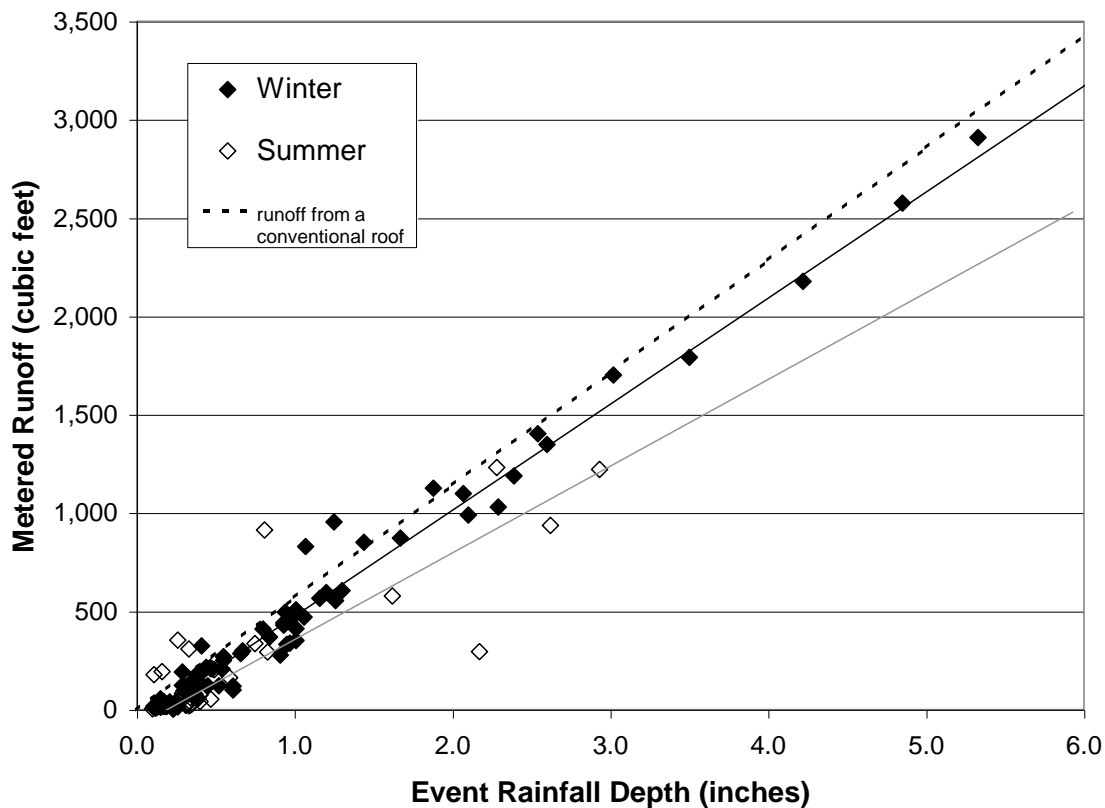
Figure MU-4: Seasonal rainfall / runoff relationship
(122 events, Oct 2004 – Jun 2007)

Looking at individual storm events, the relationship between event runoff and event rainfall is generally linear (*Figure MU-4*). Higher retentions are seen for storm events below 0.5 inches, and are minimal for larger events.

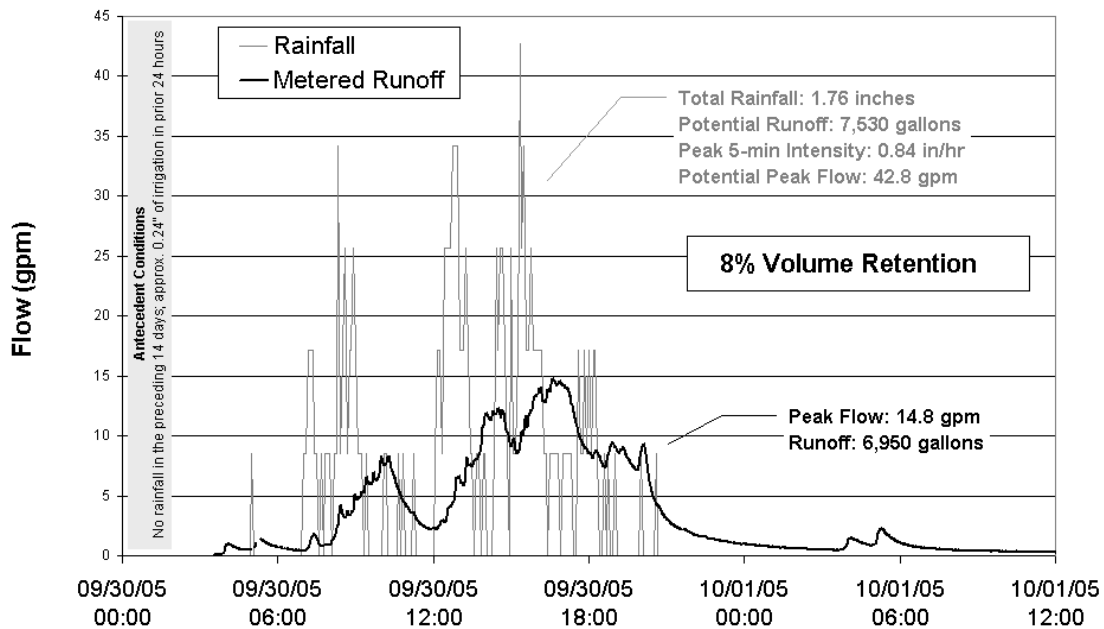
Figure MU-5: Response to September 2005 storm event, similar to summer CSO Design Storms

Two events occurred outside the May to October period when the summer design storms apply. However, both storms are close to the summer season and retentions do not differ substantially from the other events. The September 30, 2005 event is perhaps the most representative of the CSO Design Storms, and the roof runoff response for this event is shown in **Figure MU-5**.

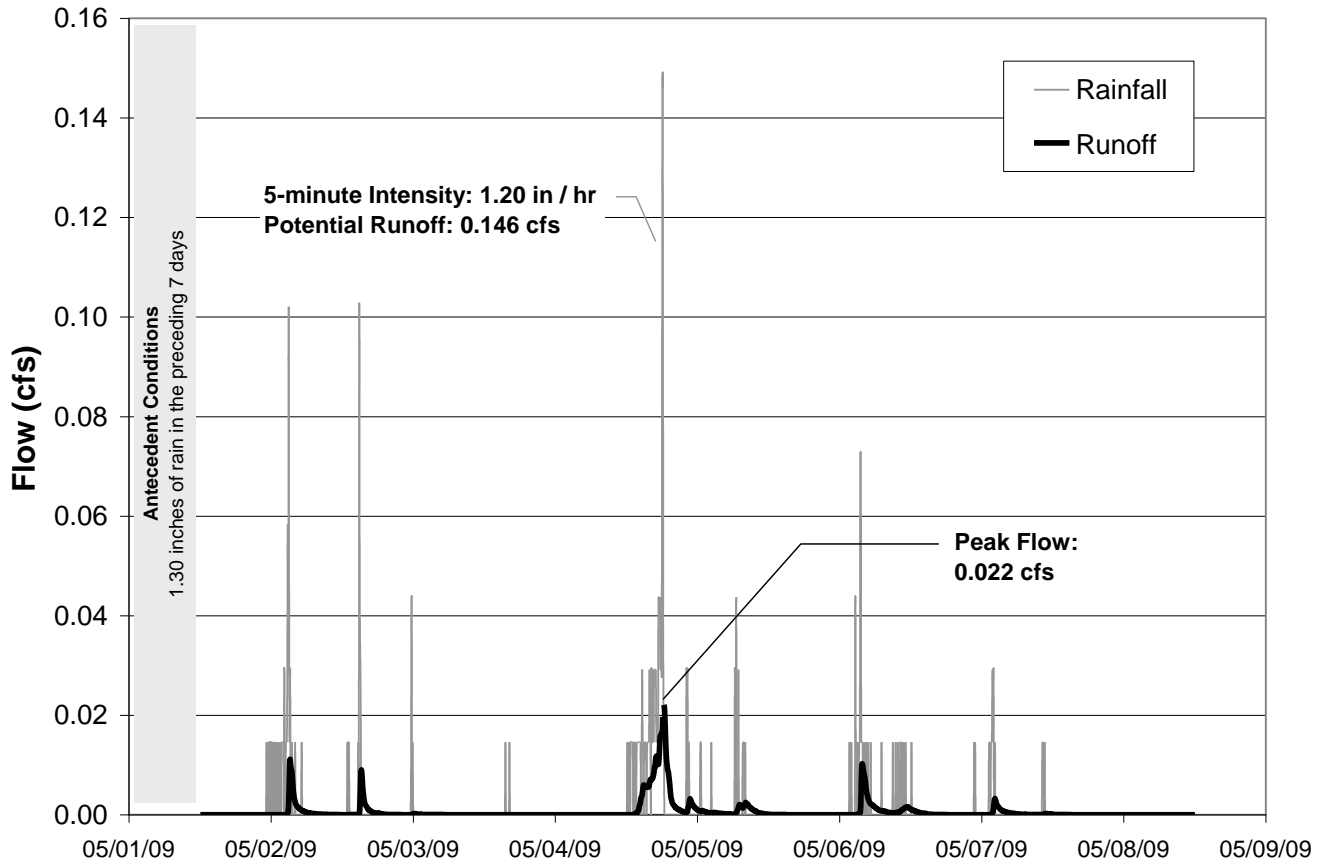
Figure PB-2: Roof runoff for the 5/4/2009 event

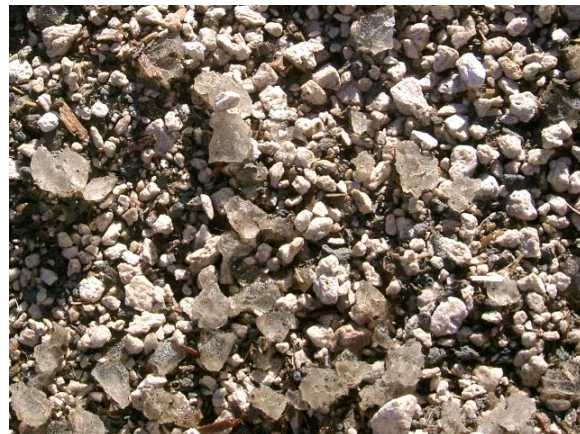
Figure PB-9: Ecoroof cross-section (left) and Stockosorb® gel in the soil media (right)

After more than 3 years of data collection, the roof appears to be performing very well. Volume retention is higher than the west side of the Hamilton Apartments, despite being thinner and using a lighter weight soil media. The addition of the Stockosorb® polymer may play a role, as well as the use of insulation above the membrane (runoff is forced to flow between, under, or over the foam insulation).

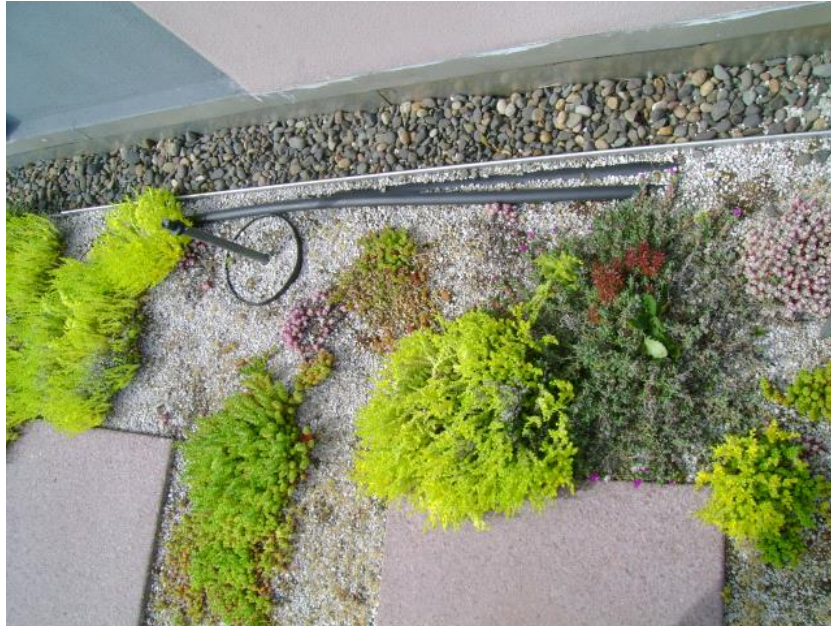
Figure PB-10: Exposed HDPE irrigation lines near the penthouse wall

The irrigation system uses an HDPE pipe system that seems to flex with temperature extremes. With only 3 inches of soil, it is difficult to keep the pipes buried and they are exposed to extremes in temperature (**Figure PB-10**). This is the likely cause of several sprinkler heads popping off their risers and several leaks at pipe joints.

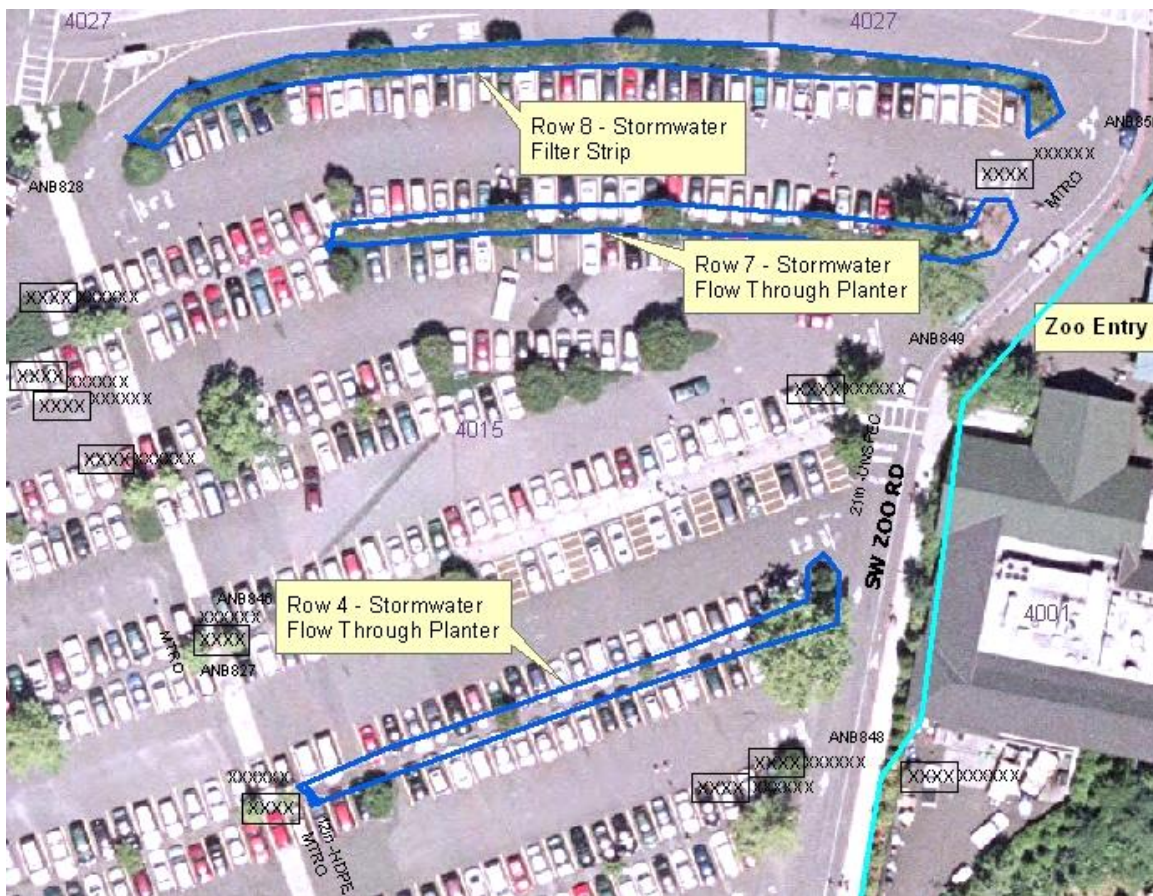
Figure OZ-1 – Facility Overview

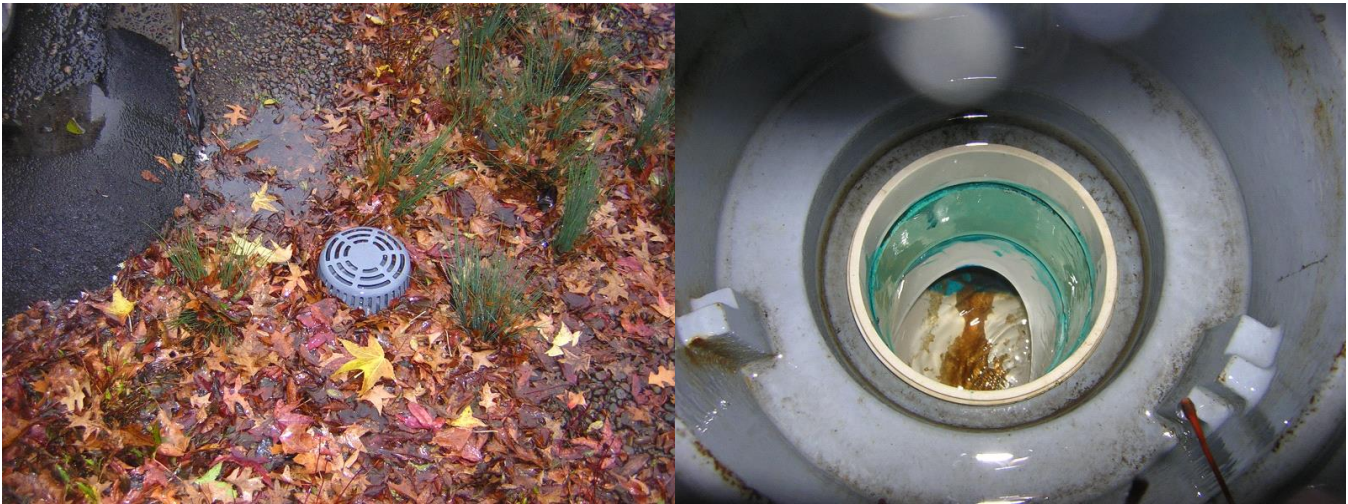
Figure OZ-10 – overflow sampling location (Row 7); flow in underdrain (right) is pumped into a sample container through the overflow dome

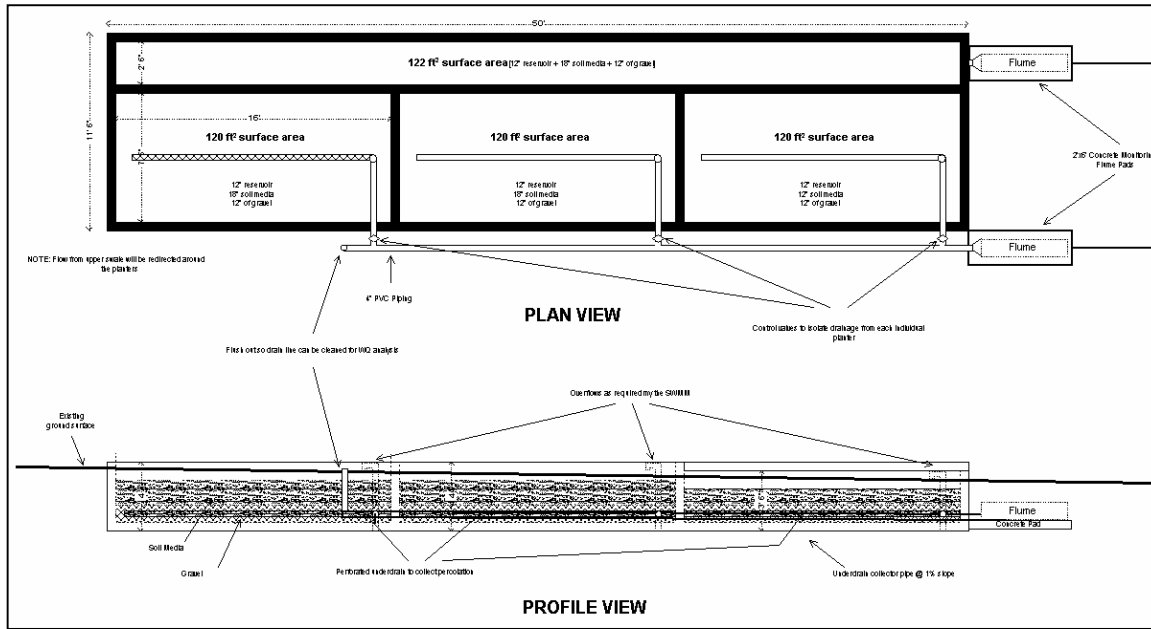
Figure WP-1: Plan and profile views of the WPCL Test Planters

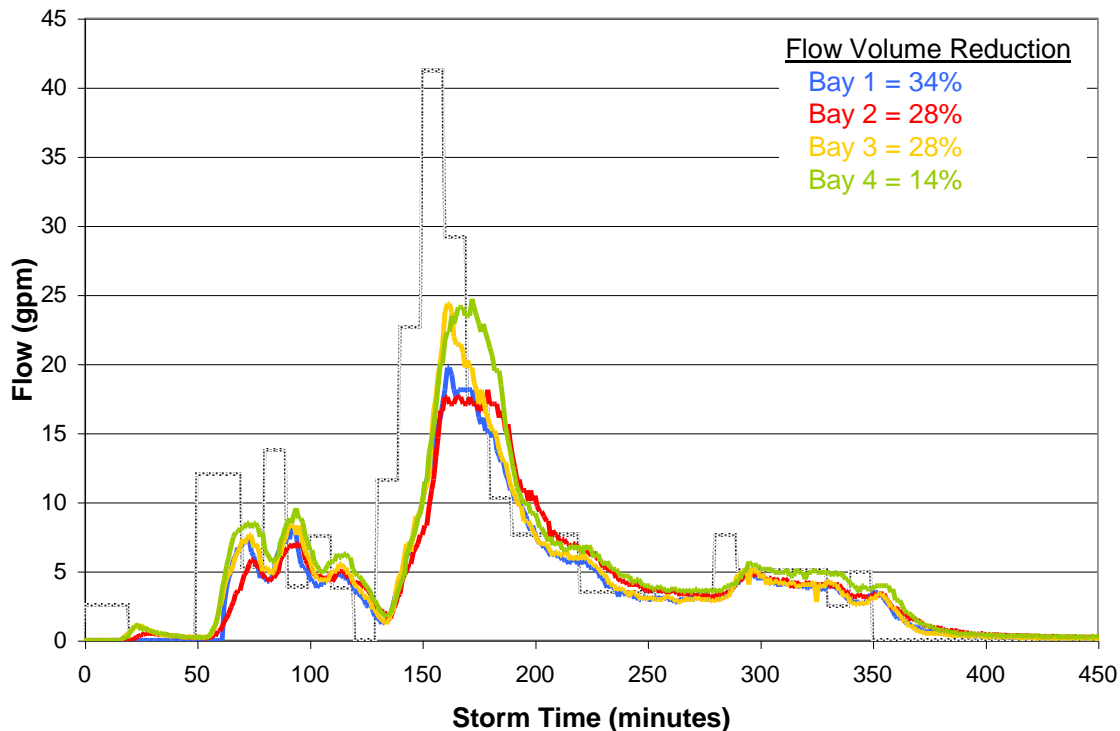
Figure WP-2: Outflows for ball bays during July 2007 test
(faded grey line represents design storm inflow)

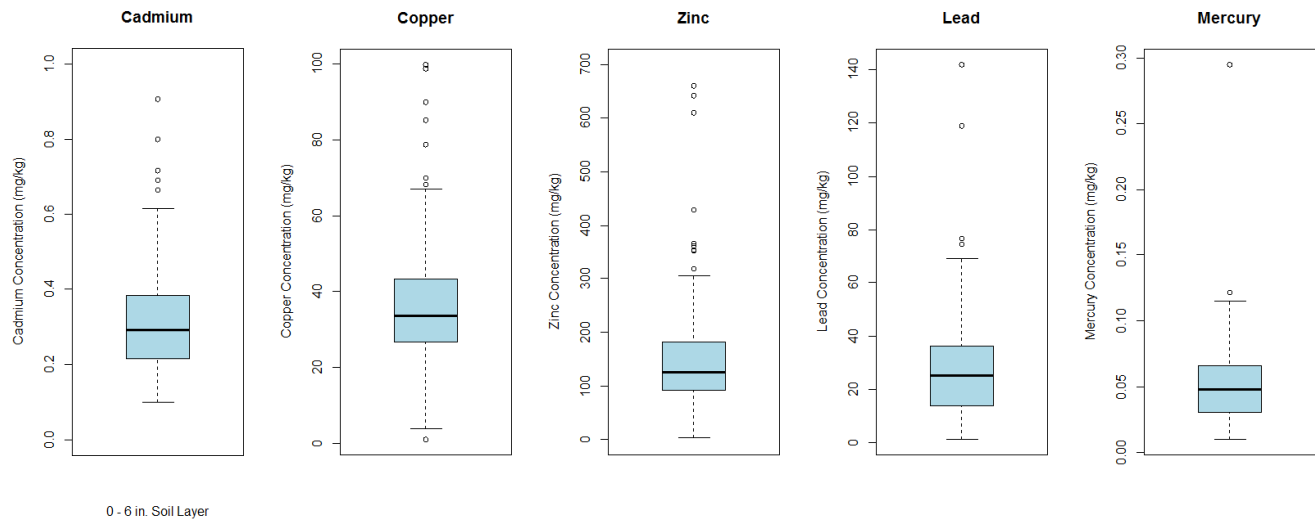
Figure SS-3: Metal levels in surface soils (0 to 6 inches)
(stormwater facility: n = 142)

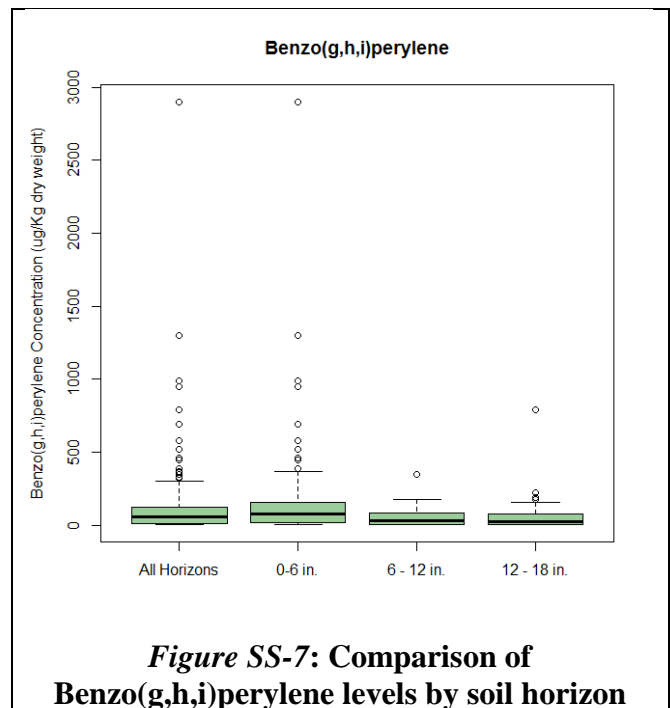
Figure SS-7: Comparison of Benzo(g,h,i)perylene levels by soil horizon
