Stormwater Management Manual

Bureau of Environmental Services

SWMM Monitoring Update, 2022

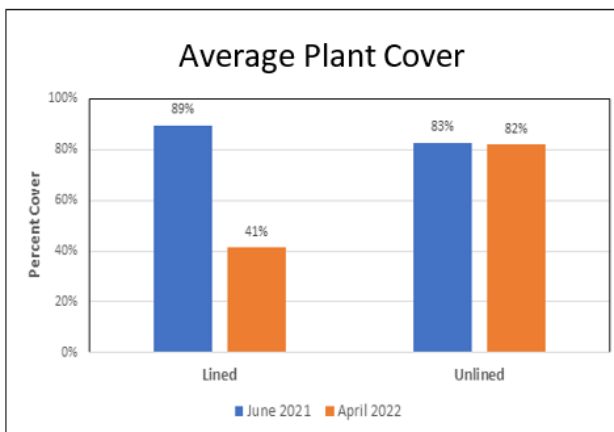
Figure 1. Slough 104B – Plant Cover

For lined facilities there was a significant downturn in the standard GSI O&M ratings for plant cover and plant health between assessments completed in June 2021 and in April 2022. In April 2022, staff were able to confirm plant mortality from summer 2021 based on new plant growth. The average score for plant cover in lined facilities fell from 1.4 to 3.8 during the interval and the average score for plant health declined from 2.0 to 3.6¹. In contrast, the average scores for unlined

facilities were stable during the period. See Figure 1 and Figure 2 for a comparison of changes in the averages for plant cover and plant health (vigor) on the two dates.

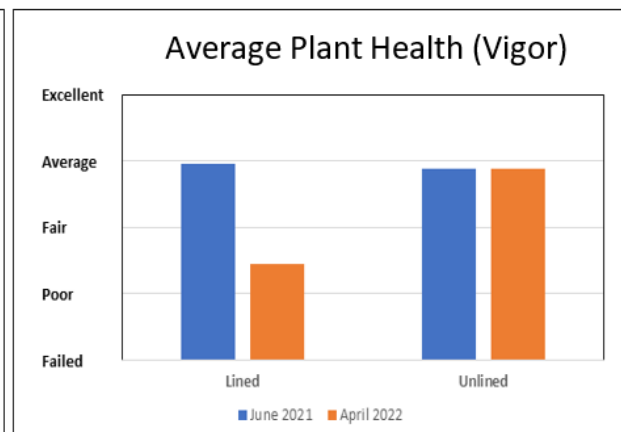
Figure 2. Slough 104B - Plant Health (Vigor)

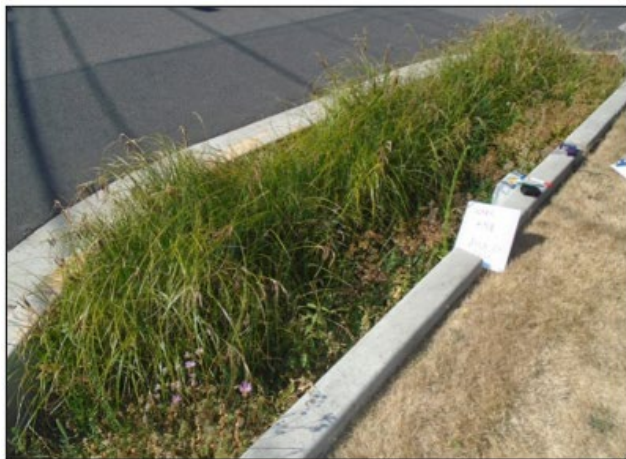
Figure 3. Facility 52 at the end of July 2021. Browning rate of 10%.

- Lined facilities exhibited strong browning - average browning at the end of the summer for the 29 lined facilities was 80-100%, with just two exceptions.
- Browning rates were 0-50% in late July in a subset of facilities with the high-fines soil blend; rates were 80-90% on the same date for a paired group of facilities with the standard soil blend.
- The underdrain type did not have a discernable effect on browning rates in the lined facilities.
- (More facilities are unshaded in comparison with conditions for the group of unlined facilities.)

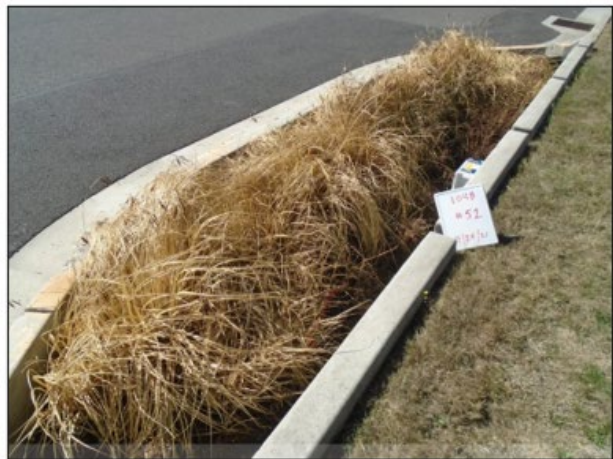
Figure 4. Facility 52 at the end of September 2021. Browning rate of 90%.

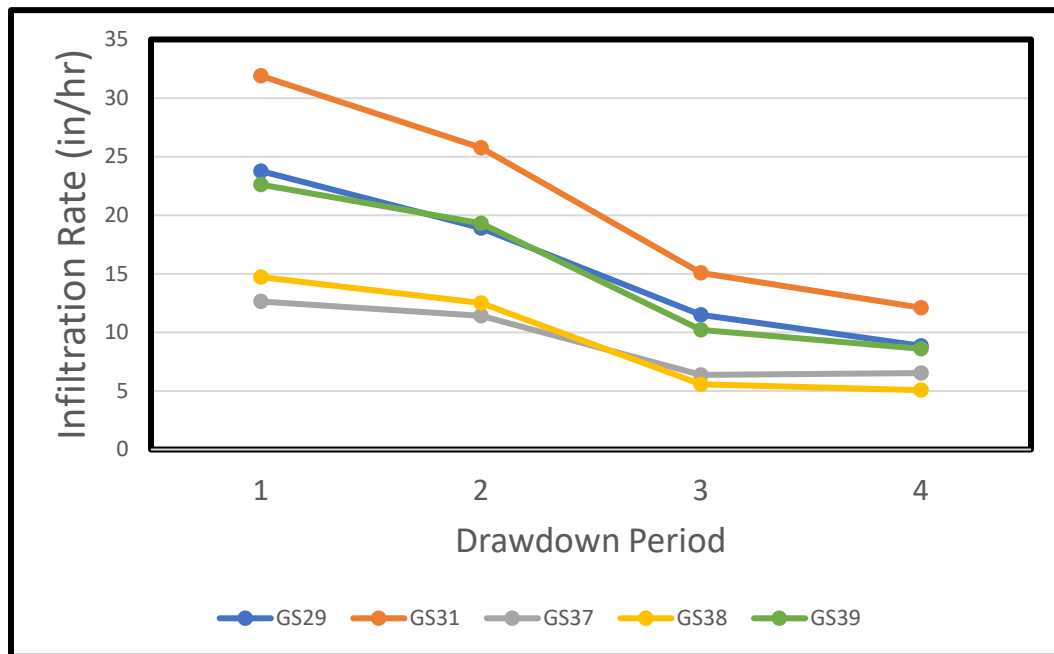
Figure 5. Winter infiltration test results, high-fines soil blend in mature facilities

In February 2022 the CRM team and Field Operations completed drawdown tests at seven lined facilities containing the high-fines soil blend. Concerns about the potential for unacceptably low infiltration rates has slowed BES' adoption of a specification with more loam. The drawdown tests were therefore an important milestone for the Slough 104B monitoring program and the development of a BES special soil specification based on the high-fines blend. The facilities were a little over three years old at the time of the tests and therefore the results reflect conditions after plant establishment - root systems are thought to significantly influence the permeability of soil blends in bioretention facilities, helping maintain porosity and infiltration rates. Staff selected February for the tests given evidence in Portland and elsewhere of slower infiltration rates in the winter due to increased water viscosity with colder temperatures.

Staff filled each of the facilities four times in succession over the course of six hours. The drawdown rates after the fourth filling, taken as the final result, ranged from 5 to 12 in/hr (see Figure 5). That range is lower than the range observed in January 2018 during similar testing of a group of lined facilities containing the standard soil blend. (Those rates ranged from 11 to 39 in/hr.) However, the average for facilities with the high-fines

blend is adequate as a basis for proceeding with a special soil specification similar in composition to the Slough 104B high-fines blend. The design assumption in the 2020 SWMM for infiltration for the imported soil blend is 6 in/hr (2020 SWMM).

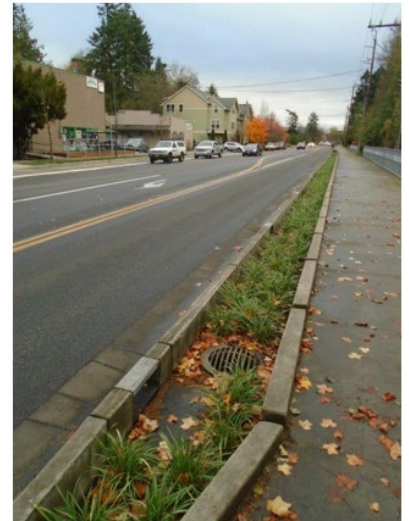
Figure 6. SW Multnomah soil retrofit

The GSI O&M team is monitoring soil moisture at two retrofit trial projects using a portable moisture meter. The projects are being implemented to test different approaches for retrofitting facilities which haven't successfully sustained plants over time. CRM is working with GSI O&M to confirm the extent to which the approaches increase plant-available soil moisture during dry periods, delaying the onset of wilting point conditions. Visual assessments of plant coverage and plant health are also part of the studies.

The portable monitoring unit employs time domain reflectometry (TDR) technology. The unit averages soil moisture over the upper 8 inches of the soil profile. The standard practice is to document the initial moisture content at field capacity (one to two days after the end of a rain or irrigation event) and to sample again at least three times over the following two weeks to develop a drying curve. The systems are hand watered approximately every two weeks. Data from the controls allow comparison of the incremental benefit of the different treatments.

The initial data for NE 97th/Glisan indicates the biochar treatment with mulch maintains soil moisture at a slightly higher level over the course of drying periods compared with the other biochar treatment and the control. The initial data for SW Multnomah indicates both the amendment and replacement approaches maintains soil moisture at a substantially higher level through drying periods compared with the control.

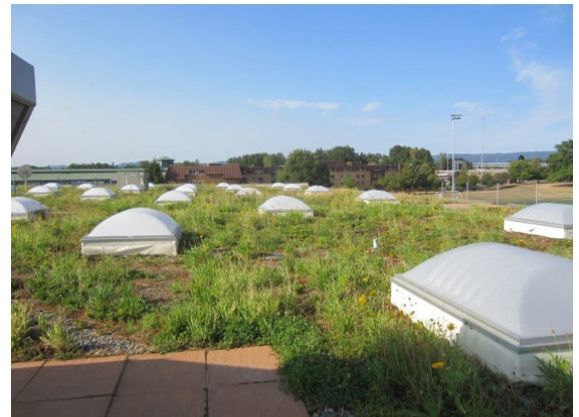
Figure 7. Walmart ecoroof

The Walmart Supercenter on Hayden Island has been the main focus of BES' ecoroof monitoring effort since the building was constructed in 2013. BES partnered with Walmart to install monitoring equipment including in-ground flumes for measuring outflow rates and other dedicated equipment. The setup provides comparative data for roof areas with three inches of growing media, five inches of growing media, and a control (conventional

roof). PSU analyzed three years of the hydrologic data ([Chang et al.,2021](#)), and found retention was similar for the two media depths, with retention more strongly influenced by storm intensity and the length of the antecedent dry weather period than the media depth. The MCA and CRM teams are currently analyzing eight years of data. The influence of different media depths is a primary focus: if monitoring confirms that shallower, lighter systems provide hydraulic benefits similar to deeper roofs, BES will have a basis for crediting roofs with shallower media layers for stormwater management.

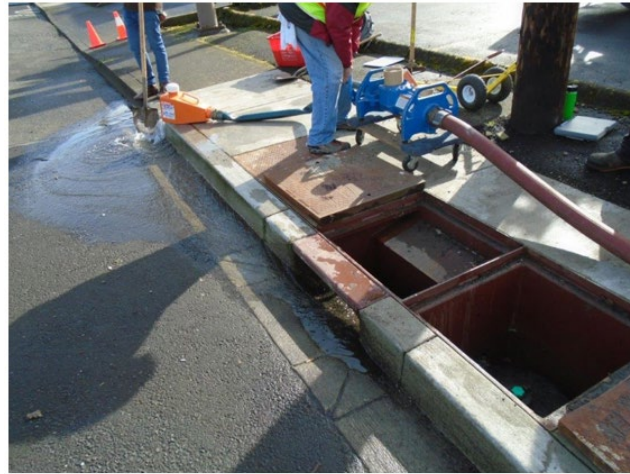
Figure 8. Flow test of catch basin MSTTs

In 2019 and 2020 the CRM team led testing of a group of catch basin MSTTs BES constructed along the Beaverton-Hillsdale Highway at SW Shattuck Road. BES installed the units to treat runoff draining to Fanno Creek. The small devices were the first of their kind in Portland along a busy arterial. The monitoring goal was to document whether the devices could continue to function for at least a year before needing maintenance; the plan called for hydraulically testing the four devices on a quarterly basis to confirm how long they continued to filter the

design flow rate. Staff completed three quarterly tests, but the fourth and final test was not completed due to logistical constraints created by the pandemic. The results were therefore inconclusive. It's important to note the data for two of the four devices in the study were brought into question due to problems with the performance of the street inlets - during site visits in late fall of 2021 staff documented repeated clogging of the curb inlets serving the two installations. PBOT has confirmed the B-H Highway is swept on a regular basis in the fall and that the inlet design is vulnerable to clogging by street sweepers.
