GENERAL LIABILITY
CLAIM AGAINST THE CITY OF PORTLAND

File Number: 2024-014643-20

3c. At approximately 2:30AM on 9 January 2024, my tenant, Jacob Long, in the basement apartment woke to use the bathroom and discovered standing water in his apartment (Figures 1-3). The entire basement floor was covered: His bedroom and closet, his living room, his bathroom, the closet under the stairs, and the utility room where the washer, dryer, hot water heater, and furnace are located. With a ruler I measured that the water was approximately four inches in depth.

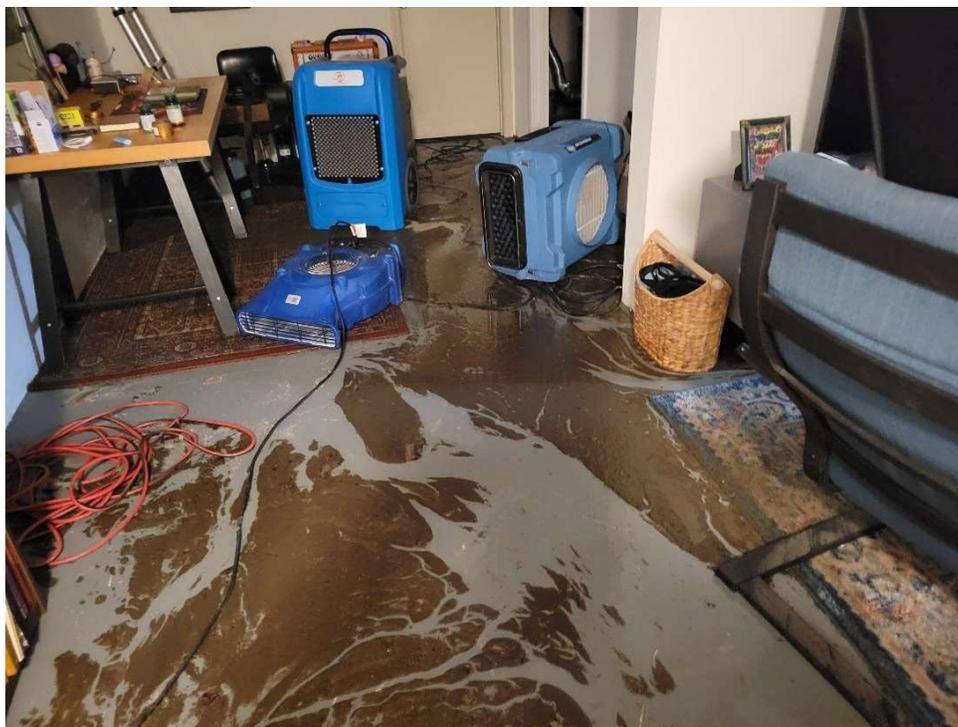
Figure 4

Later that night some amount of water did return and recede, leaving behind some solid material which I was told by 911 Restoration was mostly, but not entirely, dirt (Figure 4).

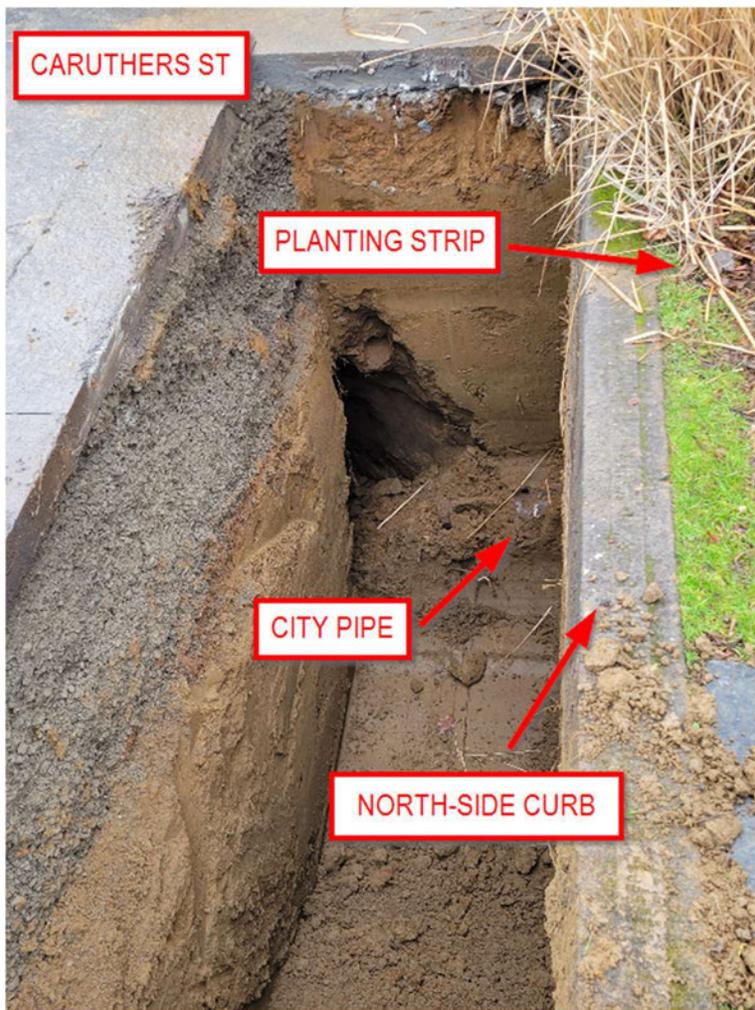
Figure 5

3d. On 10 January I coordinated to have Da Vinci's Best Plumbing, armed with a snake camera, and the Portland Water Bureau's Emergency Maintenance and Construction team on premises at the same time, so they could both witness the live camera footage. The camera was inserted into an access pipe in the front lawn and run south towards the main sewer line under Caruthers Street. It was soon discovered that the ABS pipe under my property gave way to a small section of city pipe under the planting strip which connected to what appeared to be...nothing. There was instead rocks and debris and open space.

The city of Portland workers agreed that something was amiss and began the process of digging up Caruthers Street to further investigate. They excavated a square hole directly adjacent to the northside curb of Caruthers. As seen in the attached photos (See Figures 5-8), the first leg of pipe owned by the city of Portland (beginning under the curb strip and extending a few feet into/under Caruthers Street) was unearthed, but it was crushed and connected to nothing. A sinkhole had formed and washed away the last leg of pipe that was supposed to connect to the main sewer line under Caruthers Street. One city worker proclaimed "I've been doing this a long time and I have never seen anything like this." Another told me "this is clearly a city problem, you should file a claim."

11. On 10 January the city was able to install a temporary pipe from the curb to the main sewer line under Caruthers Street. A more permanent fix will require further excavation to backfill the sinkhole but the crew had to end work to prepare for the winter storm approaching the Portland metro area. This terrible timing has the further effect of forcing me to stay in a hotel from 9 to 15 January. I am back home now, though I have no heat, so I may return to a hotel in the coming days.

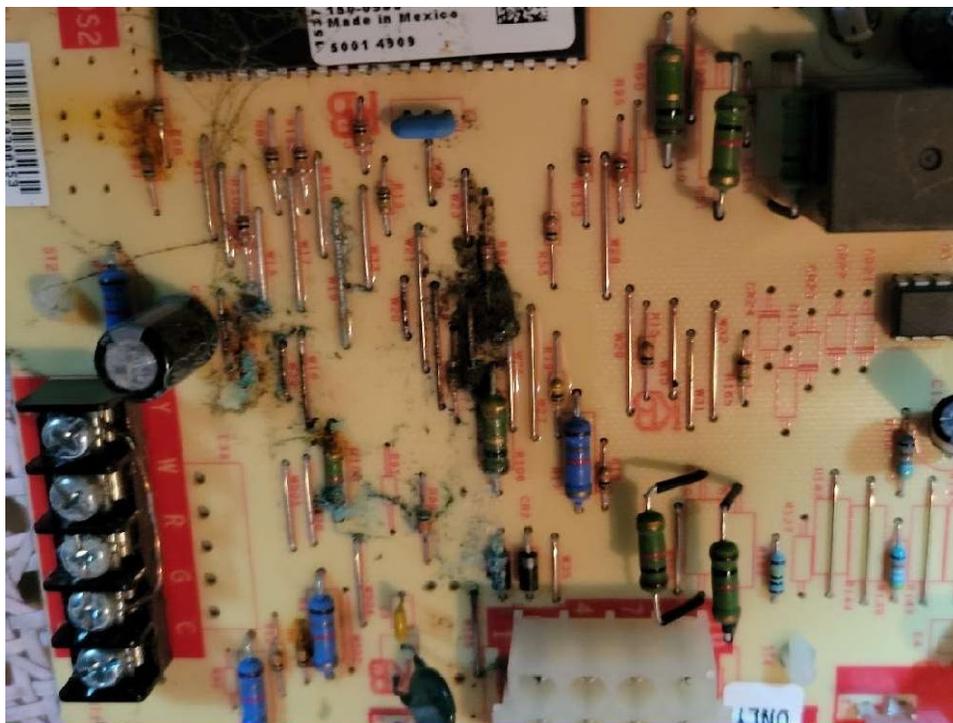
Figure 9

- On 15 January 2024 a licensed HVAC technician inspected the furnace and determined the control board was corroded and irreparably damaged (see Figures 9-11) due to being submerged in the water. He bypassed this control board and attempted to run the blower internal to the unit directly. It did not start or run, and he recommended it also be replaced.
