National Register of Historic Places Registration Form

historic name Alderway Building

street & number 521-539 SW Broadway not for publication

city or town Portland vicinity

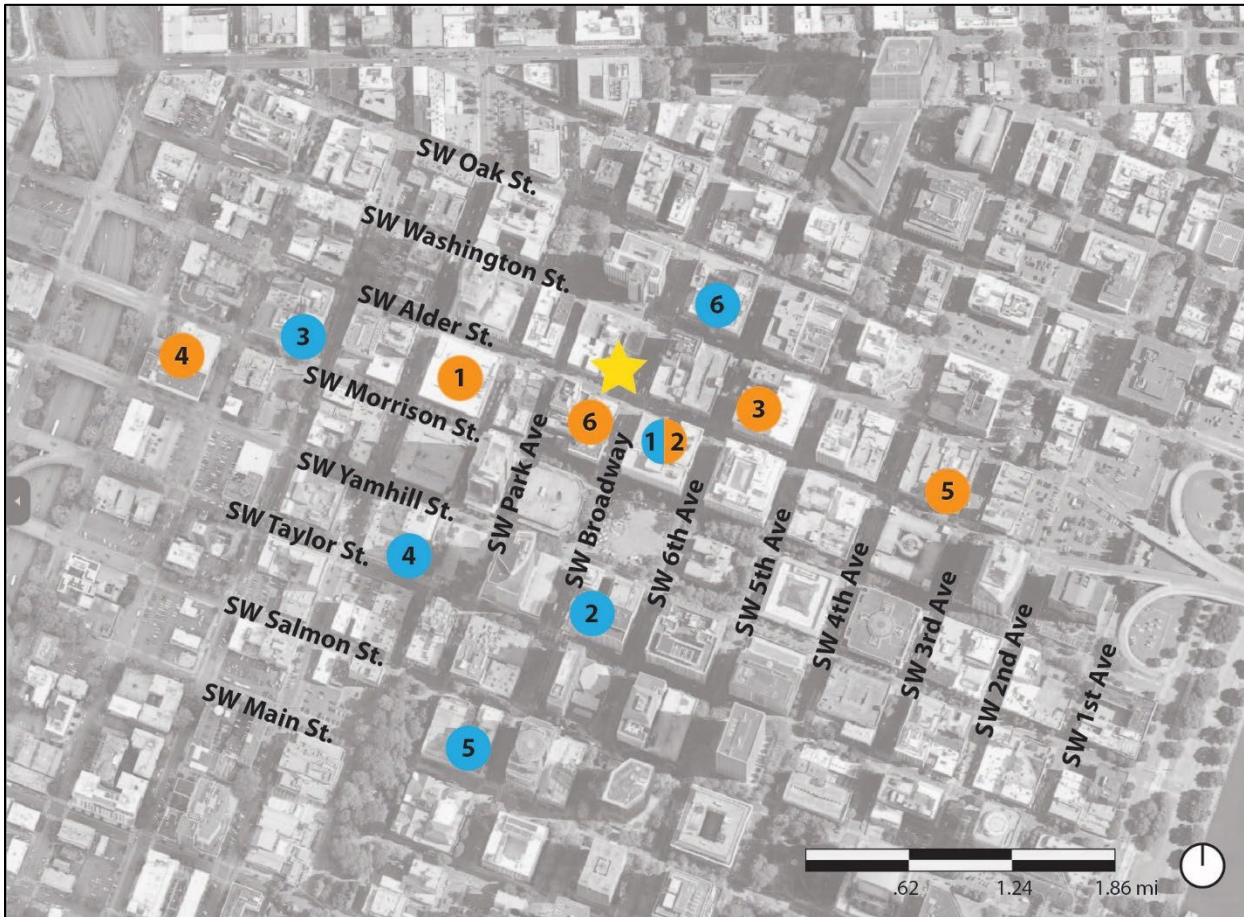
Figure 12: Map of theaters and commercial buildings discussed in comparative analysis

*Figure 12 shows the locations of all comparative theater and commercial properties.

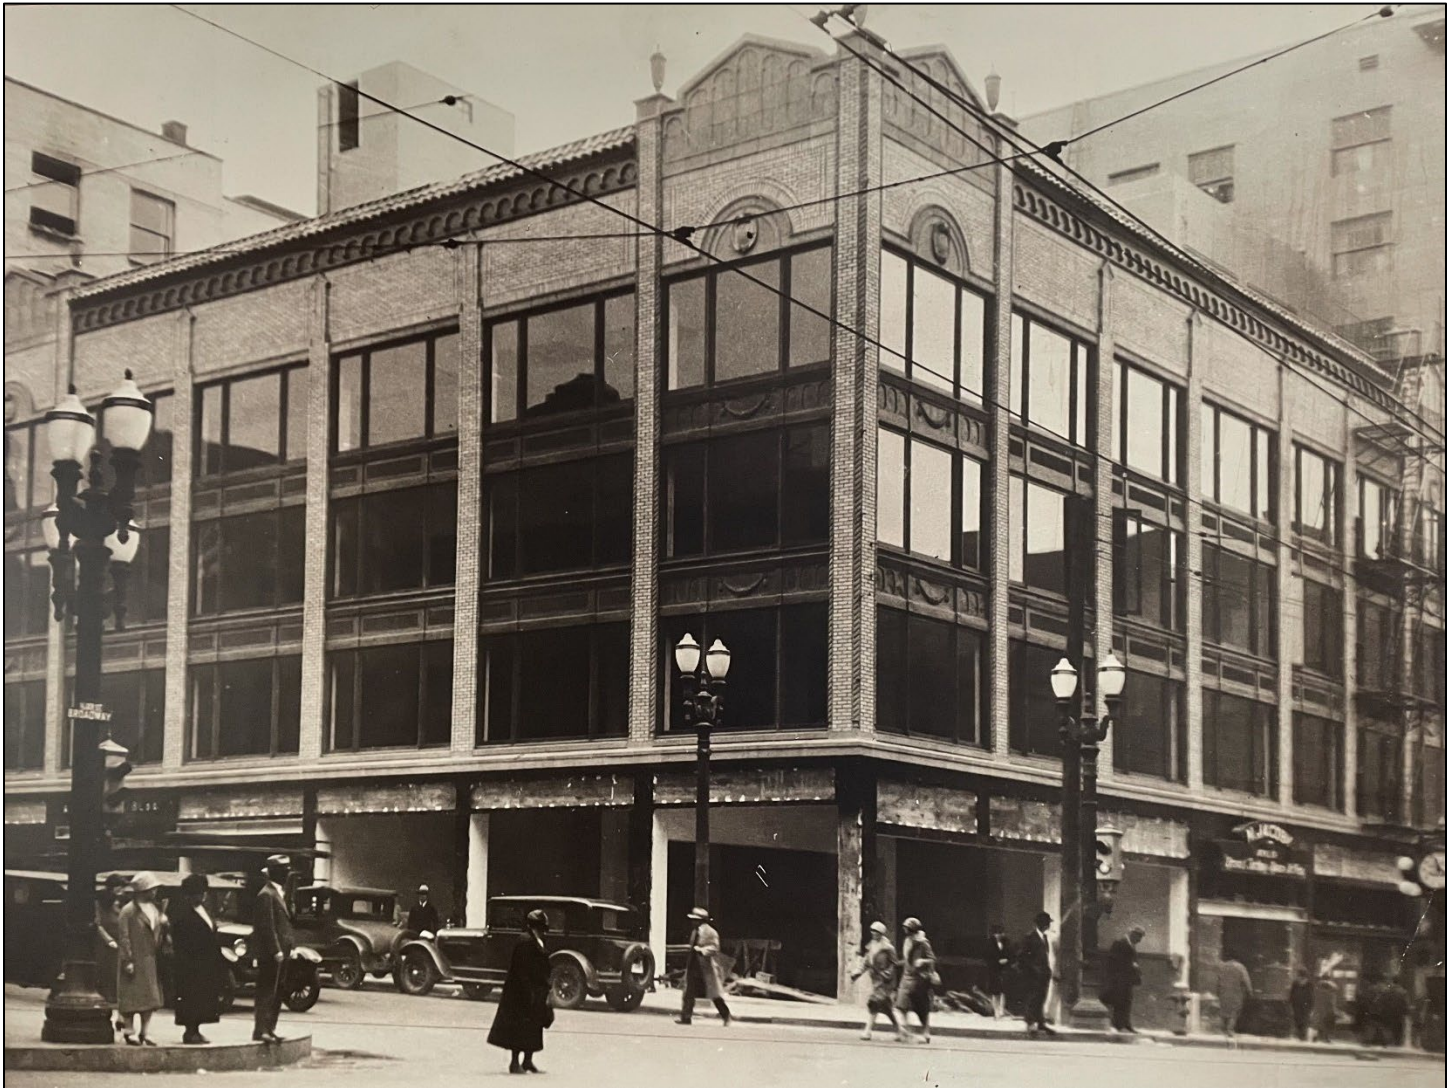
Figure 15: September 30, 1928 Construction Photo of the Alderway Building
(Oregon Historical Society)

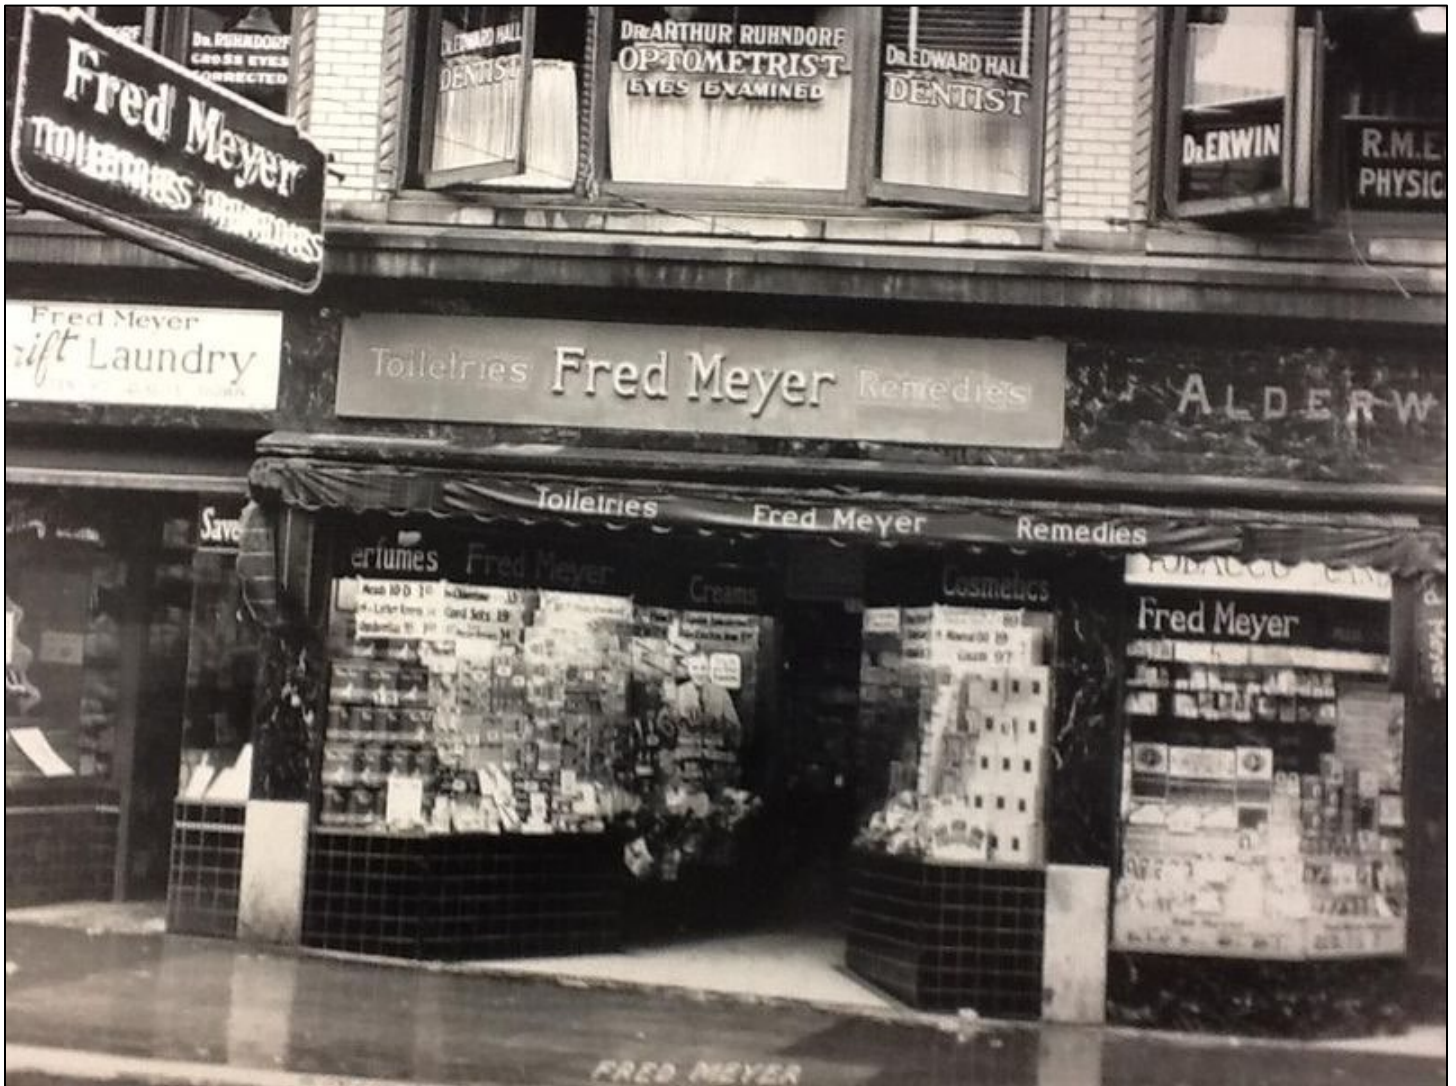
Figure 17: Historic image, Fred Meyer storefront at the west bays on SW Alder (date unknown)
(Oregon Historical Society)

women's clothing store, Multnomah Photo Supply; and Jaqueline Slipper Shop.¹⁰³ In October of 1929, a year after the building opened, Fred Meyer also opened his first self-service "Toiletries & Remedies" shop on the Alder side of the ground floor (Figure 17), a pioneering establishment billed as "a new kind of service and store selling standard nationally advertised goods, all plainly marked with Portland's lowest prices."¹⁰⁴

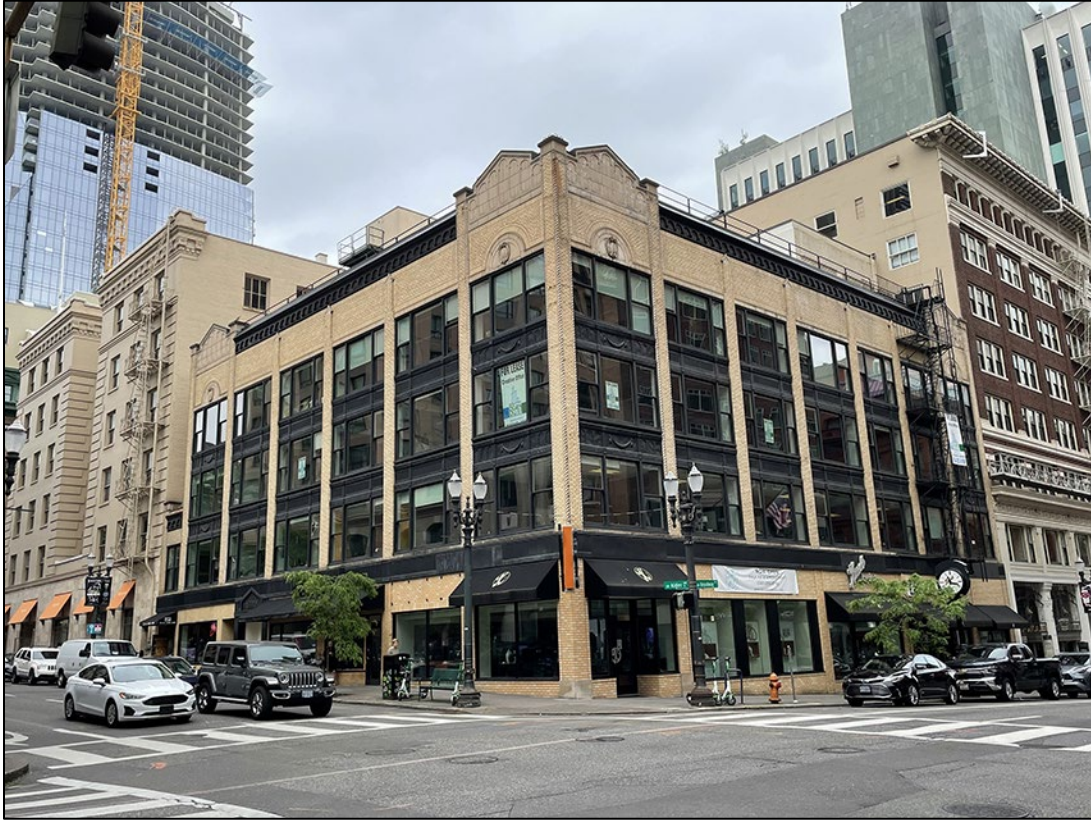
Photo 1 of 12: OR_MultnomahCounty_AlderwayBuilding_0001
Southeast corner, primary elevations (east and south), camera facing northwest.

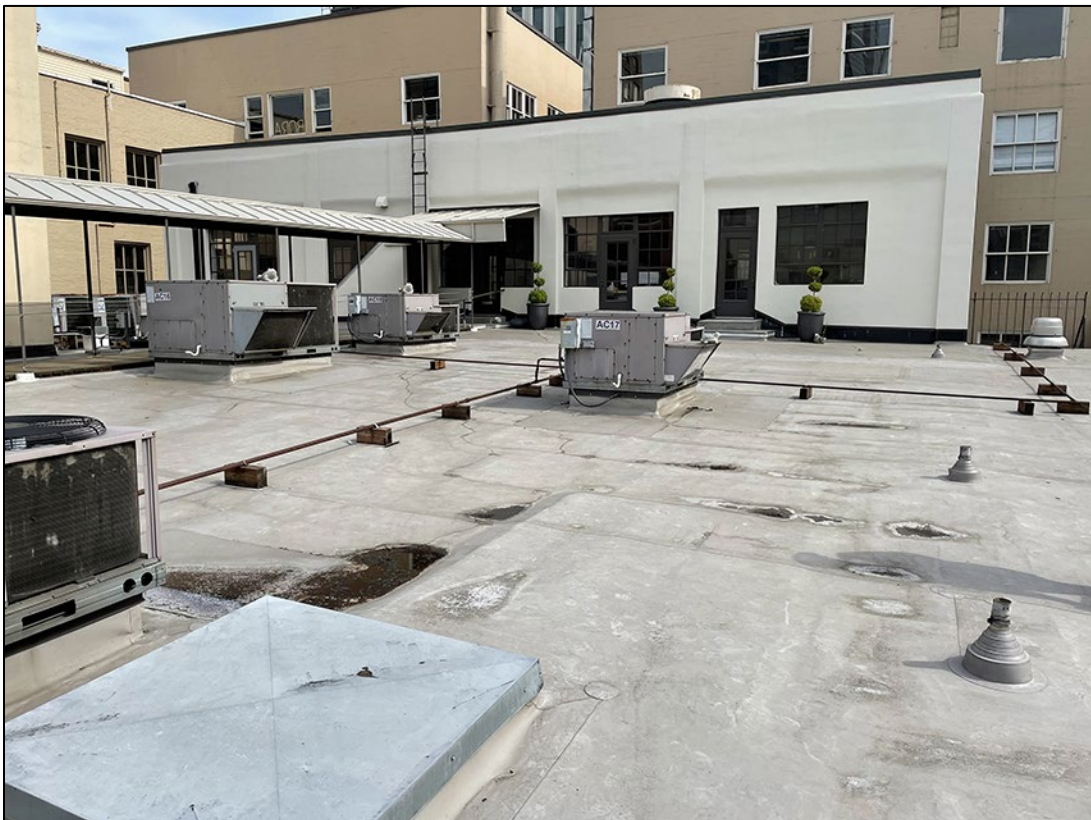
Photo 2 of 12: OR_MultnomahCounty_AlderwayBuilding_0002
Roof and south elevation of penthouse, camera facing north.

The penthouse, formerly a theater fly tower, was renovated in 1928 into tenant spaces with steel windows and doors that access the roof top (Photo 2). The south elevation of the penthouse is clad in stucco. An elevator overrun and stair doghouse project from the roof and provide access to the penthouse office via a covered walkway. East and south parapet cast stone has been capped with sheet metal flashing tying into the membrane roof system.

The penthouse, the former fly tower of the 1911 theater, was converted to shop/office space in 1928 (Photo 2). The interiors are open office with floors, walls, and ceilings finished with contemporary finishes. Steel doors access the rooftop. The rooftop is primarily occupied by HVAC equipment and is not programmed as occupied space. The elevator and stairs are accessed via a covered walkway, which remains in its original location. The penthouse is currently vacant.

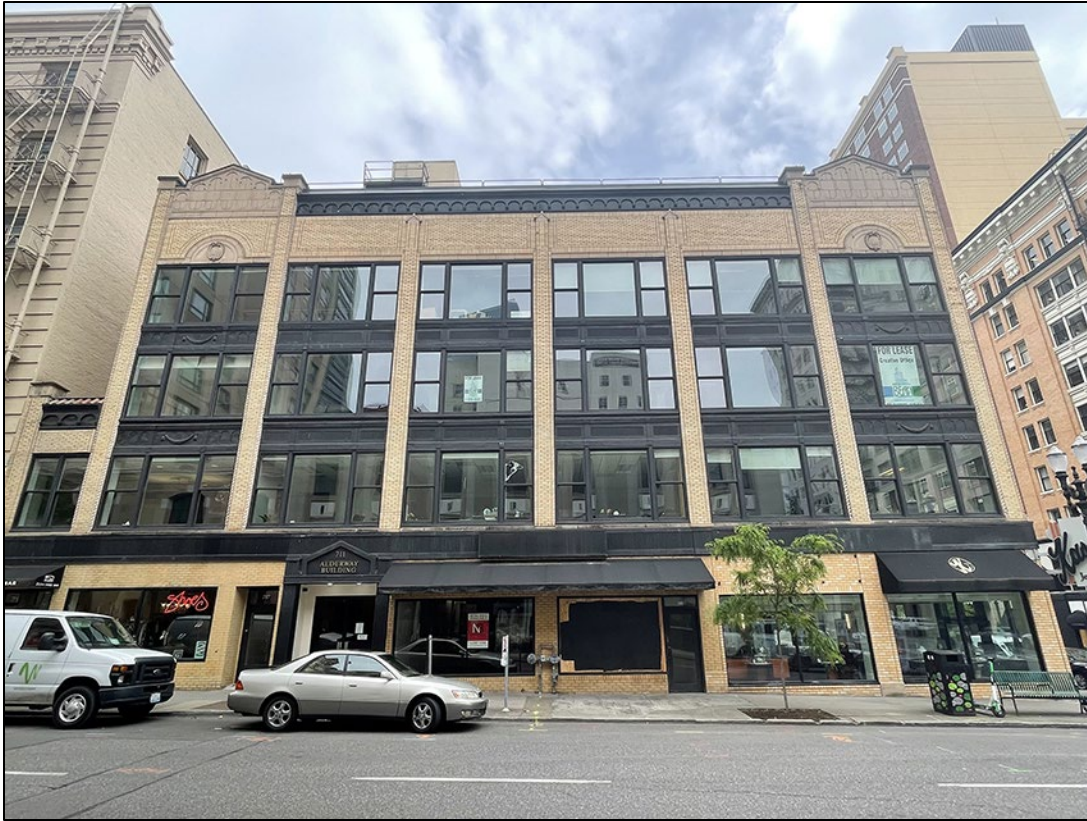
Photo 3 of 12: OR_MultnomahCounty_AlderwayBuilding_0003
Primary SW Alder St elevation (south), camera facing north.

The south elevation (Photo 3) is divided into six even four-story bays, with an additional, irregular narrow two-story bay abutting the property line to the west, with a light court above. The second- through fourth-floor levels on the six main bays are dominated by Chicago Style glazing separated by continuous vertical buff brick masonry pilasters and discontinuous horizontal formed metal spandrel panels (Photo 6). The window groupings are each composed of a wider fixed central unit with a narrower double hung unit on either side. Windows are non-original insulated wood units. The fourth floor window heads are constructed of cast stone. Above the fourth floor windows is a vertical section of buff brick masonry wall about one half story in height. This surface features brick masonry arches infilled with cast stone festoon panels at the corner bays (Photo 5). The wall surface continues vertically as a parapet, terminating at decorative gables with cast stone detailing at the corner bays and at a lower, formed metal cornice with an arch motif at the intermediate bays, capped with a formed metal parapet flashing. The vertical masonry pilasters at the corner bays continue to the parapet and are expressed on either side of the decorative gables, capped with square Doric capitals. The corner bay pilasters also feature a cast stone twisted rope detail at their outside corners. The pilasters at intermediate bays terminate at arrow-shaped cast stone copings below the decorative metal cornice. Brick masonry is primarily laid in a running bond pattern with dark mortar and raked joints. Sailor and soldier courses frame the section of brick masonry wall above the fourth floor windows. The metal spandrel panels at the corner bays feature a central garland motif flanked by arch motifs, while the intermediate spandrel panels have a simple vertical fluted pattern. The irregular, two-story bay at the west features two double hung windows at the second floor with a small section of buff brick masonry wall above and terminates at the same decorative metal cornice present at the main volume, capped with a decorative red tile parapet roof (Photo 8). The west edge of the two-story bay is bounded by a truncated brick masonry pilaster, topped with the same Doric capital as at the main volume.

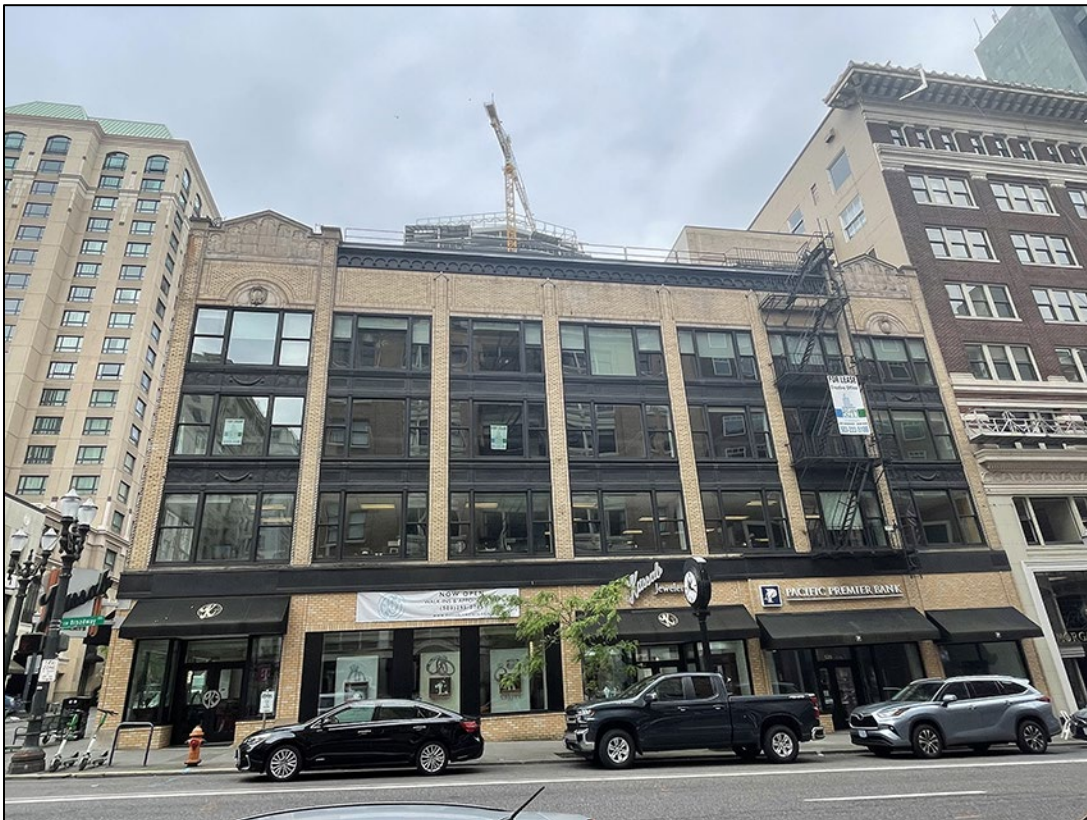
Photo 4 of 12: OR_MultnomahCounty_AlderwayBuilding_0004
Primary SW Broadway elevation (east), camera facing west.

The east elevation (Photo 4) is divided into seven bays of similar width, extending to the property line on either side. The central and southmost bays are slightly wider than the other bays. Grade slopes down to the north, creating a taller ground floor at the north and shorter ground floor to the south. The east elevation features identical finishes and detailing to the south elevation at both the ground floor and upper floors. The vertical pilasters at the ground floor do not align with the spacing of the windows above between the second and third bays from the south and between the second, third, and fourth bays from the north, due to the structural layout required for the building's previous function as a theater. A metal fire escape is located in the second bay from the north. Seven storefront windows are installed in the five ground floor bays. An exterior entry in the central bay accesses the shop occupying the central and south bays. Another exterior entry accesses the shop occupying the two north bays.

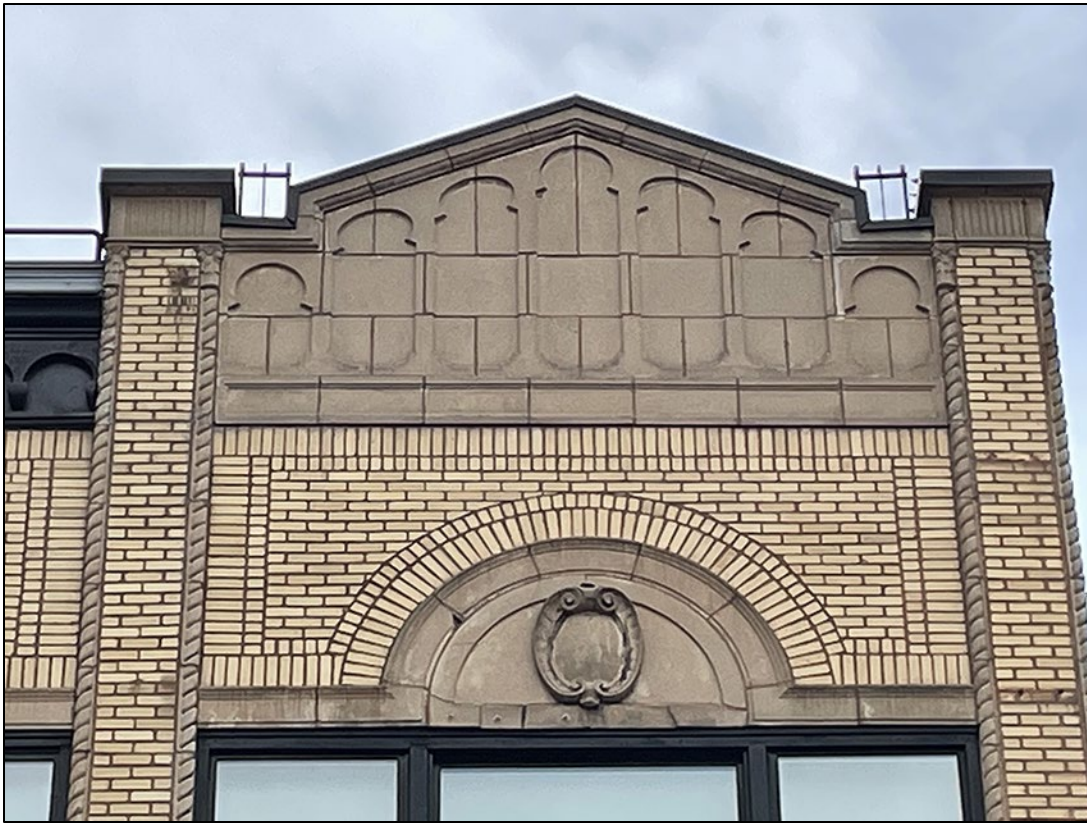
Photo 5 of 12: OR_MultnomahCounty_AlderwayBuilding_0005
Typical corner bay cast stone parapet, south elevation, camera facing north.

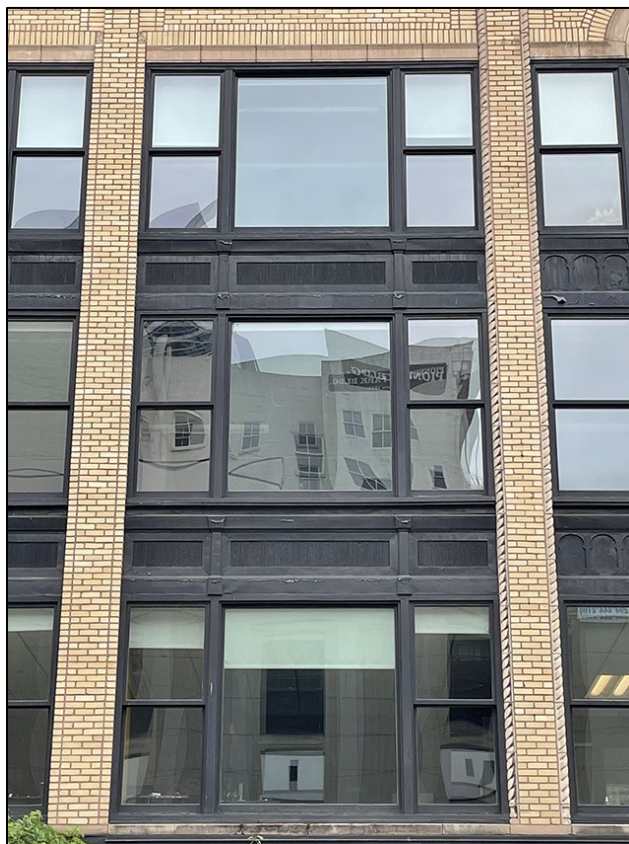
Photo 6 of 12: OR_MultnomahCounty_AlderwayBuilding_0006
Typical Chicago Style window with decorative metal spandrel panel, south elevation, camera facing north.

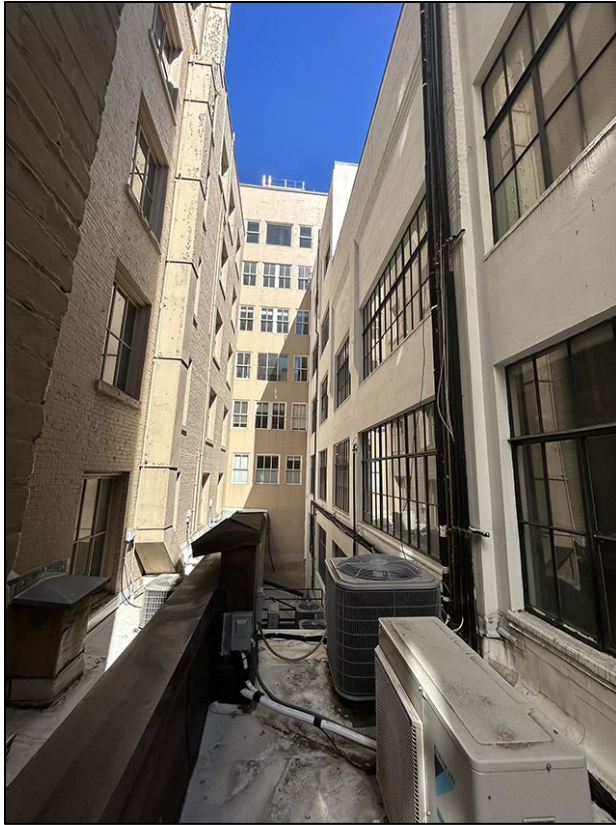
Photo 7 of 12: OR_MultnomahCounty_AlderwayBuilding_0007

Light court along west property line (west elevation of Alderway Building with steel sash windows at right), camera facing north.

The west elevation faces into a light court between the Alderway Building and Medical Building (Photo 7) and is constructed of solid brick masonry dating to 1911. Openings and multi-lite steel casement windows were added as part of the 1928 alterations.

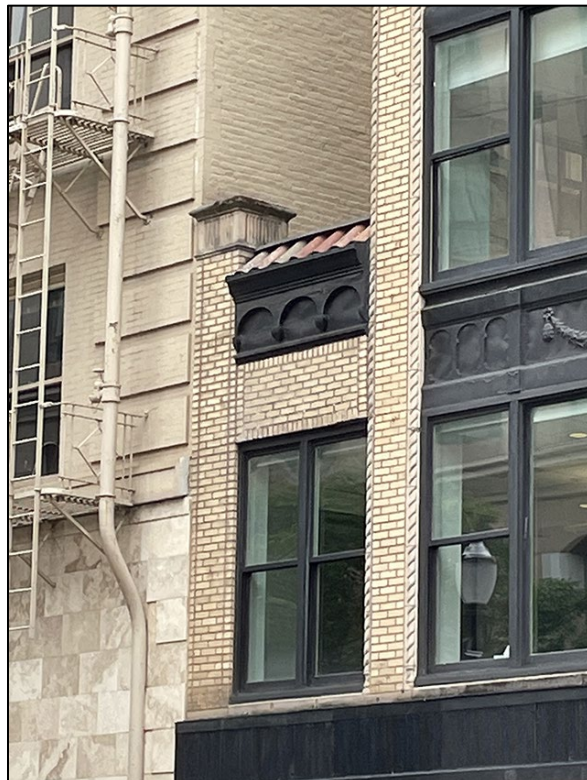
Photo 8 of 12: OR_MultnomahCounty_AlderwayBuilding_0008

Unaltered 1928 cast stone pilaster cap, metal cornice, and red terra cotta tile cornice roof at two story west bay on south elevation (light court located beyond), camera facing northwest.

- The original decorative red tile parapet roof at the south and east elevations has been replaced or covered with a metal parapet flashing. The red tile parapet roof remains at the irregular two-story bay on the south elevation.

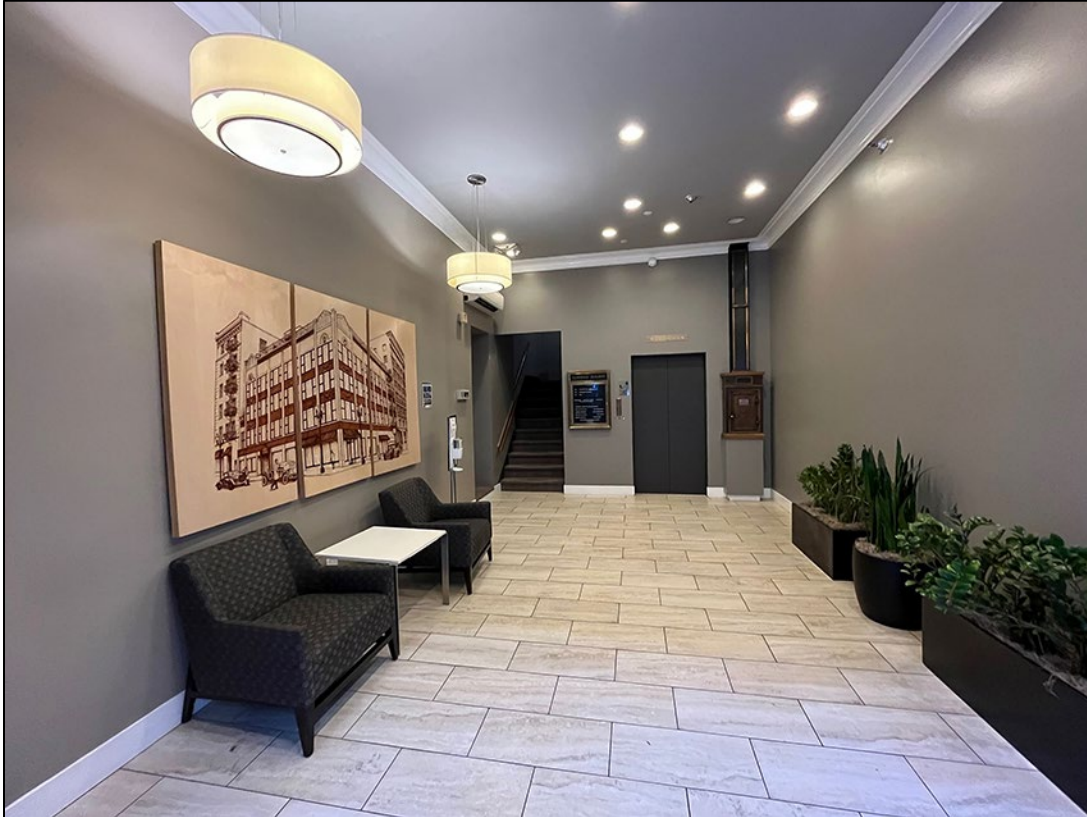
Photo 9 of 12: OR_MultnomahCounty_AlderwayBuilding_0009
Ground floor elevator lobby serving upper floors, camera facing north.

The entrance lobby (Photo 9), accessed via Alder Street, is rectangular in plan with solid walls to the east and west. The elevator and stair remain in their original locations at the north end of the space. Existing finishes are contemporary, consisting of gypsum board walls and ceiling, contemporary large-scale tile flooring, and painted wood base and crown molding. The Cutler letter box and mail chute remain in their original location. The marble stairs are presently covered in carpeting.
