# Johnson Creek Restoration Plan

# Acknowledgements

## Bureau of Environmental Services

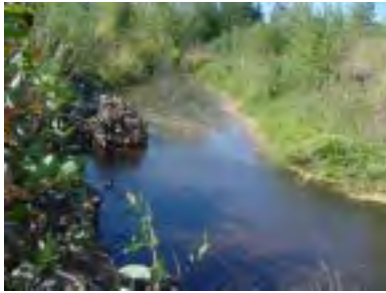
Figure 1-1: Johnson Creek Watershed

The Johnson Creek watershed is a 52-square-mile area of varied landscapes that drains six jurisdictions: the Cities of Milwaukie, Portland, Gresham, and Happy Valley and the Counties of Clackamas and Multnomah (Figure 1-1). Johnson Creek is one common feature linking the six jurisdictions. Although each jurisdiction is responsible for managing and regulating development activities within its boundaries, all six share the resources of Johnson Creek.

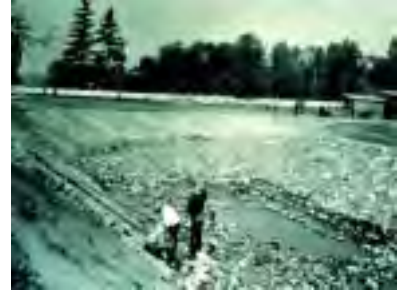
WPA rock lining and channelization (1930s)

Alteration of the natural floodplain has eliminated many of the areas that once absorbed and conveyed floods through the watershed. The most significant alteration was performed in the 1930s by the Works Progress Administration (WPA), when Johnson Creek was subjected to extensive rock-lining, channel deepening, and straightening to control flooding. These activities caused adverse impacts to the natural resources and ecological integrity of the creek, yet flood damage continued. Continued development has further changed the creek's hydrological capacity to rapidly move large volumes of water through the watershed to the detriment of residents, fish and wildlife, and water quality.

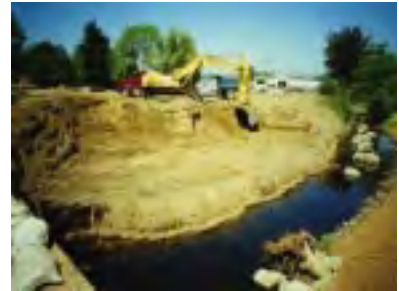
Floodplain reconnection and revegetation at Brookside (1997)

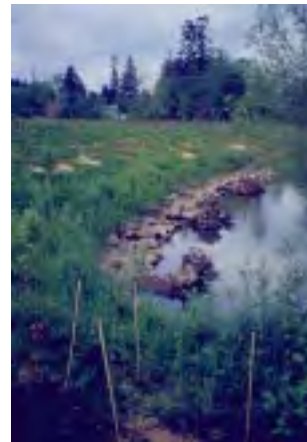
Brookside area after construction (1998)

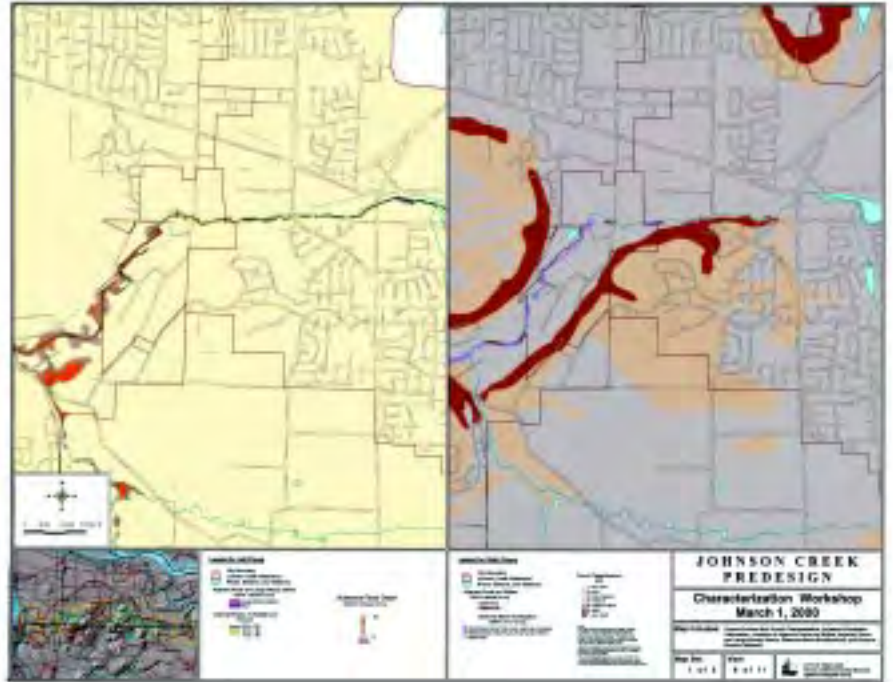
The characterization results were applied using a geographic information system (GIS). Johnson Creek was divided into 11 reaches, and representative characteristics were mapped to identify where problems and opportunities coincided. Examples of the GIS map sets used during this phase are shown in the following three panels.

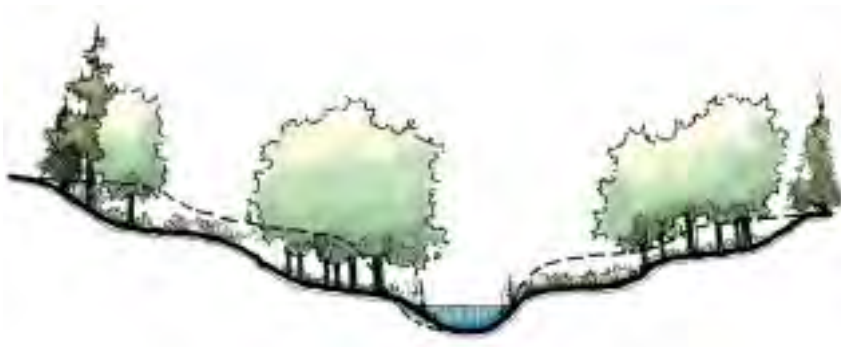
**Figure 4-2: Typical Floodplain Reconnection**

The proposed process involves working with willing property owners adjacent to the creek and/or wetland areas. For properties along the creek, the banks will be terraced back as much as possible to allow for increased connection. The actual amount of terracing and reconnection achieved will vary on a site-by-site basis. Figure 4-2 is a cross-section sketch of what floodplain reconnection will look like. It is also possible that methods for reactivating the historical floodplain based on less excavation (placement of large wood) may also be used where artificial fill has not been placed.

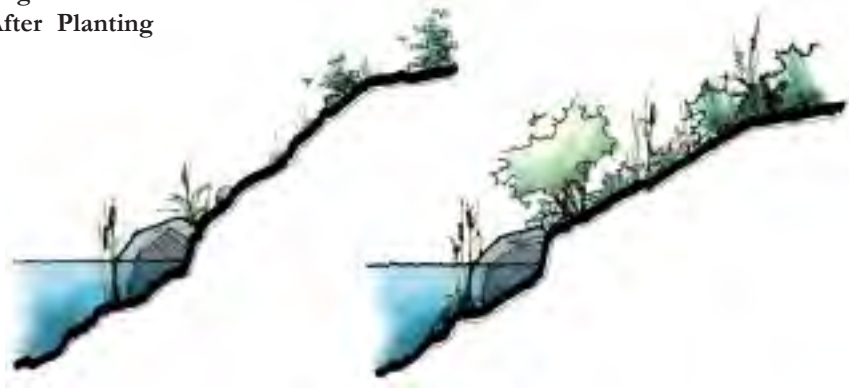
**Figure 4-3: Stream Bank  
Vegetation Before and  
After Planting**

Once stream banks have been terraced as necessary, they will be vegetated with native riparian vegetation. Planting banks devoid of vegetation with native species is an ideal way to stabilize eroding banks and provide resistance to flow, thereby helping reduce creek velocities. Replacing invasive plant species with native species improves wildlife habitat as well. These activities will serve both to reconnect Johnson Creek with its original floodplain and to enhance and restore the riparian corridor. The restoration of the riparian corridor will provide shade to the creek and, in the process, decrease water temperatures in the summer months. Riparian corridor vegetation also acts to filter sediment and pollutants from runoff, thereby improving water quality and reducing impacts of increased runoff to Johnson Creek. Reducing water temperature and improving water quality are key elements in providing ideal habitat for salmonids. Figure 4-3 is a sketch of a stream before and after re-vegetation.

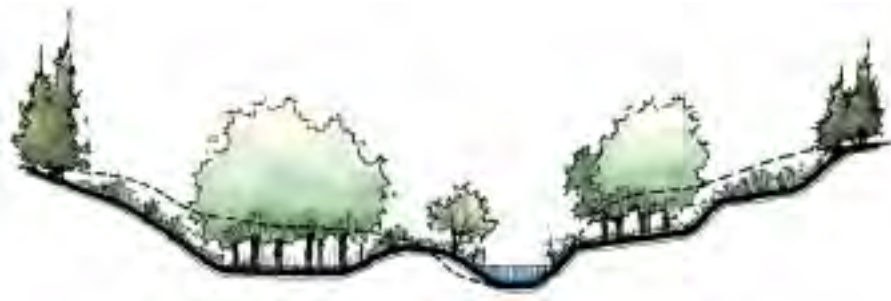
**Figure 4-4: Typical Wetland/Forest Storage Area**

Connection of backwater channels (existing and new) and increasing sinuosity of the creek are additional actions that are expected to be carried out in areas where constructed wetland/wet forest areas are designed. Backwater channels consist of old channels, oxbows, and depressions off the main channel through which water will backflow as surface elevations rise. During high flow events, these channels are especially important for fish seeking refuge from high flow velocities in the creek's mainstem. They also serve to store floodwaters.

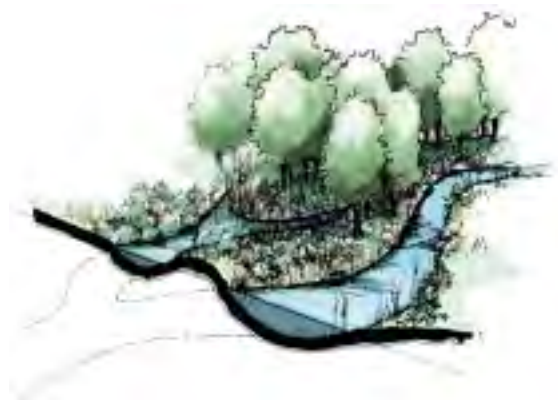
**Figure 4-5: Typical Backwater Channel**

Recommendations include both connecting existing backwater channels to the creek and creating new channels. Figure 4-5 is a three-dimensional sketch of a typical backwater channel.

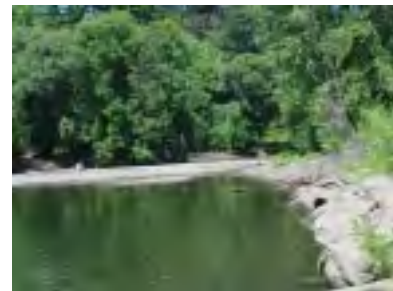
Photo 1-1:

Looking northeast at the confluence of Johnson Creek and the Willamette River. Gravel bars and native vegetation will be protected as floodplain is restored.

1. Work toward acquiring properties at the confluence through the Willing Seller Program as opportunities arise (see Photos 1-1 and 1-2). Once properties are purchased, the banks will be terraced back to enhance the floodplain along this stretch; the floodplain will be opened up as much as the properties will allow (50 to 200 feet); existing riparian vegetation will be protected as much as possible; open areas will be planted with additional native riparian vegetation; and the banks directly along the creek will be revegetated with appropriate trees that will provide shade for the creek.

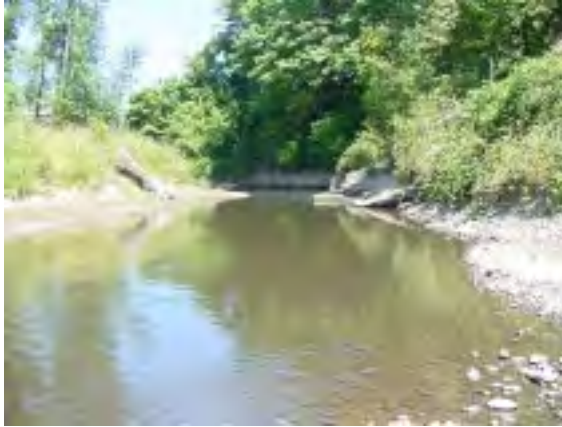
Photo 1-2:  
Facing east, looking upstream from the confluence of Johnson Creek and the Willamette River. Floodplain reconnection presents opportunities to protect and enhance the riparian corridor, increasing in-stream complexity, adding native vegetation to shade the creek, and creating wildlife habitat.

3. Increase in-stream complexity throughout the length of the creek running through this reach. This work, which will be done in conjunction with other projects in the reach, will consist of creating areas with large wood, pool/riffle sequences, and deep pools in the creek channel. Activities will be site-specific and will be determined in the project design phase (see Photo 1-2).

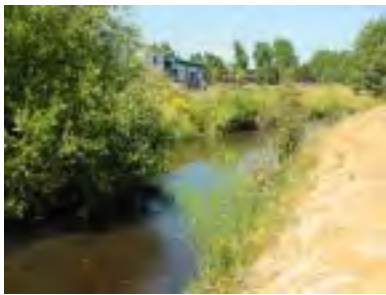
Photo 1-3:  
Facing north, looking upstream along Johnson Creek. Both banks present potential opportunities for floodplain reconnection and riparian restoration.

2. Work with willing property owners adjacent to Johnson Creek for the purpose of reconnecting Johnson Creek with its original floodplain (see Photos 1-3 and 1-4). Restoration activities on such properties will be property-specific and to the degree deemed appropriate by the property owner. Floodplain reconnection will entail removal of invasive species from the banks of the creek, as

well as removal of the WPA wall where appropriate. The banks will then be regraded to open up additional area for the creek to spread. After banks are terraced, they will be replanted with native riparian vegetation.

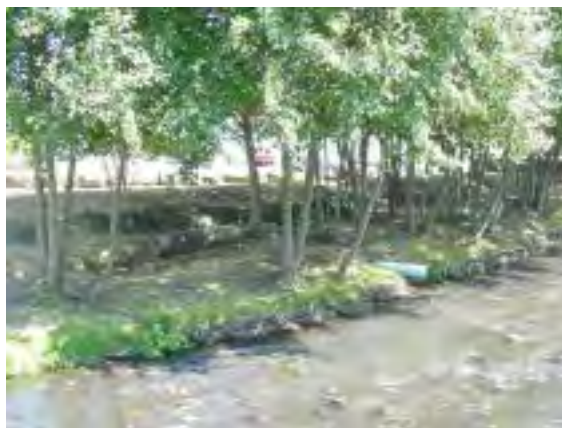
Photo 1-4:  
Looking east from west bank of Johnson Creek. This stand of native red alders should be preserved and the native vegetation enhanced to improve the riparian corridor along this section of the creek. Outfall pipes, such as the one shown here, that discharge directly into Johnson Creek will be addressed through restoration efforts.

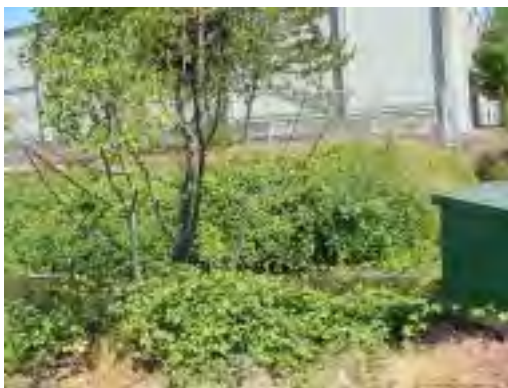
Photo 2-1:

Looking east at property along Johnson Creek that floods frequently. Opportunities exist to remove invasive plants and restore the riparian corridor with native vegetation, providing shade and habitat along the creek.

1. Work toward acquiring frequently flooded properties near the Mill End store area through the Willing Seller Program as opportunities arise (see Photo 2-1). On acquired properties, structures will be removed, creek banks will be terraced back as appropriate to reconnect the floodplain and replanted with native vegetation, and the riparian corridor will be protected and enhanced to the maximum extent possible.
2. Work with willing property owners adjacent to Johnson Creek for the purpose of reconnecting Johnson Creek with its original floodplain (see Photos 2-2, 2-3, and 2-4). Restoration activities on such properties will be property-specific and to the degree deemed appropriate by the property owner. Floodplain reconnection will entail the removal of invasive species from the

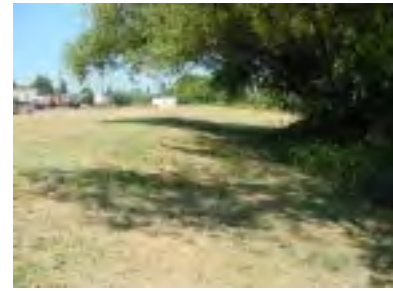
Photo 2-2:

Facing north, looking upstream from Millpoint Road overpass at an empty lot adjacent to Johnson Creek. Such open space presents opportunities for floodplain reconnection and riparian enhancement actions.

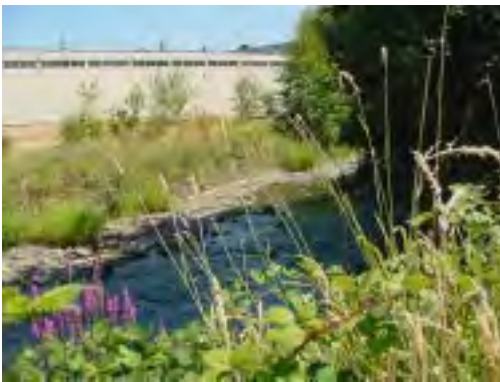
Photo 2-3:

Looking downstream (southeast) at Johnson Creek. The flat nature of the banks at this location present floodplain reconnection opportunities, while the lack of large shade trees and narrow buffer indicate the need for riparian corridor restoration.

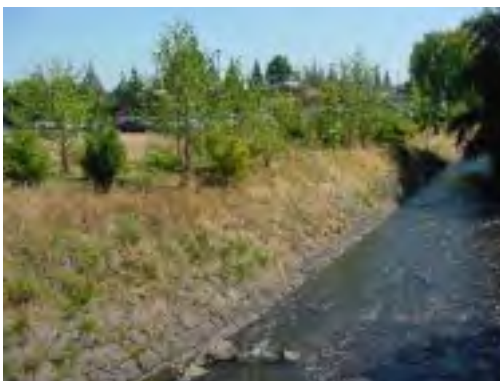
Photo 2-4:

Facing south, looking downstream. Little to no riparian corridor exists in this area. Steep banks are due to the presence of the WPA wall, resulting in no connection between Johnson Creek and its original floodplain.

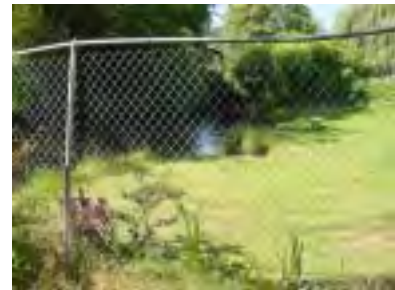
Photo 3-1:

Properties such as this one along Crystal Springs flood frequently. If acquired through the Willing Seller Program, the opportunity exists to terrace banks, restore the riparian corridor, reduce stream bank erosion, and reconnect the original floodplain.

1. Work toward acquiring frequently flooded properties along Crystal Springs tributary through the Willing Seller Program as opportunities arise. On acquired properties, structures will be removed (see Photo 3-1), creek banks will be terraced back as appropriate to reconnect the floodplain and replanted with native vegetation, and the riparian corridor will be protected and enhanced to the maximum extent possible.

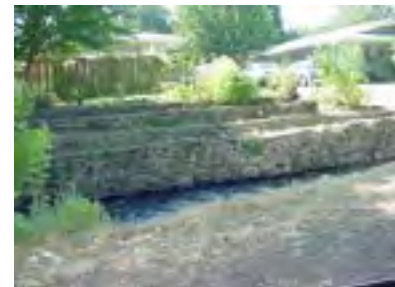
Photo 3-2:

Facing east on SE Tenino Street looking at Crystal Springs Creek, a tributary of Johnson Creek. Currently, the creek has no access to its original floodplain. An opportunity exists to work with owners of properties such as this one to naturally terrace the banks and restore the riparian corridor with native vegetation. Outfall pipes, such as the one shown here, will be addressed on a site-specific basis.

2. Work with property owners adjacent to Johnson Creek to reconnect the floodplain with the creek. Where appropriate, the banks will be terraced back as much as possible and then both the banks and the riparian corridor will be replanted with native riparian vegetation (see Photos 3-2 and 3-3). Also work with willing property owners adjacent to the creek to enhance and restore the riparian corridor, as well as stabilize creek banks exhibiting excessive erosion. On properties where it is not feasible to terrace the banks and promote reconnection of the floodplain with Crystal Springs, the emphasis will be on enhancing the riparian corridor and stabilizing the creek banks. Removing invasive vegetation and replacing it with native species will create healthier stretches of riparian corridor along the creek and help stabilize banks.

4. Increase in-stream complexity throughout the length of the creek and tributary running through this reach. This action, which will be done in conjunction with other projects in the reach, will consist of creating areas with large wood, pool/riffle sequences, and deep pools in the creek channel. Activities will be site-specific and will be determined in the project design phase (see Photos 3-2 and 3-3).

5. Address outfalls that directly impact Johnson Creek (see Photo 3-2). Outfalls may be removed or diverted through some sort of mitigation measure, such as a bio-filtration swale.
6. Remove or modify culverts along Crystal Springs that impede the movement of salmonids. Determination of whether the culverts will require improvement or removal will be determined on a site-by-site basis in the project design phase.
7. Identify areas of seeps and springs along or near the creek. Work with property owners in these areas to protect the natural resource and replant the riparian corridor with native vegetation.
8. Work with property owners near the creek to educate them about stream stewardship and the impacts of their actions on the creek. Assist them in altering their habits and practices to better protect and enhance Johnson Creek.

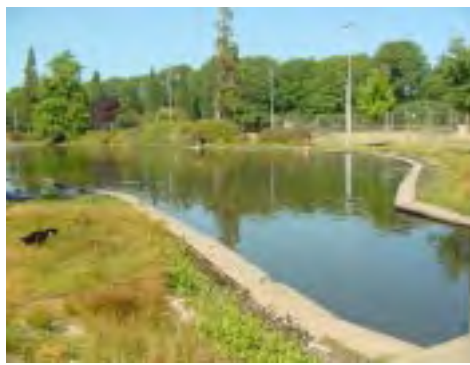
Photo 3-3:

Facing north at Westmoreland Park, looking at an impounded area of Crystal Springs Creek. Removal of the concrete that lines the creek and pond area will create opportunities to increase in-stream complexity, improve wildlife habitat, and reconnect Crystal Springs Creek to its floodplain. Another opportunity in this area is to expand the riparian corridor through native plantings.

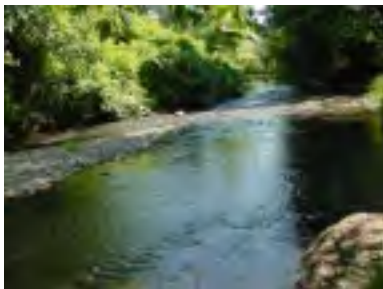
Photo 3-4:

Looking southeast from west bank of Crystal Springs at Johnson Creek Park. Opportunities exist at the confluence of Johnson Creek and a tributary, Crystal Springs, to reconnect the floodplain, protect and enhance the riparian corridor, and increase in-stream complexity.

confluence through floodplain reconnection and riparian enhancement actions. At the confluence, terrace banks as far as possible, then replant them with native riparian vegetation (see Photo 3-4).

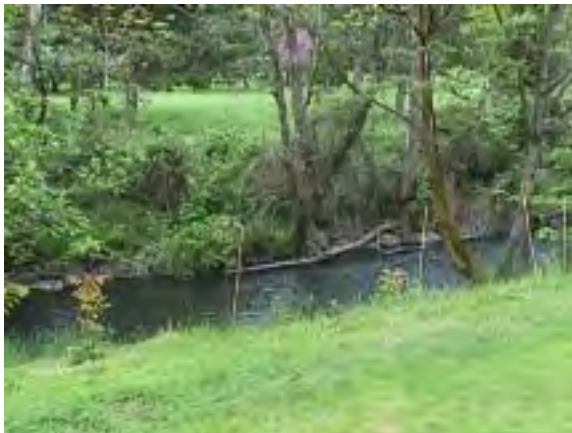
Photo 4-1:  
Looking at Eastmoreland Golf Course on the north bank of Johnson Creek. Opportunities exist to work with willing owners to reconnect properties to the Johnson Creek floodplain and increase and enhance the riparian corridor

2. Work with owners of the Eastmoreland Golf Course located on the north side of Johnson Creek) and the apartment complex (located on the south side of the creek bank) to expand the floodplain and enhance the riparian corridor. On the south side of the creek, only about 10 to 20 feet of space is available. The north side of the creek along the golf course has more room in which to work, but the banks are steeper and require removal of more invasive plants. Terracing and revegetating the banks of the creek with native species will help stabilize eroding banks throughout this reach (see Photo 4-1).

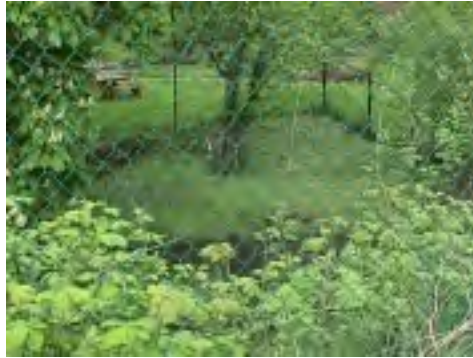
Photo 4-2:

Facing south, looking across the creek from the banks of the Racquet Club. Working with property owners to remove barriers such as fences, planting the banks with native vegetation, and reconnecting the creek with its floodplain will significantly enhance the riparian corridor and wildlife habitat.

3. Work with property owners on the north side and the south side (Racquet Club) of Johnson Creek to reconnect the floodplain, stabilize the banks of the creek, and enhance the riparian corridor. The opportunity exists to terrace the banks back 20 to 50 feet. Terracing will include removing all invasive species and replanting with native riparian vegetation. Removal of fences will facilitate wildlife passage and access to the creek (see Photo 4-2).

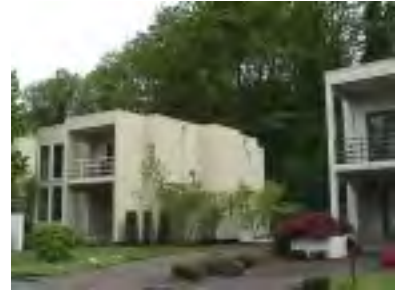
Photo: 4-3:

Facing south, looking at an apartment complex located on the south side of Johnson Creek. Residences, such as these near the creek, present an opportunity to mitigate for impervious surface through innovative techniques like eco-roofs and bio-swales.

6. Work with property owners along Johnson Creek whose properties contain large areas of impervious surface. Mitigating the effects of impervious surface by applying current technology, such as drainage swales, green rooftops, and infiltration basins, will reduce surface runoff, improve water quality, and contribute to groundwater recharge (see Photos 4-3 and 4-4).

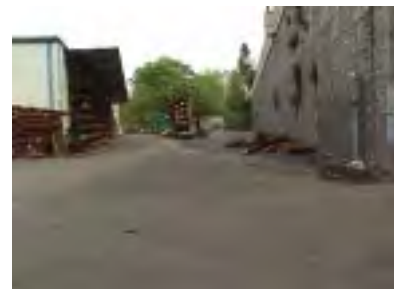
Photo 4-4:

Facing east, showing the area just north of Johnson Creek with its large areas of impervious surface. Such areas contribute to increased surface runoff and degradation of in-stream water quality. Mitigation for these effects can often be achieved through an increased and enhanced riparian corridor.

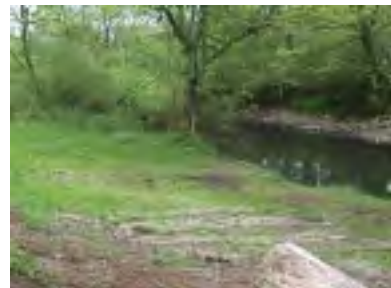
Photo 5-1:

Facing southeast, looking at Johnson Creek in Tideman Johnson Park. This area has been identified for recreating a braided channel and associated wetlands.

1. Reconnect Johnson Creek with its original floodplain by recreating a braided channel with limited associated wetlands through the Tideman Johnson Park area. The process will require lowering the stream banks so that the creek gains access to identified property areas. Most large trees and native vegetation throughout this reach should be retained as much as possible in the design of the constructed wetland or reused as appropriate. Design should take into account existing upland species (beginning about 100 feet from the north bank of the creek), and new riparian/wetland areas should be planned in such a way that they are retained. After the banks of the creek are lowered, allowing increased access by the creek, the area will be planted with native wetland and riparian vegetation. Existing native vegetation that must be removed during this action will be replanted on the site to the maximum extent possible. The banks of the creek will be planted with vegetation able to provide shade to the creek (see Photo 5-1).

During the process of regrading and lowering the banks, 300-foot channels will be created to provide off-channel fish habitat. In addition, the banks of the creek will be reshaped, developing greater sinuosity in the creek by adding meanders throughout this stretch. Upland areas adjacent to newly created meanders will be revegetated with native upland understory species. Large upland trees, such as Douglas-fir and western redcedar, should be retained and used as a basis for determining the appropriate planting scheme. Dense upland plantings will create a wildlife habitat corridor adjacent to the creek and allow for increased wildlife access to the riparian area.

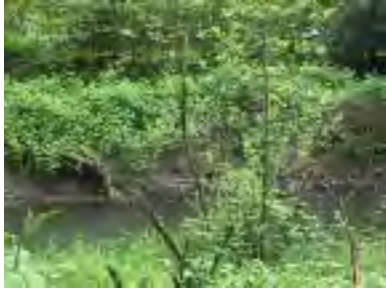
Photo 5-2:

Looking at south bank of Johnson Creek. Work with property owner to terrace banks and revegetate with native species.

non-native invasive plants, and then replanting the banks with native riparian vegetation (see Photo 5-2). The amount of terracing completed will be based on the willingness of the property owners to participate and the amount of area available adjacent to the creek.

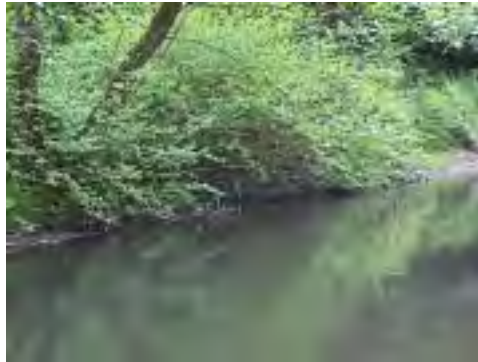
Photo 5-3:

Facing west, looking at the south bank of Johnson Creek. Work in stream to add complexity to the straight channelized areas of the creek will improve habitat conditions.

3. Increase in-stream complexity throughout this reach. This work will be done in conjunction with other actions in the reach and will consist of inserting large wood in the creek, creating pool/riffle sequences, and deepening pools in the creek channel, as well as adding sinuosity in areas where it is deemed appropriate. Activities will be site-specific and will be determined in the project design phase (see Photo 5-3).

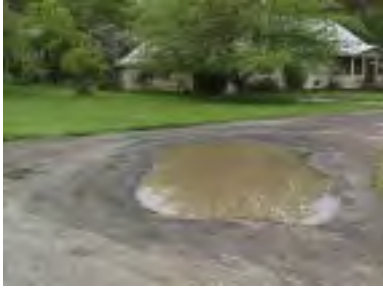
Photo 6-1:

Facing north, showing property on SE 44<sup>th</sup> Avenue near the oxbow north of Johnson Creek. This area already exhibits wetland conditions and provides opportunity to create enhanced wetlands.

access during flood events. During terracing, the WPA wall will be removed so that the creek is not restricted. The banks will then be planted with native species to increase the size and enhance the value of the riparian corridor and also provide shade for the creek. Property exhibiting wetland conditions already exists in this reach. The purpose of the work is to expand and enhance this area with additional native wetland vegetation and in the process remove such non-native invasive species as reed canarygrass and Himalayan blackberry. Existing native wetland vegetation will be maintained in the design (see Photos 6-1 and 6-2).

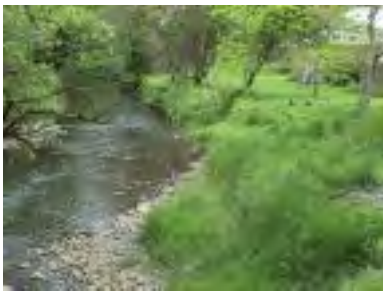
Photo 6-2:

Facing north, showing property near SE 44<sup>th</sup> Avenue on the oxbow of Johnson Creek. This area provides opportunity for floodplain reconnection through working with property owners or Willing Seller Program land acquisition.

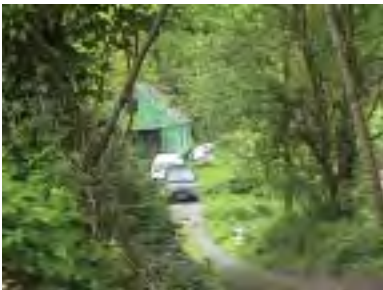
Photo 6-3:

Looking at property just below Errol Heights within proposed wildlife corridor.

3. Work with property owners to the northeast of the enhanced wetland area for the purpose of creating a wildlife corridor and protecting the tributary that extends through this section of the reach. Property owners will be encouraged to allow planting of native riparian vegetation to improve wildlife habitat and provide access to the creek from the surrounding upland areas (see Photo 6-3). Areas along the tributary have been identified as key areas for restoration opportunities.

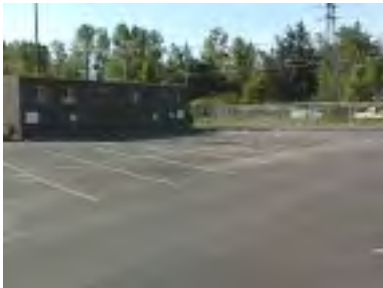
Photo 7-1:

Facing east, looking at a Precision Castparts parking lot. Opportunity exists to work with the property owner to mitigate for impervious surface, increase the riparian corridor, and reconnect the floodplain where feasible.

2. Work with willing landowners to maximize floodplain reconnection and restoration and enhancement of the riparian corridor. The banks of the creek will be terraced as much as practicable and appropriate, based on the willingness of the property owner to participate. As with any acquired properties, all invasive species will be removed and the area replanted with native riparian vegetation. Available areas will be maximized for restoration activities (see Photo 7-1).

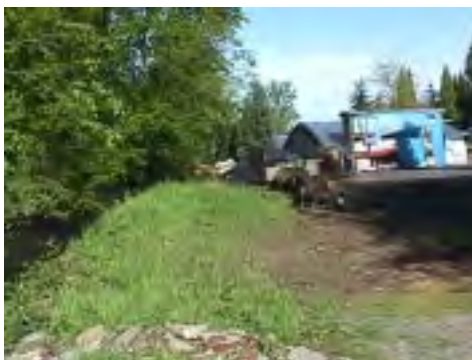
Photo 8-1:

Facing west (downstream), looking at north bank property along Johnson Creek. Opportunity exists in this area for the banks to be terraced back and the riparian corridor enhanced.

2. Work toward acquiring additional property along the north bank of Johnson Creek through the Willing Seller Program and design a constructed wetland area for the purpose of reconnecting Johnson Creek with its original floodplain. This action will entail regrading the banks of the creek and the properties as necessary to open them up for access by the creek. Many of the banks in this reach are not significantly steep, which will reduce the regrading effort required. Once regrading is completed, the property will be planted with native wetland vegetation. The banks will be planted with appropriate native riparian vegetation to create additional shade for the creek (see Photo 8-1).

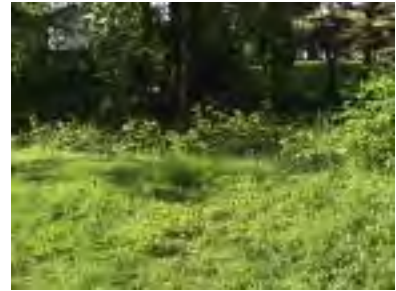
Photo 8-2:

Looking at private property on the south bank of the creek. The opportunity exists to work with landowners to reconnect the floodplain and restore the riparian corridor.

3. Work with willing property owners along the south side of the creek to reconnect the floodplain, where appropriate, and enhance and restore the riparian corridor. This process will require terracing the creek banks to increase the area available for the creek to access. The banks will then be revegetated with native plants to the extent permitted by the property owner to assist in restoring the riparian corridor through this reach. Some bank areas along the south side of the creek are potentially able to accommodate 25 to 50 feet of revegetation, though the actual size of buffer zones created will depend on the specific site and the willingness of the property owner to participate (see Photo 8-2).

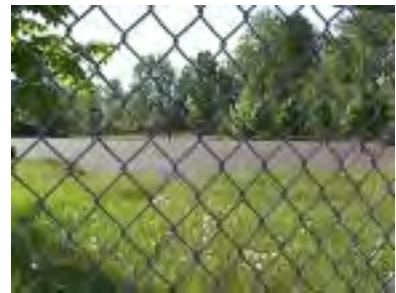
Photo 8-3:

Facing south, looking at impervious surface on the north side of Johnson Creek. Opportunity exists to mitigate for impervious surface through such techniques as bio-swales and infiltration basins

5. Work with property owners along Johnson Creek whose properties contain large areas of impervious surface. Mitigating the effects of impervious surface by applying current technology, such as drainage swales, green rooftops, and infiltration basins, will reduce surface runoff, improve water quality, and contribute to groundwater recharge (see Photo 8-3).

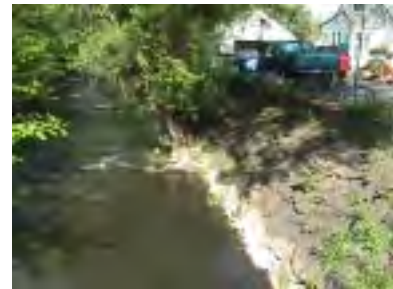
Photo 9-1:  
Looking west (downstream) at the prominent WPA wall lining the creek bank in this area.

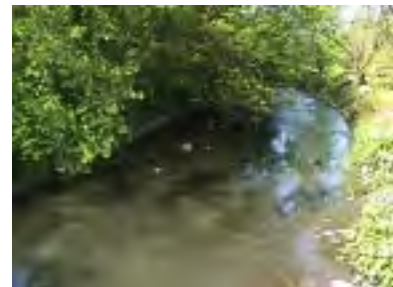
Photo 9-2:  
Facing west at the Stanley Street bridge over Johnson Creek. Opportunity exists to terrace the banks here, creating a constructed wetland and restoring the riparian corridor.

participate. Once banks have been terraced, they will be revegetated with native species (see Photos 9-2 and 9-3).

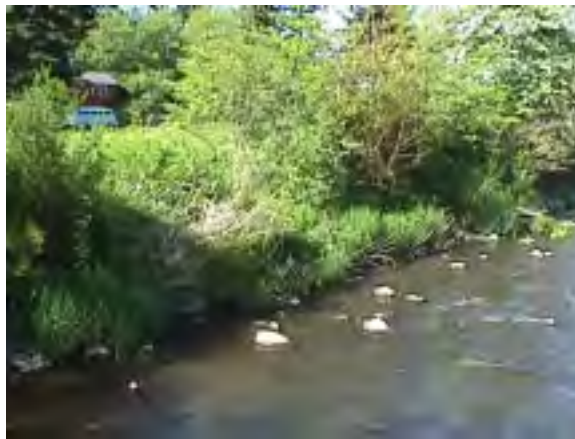
Photo 9-3:  
Facing west, looking downstream at the south bank of the creek. Areas such as this one provide opportunity to increase in-stream complexity and restore the riparian corridor.

4. Increase in-stream complexity throughout the length of the creek running through this reach. This action will be done in conjunction with other projects in the reach and will consist of creating areas of large wood, pool/riffle sequences, and deep pools in the creek channel. Activities will be site-specific and will be determined in the project design phase (see photo 9-3).

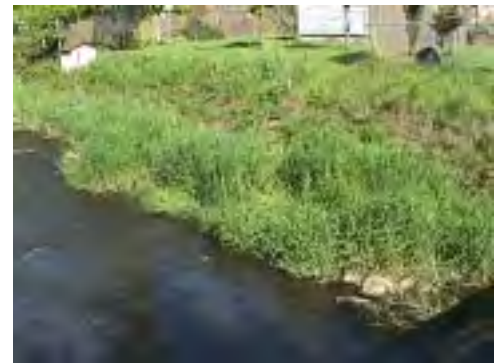
Photo 9-4:  
Facing west, looking at north bank of Johnson Creek. Through educating and working with willing property owners, Johnson Creek can be reconnected to its original floodplain and the banks revegetated to shade the creek.

6. Work with property owners near the creek to educate them about stream stewardship and the impacts of their actions on the creek. Assist them in altering their habits and practices to better protect and enhance Johnson Creek (see Photo 9-4).

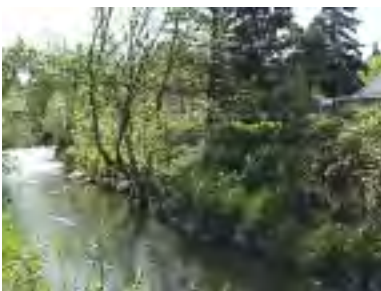
Photo 10-2:

Looking east (upstream) from SE Bell Avenue at the south bank of Johnson Creek. Opportunity exists to work with property owners to reconnect the original floodplain and restore the riparian corridor.

3. Work with other landowners adjacent to the creek to achieve the same functions as on the acquired properties. There will likely be less reconnection and riparian corridor enhancement on these properties because there is limited area to work with. The extent of the work will depend on each owner’s willingness to participate (see Photos 10-2 and 10-3).

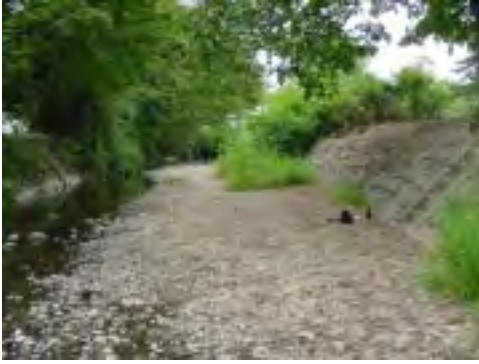
Photo 10-3:

Looking upstream near Mill Park. Note that there is little to no complexity in the stream, a limited riparian corridor, and steep WPA wall banks. Opportunity exists to restore the riparian corridor, add complexity to the creek, and reconnect the floodplain.

4. Increase in-stream complexity throughout the length of the creek running through this reach. This action will be done in conjunction with other projects in the reach and will consist of creating areas of large wood, pool/riffle sequences, and deep pools in the creek channel. Activities will be site-specific and will be determined in the project design phase (see Photo 10-3).

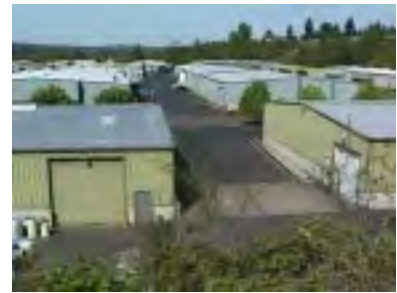
Photo 10-4:

Facing west from SE Bell Avenue, looking at impervious surface near the creek. Opportunities exist to work with property owners in reducing impacts of impervious surface through techniques such as eco-roofs and swales.

5. Work with landowners along Johnson Creek whose properties contain large areas of impervious surface. Mitigating the effects of impervious surface by applying current technology, such as drainage swales, green rooftops, and infiltration basins, will reduce surface runoff, improve water quality, and contribute to groundwater recharge (see Photo 10-4).

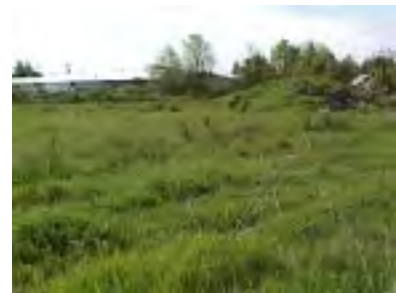
Photo 11-1:

Looking at area on north side of Johnson Creek. Opportunity exists here to reconnect the floodplain through design of a constructed wetland.

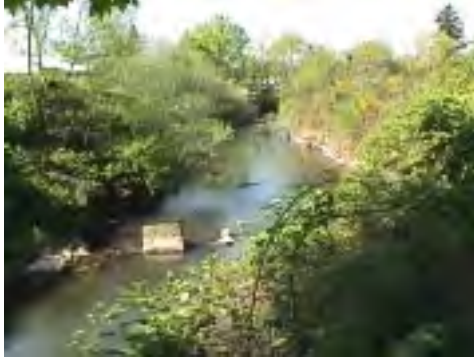
Photo 11-2:

Looking downstream on Johnson Creek near Luther Road. Opportunities exist to remove invasive species, terrace the banks, and replant the area with native riparian vegetation.

the property owners. The action of floodplain reconnection will entail removal of invasive species from creek banks, as well as removal of the WPA wall where appropriate. Creek banks will be terraced and replanted with native riparian vegetation (see Photo 11-2).

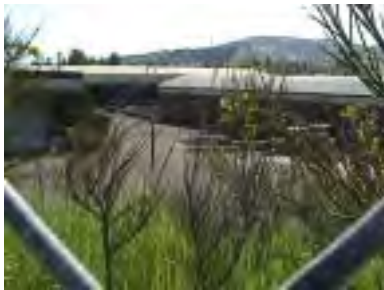
Photo 11-3:

Looking east from SE Bell Avenue. Opportunities exist to work with property owner to incorporate impervious surface improvements.

6. Work with landowners along the north side of Johnson Creek whose properties contain large areas of impervious surface. Mitigating the effects of impervious surface by applying current technology, such as drainage swales, green rooftops, and infiltration basins, will reduce surface runoff, improve water quality, and contribute to groundwater recharge (see Photo 11-3).

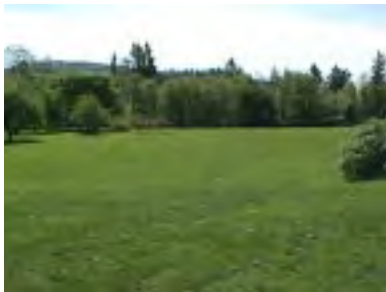
Photo 12-1:  
Looking southwest toward Johnson Creek. Through regrading of the property, the original floodplain can be reconnected with the creek.

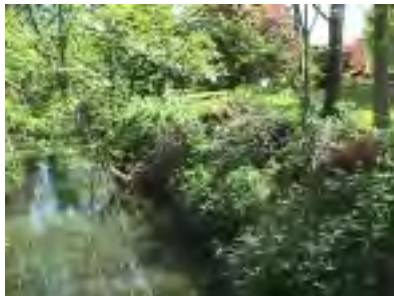
Photo 12-2:  
Looking west from footbridge on SE Lambert Avenue, north bank. Opportunity exists to terrace the banks and reconnect areas of original floodplain while enhancing the riparian corridor.

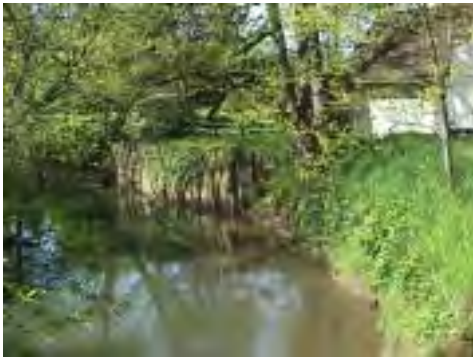
Photo 12-3:

Looking southwest from the footbridge on SE Lambert Avenue. Opportunity exists to terrace the banks, remove invasive species, and undertake floodplain reconnection actions.

3. Work with willing property owners adjacent to Johnson Creek for the purpose of floodplain reconnection. Restoration activities will be property-specific and to the degree deemed appropriate by the property owner. The action of floodplain reconnection will entail removal of invasive species from creek banks, as well as removal of the WPA wall where appropriate. Creek banks will be terraced and replanted with native riparian vegetation (see Photo 12-3).

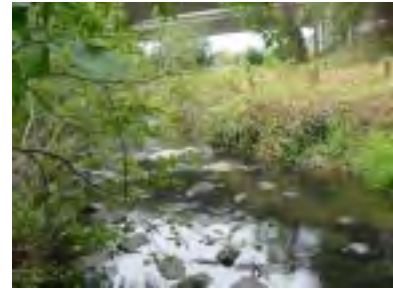
Photo 13-1:  
Looking downstream just south of Freeway Land Company near Interstate 205. Opportunities exist to terrace the creek banks and revegetate them with native plants to provide additional shade cover.

1. Work with Freeway Land Company and other property owners to maximize floodplain reconnection opportunities. This process will require removing invasive species and terracing the banks of the creek. Once terraced, the banks will be revegetated with native plant species to the extent deemed feasible by the property owner to assist in restoring the riparian corridor (see Photos 13-1 and 13-2).

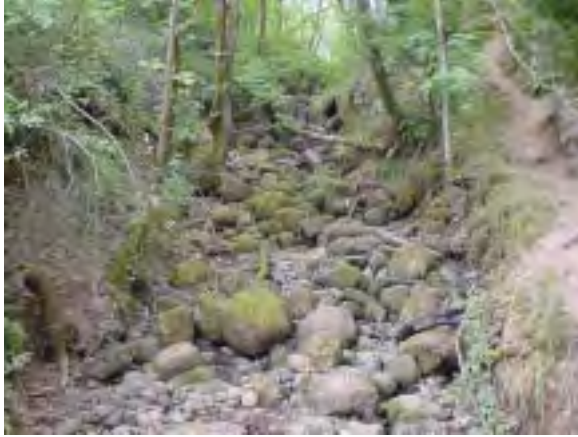
Photo 13-2:  
Johnson Creek runs through this Freeway Land Company property. The riparian buffer along the creek is in very poor condition. Opportunities exist to enhance the riparian corridor and limit the effects of surface runoff to the creek.

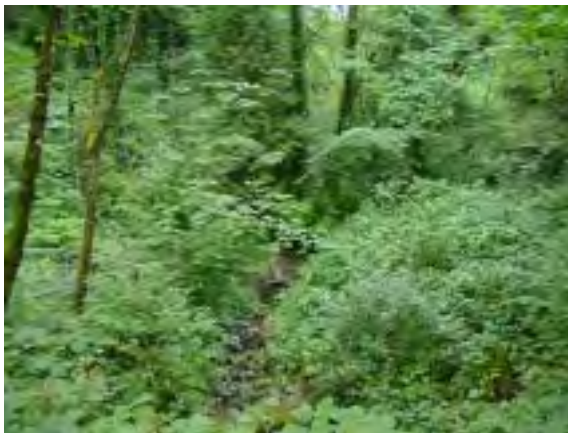
Photo 14-1:  
Looking northwest  
(downstream) at a tributary of  
Johnson Creek. Opportunity  
exists to protect and enhance  
this area.

1. Work with willing property owners adjacent to tributaries running south of Johnson Creek to restore and enhance vegetation. Along these tributaries, remove invasive species, such as Himalayan blackberry and English ivy, and replant with native riparian vegetation (see Photo 14-1).

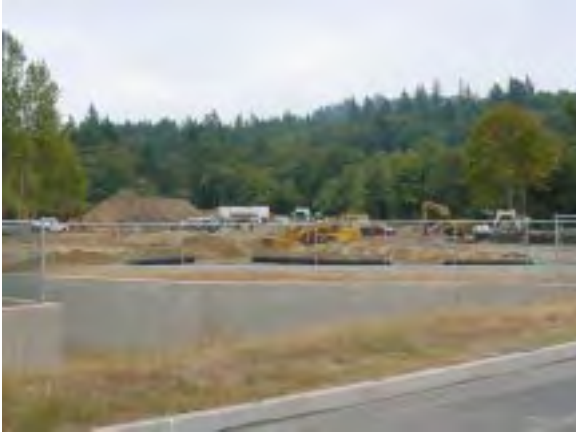
Photo 14-2:

Looking southeast at a newly developed site in a wildlife corridor area. Working with the property owner could protect and enhance the remaining corridor vegetation.

2. Work with willing property owners to realize the potential of this area as a wildlife corridor. As development continues in this area, opportunities exist to work with property owners to help maintain a wildlife corridor between Johnson Creek and nearby uplands (Mt. Scott) to the southwest. Areas of riparian vegetation can be protected while open space can be planted with native riparian vegetation (see Photo 14-2).

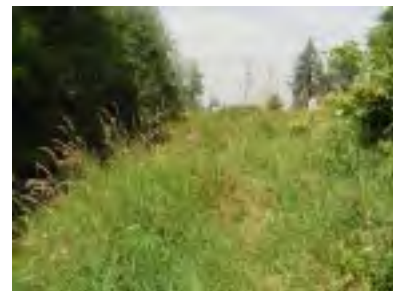
Photo 15-1:

Looking west toward an area just east of Freeway Land Company. Opportunity exists to remove invasive species, regrade the banks, and undertake floodplain reconnection actions.

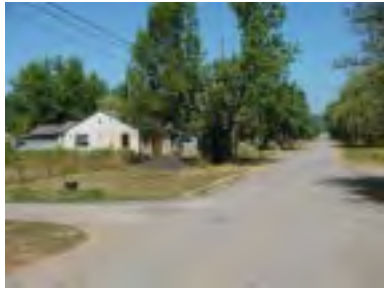
Photo 15-3:

An area near the southern end of Reach 15 along SE 106<sup>th</sup> Avenue identified as frequently flooded. Opportunities exist to acquire property through the Willing Seller Program and undertake floodplain reconnection activities.

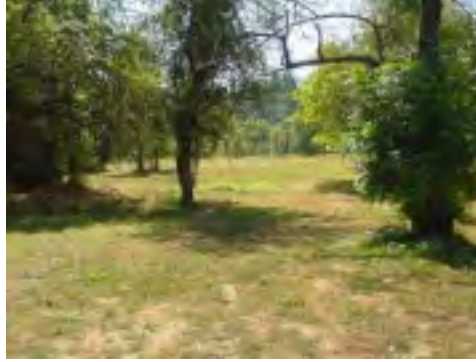
Photo 15-2:

Looking south just off SE 106<sup>th</sup> Avenue at a frequently flooded area. Opportunities exist (through the Willing Seller Program) to acquire property and undertake floodplain reconnection actions, such as constructed wetlands.

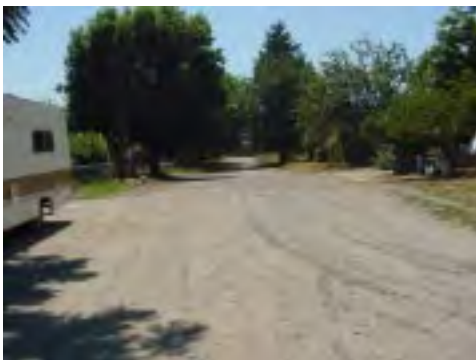
Photo 16-1:  
Looking south at the intersection of SE 104<sup>th</sup> Avenue and SE Wright Street at an area identified as flooding frequently. Opportunity exists to acquire properties and undertake floodplain reconnection actions, such as constructed wetlands.

1. Work toward acquiring frequently flooded properties through the Willing Seller Program for the purpose of designing a constructed wetland area (see Photos 16-1 and 16-2). Although this area is not directly adjacent to Johnson Creek, it is flooded during nuisance

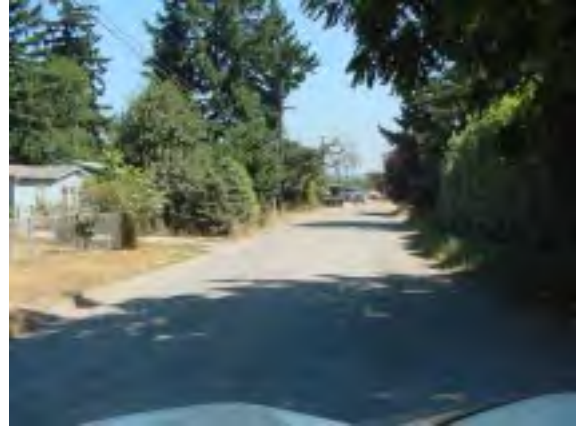
Photo 16-2:  
Looking east at  
intersection of SE 104<sup>th</sup>  
Avenue and SE Wright  
Street, which is an area of  
frequent flooding.  
Opportunities exist to  
acquire properties and  
undertake constructed  
wetland actions.

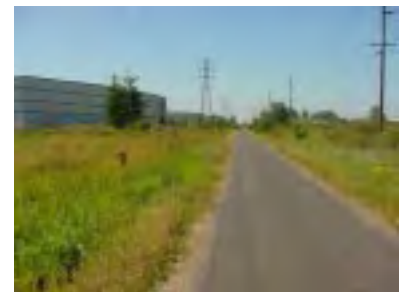
Photo 17-1:

Looking west down the Springwater Corridor. Reach 17 is on the south side of the corridor. Opportunities exist to construct a drainage way along Springwater Corridor to convey floodwaters to wetland areas.

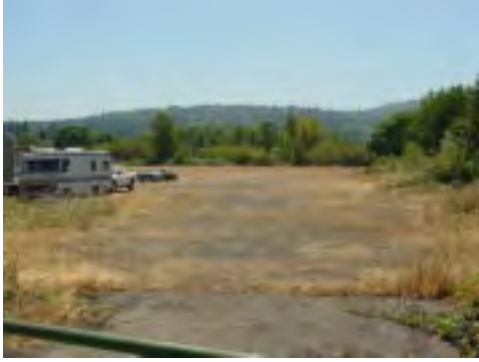
Photo 18-1:  
Looking east from SE 111<sup>th</sup>  
Avenue. Opportunities exist to  
regrade and revegetate area with  
native wetland vegetation,  
providing an environment able to  
receive floodwaters from Johnson  
Creek.

1. Work toward acquiring property through the Willing Seller Program for the purpose of constructing a wetland area designed to receive floodwater from Johnson Creek (see Photos 18-1 and 18-2). Although this area is not directly adjacent to Johnson Creek, it is periodically flooded by the creek during nuisance storm events. This action will require regrading acquired properties and planting them with native wetland vegetation. The area will then be maintained as a wetland to provide the functions associated with a wetland environment. Specific projects will be determined as part of the Lents 2040 process.

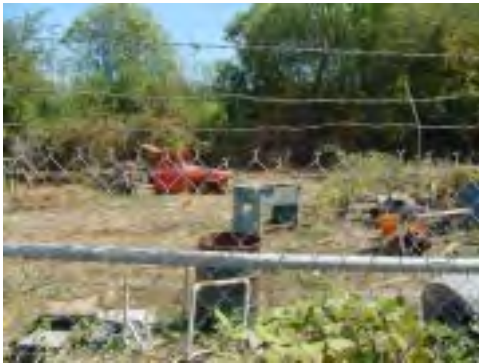
Photo 18-2:  
Looking south from SE Harold Street.  
Opportunities exist to clean up this  
site and create a constructed wetland  
area that could mitigate for the  
nuisance flood.

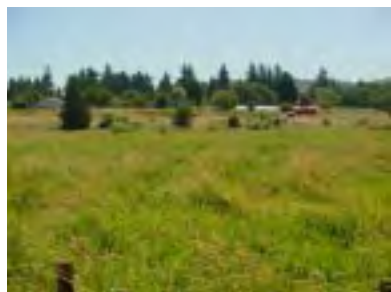
Photo 19-1:

Looking south from the Springwater Corridor. Opportunity exists to enhance wetland areas so that they have greater capacity to receive Johnson Creek's floodwaters and provide habitat.

1. Work toward acquiring property through the Willing Seller Program for the purpose of enhancing wetland areas so that they may receive additional floodwaters from Johnson Creek (see Photo 19-1). Although this area is not directly adjacent to Johnson Creek, it is periodically flooded by the creek during nuisance storm events. This action involves planting the area with native wetland vegetation, and some regrading may be required to create additional wetland areas. The area will then be maintained as a wetland to provide the functions associated with a wetland environment. Specific projects will be determined as part of the Lents 2040 process.
2. Work with property owners to educate them about stream stewardship and the impacts of their actions on the creek. Assist them in altering their habits and practices to better protect and enhance Johnson Creek.

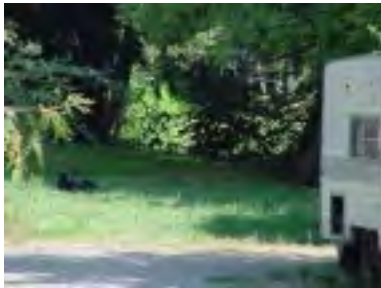
Photo 20-1:

Looking north from the Brookside area near the approximate confluence of Johnson Creek and a tributary, at an area identified as flooding frequently. Opportunity exists throughout this reach to undertake floodplain reconnection actions.

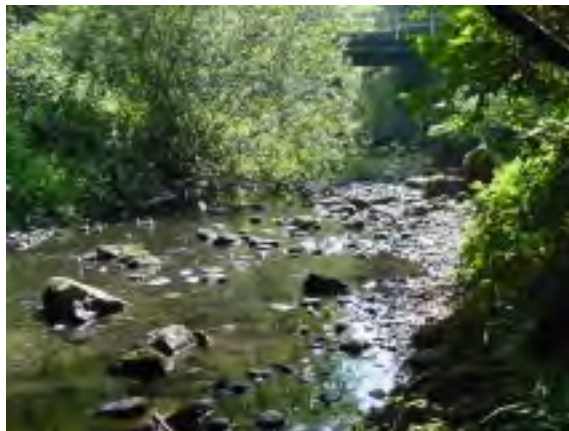
Photo 20-2:

Looking east toward the SE 122<sup>nd</sup> Avenue bridge. Opportunity exists for floodplain reconnection actions.

1. Work toward acquiring frequently flooded properties near the creek through the Willing Seller Program as opportunities arise. On acquired properties, structures will be removed, creek banks will be terraced back as appropriate to reconnect the floodplain and replanted with native vegetation, and the riparian corridor will be protected and enhanced to the maximum extent possible (see Photo 20-1).
2. Work with willing property owners adjacent to Johnson Creek for the purpose of reconnecting Johnson Creek with its original floodplain (see Photo 20-2). Activities along the creek will be

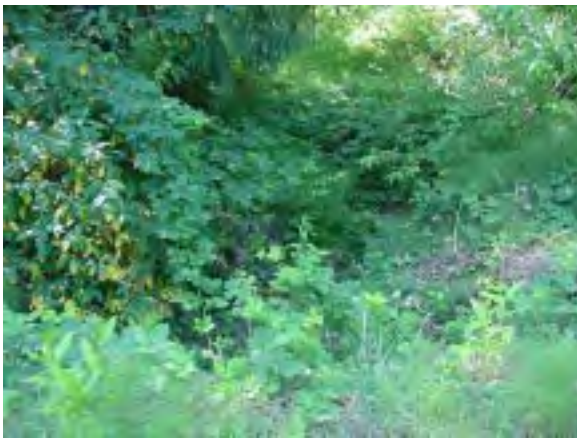
Photo 20-3:  
Looking at a tributary on the south side of Johnson Creek. The tributary can be protected and enhanced by removing invasive species and planting native plants.

3. Work with property owners along the tributaries of Johnson Creek to protect and enhance the resource. Invasive plant species will be removed and native riparian vegetation will be planted, which will help maintain a healthy connection between the tributary and Johnson Creek. Where appropriate, areas of healthy vegetation will be targeted for protection through the use of conservation easements (see Photo 20-3).

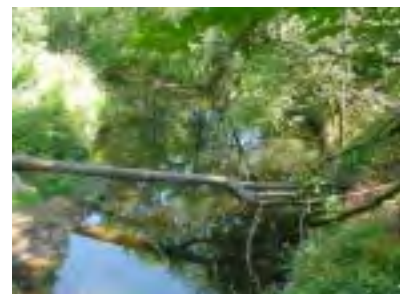
The flood management plan element of the RMP was intended to offer a reasonable level of flood protection to existing structures while preventing new development from adding to flooding problems. The element included the following actions:

Looking east along Johnson Creek near SE Deardorf Road. Opportunities exist to terrace creek banks and undertake floodplain reconnection actions.

2. Work with property owners to optimize floodplain reconnection opportunities along this reach. Where appropriate, terrace banks of the creek to expand the available room for the creek. Once banks are terraced and invasive species removed, the banks will be revegetated with native trees and shrubs. Special attention will be given to providing shade for the creek (see Photo 21-1). This process will require terracing the creek banks to open up additional room for the creek to access. The riparian corridor could be enhanced up to 100 feet in some areas.

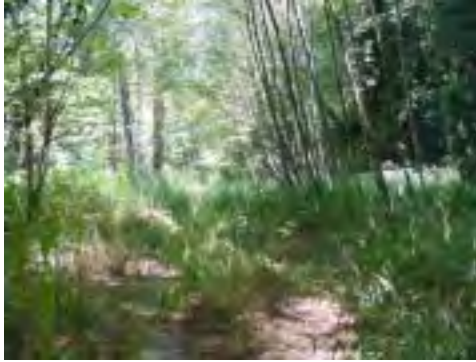
Photo 21-2:

Looking east at a creekside wetland area along a tributary to Johnson Creek. Opportunity exists to work with property owners to protect areas of riparian vegetation and enhance tributaries by removing invasive species and replanting with native riparian plants.

3. Work with property owners along the tributaries of Johnson Creek to protect and enhance the resource. Invasive plant species will be removed and native riparian vegetation will be planted, helping to maintain a healthy connection between the tributary and Johnson Creek (see Photos 21-2 and 21-3). Where appropriate, areas of healthy vegetation will be targeted for protection through the use of conservation easements.

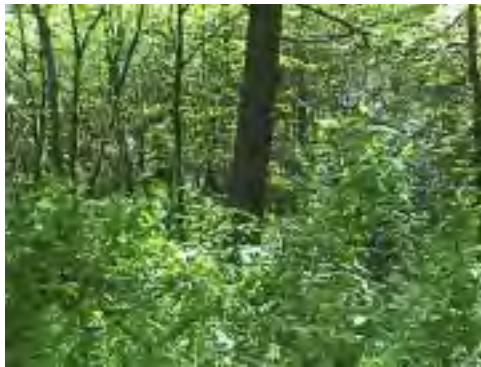
Photo 21-3 :

Looking east at a forested area near Johnson Creek. Opportunities exist to protect riparian vegetation and areas that drain to Johnson Creek.

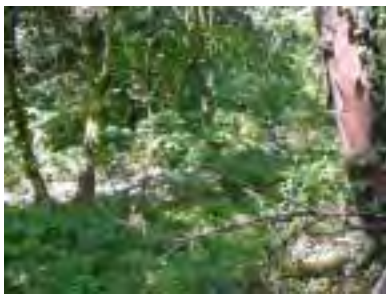
Photo 22-1:

Looking east from SE Deardorf Road at a possible area for creating a constructed wetland near the creek.

2. Work toward acquiring additional property along the western portion of this reach through the Willing Seller Program and design a constructed wetland area. The purpose of this action is to reconnect Johnson Creek with its original floodplain (see Photo 22-1). The action requires regrading the creek banks and removing non-native invasive species to open up additional area for access by the creek. After regrading, the banks will be planted with appropriate native riparian vegetation to create shade for the creek. Other actions to be completed during the process of regrading and lowering the banks include creating off-channel fish habitat and increasing sinuosity along the creek by adding meanders. Existing native vegetation, especially large trees, will be preserved as much as possible during restoration.

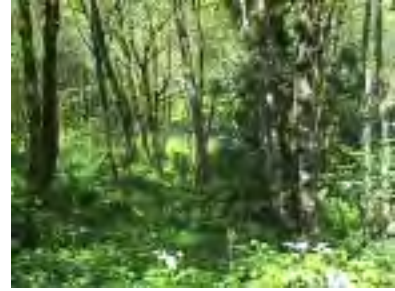
Photo 22-2:

Looking northeast from the south side of Johnson Creek. This area represents an opportunity to work with the property owner in undertaking floodplain reconnection actions.

well as removal of the WPA wall where appropriate. The banks will be regraded, terraced, and then replanted with native riparian vegetation. Enhancing the riparian corridor and increasing floodplain connection will help stabilize the stream banks (see Photos 22-2, 22-3, and 22-4).
