# Johnson Creek Restoration Plan

# Acknowledgements

## Bureau of Environmental Services

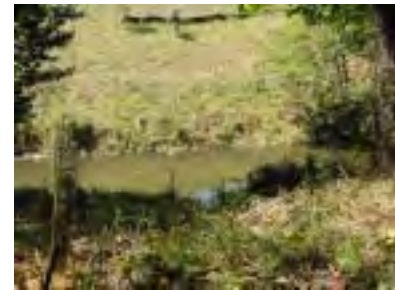
Photo 22-3:

Looking northwest off Barbara Welch Road at a potential area for floodplain reconnection actions. Work with property owners to revegetate creek banks and enhance wildlife corridors.

well as removal of the WPA wall where appropriate. The banks will be regraded, terraced, and then replanted with native riparian vegetation. Enhancing the riparian corridor and increasing floodplain connection will help stabilize the stream banks (see Photos 22-2, 22-3, and 22-4).

5. Work with property owners throughout this project area to create a wildlife corridor. Owners will be encouraged to plant native riparian vegetation to enhance habitat conditions and provide wildlife access to the creek from the surrounding upland areas (see Photo 22-3).

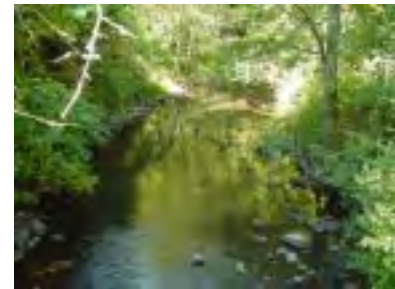
Photo 22-4:

Looking west off the SE 142<sup>nd</sup> Avenue bridge crossing. This area offers an opportunity to work with property owners to reconnect the floodplain, increase in-stream complexity, and replace invasive species with native plants.

6. Increase in-stream complexity throughout this reach. This action, which will be done in conjunction with other projects in the reach, will consist of creating areas of large wood, pool/riffle sequences, and deep pools in the creek channel. Activities will be site-specific and will be determined in the project design phase (see Photo 22-4).

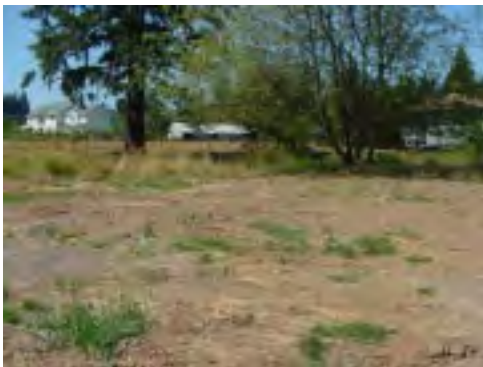
Photo 23-1:  
BES-owned property off SE 145<sup>th</sup>  
Avenue that would be part of  
floodplain reconnection actions.

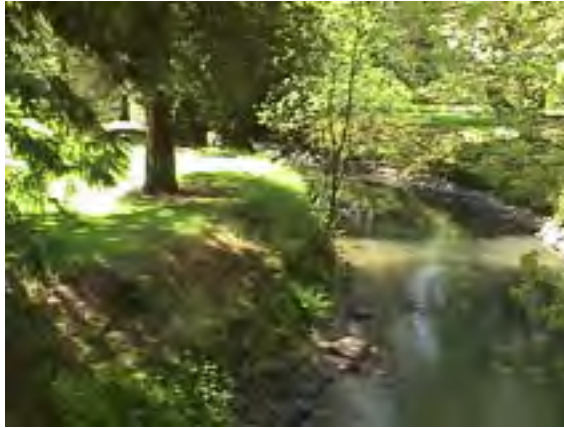
Photo 23-2:  
Looking west from the SE 158<sup>th</sup> Avenue bridge over Johnson Creek. Opportunity exists to terrace the banks, reconnect the floodplain, and restore the riparian corridor through revegetation projects and the addition of in-stream complexity.

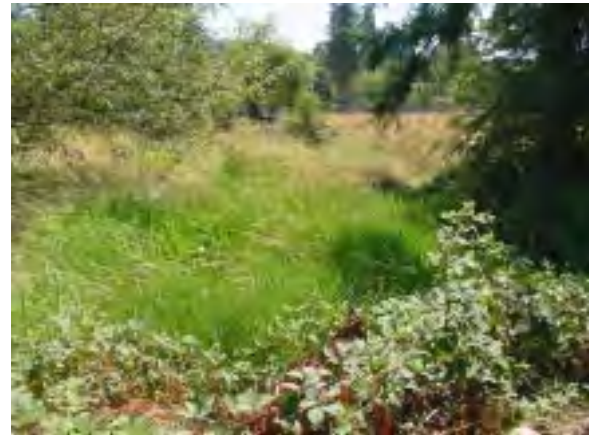
Photo 23-3:  
A wetland area in Reach 23 that could be restored to function as both floodplain and habitat after regrading and planting with native vegetation.

3. Work with property owners near the creek to encourage planting of native riparian vegetation. This action will enhance habitat conditions and provide wildlife access to the creek from the surrounding upland areas (see Photo 23-3).

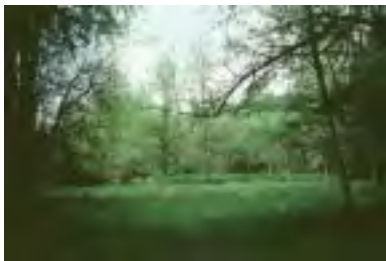
Photo 24-1:

BES-owned property off of SE 159<sup>th</sup> Avenue, site of the Alsop-Brownwood early action project. There is opportunity here to reconnect the creek to its floodplain and restore fish and wildlife habitat. The project will also create a habitat corridor from Powell Butte to the creek.

1. Work toward acquiring frequently flooded properties near the creek through the Willing Seller Program as opportunities arise. On acquired properties, structures will be removed, creek banks will be terraced back as appropriate to reconnect the floodplain and replanted with native vegetation, and the riparian corridor will be protected and enhanced to the maximum extent possible (see Photo 24-1).

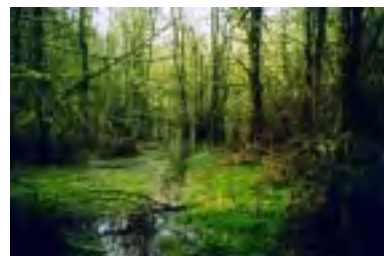
Photo 24-2:

A forested wetland near Johnson Creek. Wetlands like this one could be created on appropriate sites to provide habitat and floodplain reconnection.

adding meanders throughout this reach. Constructed wetland areas in this area will serve as a wildlife corridor as well as protect cool/cold water seeps and springs (see Photo 24-2).

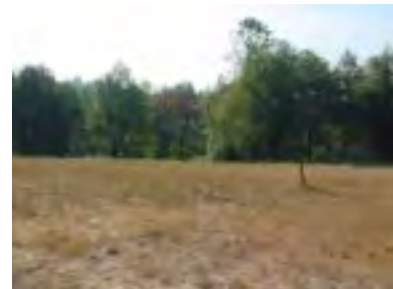
Photo 25-1:

Looking east toward Johnson Creek off of SE Circle Avenue. Opportunity exists to work with property owners to enhance floodplain reconnection.

1. Work with willing property owners adjacent to Johnson Creek for the purpose of reconnecting the creek with its original floodplain (see Photo 25-1). Activities will be property-specific and to the extent deemed appropriate by the owner. Floodplain reconnection will entail removal of invasive plant species from the banks of the creek, as well as removal of the WPA wall where appropriate. The banks will be regraded, terraced, and then replanted with native riparian vegetation. Enhancing the riparian corridor and increasing floodplain connection will help stabilize the stream banks.

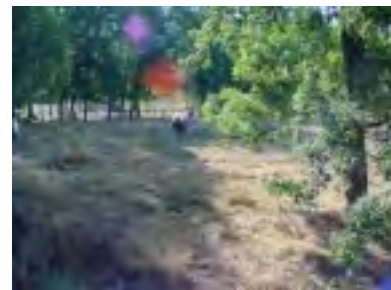
Photo 26-1:

Looking south at a pasture area adjacent to Johnson Creek, near the SE Circle Avenue overpass. It is a potential area for floodplain reconnection actions.

3. Work with willing property owners adjacent to Johnson Creek for the purpose of reconnecting the creek with its original floodplain. Activities will be property-specific and to the extent deemed appropriate by the owner. Floodplain reconnection will entail removal of invasive plant species from the banks of the creek, as well as removal of the WPA wall where appropriate. The banks will be regraded, terraced, and then replanted with native riparian vegetation. Enhancing the riparian corridor and increasing floodplain connection will help stabilize the stream banks (see Photos 26-1 and 26-2).

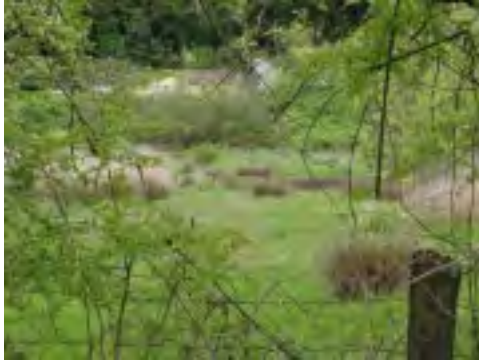
Photo 26-2:

Looking southeast from the south bank of Johnson Creek. This open area provides opportunity to work with landowners to reconnect the floodplain and enhance wetlands on their properties.

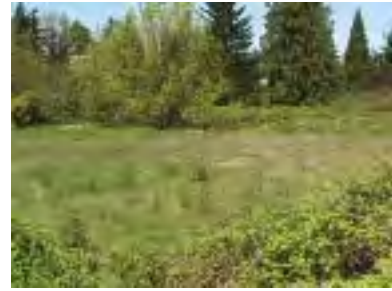
Photo 27-2:

Looking north from the Springwater Corridor on the south side of Johnson Creek. The property is situated in between the corridor and the creek and is a potential area for floodplain reconnection actions.

3. Work with willing property owners adjacent to Johnson Creek for the purpose of reconnecting the creek with its original floodplain. Activities will be property-specific and to the extent deemed appropriate by the owner. Floodplain reconnection will entail removal of invasive plant species from the banks of the creek. The banks will be regraded , terraced, and then replanted with native riparian vegetation. Enhancing the riparian corridor and increasing floodplain connection will help stabilize the stream banks and decrease the effects of excessive erosion on the creek (see Photo 27-2).

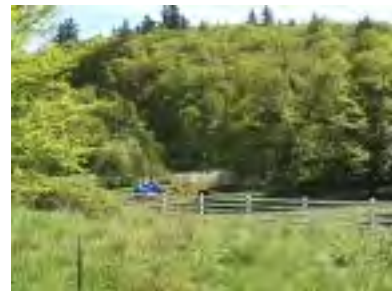
Photo 27-3:

Looking at a property on the south side of the Springwater Corridor. This area offers opportunity to work with the property owner to maintain and enhance the wildlife corridor and upland connection.

4. Work with property owners south of the Springwater Corridor for the purpose of creating a wildlife corridor from the upland areas to the creek. This corridor would be an extension of the enhanced wetland area. If a property owner is interested and the site is appropriate, a connection may be designed to allow the creek access to the property and open up additional floodplain area. Property owners will be encouraged to allow removal of invasive plant species (e.g., Himalayan blackberries, reed canarygrass) and planting of native riparian vegetation to enhance wildlife habitat conditions, as well as providing access to the creek from the surrounding upland areas (see Photos 27-3 and 27-4).

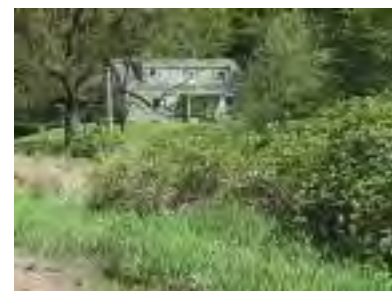
Photo 27-4:

Looking southeast from the Springwater Corridor south of Johnson Creek. This area offers an opportunity to work with the property owner to enhance the wildlife corridor and upland connections, and to potentially reconnect the floodplain.

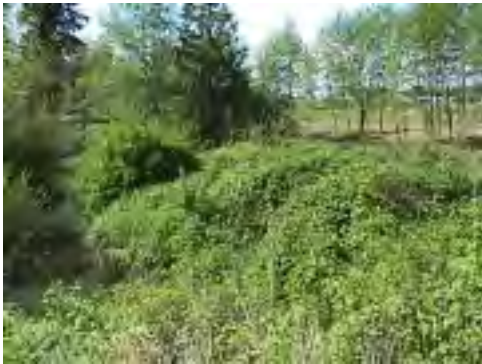
Photo 28-1:

Looking northeast from the Springwater Corridor at a potential area for floodplain reconnection and bank stabilization. The banks are predominantly covered with Himalayan blackberry, which does little to stabilize eroding banks.

1. Work with willing property owners adjacent to Johnson Creek for the purpose of reconnecting the creek with its original floodplain. Activities will be property-specific and to the extent deemed appropriate by the owner. Floodplain reconnection will entail removal of invasive plant species from the banks of the creek. The banks will be regraded, terraced, and then replanted with native riparian vegetation. Enhancing the riparian corridor and increasing floodplain connection will help stabilize the stream banks and decrease the effects of excessive erosion on the creek (see Photos 28-1, 28-2, and 28-3).

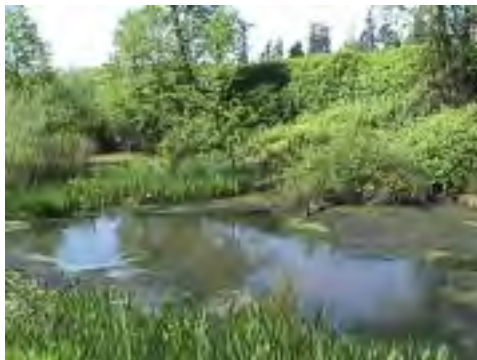
Photo 28-2:

Looking northwest from the Springwater Corridor on the north side of Johnson Creek. This is a backwater area that could potentially be reconnected to the creek to expand the floodplain.

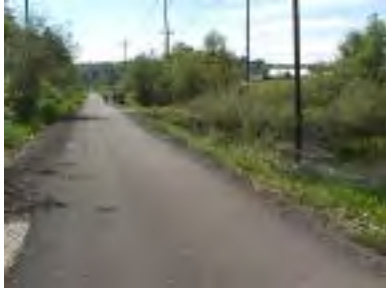
Photo 28-3:

Facing west, looking down the Springwater Corridor. Potentially, Johnson Creek, which is on the south side of Springwater Corridor, and its backwaters, which are on the north side, could be reconnected. This would provide increased and improved fish habitat.

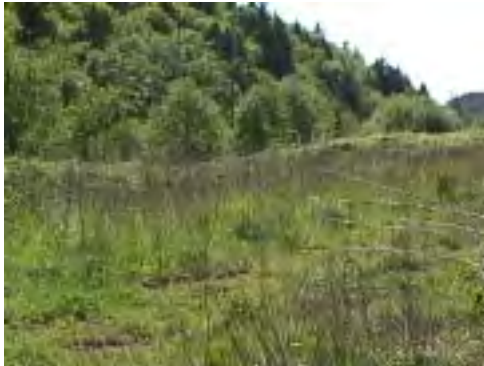
Photo 28-4:

Looking southwest above the Springwater Corridor and Johnson Creek. This open area can be replanted with native riparian vegetation to enhance wildlife corridors and the connection to upland areas.

2. Work with property owners throughout this reach to create a wildlife corridor. Owners will be encouraged to plant native riparian vegetation to enhance habitat conditions and provide wildlife access to the creek from the surrounding upland areas (see Photos 28-4 and 28-5).

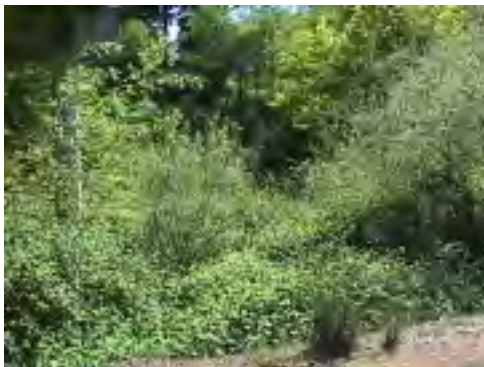
Photo 28-5:

Looking southwest from the Springwater Corridor on the north side of Johnson Creek at upland area vegetation being invaded by non-native Himalayan blackberries. Removal of invasive species and revegetation with native plants will enhance wildlife habitat.

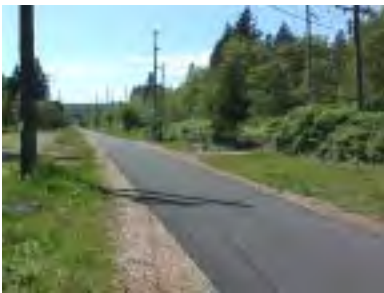
Photo 29-1:

Looking east down the Springwater Corridor. The recommended action is to connect properties on both sides of the corridor and create an enhanced wetland.

1. Work toward acquiring properties on the south side of the Springwater Corridor and some limited property on the north side of the corridor for the purpose of creating an enhanced wetlands area. These properties are mainly on the north side of Johnson Creek. Existing structures and invasive species will be removed, the banks of the creek and the property south of the Springwater Corridor will be regraded, and a channel will be constructed underneath the corridor to connect natural floodplain areas on both sides. The intent of this action is to reconnect Johnson Creek with its original floodplain through the enhancement of existing wetland areas in this reach. Areas will be expanded and enhanced with additional native wetland vegetation. Banks will be terraced and planted with native vegetation to increase the size and enhance the value of the riparian corridor, and also provide shade for the creek (see Photo 29-1).

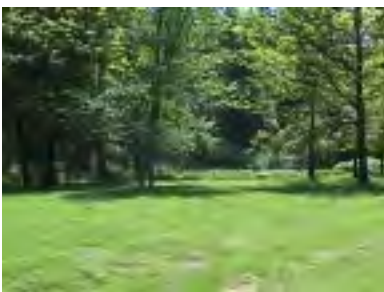
Photo 29-2:

Looking south from Springwater Corridor at the north bank of Johnson Creek. Opportunity exists here to reconnect the floodplain.

2. Work with willing property owners adjacent to Johnson Creek for the purpose of reconnecting the creek with its original floodplain. Activities will be property-specific and to the extent deemed appropriate by the owner. Floodplain reconnection will entail removal of invasive plant species from the banks of the creek. The banks will be regraded, terraced, and then replanted with native riparian vegetation. Enhancing the riparian corridor and increasing floodplain connection will help stabilize the stream banks and decrease the effects of excessive erosion on the creek (see Photos 29-2, 29-3, and 29-4).

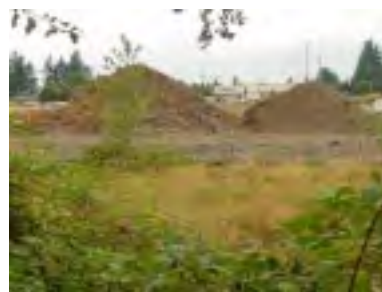
Photo 29-3:  
Looking north at a new construction site near the Springwater Corridor. A large forested area was removed for construction of a supermarket. This area presents an opportunity to incorporate property around the developed site into a wetland buffer.

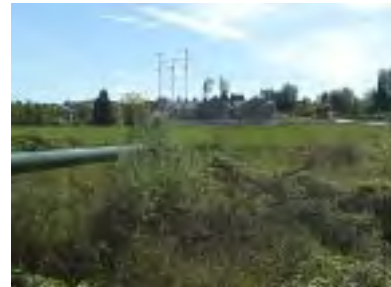
Photo 30-1:

Looking southeast from the Springwater Corridor, at the south bank of Johnson Creek. Opportunity exists in this area to reconnect the floodplain, create enhanced wetland areas, and restore the riparian corridor.

1. Work toward acquiring properties along Johnson Creek through the Willing Seller Program for the purpose of reconnecting Johnson Creek with its natural floodplain by developing an enhanced wetland area. This action will entail removing acquired homes, terracing back the banks of the creek as far as possible, and allowing the creek additional area in which to expand. The banks will then be revegetated with native plants to increase the size and enhance the value of the riparian corridor, and also to provide shade for the creek (see Photo 30-1). Property exhibiting wetland characteristics already exists in this area. The purpose of the work is to expand and enhance this area by planting additional native wetland vegetation and removing non-native invasive species, such as reed canarygrass and Himalayan blackberry. Existing native wetland vegetation will be maintained in the design (see Photo 30-2). Within this project, enhanced wetland areas will also serve as wildlife corridors. Revegetating the banks will help increase their stability and decrease the effects of excessive erosion on the creek.

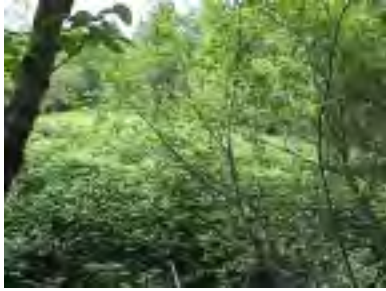
Photo 30-3:

Looking south from the Springwater Corridor, east of Pleasant View Drive, across the creek at lawn. Only blackberries are growing between the lawn and the creek, intensifying bank erosion and reducing the quality of the riparian corridor. Working with willing property owners, bank terracing and revegetation opportunities exist to restore the riparian corridor and reconnect the floodplain.

Enhancing the riparian corridor and increasing floodplain connection will help stabilize the stream banks and decrease the effects of excessive erosion on the creek (see Photos 30-3 and 30-4).

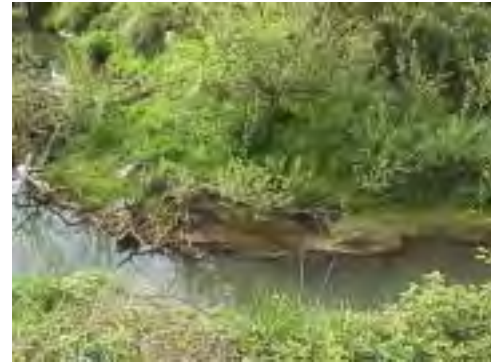
Photo 30-4:

Looking southeast, from the Springwater Corridor, east of Pleasant View Drive. Opportunity exists in areas like this along the creek to restore the riparian corridor and increase in-stream complexity.

4. Increase in-stream complexity throughout the length of this reach. This action, which will be done in conjunction with other projects in the reach, will consist of creating areas of large wood, pool/riffle sequences, and deep pools in the creek channel. Activities will be site-specific and will be determined in the project design phase (see Photo 30-4).

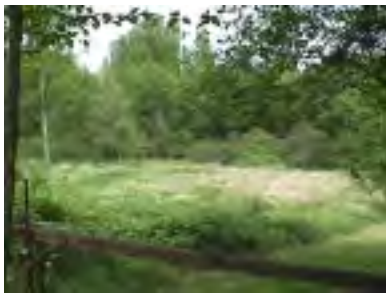
Photo 31-1:

Looking northwest from SW 14<sup>th</sup> Avenue, just east of Battaglia at a field of reed canarygrass in the foreground and Johnson Creek in the background. Opportunity exists to reconnect the floodplain through terracing and regrading the creek banks.

1. Work toward acquiring property through the Willing Seller Program for the purpose of floodplain reconnection along Johnson Creek. This action will entail development of an enhanced wetland area. On acquired property, creek banks will be terraced and regraded as far as is appropriate, and the banks will be planted with native riparian vegetation to increase the size and enhance the riparian corridor, as well as provide shade for the creek. The purpose of the work is to expand and enhance this area by removing non-native invasive species, such as reed canarygrass and Himalayan blackberry, and planting additional native wetland vegetation. Existing native wetland vegetation will be maintained in the project design. Revegetating the banks will help to increase their stability and decrease the effects of excessive erosion on the creek (see Photo 31-1).

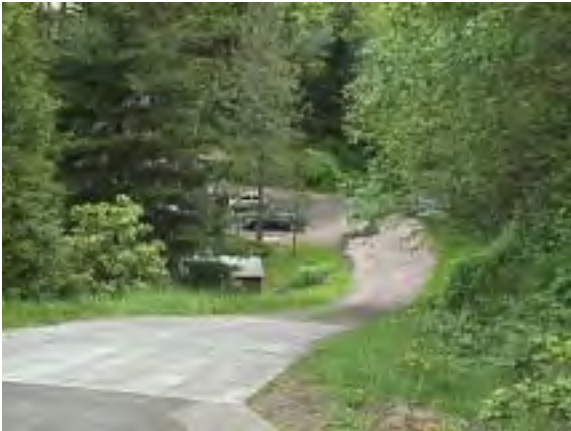
Photo 31-2:  
Looking northeast at the intersection of SW 14<sup>th</sup> Avenue and SE Heiney Road. Opportunity exists to work with property owners to protect this Johnson Creek tributary (located behind parking area).

3. Work with property owners along the tributaries of Johnson Creek to protect and enhance the resource (see Photo 31-2).

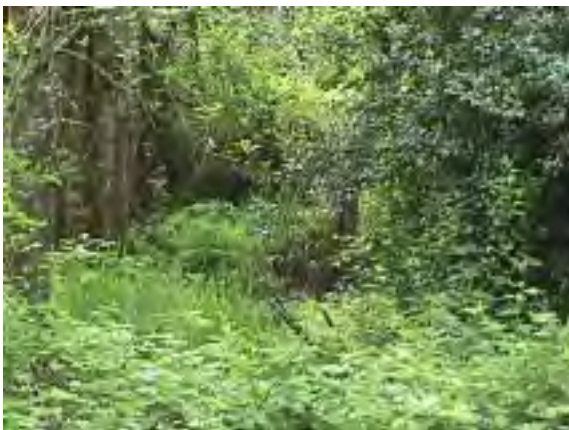
Photo 32-1:  
Looking southwest from the horse trail off of the Springwater Corridor. Vegetation consists of alder, ash, and holly, with an understory of reed canarygrass and Himalayan blackberry. Opportunity exists to enhance and protect riparian vegetation.

1. Work toward acquiring property through the Willing Seller Program for the purpose of floodplain reconnection along Johnson Creek. This action will entail development of an enhanced wetland area. On acquired property, creek banks will be terraced and regraded as far as is appropriate, and the banks will be replanted with native riparian vegetation to increase and enhance the riparian corridor, as well as provide shade for the creek (see Photo 32-1). The purpose of the work is to expand

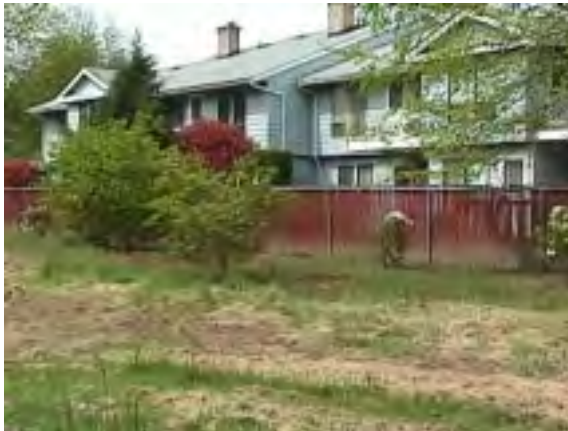
Photo 32-2:  
Looking northwest at apartments along Eastman Parkway and the Springwater Corridor. Opportunity exists to develop stormwater swales in this area to mitigate drainage to the creek.

2. Work with willing property owners adjacent to Johnson Creek for the purpose of reconnecting the creek with its original floodplain. Activities will be property-specific and to the extent deemed appropriate by the owner. Floodplain reconnection will entail removal of invasive plant species from the banks of the creek. The banks will be regraded, terraced, and then replanted with native riparian vegetation. Enhancing the riparian corridor and increasing floodplain connection will help stabilize the stream banks and decrease the effects of excessive erosion on the creek. Willing property owners near, but not adjacent, to the creek will also be assisted to promote riparian plantings and enhancement of wetland areas, as well as to mitigate additional drainage to Johnson Creek (see Photo 32-2).

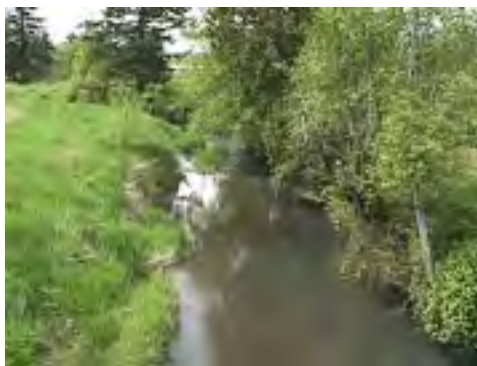
Photo 33-1:  
Looking west from the 7<sup>th</sup> Street bridge. Opportunities exist to terrace banks, replant with native riparian vegetation, and reconnect floodplain with Johnson Creek.

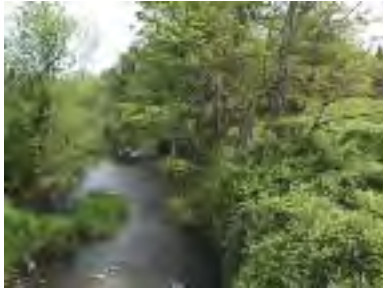
Photo 33-3:  
Looking east from the 7<sup>th</sup> Street bridge. Opportunity exists to reconnect the floodplain with Johnson Creek (terrace banks and revegetate with native vegetation).

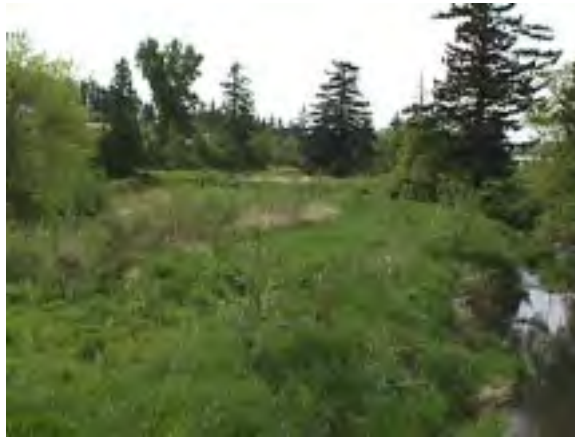
Photo 33-2:  
Looking west from the 7<sup>th</sup> Street bridge. Opportunities exist to create a wetland area here by terracing creek banks and reconnecting the floodplain.

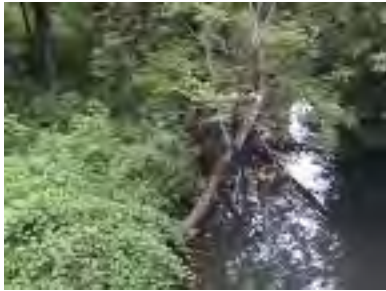
Photo 34-1:  
Looking north on Johnson Creek just east of SW Walters Road. Opportunities exist to remove invasive species and terrace banks to increase floodplain connection.

All actions are linked to the Main City Park Restoration Plan. See Photos 34-1 through 34-4.

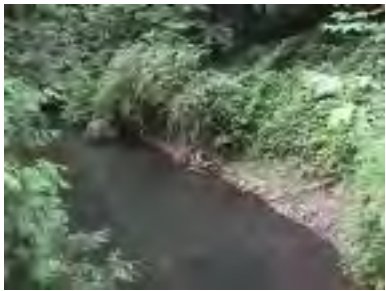
Photo 34-2:  
Looking downstream from the bridge in Main City Park. Terracing banks, removing invasive species, and replanting with native riparian vegetation will improve habitat conditions and reconnect the creek to its floodplain.

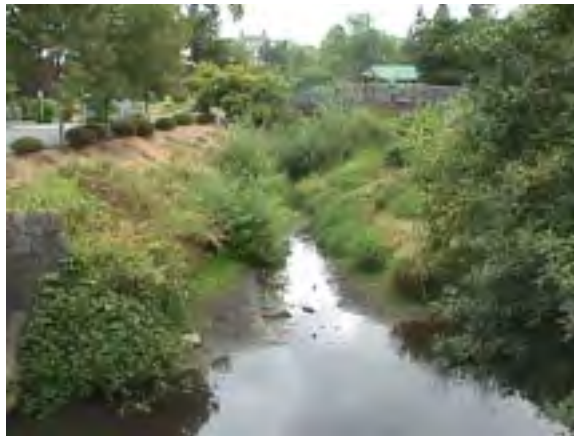
Photo 34-3:  
Looking north from Main City Park, at a small oxbow feeding into Johnson Creek. Removing invasive species and revegetating with native plants will increase bank stabilization.

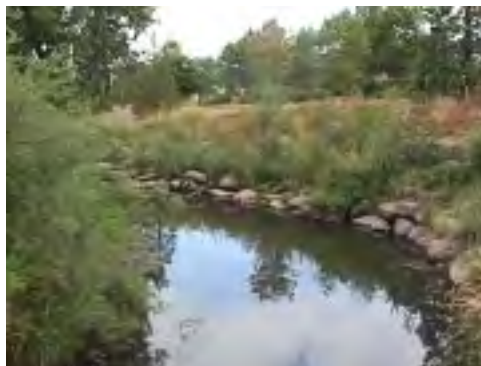
Photo 34-4:  
Looking east from Main City Park at Johnson Creek. Terracing banks and revegetating with native trees and shrubs will improve habitat conditions along the creek.

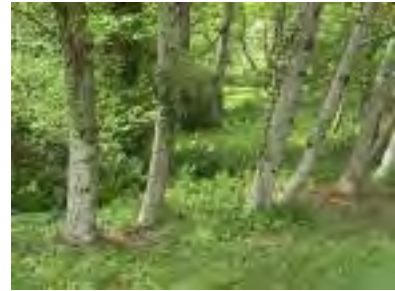
Photo 35-1:

Looking southwest near SE Park Drive and SE Roberts Avenue, east of Johnson Creek. Opportunities exist to work with property owners to excavate creek banks, allow reconnection with the floodplain, and replant with native wetland vegetation.

increasing floodplain connection will help stabilize the stream banks and decrease the effects of excessive erosion on the creek (see Photos 35-1, 35-2, and 35-3).

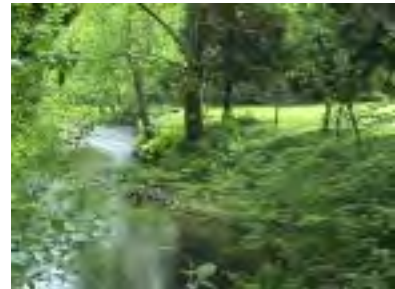
Photo 35-2:

Looking east from Regner Road off of the Springwater Corridor on a bridge (private driveway), showing vine maple, cottonwood, and many exposed cobbles. Opportunities exist to work with property owners to pull back the bank, reconnect the original floodplain in grassy area, and replant with native riparian vegetation.

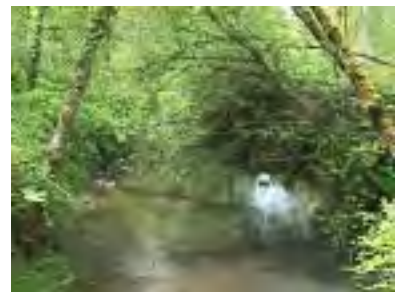
Photo 35-3:

Looking west from Regner Road off of the Springwater Corridor on a bridge (private driveway), showing salmonberry, maple, alder, blackberry, English ivy, and many exposed cobbles. Opportunity exists to work with property owners to pull back the bank, remove blackberry growth, and replant with native riparian vegetation.

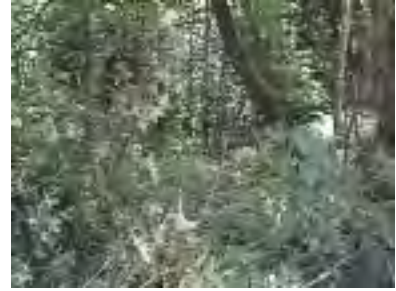
Photo 36-1:

Looking southeast, downstream from a tributary of Johnson Creek. Working with property owners to remove invasive species and revegetate with native plants to protect and enhance the area is recommended.

1. Work with property owners along the tributaries of Johnson Creek to protect and enhance the resource. Invasive species will be removed and replaced by native riparian vegetation, thereby helping to maintain a healthy connection between the tributary and Johnson Creek. Where practicable, areas of healthy vegetation will be targeted for protection through the use of conservation easements.
2. Work with property owners throughout the reach to create a wildlife corridor. Owners will be encouraged to plant native riparian vegetation that will enhance habitat conditions and provide wildlife access to the creek from the surrounding upland areas (see Photos 36-1 and 36-2).

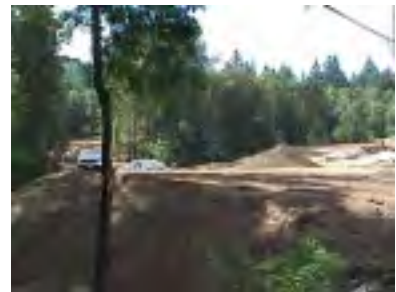
Photo 36-2:

Looking south at new development near the tributary. Opportunities exist to work with property owners to enhance and protect the wildlife corridor and promote planting of open space with native plants and shrubs.

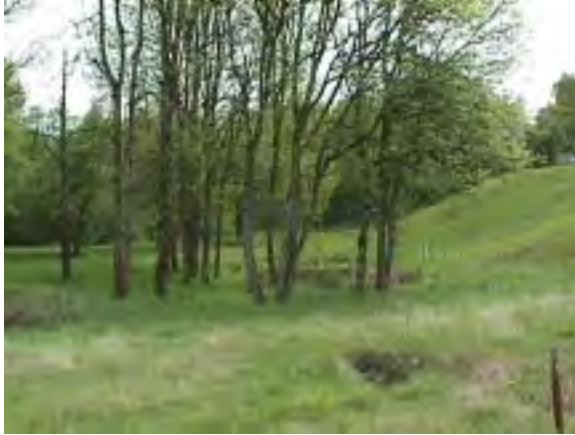
Photo 37-2:

Looking at a creek side area near the intersection of SE Elliot and Regner Roads. Working with the property owner to terrace the banks of the creek and allow this area to flood could improve habitat conditions and reconnect the floodplain.

1. Work with willing property owners adjacent to Johnson Creek for the purpose of reconnecting the creek with its original floodplain. Activities will be property-specific and to the extent deemed appropriate by the owner. Floodplain reconnection will entail removal of invasive plant species from the banks of the creek. The banks will be regraded, terraced, and then replanted with native riparian vegetation. Enhancing the riparian corridor and increasing floodplain connection will help stabilize the stream banks and decrease the effects of excessive erosion (see Photos 37-1 and 37-2).

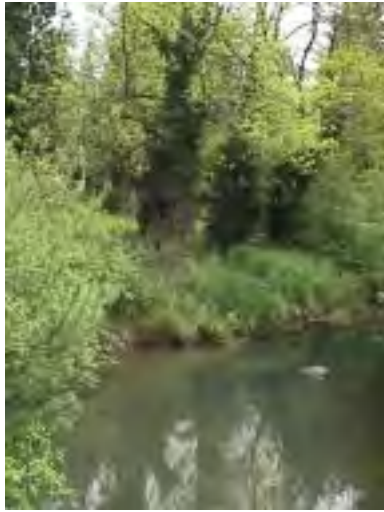
Photo 38-1:

Looking west near SE Hogan Road, south of the Springwater Corridor. Opportunity exists to work with property owners to terrace creek banks and replant them with native vegetation. Stabilization of the creek banks will help to reduce the high levels of suspended sediment in the creek.

2. Work with willing property owners adjacent to Johnson Creek for the purpose of reconnecting the creek with its original floodplain. Activities will be property-specific and to the extent deemed appropriate by the owner. Floodplain reconnection will entail removal of invasive plant species from the banks of the creek. The banks will be regraded, terraced, and then replanted with native riparian vegetation. Enhancing the riparian corridor and increasing floodplain connection will help stabilize the stream banks and decrease the effects of excessive erosion on the creek (see Photos 38-1 and 38-2).

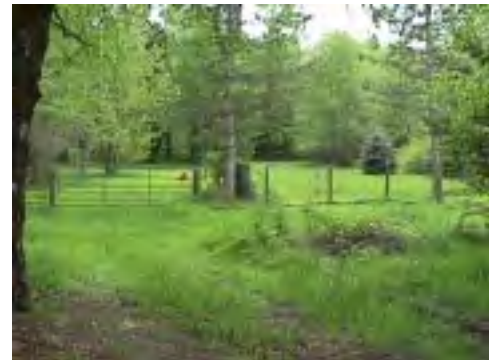
Photo 38-2:

Looking south near the Springwater Corridor and SE Hogan Road. Opportunities exist to work with property owners to terrace and revegetate creek banks, maximize open areas available along the creek, and reconnect the floodplain.

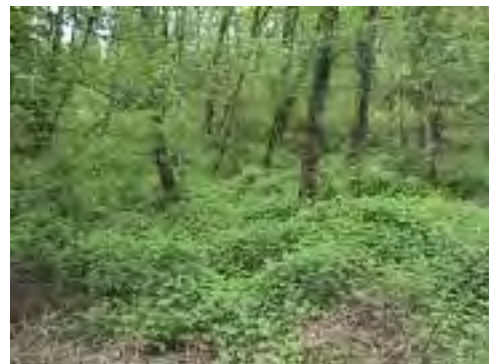
Photo 39-1:

Looking northwest along the bank of Johnson Creek. Alder and blackberry are present, possibly a riparian wetland. Work with property owners to remove blackberry growth, grade back banks, and revegetate with native plants.

1. Work with willing property owners adjacent to Johnson Creek for the purpose of reconnecting the creek with its original floodplain. Activities will be property-specific and to the extent deemed appropriate by the owner. Floodplain reconnection will entail removal of invasive plant species from the banks of the creek. The banks will be regraded, terraced, and then replanted with native riparian vegetation. Enhancing the riparian corridor and increasing floodplain connection will help stabilize the stream banks and decrease the effects of excessive erosion on the creek (see Photos 39-1 and 39-2).
2. Work with property owners along the tributaries of Johnson Creek to protect and enhance the resource. Invasive species will be removed and replaced with native riparian vegetation, thereby helping to maintain a healthy connection

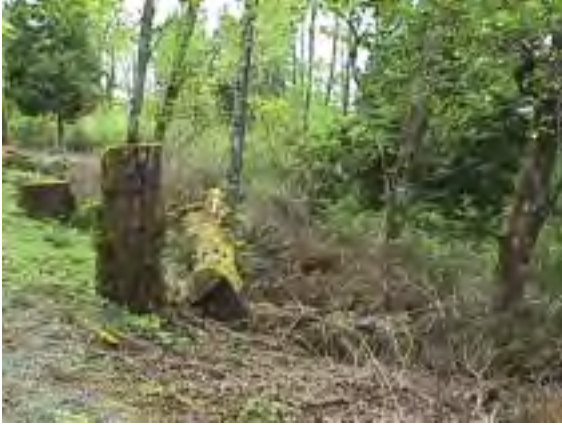
Photo 39-2:  
Looking upland from the south  
bank of Johnson Creek.  
Opportunity exists to work with  
property owner to replant the  
area with native riparian  
vegetation.

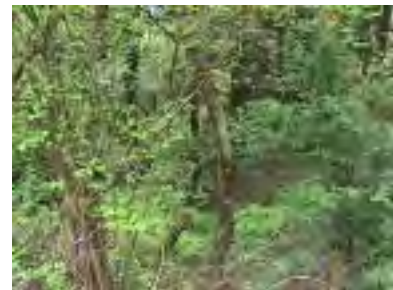
Photo 40-1:

Looking east from the intersection of SE 252<sup>nd</sup> Avenue and Telford Road. Opportunity exists to work with the property owner to maintain this riparian vegetation up to 200 feet from creek and reconnect the floodplain.

1. Work with willing property owners adjacent to Johnson Creek for the purpose of reconnecting the creek with its original floodplain. Activities will be property-specific and to the extent deemed appropriate by the owner. Floodplain reconnection will entail removal of invasive plant species from the banks of the creek. The banks will be regraded, terraced, and then replanted with native riparian vegetation. Enhancing the riparian corridor and increasing floodplain connection will help stabilize the stream banks and decrease the effects of excessive erosion on the creek (see Photos 40-1 and 40-2).

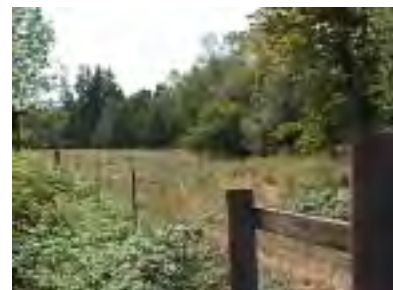
Photo 40-2:

Looking southeast from a point near the middle of the reach on the north side of Johnson Creek just off the Springwater Corridor. This open area presents opportunity to work with landowners on floodplain reconnection actions.

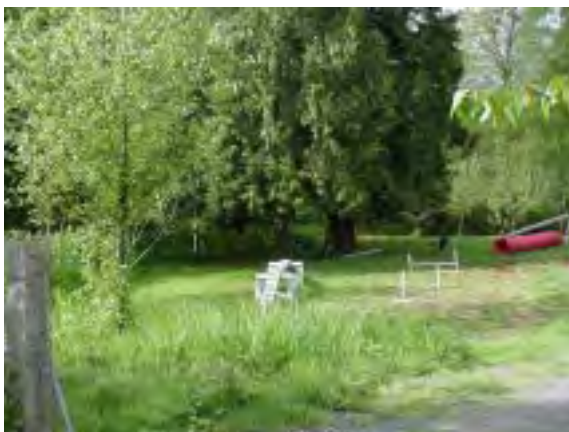
Photo 41-1:

Looking south near the intersection of the Springwater Corridor and SE McNutt Road. Johnson Creek is on the left in the background. The north bank is very grassy; the south bank contains a narrow tree buffer. Opportunity exists to work with the property owner in reconnecting the floodplain and restoring the riparian corridor.

Activities will be property-specific and to the extent deemed appropriate by the owner. Floodplain reconnection will entail removal of invasive plant species from the banks of the creek. The banks will be regraded, terraced, and then replanted with native riparian vegetation. Enhancing the riparian corridor and increasing

floodplain connection will help stabilize the stream banks and decrease the effects of excessive erosion on the creek (see Photos 41-1 and 41-2).

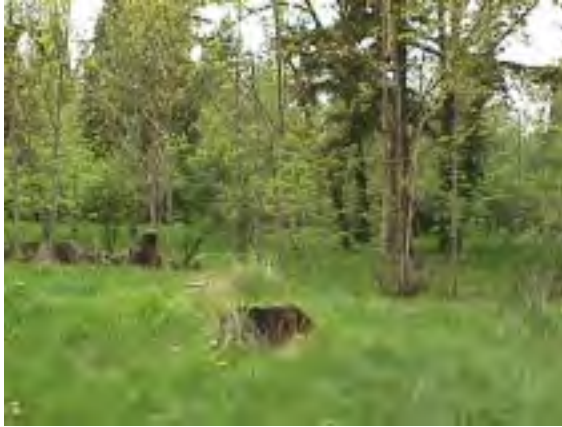
Photo 41-2:  
Looking north of the intersection of SE Kane and McNutt Road. Opportunity exists to work with the property owner to revegetate this grassy area up to 200 feet from creek.

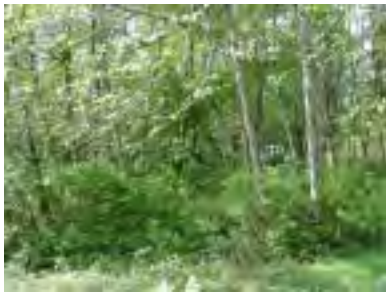
Photo 42-1:

Looking south from the intersection of the Springwater Corridor and SE 262<sup>nd</sup> Avenue at the north bank of Johnson Creek. Opportunity exists to work with willing landowners to reconnect the floodplain, increase in-stream complexity, and restore the riparian corridor.

1. Work with willing property owners adjacent to Johnson Creek for the purpose of reconnecting the creek with its original floodplain. Activities will be property-specific and to the extent deemed appropriate by the owner. Floodplain reconnection will entail removal of invasive plant species from the banks of the creek. The banks will be regraded, terraced, and then replanted with native riparian vegetation. Enhancing the riparian corridor and increasing floodplain connection will help stabilize the stream banks and decrease the effects of excessive erosion on the creek (see Photos 42-1 and 42-2).

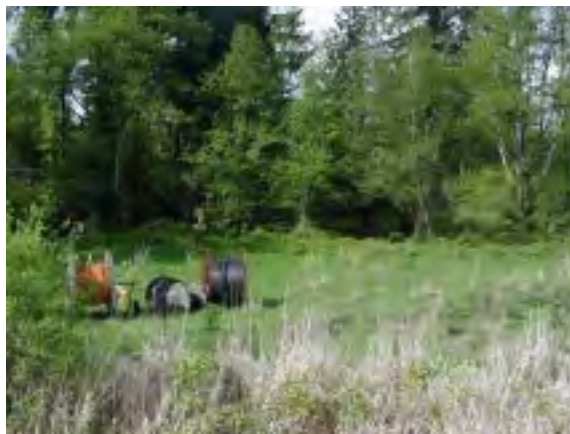
Photo 42-2:

Near the intersection of the Springwater Corridor and SE 262<sup>nd</sup> Avenue, facing south, looking at the north bank of Johnson Creek. Opportunity exists to work with willing landowners to reconnect the floodplain, increase in-stream complexity, and restore the riparian corridor.

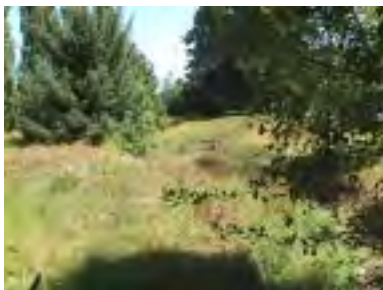
Photo 43-1:

Looking east toward a tributary of Johnson Creek. Opportunity exists for possible floodplain reconnection actions, working with willing property owners.

1. Work with property owners along the tributaries of Johnson Creek to protect and enhance the resource (Photo 43-1). At each tributary confluence, undertake floodplain reconnection actions. Where appropriate, assist landowners of other identified properties to enhance the riparian corridor by removing invasive vegetation and replanting with native species.
2. Remove or modify culverts that impede salmonid movement. Determination of whether a culvert will require improvement or removal will be decided on a site-by-site basis in the project design phase.
3. Work with property owners near the creek to educate them about stream stewardship and the impacts of their actions on the creek. Assist them in altering their habits and practices to better protect and enhance Johnson Creek.

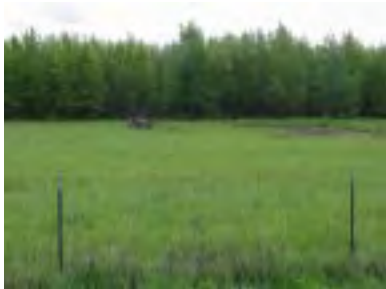
Photo 44-1:

Looking at a property on the east side of SE 262<sup>nd</sup> Avenue near SE Telford Road, facing east. There is a cottonwood forest in background. Opportunity exists to work with property owner to replant this area with native vegetation and reconnect floodplain.

1. Work with willing property owners adjacent to Johnson Creek for the purpose of reconnecting the creek with its original floodplain. Activities will be property-specific and to the extent deemed appropriate by the owner. Floodplain reconnection will entail removal of invasive plant species from the banks of the creek. The banks will be regraded, terraced, and then replanted with native riparian vegetation. Enhancing the riparian corridor and increasing floodplain connection will help stabilize the stream banks and decrease the effects of excessive erosion on the creek (see Photos 44-1 and 44-2).

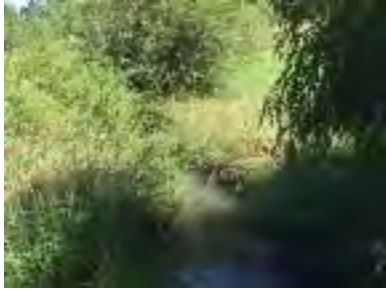
Photo 45-1:

Looking east from SE 267<sup>th</sup> Avenue, upstream on Johnson Creek. Opportunities exist in this area to work with willing landowners to reconnect the floodplain, restore the riparian corridor, and increase in-stream complexity.

1. Work with willing property owners adjacent to Johnson Creek for the purpose of reconnecting the creek with its original floodplain. Activities will be property-specific and to the extent deemed appropriate by the owner. Floodplain reconnection will entail removal of invasive plant species from the banks of the creek. The banks will be regraded, terraced, and then replanted with native riparian vegetation. Enhancing the riparian corridor and increasing floodplain connection will help stabilize the stream banks (see Photos 45-1, 45-2, and 45-3).

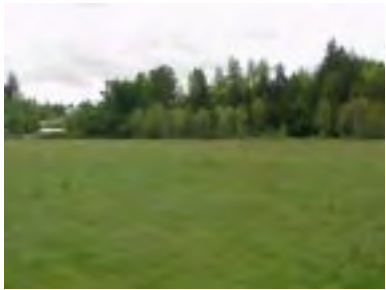
Photo 45-2:

Looking northwest at the property bounded by SE 267<sup>th</sup> Avenue, Stone Road, and Highway 26. Work with landowners to reconnect this area with the original floodplain of Johnson Creek.

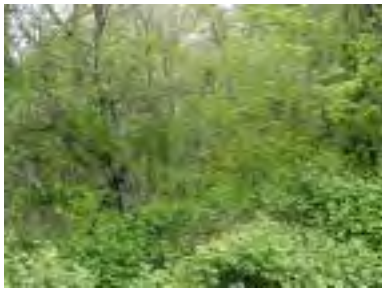
Photo 45-3:

Looking north on the property bounded by SE 267<sup>th</sup> Avenue, Stone Road, and Highway 26. Work with the landowner to enhance this riparian wetland and reconnect it to the creek.

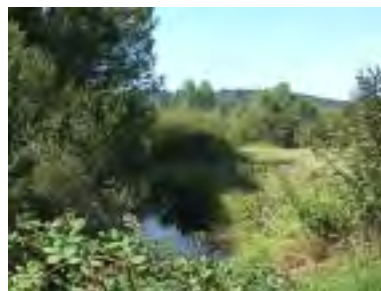
Photo 46-1:

Looking west from SE 282<sup>nd</sup> Avenue. The potential exists to work with property owners on the north bank to implement floodplain reconnection actions.

2. Work with willing property owners adjacent to Johnson Creek for the purpose of reconnecting the creek with its original floodplain. Activities will be property-specific and to the extent deemed appropriate by the owner. Floodplain reconnection will entail removal of invasive plant species from the banks of the creek. The banks will be regraded, terraced, and then replanted with native riparian vegetation. Enhancing the riparian corridor and increasing floodplain connection will help stabilize the stream banks (see Photos 46-1, 46-2, and 46-3).

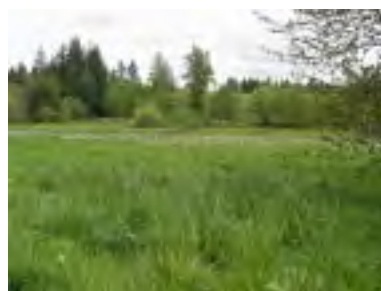
Photo 46-2:

Looking north from SE Stone Road just east of intersection with Highway 26. The creek is in the distance, with a narrow riparian corridor. Opportunity exists to terrace the banks and revegetate the corridor with native plants.

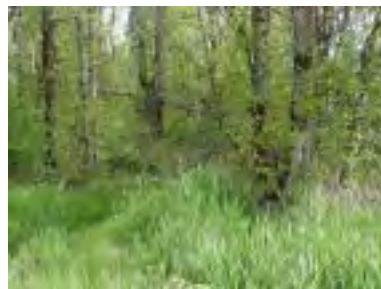
Photo 46-3:

Looking north from a property on SE Stone Road just east of intersection with Highway 26. Opportunity exists to work with landowners to protect and enhance this riparian wetland.

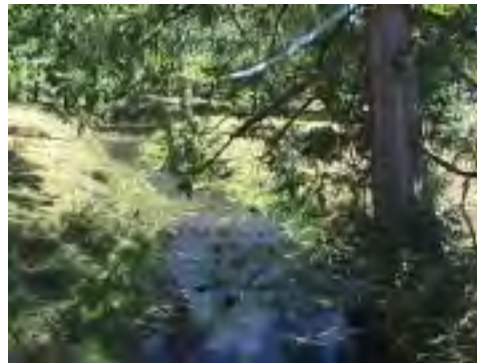
Photo 47-4:  
Looking east just off SE Short Road at open area along Johnson Creek. Work with property owners to reconnect the floodplain, restore the riparian corridor, and add in-stream complexity to the creek.

5. Increase in-stream complexity throughout the length of the creek running through this reach. This action will be done in conjunction with other projects in the reach and will consist of creating areas of large wood, pool/riffle sequences, and deep pools in the creek channel. Activities will be site-specific and will be determined in the design phase (see Photo 47-4).

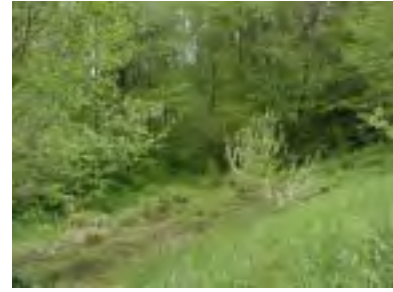
Photo 47-1:  
Looking east from SE Stone Road near the intersection with SE Short Road. Work with the landowner to revegetate a 200-foot corridor and reconnect the floodplain.

3. Work with willing property owners adjacent to Johnson Creek for the purpose of reconnecting the creek with its original floodplain. Activities will be property-specific and to the extent deemed appropriate by the owner. Floodplain reconnection will entail removal of invasive plant species from the banks of the creek, as well as removal of the WPA wall where necessary. The banks will be regraded and terraced and then replanted with native riparian vegetation. Enhancing the riparian corridor and increasing floodplain connection will help stabilize the stream banks (see Photos 47-1 through 47-3).

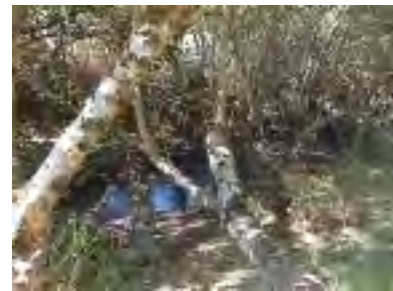
Photo 47-2:  
Looking northeast toward Johnson Creek just north of SE Stone Road. Work with property owners to undertake floodplain reconnection actions.

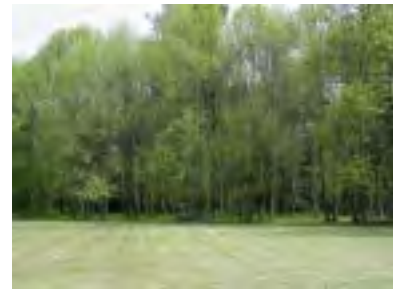
Photo 47-3:  
Looking north on SE Stone Road between SE 282<sup>nd</sup> and SE 287<sup>th</sup> Avenues. Opportunity exists to work with landowners to expand the riparian corridor 200 feet, enhance the forest, revegetate the grassy area with native plants, and reconnect the floodplain.

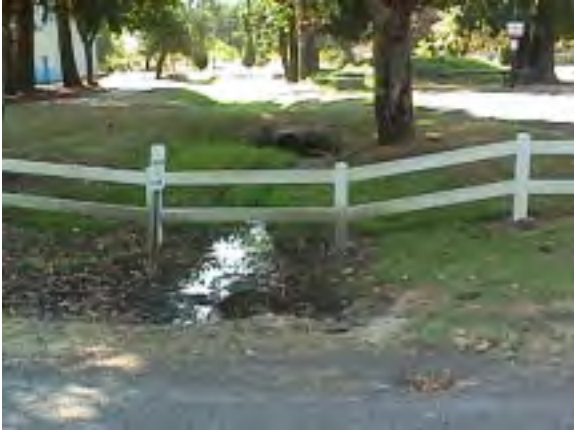
Photo 48-1:  
Looking south near SE 282<sup>nd</sup> Avenue along a tributary on the south side of Johnson Creek. Work with property owners to revegetate the tributary's banks.

1. Work with property owners along the tributaries of Johnson Creek to protect and enhance the resource. Invasive species will be removed and replaced by native riparian vegetation, thereby helping to maintain a healthy connection between the tributary and Johnson Creek. Where practicable, areas of healthy vegetation will be targeted for protection through the use of conservation easements (see Photos 48-1, 48-2, and 48-3).

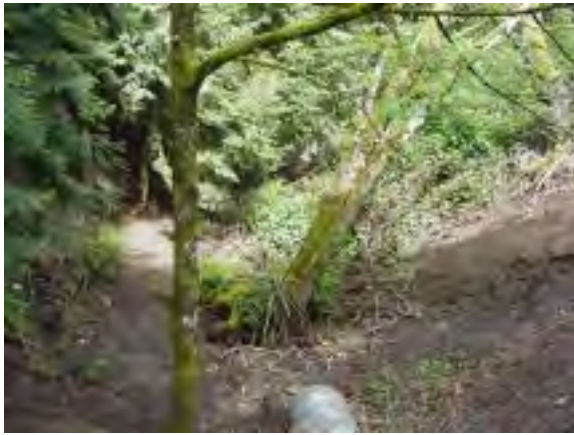
Photo 48-2:  
Looking west from SE 287<sup>th</sup> Avenue at a tributary of Johnson Creek. Mature cedars and maples are present, but the creek bed is filling in with blackberry growth. Work with the property owner to remove blackberries and revegetate with native riparian plants.

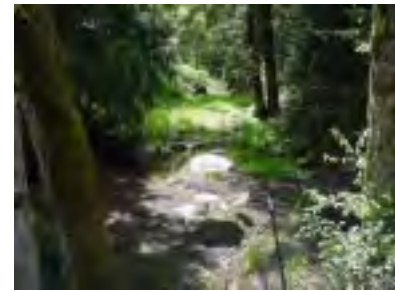
Photo 48-3:  
Looking east from SE 287<sup>th</sup> Avenue toward the tributary. Mature cedars and maples are present, but the creek bed is filling in with grass. Work with the property owner to remove grass and replant native vegetation.

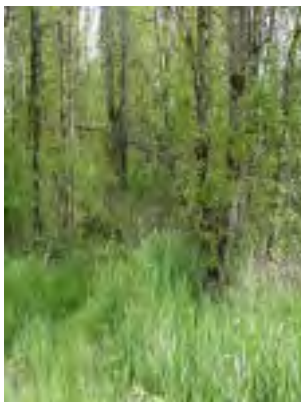
Photo 48-4:  
Looking south from SE Wheeler Road at the tributary crossing. This is a very dense, mature riparian corridor, with large cedars. Work with the property owner to protect the riparian/wildlife corridor area up to 200 feet from creek.

2. Work with property owners throughout the reach to create a wildlife corridor. Owners will be encouraged to plant native riparian vegetation to enhance habitat conditions and provide wildlife access to the creek from the surrounding upland areas (see Photo 48-4).
3. Work with property owners near the creek to educate them about stream stewardship and the impacts of their actions on the creek. Assist them in altering their habits and practices to better protect and enhance Johnson Creek.

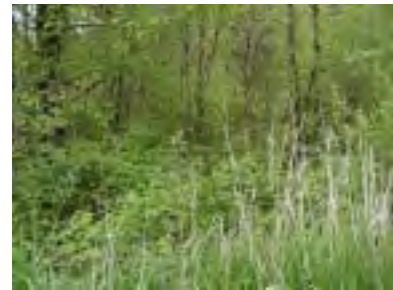
Photo 49-1:

Looking west toward the property at the intersection of SE 307<sup>th</sup> Avenue and SE Orient Drive. Young but thick riparian vegetation is present; red osier dogwood, alder, and reed canarygrass predominate. Work with the property owner to protect riparian corridor to greatest possible extent, remove reed canarygrass, and enhance with native vegetation.

1. Work with willing property owners adjacent to Johnson Creek for the purpose of reconnecting the creek with its original floodplain. Activities will be property-specific and to the extent deemed appropriate by the owner. Floodplain reconnection will entail removal of invasive plant species from the banks of the creek. The banks will be regraded, terraced, and then replanted with native riparian vegetation. Enhancing the riparian corridor and increasing floodplain connection will help stabilize the stream banks (see Photos 49-1 and 49-2).

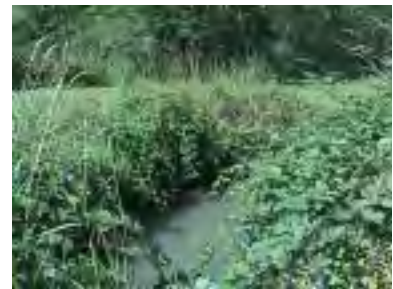
Photo 49-2:

Looking west from SE Orient Drive at the edge of Reaches 49 and 50. Opportunity exists to work with property owners to complete floodplain reconnection actions, restore riparian vegetation to shade the creek, and increase in-stream complexity.

3. Increase in-stream complexity throughout the length of the creek running through this reach. This action, which will be done in conjunction with other projects in the reach, will consist of creating areas of large wood, pool/riffle sequences, and deep pools in the creek channel. Activities will be site-specific and will be determined in the project design phase (see Photo 49-2).

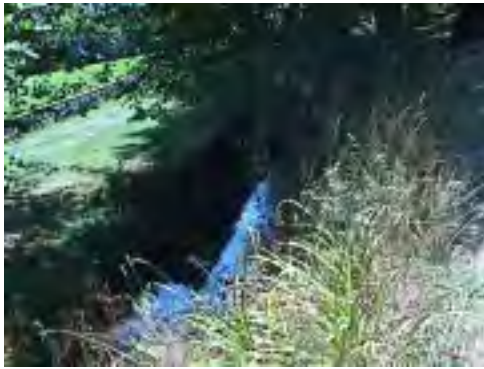
Photo 50-1:  
Looking southeast from SE Orient Drive. Opportunity exists to implement floodplain reconnection actions.

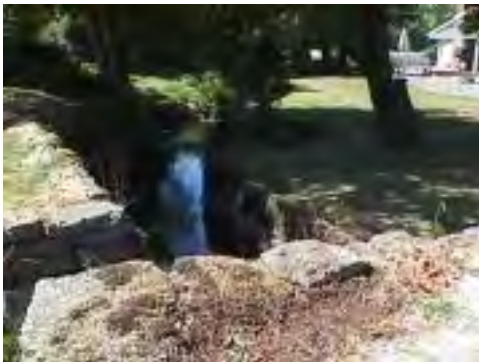
Photo 50-2:  
Looking west from SE 307<sup>th</sup> Avenue just north of SE Orient Drive. Work with property owners to undertake floodplain reconnection actions and restore the riparian corridor.

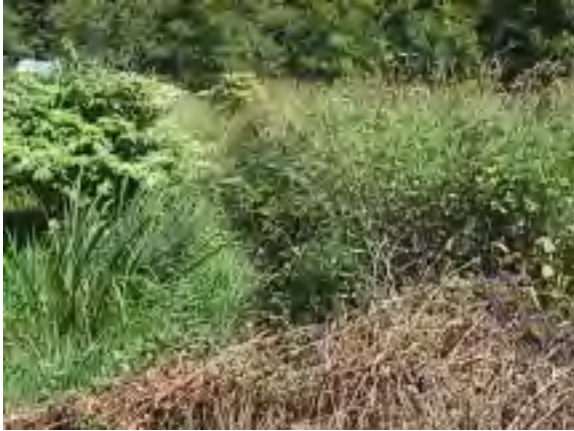
Photo 52-1:  
Looking east from SE 307<sup>th</sup>  
Avenue just north of SE  
Orient Drive at Johnson  
Creek. Opportunity exists to  
work with landowners to  
implement floodplain  
reconnection and riparian  
restoration.

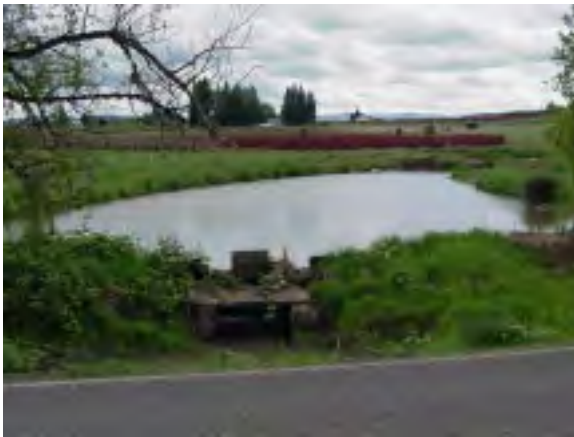
Photo 52-2:  
Looking west from SE  
Revenue Road at a dam in  
foreground. The area is  
located just southeast of  
Reach 52 but is an  
example of practices  
employed in this area. This  
drainage way leads to  
Johnson Creek. Work with  
land owners to restore  
native riparian vegetation.

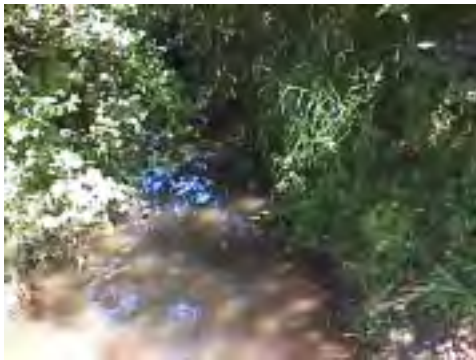
Photo 53-1:

Looking east from SE Revenue Road at Johnson Creek. Work with property owner to terrace the creek banks and revegetate them to enhance and restore the riparian corridor.

1. Work with willing property owners adjacent to Johnson Creek for the purpose of reconnecting the creek with its original floodplain. Activities will be property-specific and to the extent deemed appropriate by the owner. Floodplain reconnection will entail removal of invasive plant species from the banks of the creek. The banks will be regraded, terraced, and then replanted with native riparian vegetation. Enhancing the riparian corridor and increasing floodplain connection will help stabilize the stream banks (see Photos 53-1 and 53-2).
