# Johnson Creek Restoration Plan

# Acknowledgements

## Bureau of Environmental Services

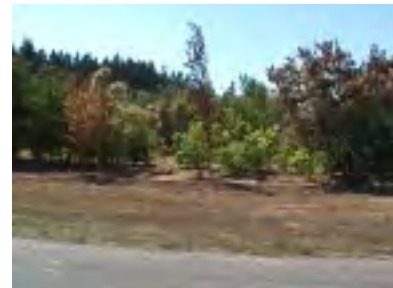
Photo 53-2:

Looking west from SE 327<sup>th</sup> Avenue north of Johnson Creek. Work with property owners to revegetate this open space and reconnect the floodplain.

1. Work with willing property owners adjacent to Johnson Creek for the purpose of reconnecting the creek with its original floodplain. Activities will be property-specific and to the extent deemed appropriate by the owner. Floodplain reconnection will entail removal of invasive plant species from the banks of the creek. The banks will be regraded, terraced, and then replanted with native riparian vegetation. Enhancing the riparian corridor and increasing floodplain connection will help stabilize the stream banks (see Photos 53-1 and 53-2).

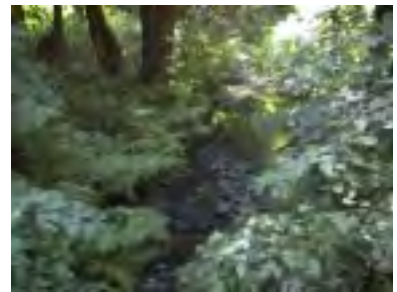
Photo 54-1:

Looking at a riparian/wetland area just off of Bluff Road. Work with property owners to protect and enhance the riparian corridor, removing invasives and planting additional native species.

1. Work with willing property owners adjacent to Johnson Creek for the purpose of reconnecting the creek with its original floodplain. Activities will be property-specific and to the extent deemed appropriate by the owner. Floodplain reconnection will entail removal of invasive plant species from the banks of the creek. The banks will be regraded, terraced, and then replanted with native riparian vegetation. Enhancing the riparian corridor and increasing floodplain connection will help stabilize the stream banks (see Photos 54-1 and 54-2).

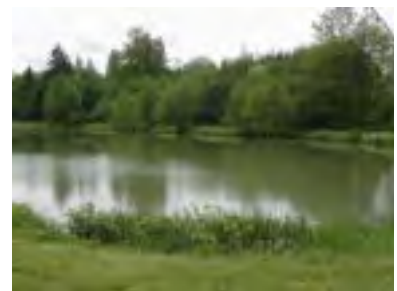
Photo 54-2:

Looking west near SE 322<sup>nd</sup> Place toward a pond on Johnson Creek. Work with property owners to terrace banks and enhance the stream and riparian corridor.

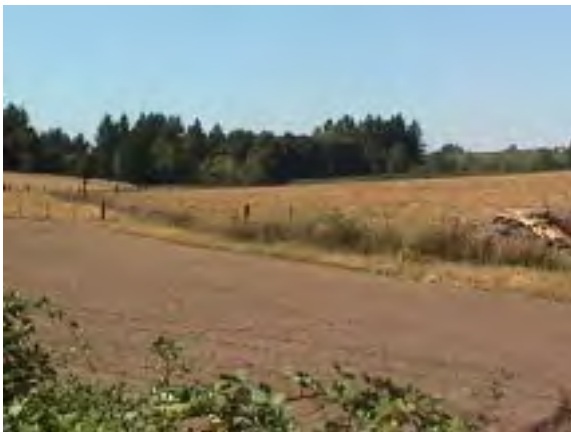
Photo 55-1:  
Looking northwest from SE Bluff Road at a tributary drainage of Johnson Creek. Work with property owners to restore and protect the resource.

1. Work with willing property owners adjacent to Johnson Creek for the purpose of reconnecting the creek with its original floodplain. Activities will be property-specific and to the extent deemed appropriate by the owner. Floodplain reconnection will entail removal of invasive plant species from the banks of the creek. The banks will be regraded, terraced, and then replanted with native riparian vegetation. Enhancing the riparian corridor and increasing floodplain connection will help stabilize the stream banks (see Photos 55-1 and 55-2).

2. Work with property owners along the tributaries of Johnson Creek to protect and enhance the resource. Invasive species will be removed and replaced by native riparian vegetation, thereby helping to maintain a healthy connection between the tributary and Johnson Creek. Where practicable, areas of healthy vegetation will be targeted for protection through the use of conservation easements (see Photos 55-1 through 55-4).

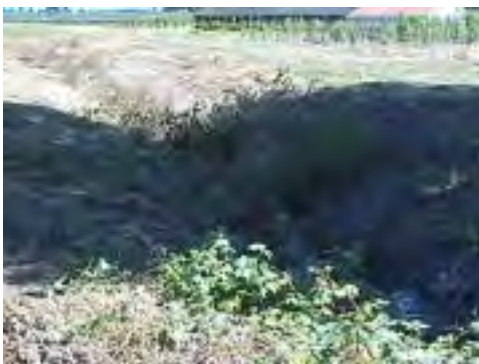
Photo 55-2:  
Looking southeast from SE Bluff Road toward a tributary drainage of Johnson Creek. Work with property owners to restore and protect this resource.

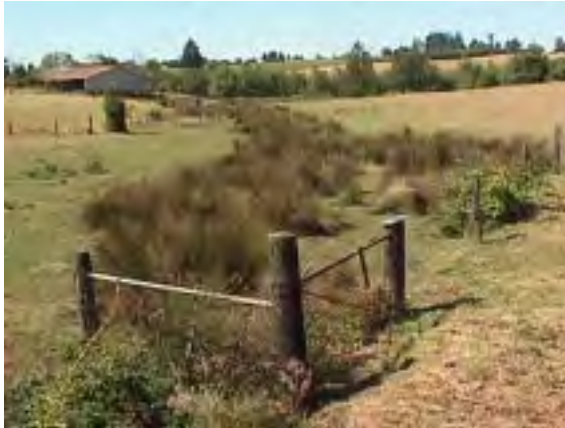
Photo 55-3:  
Looking northwest from SE Bluff Road. Work with property owners to restore and protect this tributary drainage of Johnson Creek.

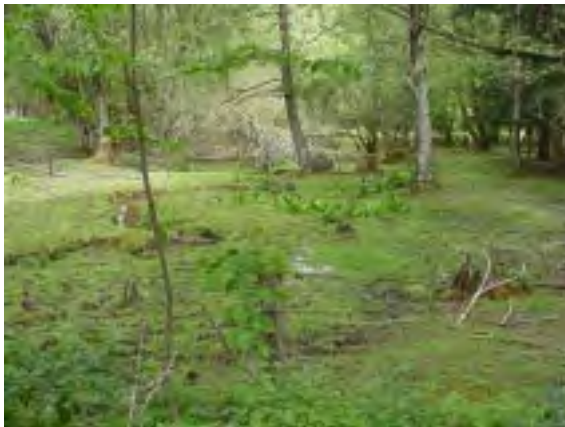
Photo 55-4:  
Looking north from SE Bluff Road along Johnson Creek at a wetland drainage on the south side of the creek in winter. Work with landowners to protect and enhance this riparian wetland.

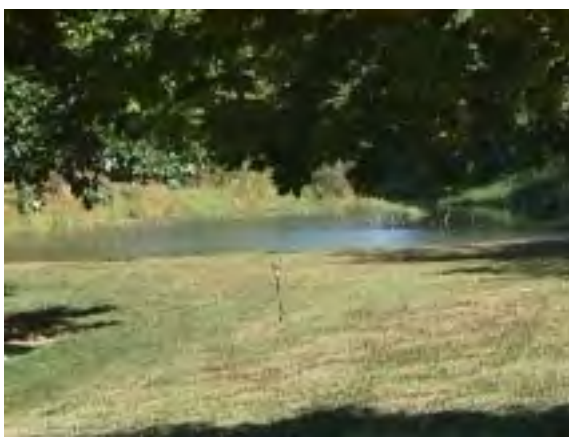
Photo 56-1:

Looking east from SE 347<sup>th</sup> Avenue at a large pond adjacent to Johnson Creek. Work with property owners to restore the riparian corridor.

The banks will be regraded, terraced, and then replanted with native riparian vegetation.

Enhancing the riparian corridor and increasing floodplain connection will help stabilize the stream banks (see Photos 56-1 and 56-2).

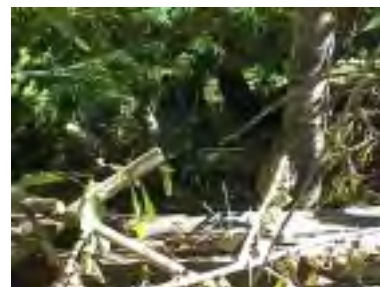
Photo 56-2:

Looking east from SE 347<sup>th</sup> Avenue along Johnson Creek. Work with property owners to restore and enhance the riparian corridor and add in-stream complexity.

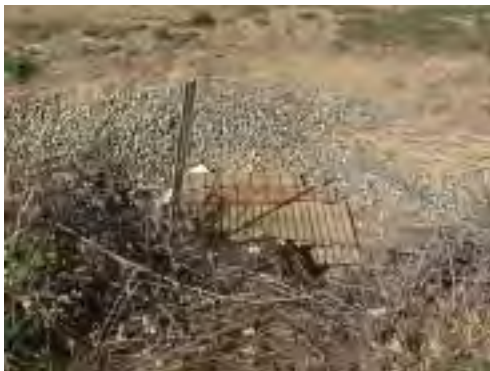
Photo 57-2:

Looking west from SE Bluff Road at an area where Johnson Creek appears to be piped. Opportunity exists to work with landowners to daylight Johnson Creek, restore its riparian corridor, and improve in-stream conditions.

1. Work with willing property owners adjacent to Johnson Creek for the purpose of reconnecting the creek with its original floodplain. Activities will be property-specific and to the extent deemed appropriate by the owner. Floodplain reconnection will entail removal of invasive plant species from the banks of the creek. The banks will be regraded, terraced, and then replanted with native riparian vegetation. Enhancing the riparian corridor and increasing floodplain connection will help stabilize the stream banks (see Photos 57-1 and 57-2).

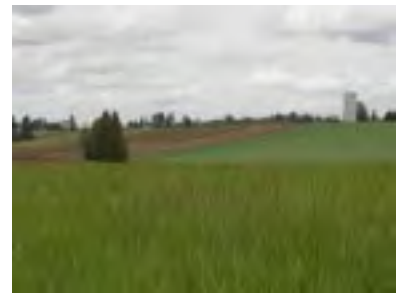
Photo 57-1:

Looking northwest from SE Bluff Road. Opportunity exists to work with landowners in this area to restore the riparian corridor, reconnect the floodplain, and create a wildlife corridor.

2. Work with property owners throughout this reach to create a wildlife corridor reconnecting upper reaches of the Johnson Creek watershed with the Sandy River by replanting open lands with riparian vegetation (see Photo 57-1).
3. Increase in-stream complexity throughout the length of the creek running through this reach. This action, which will be done in conjunction with other projects in the reach, will consist of creating areas of large wood, pool/riffle sequences, and deep pools in the creek channel. Activities will be site-specific and will be determined in the project design phase (see Photo 57-2).
3. Work with property owners near the creek to educate them about stream stewardship and the impacts of their actions on the creek. Assist them in altering their habits and practices to better protect and enhance Johnson Creek.

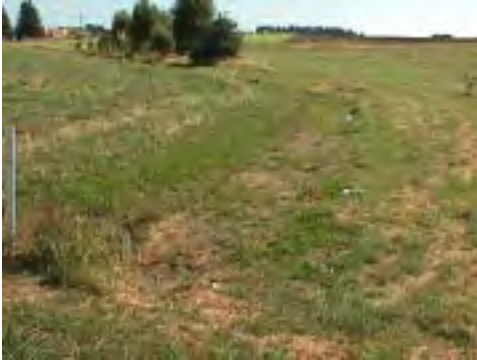
Photo 58-1:  
Looking south from SE Bluff Road at Johnson Creek near the headwaters of the creek. Work with property owners to restore and protect drainages.

1. Work with willing property owners adjacent to Johnson Creek for the purpose of floodplain reconnection, enhancement and restoration of the riparian corridor, and protection of drainage areas in the watershed. This process will require terracing creek banks and drainage areas. The extent of terracing will be property-specific and will depend on the owner's directive. After the banks are terraced and non-native species are removed, the banks will be revegetated with native species to restore and enhance the riparian corridor (see Photos 58-1, 58-2, and 58-3).

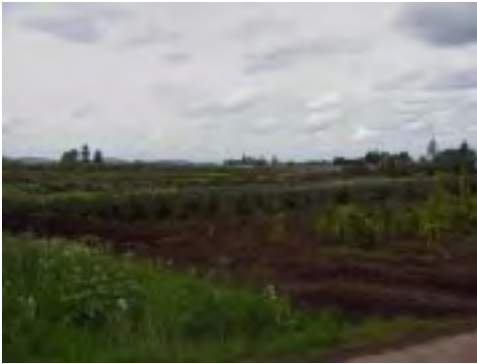
Photo 58-2:  
Looking northeast from SE 362<sup>nd</sup> Avenue near the headwaters to Johnson Creek. Work with property owners to restore the riparian corridor.

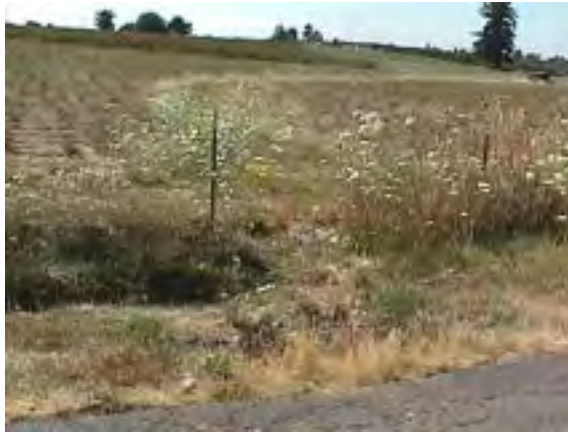
Photo 58-3:  
Looking west from SE 362<sup>nd</sup> Avenue at what most likely is Johnson Creek running through this plowed field. Work with the property owner to restore and protect the creek in headwaters of the Johnson Creek watershed.
