**Status and Distribution of Native Turtles in the Columbia Slough and  
Johnson Creek Watersheds: Results of 2009 Surveys**

**December, 2009**

Northwest Ecological Research Institute  
130 NW 114<sup>th</sup> Avenue  
Portland, OR 97229

City of Portland,  
Bureau of Environmental Services  
1120 SW 5<sup>th</sup> Avenue  
Portland, OR 97204

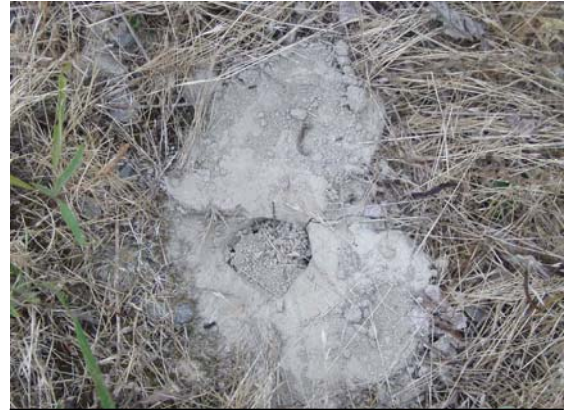
Painted turtle nest at east side of pond south of pump station.

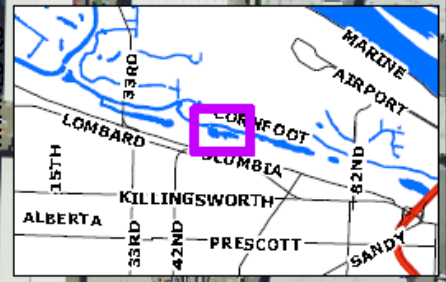
Location of management recommendations at Whitaker Ponds.

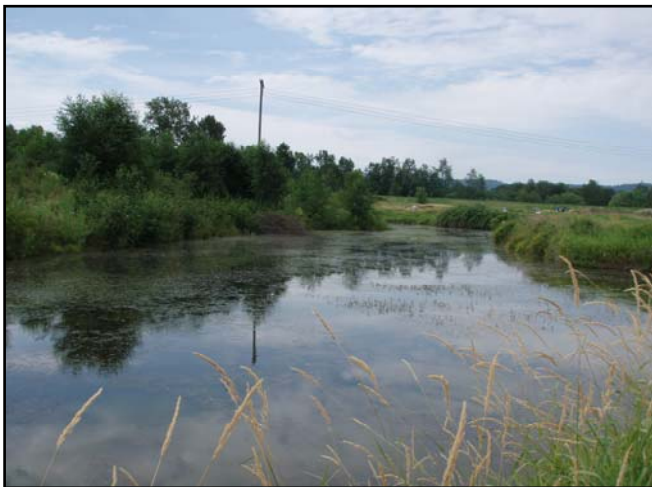
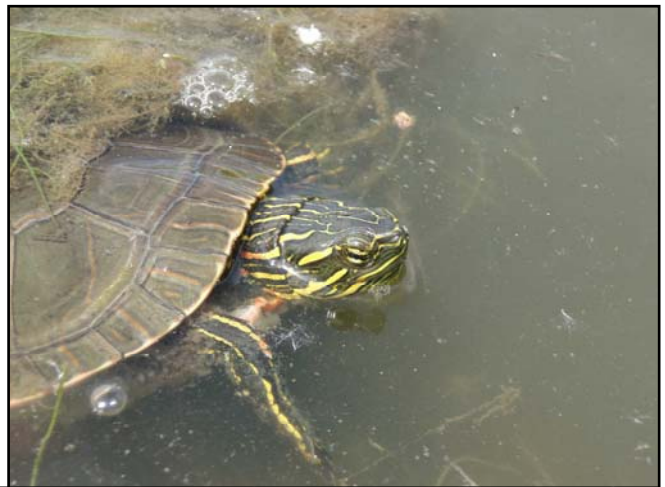
*Left:* Water hazard on the 17<sup>th</sup> green of the Heron Lakes Golf Course. View looking west.  
*Right:* Western painted turtle at surface of 17<sup>th</sup> green water hazard, in algae mat.

**Comments:** Management for turtles on the Heron Lakes Golf Course presents a challenge, as most of the measures required to improve the situation for painted turtles run contrary to the desired management of the course. For example, turtles prefer areas with little disturbance, as well as barren, exposed soil for egg laying (as opposed to manicured greens). Most of the Heron Lakes course consists of areas that are attractive to turtles as nesting sites (e.g., greens and sand traps), but in which nests will ultimately fail. Because of the course's proximity to an existing source of turtles (the Columbia Slough), painted turtles will undoubtedly continue to wander onto the course. Sue Beilke (*pers. comm.*) reports observation of a small number ( $n \leq 5$ ) of turtles on the course for approximately the past 15 years. Unfortunately, it is likely that the population of turtles present is declining, and inadequate habitat currently exists to support a self-sustaining population of painted turtles over the long run.

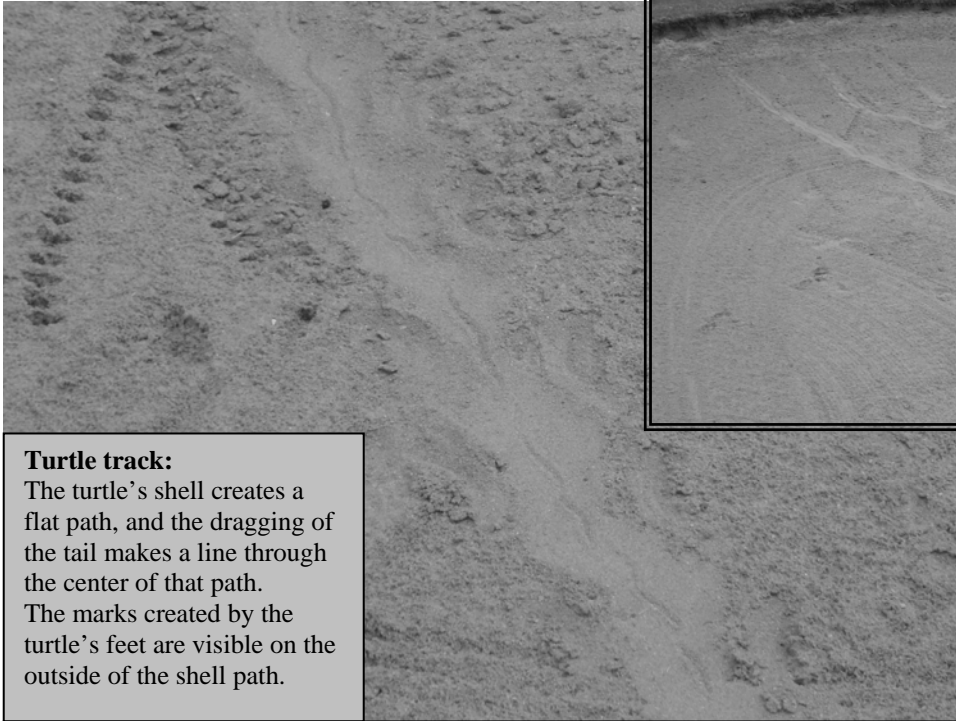
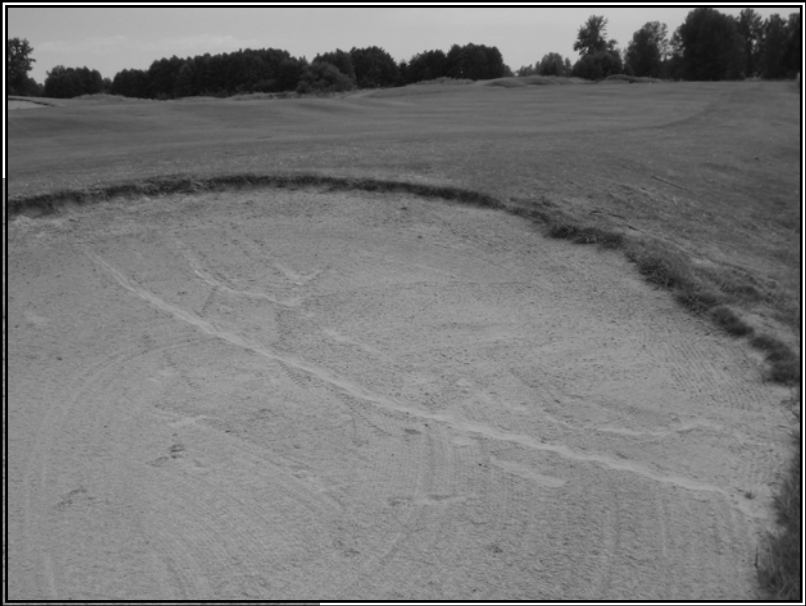
**Turtle track:**  
The turtle's shell creates a flat path, and the dragging of the tail makes a line through the center of that path. The marks created by the turtle's feet are visible on the outside of the shell path.

Track made by nesting female painted turtle in sand trap on 17<sup>th</sup> green, Heron Lakes Golf Course.  
*Inset:* Larger view. Set of tracks on the right is wandering and erratic, and leads out of pond. The set of tracks on the left leads back to the water, and is much more direct. Nest attempt (incomplete) is visible at top of sand trap.

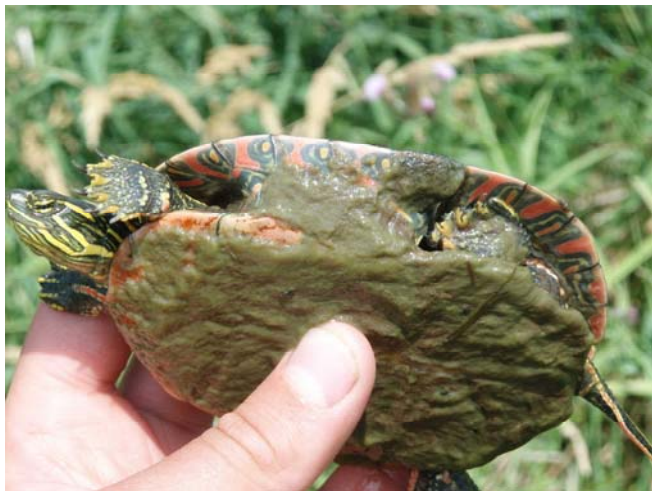
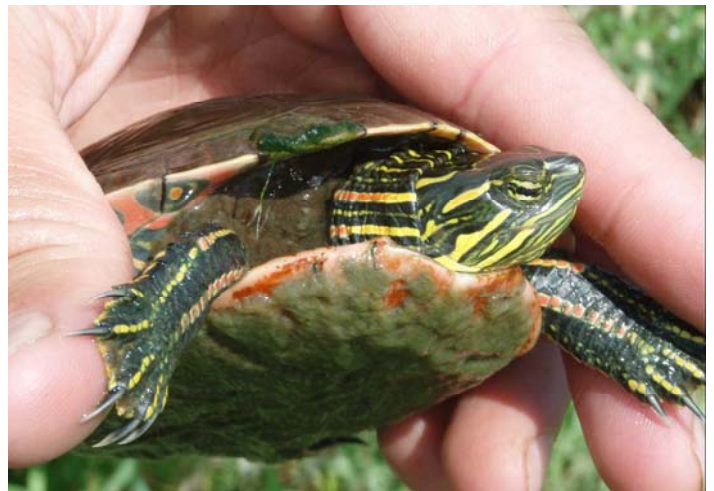
Brown algae growth on the plastron and skin surfaces of a juvenile painted turtle from the 17<sup>th</sup> green water hazard, Heron Lakes Golf Course.

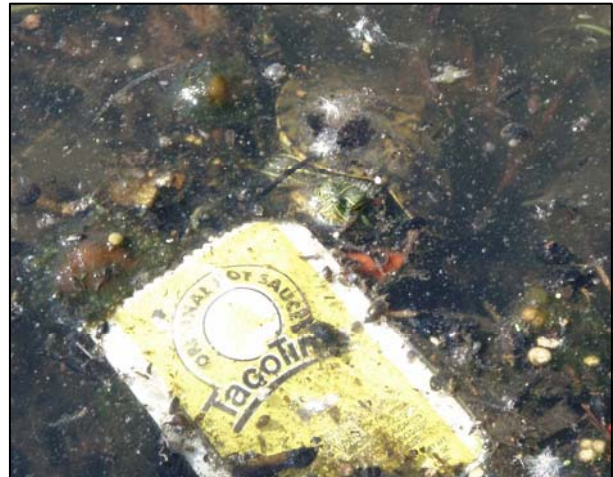
Juvenile slider turtle in the pristine waters of the St. Johns maintenance bay.

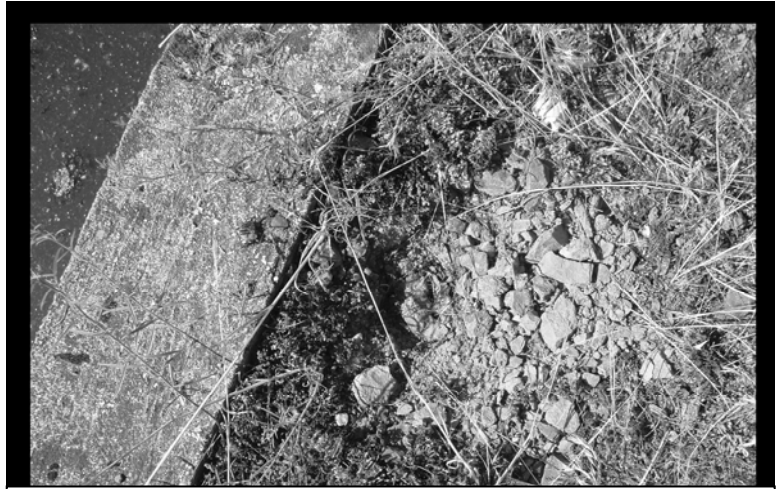
Turtle nest attempt at the St. Johns maintenance bay. Pile of light-colored gravel on the right is that removed from the nest hole by the turtle. To the left of the nest is the concrete wall of the maintenance bay.
