*Evaluation of Environmental Conditions  
At Candidate Industrial Sites  
Regional Industrial Inventory Project  
Portland Metropolitan Area, Oregon*

Prepared for:  
Group Mackenzie

August 2, 2012  
1901-00

Ash Creek Associates, Inc.  
Environmental and Geotechnical Consultants

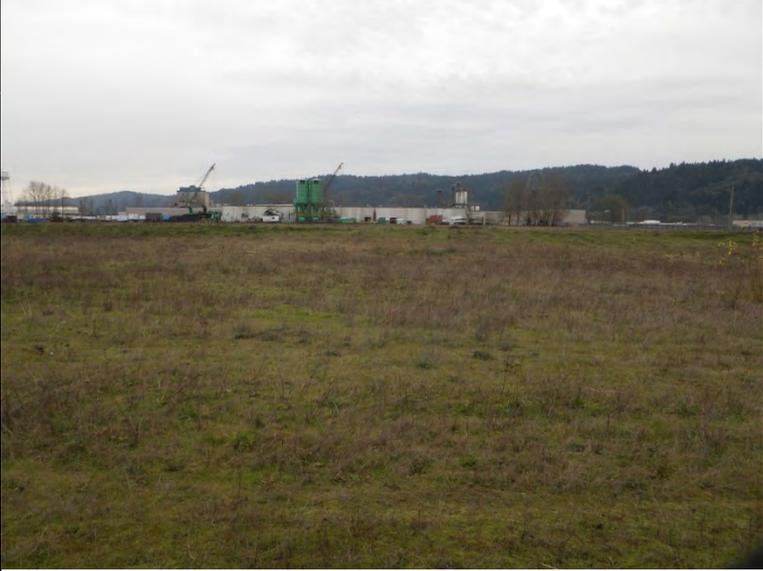
<p><b>Photo No:</b> 1</p>	
<p><b>Photo Date:</b> Jan. 31, 2012</p>

<p><b>Orientation:</b> South</p>	
<p><b>Description:</b> Field at site, viewed from North Time Oil Road. View to the south.</p>	
<p><b>Photo No:</b> 2</p>	
<p><b>Photo Date:</b> Jan. 31, 2012</p>

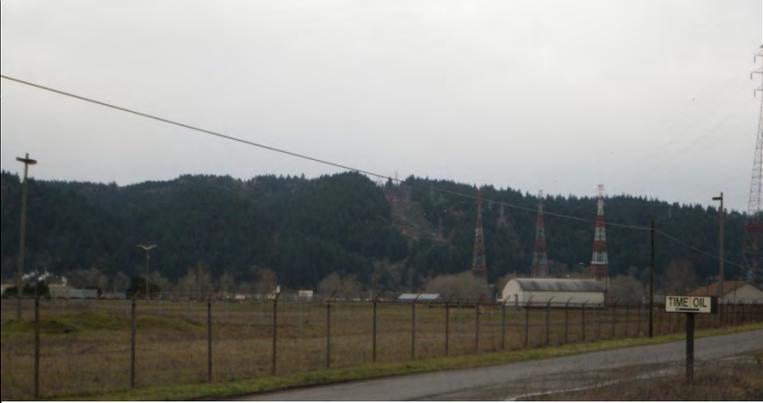
<p><b>Orientation:</b> West</p>	
<p><b>Description:</b> Field at site, along with several on-site structures, viewed from North Time Oil Road. View to the west.</p>

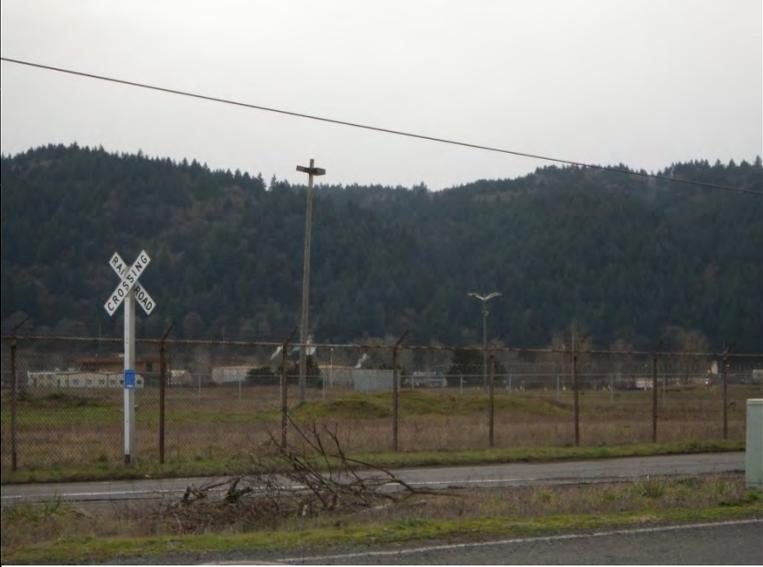
<p><b>Photo No:</b> 3</p>	
<p><b>Photo Date:</b> Jan. 31, 2012</p>

<p><b>Orientation:</b> Southwest</p>	
<p><b>Description:</b> Field at site, viewed from North Time Oil Road. View to the southwest.</p>	
<p><b>Photo No:</b> 4</p>	
<p><b>Photo Date:</b> Jan. 31, 2012</p>

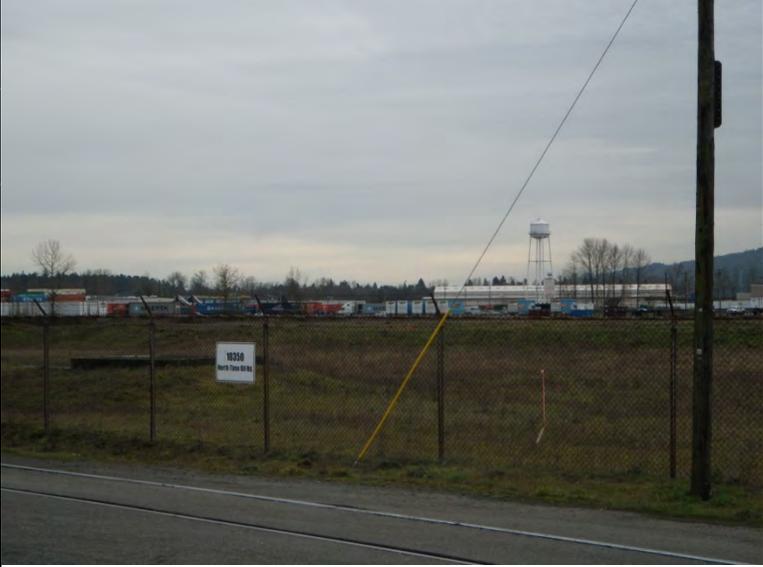
<p><b>Orientation:</b> Southeast</p>	
<p><b>Description:</b> Field at site, viewed from North Time Oil Road. View to the southeast.</p>

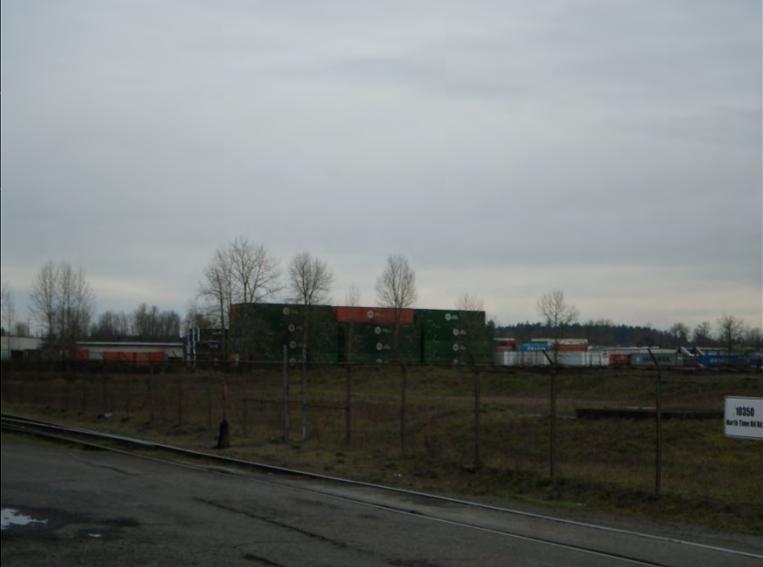
<b>Photo No:</b> 5	
<b>Photo Date:</b> Jan. 31, 2012

<b>Orientation:</b> East	
<b>Description:</b> Field at site, viewed from North Time Oil Road. View to the east.

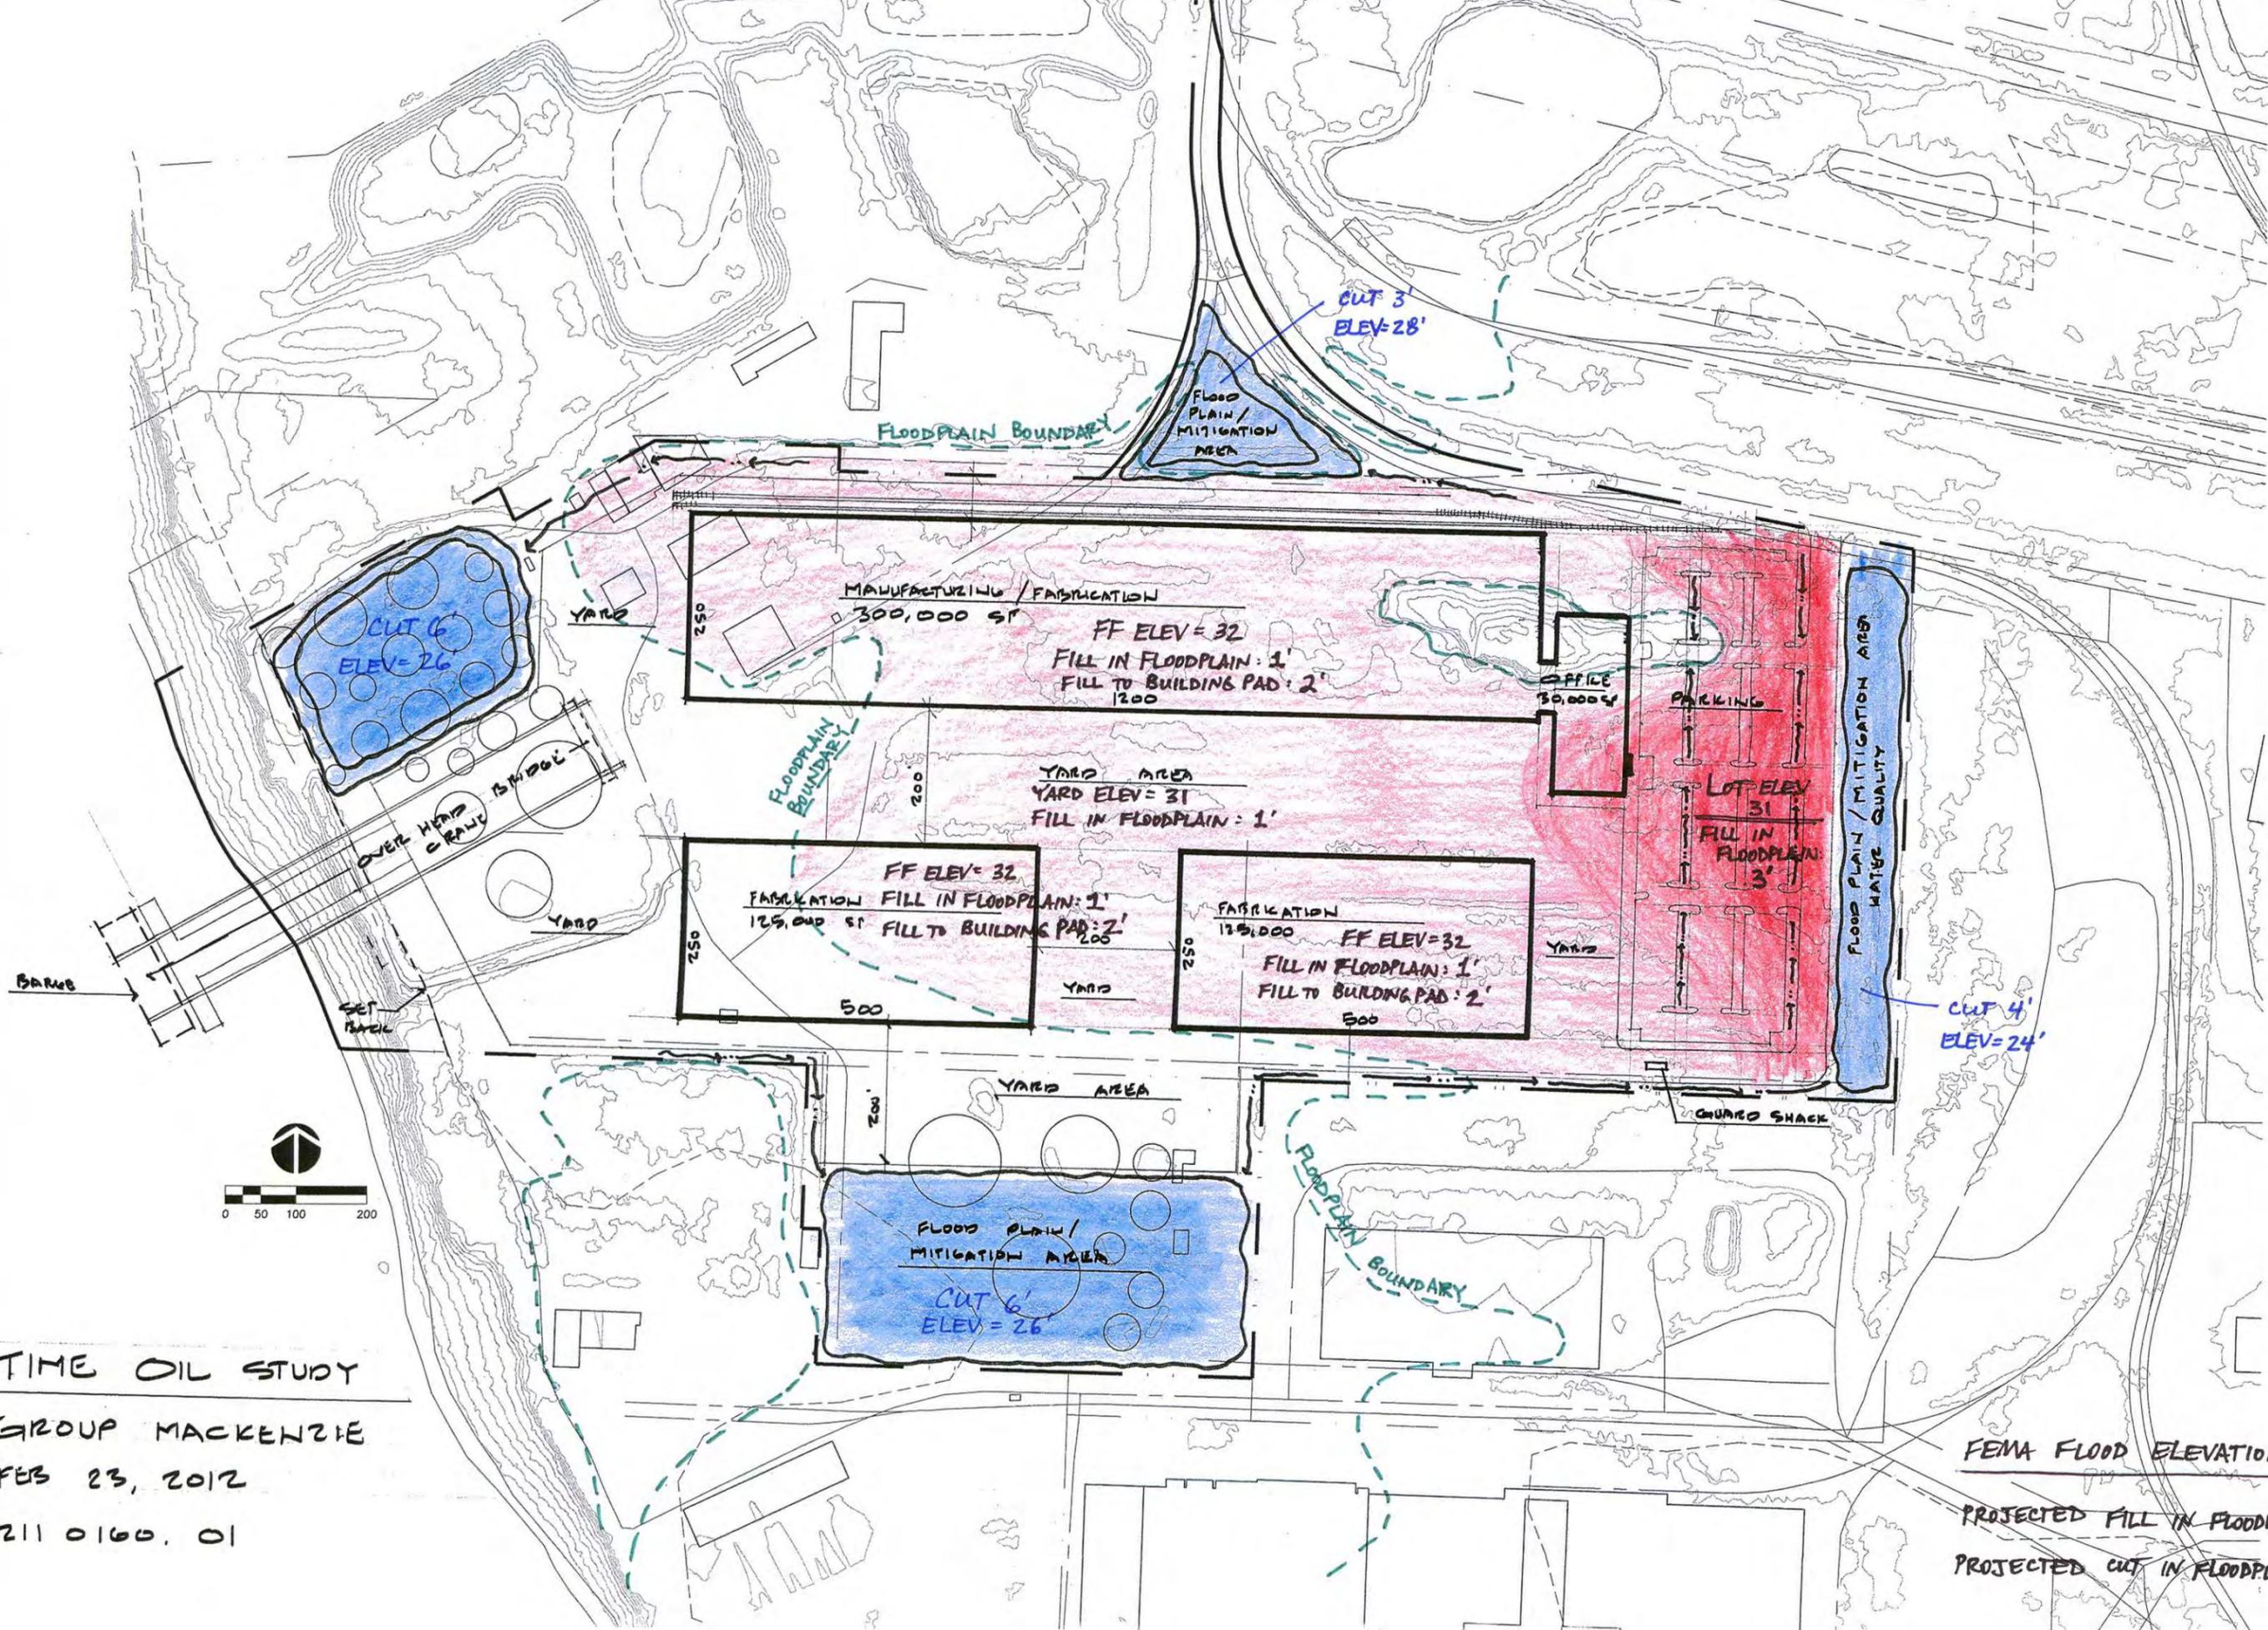
**Conceptual Redevelopment Drawing**

TIME OIL STUDY  
 GROUP MACKENZIE  
 FEB 23, 2012  
 211 0160. 01

FEMA FLOOD ELEVATION = 31 FT  
 PROJECTED FILL IN FLOODPLAIN: 42,000 ± cy  
 PROJECTED CUT IN FLOODPLAIN: 43,000 ± cy

**Capping Contaminated Soil.** Impacted soil will be excavated from cut areas and placed in portions of the site scheduled for filling (i.e. underneath building footprints and other operations areas). DEQ requires a Solid Waste Letter of Authorization (SWLA) prior to the removal and permanent placement of impacted soil at the site. It will be necessary to install a cap over the impacted soil. We assume that the cap will consist of asphalt or cement concrete pavement (including building foundations), clean soil, or a combination of these materials. The cap will be protective of human health by preventing direct contact with the soil and by preventing movement of the soil. A Soil Management Plan (SMP) will be necessary to address risks associated with construction worker exposure and to address long-term requirements for inspection and maintenance of the caps (e.g., annual inspections, sealing observed cracks, etc.). Alternatively, clean soil could be imported to the site and used to raise selected areas above the flood plain elevation, reducing the risk of construction worker exposure to impacted media.

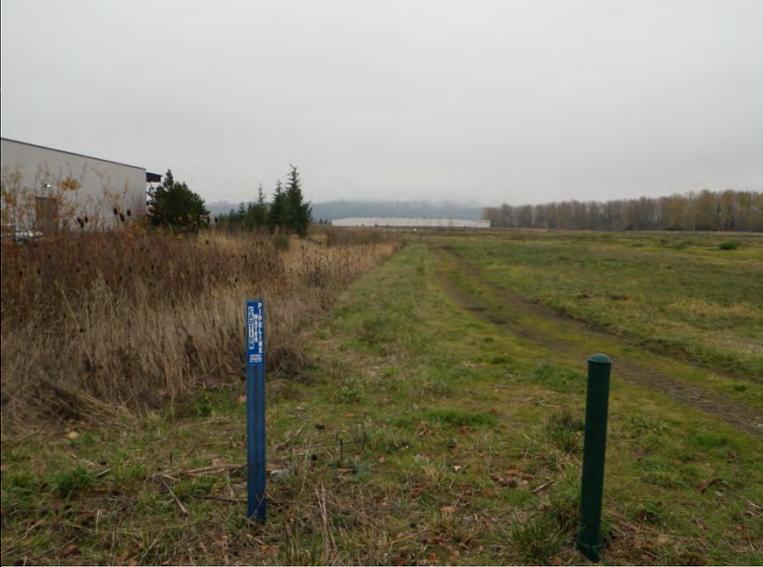
<p><b>Photo No:</b> 1</p>	
<p><b>Photo Date:</b> Dec. 7, 2011</p>

<p><b>Orientation:</b> North</p>	
<p><b>Description:</b></p> <p>Agricultural area viewed from NE Portal Way. A buried natural gas pipeline marker is visible in the foreground.</p>	
<p><b>Photo No:</b> 2</p>	
<p><b>Photo Date:</b> Dec. 7, 2011</p>

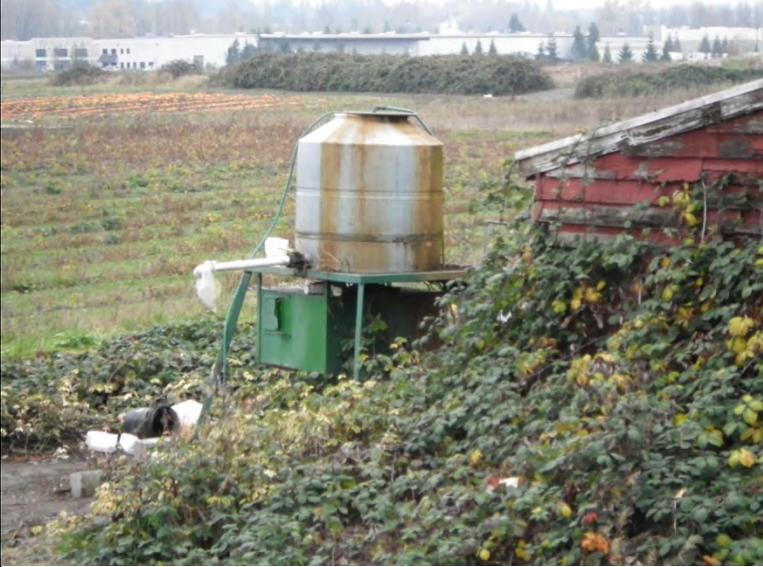
<p><b>Orientation:</b> Southwest</p>	
<p><b>Description:</b> Irrigation shed and water tank near NE Interlachen Lane.</p>

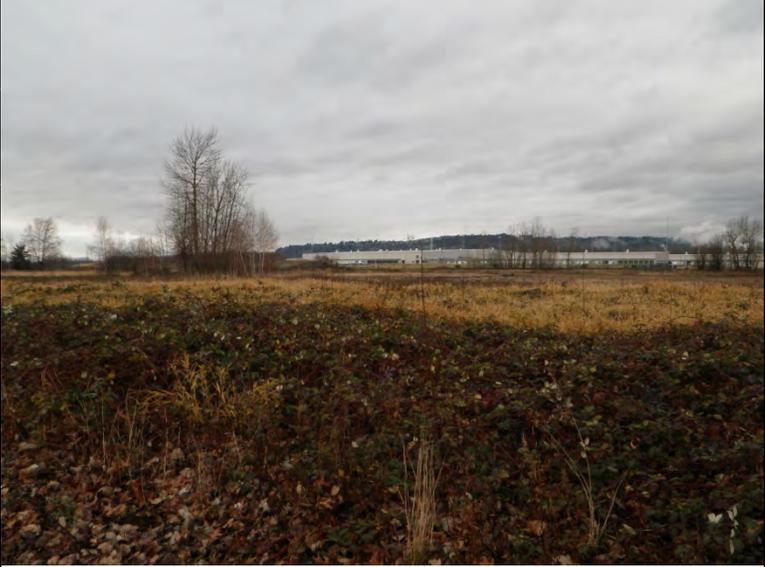
<p><b>Photo No:</b> 1</p>	
<p><b>Photo Date:</b> Dec. 27, 2011</p>

<p><b>Orientation:</b> Northwest</p>	
<p><b>Description:</b> Field viewed from NW Graham Road.</p>	
<p><b>Photo No:</b> 2</p>	
<p><b>Photo Date:</b> Dec. 27, 2011</p>

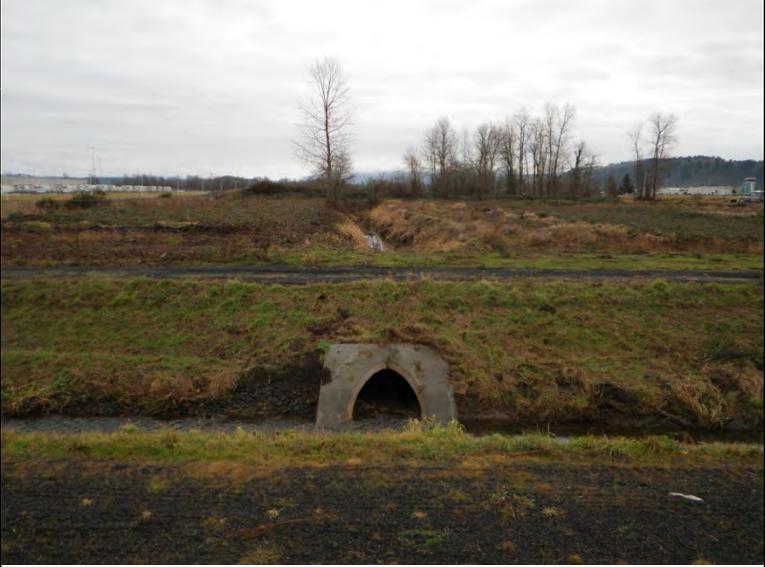
<p><b>Orientation:</b> East</p>	
<p><b>Description:</b> Field and drainage channels viewed from NW Sundial Road.</p>

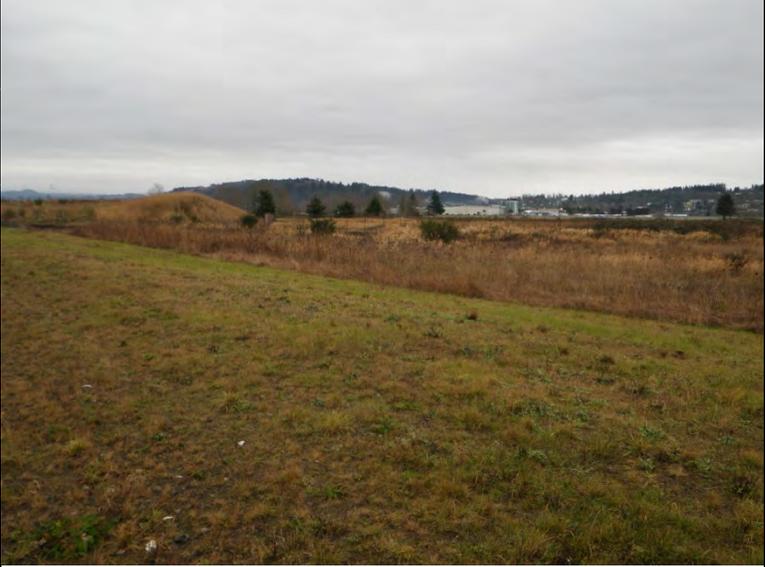
<p><b>Photo No:</b> 3</p>	
<p><b>Photo Date:</b> Dec. 27, 2011</p>

<p><b>Orientation:</b> Southeast</p>	
<p><b>Description:</b> Field viewed from NW Swigert Way.</p>	
<p><b>Photo No:</b> 4</p>	
<p><b>Photo Date:</b> Dec. 27, 2011</p>

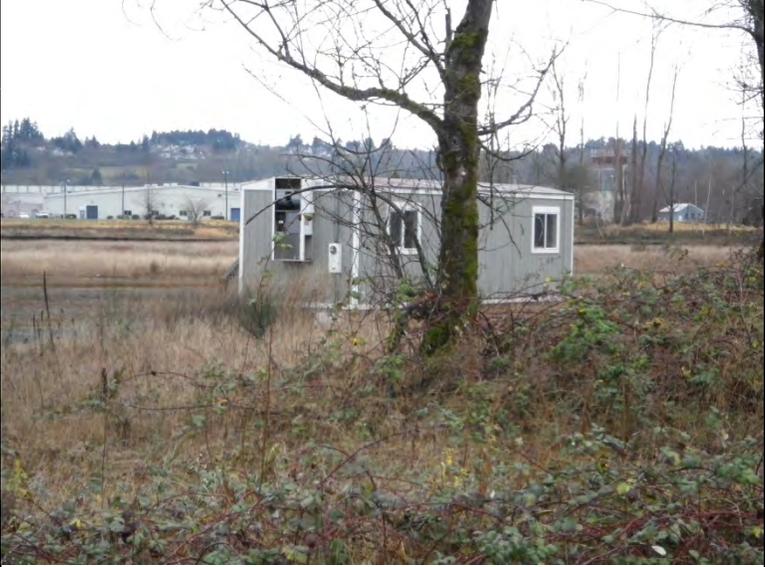
<p><b>Orientation:</b> Southwest</p>	
<p><b>Description:</b> Job trailer, viewed from NW Swigert Way.</p>

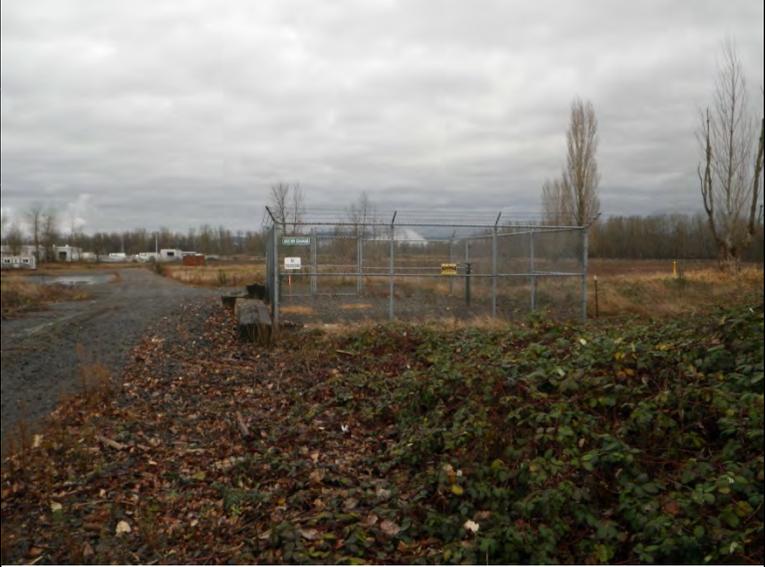
<p><b>Photo No:</b> 5</p>	
<p><b>Photo Date:</b> Dec. 27, 2011</p>

<p><b>Orientation:</b> North</p>	
<p><b>Description:</b>                  Field viewed from NW Graham Road. A natural gas pipeline valve is located in the fenced area.</p>	
<p><b>Photo No:</b> 6</p>	
<p><b>Photo Date:</b> Dec. 27, 2011</p>

The site was observed on December 27, 2011 from public rights of way. The site is currently undeveloped and generally vacant. A natural gas pipeline valve structure is present at the south side of the site near NW Graham Road. It appears that the buried natural gas pipeline traverses a portion of the site. A drainage ditch, which generally runs in a west-east alignment, is present at the central portion of the site. The property north of the site (also part of the former Reynolds/Alcoa facility) is occupied by a Federal Express distribution center. The Troutdale airport is present south of the site. Vacant parcels are present west and east of the site. A photograph log is included in Attachment B.

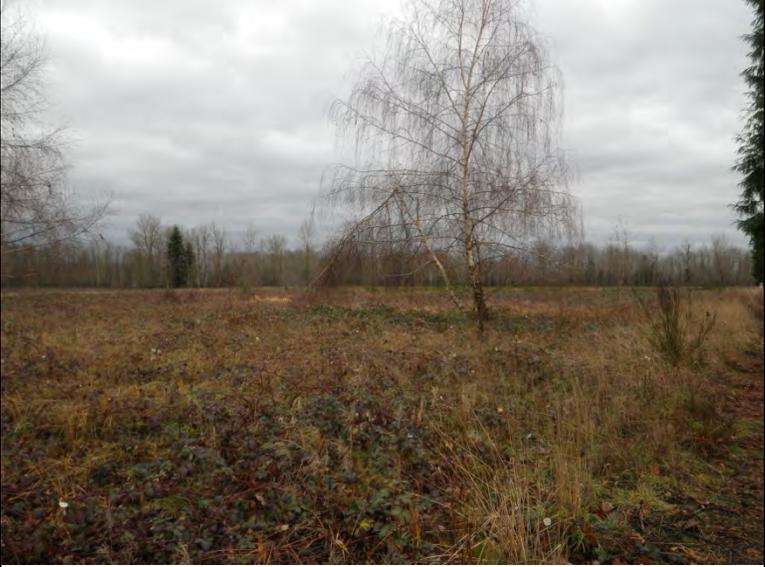
<p><b>Orientation:</b> Northeast</p>	
<p><b>Description:</b>                  Field viewed from NW Graham Road.</p>

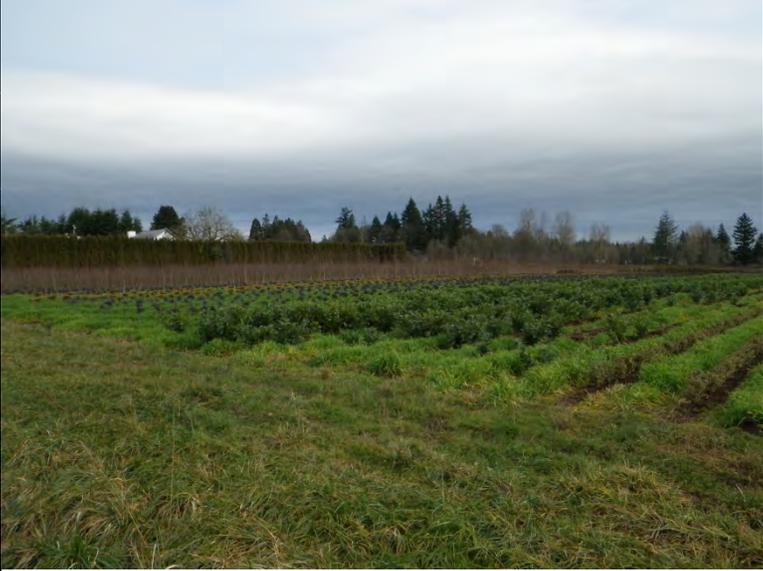
<p><b>Photo No:</b> 1</p>	
<p><b>Photo Date:</b> Dec. 27, 2011</p>

<p><b>Orientation:</b> Northeast</p>	
<p><b>Description:</b> Agricultural area viewed from SE 267<sup>th</sup> Avenue.</p>	
<p><b>Photo No:</b> 2</p>

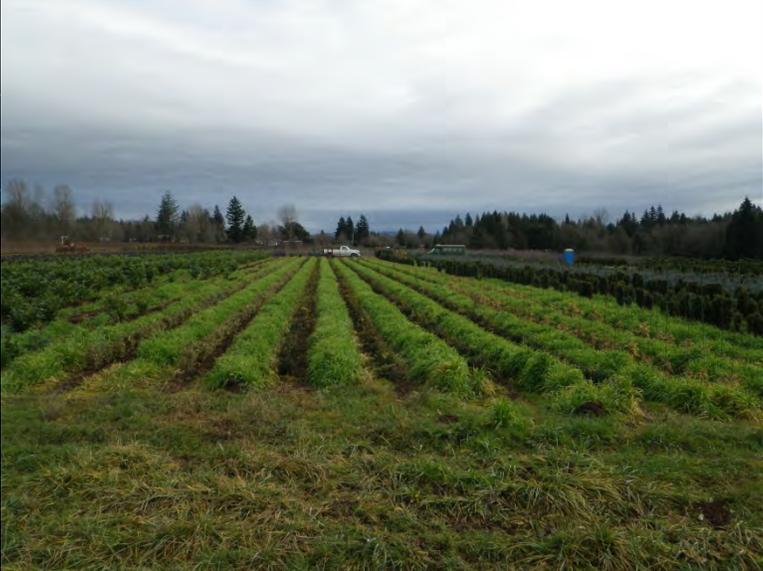
<p><b>Photo Date:</b> Dec. 27, 2011</p>	
<p><b>Orientation:</b> East</p>	
<p><b>Description:</b> Agricultural area viewed from SE 267<sup>th</sup> Avenue.</p>

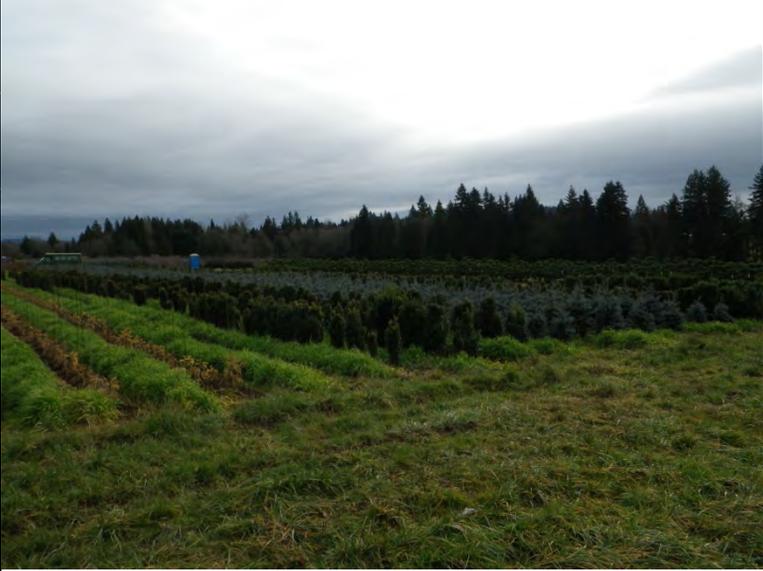
<p><b>Photo No:</b> 3</p>	
<p><b>Photo Date:</b> Dec. 27, 2011</p>

<p><b>Orientation:</b> Southeast</p>	
<p><b>Description:</b> Agricultural area viewed from SE 267<sup>th</sup> Avenue.</p>	
<p><b>Photo No:</b> 4</p>	
<p><b>Photo Date:</b> Dec. 27, 2011</p>

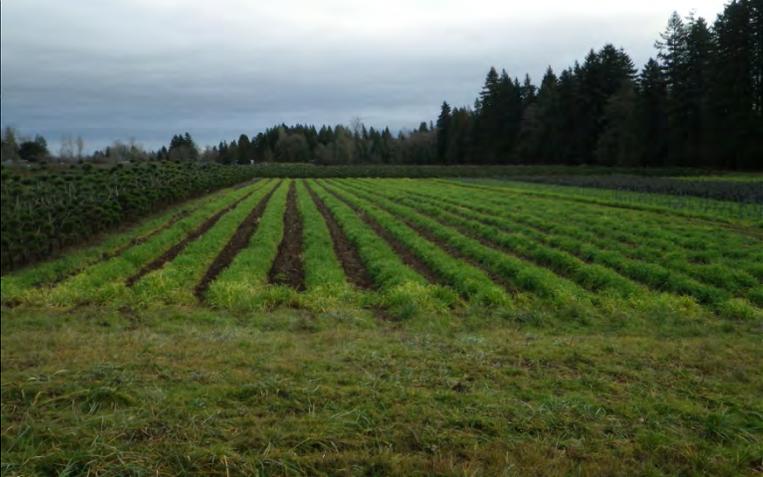
<p><b>Orientation:</b> East</p>	
<p><b>Description:</b> Agricultural area viewed from SE 267<sup>th</sup> Avenue.</p>

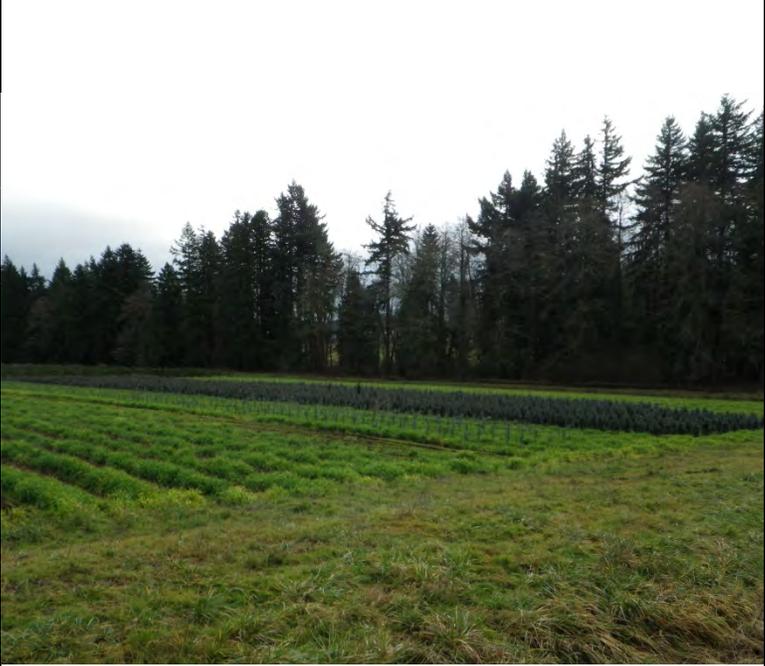
<p><b>Photo No:</b> 5</p>

<p><b>Photo Date:</b> Dec. 27, 2011</p>	
<p><b>Orientation:</b> Southeast</p>	
<p><b>Description:</b> Agricultural area viewed from SE 267<sup>th</sup> Avenue.</p>	
<p><b>Photo No:</b> 6</p>

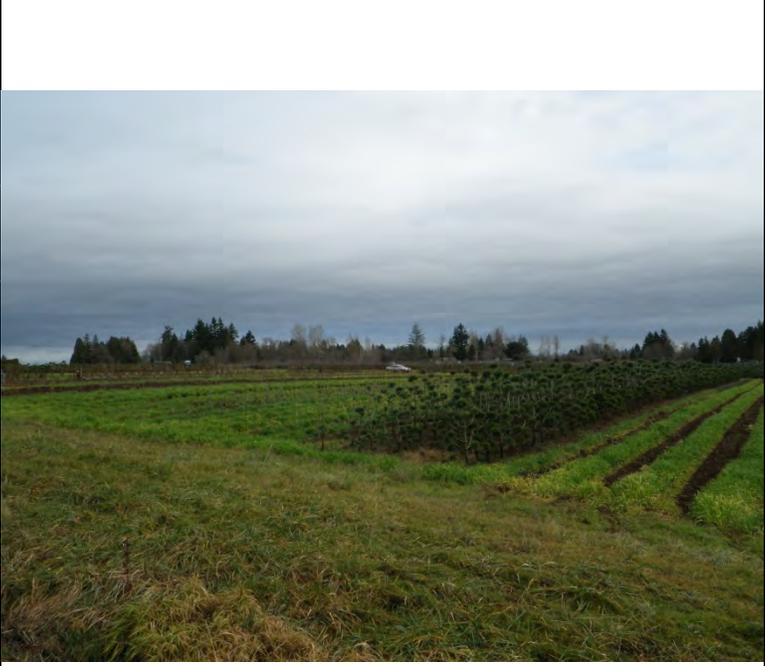
<p><b>Photo Date:</b> Dec. 27, 2011</p>	
<p><b>Orientation:</b> Northeast</p>	
<p><b>Description:</b> Agricultural area viewed from SE 267<sup>th</sup> Avenue.</p>

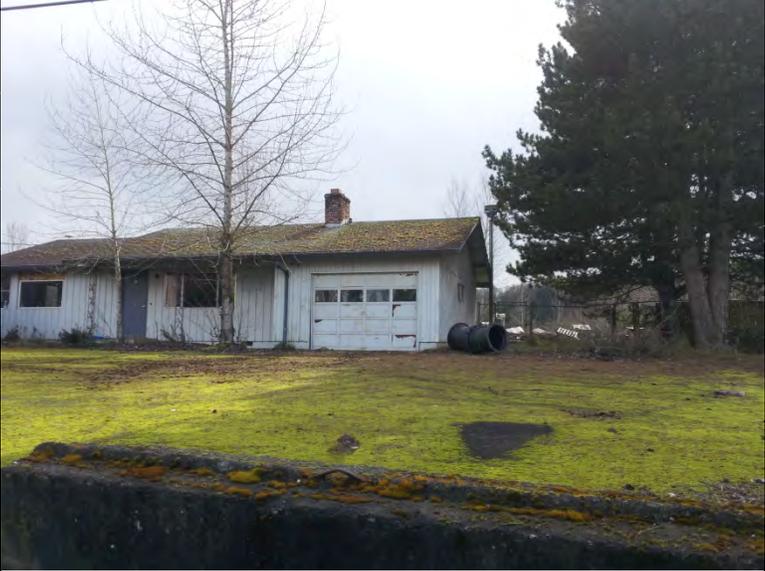
<p><b>Photo No:</b> 1</p>	
<p><b>Photo Date:</b> March. 6, 2012</p>	
<p><b>Orientation:</b> South</p>	
<p><b>Description:</b>                  Unused dwelling/office adjacent to SE Capps Road.</p>

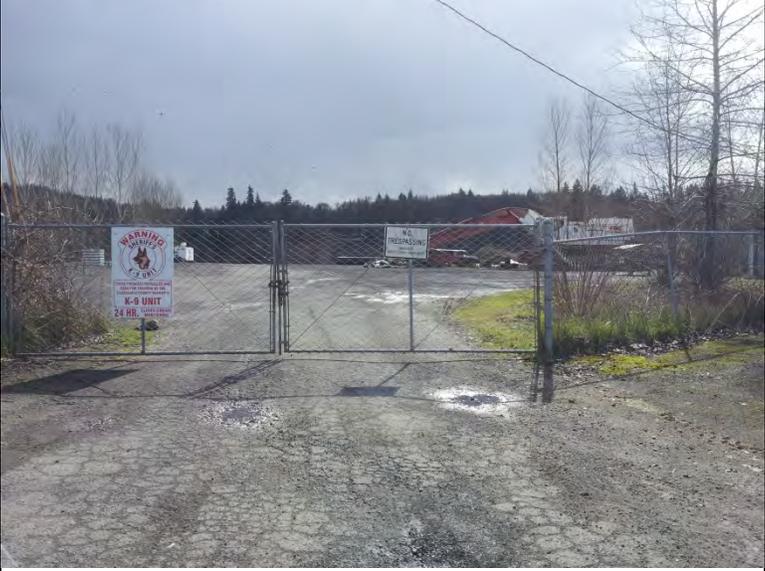
<p><b>Photo No:</b> 2</p>	
<p><b>Photo Date:</b> March. 6, 2012</p>	
<p><b>Orientation:</b> South</p>	
<p><b>Description:</b>                  Heavy equipment storage area adjacent to SE Capps Road.</p>

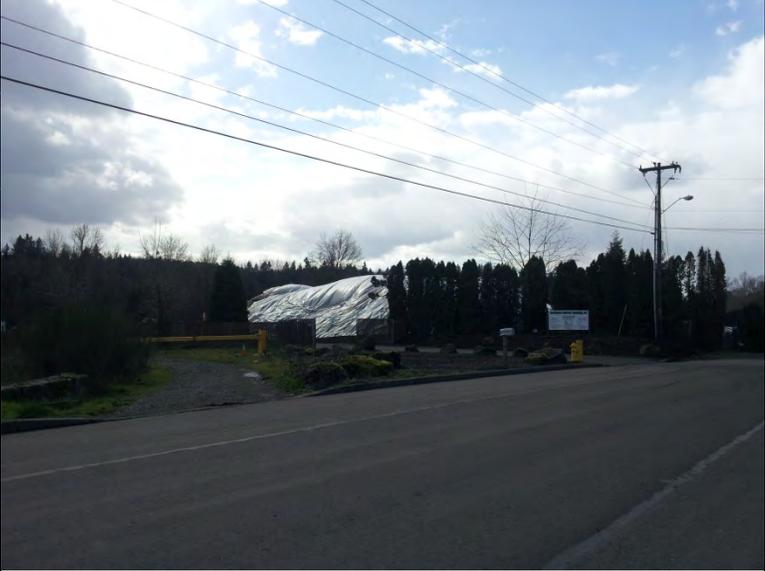
<p><b>Photo No:</b> 3</p>

<p><b>Photo Date:</b> March. 6, 2012</p>	
<p><b>Orientation:</b> Southwest</p>	
<p><b>Description:</b>  Clackamas Compost Products facility, at southwest portion of the site.</p>	
<p><b>Photo No:</b> 4</p>

- An exterior maintenance area, operated by Clackamas Compost Products (tax lot 1800), was identified as a potential REC due to the use and possible spillage of hazardous substances.

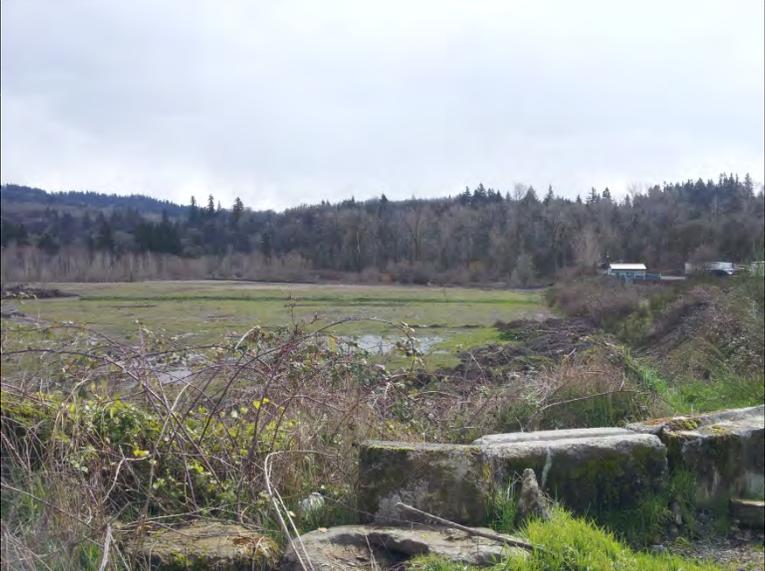
<p><b>Photo Date:</b> March. 6, 2012</p>	
<p><b>Orientation:</b> West-southwest</p>	
<p><b>Description:</b>  Former Clackamas Sand and Gravel pit, viewed from SE Wilde Road.</p>

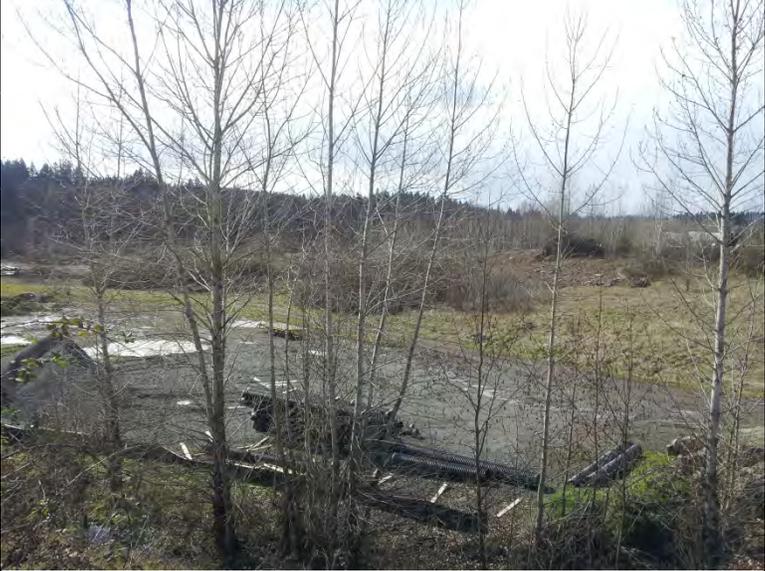
<p><b>Photo No:</b> 5</p>	
<p><b>Photo Date:</b> March. 6, 2012</p>	
<p><b>Orientation:</b> Southwest</p>	
<p><b>Description:</b>  Former Clackamas Sand and Gravel pit, viewed from SE Wilde Road.</p>

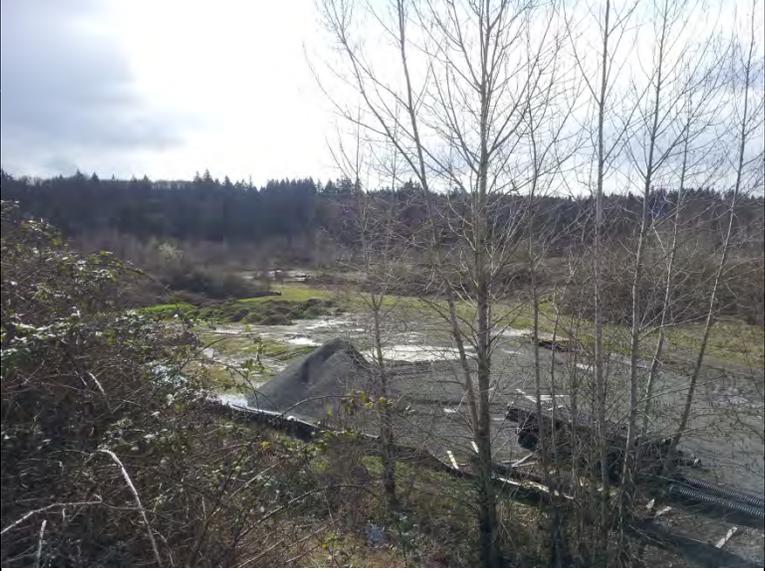
<p><b>Photo No:</b> 6</p>	
<p><b>Photo Date:</b> March. 6, 2012</p>	
<p><b>Orientation:</b> West</p>	
<p><b>Description:</b>  Former Clackamas Sand and Gravel pit, viewed from SE Wilde Road.</p>

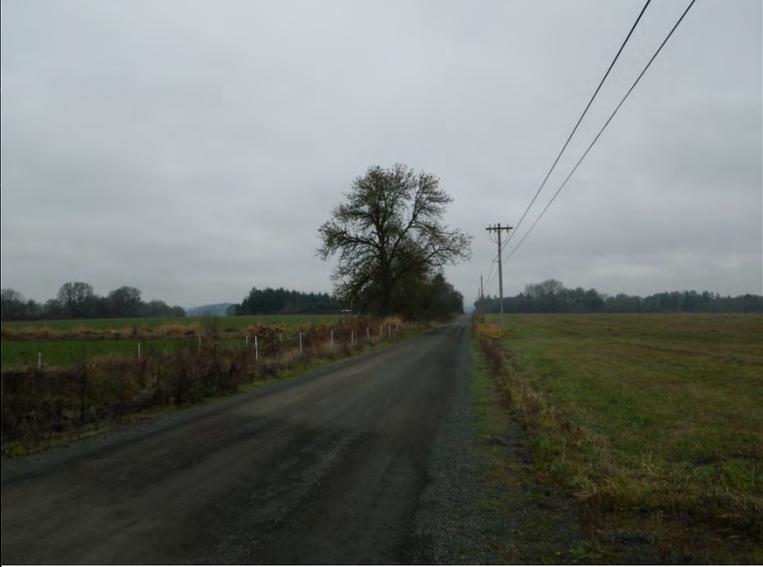
<p><b>Photo No:</b> 1</p>	
<p><b>Photo Date:</b> Dec. 7, 2011</p>

<p><b>Orientation:</b> North</p>	
<p><b>Description:</b> Agricultural fields viewed from NW 253<sup>rd</sup> Avenue.</p>	
<p><b>Photo No:</b> 2</p>	
<p><b>Photo Date:</b> Dec. 7, 2011</p>

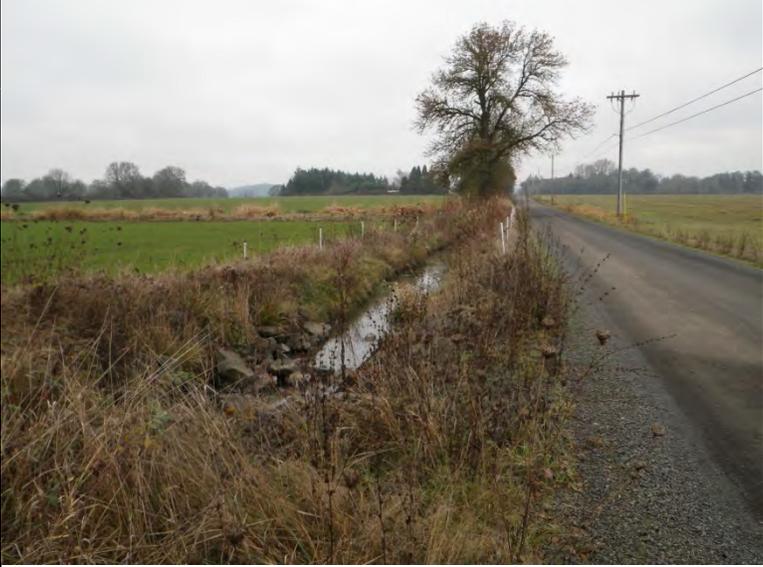
<p><b>Orientation:</b> North</p>	
<p><b>Description:</b> Agricultural fields and a stormwater ditch viewed from NW 253<sup>rd</sup> Avenue..</p>

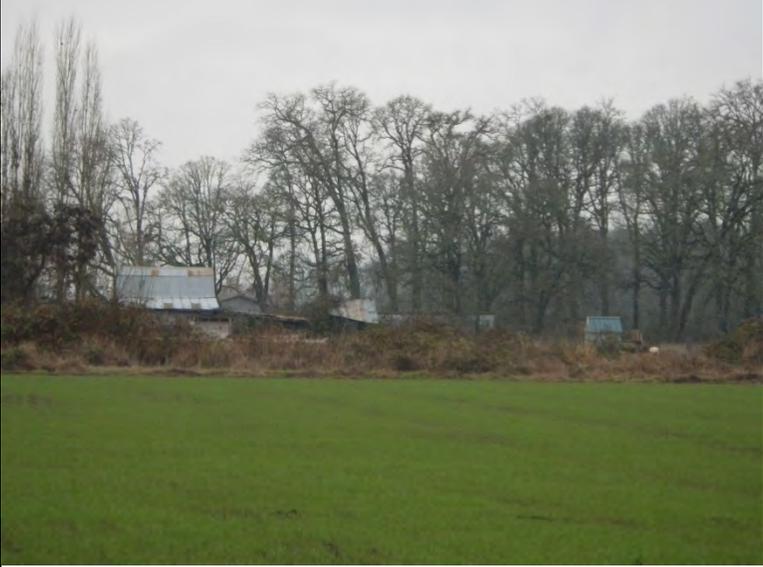
<p><b>Photo No:</b> 3</p>	
<p><b>Photo Date:</b> Dec. 7, 2011</p>

<p><b>Orientation:</b> West</p>	
<p><b>Description:</b> An agricultural field, barn and accessory structures at the southeast portion of the site, viewed from NW 253<sup>rd</sup> Avenue.</p>	
<p><b>Photo No:</b> 4</p>	
<p><b>Photo Date:</b> Dec. 7, 2011</p>

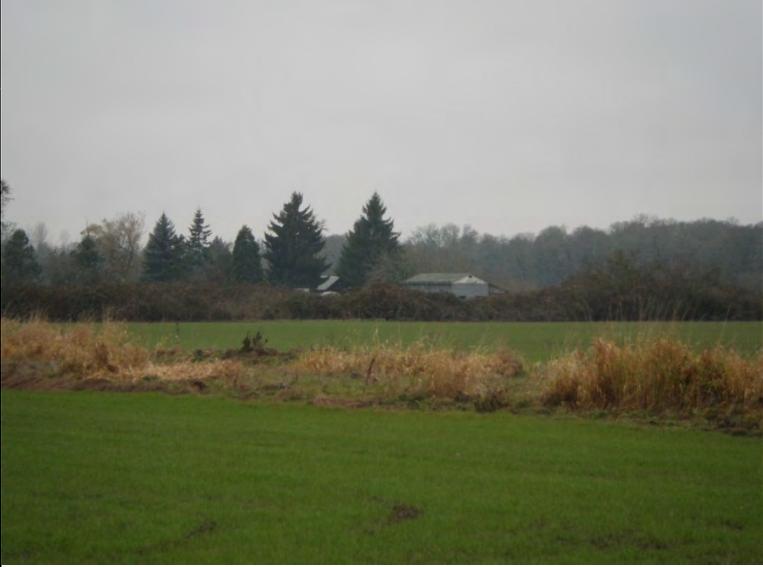
<p><b>Orientation:</b> Northwest</p>	
<p><b>Description:</b> View of an agricultural field, with a dwelling and farm structures visible in the background. The photograph was taken from NW 253<sup>rd</sup> Avenue.</p>

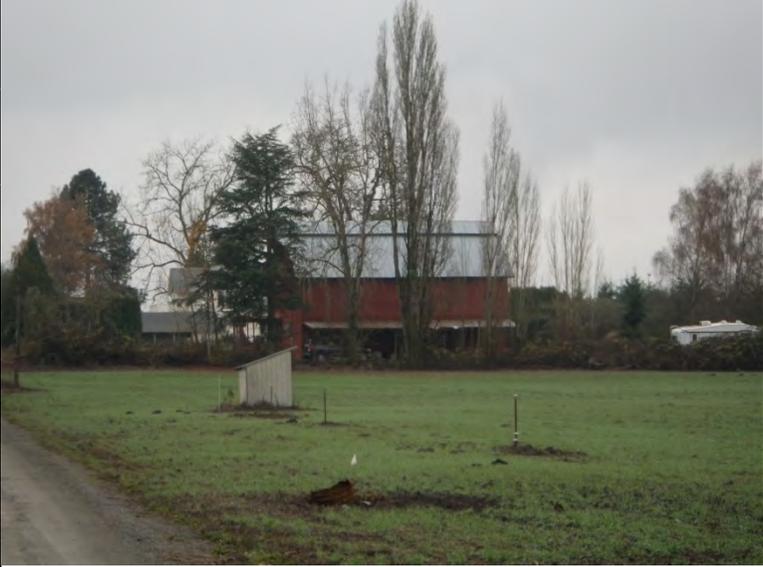
<p><b>Photo No:</b> 5</p>	
<p><b>Photo Date:</b> Dec. 7, 2011</p>

<p><b>Orientation:</b> South</p>	
<p><b>Description:</b> A dwelling and barn at the east side of the site, viewed from NW 253<sup>rd</sup> Avenue.</p>	
<p><b>Photo No:</b> 6</p>	
<p><b>Photo Date:</b> Dec. 7, 2011</p>

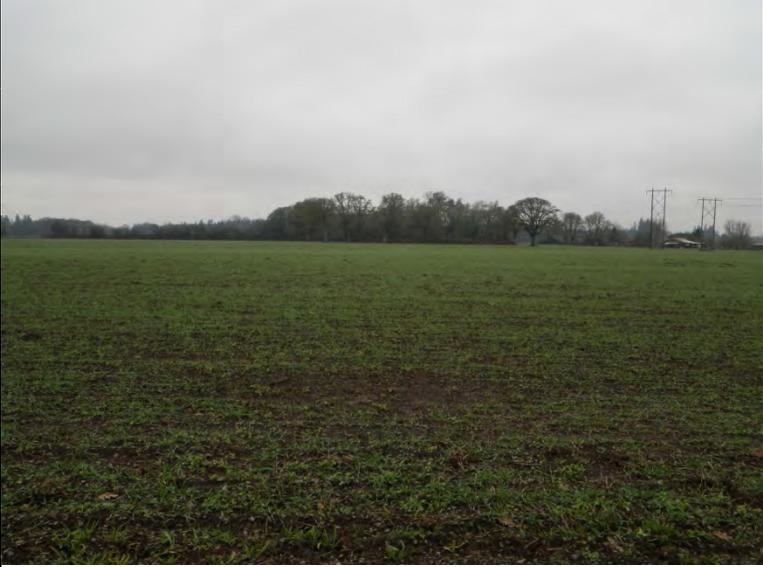
<p><b>Orientation:</b> West</p>	
<p><b>Description:</b> Taken from NW 253<sup>rd</sup> Avenue, on the East boarder of the lot, looking West toward an agricultural field containing grass.</p>

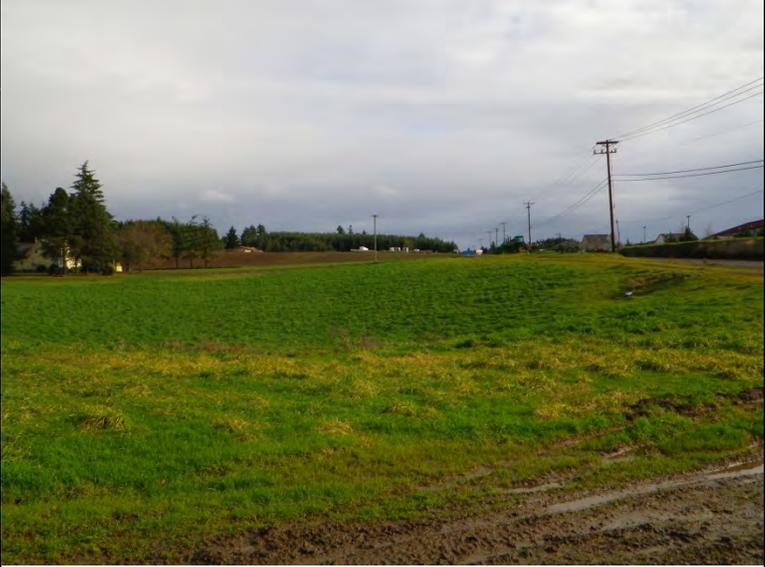
<p><b>Photo No:</b> 1</p>	
<p><b>Photo Date:</b> Dec. 27, 2011</p>

<p><b>Orientation:</b> East</p>	
<p><b>Description:</b> Agricultural area viewed from SE 162<sup>nd</sup> Avenue.</p>	
<p><b>Photo No:</b> 2</p>	
<p><b>Photo Date:</b> Dec. 27, 2011</p>

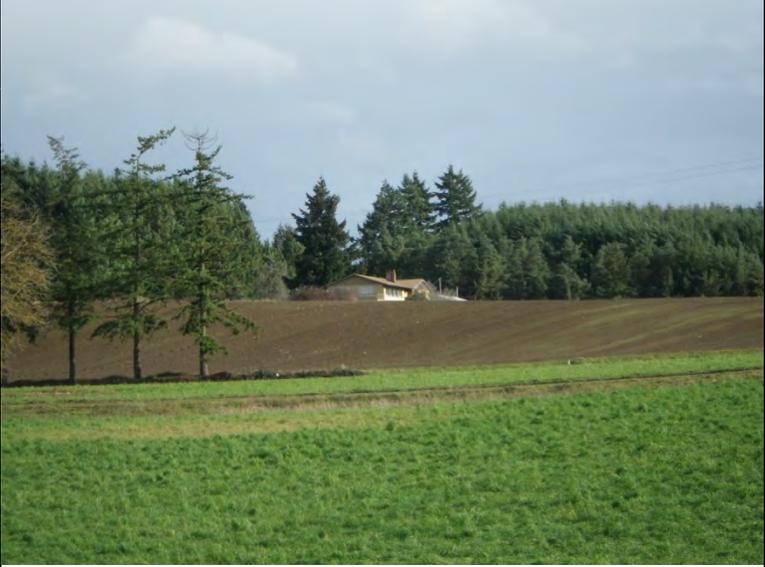
<p><b>Orientation:</b> Northeast</p>	
<p><b>Description:</b> Agricultural area viewed from SE 162<sup>nd</sup> Avenue.</p>

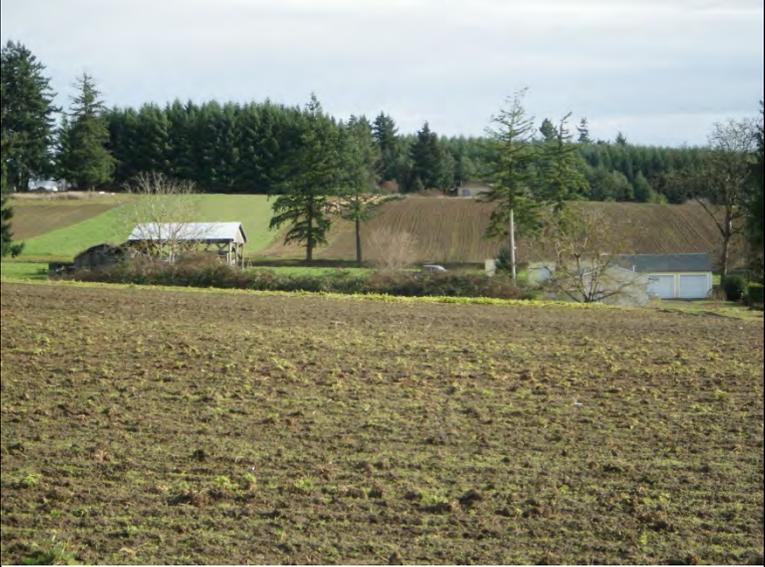
<p><b>Photo No:</b> 3</p>	
<p><b>Photo Date:</b> Dec. 27, 2011</p>

<p><b>Orientation:</b> East</p>	
<p><b>Description:</b>                  Agricultural area and accessory structures viewed from SE 162<sup>nd</sup> Avenue.</p>	
<p><b>Photo No:</b> 4</p>	
<p><b>Photo Date:</b> Dec. 27, 2011</p>

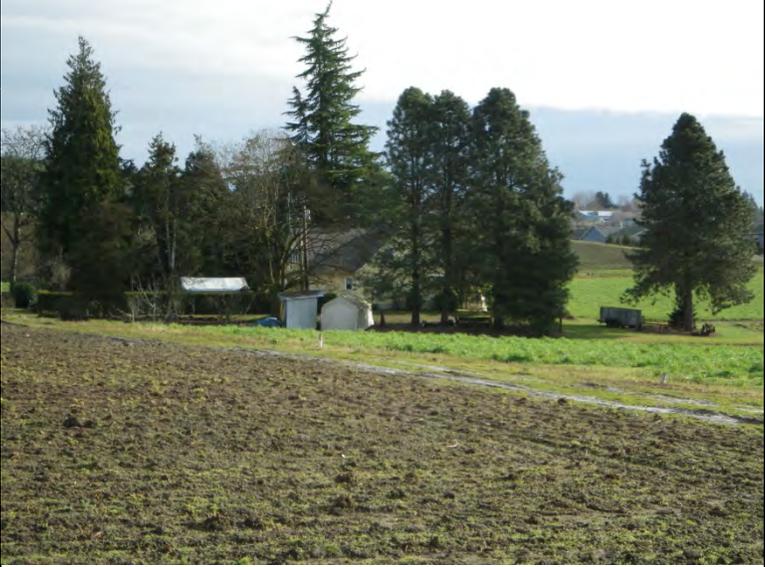
<p><b>Orientation:</b> East</p>	
<p><b>Description:</b>                  Agricultural area, dwelling, and accessory structures viewed from SE 162<sup>nd</sup> Avenue.</p>

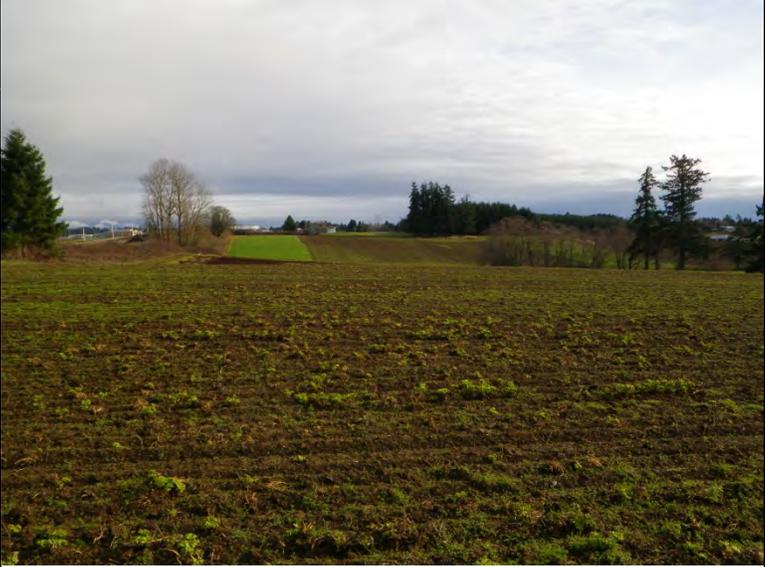
<p><b>Photo No:</b> 5</p>	
<p><b>Photo Date:</b> Dec. 27, 2011</p>

<p><b>Orientation:</b> East</p>	
<p><b>Description:</b> Agricultural area viewed from SE 162<sup>nd</sup> Avenue.</p>	
<p><b>Photo No:</b> 6</p>	
<p><b>Photo Date:</b> Dec. 27, 2011</p>

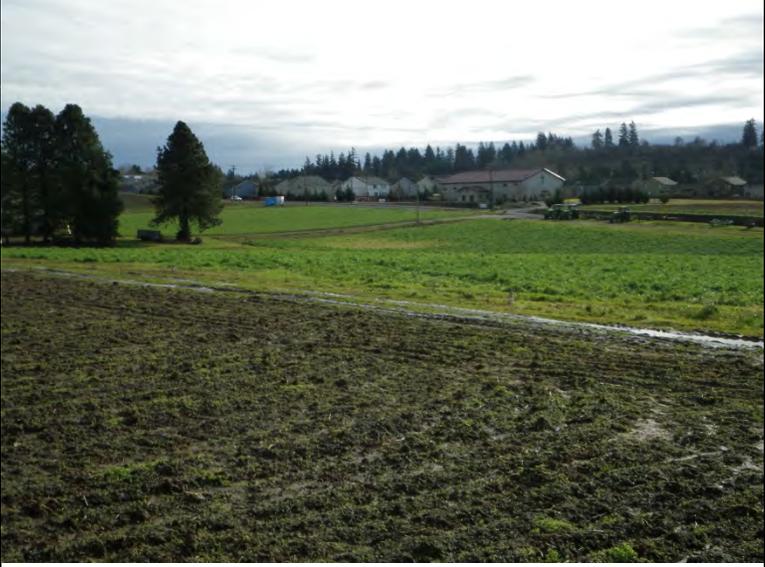
<p><b>Orientation:</b> Southeast</p>	
<p><b>Description:</b> Agricultural area viewed from SE 162<sup>nd</sup> Avenue.</p>

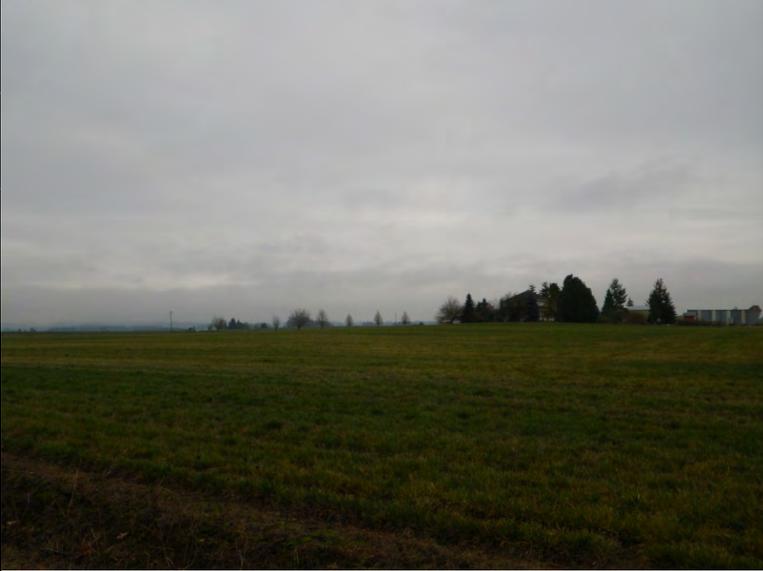
<p><b>Photo No:</b> 1</p>	
<p><b>Photo Date:</b> Dec. 7, 2011</p>

<p><b>Orientation:</b> East</p>	
<p><b>Description:</b> Agricultural fields at the west side of the site, viewed from NW Sewell Road. A dwelling and accessory structures are visible in the background.</p>	
<p><b>Photo No:</b> 2</p>	
<p><b>Photo Date:</b> Dec. 7, 2011</p>
