*Evaluation of Environmental Conditions  
At Candidate Industrial Sites  
Regional Industrial Inventory Project  
Portland Metropolitan Area, Oregon*

Prepared for:  
Group Mackenzie

August 2, 2012  
1901-00

Ash Creek Associates, Inc.  
Environmental and Geotechnical Consultants

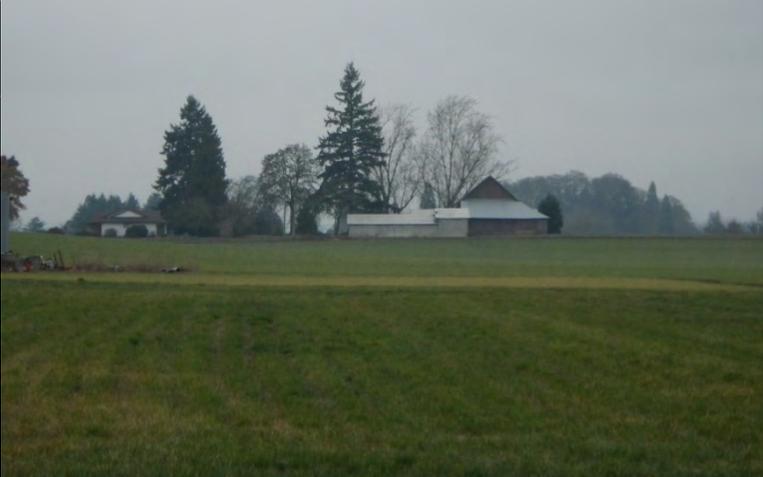
<p><b>Orientation:</b> East</p>	
<p><b>Description:</b> Agricultural fields at the west side of the site, viewed from NW Sewell Road. A dwelling and accessory structures are visible in the background.</p>

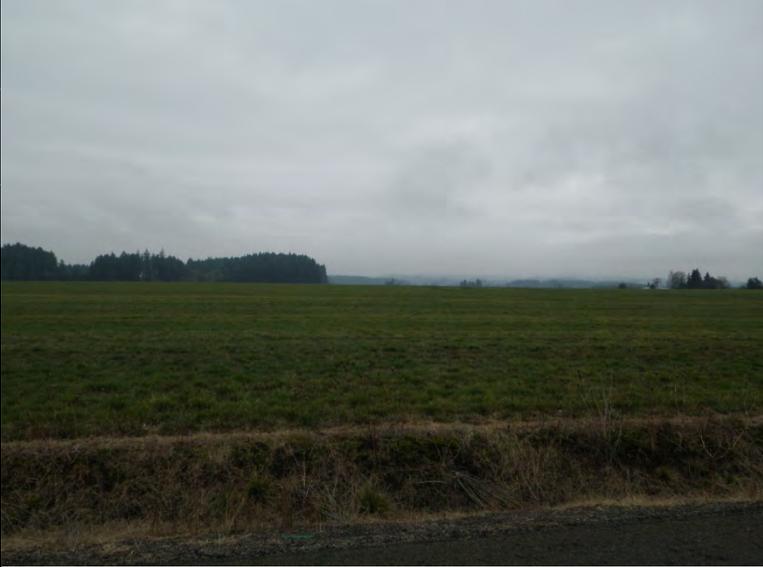
<p><b>Photo No:</b> 3</p>	
<p><b>Photo Date:</b> Dec. 7, 2011</p>

<p><b>Orientation:</b> Northwest</p>	
<p><b>Description:</b>  Agricultural fields at the west side of the site, viewed from NW Meek Road.</p>	
<p><b>Photo No:</b> 4</p>	
<p><b>Photo Date:</b> Dec. 7, 2011</p>

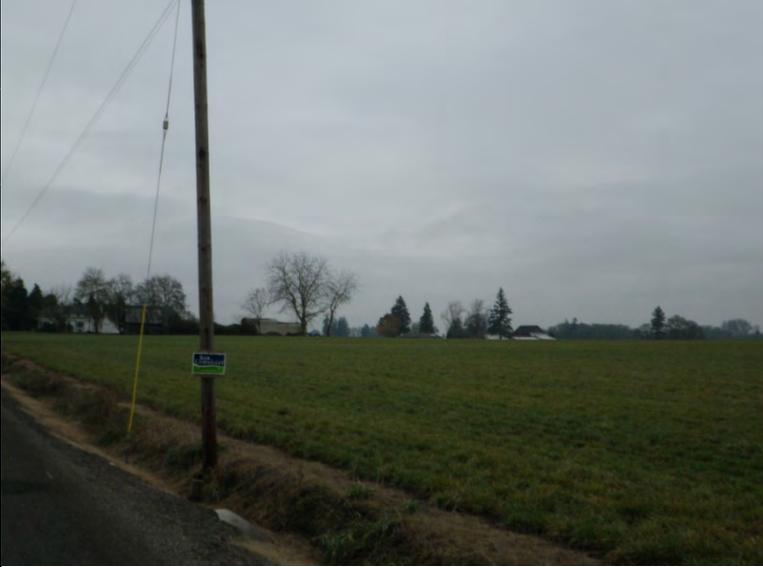
<p><b>Orientation:</b> East</p>	
<p><b>Description:</b>  Agricultural fields, a dwelling, and accessory structures at the central portion of the site, viewed from NW Meek Road.</p>

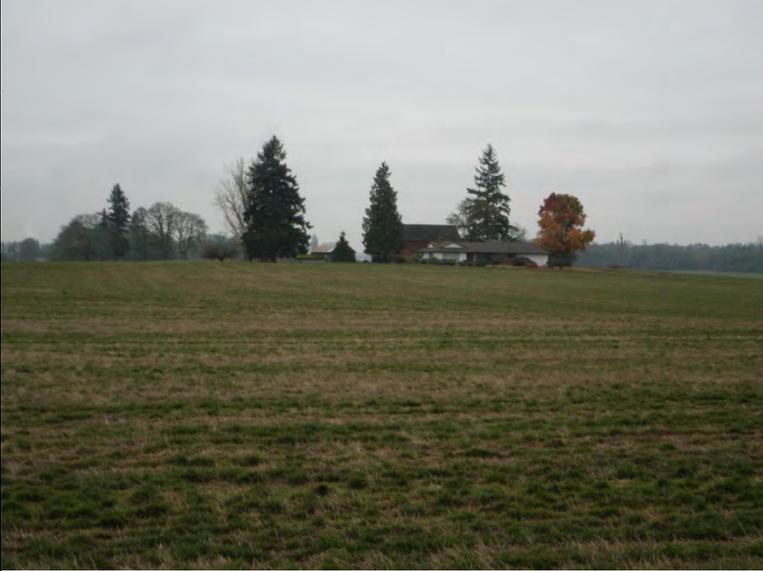
<p><b>Photo No:</b> 5</p>	
<p><b>Photo Date:</b> Dec. 7, 2011</p>

<p><b>Orientation:</b> South</p>	
<p><b>Description:</b>  Agricultural fields, a dwelling, and accessory structures at the central portion of the site, viewed from NW Meek Road.</p>	
<p><b>Photo No:</b> 6</p>	
<p><b>Photo Date:</b> Dec. 7, 2011</p>

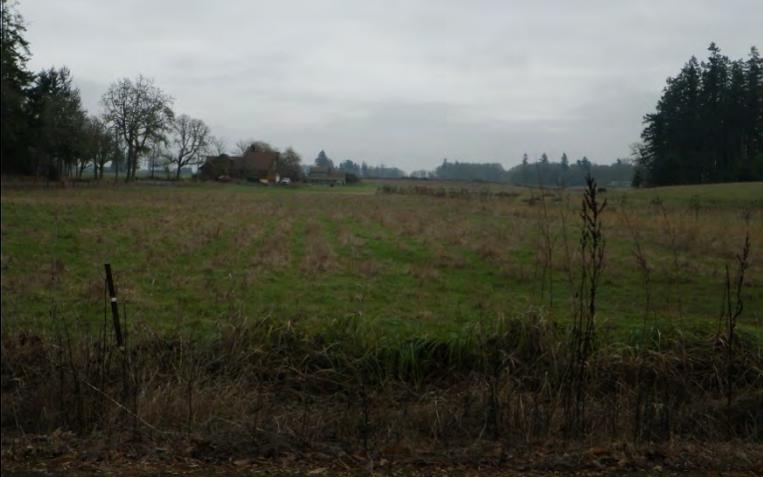
<p><b>Orientation:</b> East</p>	
<p><b>Description:</b>  Agricultural fields, a dwelling, and accessory structures at the southwest portion of the site, viewed from NW Sewell Road.</p>
