National Register of Historic Places Registration Form

historic name Brooks, Andrew J. and Minnie J., House

street & number 2216 SE 32nd Avenue

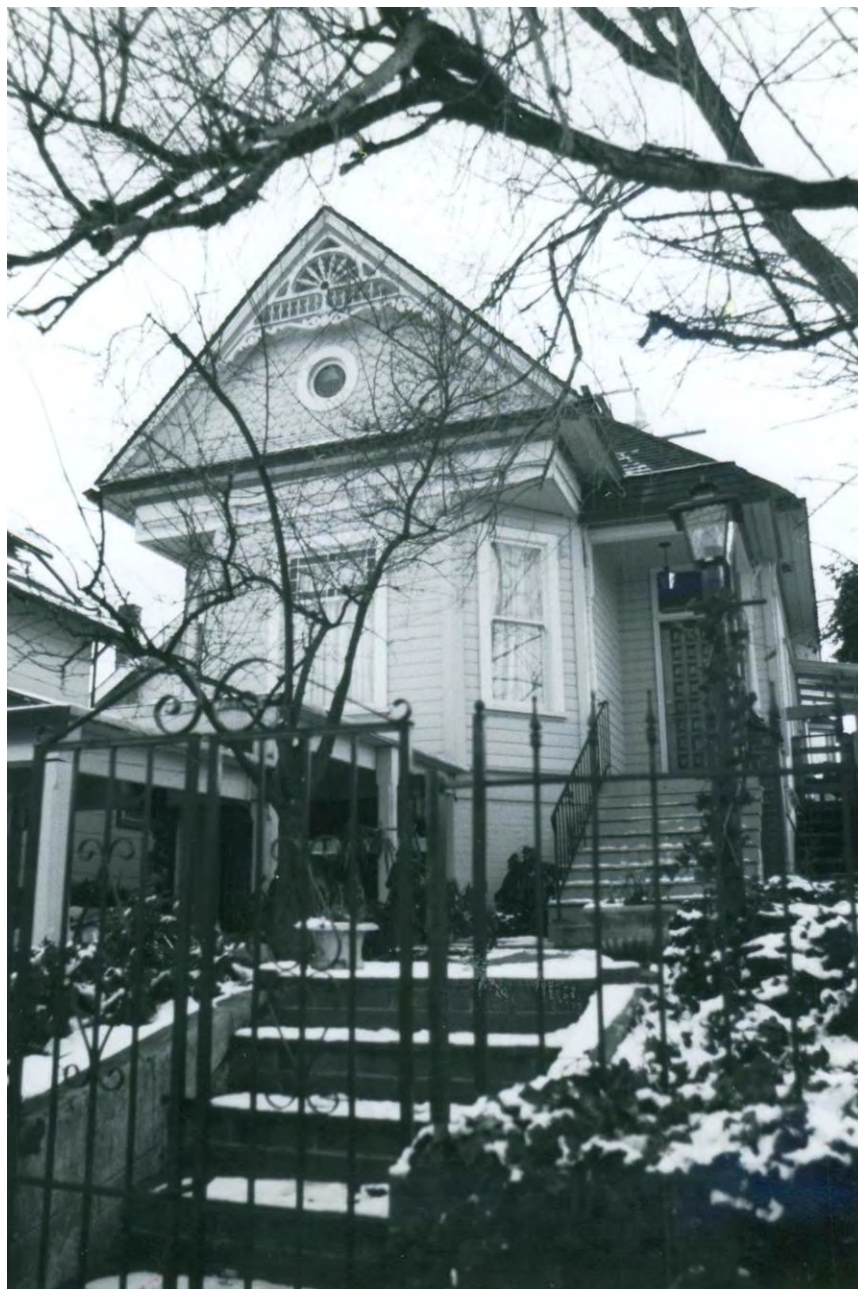
1 of 6: Brooks House in the 1981 when the house was owned by Wallace Casebeer. Note the deck at the right of the picture, as well as the entry stairs and the door.

Wallace Ray Casebeer filed for a building permit in 1974 to build a concrete staircase in the front porch. The front door was also replaced with a multi-panel wood door.⁷ In 2001, current owner Carol Passey replaced the railing with turned wood balusters and restored the Queen Anne features of the porch, and covered the steps with tongue-and-groove wood boards (Historic Photos 1 and 2).

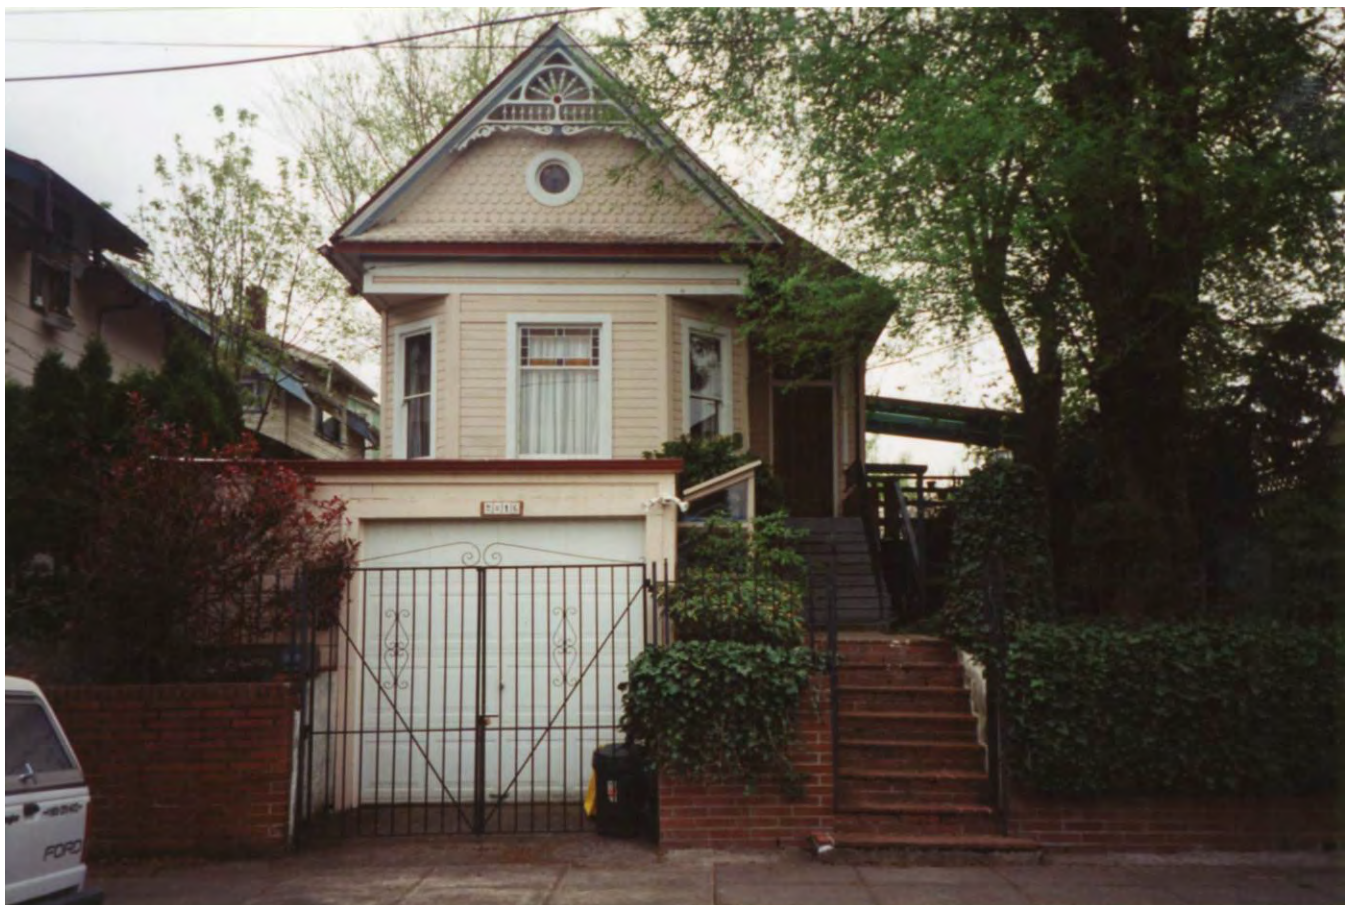
2 of 6: Main façade of the Brooks House in 2000 when the house was owned by Wallace Casebeer. Note the deck at the right of the picture, as well as the entry stairs and the door.

The brick foundation walls were exposed in 1937-1938 during excavation to construct a garage – removed in the 2000s – today have been modified to serve as an entrance with a simple door on the south side and a window on the north side (Photo 3 and Historic Photos 2 and 3). This wall has been clad with brick re-used

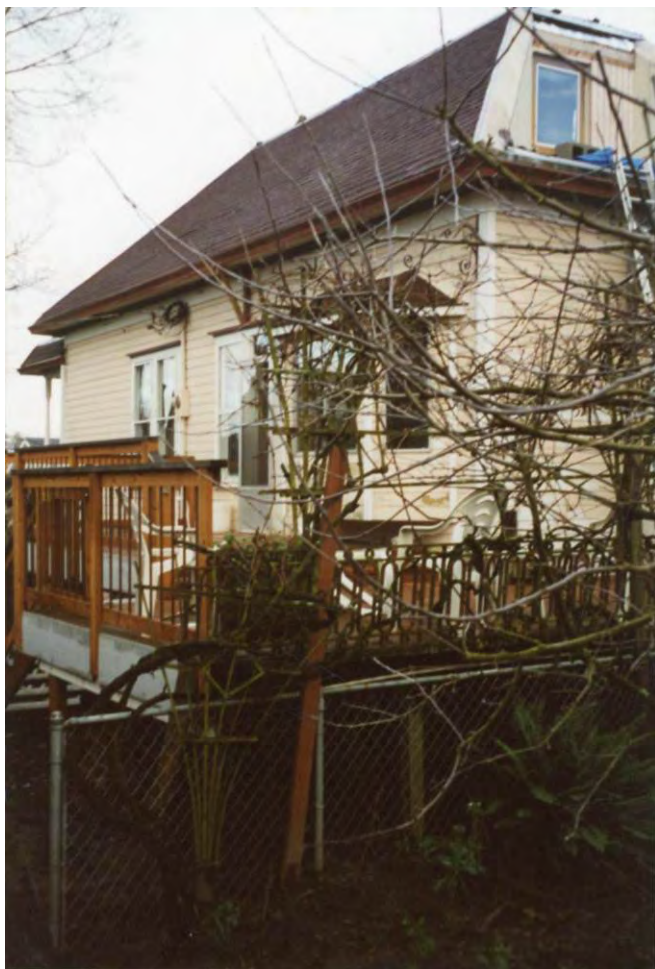
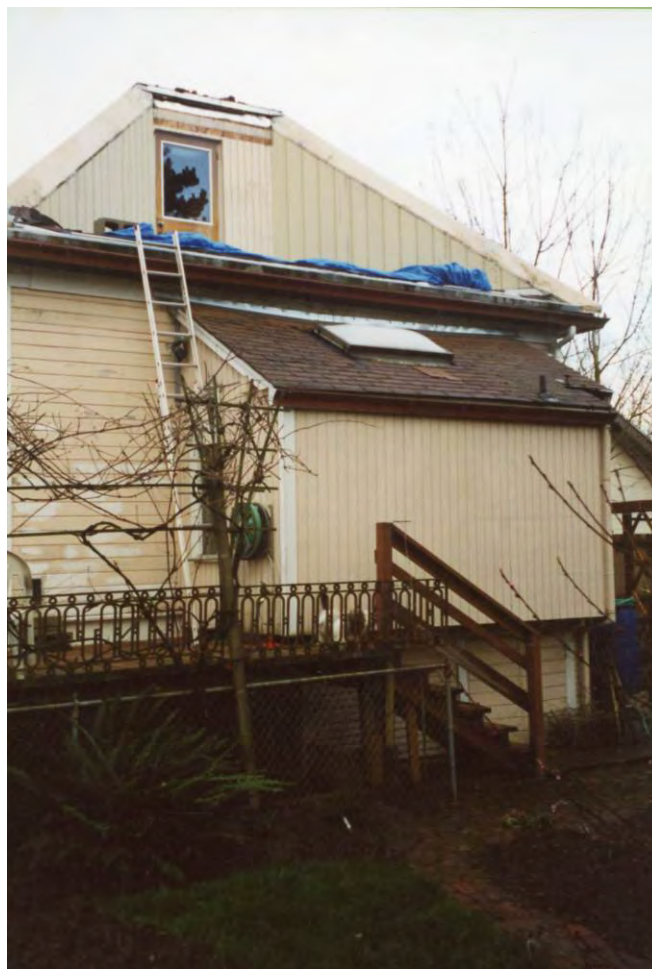
3 of 6: The photographs at the left is the south façade before removal of deck and bay window at the kitchen. The photograph at the right is the east façade with the kitchen extension to the rear porch, as well as the deck. Note the open deck area in the attic.

The present kitchen was renovated in an early 1900s-style with a stove replica and wooden counters (see Photo 13). A new pair of double-hung windows is located in the south wall, where a shadow of the original fenestration was found in the 2000s as shown in the historic pictures. There is a window on top of the sink and a door to the rear porch; both are new as indicated before (Historic Photo 3 and Photo 6).

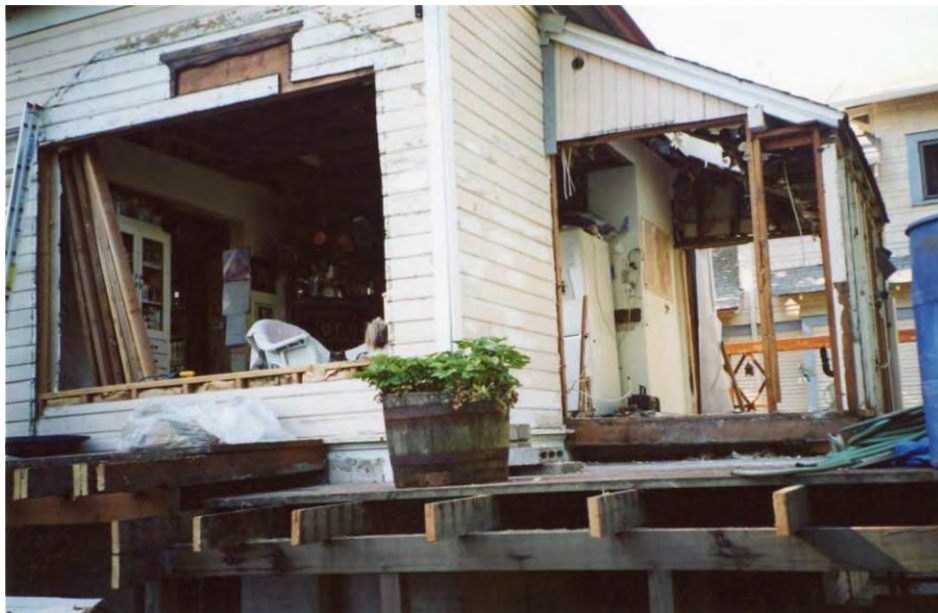
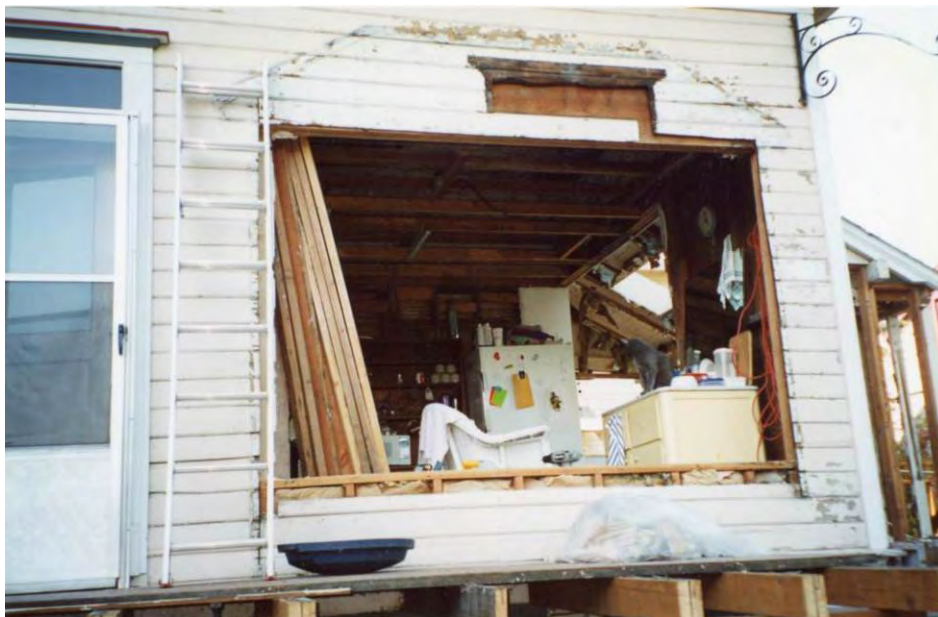
4 of 6: Photographs taken during summer 2002. The upper photograph shows the removal of the kitchen addition and the bay window. The lower photo shows the area where the bay window was removed with the shadow of the original placement of the kitchen window. Note also the door in the left side of the lower photo that used to connect the dining room with the deck.

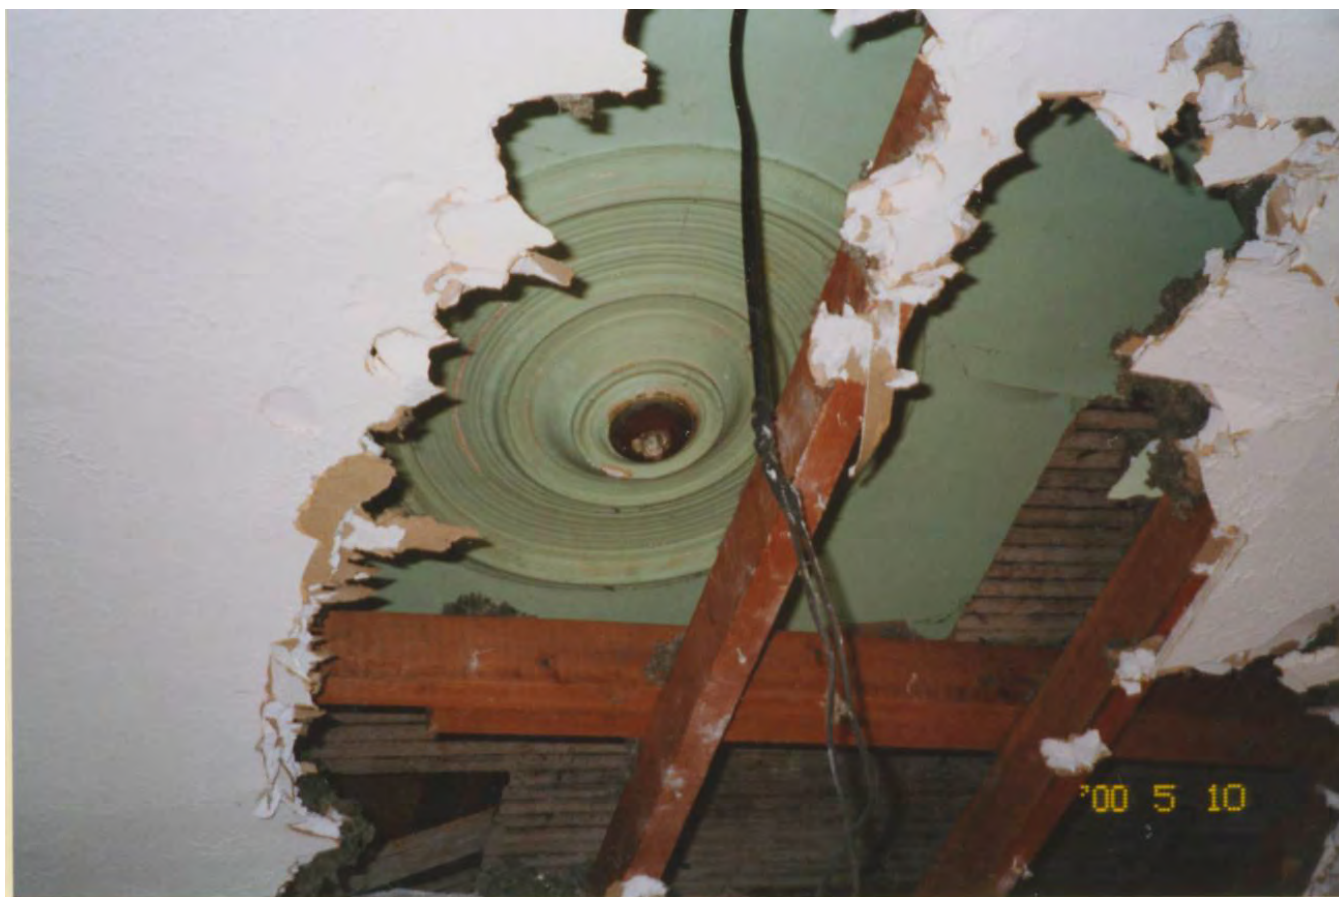
5 of 6: Photograph taken in 2000. This was the original ceiling medallion found in the dining room after the removal of the dropped ceiling.

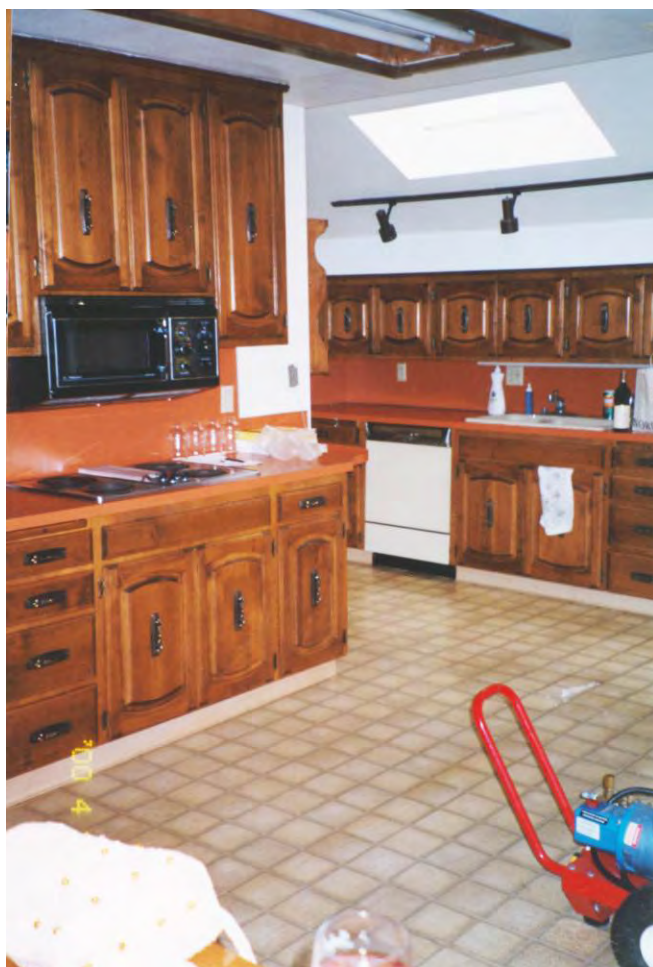
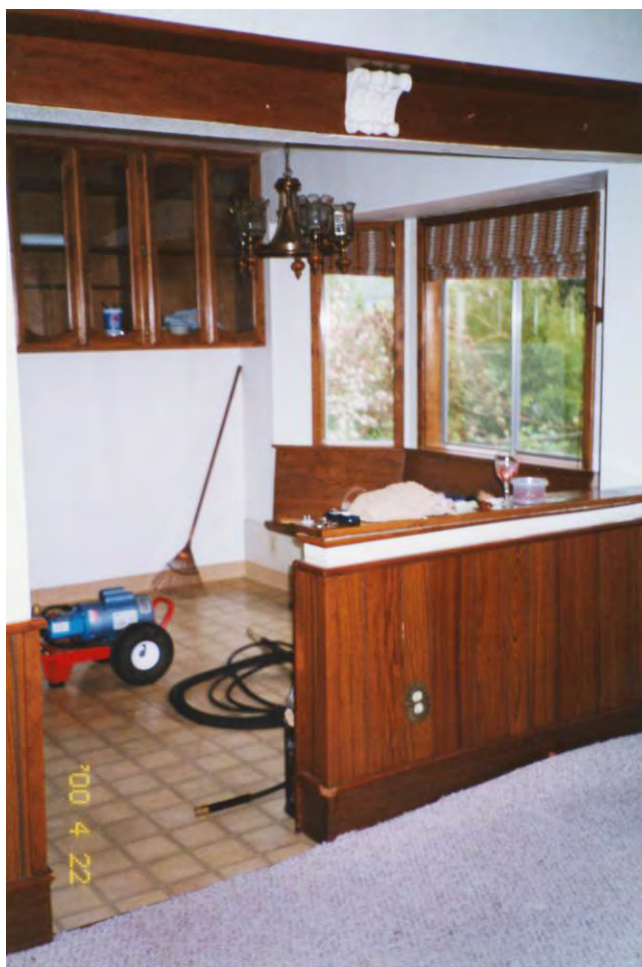
6 of 6: Photo of the kitchen in 2000 as it was remodeled by Wallace Casebeer in 1970s and 1980s. The left photograph is from the kitchen entry with the camera facing northeast. The skylight is in the former rear porch area. The photo at the right is from the dining room to the kitchen, with the camera facing southeast. The photo shows the bay window that was removed, as shown in the historic photograph 6.

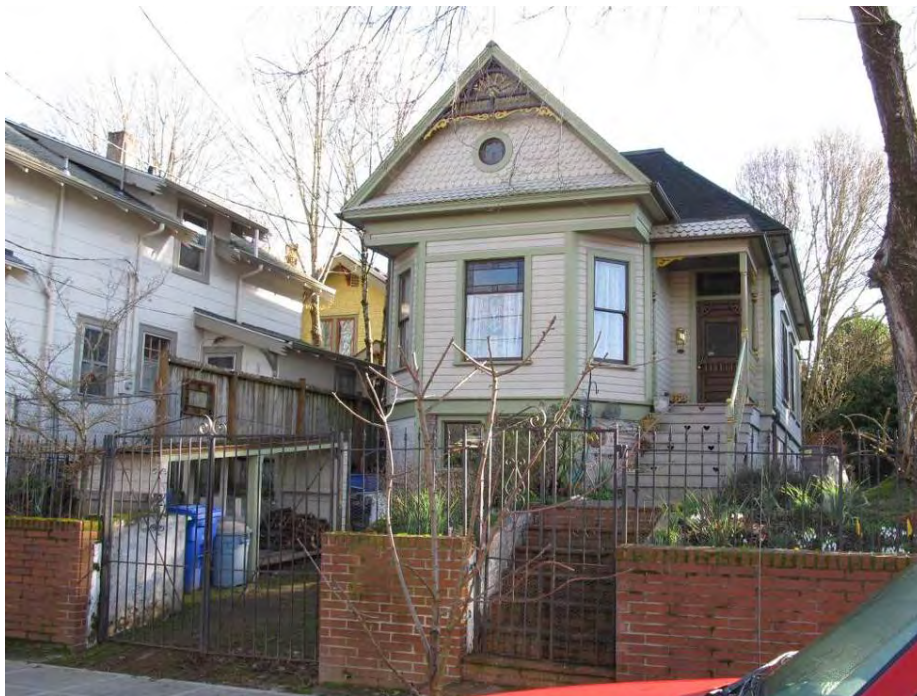
Photo 1 of 15. (OR_MultnomahCounty_AndrewJMinnieJBrooksHouse_0001)

West façade (main) and south façade (right), camera facing northeast.

Access to the front of the house from the public sidewalk is via a seven concrete steps that extend from the back of the public sidewalk to the main level of the lot, which is about ten feet above grade (Photo 1). The yard is retained by a reinforced concrete wall that is faced with brick along the sidewalk, surmounted by a wrought-iron fence. The entry stair is located at about the center of the lot, with a narrow, brick-paved driveway located to its immediate north. To the north of the driveway is a small shed used as a woodshed and trash enclosure, constructed in 2000. The driveway is separated from the public sidewalk by a hinged metal gate (Figure 3 and Photos 1 and 3).¹⁵

Pedestrian access, as previously described, is achieved via a set of concrete steps from the street (Photo 1). The front yard is landscaped with a variety of plants that include shrubs, azaleas and two mature trees, a maple and an elm, that stand in the southwest corner of the lot (Photo 2). A short concrete path connects the concrete steps of the lower access to join nine enclosed wood steps that access the front entry porch.

There is also a set of narrow concrete steps connecting the driveway and the path to the house, at the end of the retaining wall south of the driveway (Figure 3 and Photo 1).

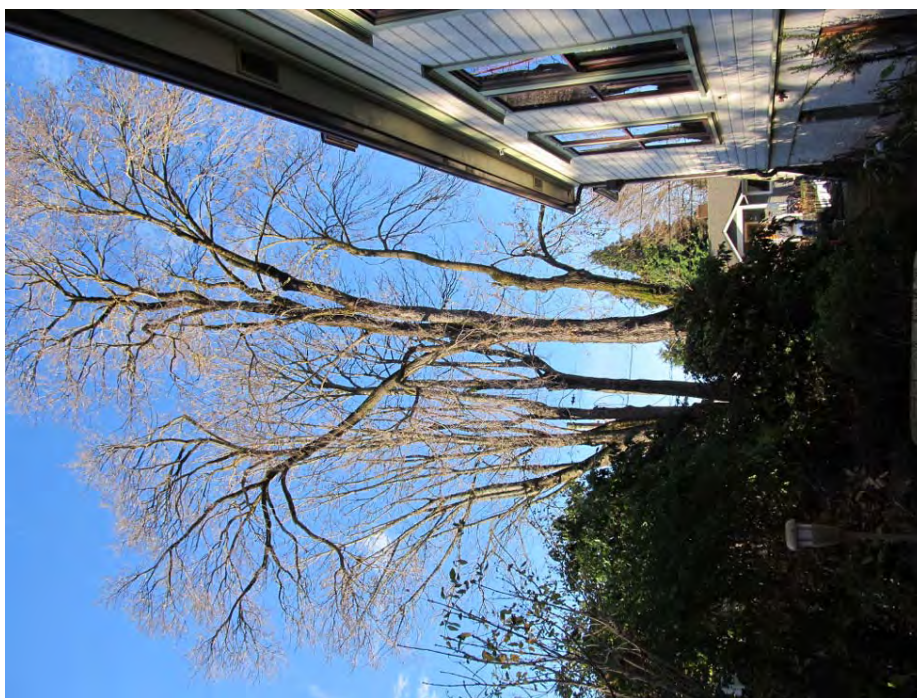
Photo 2 of 15. (OR_MultnomahCounty_AndrewJMinnieJBrooksHouse_0002)

Mature maple and elm trees in front yard. South façade at right. Camera facing west.

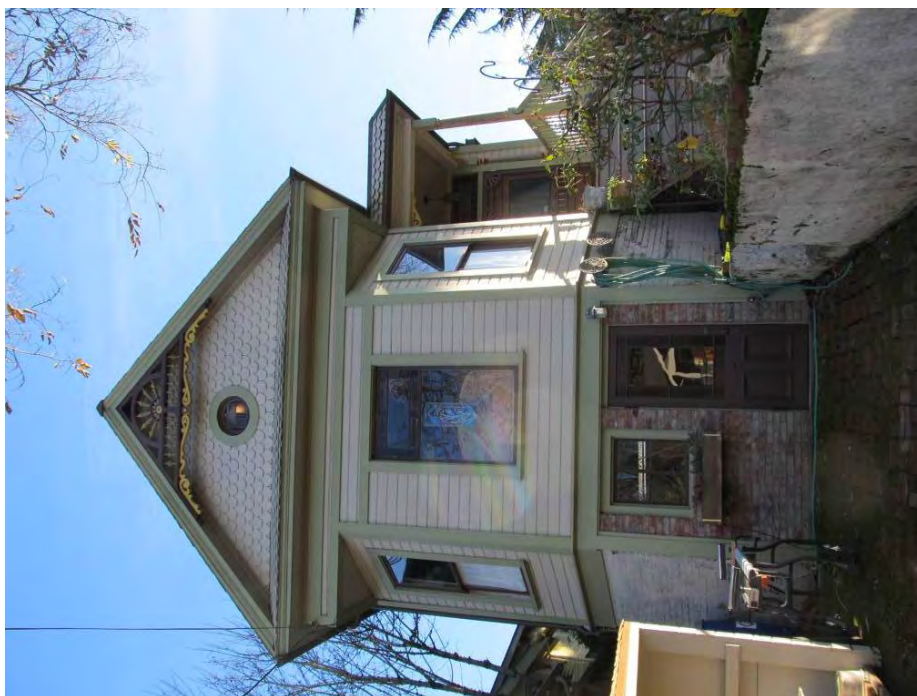
Photo 3 of 15. (OR_MultnomahCounty_AndrewJMinnieJBrooksHouse_0003)
West façade (main) from the driveway. Camera facing east.

The Brooks House sits on a brick foundation and is clad with V-groove wood drop siding. It is embellished with wood octagonal imbrication in the upper part of the front gable, which extends to the eave return, and the truncated hipped roof of the porch (Photos 3 and 4). A plain frieze board with bed molding is located under narrow boxed eaves. A broad canted bay is located under the main front gable, which is characterized by its multiple decorative patterns, typical of the Victorian era. The gable end is ornamented with spindle-work, which appears original to the house. The plain frieze board surmounts the bay window, which is missing its decorative brackets and pendants, as seen in similar houses in the city. This corner has a wood soffit and simple wood trim. Corner boards and horizontal wood trim board finish the front, which also includes a wood water table and water cap (Photo 3).

from the site and framed with corner boards. The fenestration pattern on this facade is regular and consistent with the style of the building. The windows on the sides of the bay are double-hung, one-over-one-light with lambs tongue and a simple wood surround. There is a Queen Anne window in the center of the bay with decorated upper sash. All these windows appear to be original to the house. The basement window on this facade is a casement window with four panes that was found underneath the porch during renovations of the house in the 2000s. The wood door at this level was salvaged from another building and has a glass pane on top, decorated in a similar pattern as the Queen Anne window.² A circular window with stained glass and simple wood trim is located in the center of the gable, under the spindlework, (Photos 3 and 4).

The main entrance is reached by a set of nine enclosed wood steps perforated with heart shapes in the risers. The wood handrail reaches the newel post on the last tread, the balusters are carried by a simple wood rail, and every piece is ornamented. The bottom of some balusters have been damaged by the weather. The handrail reaches the turned porch support and extends to the wall on the south side of the door in an engaged column, in the same style as the freestanding support. The engaged columns are the only original piece on the porch; however, the restored post and handrails were designed to match the original patterns. The entrance porch is finished in wood tongue-and-groove flooring on top of a concrete pad that was constructed in the 1970s. The main door is a decorative panel door with a light in the upper portion. The door is not original to the house. A stained glass transom embellishes the door (Photo 3 and 9).

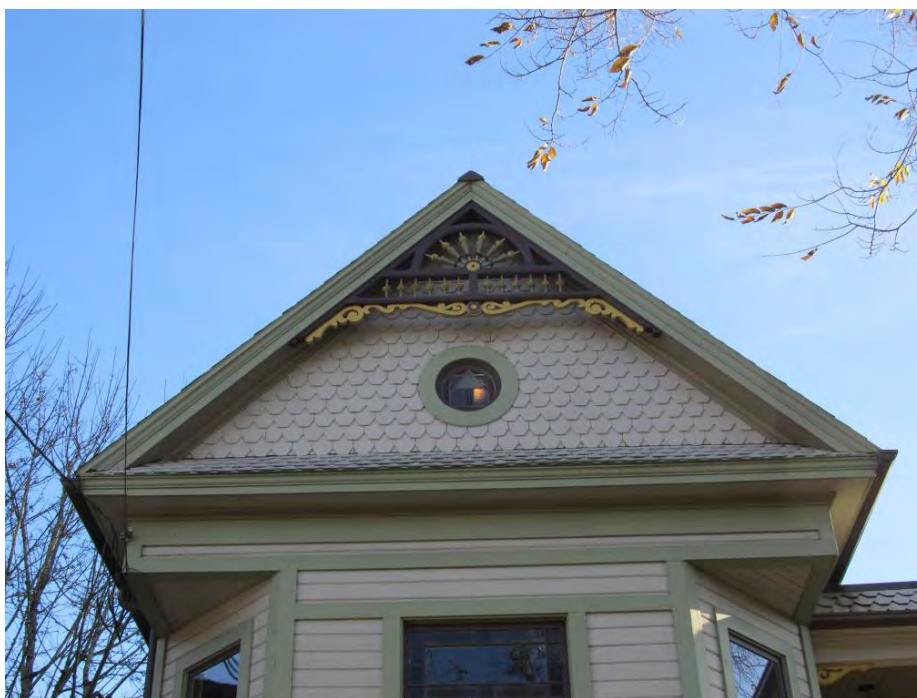
Photo 4 of 15. (OR_MultnomahCounty_AndrewJMinnieJBrooksHouse_0004)
Detail of the gable at west façade (main). Camera facing east.

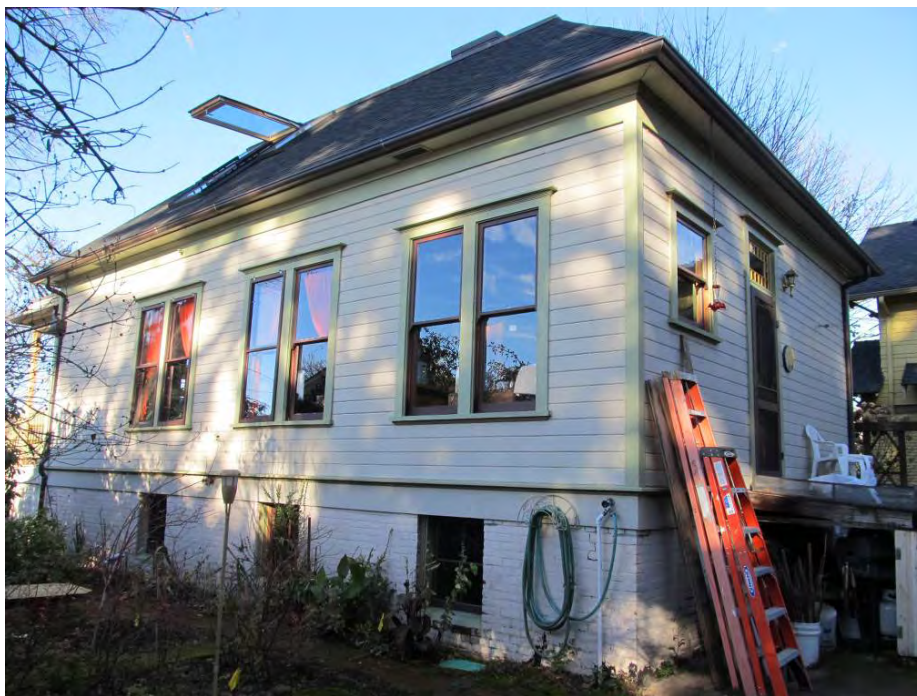
Photo 5 of 15. (OR_MultnomahCounty_AndrewJMinnieJBrooksHouse_0005)

South façade (left) and east façade (right). Camera facing northwest.

The east facade is very simple (Photos 5 and 6). There is a door just south of center with a small double-hung window in the southern side of the facade. The door is surmounted by a transom window and covered with a screen door. Both the door and transom feature stained glass typical of the Victorian era and are not original to the house. A temporary wood deck is reached by a set of wood steps. The area underneath the deck is used for storage and is clad by drop siding. There is a set of hinged double doors in the east facade, north of the stairs, which allows access to storage under the deck.

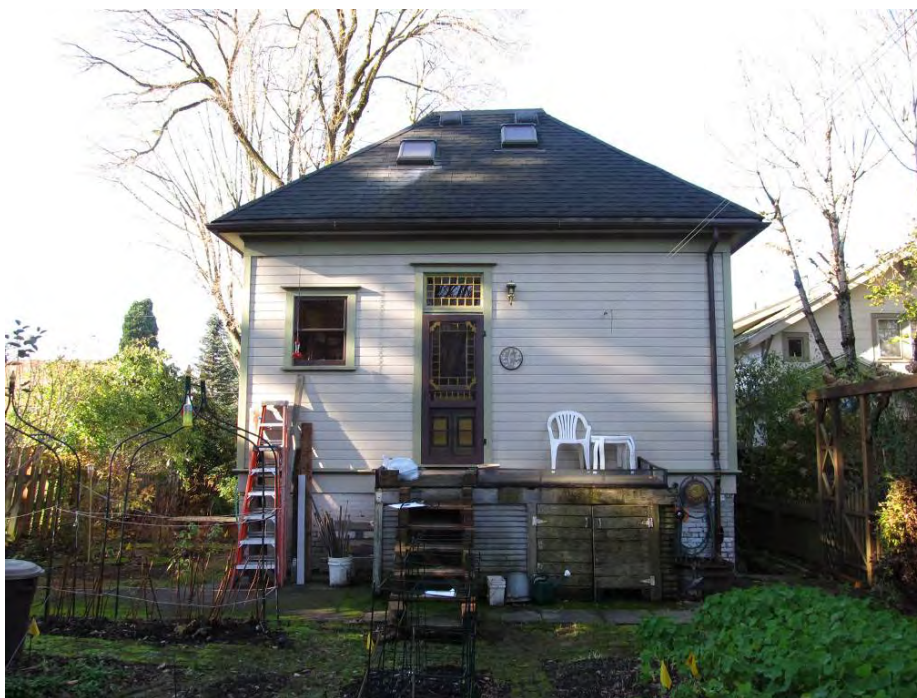
Photo 6 of 15. (OR_MultnomahCounty_AndrewJMinnieJBrooksHouse_0006)

East façade (rear). Note the fence on the left. Camera facing west.

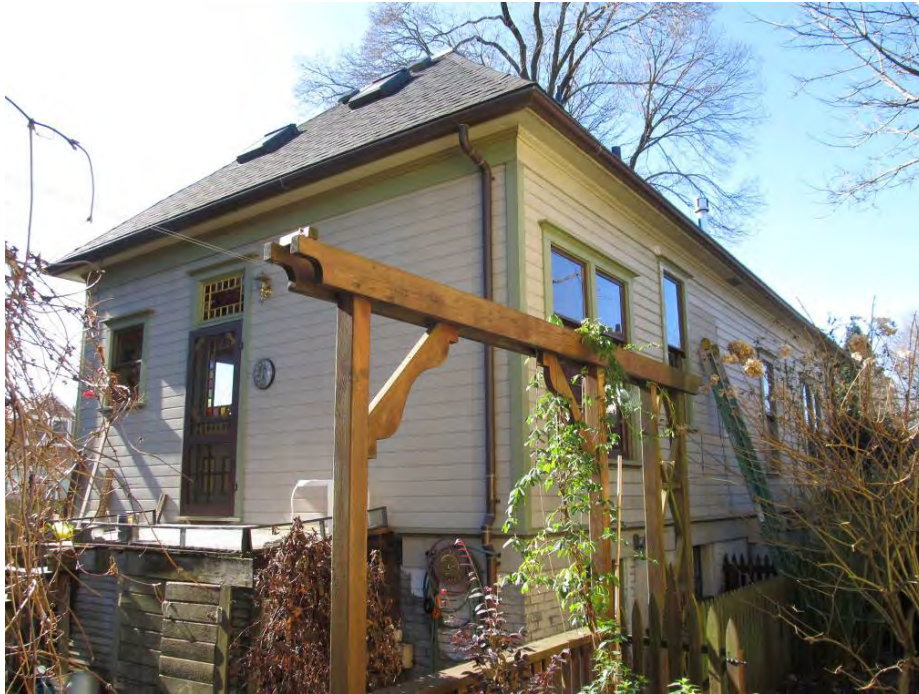
Photo 7 of 15. (OR_MultnomahCounty_AndrewJMinnieJBrooksHouse_0007)

East façade (left) and north façade (right). Camera facing southwest.

A wooden picket fence encloses north and south yards and a tall vertical board fence with lattice on top encloses the east boundary. The east side of the north fence has a gate that connects with the lot to the northeast (Photo 7). This gate is close to the basement entrance located on the north façade. This entrance is accessed by a set of concrete steps that appears to be original to the house (Photo 8). The north fence is very close to the house, just three feet from the building (Figure 3 and Photos 6 and 7).

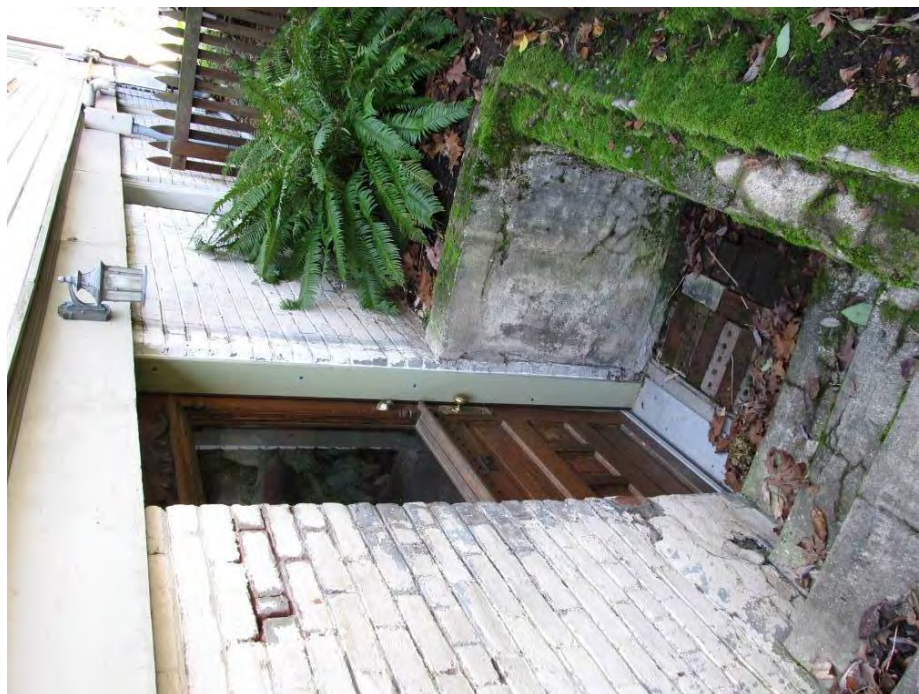
Photo 8 of 15. (OR_MultnomahCounty_AndrewJMinnieJBrooksHouse_0008)

North façade. Door that access to the basement. Camera facing southwest.

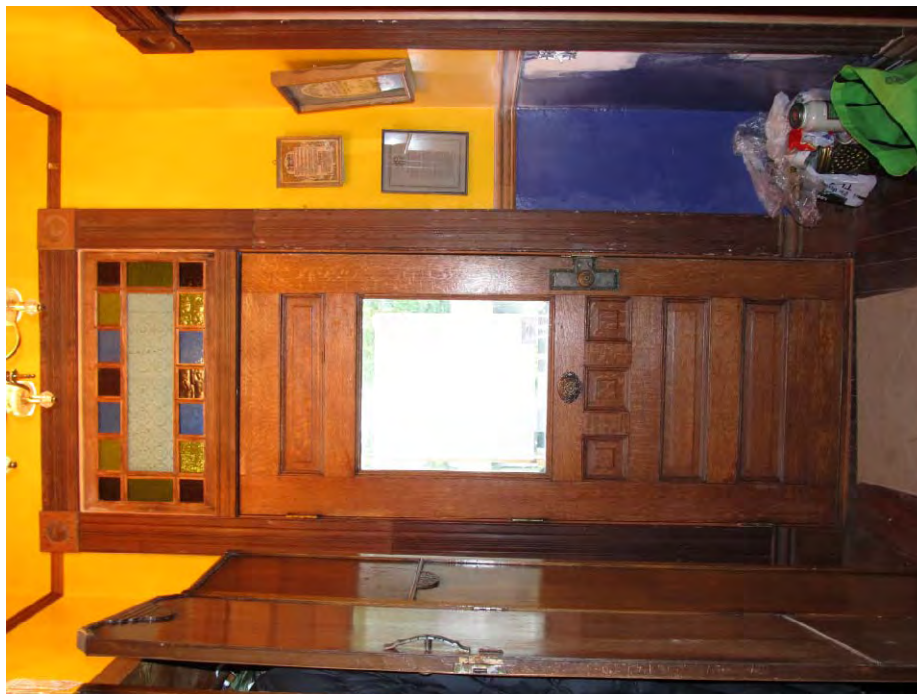
Photo 9 of 15. (OR_MultnomahCounty_AndrewJMinnieJBrooksHouse_0009)

Interior. Main entry door at foyer or entry hall, entry to the parlor at right. Camera facing west

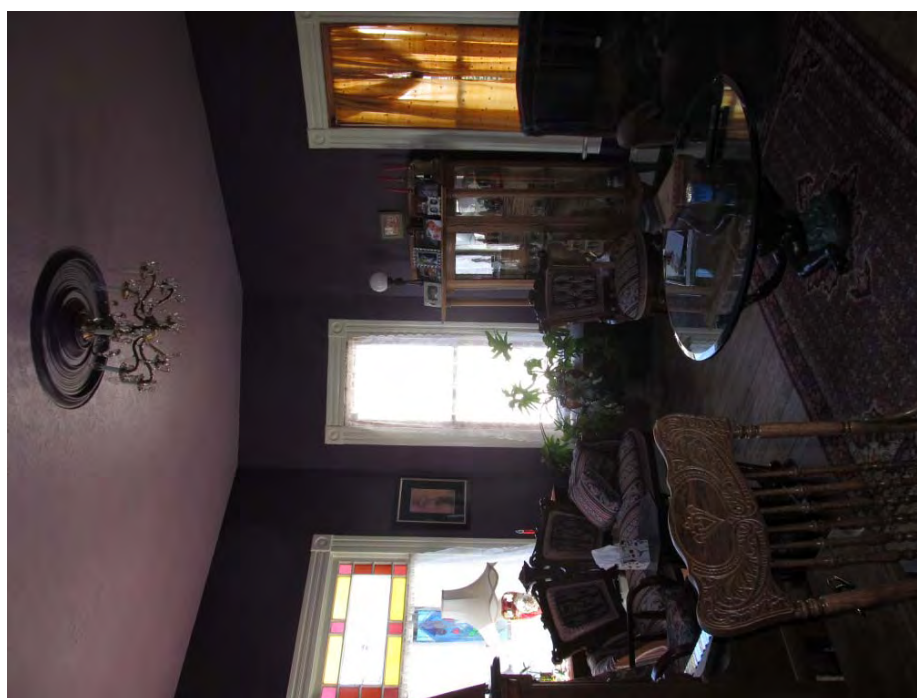
Photo 10 of 15. (OR_MultnomahCounty_AndrewJMinnieJBrooksHouse_0010)

Interior. View of the parlor from the door at the foyer. Camera facing northwest.

Following the design of Queen Anne houses, the parlor for receiving guests is off the foyer in the bay window area (Photo 10). The original ceiling plaster medallion located in the center of the room was found during a restoration process in 2001 (Photo 11 and Historic Photo 5). The window trim is similar to the doors with wood trim and corner blocks. There is a salvaged period Victorian gas furnace with a metal grid in the east wall. There is no mantel.⁴

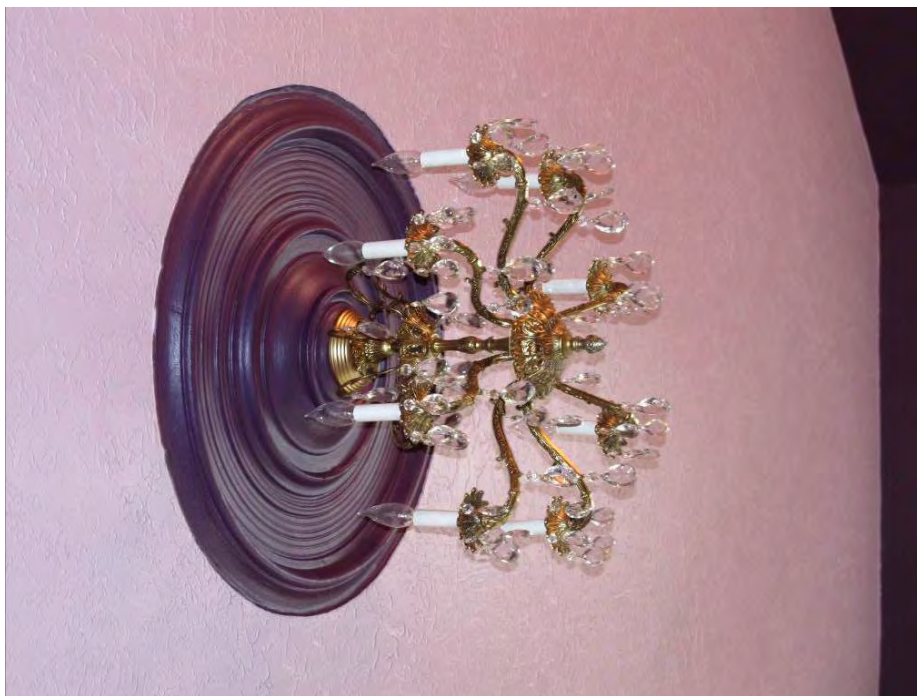
Photo 11 of 15. (OR_MultnomahCounty_AndrewJMinnieJBrooksHouse_0011)
Interior. Detail of original ceiling plaster medallion at parlor.

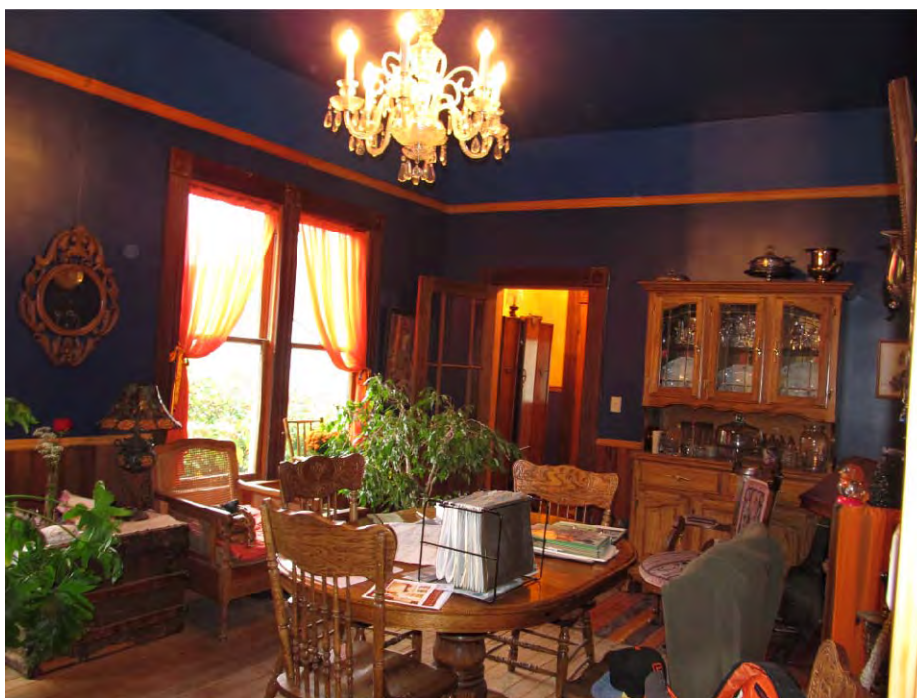
Photo 12 of 15. (OR_MultnomahCounty_AndrewJMinnieJBrooksHouse_0012)
Interior. Dining room, at the center is the entry door from the foyer. Camera facing southwest.

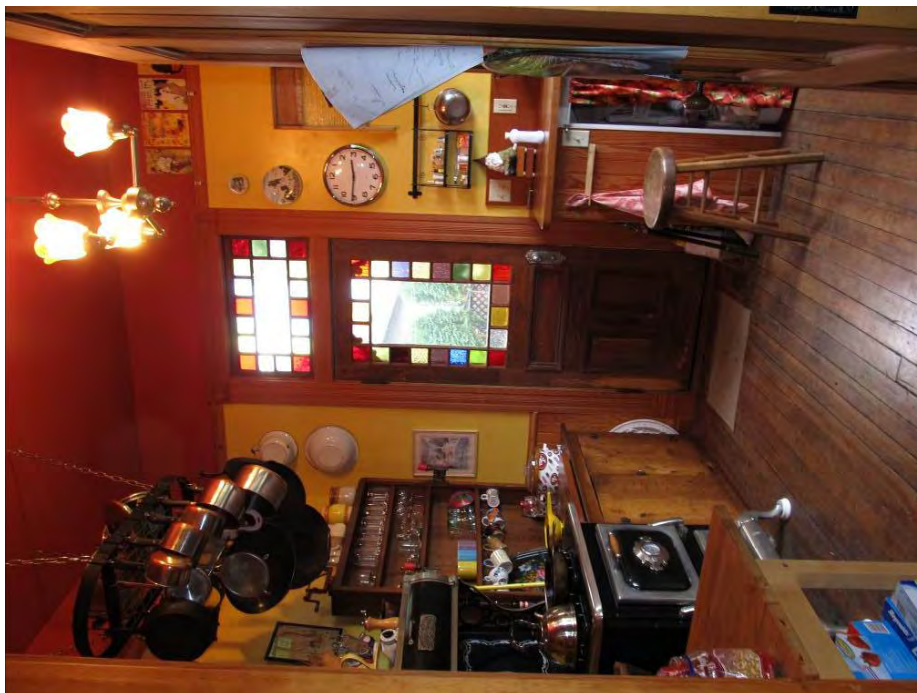
Photo 13 of 15. (OR_MultnomahCounty_AndrewJMinnieJBrooksHouse_0013)

Interior. Kitchen, view from the wall between dining room and kitchen. The door leads to the rear porch. Camera facing northeast.

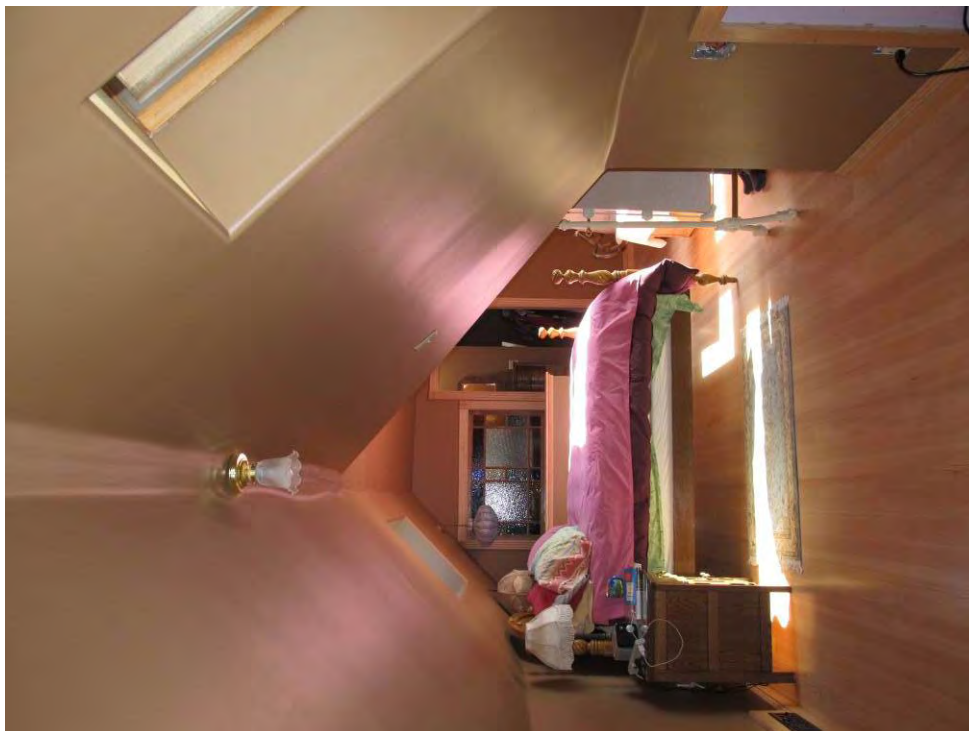
Photo 15 of 15. (OR_MultnomahCounty_AndrewJMinnieJBrooksHouse_0015)

Interior. View of the attic, at end is a half wall from the stairs and the bathroom. Camera facing east.

The attic apparently was not originally accessed by a staircase; there was probably a pull down ladder in the hallway between the bedroom and the bathroom or in the dining room, though evidence has not been found. Today a hollow-newel wood staircase is located between the downstairs bedroom and the bathroom. This staircase, as explained above, runs from the attic to the basement. In the attic, it lands in the center of the space and divides the area in two. This whole level is the master bedroom. There is a sleep chamber in the west side and a bathroom on the east side of the stairs. There are three skylights that allow light in the south slope of the roof, two in the sleeping area, as well as one small skylight in the western end of the room, used as a reading area. There is another skylight in the north slope next to the landing of the stairs. In the bathroom, there are four skylights, one on the top flat area of the hipped room, one on the north slope and two on the east slope. All these changes were underway in 2012-2013 and were not finished at the time of this nomination. A wall separates the bathroom from the rest of the space. There are storage/closets along the knee area.

The 1970s spiral staircase in the northwest corner of dining room was removed in 2012 (Figure 6).¹³ Some of the original wainscoting found in the kitchen, bathroom, and dining room was restored, in some cases reproduced to install in areas where it had been lost. The floors were also restored in some cases and replaced in kind in some areas. All the historic interior doors that were replaced in the 1970s by modern doors and the current owner restored them with period doors salvaged from other buildings.¹⁴ The 1970s kitchen extension was removed and the kitchen reduced to its original size (Historic Photo 4). During the renovation, the original placement of the sink was found in the southeast corner facing the east wall, where the new sink is now located. The original stove left a shadow on the wood floor in the northwest corner of the kitchen (Figures 4 and 6). The bedroom and bathroom on the main level were renovated. A closet that used to stand between the bedroom and the bathroom was removed to open space for the present staircase. The attic was also altered during this period. The changes made in the 1970s were removed and the roof was completely redone and reinforced. The chimneys were removed and the area in the attic became a large space that is used today as the master bedroom. A bathroom was built, as previously explained, in the eastern side of the attic (Photo 15 and Figure 5).
