Portland Watershed Report Cards

Portland City Council
April 22, 2015

NICK FISH, COMMISSIONER
JAMES HAGERMAN, INTERIM DIRECTOR

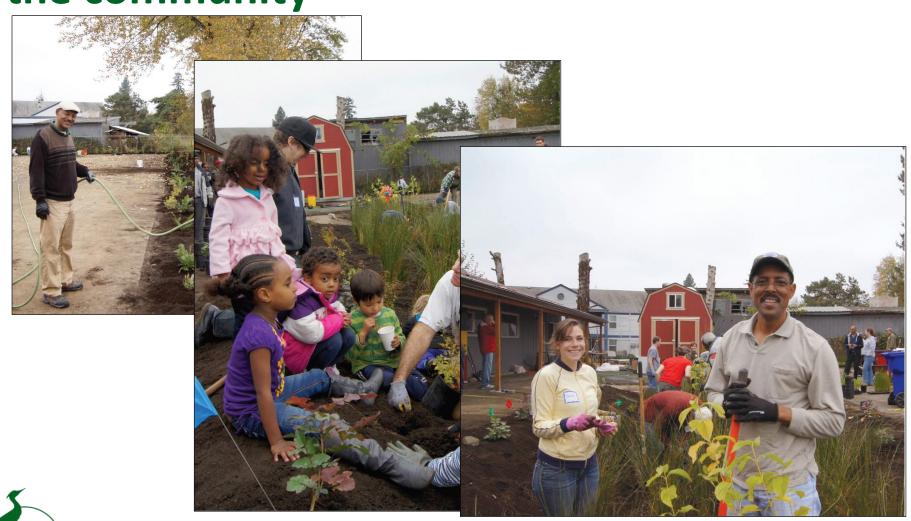
Mason Flats: Managing stormwater and improving habitat in the Columbia Slough

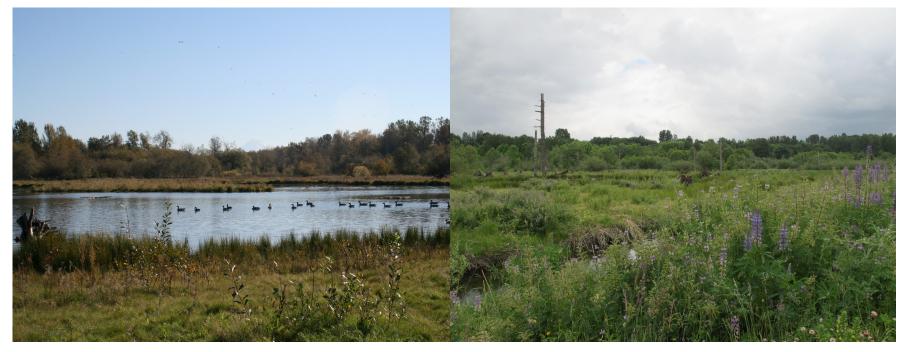
Improved Hydrology, Water Quality, and Habitat

- Restored wetlands and channels capture stormwater runoff from 600 acres of streets, residential and commercial area in NE Portland
- Reduces pollutants, provides more clean, cold water to the Slough
- Removed invasives, enhanced native trees and plants
- Provides 25 acres of habitat for native fish and wildlife (like turtles, migratory birds, pollinators)
