MEMORANDUM

RE: North Suttle Road Engineering Study

Limited Geotechnical Design Study

North Suttle Road

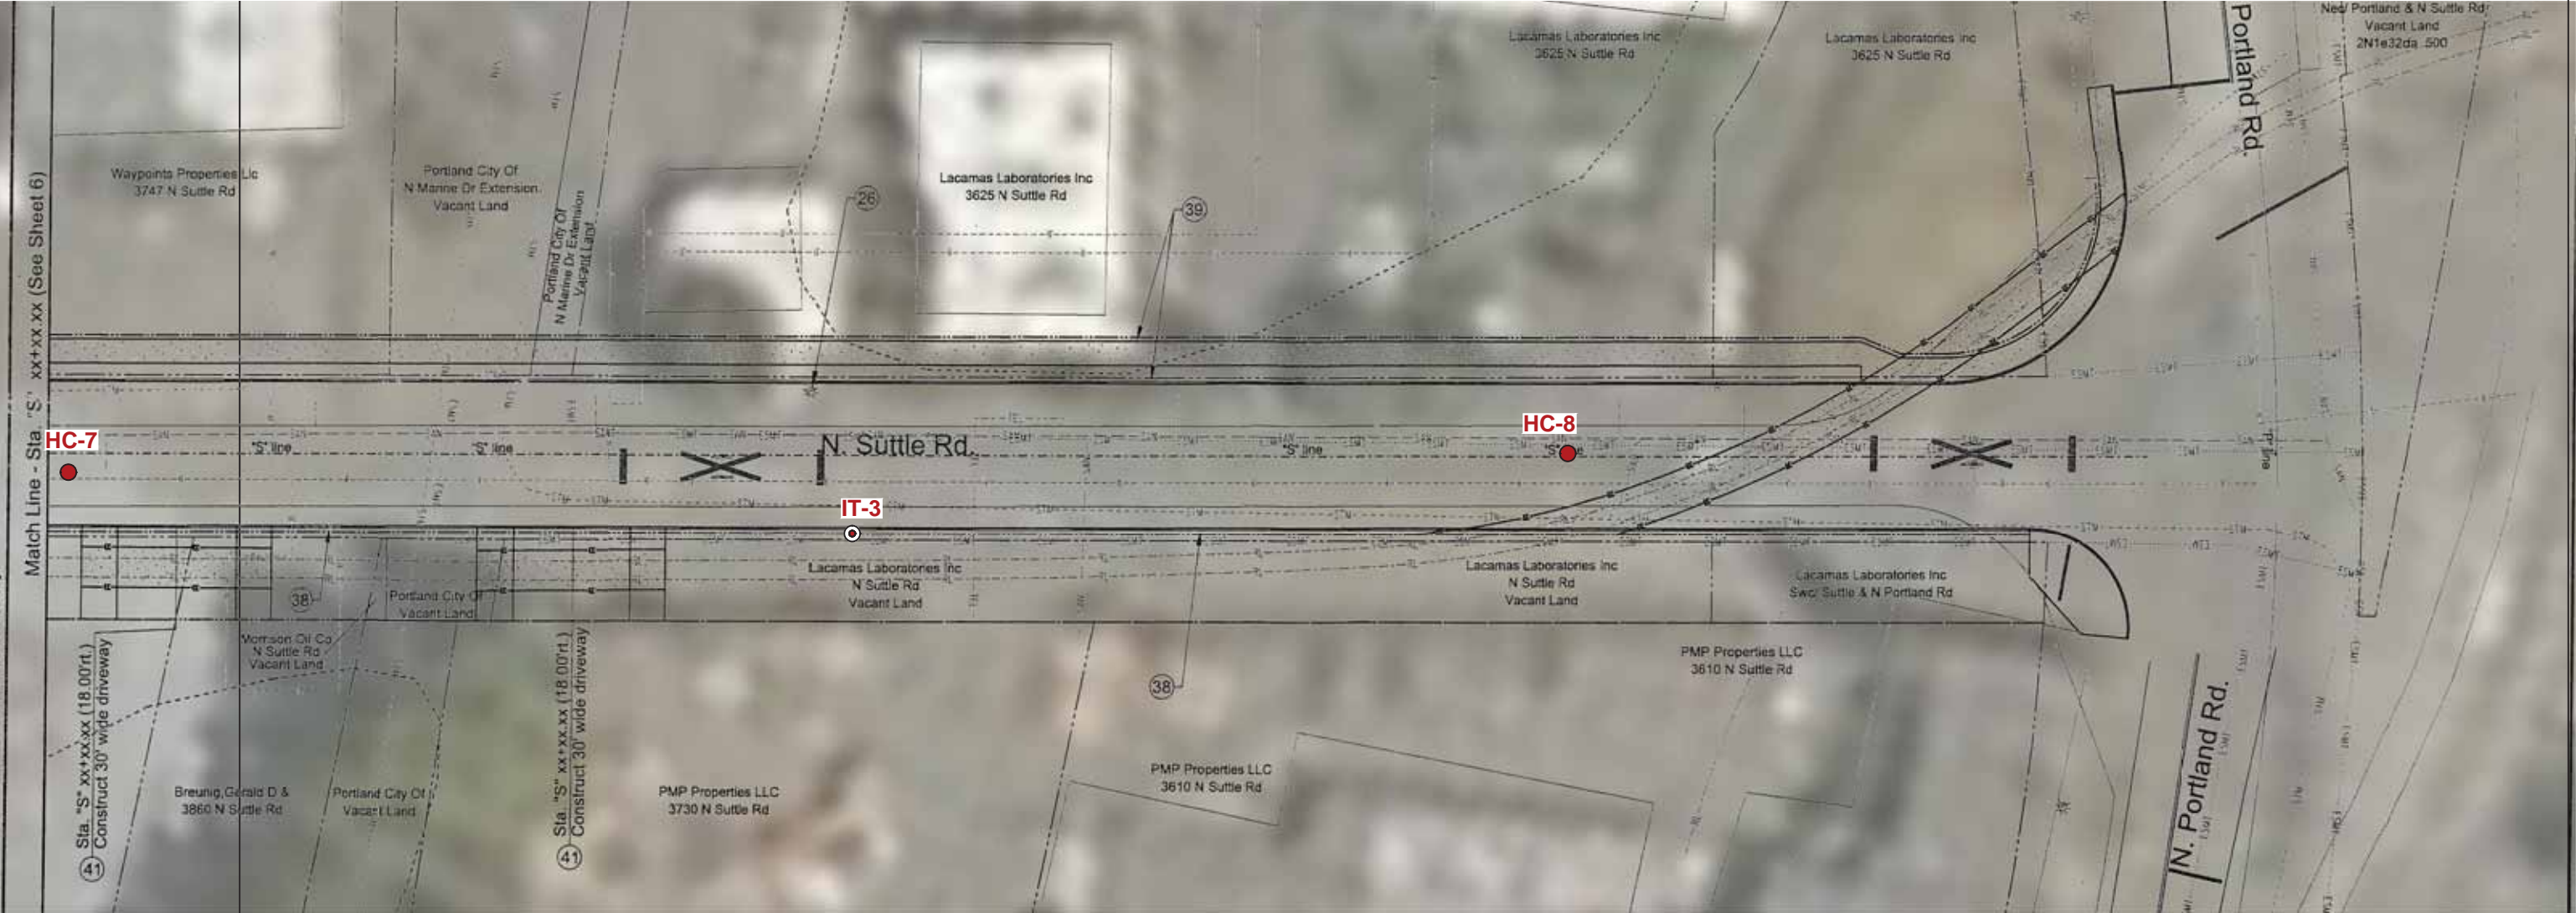
Figure
2
Sheet 4 of 5

subgrade. We further explored subsurface soil conditions by excavating eight soil borings, designated HC-1 through HC-8, and three infiltration tests borings, designated IT-1 through IT-3. The soil borings were advanced to depths ranging from approximately 1 to 9 feet bgs. The adjacent *in situ* infiltration tests were completed to depths ranging between approximately 2.75 and 3.5 feet bgs. DCP probes were generally advanced between 0.7 and 4 feet bgs. Locations of the borings and infiltration tests are shown on Figure 2.

We performed three falling head field infiltration tests (IT-1 through IT-3) at the locations shown on Figure 2. The field infiltration tests were conducted in general accordance with the methodologies outlined in Chapter 2, Section 2.3.6 of Portland’s *Stormwater Management Manual* (SWMM) (Portland 2016) for “falling head encased borehole” tests. However, a formal “depth to groundwater study” was not completed, and the number of infiltration tests completed is not sufficient for final design; therefore, the following data should be considered preliminary in nature. The field test methods are briefly described in Appendix A of this report.

Figure 2 of the report illustrates the locations of the explorations. Exploration locations were estimated in the field based on existing landmarks.
