## About Your Building

<b>Building Name</b>	Eastgate
<b>Address</b>	9220 S.E. Stark Street
<b>Portland Building ID</b>	1S2E04AB-600-B1
<b>EnergyStar Score</b>	Not Available

<b>Electricity</b>	Jan 2019 - Dec 2019
<b>Gas</b>	Jan 2019 - Dec 2019
<b>Bldg. Size</b>	36,900 s.f.
<b>Bldg. Type</b>	Fitness Center/Health Club/Gym

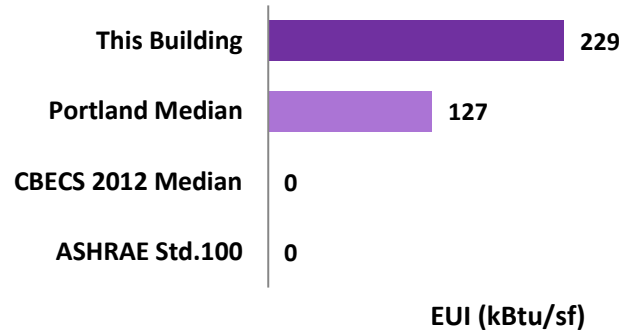
The chart to the right compares your building's annual energy use intensity (EUI) with national and local standards. EUI is a common energy metric that measures your building's energy use per square foot by dividing total annual energy use by the size of your building. This building type does not have well-established national reference benchmarks available for comparison. However, the median Portland performance is included per the 2019 disclosure data\*\*\* for comparison.

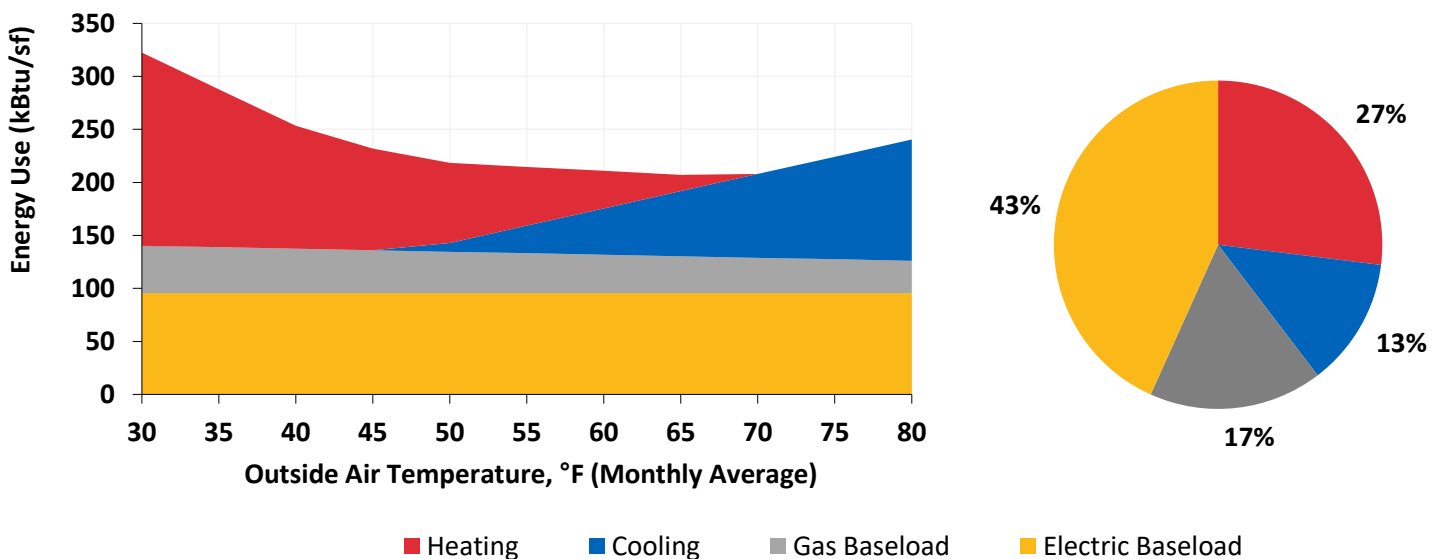
## How Energy is Used in Your Building

The chart below shows your building's total energy use at a range of outside temperatures and is split into four end-use categories: heating (electric and gas), cooling, electric baseload (e.g. plugs, lights, and equipment), and thermal baseload (e.g. gas used for water heating). This offers insights into energy consumption patterns, including how your building's energy use is allocated. FirstView identifies end-uses with high usage compared to similar buildings in the diagnostics on page 1. [Click here](#) to learn more.

Category	Status
Heating and Ventilation Efficiency	Poor
Cooling Efficiency	Typical
HVAC Reheat	Apparent Excessive Reheat
Gas Baseload	High
Light and Plug Loads	High
External/Process Load	High
Portfolio Manager Data Consistency	Orderly

- This building may be a good candidate for potential heating system improvements. Excess outside air rates, high outside air infiltration, poor control settings, and 24-hour fan schedules may be present.

- This building may have issues with excess HVAC reheat. Overcooling and re-heating, or simultaneous heating and cooling may be present. Reviewing and updating control sequences and system setpoints may yield significant savings.

- This building has a high gas baseload, which is most likely associated with hot water use for laundry. Adjusting water heater set points and upgrading to high efficiency water heaters and appliances may yield significant savings.

- This building has an elevated electrical baseload. Barring process electrical loads, savings may be available via lighting upgrades, updates to EnergyStar rated appliances, and/or plug load management. Buildings with electric water heaters may also benefit from an upgrade to heat pump water heaters.
