APPEAL SUMMARY

Appeal ID: 15723	Project Address: 7210 N Burlington Ave
Hearing Date: 8/23/17	Appellant Name: Gene Bolante
Case No.: B-004	Appellant Phone: 503-390-6500
Appeal Type: Building	Plans Examiner/Inspector: Marc Vieno, Thomas Ng
Project Type: commercial	Stories: 3 Occupancy: R-2 Construction Type: V-B
Building/Business Name: Ivanhoe 4	Fire Sprinklers: Yes - Throughout
Appeal Involves: Erection of a new structure	LUR or Permit Application No.:
Plan Submitted Option: pdf [File 1] [File 2] [File 3] Proposed use: Multi-Family

APPEAL INFORMATION SHEET

Application of Spray Foam Insulation Under Plywood and OSB Roof Sheathing

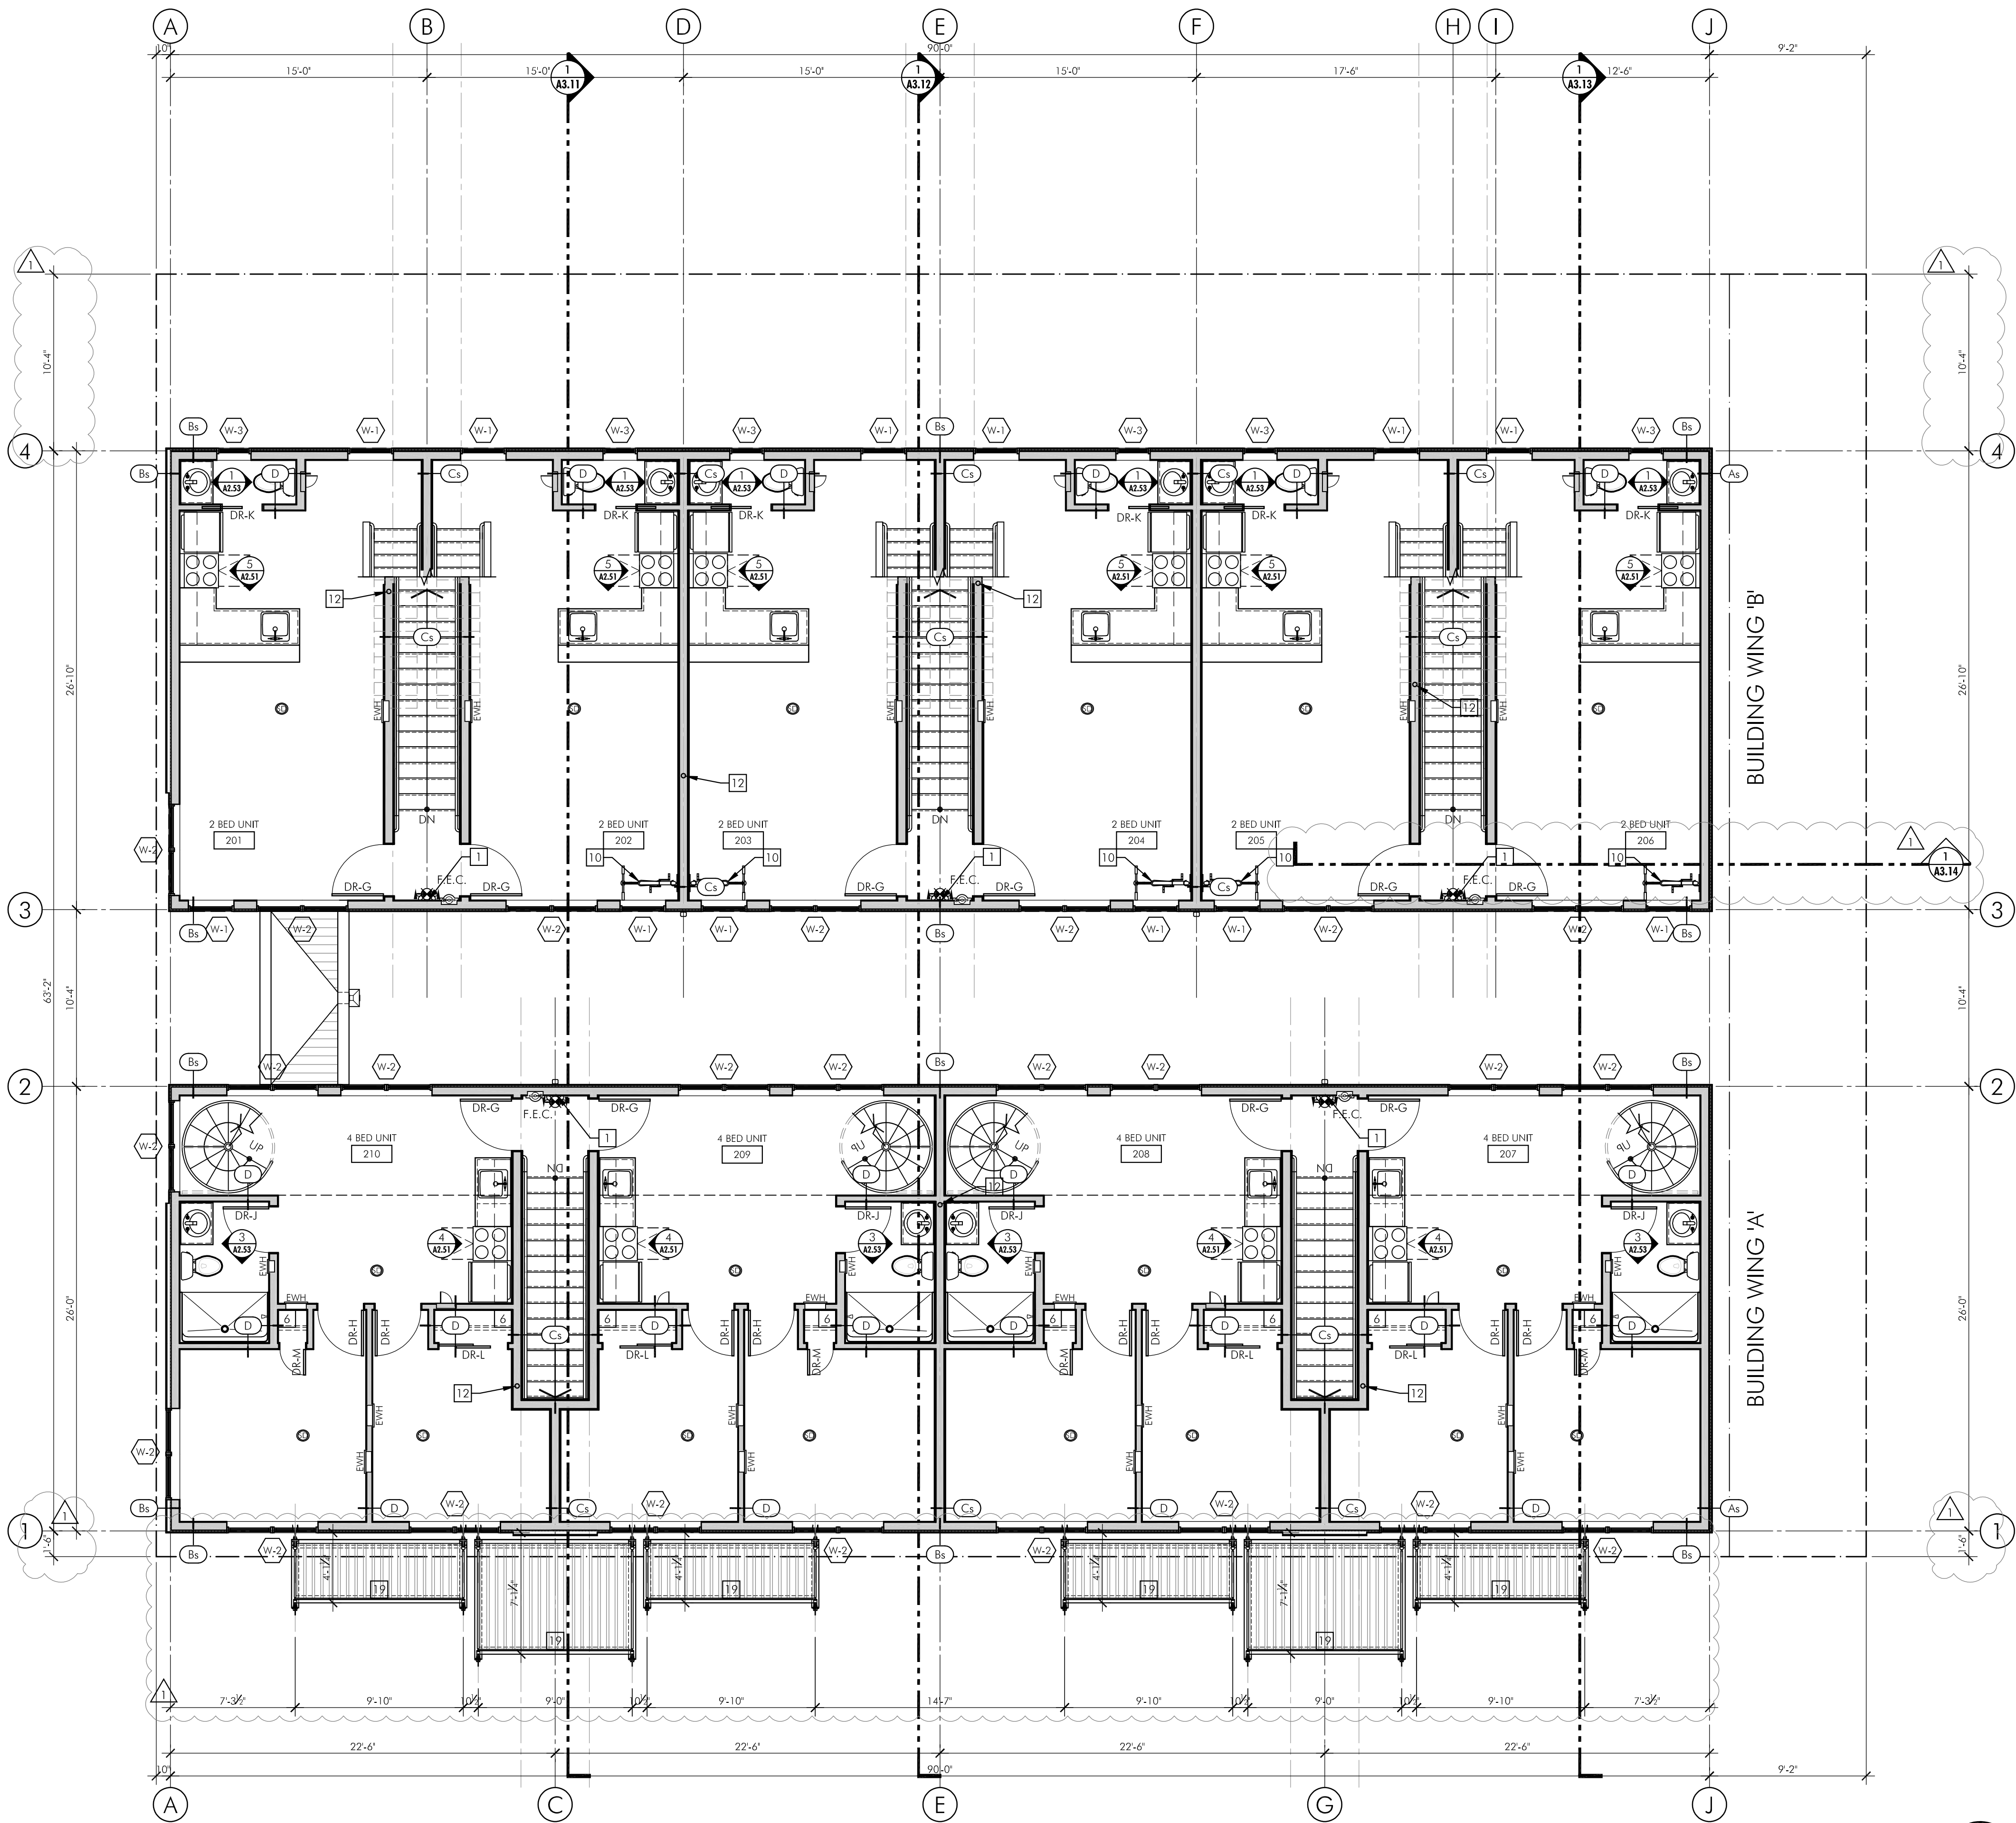
1 LEVEL 02: FLOOR PLAN
0' 2' 4' 6' 8' 10' 12' 14' 16' 3/16" = 1'-0"

LONG TERM BIKE STORAGE MONITORED BY SECURITY CAMERA.

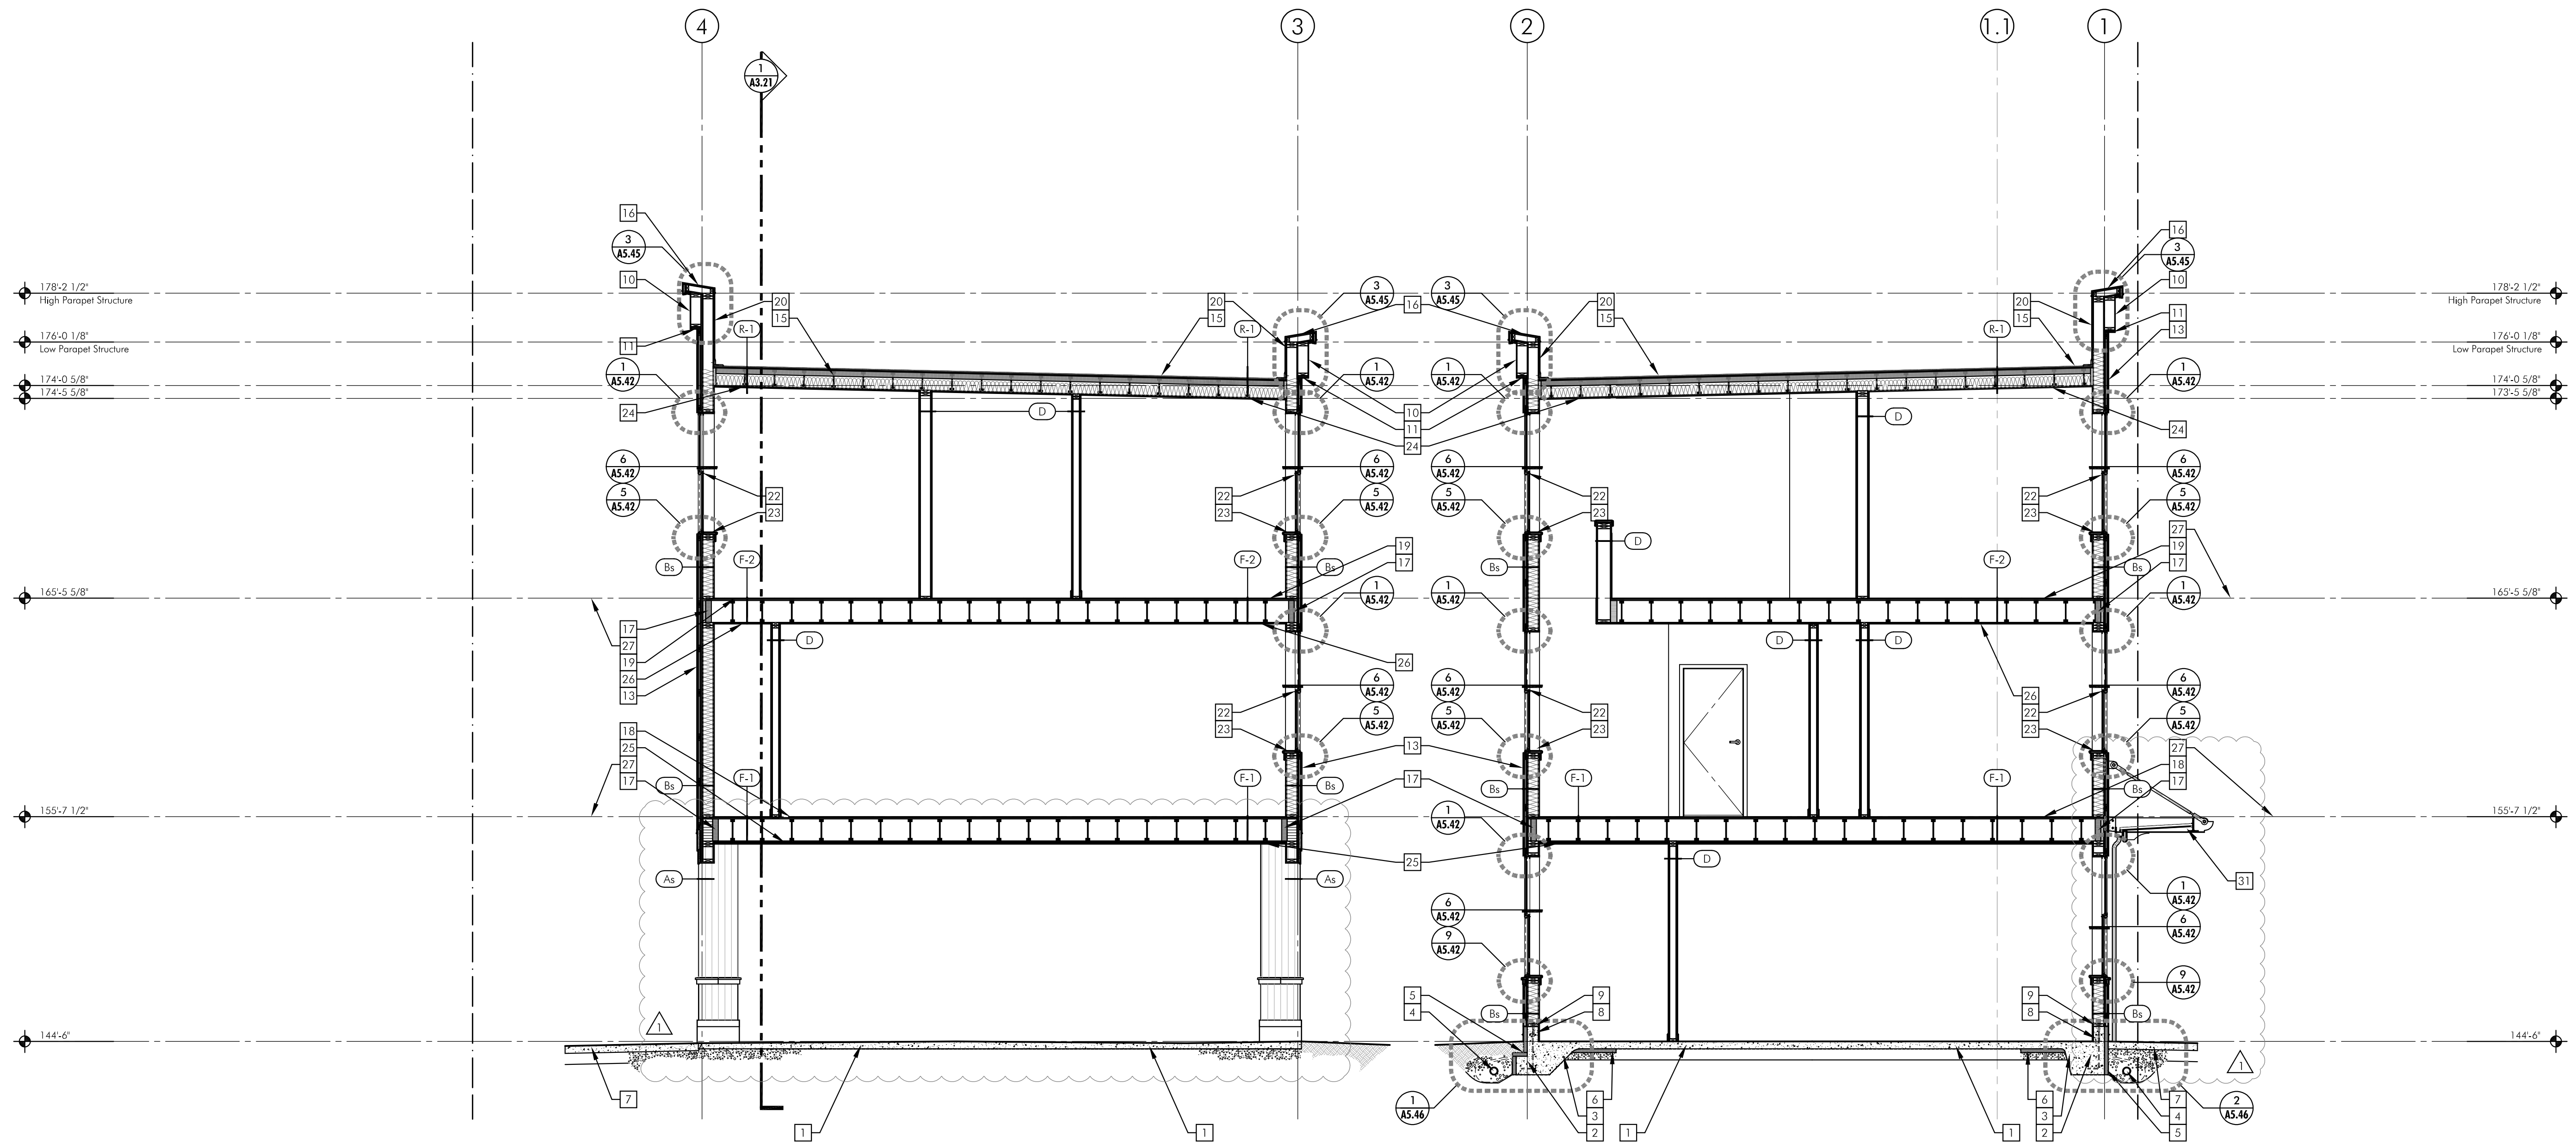
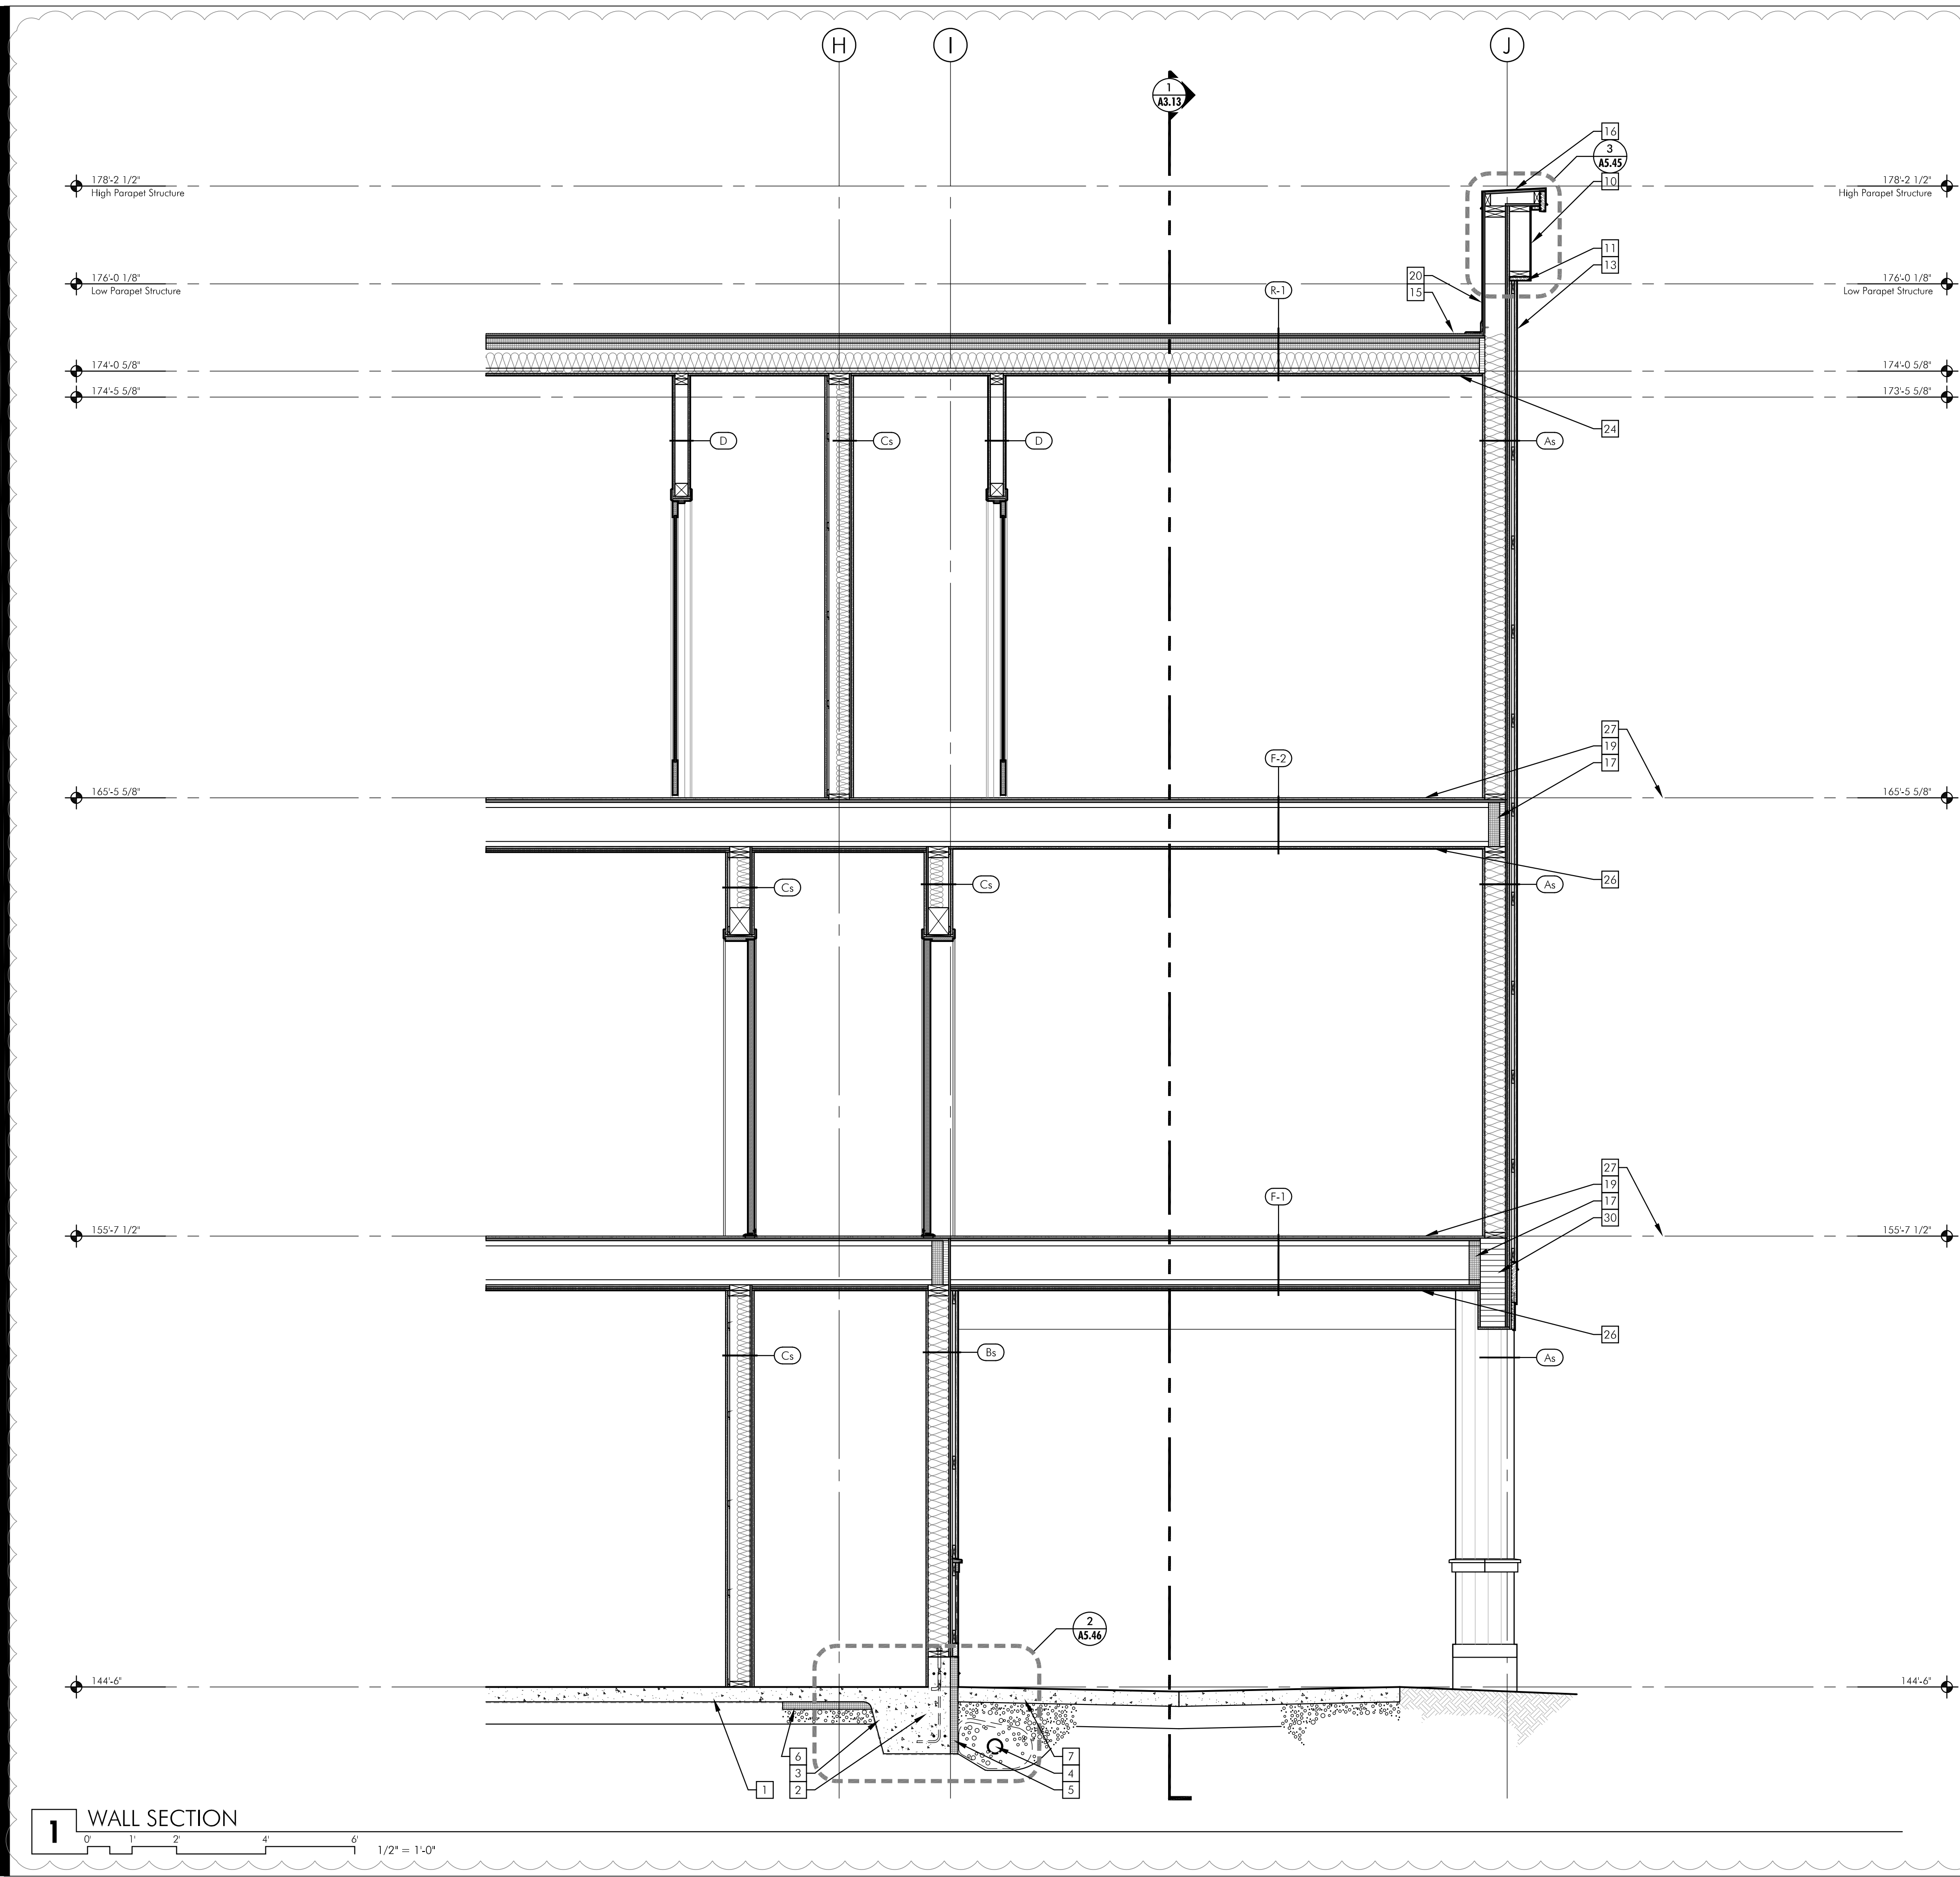
1 BUILDING SECTION

4" Ø PERFORATED FOUNDATION DRAIN WITH MINIMUM 6" DRAIN ROCK COVER ALL AROUND. CONNECT TO STORM SEWER.
- 5

PROVIDE 2" RIGID EXTRUDED POLYSTYRENE (R-10) INSULATION AT OUTSIDE FACE OF FOUNDATION FROM TOP OF CONC CURB TO BOTTOM OF FOOTING AT FULL PERIMETER OF FOUNDATION. PROVIDE 2" RIGID POLYSTYRENE (R-10) INSULATION HORIZONTALLY UNDER SLAB EXTENDING 2'-0" AROUND PERIMETER OF BUILDING AS SHOWN.
- 6

PROVIDE 2" RIGID EXTRUDED POLYSTYRENE (R-10) AT UNDERSIDE OF S.O.G. EXTENDING INWARDS 2'-0" AT FULL PERIMETER OF FOUNDATION.
- 7

AT BACK SIDE OF PARAPET, INSTALL ROOFING MEMBRANE FLASHING, LAPPED OVER SINGLE PLY ROOF MEMBRANE PER MANUFACTURER'S RECOMMENDATIONS AND EXTEND UP AND OVER TOP OF PARAPET FRAMING, OVER WEATHER RESISTIVE BARRIER, MIN. 4" LAP, TAPE SEALED.
- 21

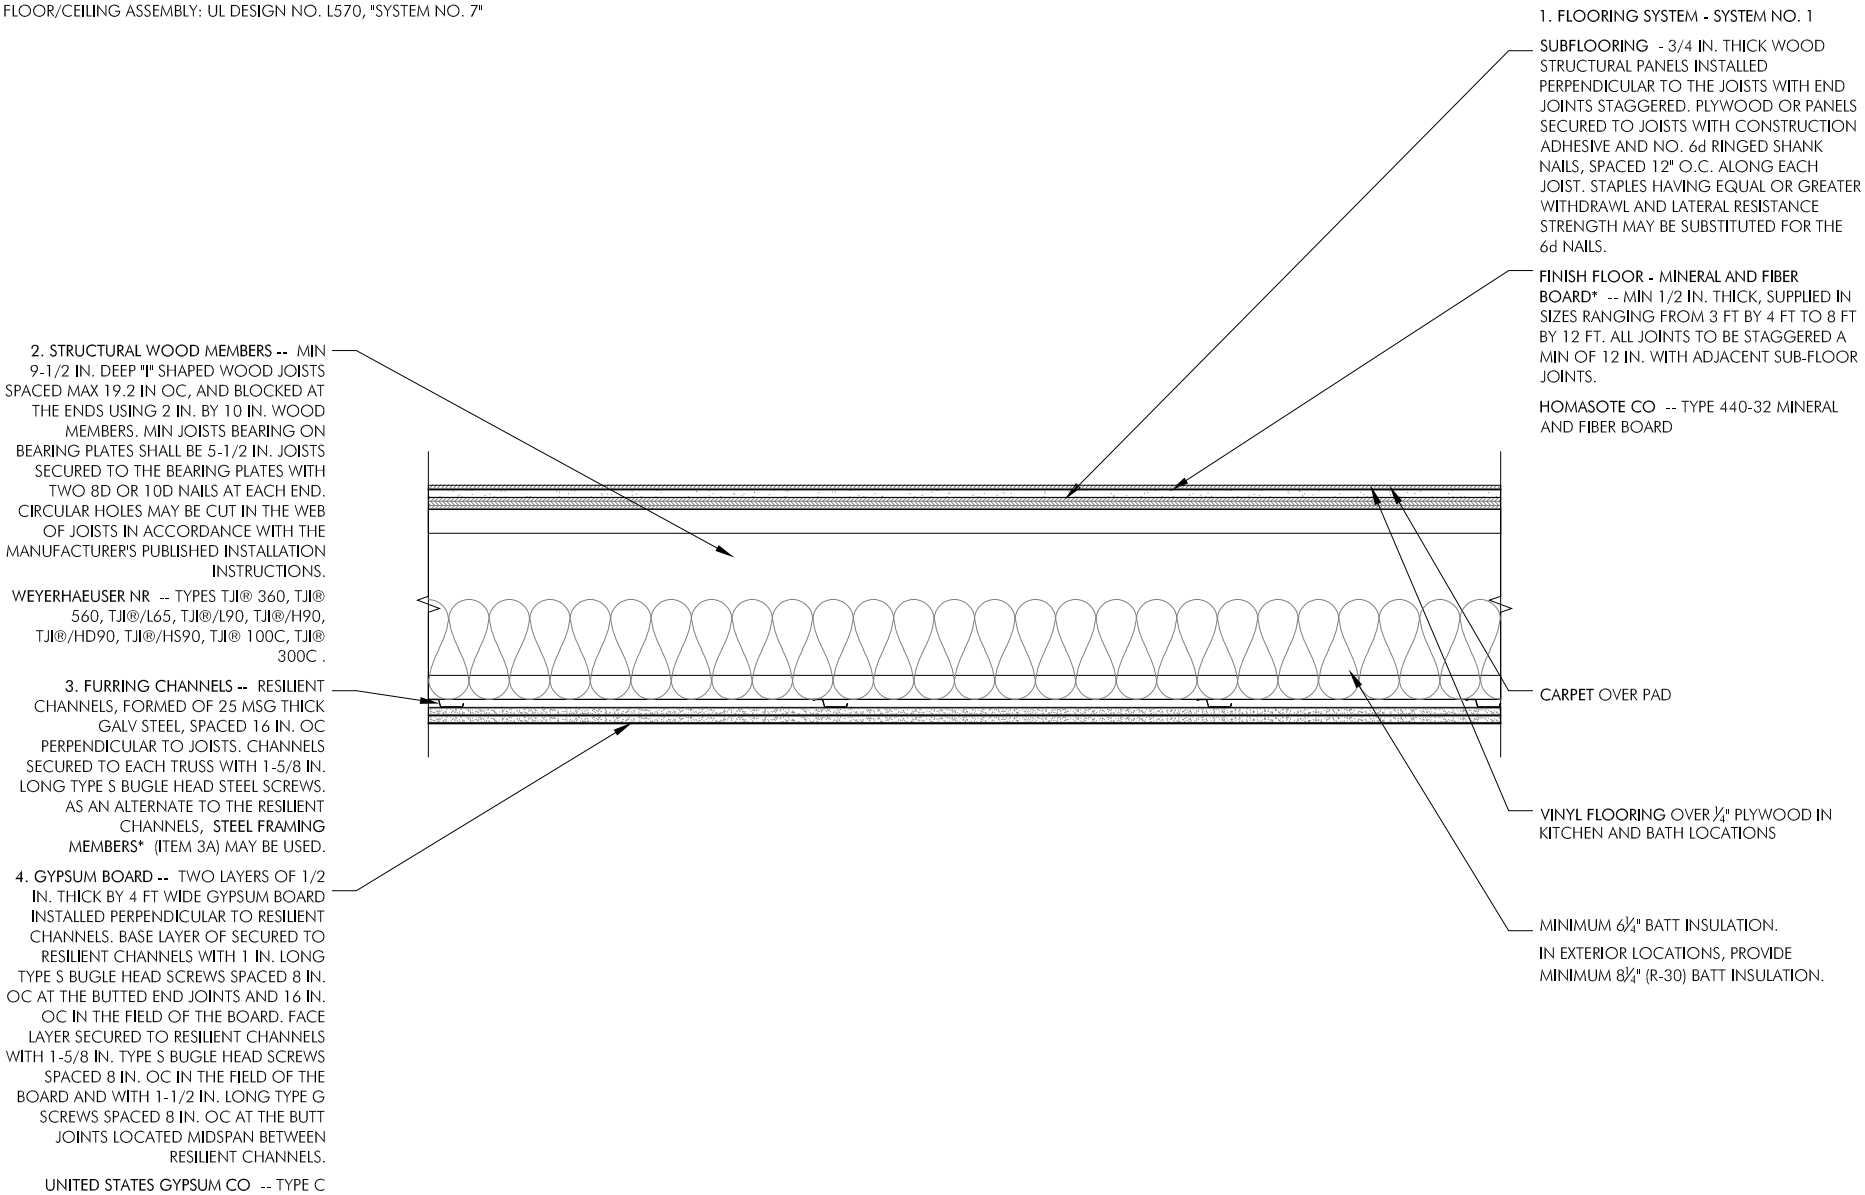
F.R.	1-HOUR
STC	CARPET 51, IIC 75 VINYL 52, IIC 50

EXTERIOR WALL ASSEMBLY: GA FILE NO. WP
8105 (GENERIC) INCREASE FASTENER
LENGTH ON STRUCTURAL PANEL SIDE BY
PANEL THICKNESS

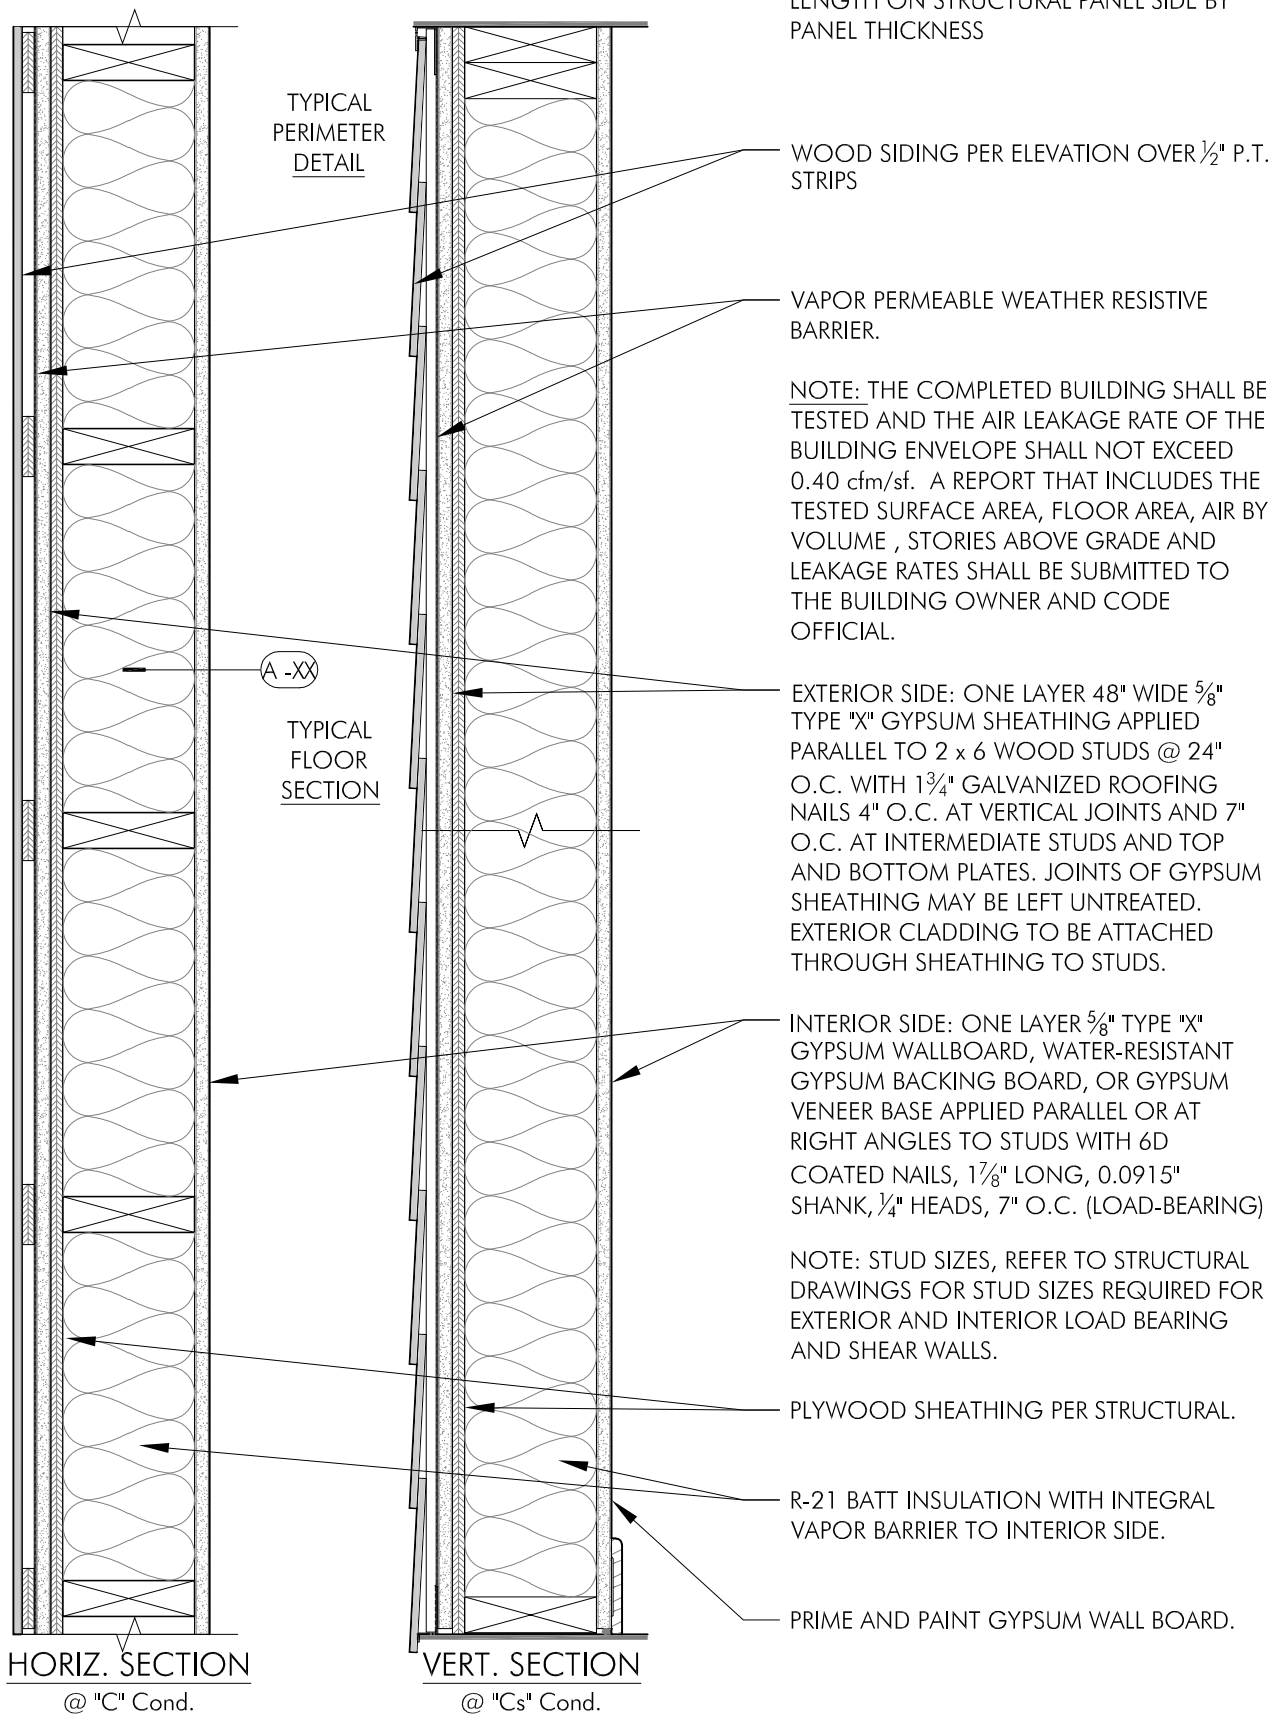
F.R.	1 Hour	EXTERIOR WALL TYPE:	A
STC		R-21 THERMAL BATT INSULATION	As

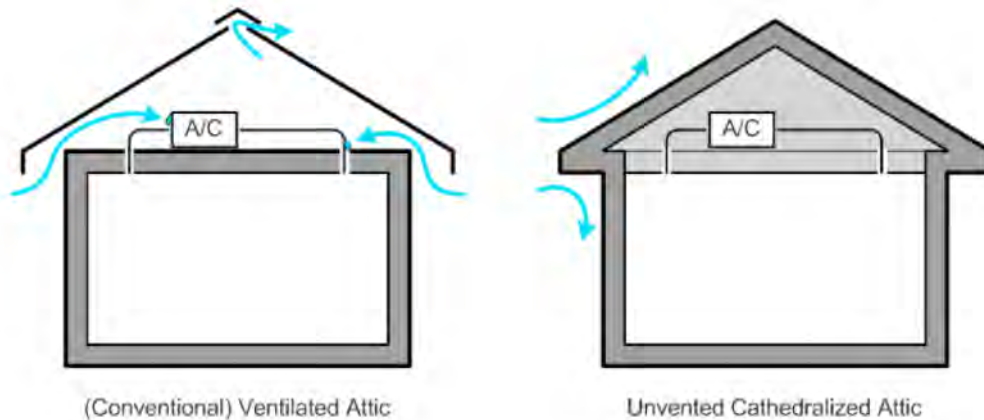
Figure 1. Cathedralized or unvented attics

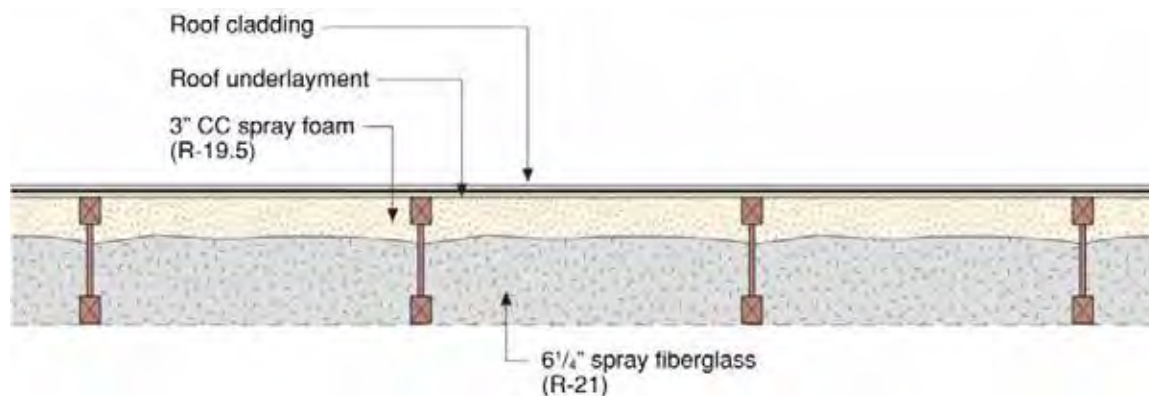
All unvented attic and cathedral ceiling designs must provide for either a very high degree of airtightness or avoidance of condensation by warming sensitive surfaces. To meet durability goals in most applications, the airtightness must be provided by a continuous membrane—preferably adhered to the top surface of the structural roof deck and under rigid insulation that provides condensation control. In designs where the airtightness is provided between framing elements, SPF has been found to be a practical solution. However, all wood-to-wood joints in the framing must still be sealed. Figure 2 shows the application of SPF to form an air barrier in a hybrid roof system.

Figure 2. Example high-R hybrid unvented cathedralized ceiling/attic

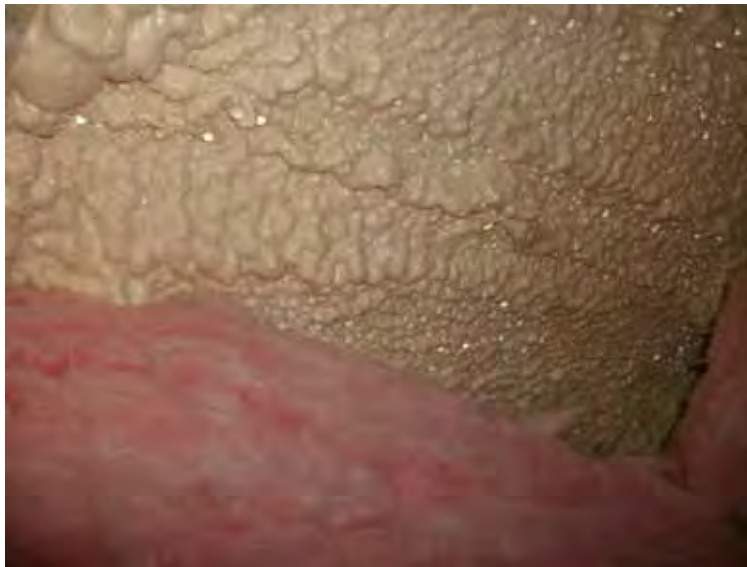
A roof that does not meet the IRC has the potential to have condensation within the assembly. As an example, the roof shown in Figure 3 was designed as an unvented roof assembly using ccSPF against the underside of the sheathing and batt insulation inboard of the SPF. The ccSPF in some locations was only 1 in. thick and R-28 batt was installed to the interior. The IRC requirement for climate zone 5 is R-25 for the SPF in this case and only R-6 to R-10 was present in this home. This resulted in condensation forming on the face of the ccSPF as the face of the SPF was colder than the dew point of the interior air. The quantity of condensation was further increased as the relative humidity (RH) in the house was quite high because drywall mudding and painting were underway. It is important for condensation control to maintain possible condensation surface temperatures above the dew point of the interior air.

Figure 3. ccSPF unvented roof with condensation

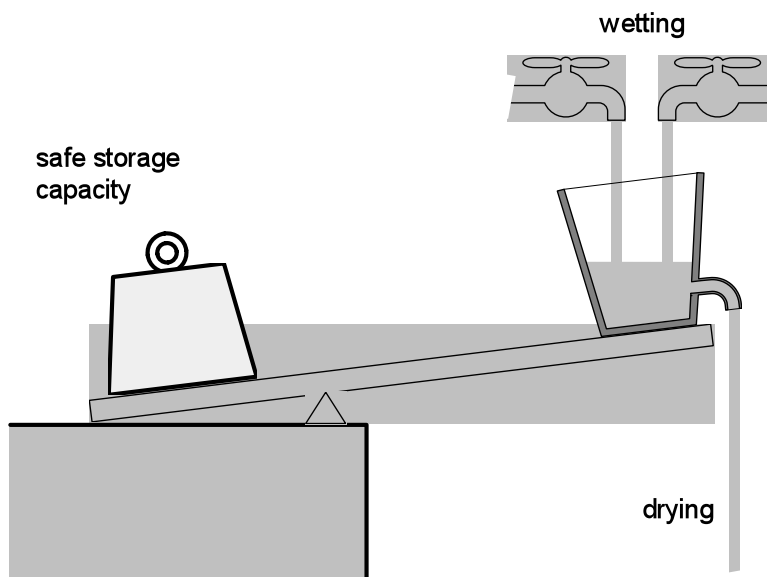
The safe storage capacity (balance of wetting and drying) of an individual material or enclosure system is fundamental to good building design (Figure 4). It is rarely economical to build an enclosure with no risk of wetting; therefore, managing the risk is important. In any building enclosure, building materials should be chosen based on moisture tolerance that correlates to the risk of moisture accumulation in the enclosure.

Figure 4. Moisture balance of wetting and drying

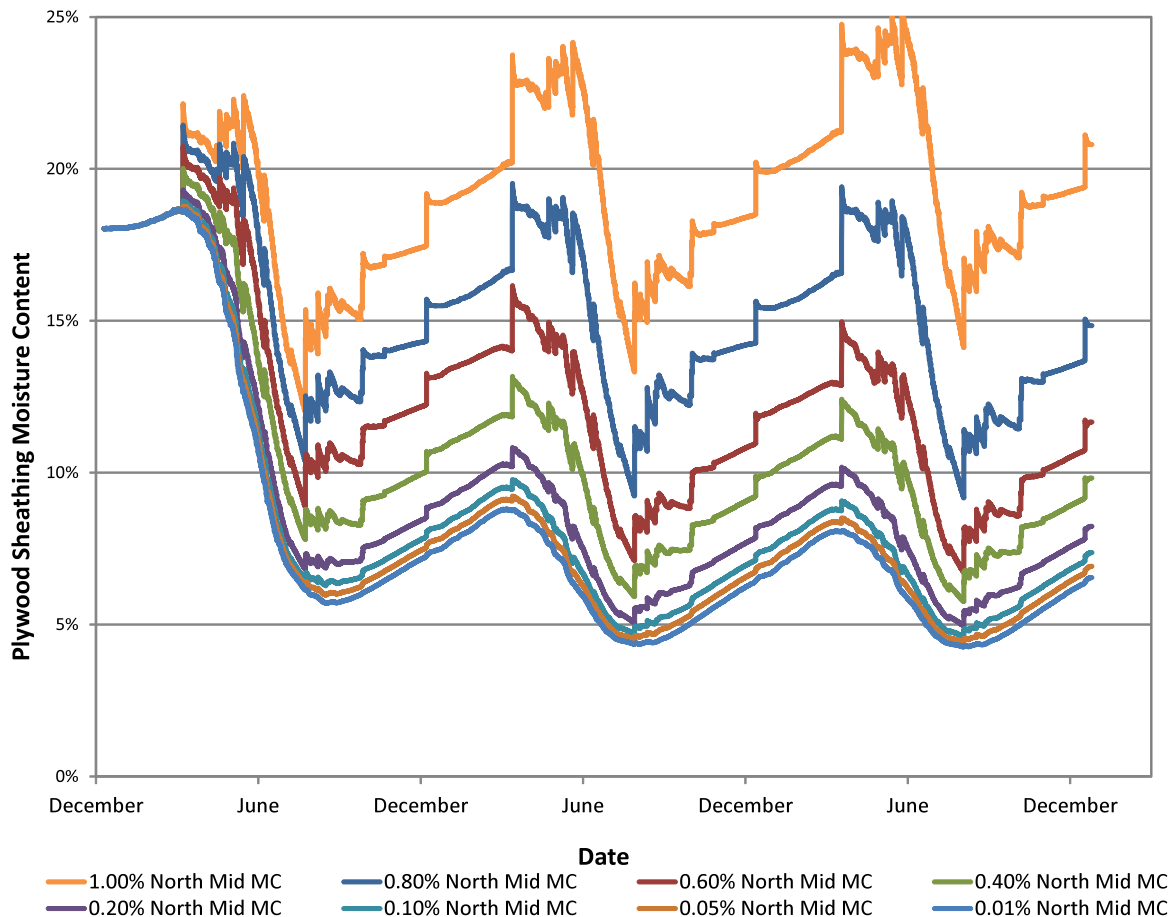
plane. For the roof systems analyzed, fractions of the ASHRAE 1% rainfall (ranging from 0.01% to 1.00% of total rainfall) is able to pass the fully adhered membrane and come in contact with the wood-based sheathing. This is the amount of water that is modeled and has to dry through the roofing system or accumulate and possibly cause damage. Figure 5 shows the correlated plywood sheathing MCs for 0.01%–1.00% rainfall leaks for the roof system described with ccSPF and cellulose insulation. Over the three-year analysis period, all of the injection scenarios are within the safe range and are not maintained above 25% MC. For the 0.80% and 1.00% cases there appears to be an increasing trend long term, which could likely lead to damage; the rest of the assemblies demonstrated a decreasing trend in MC.

Figure 5. Minneapolis plywood sheathing MC of ccSPF unvented roof

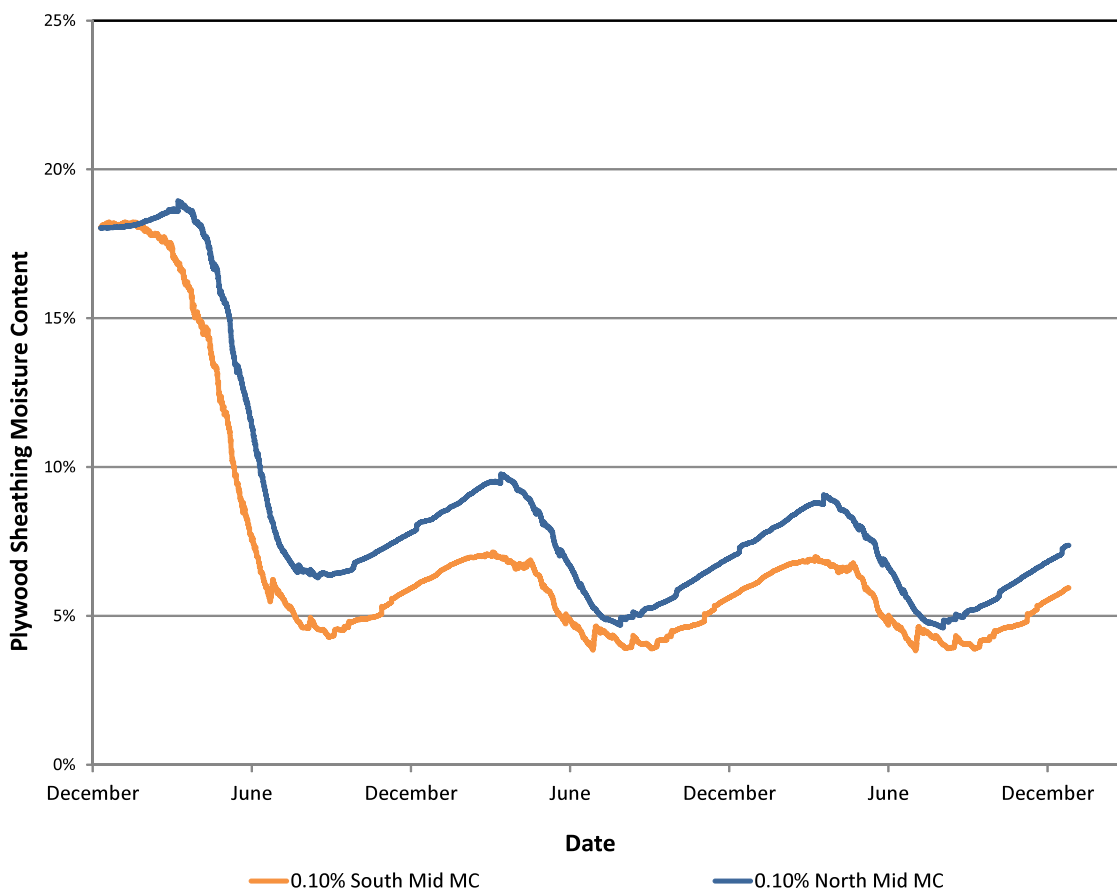
Table 7 shows plywood sheathing MCs at 0.10% rainfall contacting the plywood on a north orientation and a south orientation with ccSPF and cellulose insulation. The graph shows that the north orientation increases the peak MC of the sheathing by up to 3% but that the sheathing MCs all remain well below any level of risk.

Figure 6. Minneapolis sheathing MC—north versus south

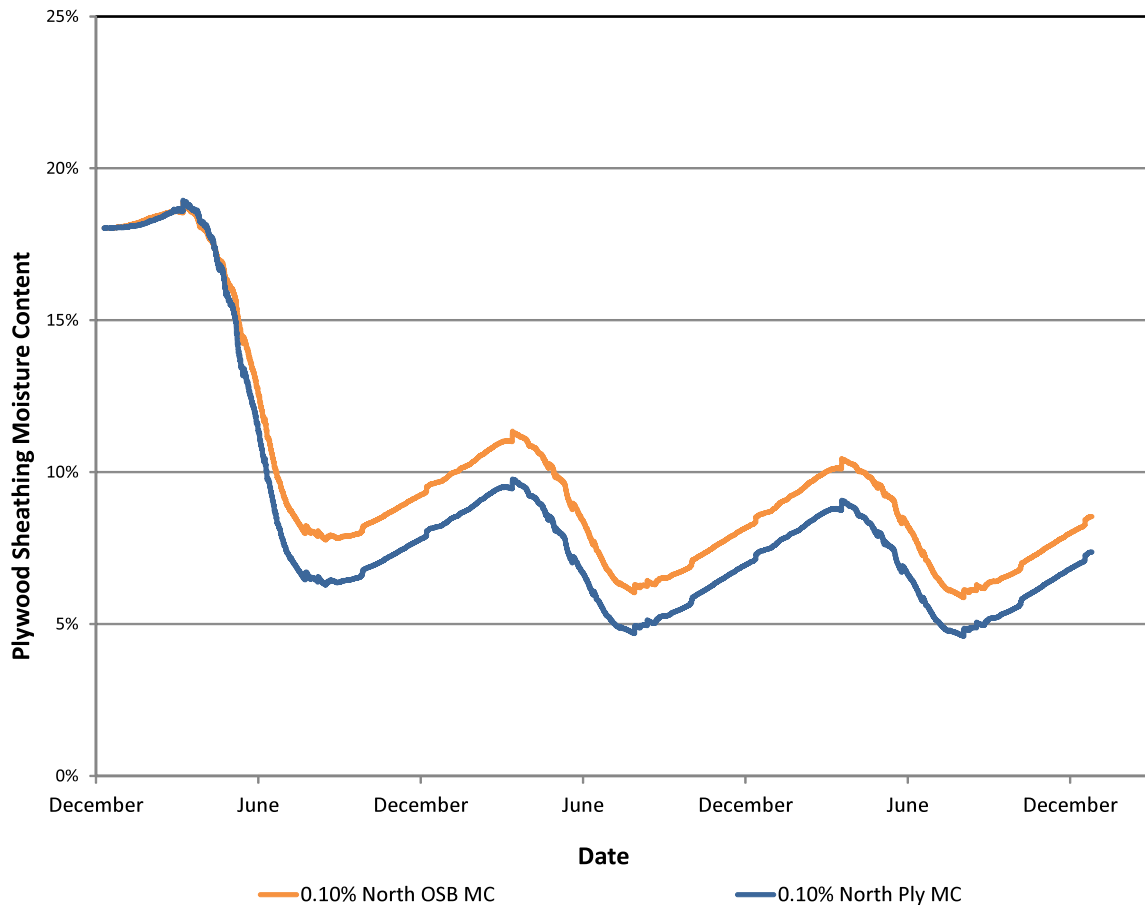
Figure 7 shows sheathing MCs at 0.10% rainfall contacting the sheathing considering OSB and plywood sheathing at ½-in. thick on the north orientation with ccSPF and cellulose insulation. The graph shows that OSB sheathing maintains 1%–1.5% higher MC than plywood, but also that the sheathing MCs all remain well below any level of risk.

Figure 7. Minneapolis sheathing MC—OSB versus plywood

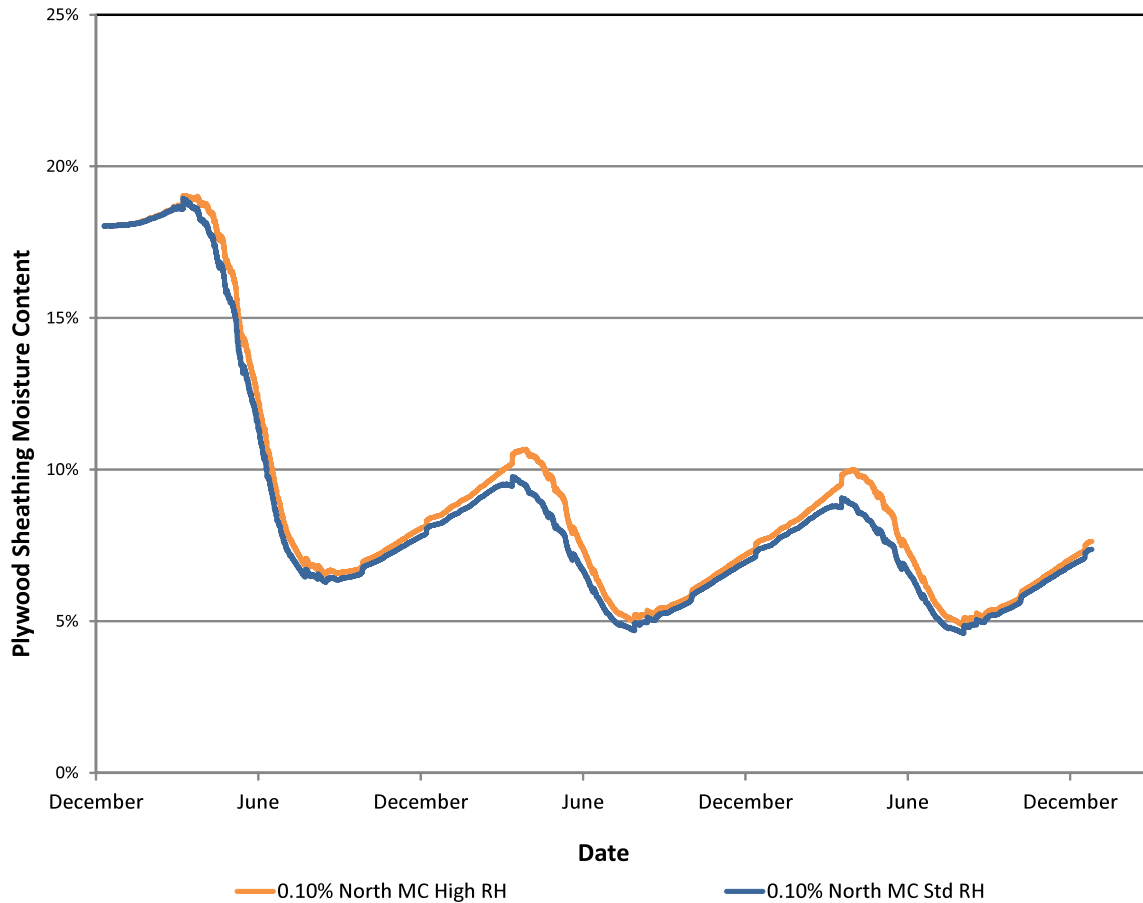
Peak plywood sheathing MC was affected by up to 1% when considering two interior RH scenarios (Figure 8). The first scenario allowed wintertime interior RH to fall to 30% while the second only fell to 40%. Both scenarios had summertime RH of 60%. In both scenarios the sheathing MCs all remain well below any level of risk.

Figure 8. Minneapolis plywood sheathing MC based on standard and high interior RH
