APPEAL SUMMARY

Appeal ID: 15723	Project Address: 7210 N Burlington Ave
Hearing Date: 8/23/17	Appellant Name: Gene Bolante
Case No.: B-004	Appellant Phone: 503-390-6500
Appeal Type: Building	Plans Examiner/Inspector: Marc Vieno, Thomas Ng
Project Type: commercial	Stories: 3 Occupancy: R-2 Construction Type: V-B
Building/Business Name: Ivanhoe 4	Fire Sprinklers: Yes - Throughout
Appeal Involves: Erection of a new structure	LUR or Permit Application No.:
Plan Submitted Option: pdf [File 1] [File 2] [File 3] Proposed use: Multi-Family

APPEAL INFORMATION SHEET

Application of Spray Foam Insulation Under Plywood and OSB Roof Sheathing

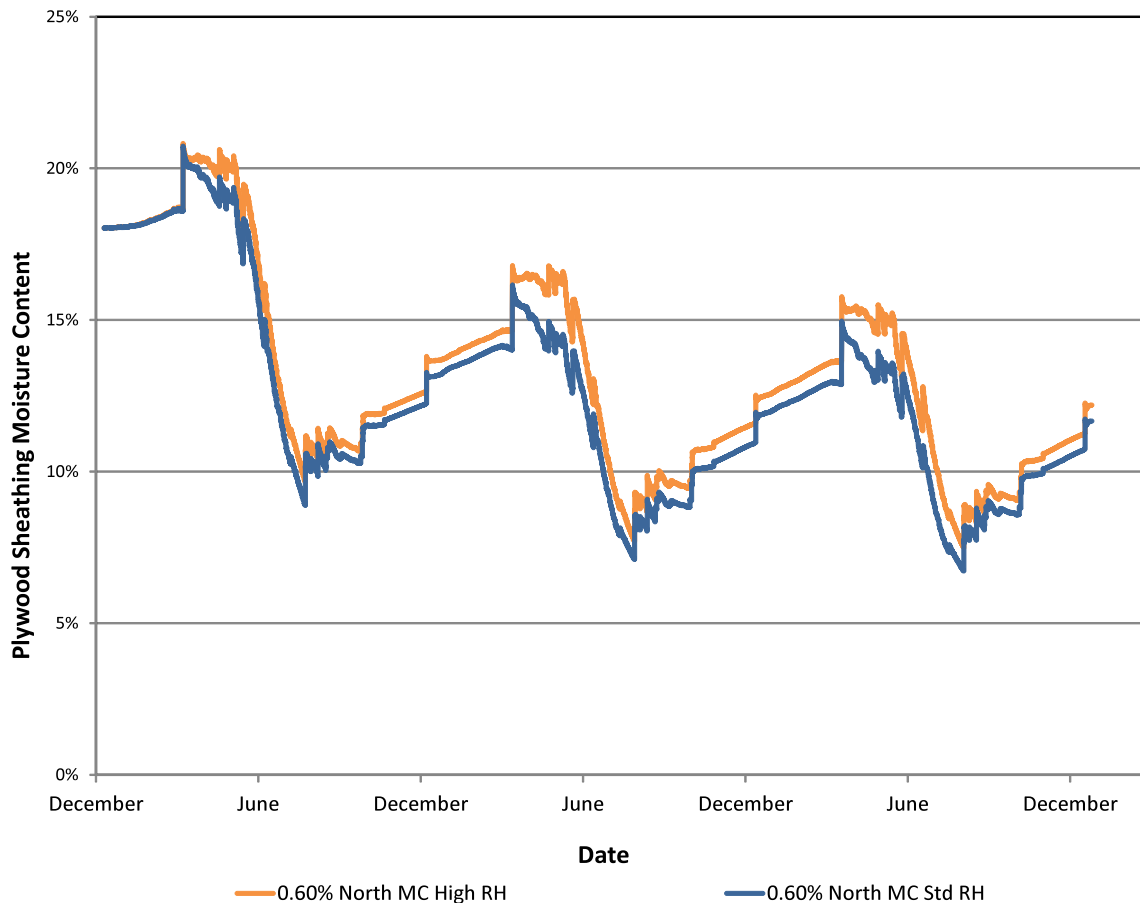
To determine if the interior RH affects a larger leak in a different way, the 0.60% leak was analyzed at the standard and high RH scenarios. As shown in Figure 9, the MC of the sheathing is affected only slightly more by the change in interior RH. The sheathing MCs all remain well below any level of risk.

Figure 9. Minneapolis plywood sheathing MC based on interior RH—larger leak

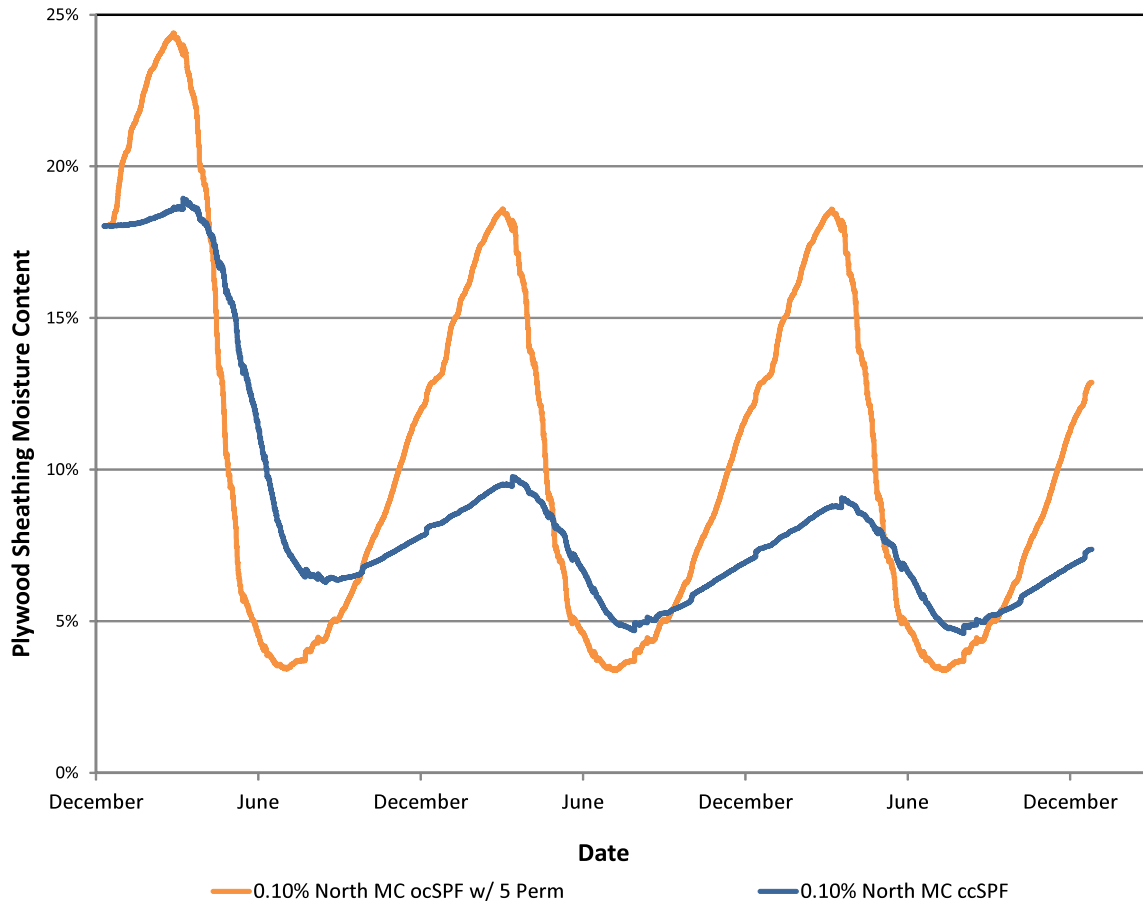
The type of SPF was analyzed in Figure 10. The ocSPF in this case requires a Class II vapor retarder installed on the interior face of the insulation. A 5 perm coating was modeled, as this represents the actual effective achieved perm value based on BSC experience with spray-applied Class II vapor retarder coatings. Figure 10 shows sheathing MCs at 0.10% rainfall contacting the plywood sheathing on the north orientation. The ocSPF MC varies significantly more than the ccSPF, but both remain within safe wood MCs. The ocSPF dries much faster than the ccSPF during warm weather, but also has the ability to pass more moisture from the interior to the exterior during cold weather and hence the MC of the plywood increases significantly more during those periods.

Figure 10. Minneapolis plywood sheathing with ccSPF and ocSPF

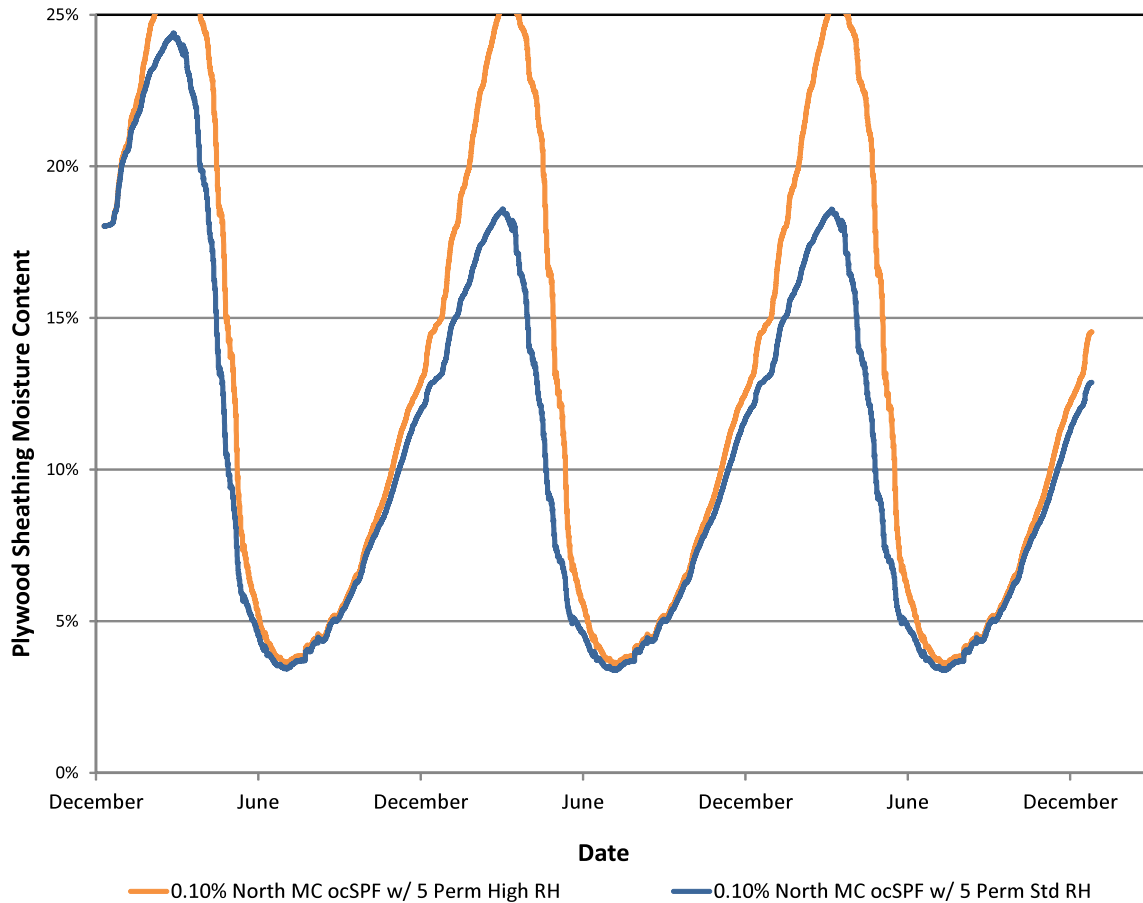
Because the ocSPF more easily tracks interior RH, a comparison using only ocSPF was completed. Figure 11 shows the effect of increased RH on a system using ocSPF and a 5-perm coating with a 0.10% rainfall leak. With elevated interior wintertime RH of 40%, the plywood sheathing MCs rise above 25%, but are not sustained for a significant period of time. If interior RH is kept below 35% in this climate zone, this system can operate safely.

Figure 11. Minneapolis plywood sheathing MC ocSPF and high RH

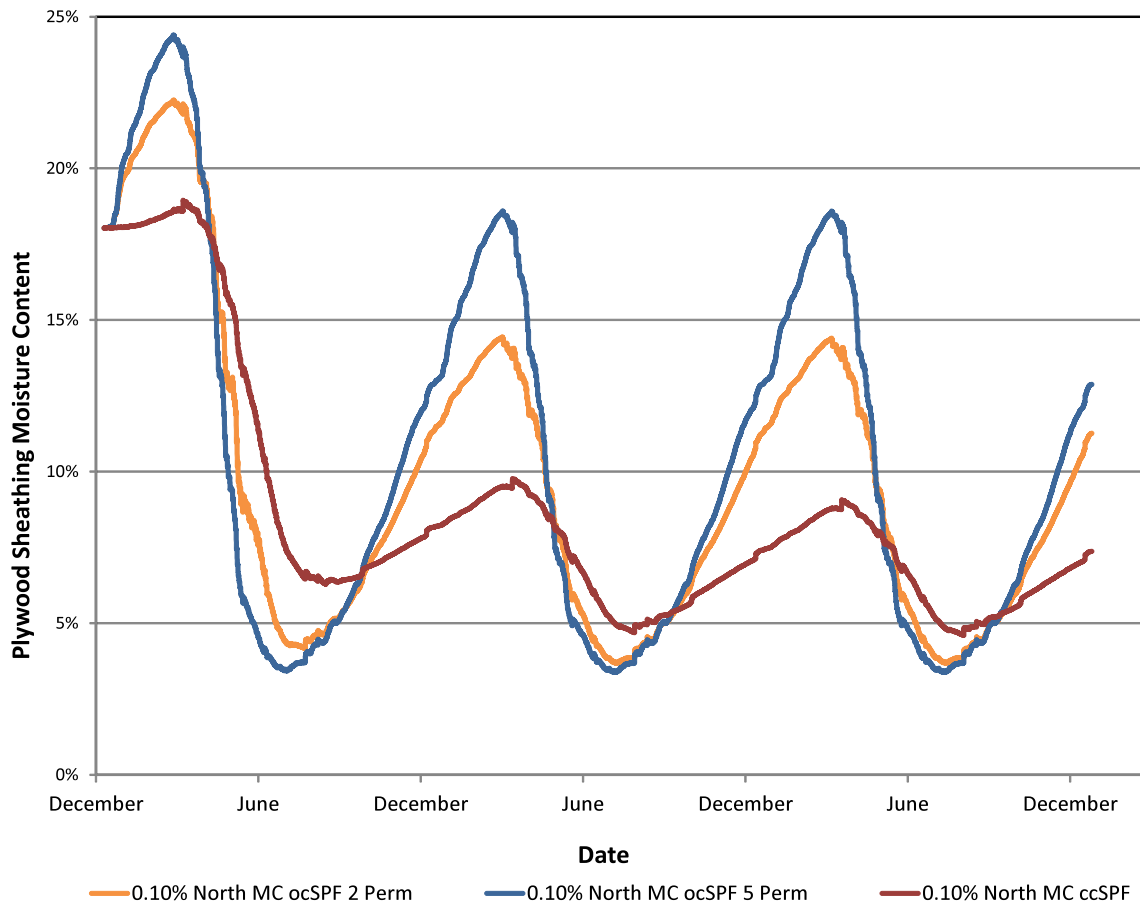
The coating on the interior of the ocSPF plays a significant role in the vapor transmission from the interior to the exterior in a cold climate. The ocSPF system in Figure 11 was altered to include an effective 2 perm coating instead of the 5 perm coating previously considered. This was modeled and compared to the ccSPF system. With a 0.10% rain leak, the MC of the sheathing is shown in Figure 12. The 2 perm coating with standard RHs reduces the sheathing MC by almost 5%, while using ccSPF decreases it another 5%. Both the 2 perm coating and 5 perm coating on ocSPF dry the sheathing faster than ccSPF, but both get the sheathing wetter during cold weather than ccSPF.

Figure 12. Minneapolis sheathing MC—ocSPF, 2 perm coating, and 5 perm coating

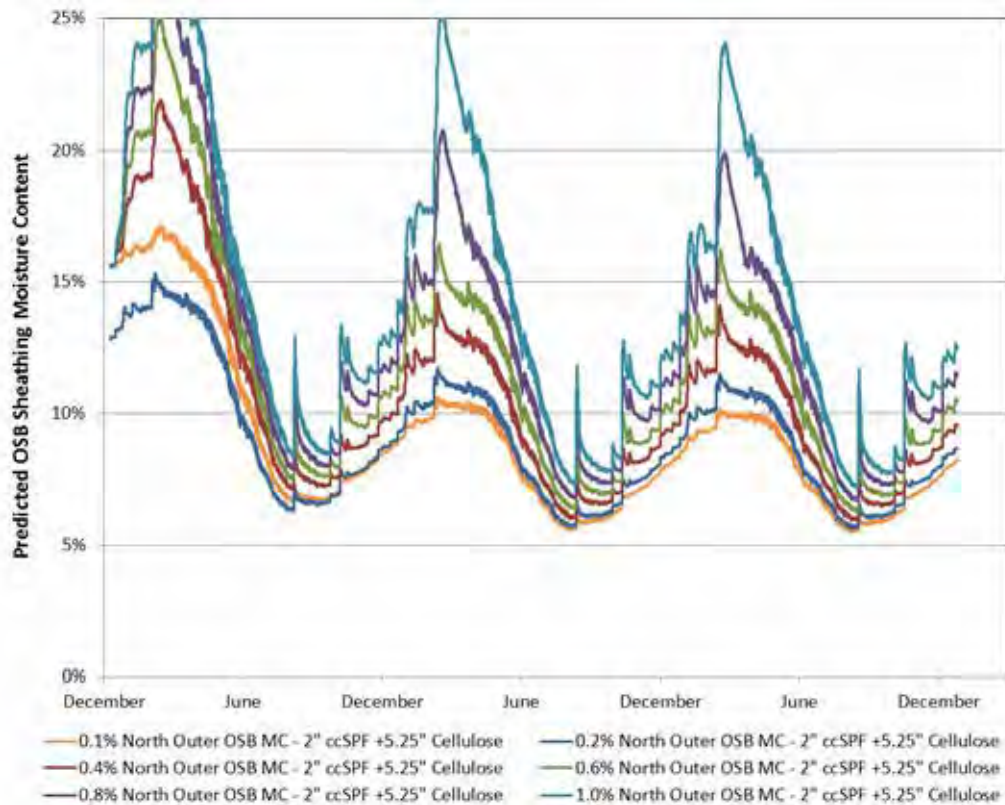
cycle 8%–24% MC with the influences of both indoor RH and up to the full 1% rainwater leak (Figure 13). The three-year analysis shows a drying trend of the system, although it is not recommended to allow MCs to regularly attain more than 25% for long durations, as occurs with the full 1% leakage. When the cellulose is replaced with fiberglass insulation (Figure 14) a very similar model is produced. In this system, cellulose and fiberglass perform nearly identically.

Figure 13. Seattle sheathing MC north 2 in. ccSPF + 5.25 in. cellulose

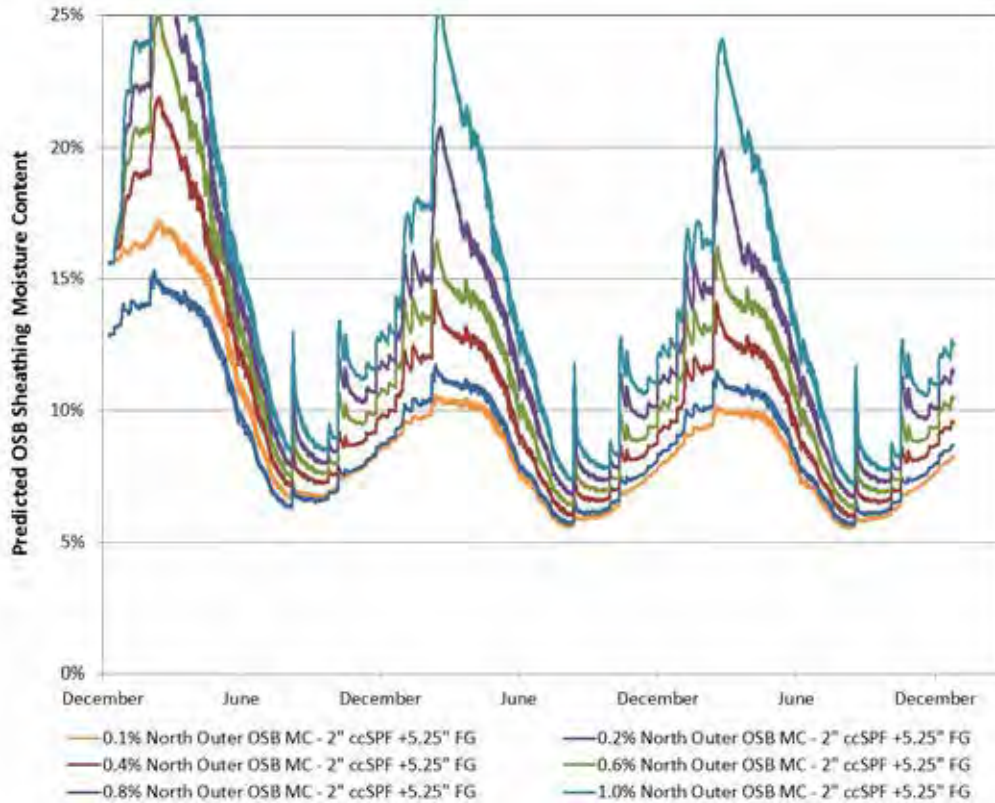
Figure 14. Seattle sheathing MC north 2 in. ccSPF + 5.25 in. fiberglass

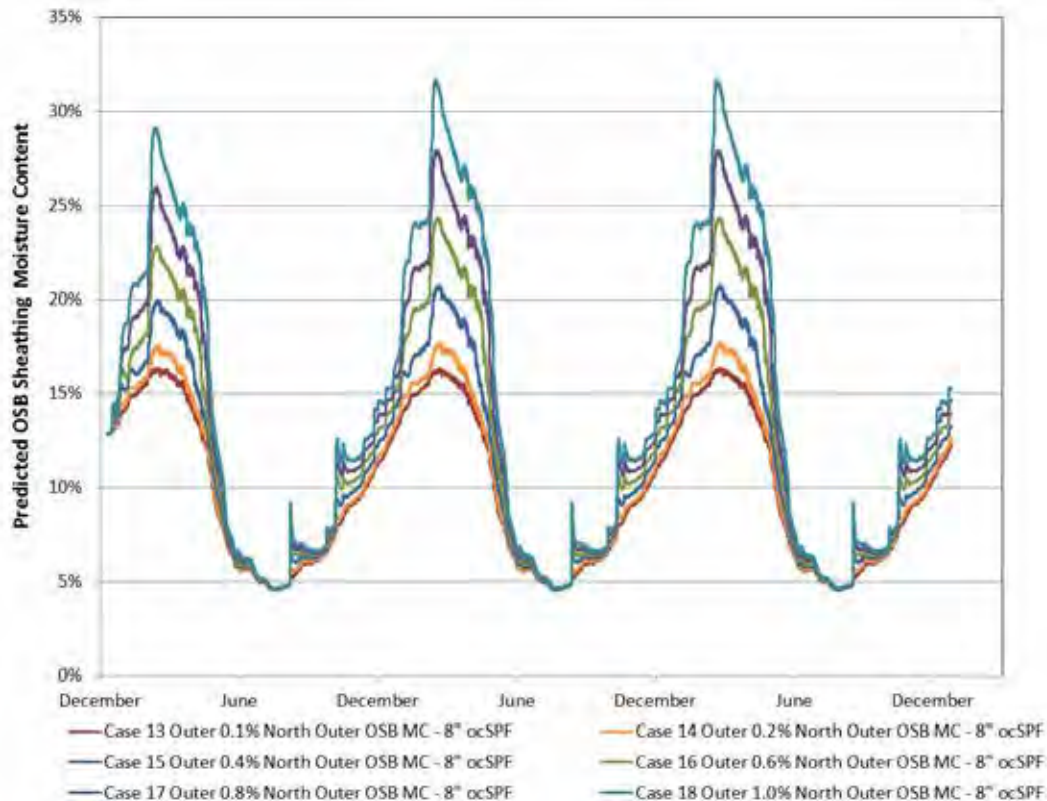
Climate zone 4 is a difficult climate in that there is relatively continuous rain-based wetting as well as inward and outward vapor drives due to the heating and cooling of the homes during the alternating seasons. Figure 15 shows the sheathing MC as modeled between 0.1% and 1% of the rainwater. The modeling shows an increasing trend to the sheathing MC if more than 0.6% of rainwater leaks into the assembly. This correlates with the data analyzed for Minneapolis. In the Seattle case, both rainwater leakage year round and outward vapor drive in cold weather caused increased MCs in the sheathing while drying abruptly occurred during warm weather with the relatively high vapor ocSPF.

Figure 15. Seattle sheathing MC north 8 in. ocSPF

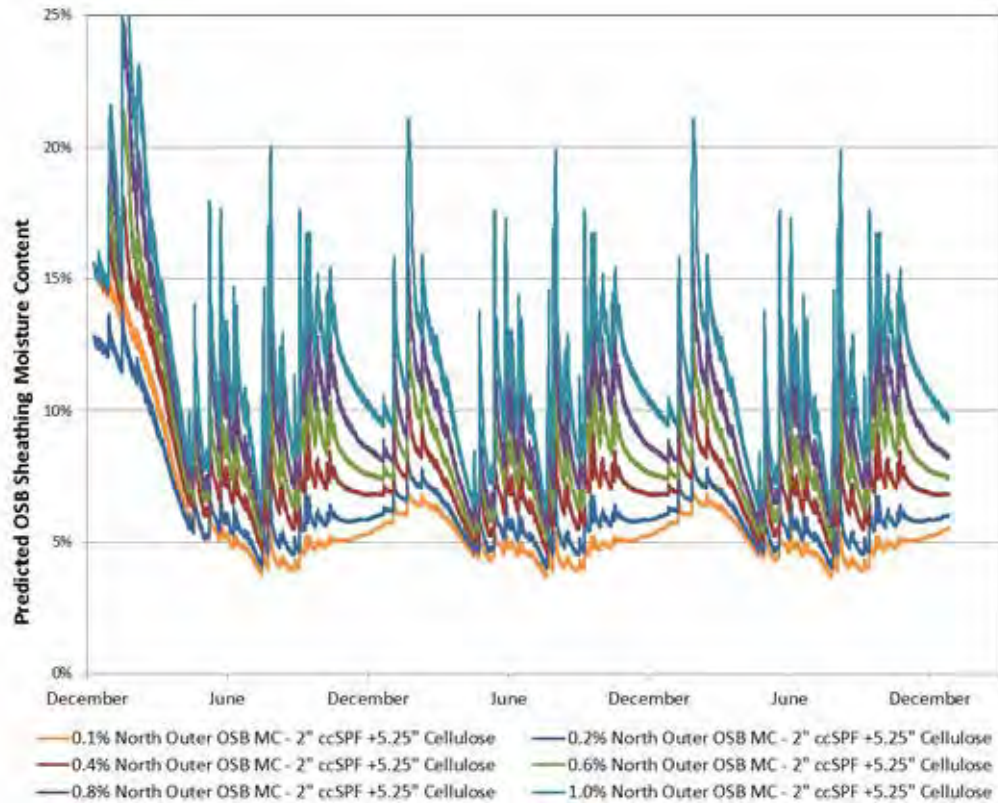
The Miami climate modeling shows that although the systems will be exposed to significant wetting throughout the year, there is also an equally large vapor drive produced by the heat and solar exposure, which forces the incidental moisture through the assembly and into the interior of the home. Figure 16 and Figure 17 are very similar graphs showing the sheathing MC of ccSPF-insulated unvented cathedralized roofs using cellulose and fiberglass insulation. Both systems safely dry out the full 1% of the rainwater leakage into the interior space. Figure 18 shows the sheathing MC for an ocSPF insulated roof in Miami and indicates that the full 1% rainwater leak is easily managed by the roof with significant inward vapor drives due to temperature and solar incidence with very limited outward vapor drives usually initiated by cooler outdoor weather.

Figure 16. Miami sheathing MC north 2 in. ccSPF + 5.25 in. cellulose

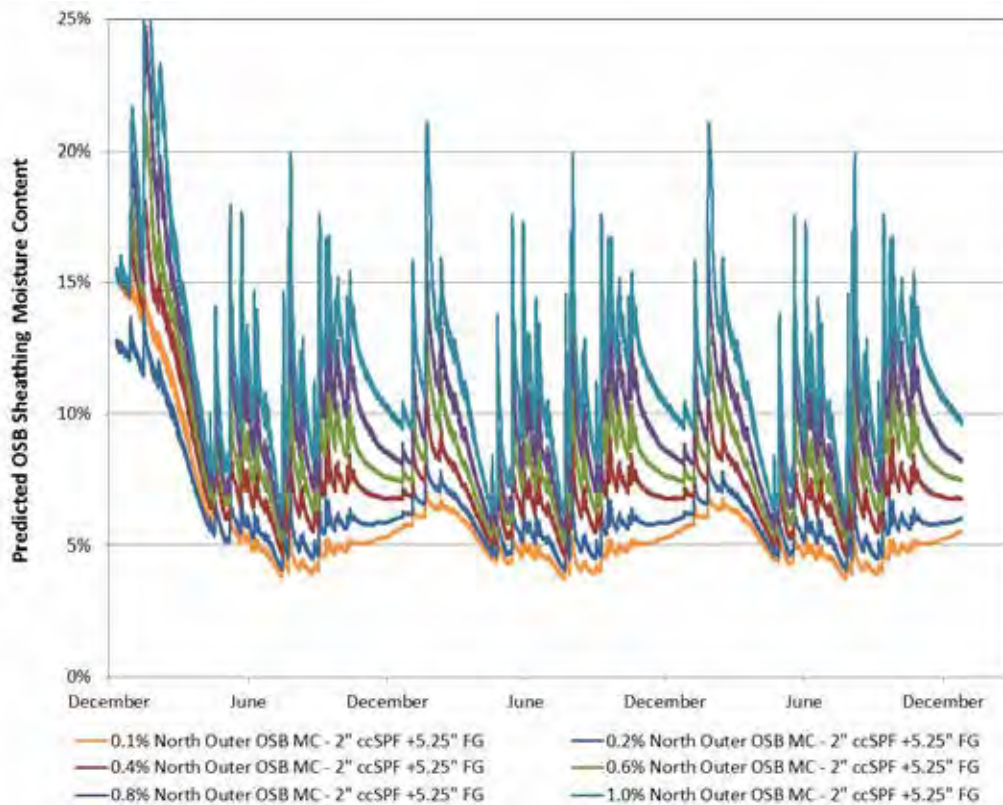
Figure 17. Miami sheathing MC north 2 in. ccSPF + 5.25 in. fiberglass

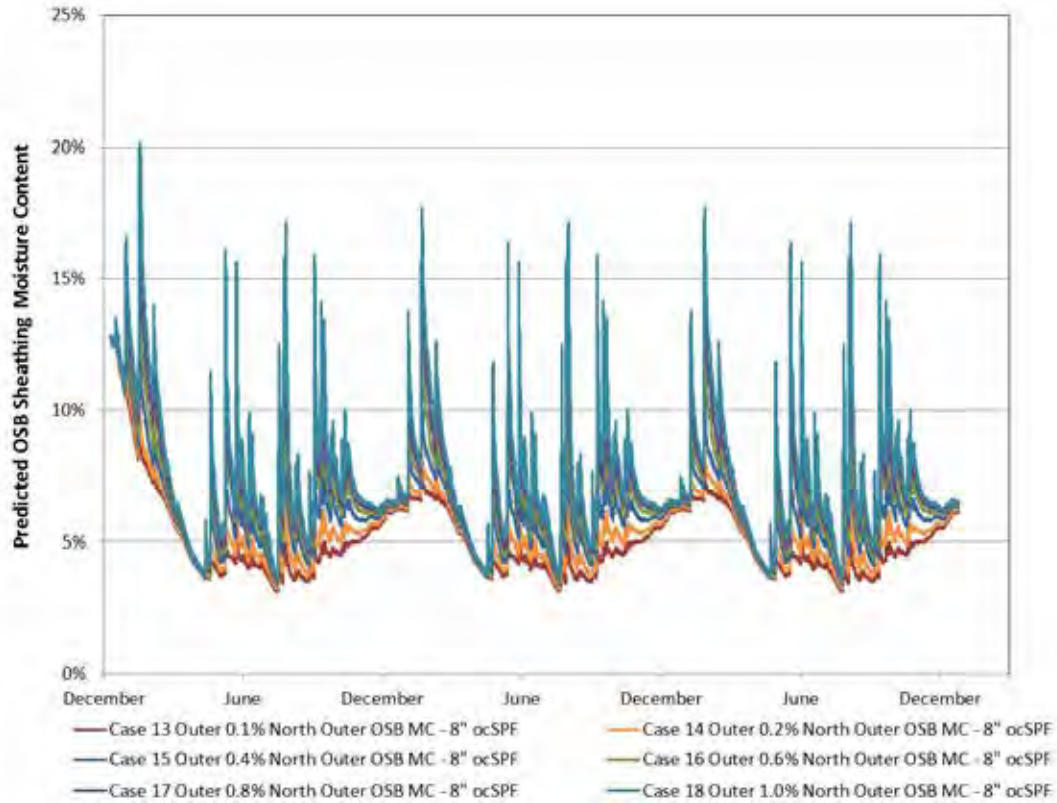
Figure 18. Miami sheathing MC north 8 in. ocSPF

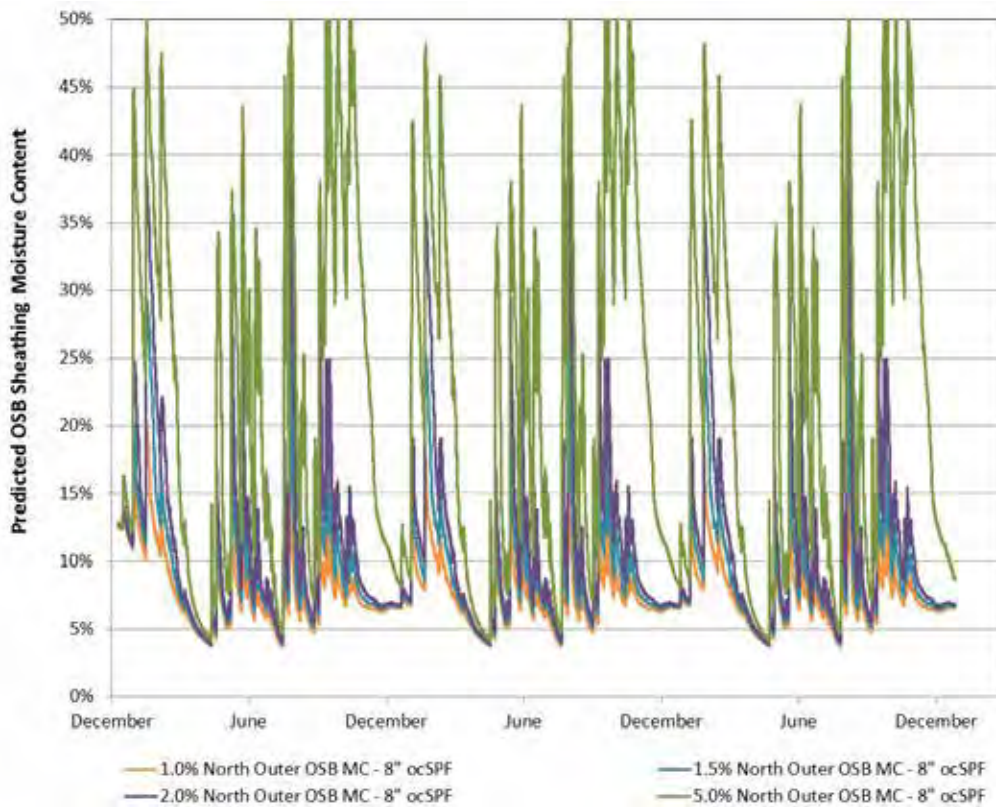
The Miami modeling was then further stressed to determine its upper limit of wetting. Using the ocSPF case, the rainwater percentage was increased from 1% to 1.5%, 2.0%, and then 5%. Figure 19 shows the sheathing MCs for the high leak rates in Miami using ocSPF. At the 2% step the roof began to have extended periods of time with the exterior layer of the sheathing experiencing MCs above 25% and as such the dryable limit was chosen as 1.5%.

Figure 19. Miami sheathing MC north 8 in. ocSPF high stress

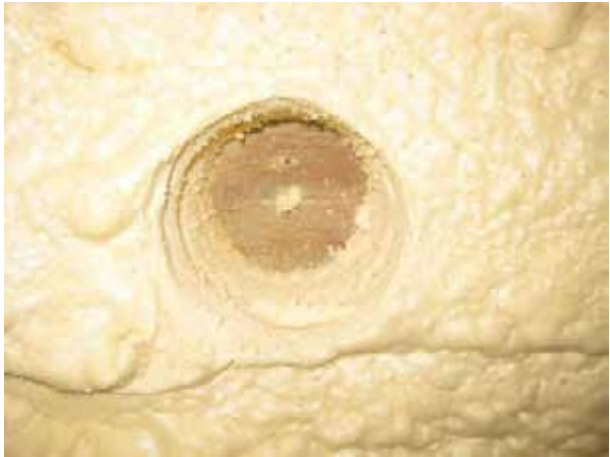
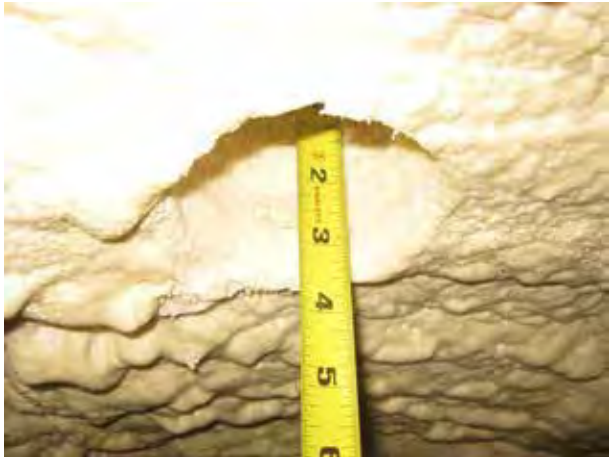
5.1 House 1: New Orleans, Climate Zone 2, June 2012

<p>Description</p> <ul style="list-style-type: none"> • Built 2009 • Cathedralized attic • R-21—~3.5 in. ccSPF below OSB roof sheathing <p>Exploration Findings</p> <ul style="list-style-type: none"> • All sheathing locations investigated are within safe MC readings <p>Exploration Location 1—North Lower</p> <ul style="list-style-type: none"> • 6% moisture content reading • No visible signs of moisture damage <p>Exploration Location 2—West Upper</p> <ul style="list-style-type: none"> • 7.5% MC reading • No visible signs of moisture damage <p>Exploration Location 3—East Upper</p> <ul style="list-style-type: none"> • 6.5% MC reading • No visible signs of moisture damage <p>Exploration Location 4—West Lower</p> <ul style="list-style-type: none"> • 7.0% MC reading • No visible signs of moisture damage <p>This information correlates well to modeling of warm locations with drives that enhance drying and have limited wetting.</p>

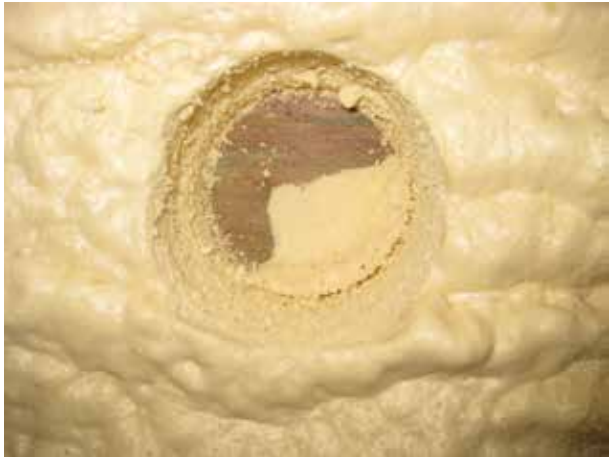
5.2 House 2: New Orleans, Climate Zone 2, July 2012

<p>Description</p> <ul style="list-style-type: none"> Built 2009 Cathedralized attic R-21—~3.5 in. ccSPF below OSB roof sheathing <p>Exploration Findings</p> <ul style="list-style-type: none"> All sheathing locations investigated are within safe MC readings <p>Exploration Location 3—East Upper</p> <ul style="list-style-type: none"> 6% MC reading No visible signs of moisture damage <p>Exploration Location 4—West Lower</p> <ul style="list-style-type: none"> 7% MC reading No visible signs of moisture damage <p>This information correlates well to modeling of warm locations with drives that enhance drying and have limited wetting.</p>
---	---

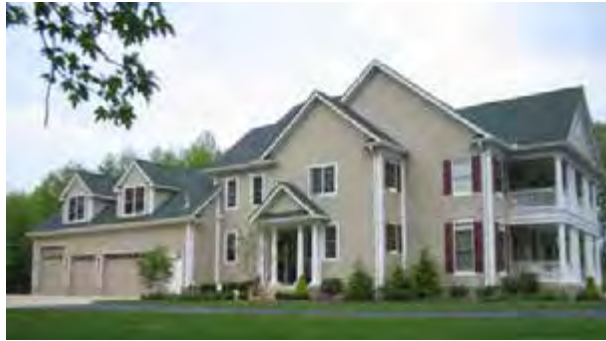
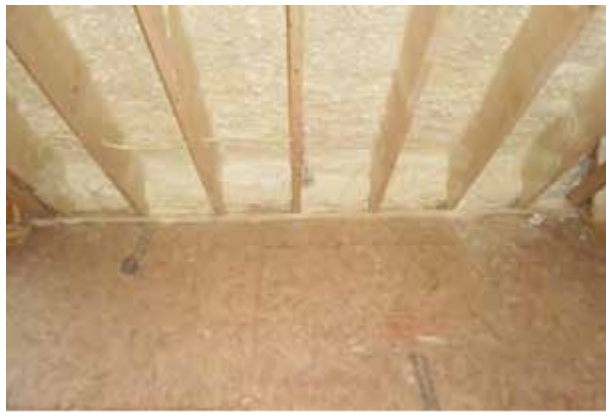
5.5 House 5: Westerville, Climate Zone 5, June 2012

Description

- Built 2004
- Unvented cathedralized attic
- R-12—~2 in. ccSPF below roof sheathing
- R-28 fiberglass batt
- ½-in. drywall with latex paint

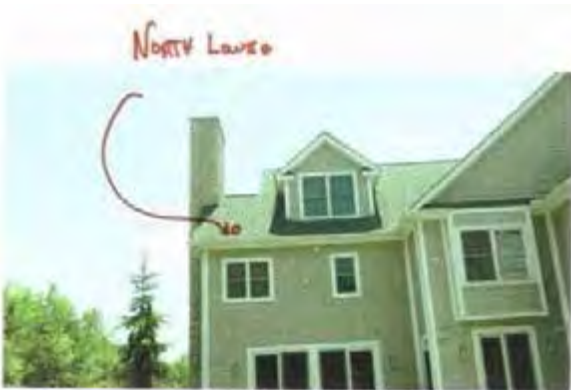
Exploration Location 1—North Lower

- 13.5% MC reading
- This location had a roof leak in the 6 months before the MC reading

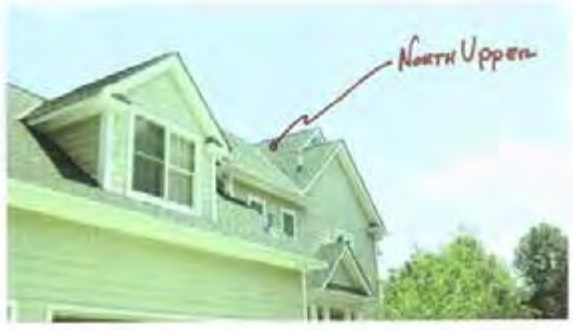
<p>Exploration Location 2—North Upper</p> <ul style="list-style-type: none"> • 7% MC reading • No visible signs of moisture damage

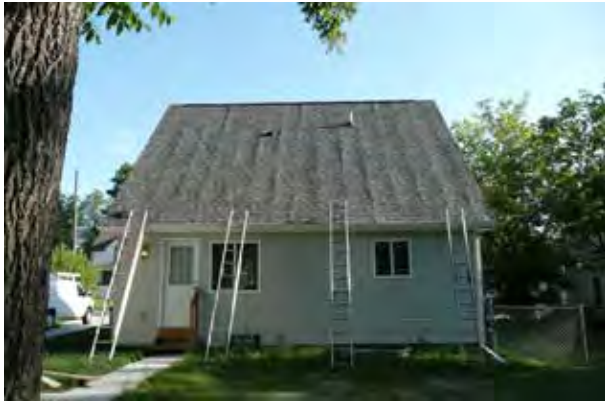
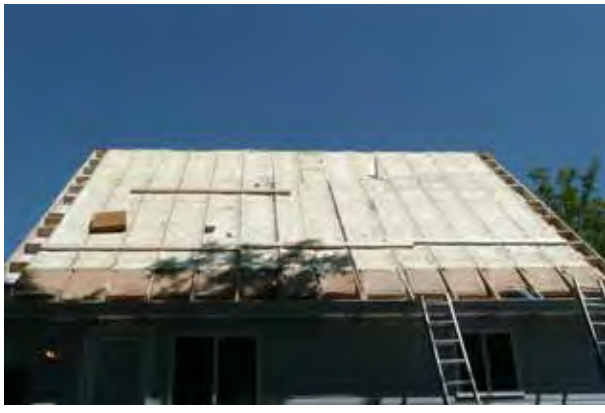
5.6 House 6: Pontiac, Climate Zone 5, July 2012

<p>Description</p> <ul style="list-style-type: none"> • New Home January 2012 • Cathedralized attic • R-40—~6 in. ccSPF below OSB sheathing <p>Exploration Findings</p> <ul style="list-style-type: none"> • Roof sheathing dry in all locations • Roof sheathing structural failure <p>Exploration Locations</p> <ul style="list-style-type: none"> • OSB swelled and deteriorated • During July exploration OSB was dry • OSB was able to dry to the interior • Roof sheathing MC < 6% in all locations when tested in July • Roof sheathing was removed and replaced • Manufacturer's analysis report concluded that the SPF was installed over very wet OSB, which sealed in the liquid water causing the deterioration
---	--

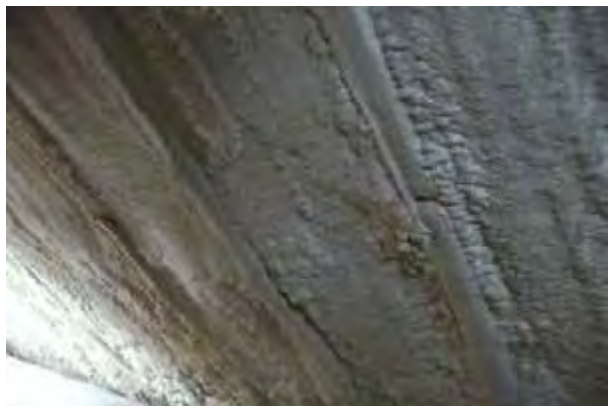
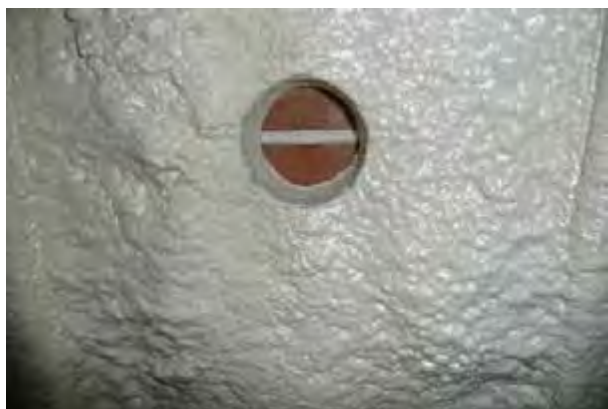
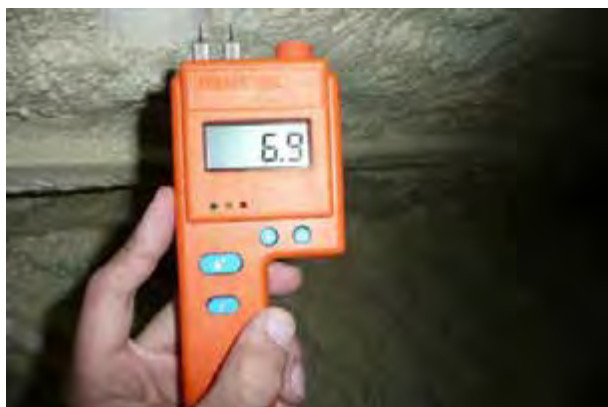
5.7 House 7: Minneapolis, Climate Zone 6, July 2012

Description

- 1941, retrofit 2012
- Cathedralized attic
- R-21—~3.5 in. ccSPF below 1x board roof

- 6.9% MC reading
- No visible signs of moisture damage

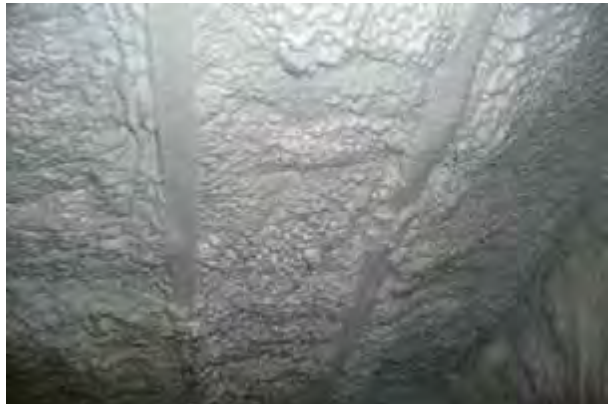
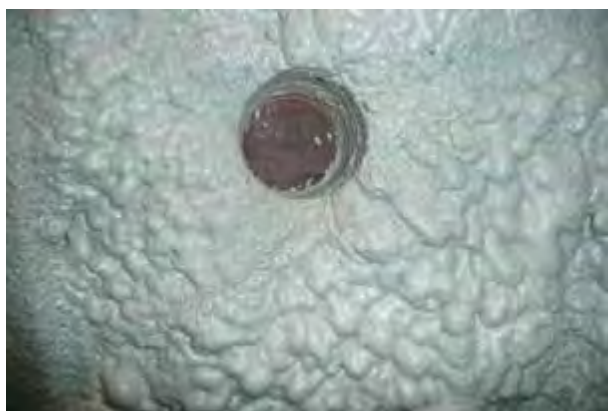
5.8 House 8: Minneapolis, Climate Zone 6, July 2012

Description

- Built 1914, retrofit January 2009
- Cathedralized attic
- R-21—~3.5 in. ccSPF below 1x board roof

- 6.7% MC reading
- No visible signs of moisture damage

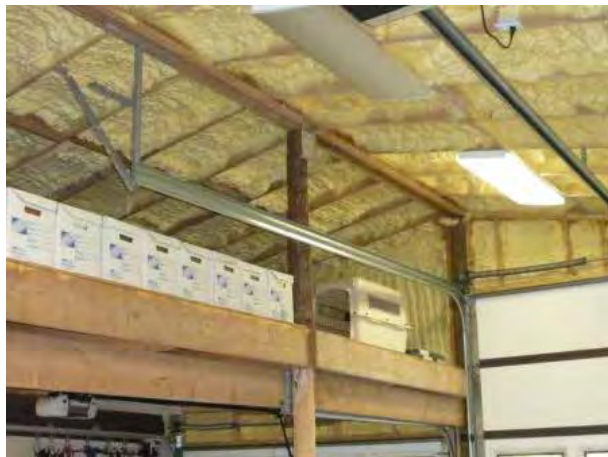
5.9 House 9: Juneau, Climate Zone 7, July 2012

Description

- Under construction 2012
- Cathedralized attic in heated garage
- R-15—~4 in. ocSPF below sheathing

- 12.9% MC reading

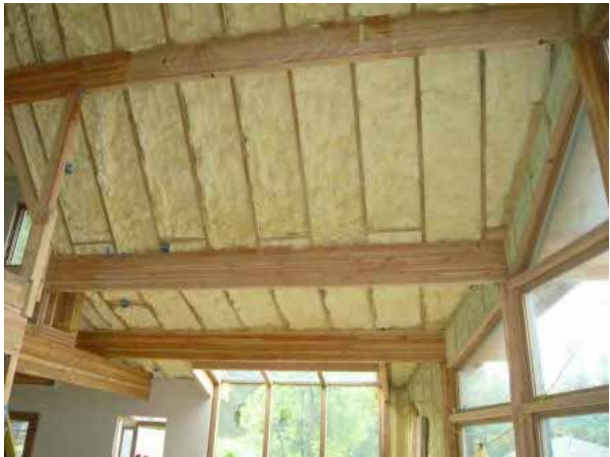
5.10 House 10: Juneau, Climate Zone 7, July 2012

<p>Description</p> <ul style="list-style-type: none"> • New home 2012 • Cathedralized attic • R-19—~3 in. ccSPF below sheathing • R-28—~7.5 in. ocSPF below ccSPF <p>Exploration Findings</p> <ul style="list-style-type: none"> • All sheathing locations investigated are within safe MC readings <p>Exploration Location 1—East Lower</p> <ul style="list-style-type: none"> • 16.9% MC reading (sheathing) • No visible signs of moisture damage <p>Exploration Location 2—West Upper</p> <ul style="list-style-type: none"> • 15.1% MC reading (sheathing) • 14.1% MC reading (framing) • No visible signs of moisture damage
---	--

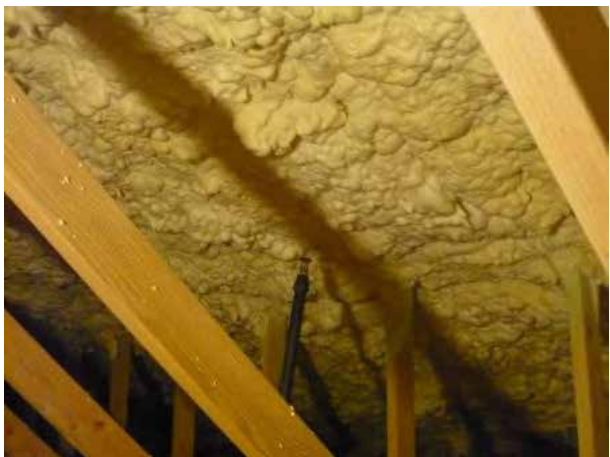
5.11 House 11: Juneau, Climate Zone 7, July 2012

<p>Description</p> <ul style="list-style-type: none"> • Built in 2009 • Apartment above commercial paint supply store • Cathedralized attic • R-19—~3 in. ccSPF below sheathing • R-20—~5.5 in. ocSPF below ccSPF <p>Exploration Findings</p> <ul style="list-style-type: none"> • All sheathing locations investigated are elevated. Due to the unique situation of the interior conditions, it is recommended that this location and its interior conditions be monitored further. <p>Exploration Location 1—South Mid</p> <ul style="list-style-type: none"> • 22.9% MC reading • No visible signs of moisture damage <p>Exploration Location 2—North Mid</p> <ul style="list-style-type: none"> • 21.2% MC reading • No visible signs of moisture damage
--	--

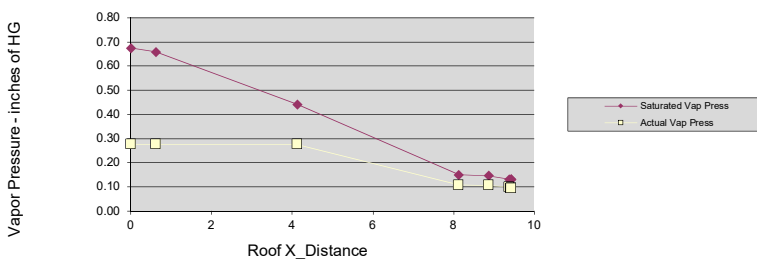
Vapor Pressure in Roof

Temperature in Red Box must Exceed Dew Point temperature to avoid Condensation.

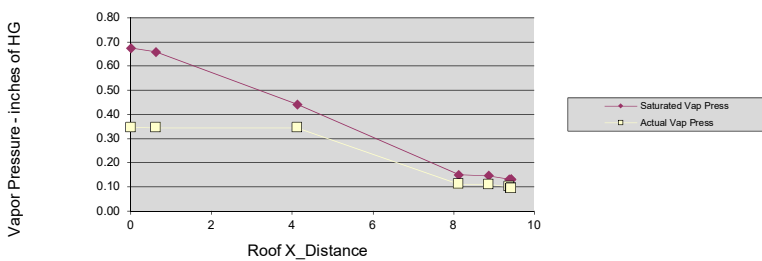
Vapor Pressure in Roof

Temperature in Red Box must Exceed Dew Point temperature to avoid Condensation.

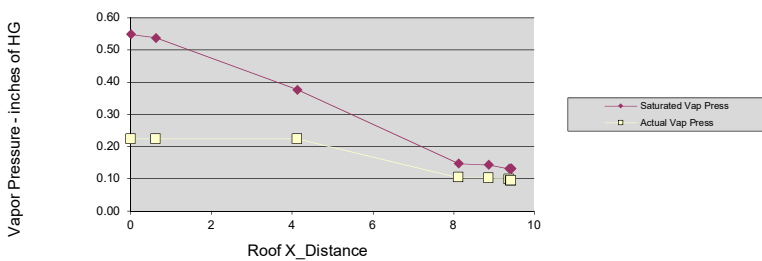
Vapor Pressure in Roof

Temperature in Red Box must Exceed Dew Point temperature to avoid Condensation.

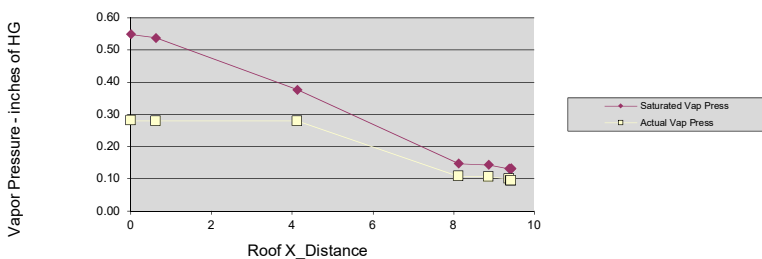
Vapor Pressure in Roof

Temperature in Red Box must Exceed Dew Point temperature to avoid Condensation.

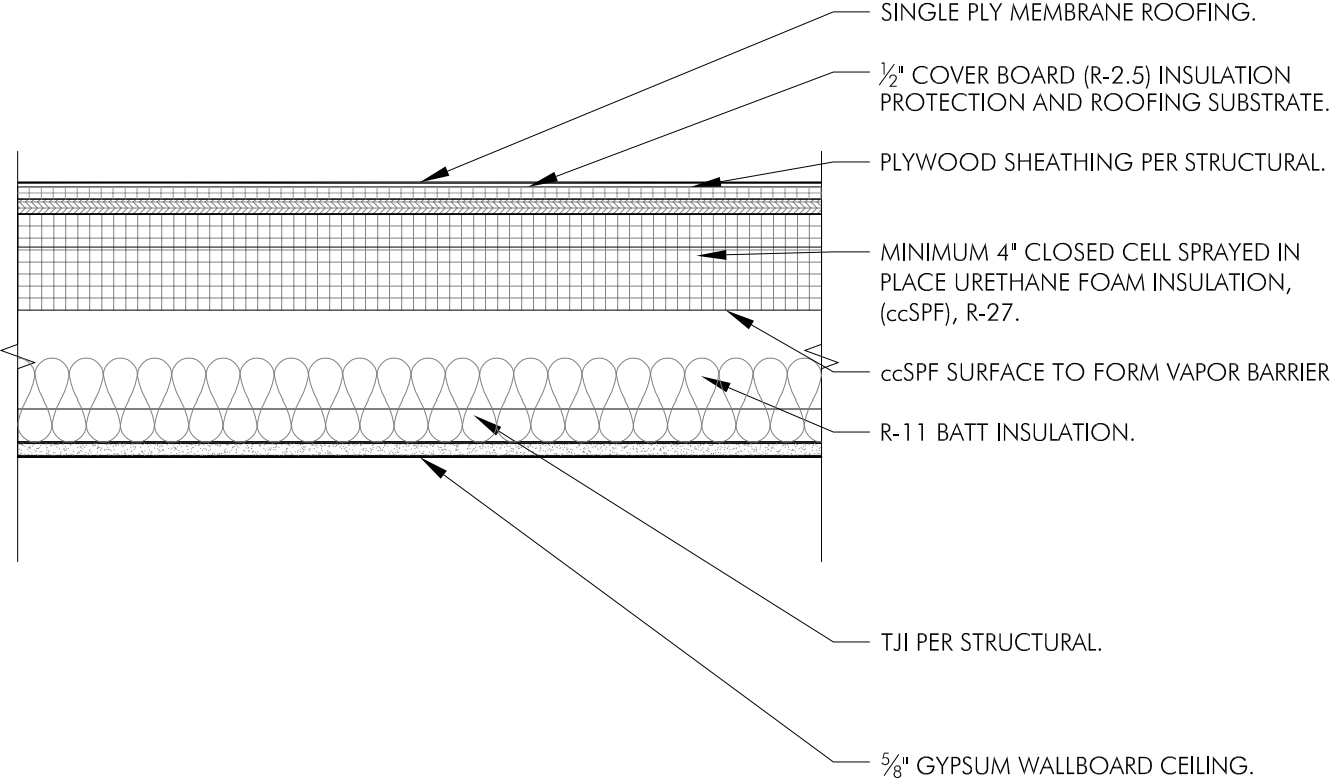
AVERAGE R-VALUE FOR THE ENTIRE ROOF ASSEMBLY IS COMPUTED AT R-38, BASED ON A RATIO OF 12% FOR FRAMING AND 88% FOR INSULATED CAVITY.

PRIME AND PAINT CEILING.

Proposed Design Unvented roof design per the attached details for Roof Type R-1 and R-2: Principally the design includes structural plywood roof sheathing on 9½" TJI roof joists and an applied gyp brd ceiling membrane to the bottom of the roof joists. Prior to installation of the ceiling membrane, 4" of closed cell Spray Foam Insulation (cSPF) is applied to the underside of the roof sheathing and the balance of the cavity is filled with bat insulation.

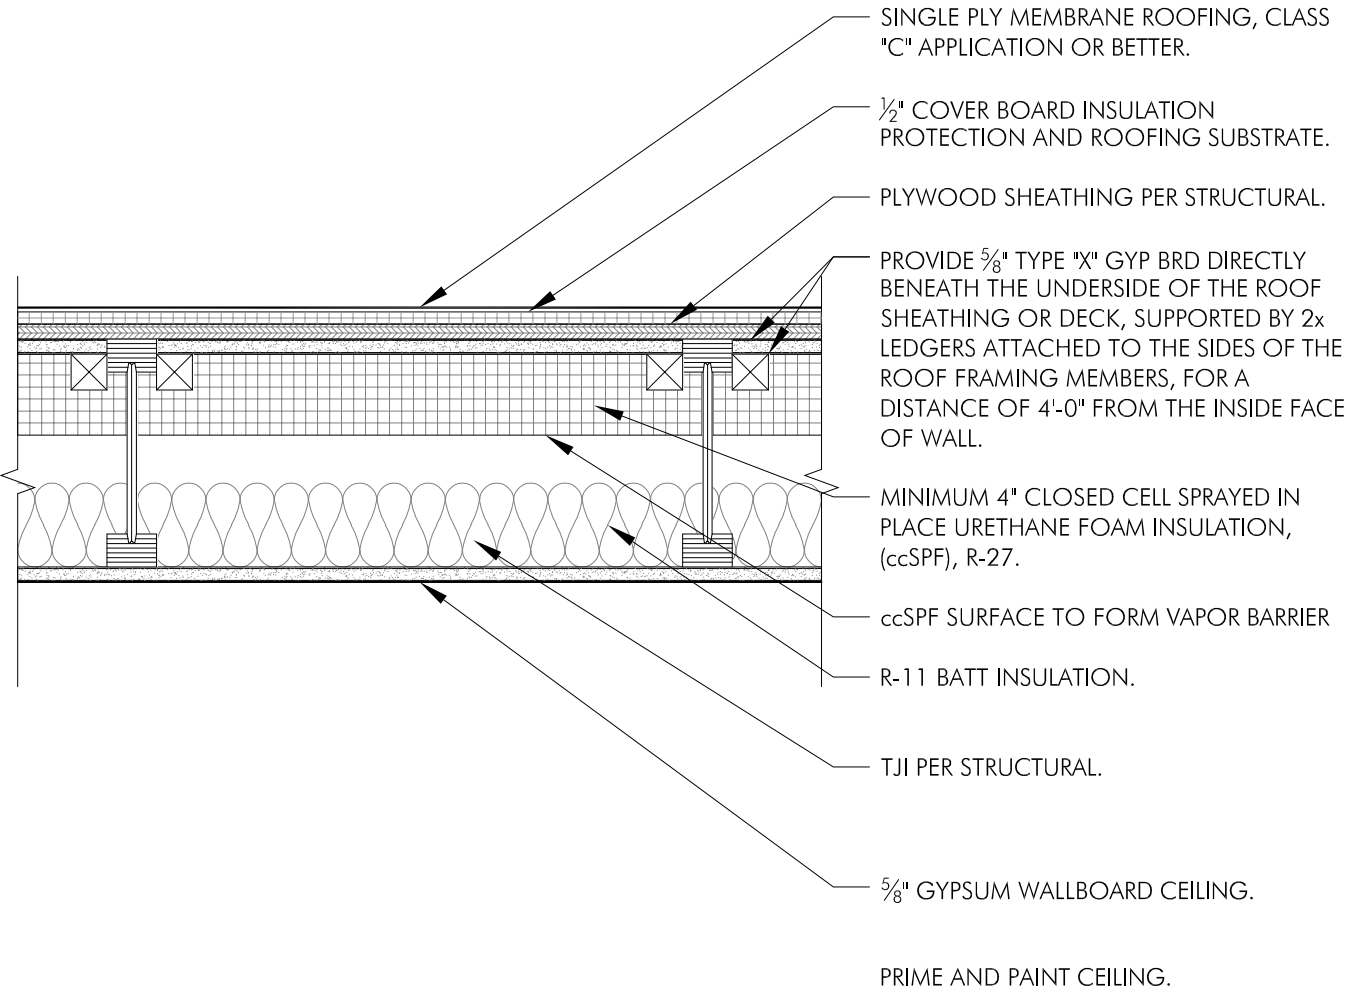
ROOF/CEILING ASSEMBLY: PROTECTED PER
OSSC 2014 Paragraph 705.11.5.2.

F.R.	N/A but PROTECTED	ROOF/CEILING ASSEMBLY:	R-2
STC		WITH SOUND ATTENUATION BLANKETS

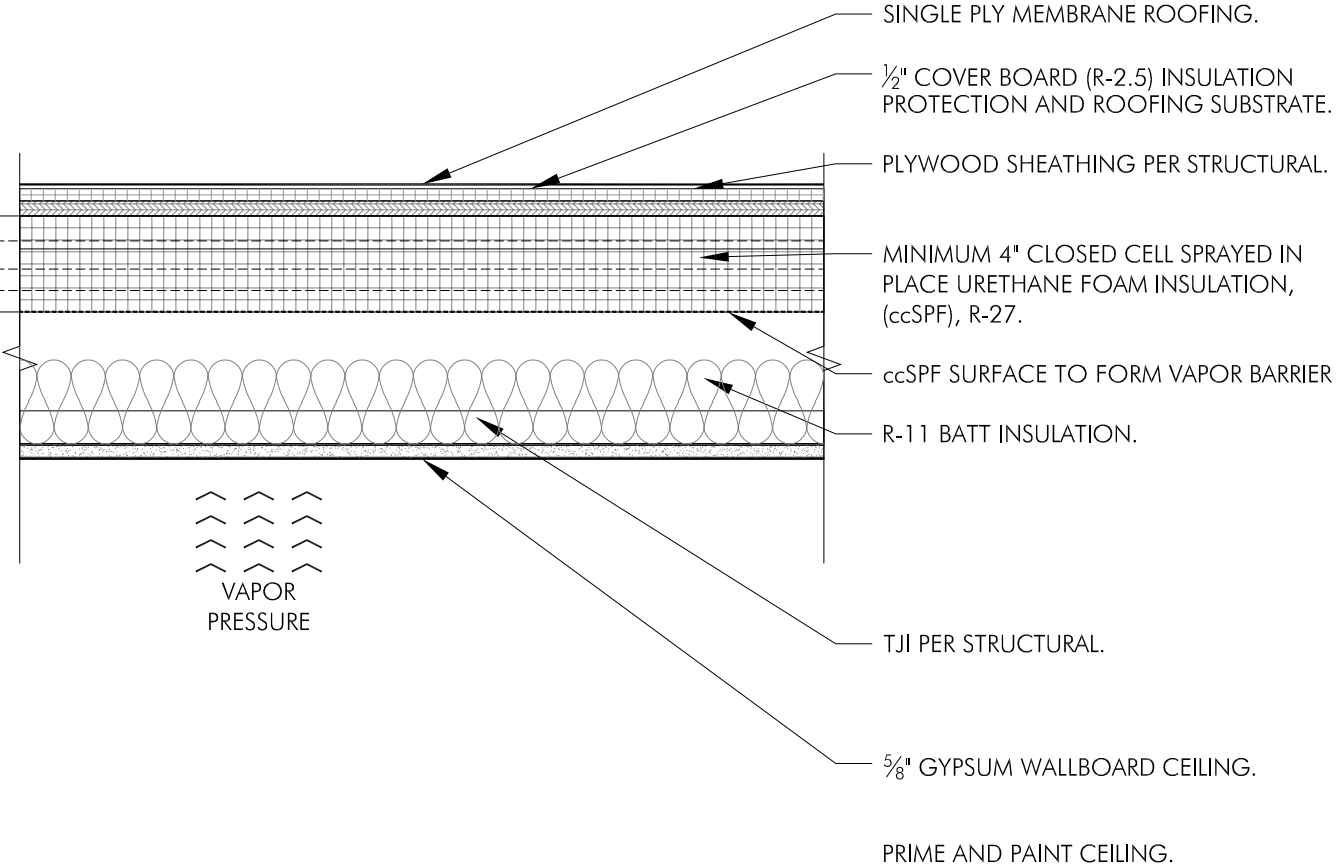
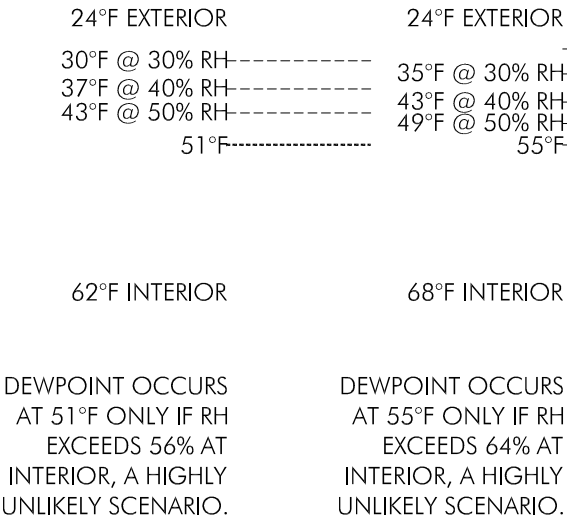
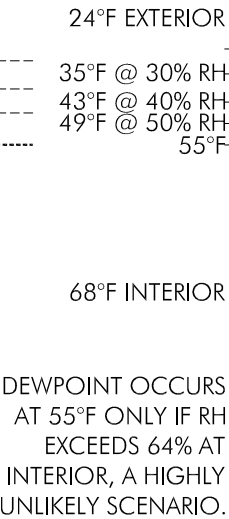
AVERAGE R-VALUE FOR THE ENTIRE ROOF
ASSEMBLY IS COMPUTED AT R-38, BASED
ON A RATIO OF 12% FOR FRAMING AND
88% FOR INSULATED CAVITY.

F.R.	N/A	ROOF/CEILING ASSEMBLY:	R-1
STC		WITH SOUND ATTENUATION BLANKETS
