TECHNICAL MEMORANDUM No. OF47-1

## City Outfall Basin 47 Inline Solids Sampling

SUBJECT: **Portland Harbor Source Control Investigation**

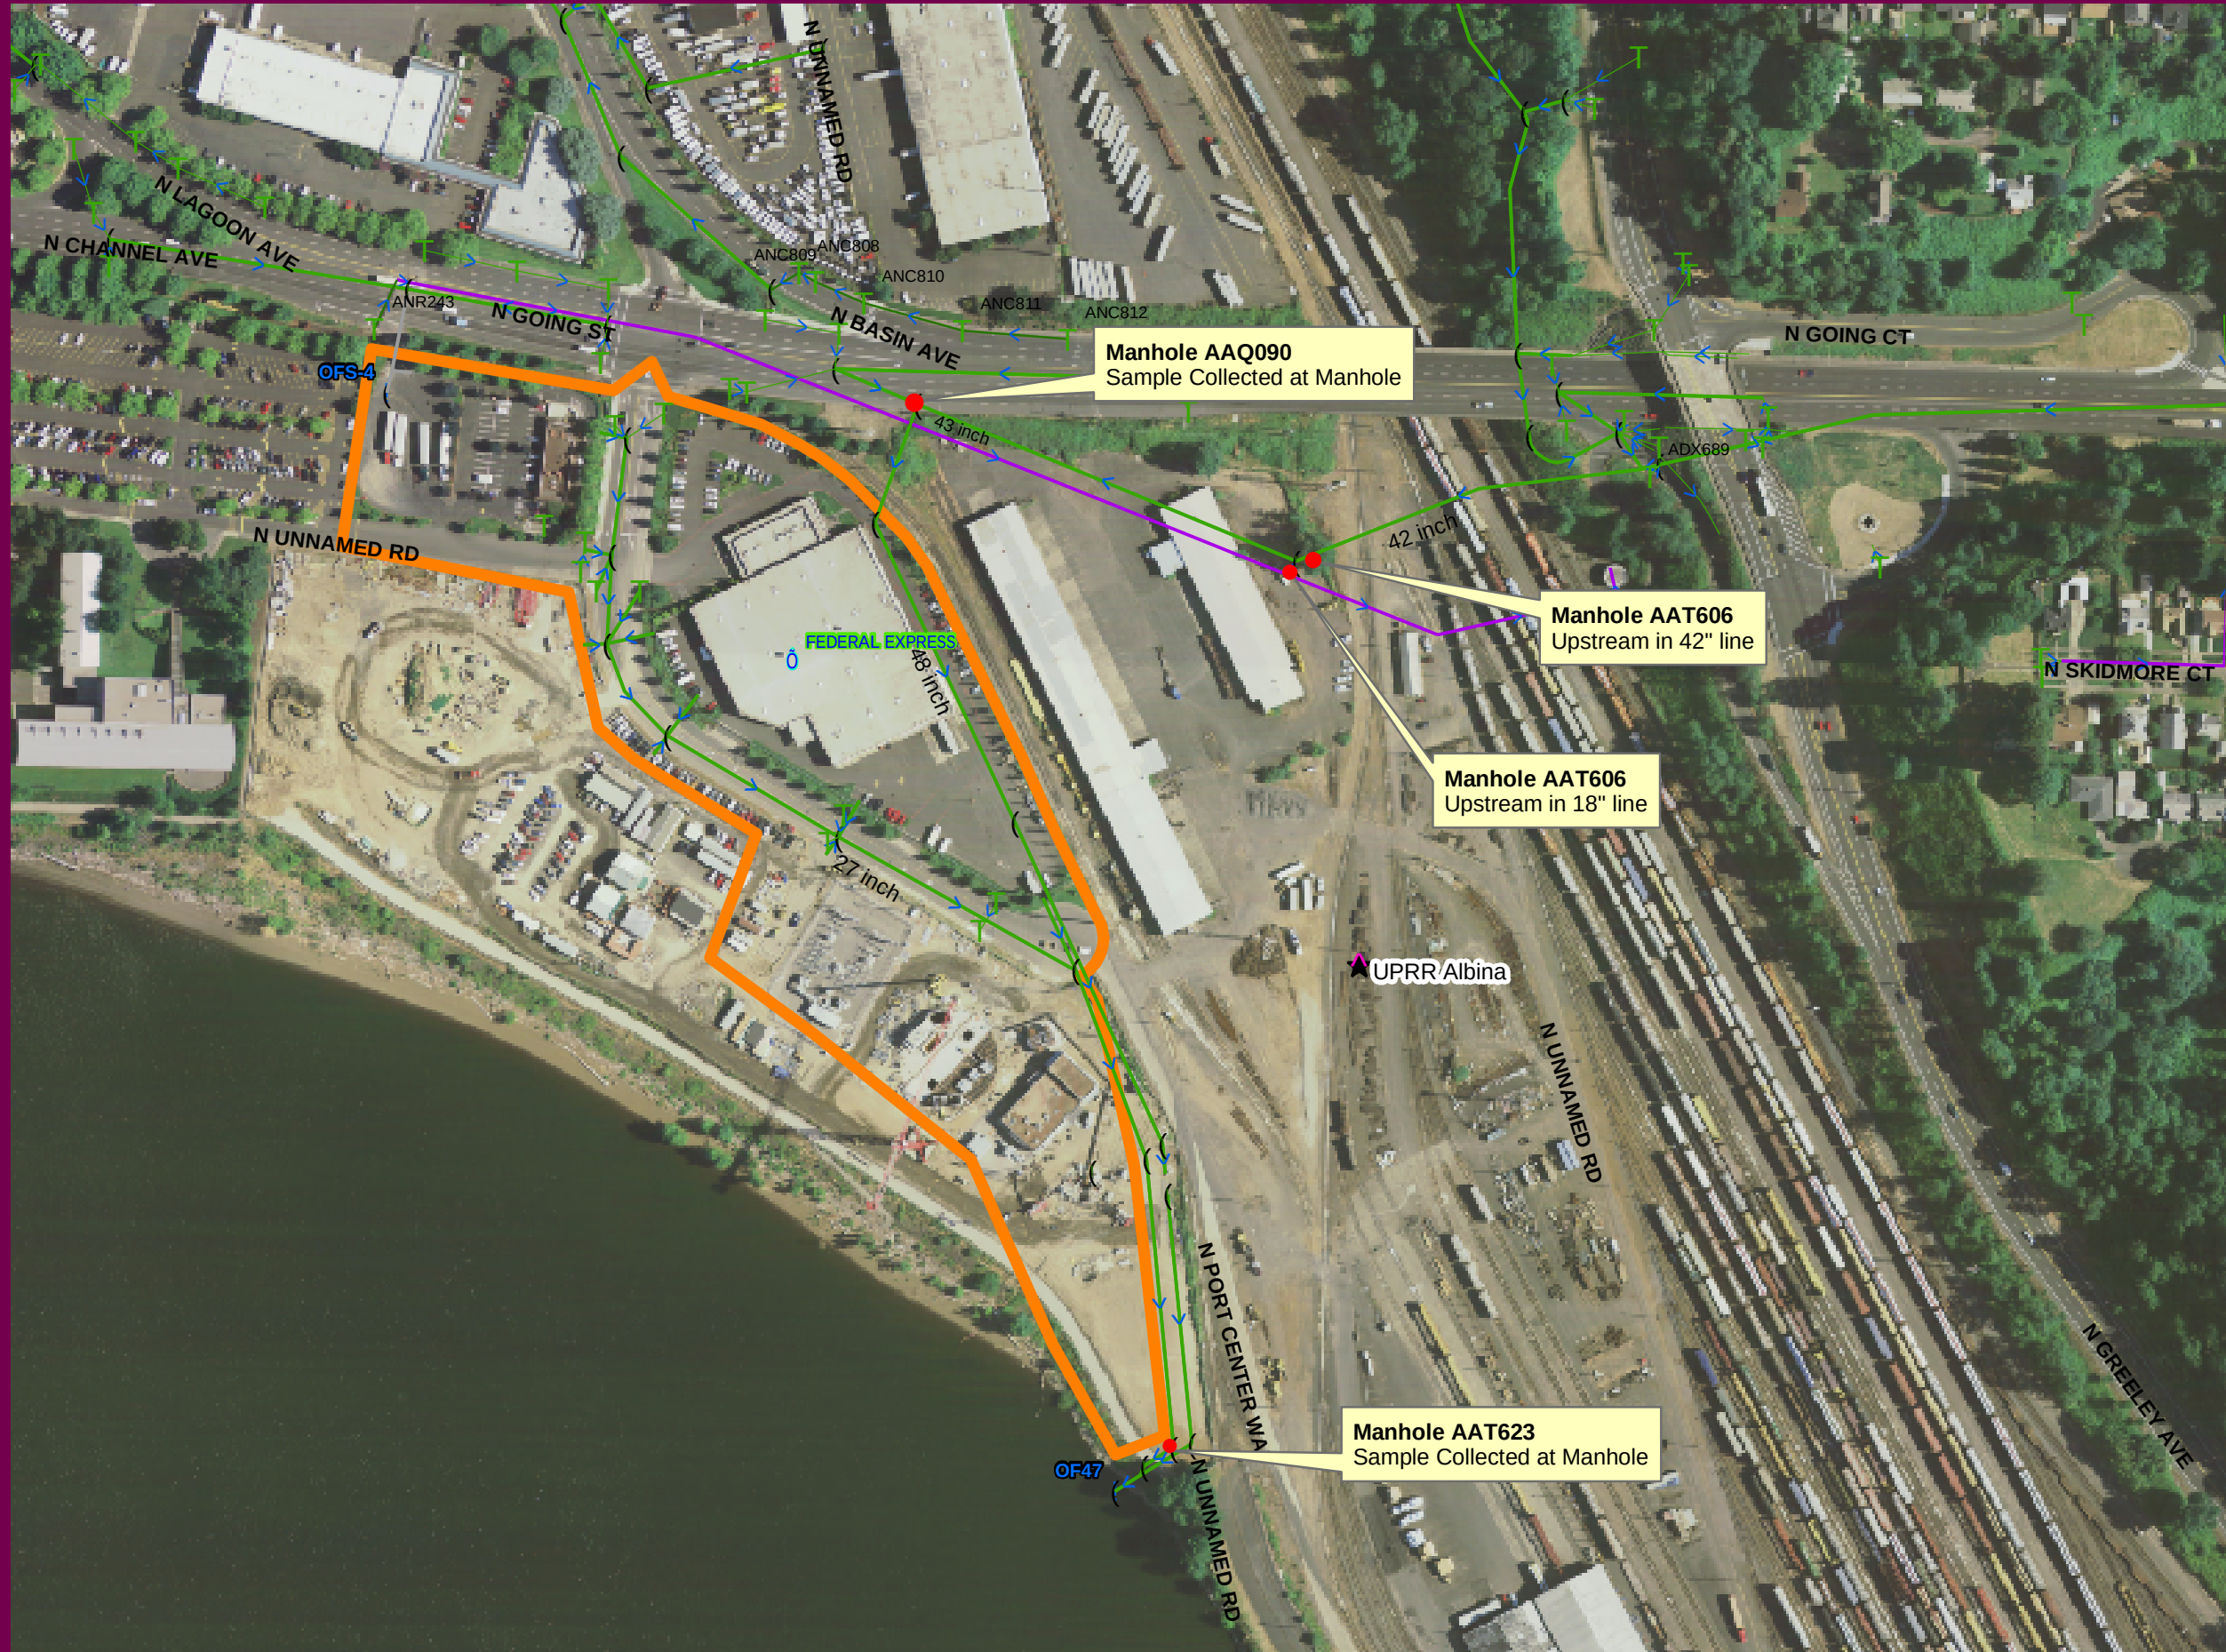
**Figure 1**  
**Basin 47**  
**Inline Solids**  
**Sample Locations**

After completion of this source investigation, stormwater in the eastern branch was redirected to the Columbia Boulevard Wastewater Treatment Plant along with combined flows. Figure 1 displays the stormwater conveyance system in the vicinity of Outfall 47.

The City coordinated with DEQ regarding this source control investigation before conducting this work. Inline solids were sampled at four locations on June 28, 2006 (see Figure 1). Target sampling locations were selected to represent inline solids above, at and below the industrial portions of the basin. Actual sampling locations were chosen based on inline solids availability. To represent the basin contributions above the industrialized portion of the basin, several

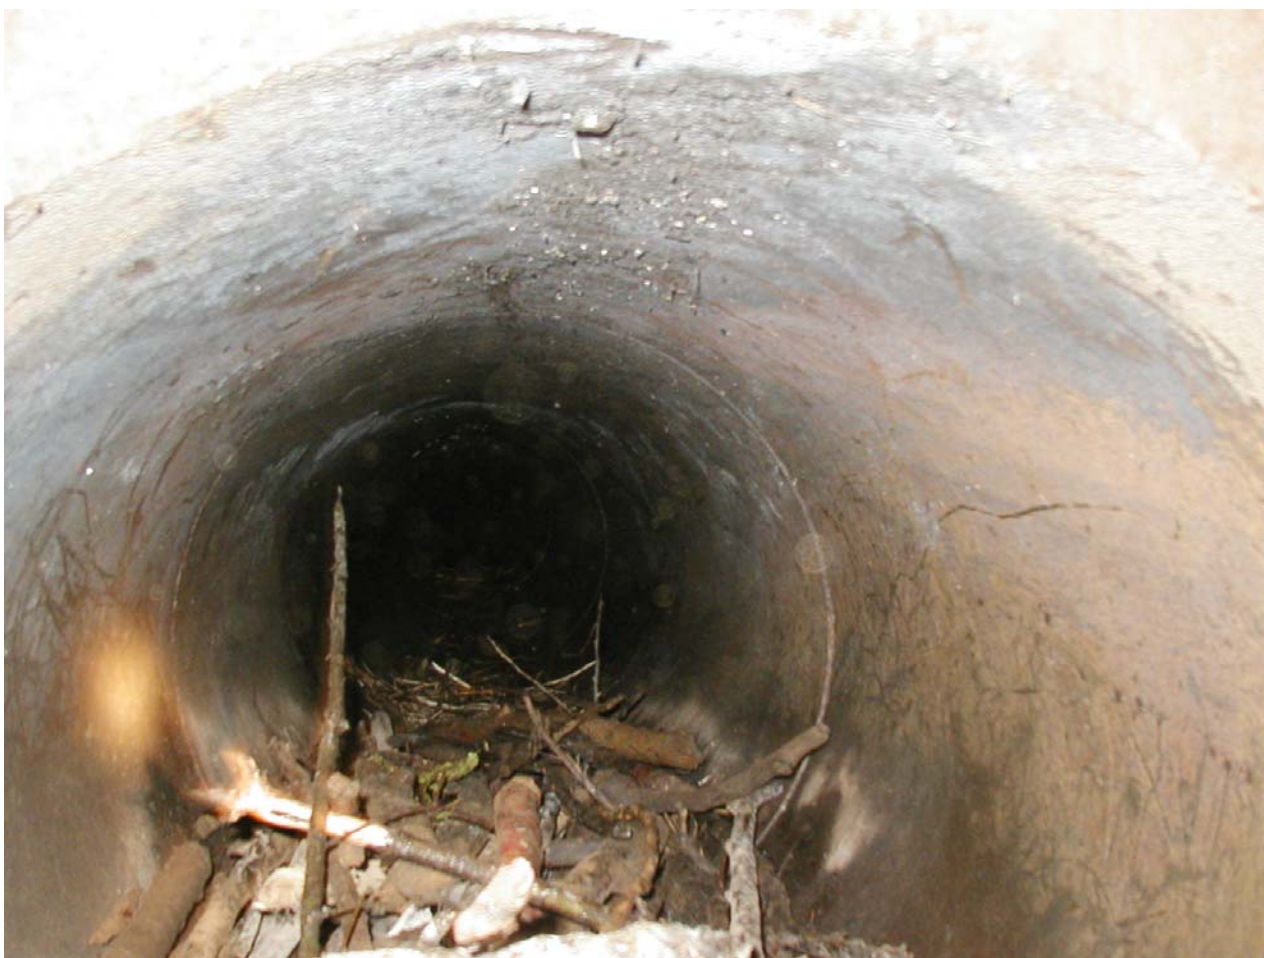
Manhole AAT623: Inline solids were sampled at manhole AAT623, after clearing away driftwood that had accumulated at this location (see Photo 1). Manhole AAT623 is located upstream of the convergence of the western and eastern branches and downstream of all known connections. Solids were sandy in nature and did not have any odor.

**Photo 1 (June 2006).** Looking downstream from manhole AAT623. Inline solids were collected at this location underneath the driftwood.

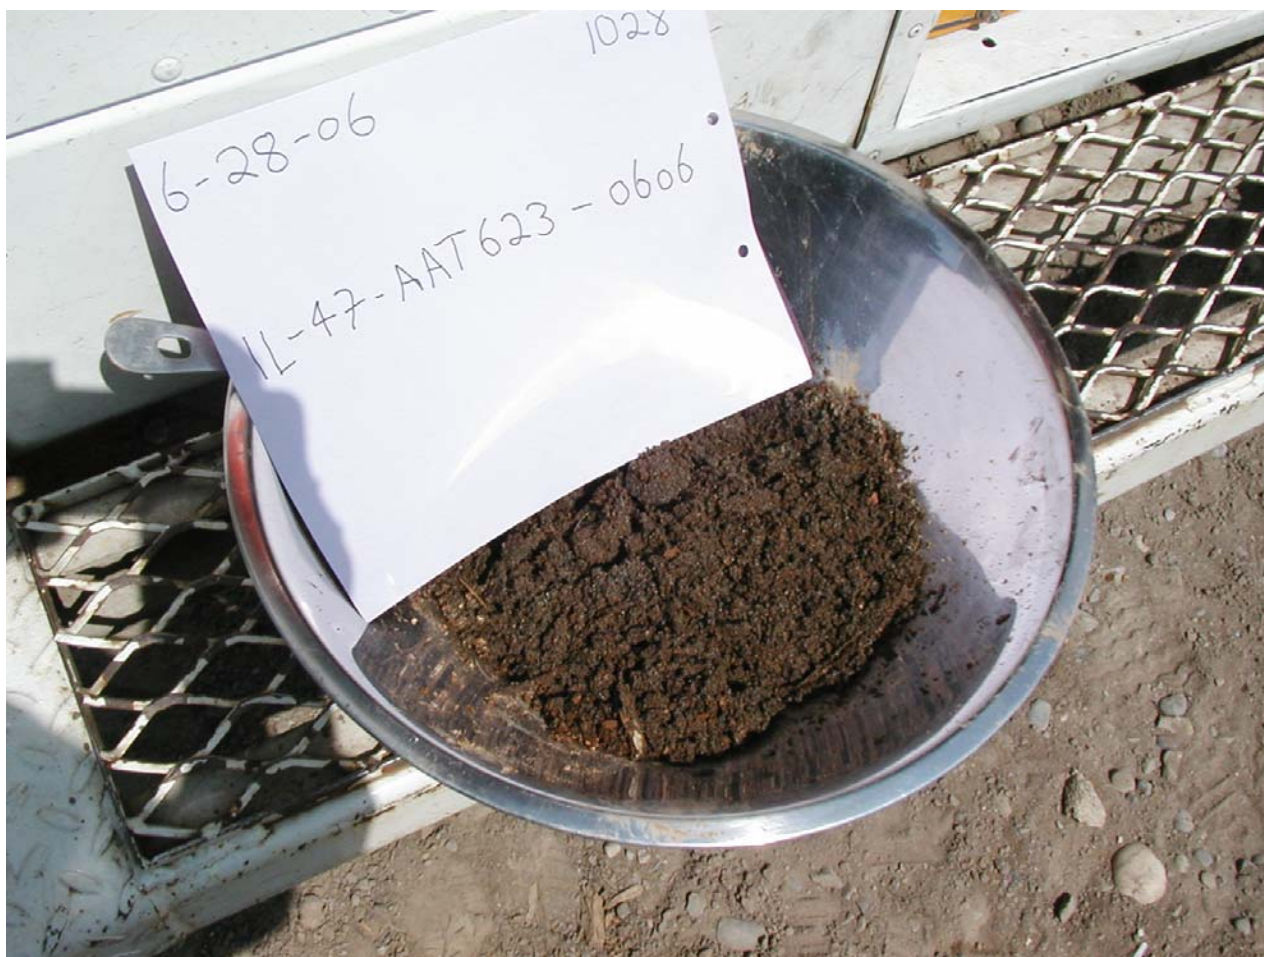
**Photo 2 (June 2006).** Solids collected from manhole AAT623.

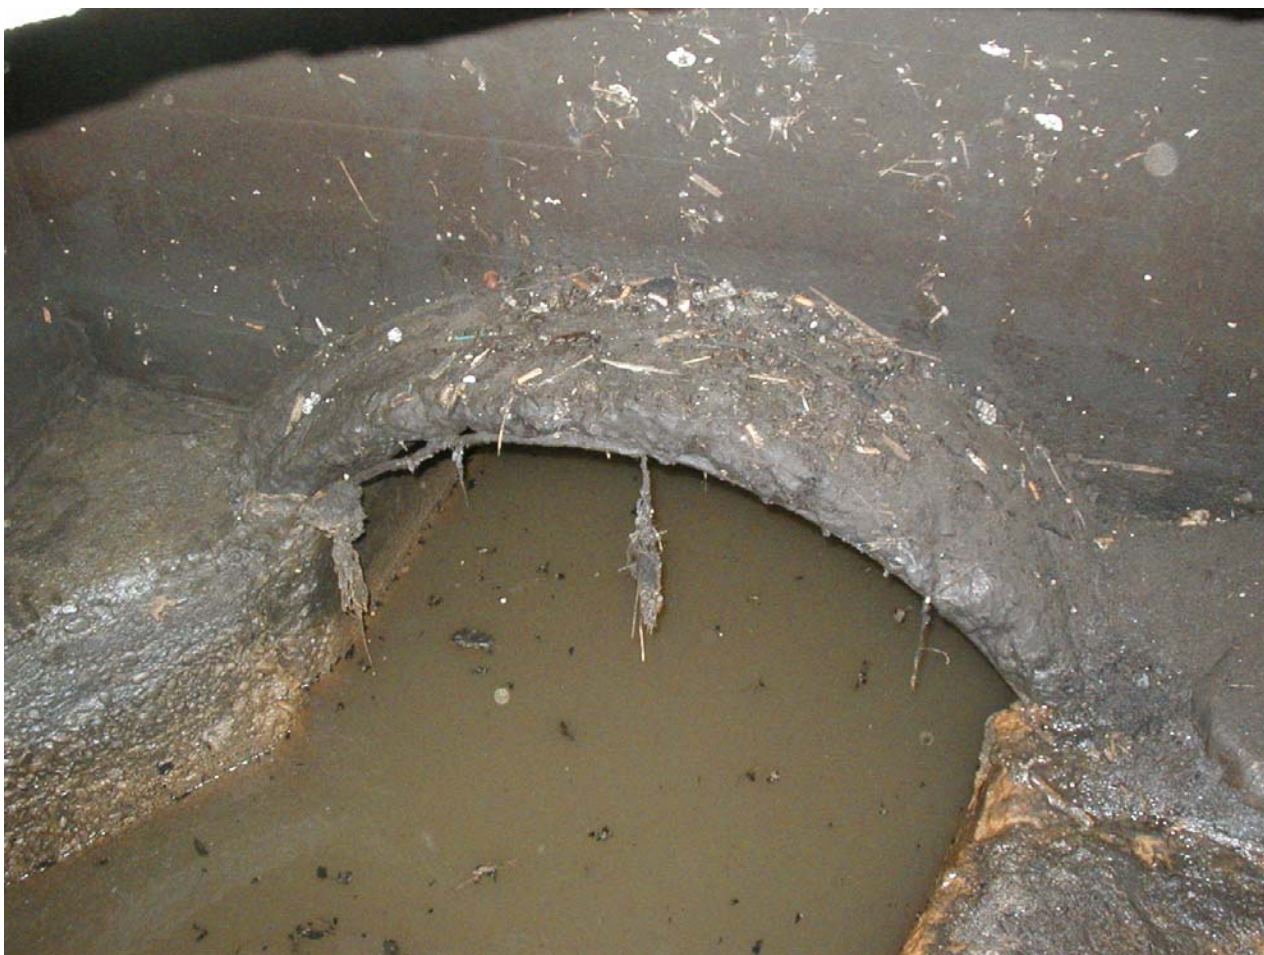
Manhole AAQ090: Inline solids were sampled from a ledge above the 48-inch-diameter line at manhole AAQ090 because the line was flooded at the time of the sampling event (see Photos 3 and 4). Manhole AAQ090 is located in the eastern branch on the south side of N. Going Street, downstream of all known industrial connections. Solids in this location represent discharges from the eastern branch. The sample was comprised of fine sands and silt. A slight sheen was noted on the sample but no odors were detected.

**Photo 3 (June 2006).** Inside manhole AAQ090. The line was flooded, so a sample was collected from accumulated solids on the ledge above the floor of the manhole (see Photo 4).

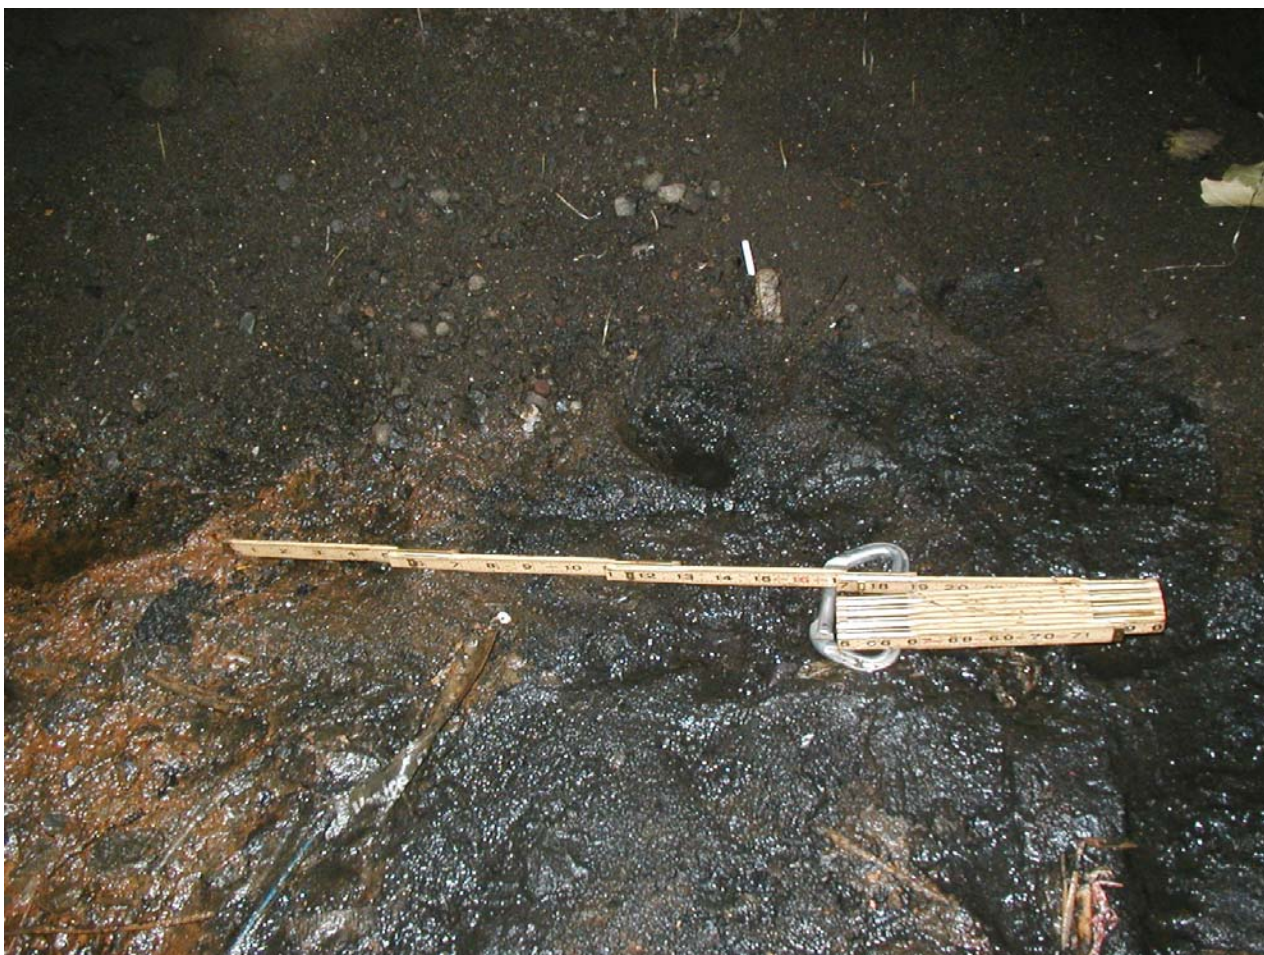
**Photo 4 (June 2006).** A solids sample was collected on this ledge, above the flooded floor of manhole AAQ090.

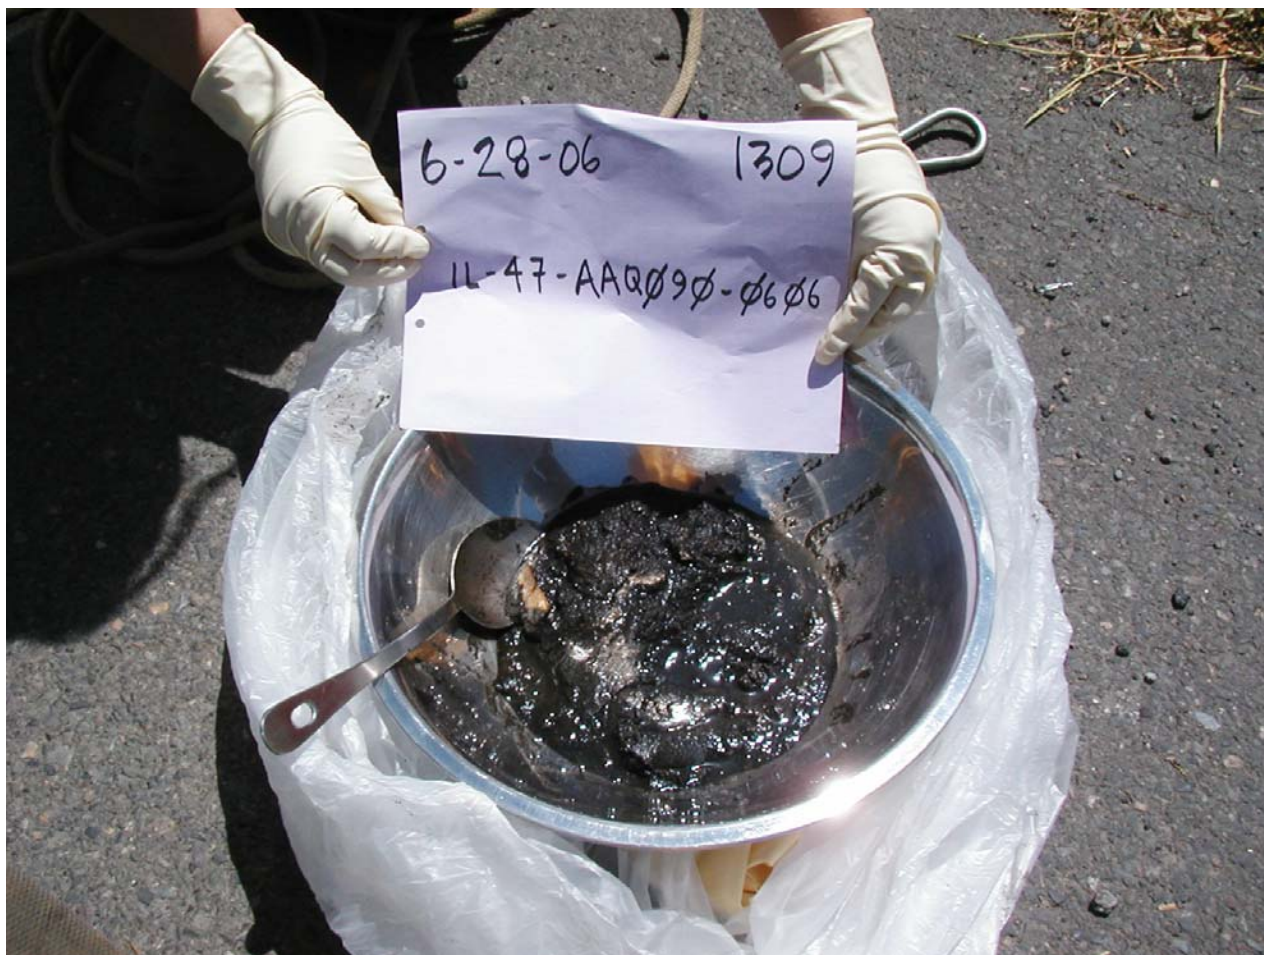
**Photo 5 (June 2006).** Solids collected from manhole AAQ090.

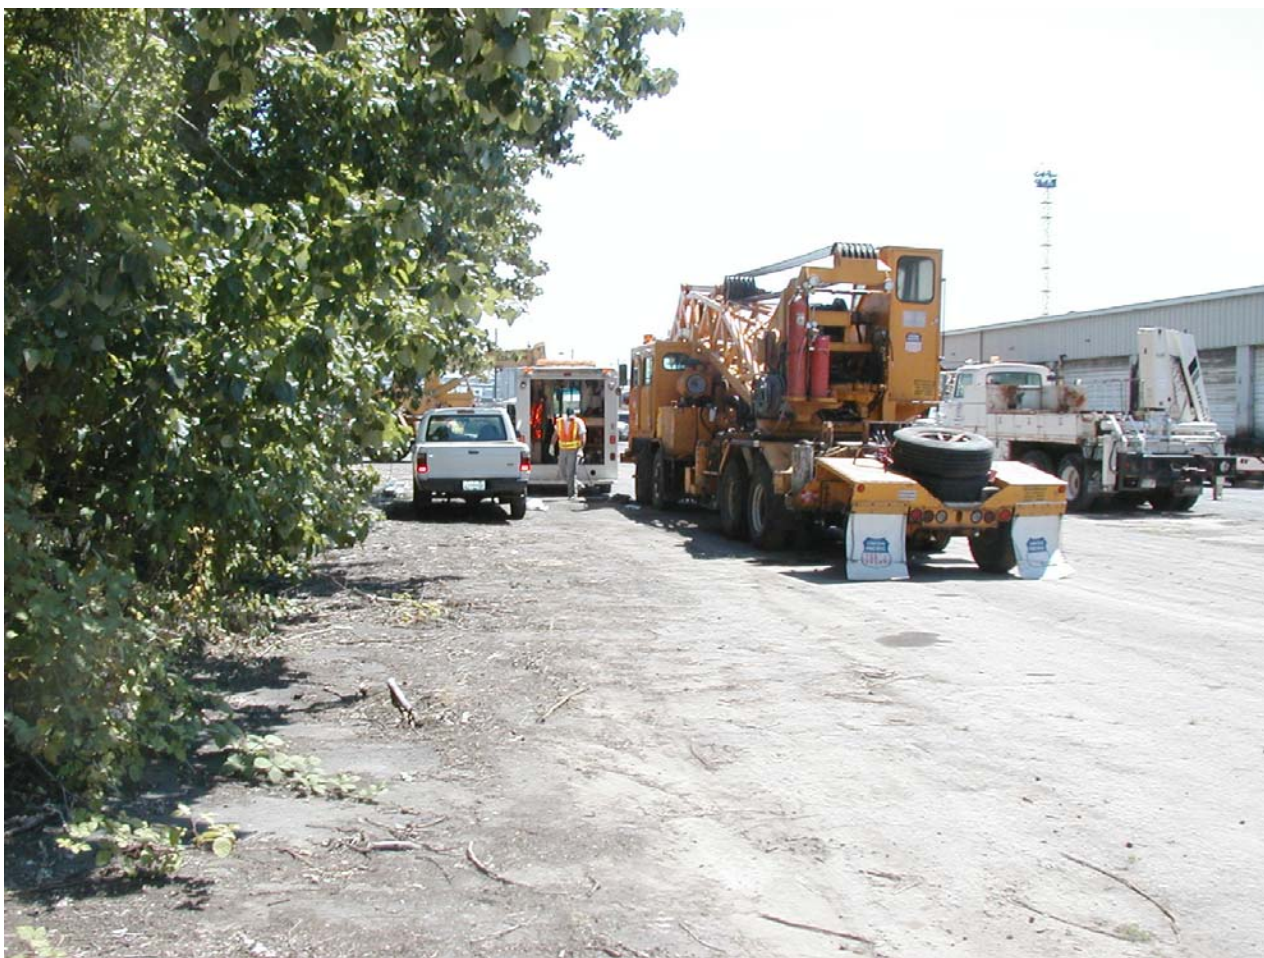
Manhole AAT606 (42-inch line): Inline solids were sampled from the 42-inch line approximately 5 to 10 feet upstream of manhole AAT606 (see Photo 6). UPRR is in the process of evaluating the configuration and points of connection for the on-site conveyance system in this area. Based on a review of City plumbing records and maps provided by UPRR (CH2M Hill, 2007), it appears that there are connections from the UPRR north yard upstream and downstream of this manhole. The sample was comprised of fine sands and silt. No odor or visual evidence of contamination was detected in the sample.

**Photo 6 (June 2006).** Aboveground location of manhole AAT606 in the UPRR north yard. Two samples were collected at this location, one from the upstream 42-inch-diameter main line and one from an 18-inch-diameter lateral entering from the southwest.

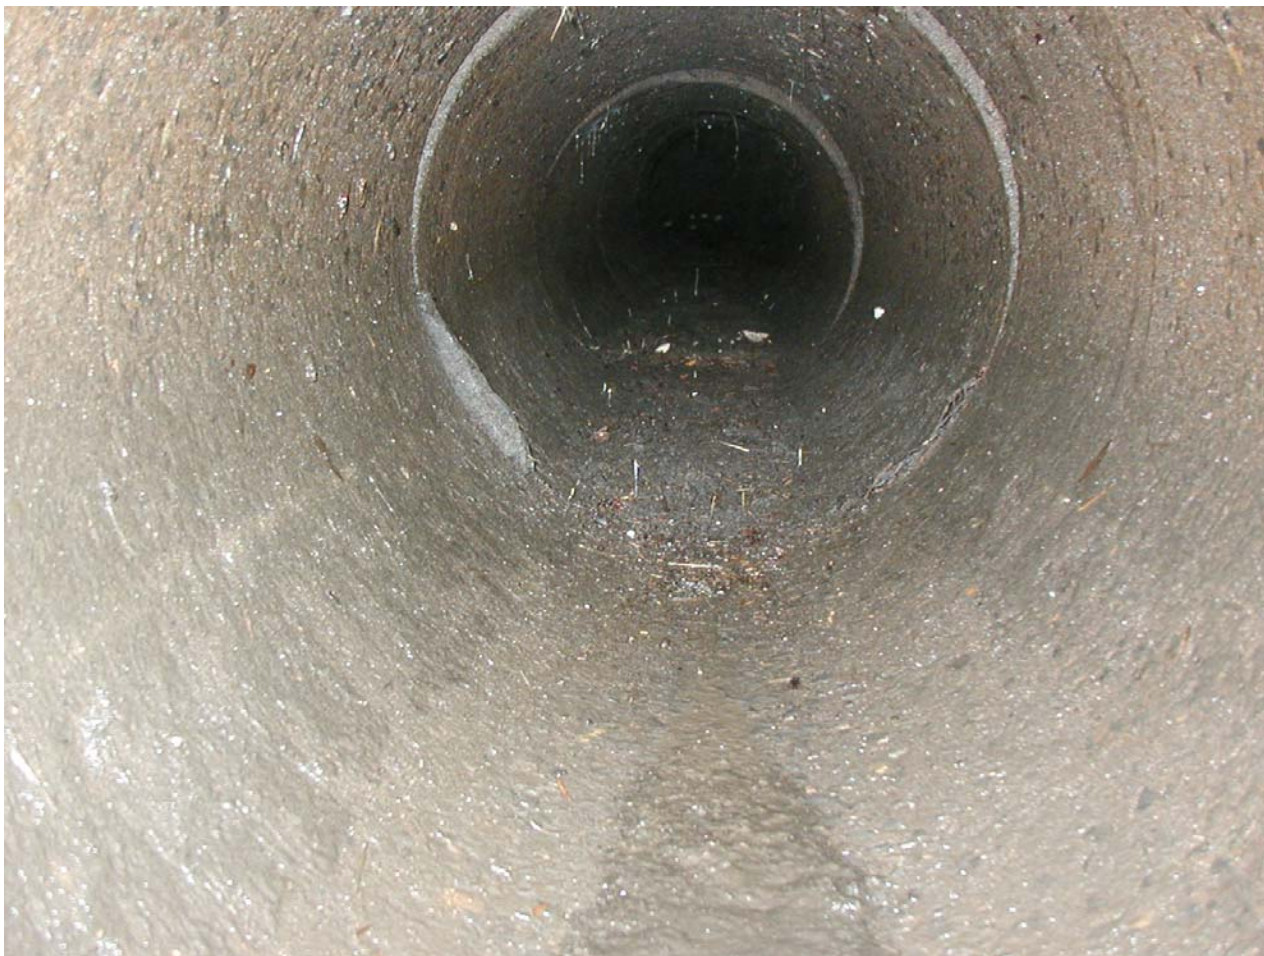
**Photo 7 (June 2006).** Looking upstream from manhole AAT606 in the 42-inch-diameter line. Inline solids were collected approximately 5 to 10 ft upstream from the manhole.

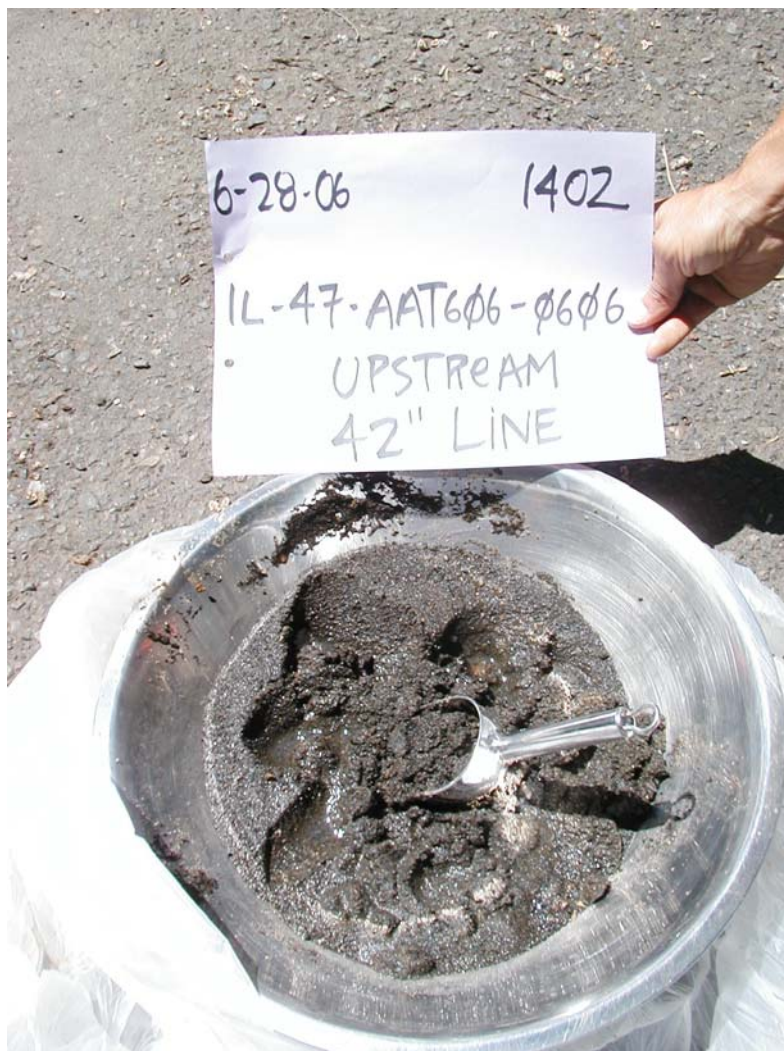
**Photo 8 (June 2006).** Inline solids collected from the 42-inch-diameter line. This sample identification code is AAT606-W.

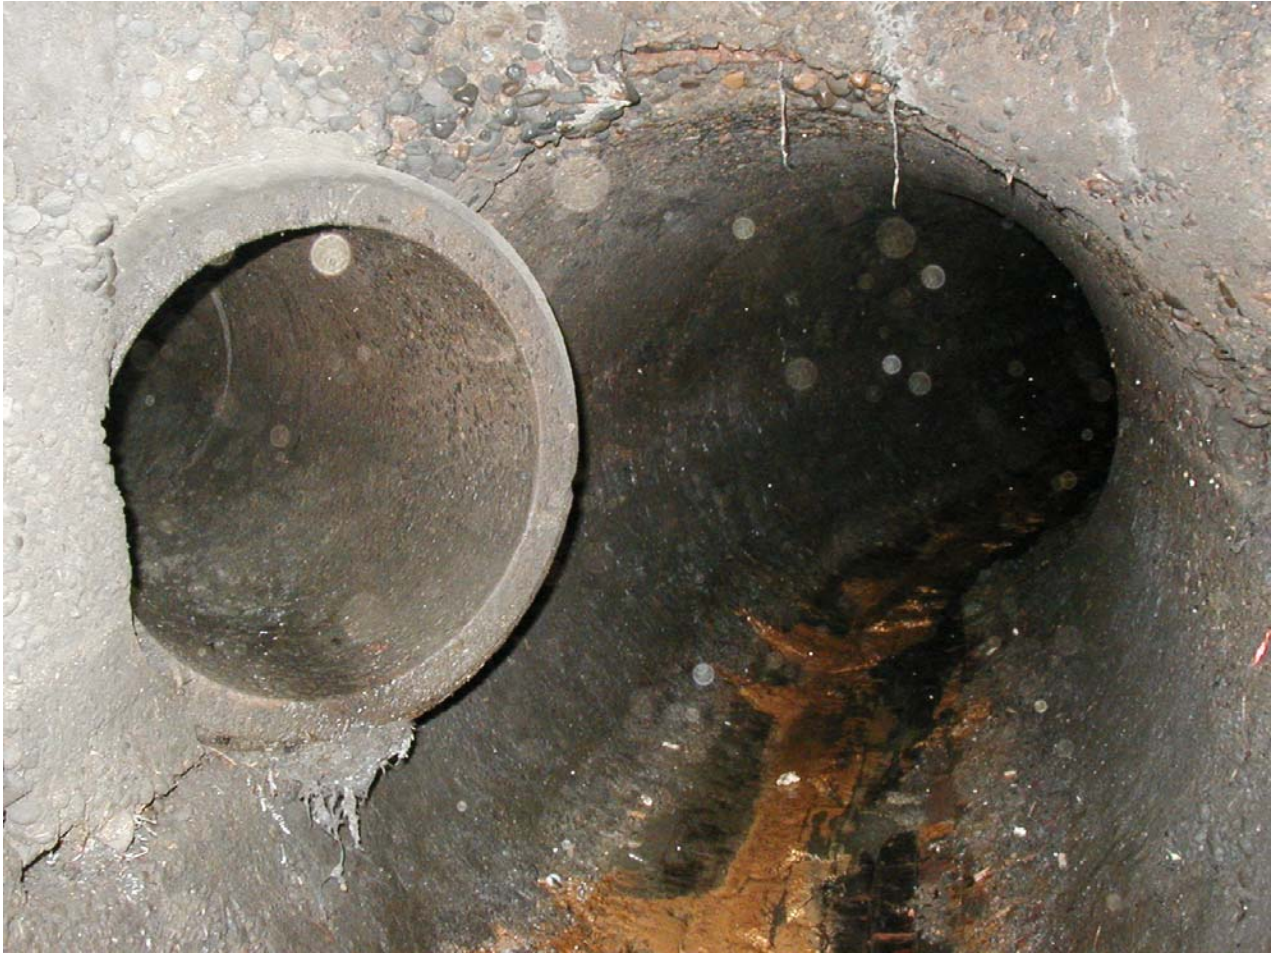
Manhole AAT606 (18-inch line): Inline solids were sampled from an 18-inch lateral just upstream from manhole AAT606. This line is the diversion point from the combined line that discharges to the Swan Island pump station. No odor or visual evidence of contamination was detected in the sample. Abundant organic matter was observed along with fine sands and silt.

**Photo 9 (June 2006).** Looking downstream from manhole AAT606, where the 18-inch-diameter lateral enters the manhole from the southwest. Inline solids were collected from the 18-inch line.

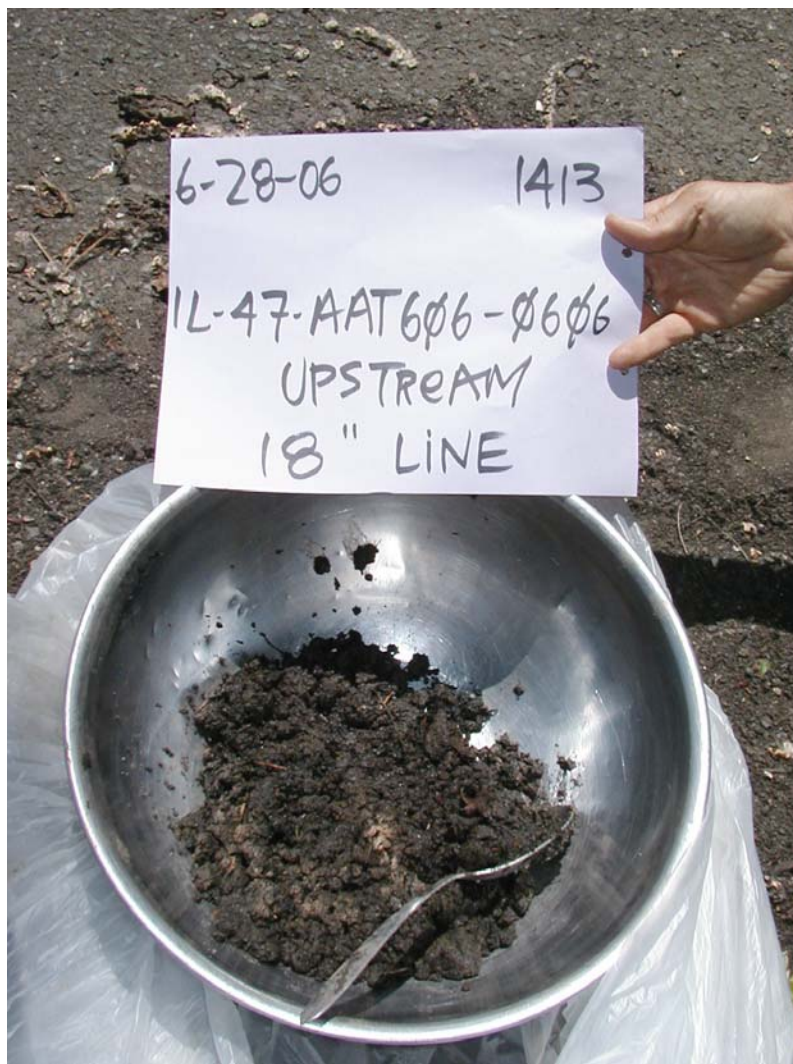
**Photo 10 (June 2006).** Inline solids collected from the 18-inch-diameter lateral. This sample identification code is AAT606-S.
