Outfall Basin S-2 Sediment Trap Investigation

Technical Memorandum No. OF S2-1
City of Portland Outfall Project
ESCI No. 2425

June 2012

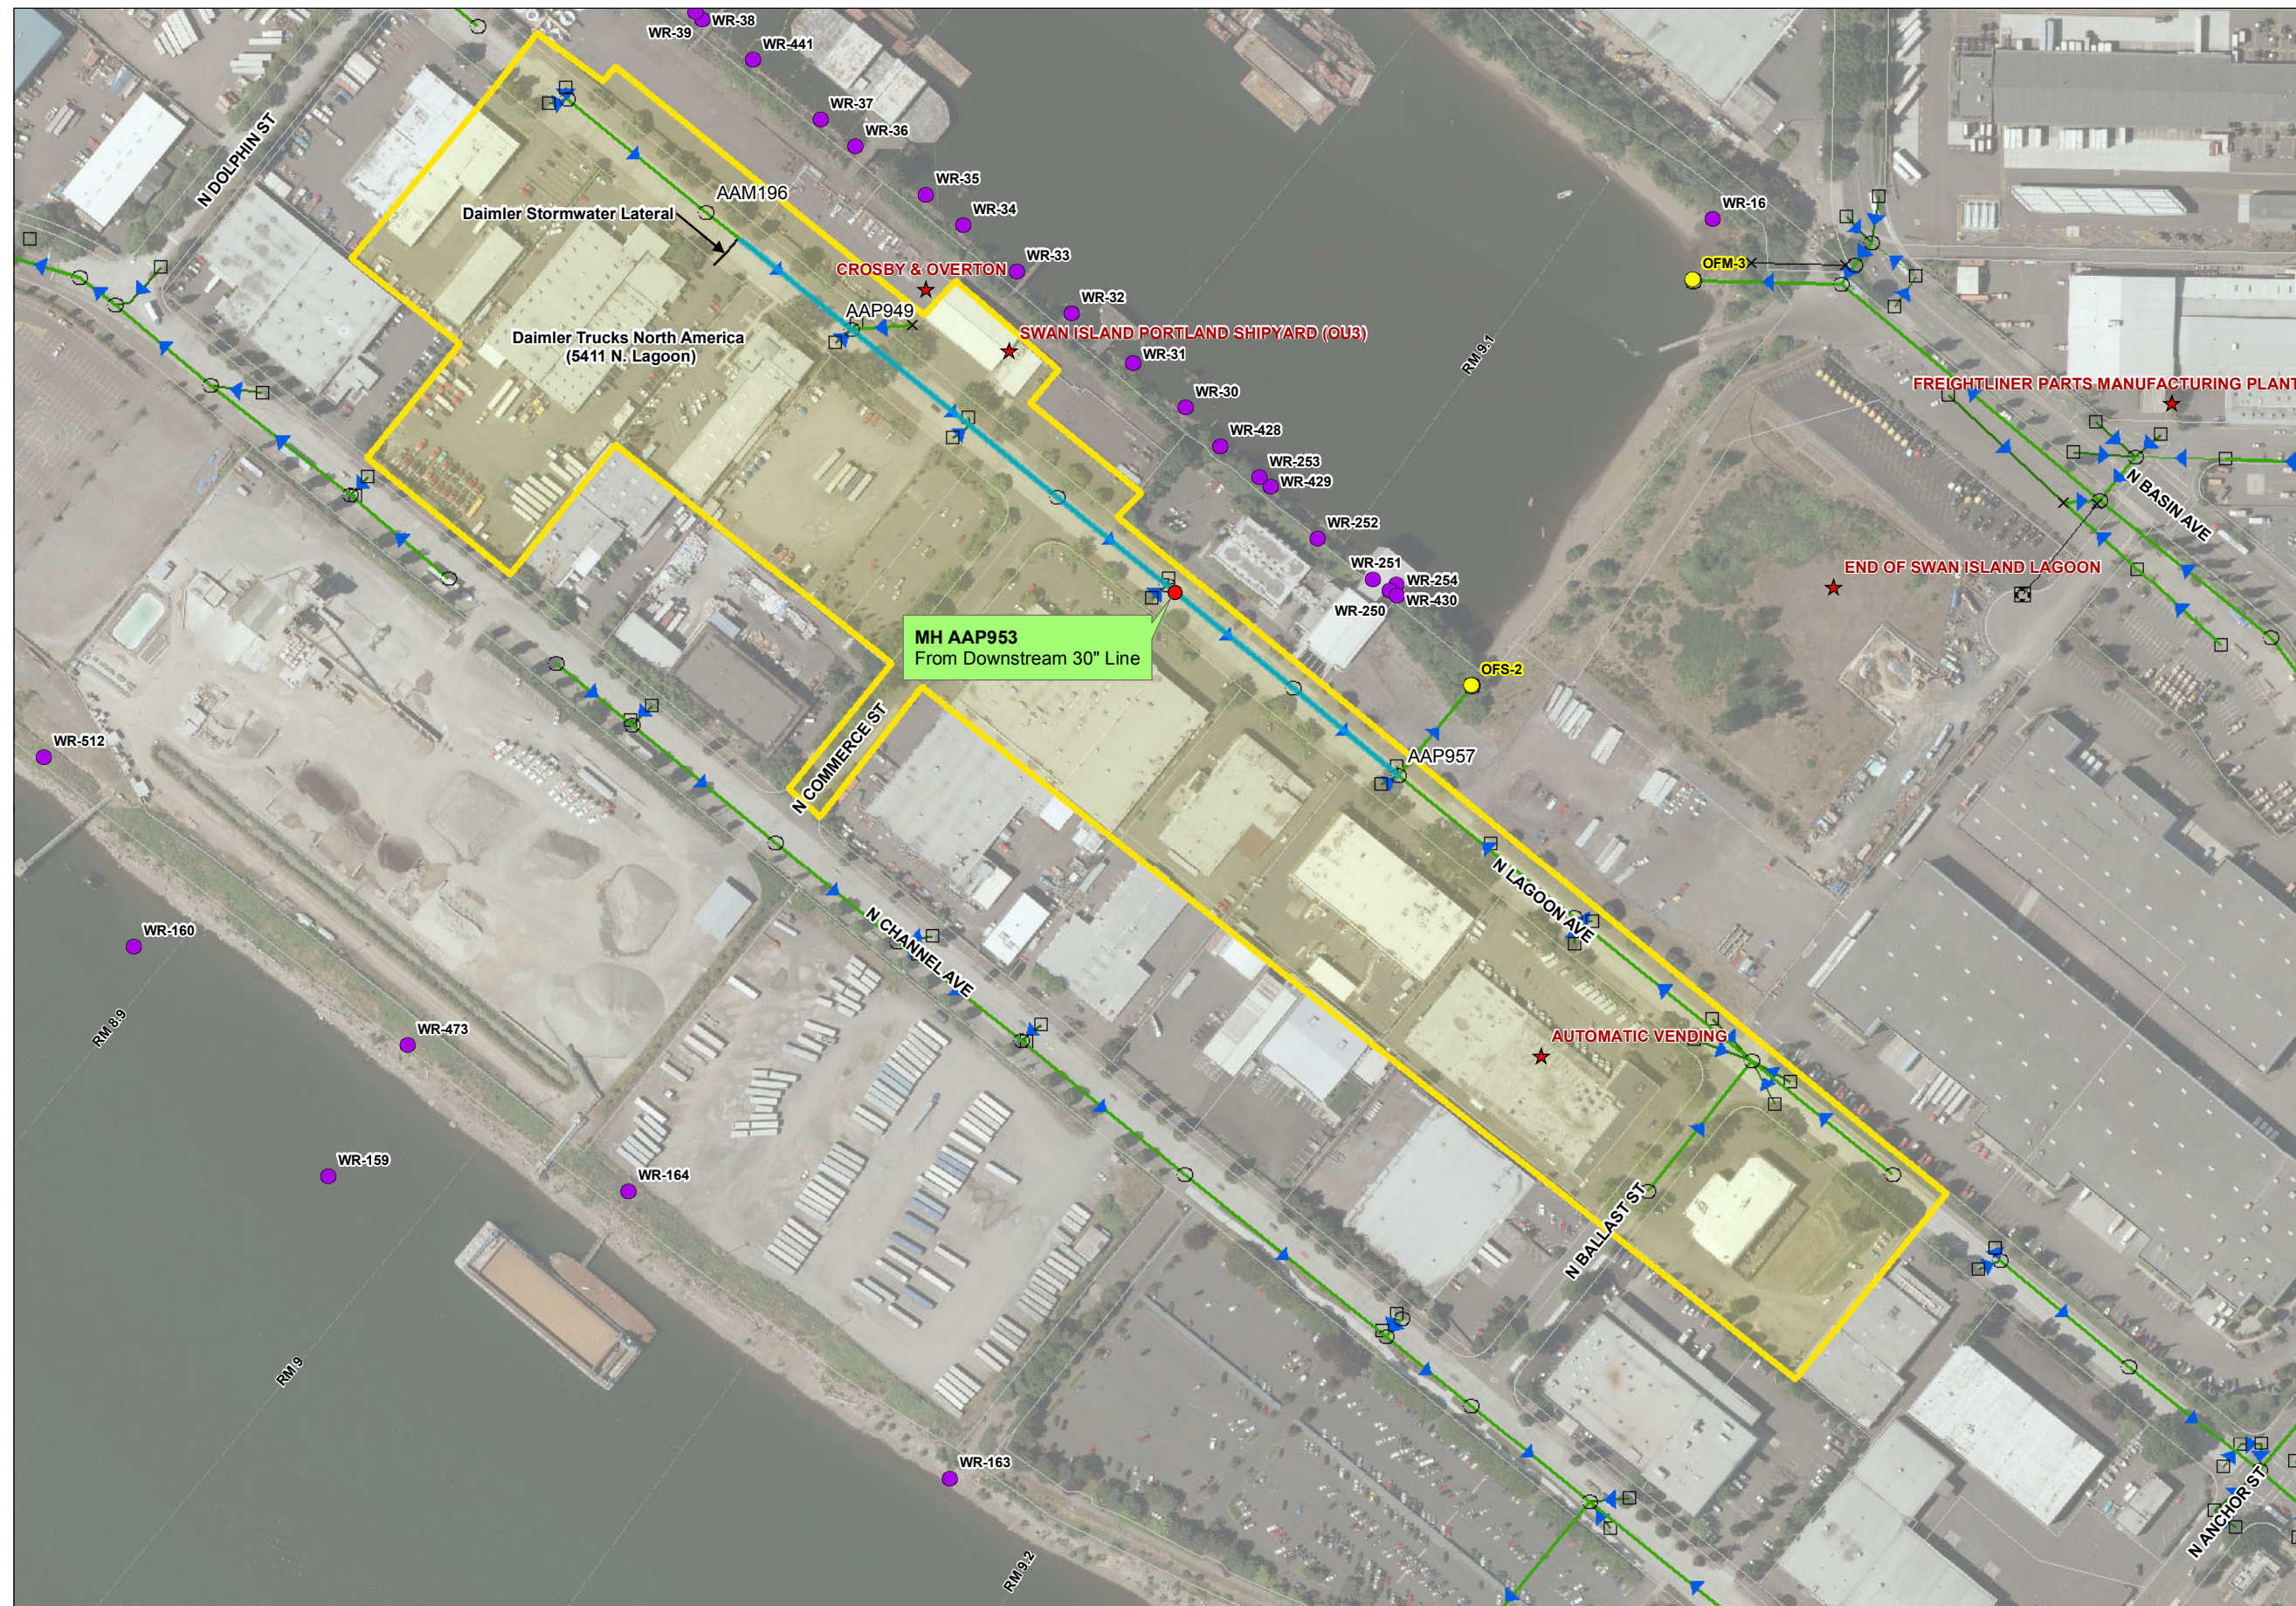
FIGURE 1
Outfall Basin S-2
Drainage Basin Overview
and Sample Location

Outfall S-2, a 36-inch outfall pipe, drains a 27-acre stormwater-only basin. Stormwater runoff from this drainage basin is conveyed by the main stormwater line running along N. Lagoon Avenue to the outfall pipe, which connects to the N. Lagoon line at manhole AAP957 and discharges at the southeast end of the Swan Island Lagoon, at approximately river mile 9.1. The Outfall Basin S-2 stormwater conveyance system and basin boundary are shown on Figure 1.

Facilities listed in DEQ's Environmental Cleanup Site Information (ECSI) database are considered potential upland sources to City stormwater conveyance systems. Operable Unit 3 (OU3) of Shipyard upland facility is the only ECSI site located in the western branch of Basin S-2. The City also considers facilities permitted by DEQ under the National Pollutant Discharge Elimination System (NPDES) industrial stormwater discharge permit program as potential upland sources due to stormwater exposures to industrial operations; no NPDES-permitted facilities discharge to Basin S-2. In addition, the City identified the Daimler facility located at 5411 N. Lagoon Avenue as a potential current source to the system based on the 2009 release and the possibility of legacy contaminants in the onsite conveyance system (see above). These two facilities are briefly described below and shown on Figure 1.

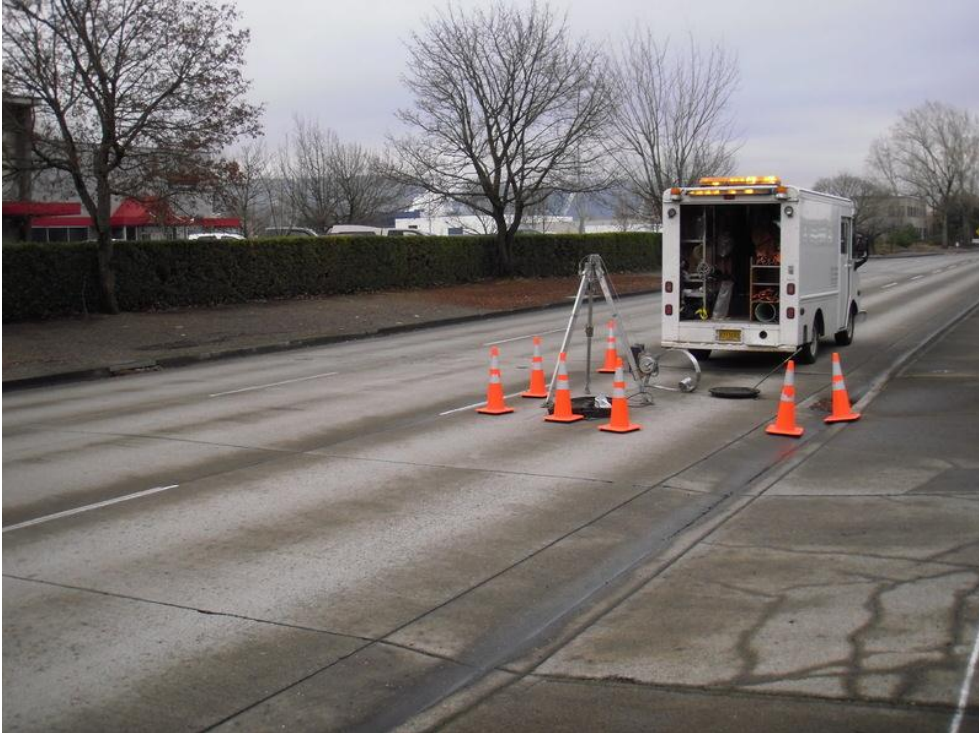
Photo 1 (December 22, 2010). Setup for sediment trap installation at manhole AAP953. View is to the northwest along N. Lagoon Avenue.

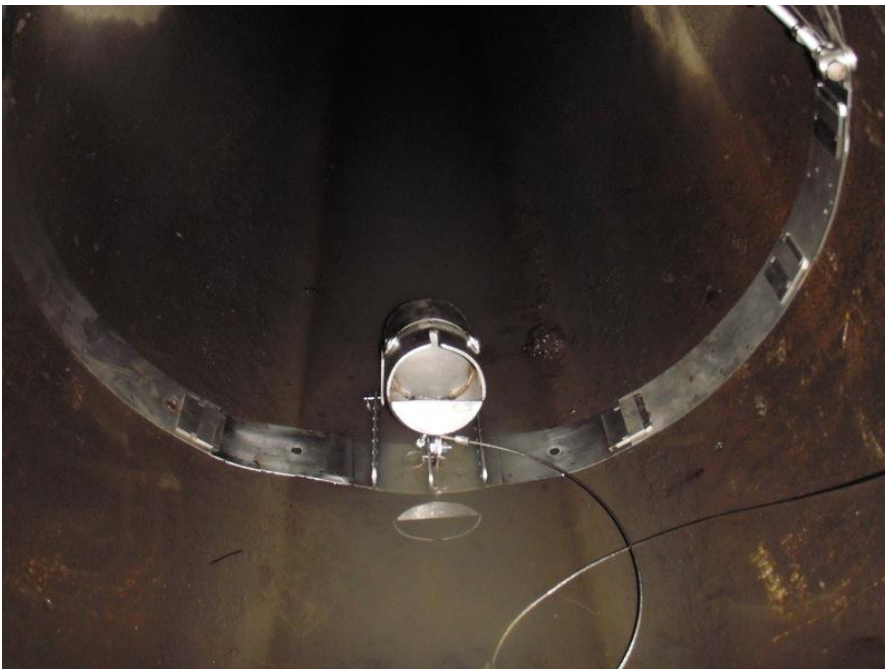
Photo 2 (December 22, 2010). Screened Inline Flow-Through (SIFT)© ¹ sediment trap installed in the 30-inch diameter outgoing line at manhole AAP953. SIFT trap is positioned 3 feet downstream of manhole.

The sediment trap deployment and sampling activities were completed in accordance with the SAP (BES, 2010a). A Screened Inline Flow-Through (SIFT®)³ sediment trap was installed in the outgoing 30-inch line in manhole AAP953 on December 22, 2010 (see Figure 1). The sediment trap was inspected periodically to assess the volume of trapped solids, note general conditions, and remove any debris that might be obstructing the opening of the trap chamber. Accumulated solids were removed as needed during the field inspections and archived. The final round of solids removal and archiving was conducted on April 18, 2011. During the following inspection,

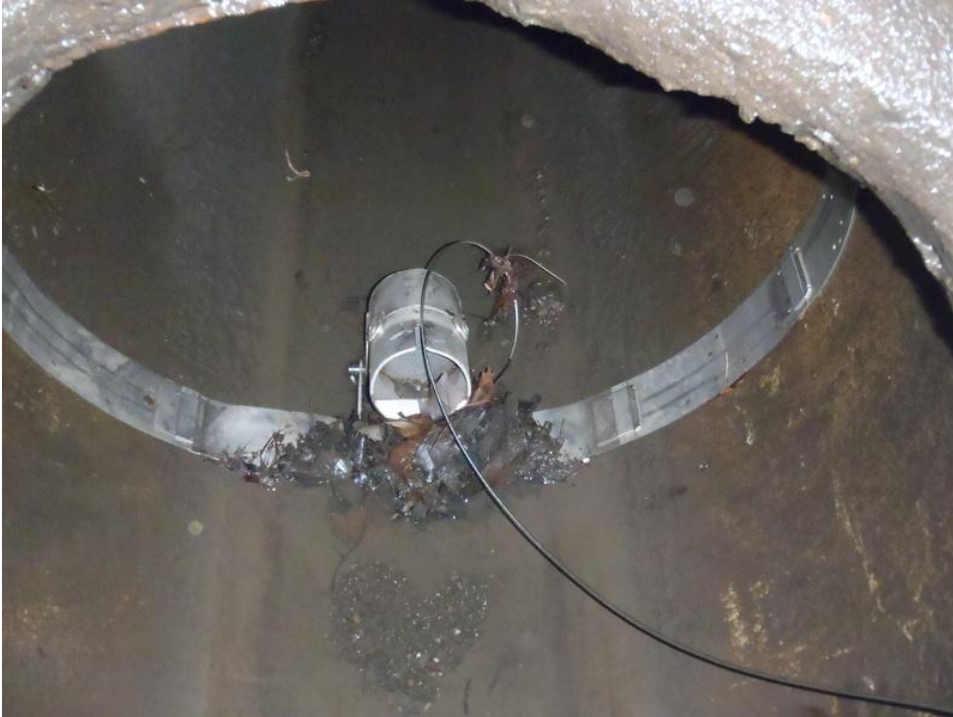
Photo 3 (January 26, 2011). Sediment trap with accumulated solids and organic matter during first monthly field check.

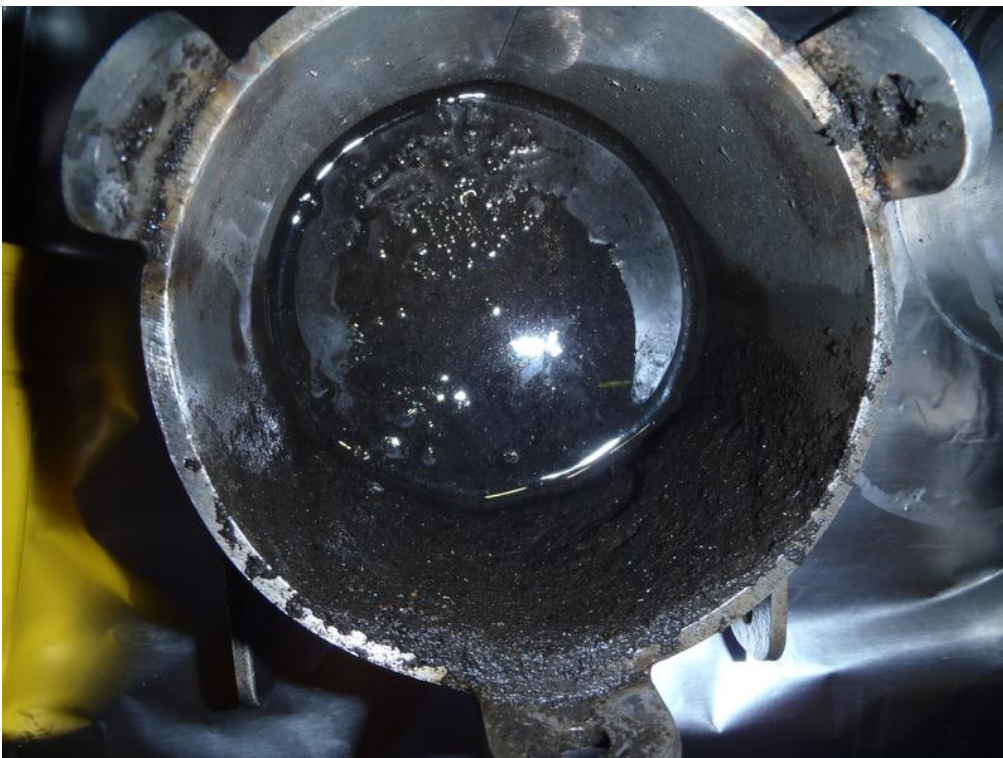
Photo 4 (March 7, 2011). Stormwater solids in secondary chamber at time of second monthly field check.

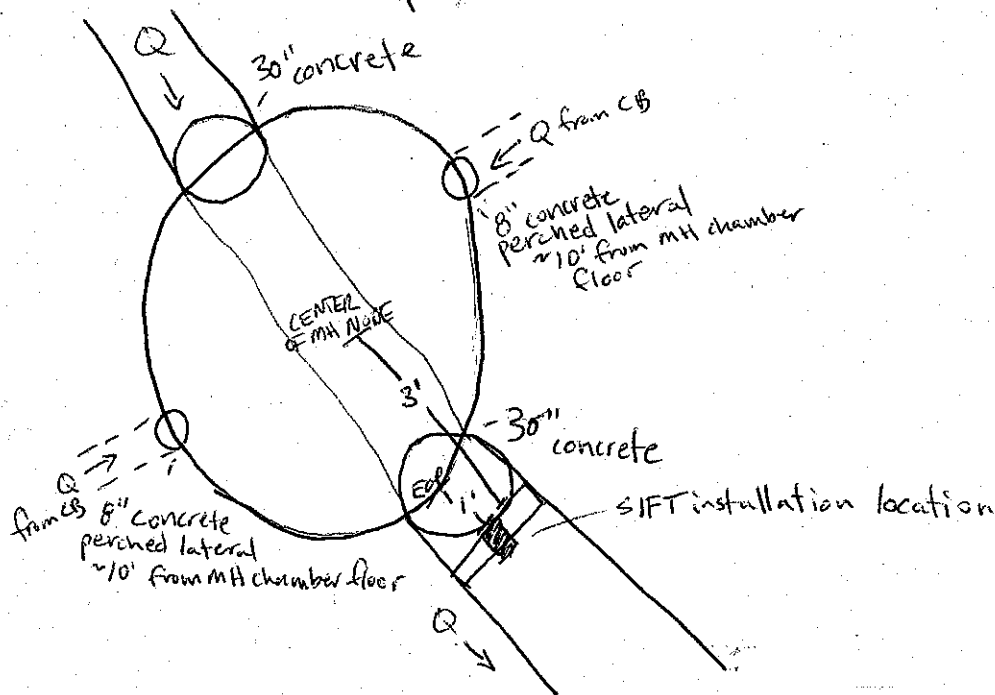
SED TRAP SITE DIAGRAM

Sketch map of the lateral(s) and layout of manhole, showing approx sed. trap location, manhole elevation and inline sediment if present. Orient drawing using the top of the page as north):

SIFT installed at 15° with 4 3/4 in. to top of weir
