## STAFF REPORT AND RECOMMENDATION TO THE PLANNING COMMISSION

**FILE NUMBER: R/W #8796**

Street Vacation Request:	SE Lambert St, SE Malden Ct, & SE Malden St (West Lents Floodplain Restoration Project)
Petitioner:	Portland Bureau of Environmental Services (BES) Roslyn Gray, <a href="mailto:roslyn.gray@portlandoregon.gov">roslyn.gray@portlandoregon.gov</a> , 503-320-6736; Tressie Word, <a href="mailto:tressie.word@portlandoregon.gov">tressie.word@portlandoregon.gov</a>
Purpose:	The primary objective of this restoration project is to restore fluvial processes, floodplain function, and habitat resilience to a dynamic stream-wetland corridor as Johnson Creek passes through the project area.
Neighborhood:	Lents
State ID:	1S2E21CB (-4900, -4700, -4600, -4100, -4200, -4400, -4000) 1S2E21CC 1800; 1S2E21CA (-3100, -2500, -2600, 2701, -2800, 2200, -2400, -2300, -2100, -1400, -1500, -1600)
Designation/Zones:	OS, OSc, OSp, IG2bp, IG2c, IG2bc, RM1 Open Space (OS); Residential Multi-Dwelling 1 (RM1); General Industrial 2 (IG2); Overlay zones: Environmental Conservation (c), Environmental Protection (p), Buffer (b)

# Wetland Delineation Report

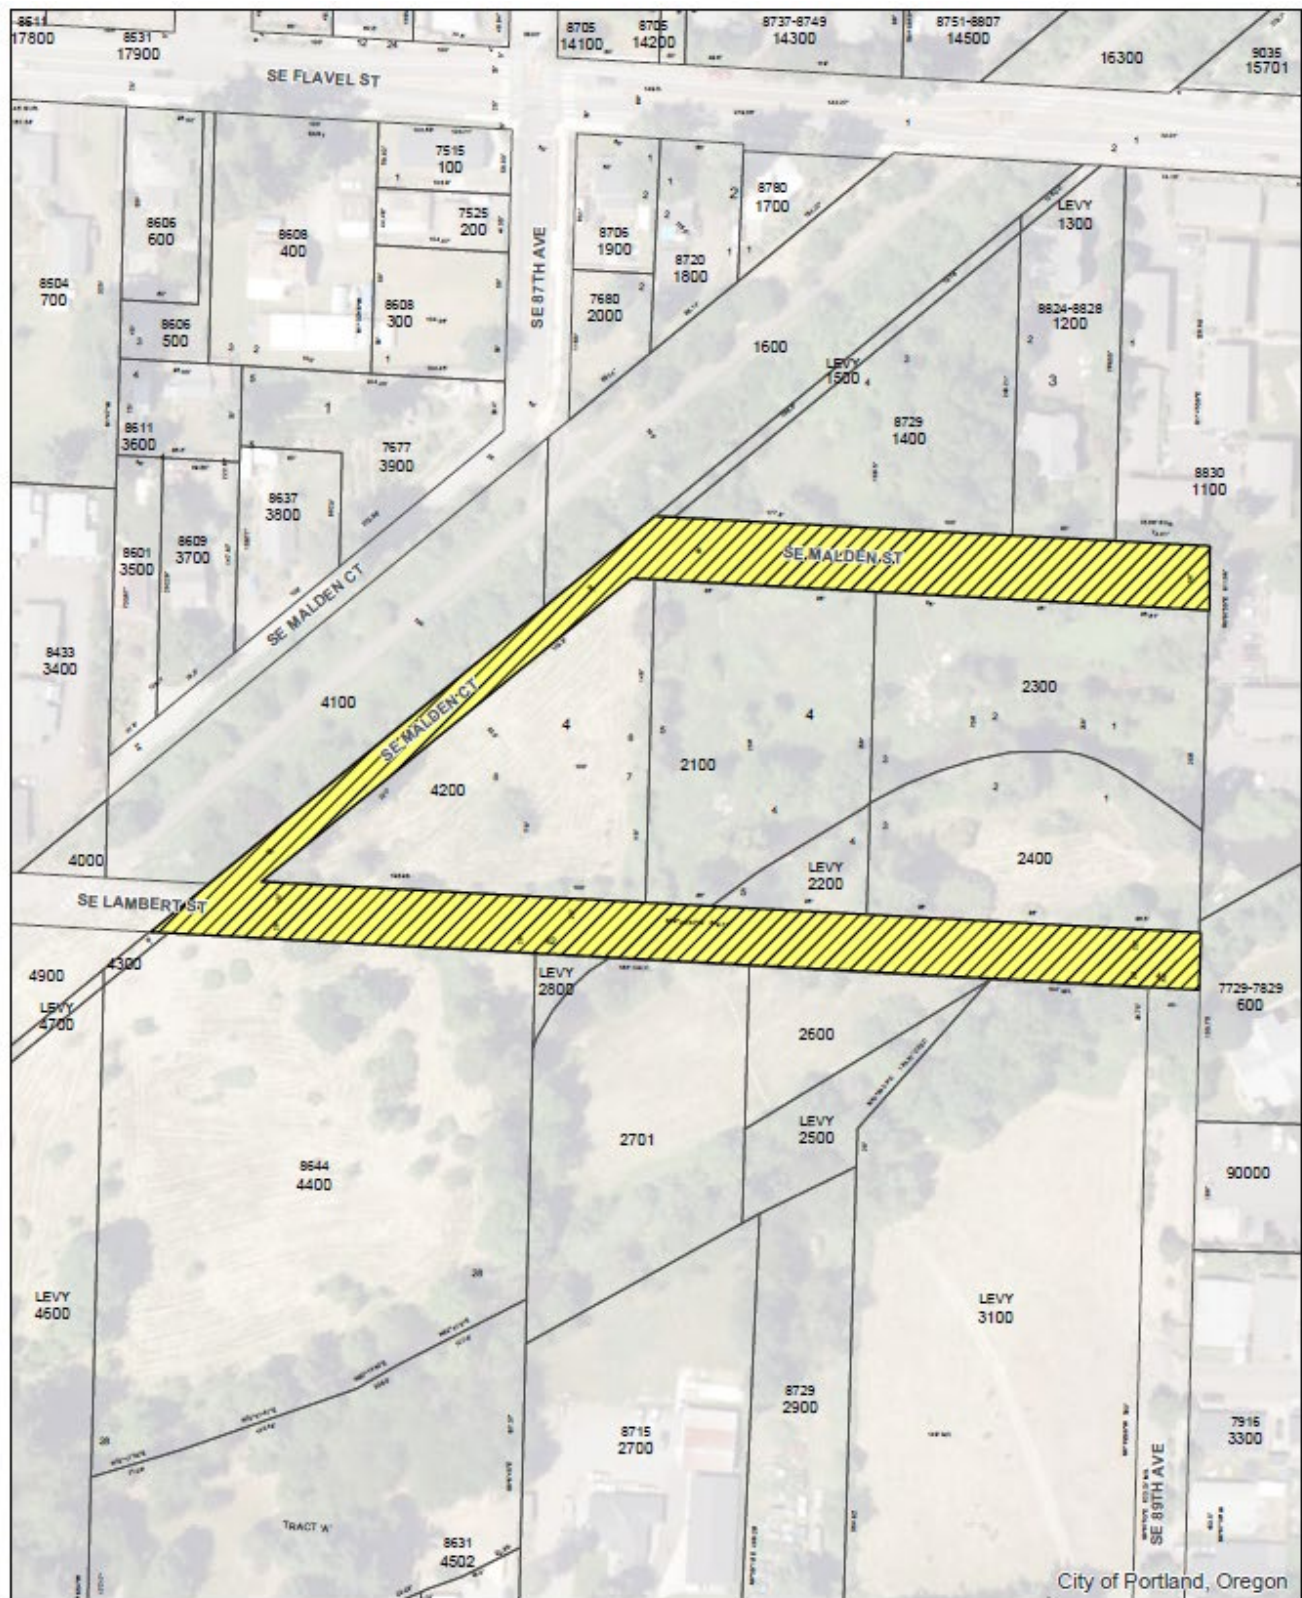
**Exhibit 3: Area Proposed for Vacation**

**SE Lambert Street, SE Malden Court, and SE Malden Street**

The staff recommendation is **approval** of the vacation of the area shown on Exhibit 2, with conditions:

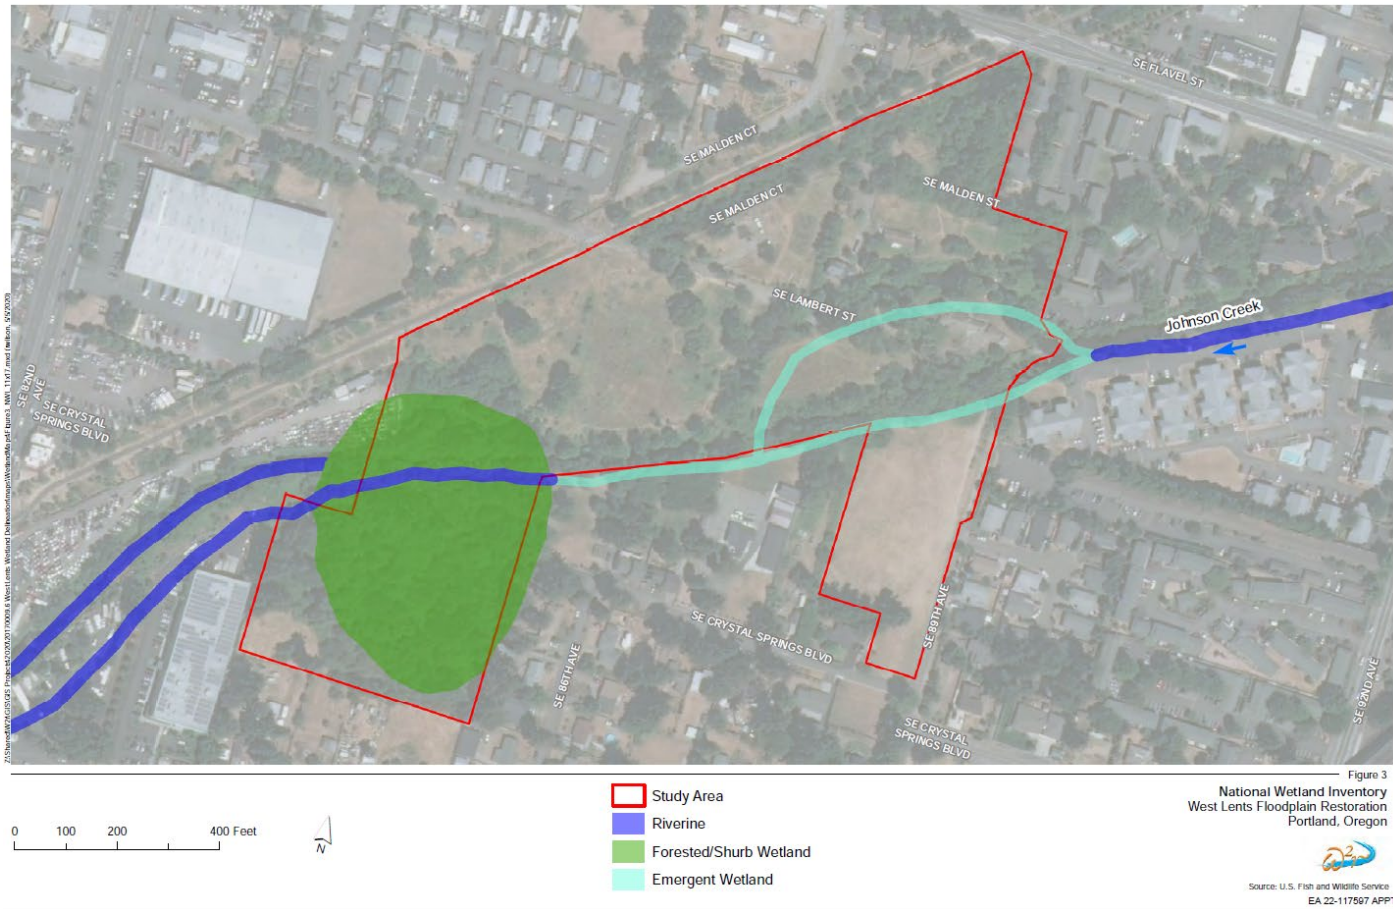
A Local Wetland Inventory (LWI) was not available for this area. The National Wetland Inventory (NWI, Figure 3) shows the potential for freshwater emergent wetlands to be found along Johnson Creek within the study area. Only Wetland C, a stormwater ditch, that discharges into the overflow channel was identified in this area during the field investigation. On the west side of the study area, the NWI shows a large freshwater forested/shrub wetland bisected by potential riverine wetlands. Wetlands were not identified during the field investigation in this area. Therefore, the results of the field investigation show that wetland areas occur at the study area less than what is shown in the NWI data provided by the U.S. Fish and Wildlife Service (USFWS).

Aerial Photo showing surrounding wetlands

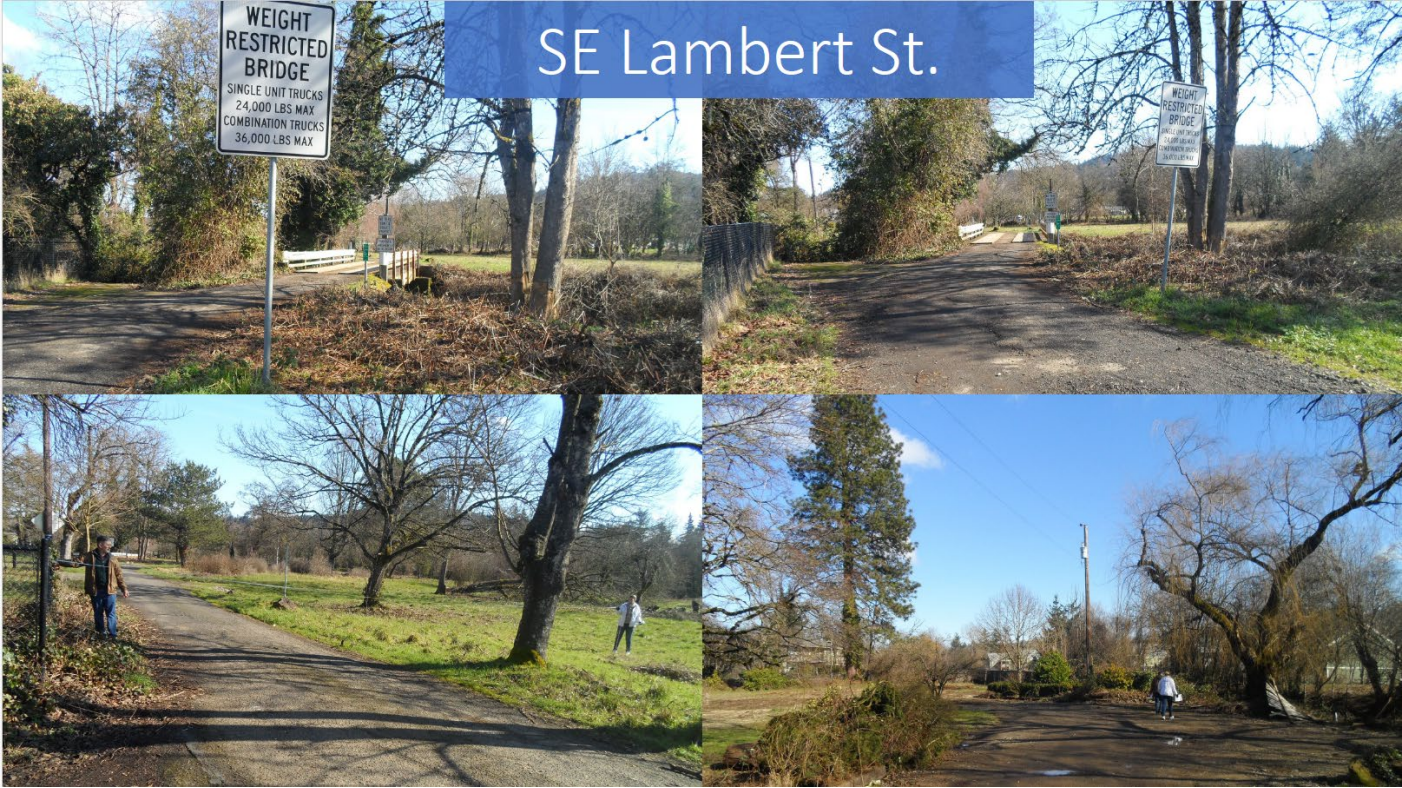
SE Lambert St, multiple views

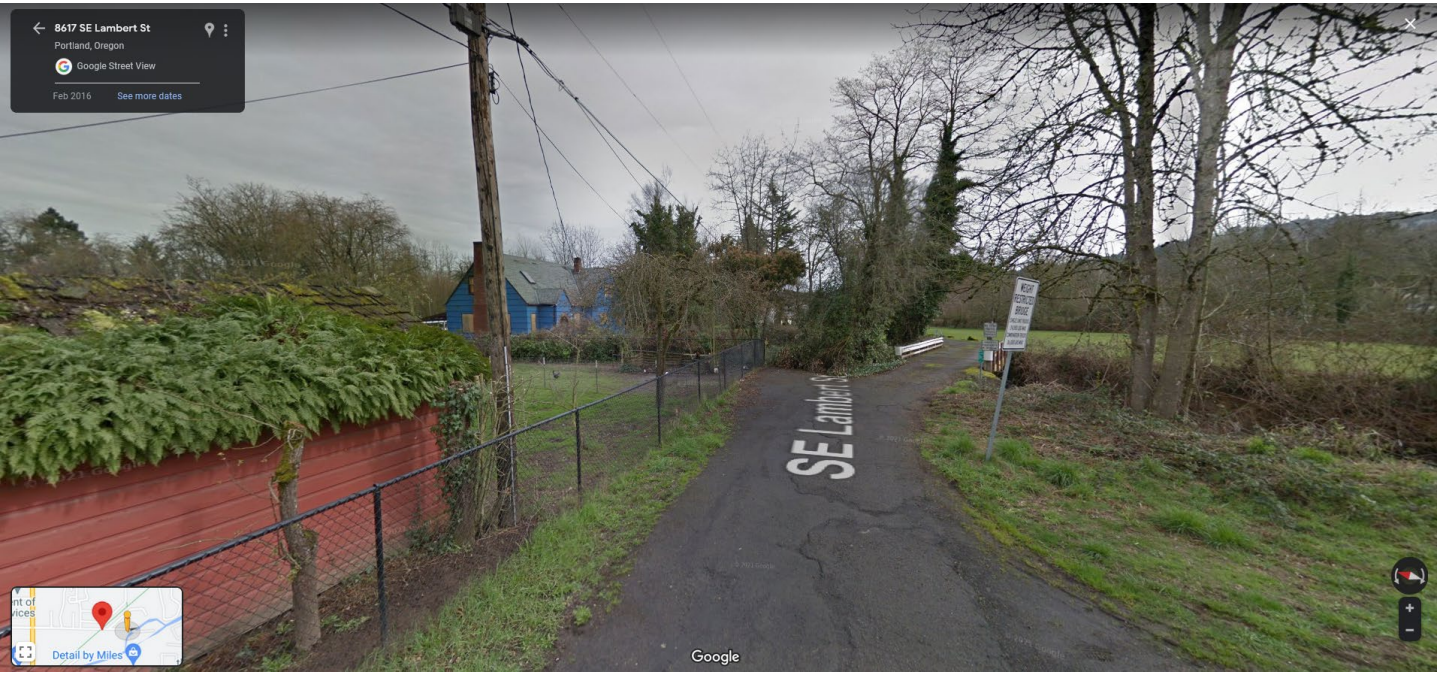
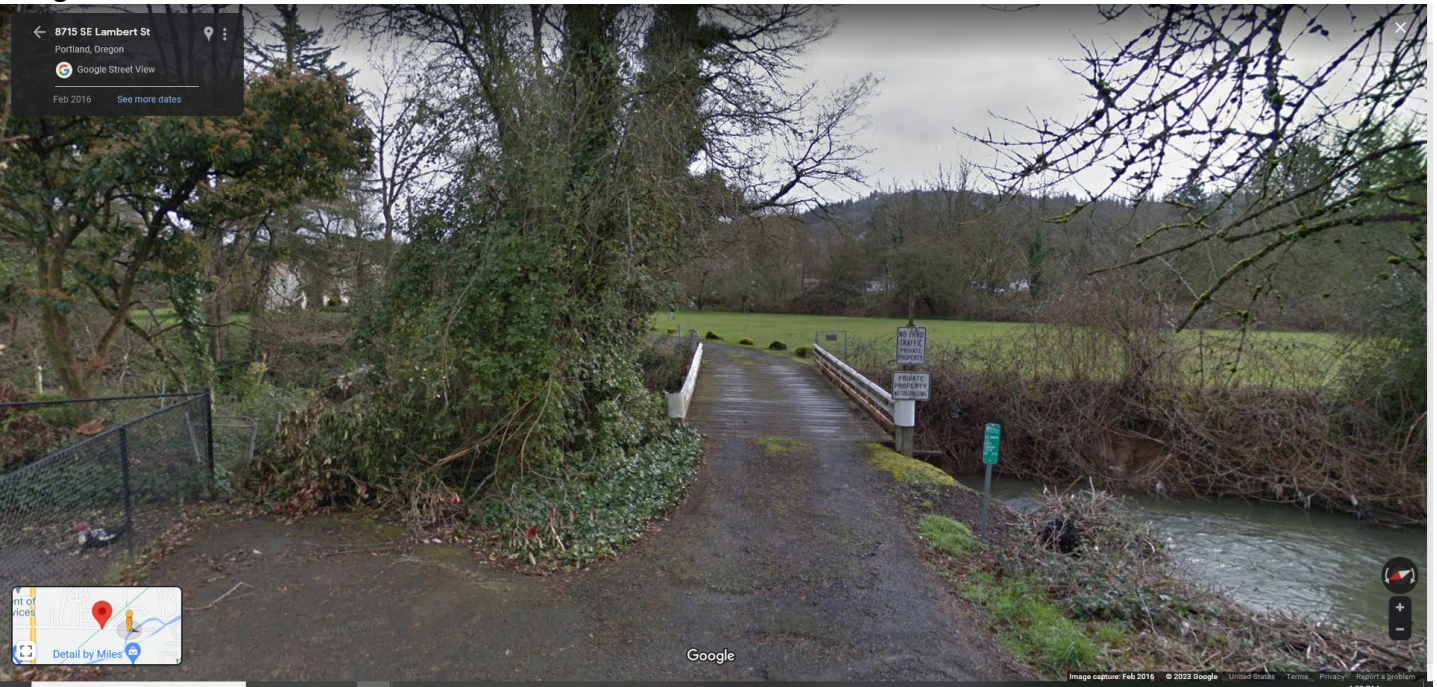
Bridge at end of SE Lambert

Commenting Party	Response Date	Comments / Conditions
		3) If at any time after recording if the street vacation ordinance BES elects to remove the existing bridge described above, wholly or in part, including the bridge and all of its appurtenances, including but not limited to girders, abutments, deck, rails, fences, signs, and wingwalls, all direct and indirect costs associated with this work shall be borne by BES.
<b>PBOT Street Lighting</b> Daniel Spoelstra Daniel.Spoelstra@portlandoregon.gov 503-823-4111	6/5/23	<b>No objection subject to the following condition:</b> There are four existing PBOT owned and maintained streetlights located within the vacation area and are mounted to utility poles owned by PGE and/or Century Link/LUMEN. Said streetlights need to be removed and salvaged by PBOT contractors at BES expense. Estimated cost for this work is \$1,200.
<b>PBOT Parking Control</b> Peter Wojcicki	1/17/23	No objection.

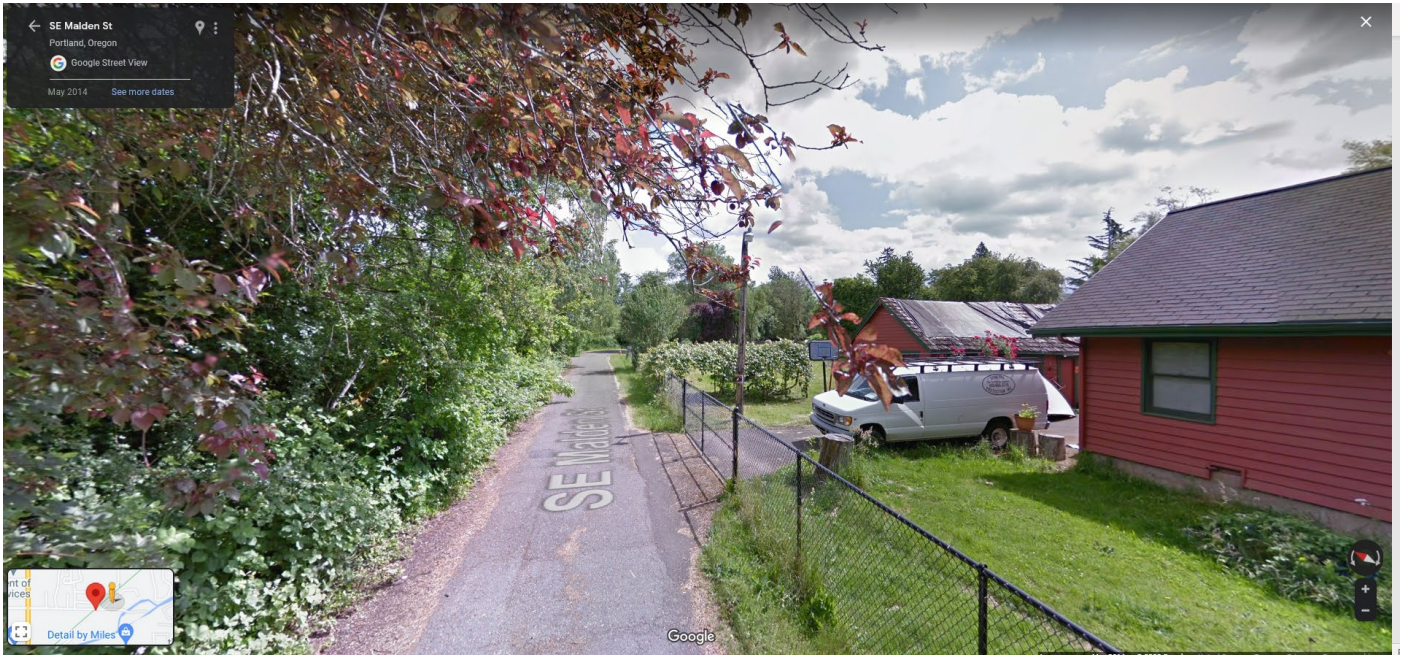
Closed-off second driveway on SE Malden Ct for single-family house on SE Lambert St that has since been demolished
