Stormwater Management Manual

Bureau of Environmental Services

Maintenance Interval for Contech Catch Basin StormFilter Units on the Beaverton-Hillsdale Highway

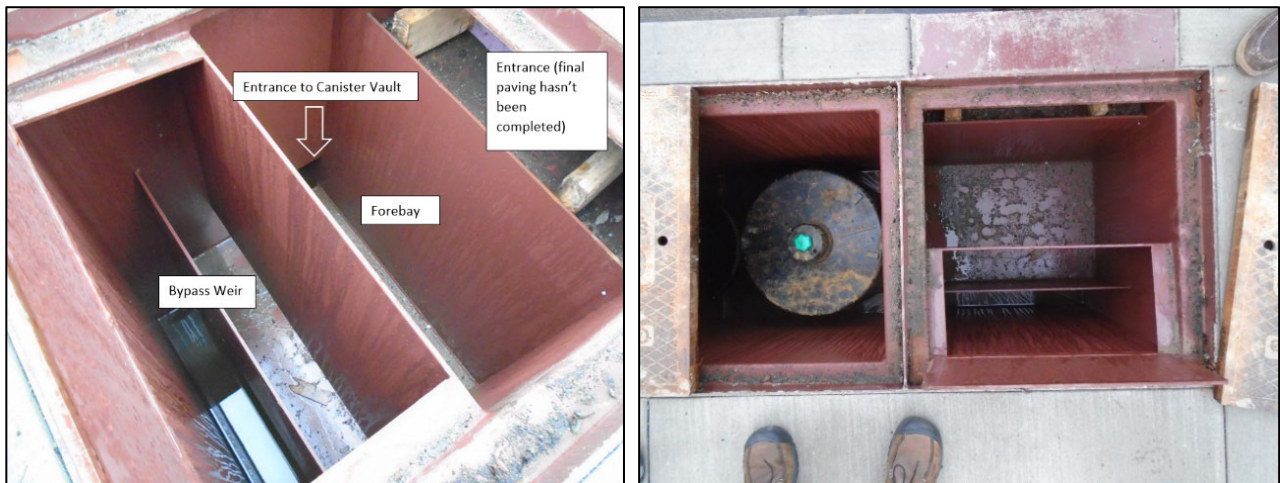
The CBSF units are located behind the curb and under the sidewalk. Each unit has a standard City of Portland P-305 curb inlet with an opening 2 feet wide and 6 inches tall, depressed 2" at the opening. The units contain 2, 3, or 4 filter cartridges depending on the catchment size. The steel vault for each of the facilities was custom-fabricated by a local metal shop. Each unit includes a forebay. The cartridges are loaded with Contech's Zeolite/Perlite/Granular activated carbon (ZPG) media. The following photos show the typical setup for the entrance and the forebay in relation to the adjacent cartridge vault.

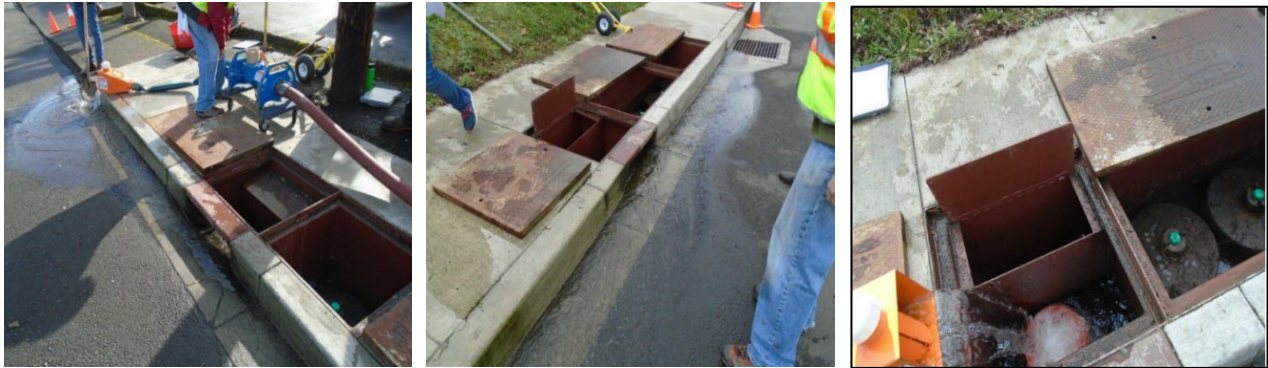
BES hired a 3,500 gallon water truck and used BES' SENSUS 1250 closed-channel water meter to test the units. Flow from the hose exiting the meter was directed into the forebay of the tested unit, using a diffuser and a bucket as needed to disperse incoming flows and to avoid suspending existing sediment. Staff slowly increased the flow rate until bypass occurred and slowly reduced the flow to the point where the flow stabilized at the level of the bypass bar for at least a minute. This stabilized flow rate was documented as the treated flow rate for the unit and compared with the design flow rate for the individual units.

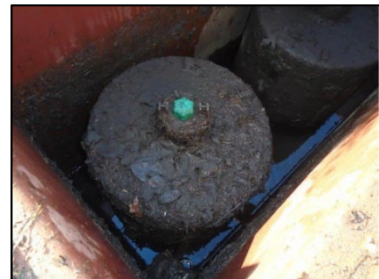
Table 3. Sediment depths after 3 quarters

Sediment Depths; February 14, 2022			
Facility	Vault Floor	Cartridge Tops	Forebay
SF02	3"	.5"	4-9"
SF03*	Not Recorded	0"	10"
SF04	7"	.5-1"	2.5"
SF05*	5"	0"	2"

* The data for SF03 and SF05 likely aren't representative given the repeated inlet clogging and bypass observed during December 2019.

The sediment depths on the vault floor and cartridge tops for SF02 and SF04 are close to or meet and exceed the Contech thresholds indicating maintenance is needed. The lack of sediment on the cartridge tops for SF03 and SF05, compared with observations from the other two facilities, supports the observation that some runoff was bypassing the facilities and that they weren't being loaded consistently with stormwater.

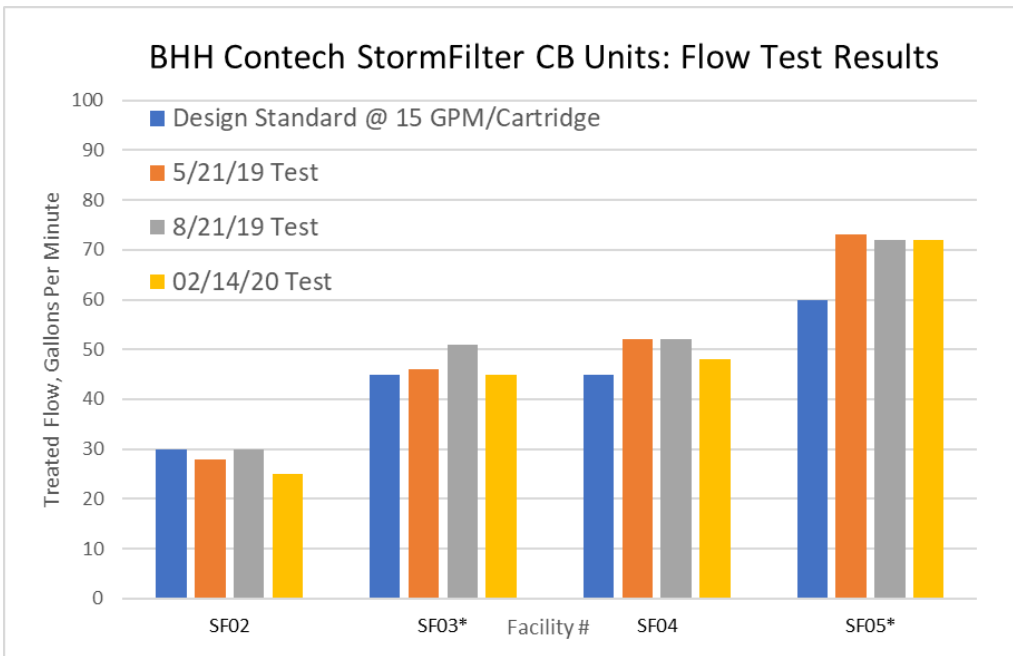
Figure 2 displays results from the hydraulic testing completed by BES staff. The graph includes the design flow rate (in blue) for reference.

Figure 2. Facility design standards and hydraulic test results*

* The data for SF03 and SF05 likely aren't representative given the repeated inlet clogging and bypass observed during December 2019.

On February 14, 2020 the flow rate for SF04 is still slightly higher than the design rate, while the flow rate for SF02 is slightly lower than the design rate. The evidence suggests the two systems were performing close to their design flow rates after more than 9 months and approximately 23 inches of rain. That said, the dip in the treated flow rate for SF02 may indicate the beginning of clogging. It's important to note that facilities SF02 and SF04 both met CONTECH guidance thresholds for triggering maintenance based on sediment depths on February 14, 2020. As previously noted the results for SF03 and SF05 are being discounted due to evidence the inlets for those facilities are susceptible to clogging.
