Washington Park Reservoir Improvements Project

Application for Historic Demolition Review

Prepared for:
Portland Water Bureau

December 2014

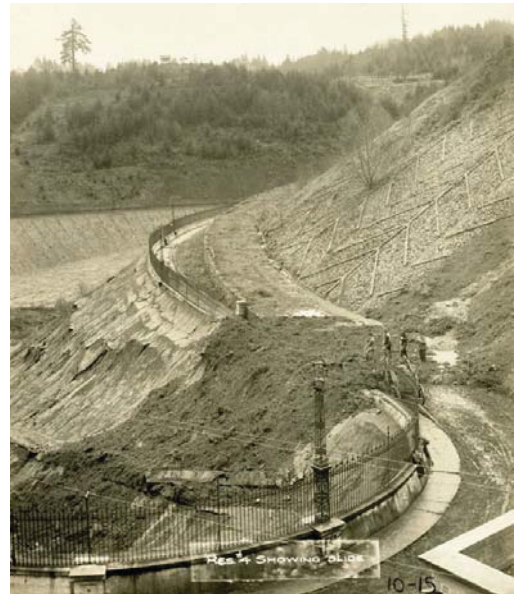
Figure 5. Early landslide damage to Reservoir 4

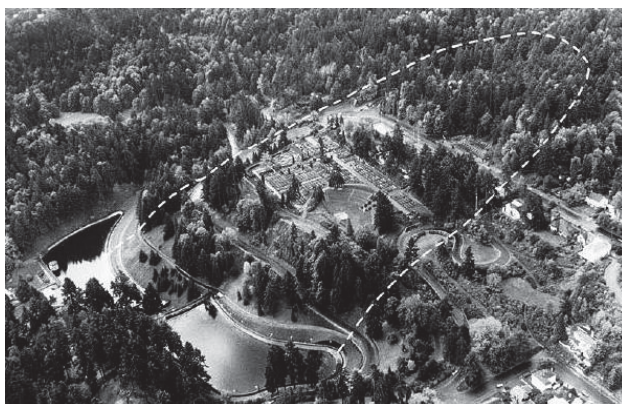
Figure 6. Outline of ancient landslide (Turner Schuster)

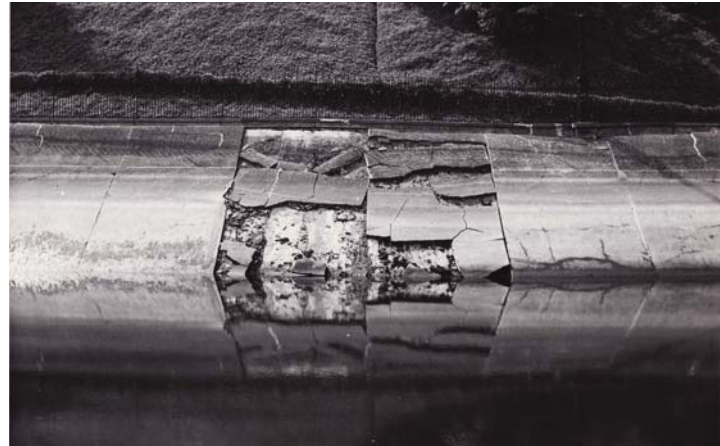
Figure 8. Photo of reservoir basin deterioration due to aging and slide movement

Condition assessments were performed at the Washington Park Reservoir site in 1997 and 2001. Based on these condition assessments, the 120 year old reservoirs and structures are nearing the end of their useful service life. Should the existing reservoirs be maintained, they would require significant maintenance and retrofitting as they continue to age and will ultimately need to be completely replaced. Both reservoirs would continue to require ongoing repairs due to landslide activity (see Figure 9). The reservoir piping, gate houses and other historical features would require maintenance and upgrades or would continue to deteriorate.

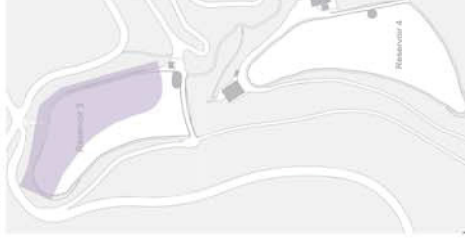
A new buried drinking water reservoir will be constructed at the upper reservoir area, outside of the historic landslide area. This buried feature will be visibly expressed by a two-level reflecting pool that will be constructed over the new reservoir (see VISIBLE WATER). The original drinking water storage function is no longer needed at the lower reservoir, but the lower reservoir area will serve environmental functions: stormwater, overflow, drainage, and dechlorination. The lower reservoir area will show the effects of time and the reclamation of nature to express these environmental functions. The site will be restored to its original function as a recreational destination.

Proposed buried reservoir location

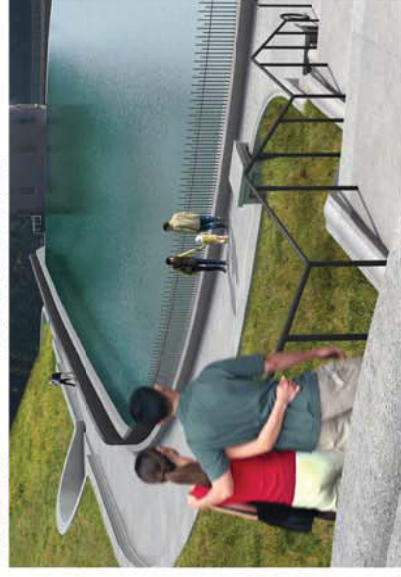
The Grand Stairway will be reconstructed in a design close to the original stair. It will be generally open to the public during Park hours. The roadway between the two reservoir areas will be rebuilt in harmony with the new topography (landslide-stabilizing fill added). The roadway will include retaining walls. The roadway will be open to pedestrians as an ADA-accessible route and to service vehicles.

The historic sense of open water is maintained.

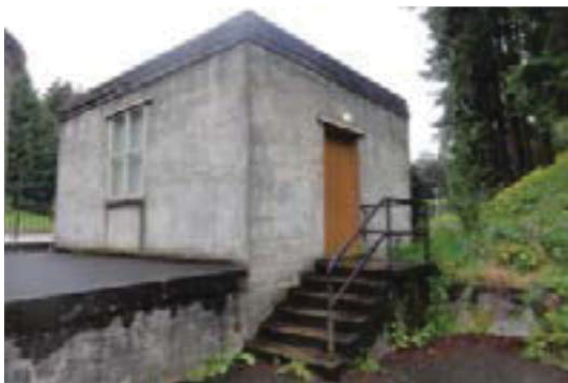
Figure 28. Weir Building (NR Nomination 2004)

“Adjacent to the east is a smaller utilitarian concrete “36 Weir Building” (Screen House). Construction of this building is thought to date back to the building of the Westside Supply Line in 1945. It has a metal door facing east and two over two fixed pane wood windows on each of the other facades. Concrete steps lead up to this building. It is in good condition.”

As described in Part 1, Gatehouse 3 cannot be preserved without the removal of the Weir Building. The location of the Weir Building, built in 1946 and now functionally obsolete, was strictly utilitarian, with none of the "City Beautiful" concepts of harmony between structures and the landscape. It was placed in a highly unfortunate spot close to the oval Gatehouse 3 building (see Figure 43). The low, square, unabashedly concrete building creates a jarring dissonance between the curving, graceful forms of the Dam, Reservoir, and Gatehouse. Removal of the Weir Building restores space around the Gatehouse and recaptures some of the original views of the other contributing structures.

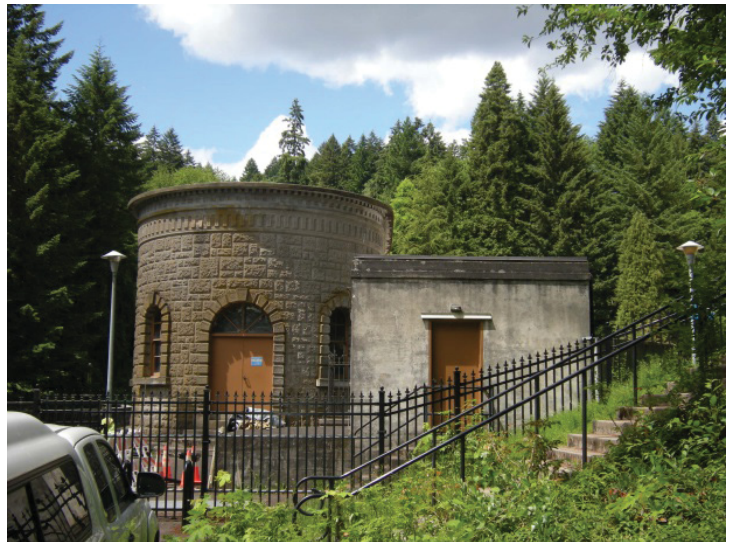
The Weir Building, which was unfortunately sited next to the Gatehouse and as a result, negatively impacts some of the most significant views of Gatehouse 3 and upper reservoir, is proposed for demolition. The existing Reservoir 3 basin must be taken out, which entails a large-scale removal of earth and concrete. The earthwork needed for this removal and the shoring needed to protect and support Gatehouse 3 while the site is being excavated will require the removal of the Weir Building.

The Weir Building was designed in 1945 and completed in 1946. In style the structure is Modern/Utilitarian, but it has lost some integrity with its windows and doors no longer original. It is also functionally obsolete. As noted previously, the location of the structure was strictly utilitarian, with none of the “City Beautiful” concepts of harmony between structures and the landscape. Removal of the Weir Building restores space around Gatehouse 3 and re-opens the original views of the other contributing structures. The Weir Building would not survive relocation, as it is a poured concrete structure.

Figure 42. Utilitarian Weir Building next to Gatehouse 3

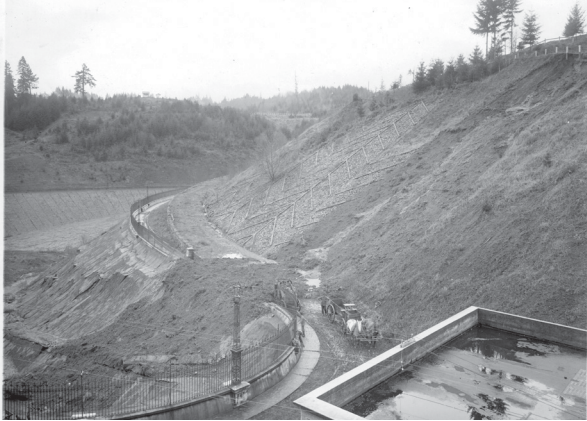
Figure 9: Reservoir 4, Landslide, ca. 1904

Underground land movement caused the basin lining of the reservoirs to break apart as early as 1897. Historic photographs have documented continued damage to the reservoir basins, roads, parapet walls, and decorative fence, necessitating reconstruction of damaged areas within each reservoir. In 1904, Reservoir 4 was affected by a landslide on the northwest side of the basin resulting in repairs to the parapet wall and basin lining. Period photographs depict Reservoir 3 being relined in 1904 and a damaged bulkhead being removed from the basin. The west segment of the parapet wall appeared to be removed during the reconstruction. Rebuilding and repair of

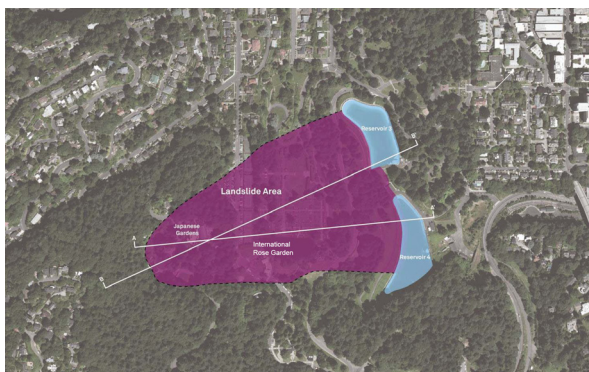
Figure 10: Landslide zone

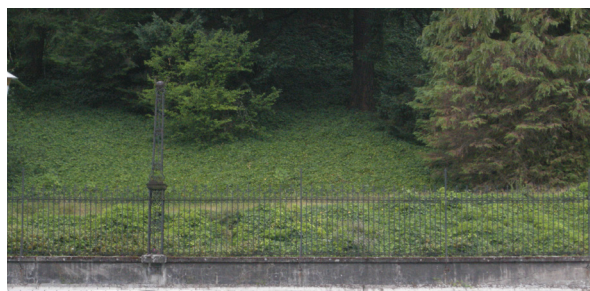
Figure 13: Reservoir 3, inside parapet wall

Each reservoir's parapet wall has been repaired and/or replaced over time as a result of land movement and material failures. Portions of the northwest and small sections in the southwest wall of Reservoir 3 and the north and northwest walls of Reservoir 4 were reconstructed with similar character as the original. Original walls are capped with a concrete wash added after original construction to create a sloped water shedding surface. Existing parapet walls, both replaced and original, have continuous horizontal cracks extending around most of the reservoir's perimeter contributing to each wall's disrepair. (See drawings within Appendix D)

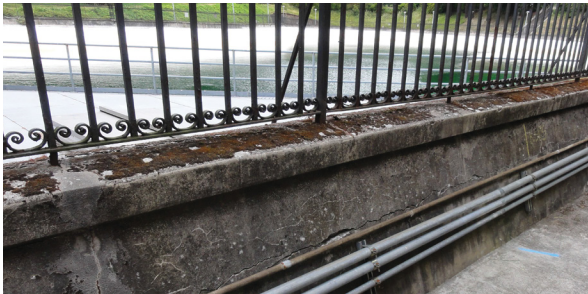
The east portion of the parapet is original and in relatively fair condition. Horizontal hairline cracks span discrete portions becoming more substantial in certain areas. The horizontal cracks meet the wrought iron fence attachment at the inside of the parapet wall. The cause of the horizontal cracking is most likely resulting from corrosion of the reinforcement due to inadequate depth of concrete cover. Vertical cracking on the inside and exterior faces is common and typically emanates from the iron fence posts embedded within the parapet coping.

Figure 14: Reservoir 3, parapet wall deficiencies

The southwest portion of parapet wall appears to be an original section and is in poor condition. Large portions of the parapet coping has been previously repaired and the repairs are delaminating and failing. Efflorescence is usually present where the wall is delaminating. The hillside face of the wall has begun to spall at the sidewalk level and in some areas a very large, deep horizontal crack has formed. The decorative iron fence in this portion is tilting outwards.

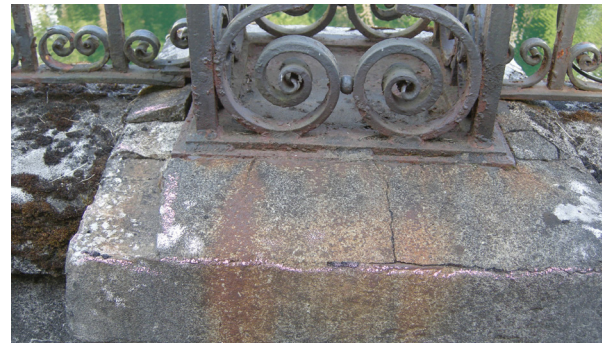
Corbelled columns with crown and chamfered caps provide the base for mounting the fence lamp posts and interrupt the parapet wall on both faces. The original concrete is in poor condition and the top crown has delaminated in large areas and parts are broken or missing. The corners of the chamfered detail have multiple cracks and are breaking off. The horizontal cracks from the parapet wall continue across these bases and efflorescence is heavy along these cracks. Rebuilt columns are in good condition with predominately horizontal cracks.

Figure 15: Reservoir 3, concrete delamination at the parapet wall column

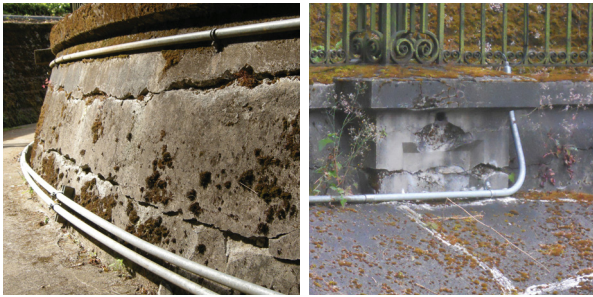
Consistent horizontal cracks stretch across the outside face of the parapet wall and branch into multiple parallel cracks that spider across the surface. At the southwest corner of Reservoir 4, horizontal cracks extend through the entire depth of the parapet and large areas of the wall are broken. High biological growth in shaded areas has increased the wear to the original concrete and accelerated the cracking in the parapet coping.

Figure 17: Large horizontal cracks at the southwest corner of Reservoir 4

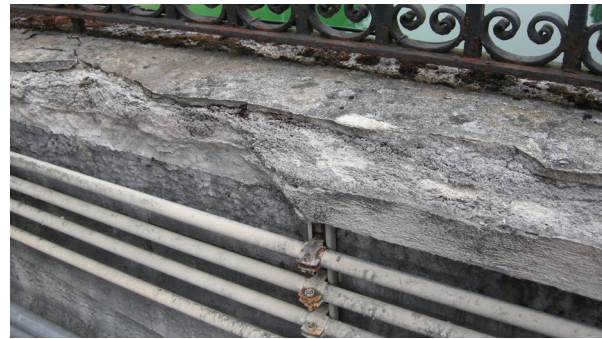
The parapet wall along the Reservoir 3 dam no longer has its original finish. A rough concrete wash with a brush finish has been troweled onto the original concrete surface creating a different finish and texture than the original parapet walls. In addition, the wash has begun to discolor with a marbled black biological growth. The wash has begun to delaminate and spall to reveal the underlying concrete, noticeably common under the coping and within the recessed pattern on the exterior parapet face. Efflorescence is present under the coping and next to the electrical conduit.

Figure 18: Broken coping on the dam parapet at Reservoir 3 :2013

The parapet coping is delaminating from the underlying concrete structure and large segments are broken. Biological growth is present in most cracks and under the coping ledge. Some cracks around electrical conduit attachments are likely a result of their installation. Large cracks appear to the southwest corner of the parapet wall, directly before the wall curves to the north and changes in parapet style.

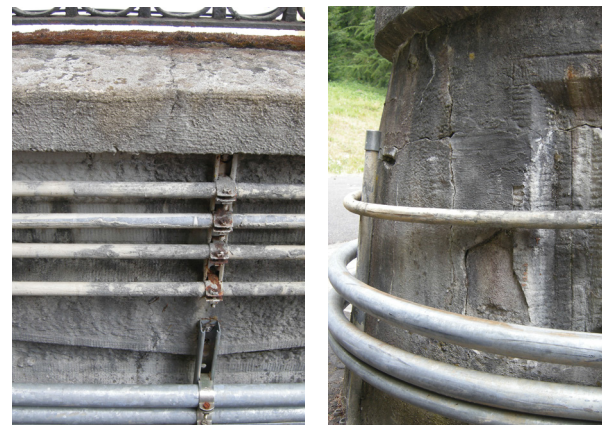
Figure 19: L- Finish and discoloration ; R - Large cracks around southwest corner

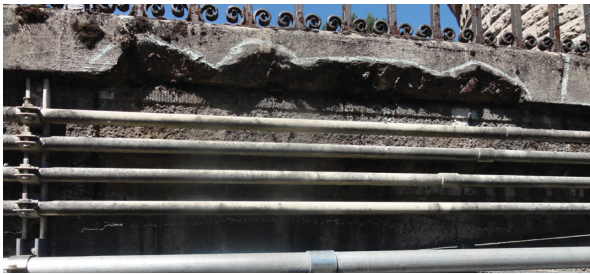
Vertical hairline cracks are persistent in the coping throughout this portion of the wall and efflorescence is present underneath the coping ledge at these small cracks. Concrete wash on the coping is weathered through this area. Heavy biological growth is present underneath the top coping, especially where the cracks and faux joints are present.

Figure 20: Reservoir 4, dam parapet coping delaminated

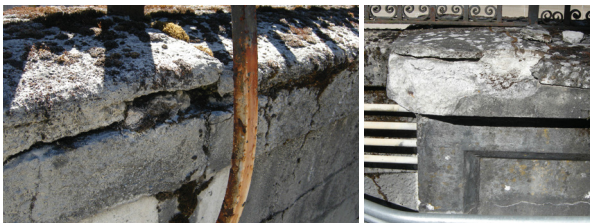
Large segments of the lower coping are missing and the top wash is starting to delaminate, including the culminating crown and chamfered capped columns that boarder the wall. Large broken pieces of coping are missing where the wall curves to meet Gatehouse 4. Diagonal cracks are present where the wall curves to meet the south ending crown and chamfered capped columns.

Figure 21: Reservoir 4, dam parapet coping delaminated

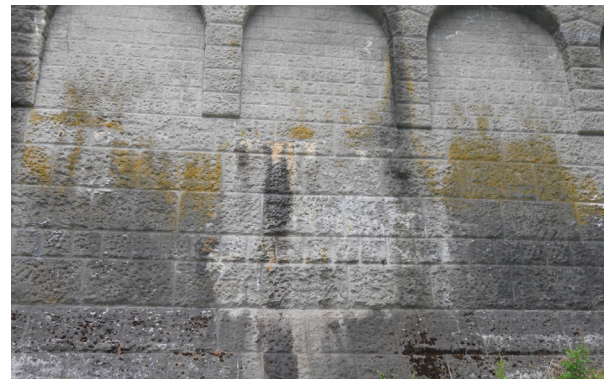
Multiple hairline cracks span the entire length of the structure and two larger cracks towards the bottom of the dam have heavy efflorescence. Water is seeping out of these cracks and has stained the concrete. Crack monitoring devices are visible and present at the two large cracks. Efflorescence can be seen in historic photographs as early as 1917, implying that cracking in the dam face was an early issue which has been repaired over time. Efflorescence is heavy along a crack that spans the length of the dam underneath the dentil element. Drains from the adjacent walkway wash water down the dam surface and have caused black biological growth and water stains to continue down the wall. Most of the wall is discolored with orange and black biological growth, water stains, and efflorescence. Efflorescence stalactites extend from the underside of some arches.

Figure 22: Reservoir 3, dam face water leaking from crack with efflorescence

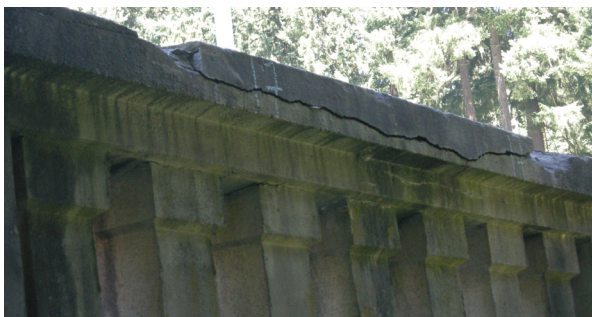
Coping wash on interior walkway side appears to be a later addition and has rougher appearance than other original site finishes. Portions of the coping have completely detached from the original concrete and are hollow due to delamination between the concrete and the coping wash. Large segments of the coping along the inside and outside faces have broken and are missing. Where segments of coping are missing the twisted iron reinforcement is visible and set at an inconsistent depth. This is likely a sign of previous repair. Larger cracks have been repaired with white caulk, which stands out from the original appearance of the concrete. Small vertical cracks are common on corners of the columns and efflorescence has surfaced along these cracks. In some cases, corner segments of the columns have broken and are missing. Detailed original hand finishing around each bay has

Figure 23: Reservoir 3, broken segment of the baluster coping

been obscured by the wash in several areas. A diagonal crack on west side resulting from ground movement has completely separated sections of concrete. The reinforcing bar and daylight are visible through

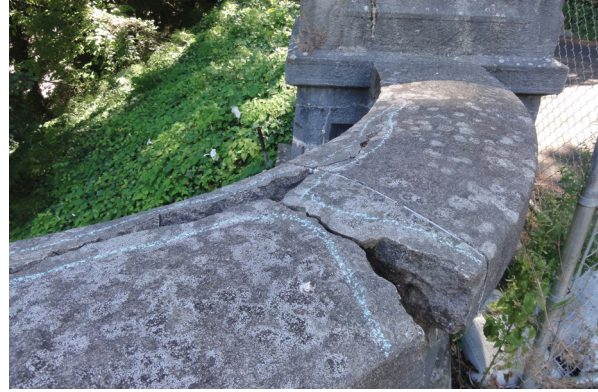
Figure 24: Reservoir 3, Large broken segment of the baluster rail

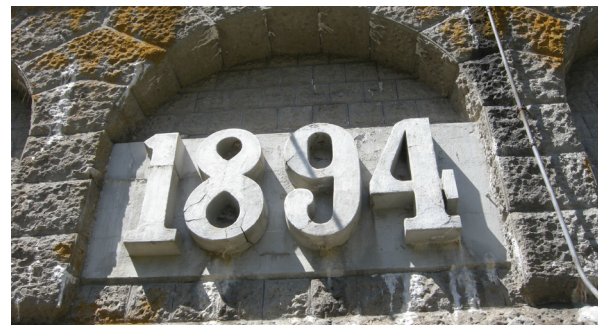
Figure 25: Reservoir 4, 1894 icon, cracks, biological growth, efflorescence

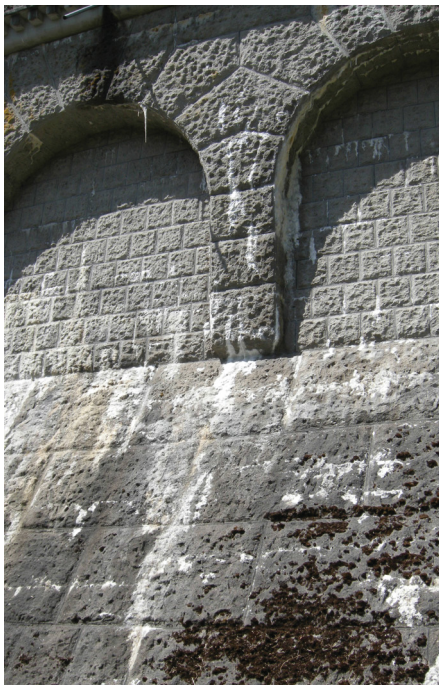
ing at a height of approximately 20 feet, the upper 12 feet of the dam are vertical on both sides while the exterior of the lower portion is battered at a slope approximating 1.5: 1. The top section of the dam is composed of seventeen arches using the design of a blind arcade to give the appearance of a classic viaduct. Capping this arcade is an ionic dentil, similar in style to Gatehouse 3. The edge of the walkway and baluster are separated by a 12 inch band detailed with a combed boarder and brush hammered finish. The dam extends down only a couple of course below the arcade and continues to get wider at its base. The coursing detail of the concrete alternates between small and large blocks and is defined by a faux mortar joint. The blocks within the arches are smaller in scale. All the concrete blocks have been hand chiseled to have a quarry-face appearance. The original concrete "1894" construction date is intact.

Figure 26: Reservoir 4, efflorescence, continuous crack, and staining on dam face

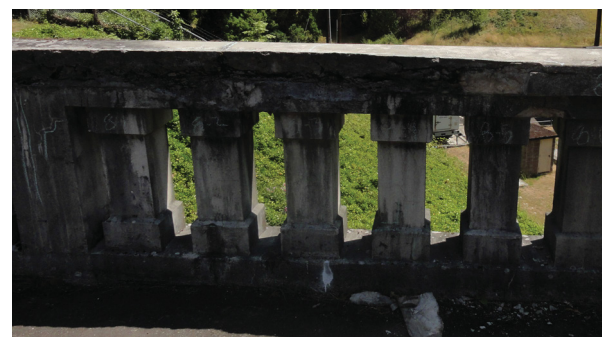
Cracks in the top of the coping and delamination show the failure of previous repairs. Large horizontal portions have completely detached from the concrete and sound hollow. Small vertical cracks are common on the inside face of the baluster coping. In some cases segments of the columns have broken off. The original lamppost bases frame the baluster and

Figure 27: Reservoir 4, baluster delaminated and broken coping

are missing their original iron lamps. Multiple hairline cracks run across the face of these and efflorescence is weeping from the cracks.

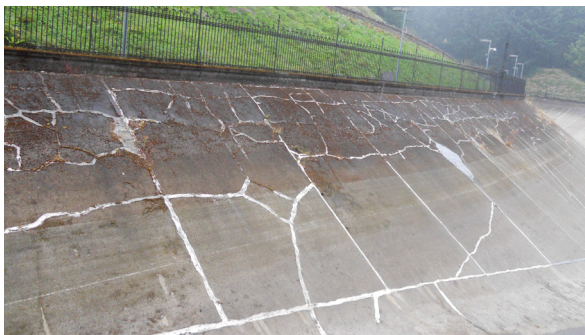
Figure 28: Reservoir 4 basin

The northwest section and northeast section of the lining were demolished and rebuilt in 1976. It is evident that rebuilding took place where the concrete changes in color and texture and the consistent cracking becomes almost absent. Prolific cracking of the basin has been repaired with white caulking.

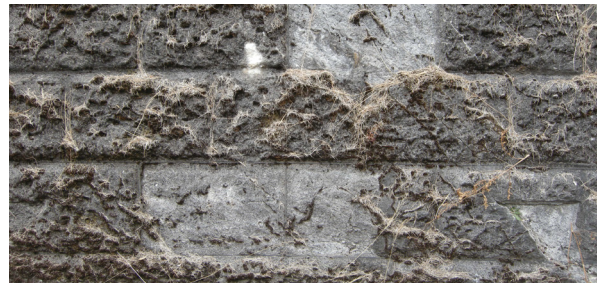
Common to the Ransome concrete structures on site, the northwest retaining wall on Reservoir 3 has several hairline cracks running horizontally across most of the structure. These are parallel and spaced at intervals between one and two feet. Cracks likely correspond to oxidizing twisted iron reinforcing bars located within the concrete. Efflorescence is heavy in some areas, especially along the horizontal hairline cracks and may result from increased water migration under applied force stemming from soil pressure on the back side of the wall and no alternative drain path.. Three of the concrete stone faces have spalled off completely. A crack continues under the parapet cap and along the top of the retaining wall. Large vertical cracks show where the wall has been pushed forward from landslides. Part of the vertical crack has been repaired and patched, however the north side of the wall is pulling out of plane with the south side causing the repair to fail. Large cracks and separation in the wall have further degraded the retaining wall and moved the wall beyond the plane of the parapet

Figure 29: Reservoir 3, spalled faces of Ransome concrete at the northwest wall

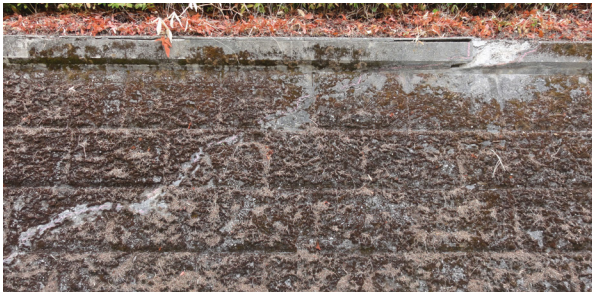
The southeast retaining wall is similar to the northwest and also exhibits several horizontal hairline cracks across most of the structure. The cracks likely correspond to the location of the reinforcing bars within the concrete. Efflorescence is heavy in some areas, especially along the horizontal hairline cracks. A crack continues under the parapet cap and along the top of the retaining wall. Additional horizontal cracks run across sections of the top cap and have contributed to sections breaking off. Patching is sporadic and failing. There are continuous cracks where the wall meets the gutter and these have also been previously patched, however the repair is failing. The faux mortar joints have started breaking off in small segments sporadically

Figure 30: Reservoir 3, retaining wall

across the wall. A jogged crack cuts diagonally across the wall and continues vertically to break through the top coping.

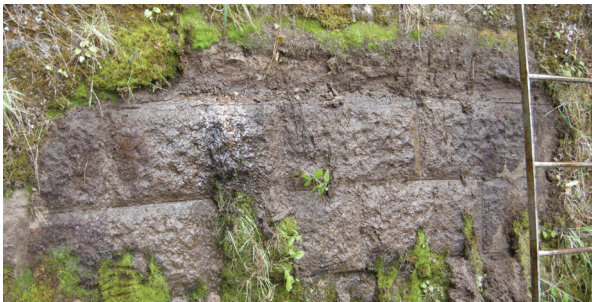
This retaining wall is located in the shade of the surrounding park, resulting in an overgrowth of plants and moss that mask most of the concrete. The hill behind drains into the back of the wall and soil pressure

Figure 31: Reservoir 4, retaining wall, water saturated and biological growth

pushes water through the retaining wall contributing to biological growth. The saturation of the concrete and plant growth on the wall increase water migration resulting in degradation of the concrete mix resulting in large spalls. The top coping appears intact, but it is cracking along the joint where it meets the wall. As the coping descends towards the West gutter, the coping becomes cracked and large pieces are missing exposing the ground behind.

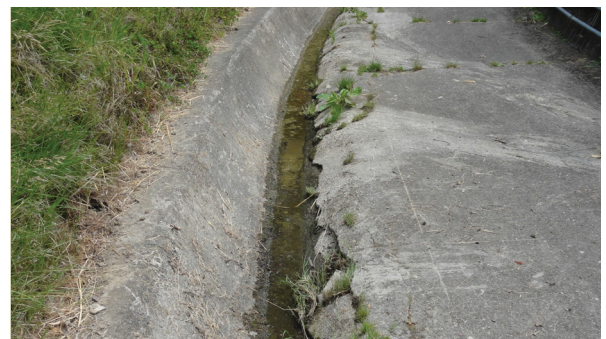
East of Reservoir 3, the original gutter and sidewalk remain and are in fair condition. Cracks in the gutter along the lower section have been patched in places. Patches do not match the original concrete. Where the concrete walkway intersects the gutter it is com-

Figure 32: Reservoir 3, walkway and gutter

mon to see cracks and breaks. A continuous horizontal crack runs along the gutter's low height retaining wall on east hillside. Parts of the concrete have broken off along this crack and moss is commonly pres-

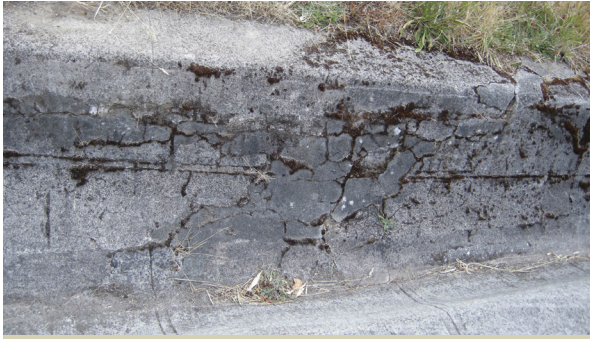
ent. A large segment of concrete is broken and deeply cracked forming a hole in the east gutter where it meets the west retaining wall.

Figure 33: Reservoir 3, walkways & gutters

The gutter changes to a U-shape adjacent to the northwest retaining wall and has few deficiencies except for a large crack resulting from the movement of the retaining wall. South of the retaining wall the gutter has been rebuilt and changes to a V shape. Here another low height retaining wall rises from the gutter and has continuous horizontal cracks. Small areas have spalled or broken but most have been repaired.

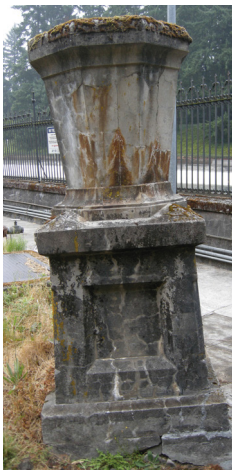
Figure 34: Southwest planter tilting

The gutter terminates to the southwest at a large planter in poor condition. Hairline cracks are visible on every surface and efflorescence is present along the cracks. Corners of the planter have chipped off and the planter no longer stands straight.

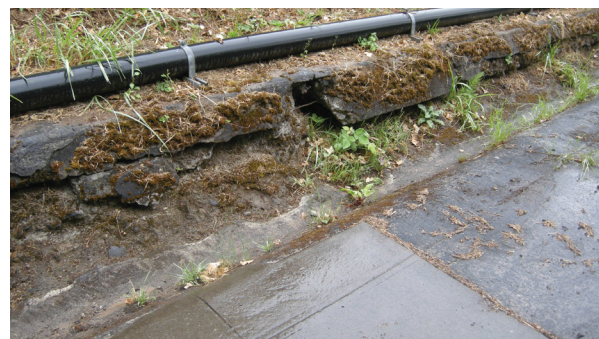
The southwest gutter is in disrepair. Horizontal cracks have caused large portions of the gutter's parapet to completely break. The patented twisted reinforcing iron from Ramsome's construction is visible in areas. Biological growth is heavy and the earth is visible where concrete is missing. Original segments of the walkway in this area have been replaced and multiple patches are failing.

The south portion of the gutter is in better condition but exhibits similar cracking as the southwest gutter. A continuous crack runs along the bottom of the gutter and at the intersection of the gutter and the gutter

Figure 35: Gutter damage and exposed reinforcing

parapet. Parts of the gutter wall have begun to spall and break off along this crack. Moss and plants are growing out of cracks along a majority of the gutter parapet. Some previous repair and patching has been done to the cracks in the gutter and walkway, however cracking still extends around these repairs.

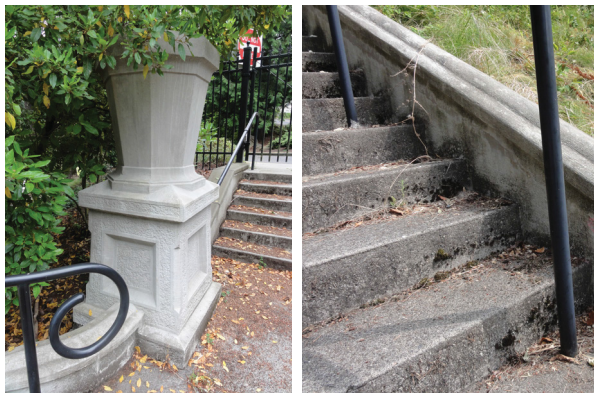
Figure 36: Reservoir 3 entry stairway

Extensive repairs to the stairs in 2008 replaced the majority of original material and added new painted metal railings. Vertical cracks repeat along the stair's parapet and commonly run through the coping. A mid-level continuous hairline crack runs the length of the parapet. The parapet wall and the end chamfered bases have been brushed with a rough wash. Both urns/planters are in good condition, however the top west planter is broken at a corner. Previous repairs and patching are visible on the stairs and are otherwise in good condition.

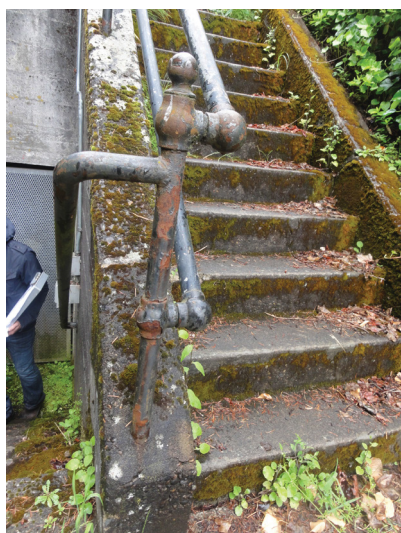
Figure 37: Reservoir 4 stairway handrails

Concrete stairs exist north of Pump House 1 leading to pathways above the north end of Reservoir 4. Although the location and direction are historic, the materials have had ongoing alterations and no longer retain the original material integrity. Treads and the handrails have been replaced.

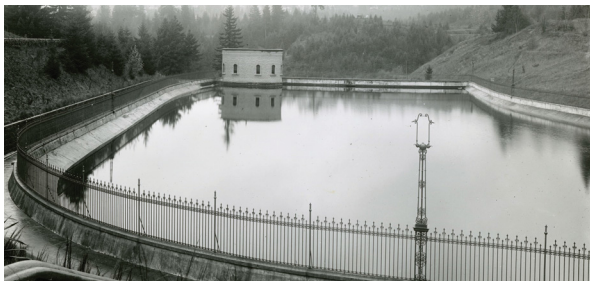
Figure 38: 1912 condition of fence and lamppost

Attention to detail was emphasized in all the wrought iron fences and lampposts, crafted by an award-winning local ironsmith Johan Tuerck and design by the architectural firm Whidden and Lewis.¹ Six feet in height, the fence is decorated with double-sided curls at the lower and upper rails. The $\frac{3}{4}$ -inch vertical bars alternate in height and are topped with spears, in addition there are ornamental hammered metal leaves on each of the taller bars. Each bay of fencing, defined as the length bounded by taller vertical components, is anchored by an iron bar embedded fourteen

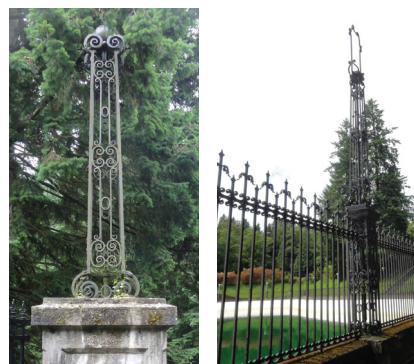
Ornamental lampposts within the fence encircling the reservoirs are created from four wrought iron bars. Reservoir 3 has five lampposts and Reservoir 4 has seven lampposts set within the fence. Two free-standing lampposts decorate the dam baluster at

Figure 41: Free-standing lamppost at the baluster of Dam 3 and lamppost at Reservoir 3

Reservoir 3. The freestanding lampposts at Reservoir 4 are missing. Based on a review of the original drawings, all the components comprising the lantern portion of the lamps are missing.

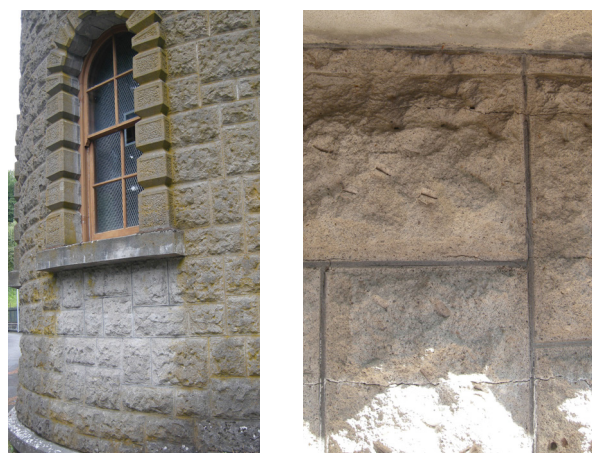
Deficiencies on the west elevation consist of continuous horizontal hairline cracks along the bottom of the structure and along the top cornice. There are pipes embedded in the concrete towards the north side. Most of the wall is yellowed and stained from biological growth except directly under the windows.

Figure 43: Biological growth; Repetitive horizontal cracks

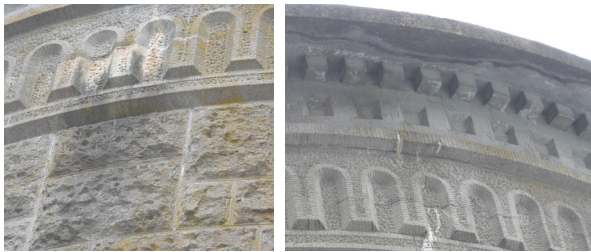
The north elevation has distinct staining and efflorescence on the frieze suggesting some recent water damage from the roof. Heavier biological growth is concentrated around the bottom of the protruding water-table molding.

Figure 44: Crack along the frieze with staining and efflorescence

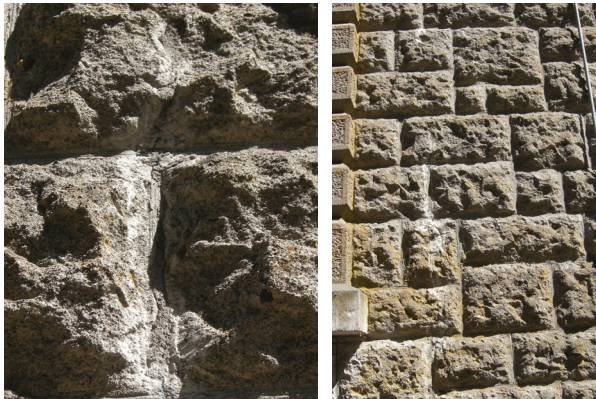
Hairline cracks run horizontally along the bottom section of the south elevation. A large vertical crack extends up the wall likely resulting from the corrosion of the internal iron downspout. Parts of the projecting water table base have spalled or cracked and biological growth is present.

Figure 45: Crack along internal downspout

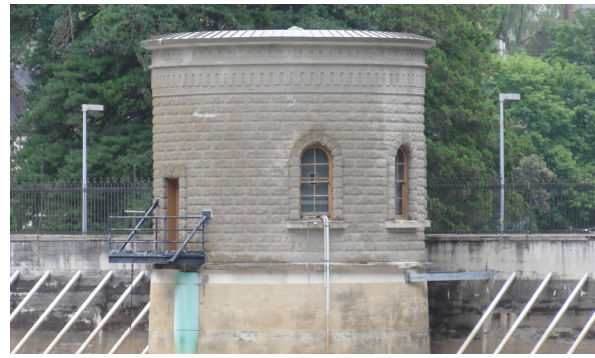
Figure 46: Gatehouse 4 deficiencies

On the east elevation, a crack runs above the door and is surrounded by stains from water and/or biological growth. Stains and biological growth are heavy

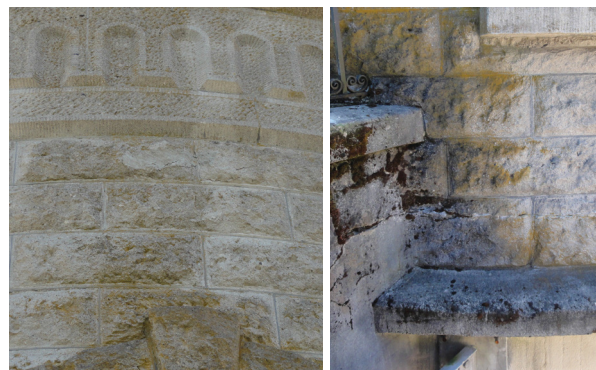
Figure 47: Staining and previous repairs above east door; Staining and continuous crack

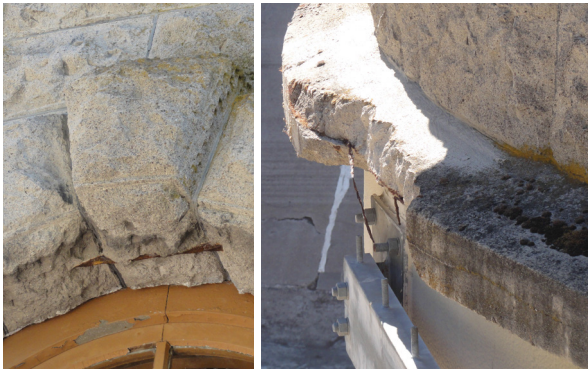
Large pieces of the lower water table base have broken off along the south elevation. A horizontal crack runs parallel with the water table base corresponding to reinforcing bar locations within the concrete. Where concrete pieces have broken off, reinforcing bar can be seen. Rust and corrosion are clearly visible within the concrete. The southeast window's

Figure 48: Exposed reinforcing at southeast window surround; Broken water-table base

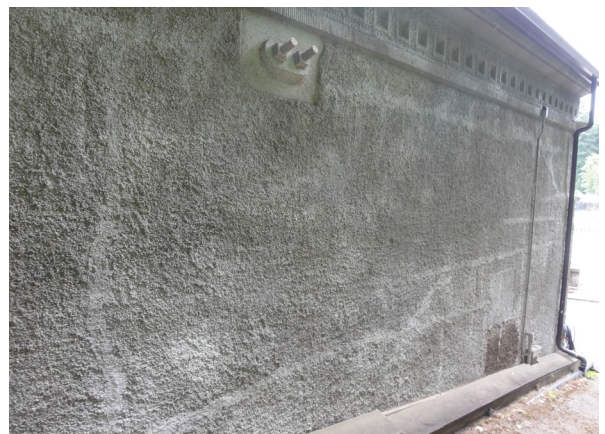
Two post tension cables with nutted ends, spaced approximately 6 inches apart, are present at mid-point along the west and east elevations slightly below the decorative cornice. It is unknown if these post tension cables are still functional. It appears that the post tension concrete beam has been replaced with steel framing for the roof.

Figure 50: West elevation; previous repairs to multiple horizontal cracks

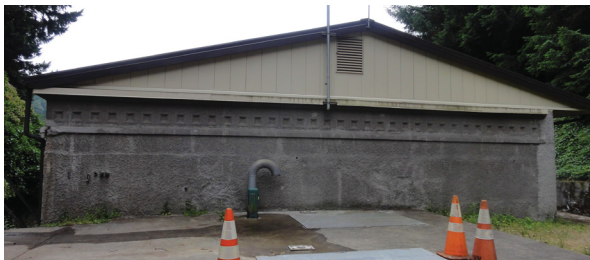
A repaired horizontal crack below the entablature encircles the entire building. Two squares of plaster patching on the south side of the west elevation do not match the wall color. Part of the cornice has broken off at the north corner. Previous photos show a shed attached to the northwest corner of the building. There are obvious repairs and patches that mark the location of the shed. The entablature does not exist in this recessed area and each corner has thick plaster applied as a repair.

Figure 51: North elevation; Stuccoed window openings, horizontal cracks

The Pump House is depressed below grade on the north elevation and two window openings are half above grade and half below grade. Similar to the

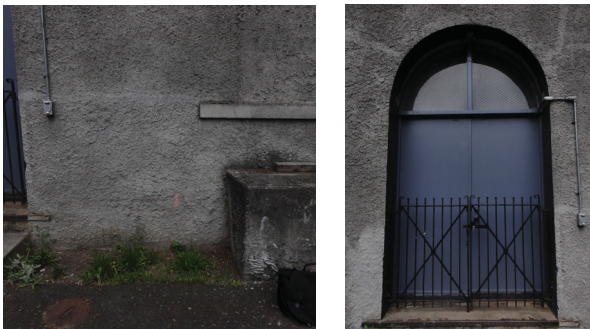
Figure 52: Previously repaired cracks on the south elevation

south elevation, the two window openings have been covered with a plaster stucco of a lighter coloration and rougher texture than the rest of the wall. A repaired horizontal crack runs at the same height as the other elevations. A large portion of the western corner has been repaired where the shed likely attached to the exterior. The original rain scupper to the east has broken and been unsympathetically repaired by adding a drainage pipe section.

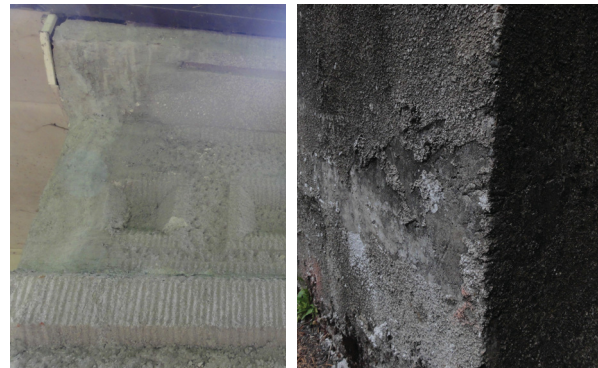
Figure 53: Stucco delaminating

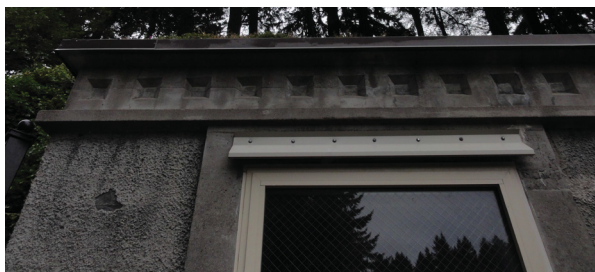
Several cracks across the northwest façade have been previously repaired with a material that doesn't match the original stucco. The retaining wall west of the door has a large area of biological growth and the stucco finish is delaminating. Additional previous repairs appear on the northwest elevation and to the left of the door a large patch of new stucco doesn't match the original texture or color.

Figure 54: Stucco delamination; horizontal crack along cornice

An original replica of the rain scupper designed to match those on Pump house 1 has been repaired and is failing. Under the scupper the corner of the building has become stained and deteriorated from water draining down the face of the building.

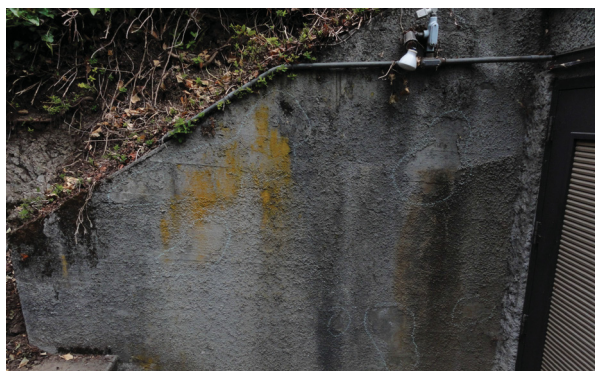
Figure 55: Delamination of stucco; biological growth; previous repair along door

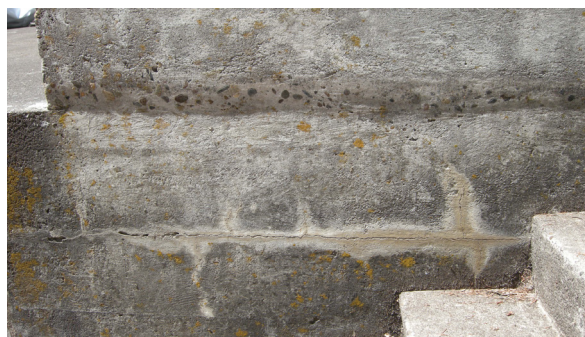
Figure 56: Crack and efflorescence

deficiencies are cracking along the interface between the wall and the floor slab. Efflorescence is visible along some of these cracks. There is biological growth along the edges of the protruding water vault. Two spots on the wall appear to have been ground down, exposing the aggregate.

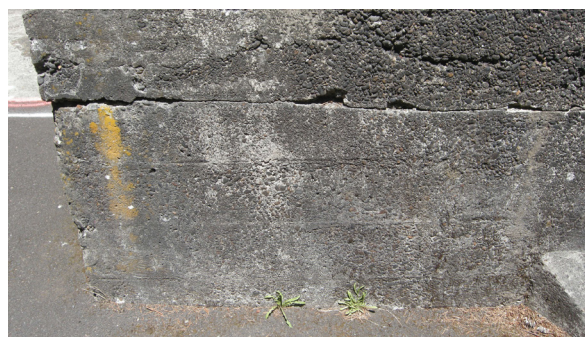
Figure 57: Continuous crack along slab edge

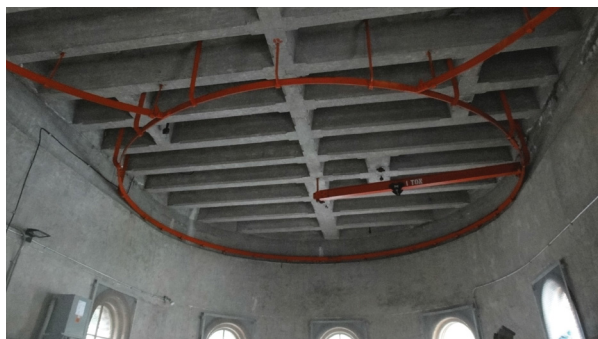
Figure 58: Gatehouse 3, original overhead trolley

ing interior original overhead trolley and the original iron stairs.

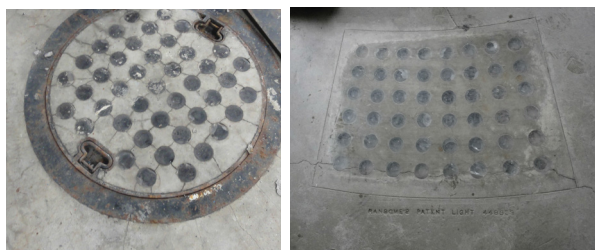
Preserved historic equipment in Gatehouse 3 and Gatehouse 4 includes existing original wheeled valves, water level measurement, and mechanical equipment. Preserved historic equipment is no longer used.

Figure 59: Gatehouse 4, original Ransome Patent Lights

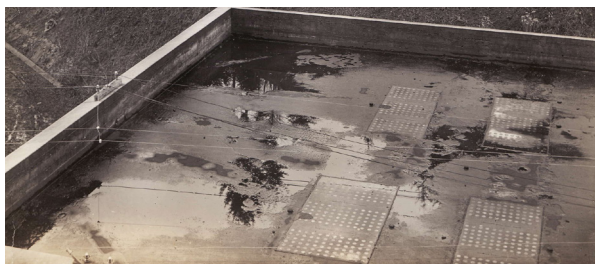
Figure 60: Pump House 1, original Ransome Patent Lights

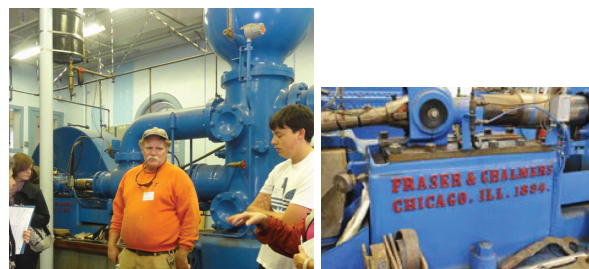
Equipment in Pump House 1 includes the historical and operational 1894 Pelton pump 'Thumper' Fountains

Figure 61: Pumphouse, original pump 'Thumper'

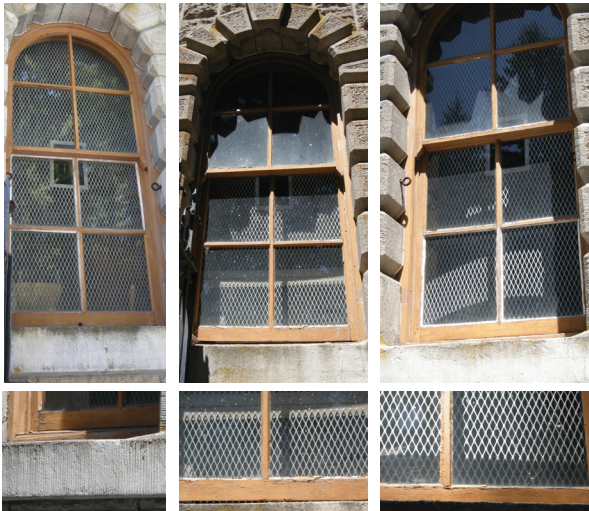
Figure 64: North and south windows

Gatehouse 3 Deficiencies

The window sashes are in good condition. The sealant has been replaced and appears in good condition. Some of the wood sills have begun deteriorating and paint is peeling on most of the windows.

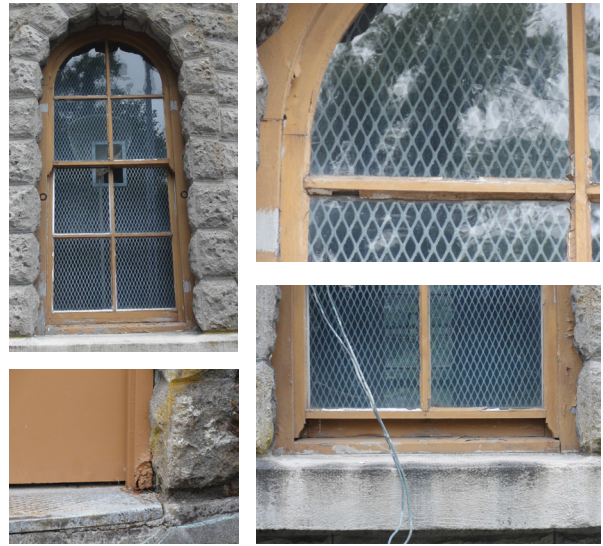
Figure 65: Gatehouse 4 door corrosion, window sealant deterioration, and peeling paint

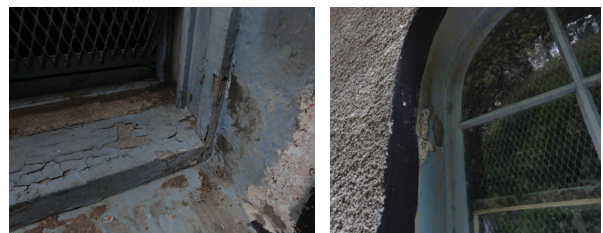
Figure 66: Peeling paint on south east window of Pump House 1

The south window on the east elevation has a thick coating of paint. Some of the window stops have been replaced and are different in color and have a slightly different texture. Paint is peeling from the surface possibly due to water damage. The sides of the frame are smooth but the sill has a combed texture.

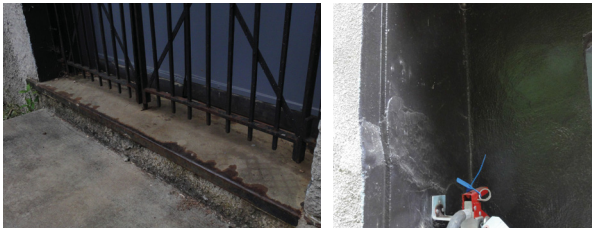
Figure 67: L- South door, original cast iron sill; R- East door, jog in frame

The front south door is not original and is in good condition finished with several coats of paint. The east door is not original. The frame and surrounding area is finished with a spray applied coating and has a different texture than the original stucco. The frame and door appear in good condition. On the left side frame, the concrete and frame jog out slightly above the fire extinguisher; evidence of the effect of the ground movement on the pump house.

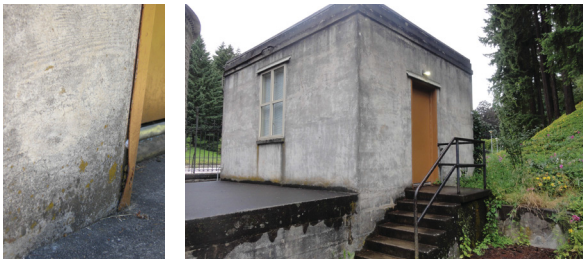
Figure 68: 36 Weir Building entrance and door jamb

A simple unadorned building, 36 Weir building was constructed with board forms and poured concrete. The form work outlines are visible on the exterior. No additional exterior finishes were applied to the walls. The door is not original and the windows were replaced in the late 1990s.

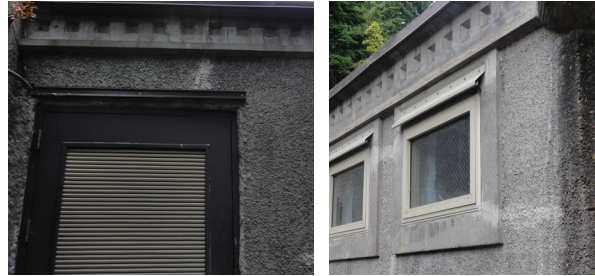
Figure 69: Generator Building new windows and doors

The generator building's windows are non-historic. The metal door and windows were installed in 2003 and replaced the original doors/windows.
