SFA Design Group, LLC
STRUCTURAL | CIVIL | LAND USE PLANNING | SURVEYING
9020 SW Washington Square Dr., Suite 505
Portland, Oregon 97223
P: (503) 641-8311 F: (503) 643-7905
www.sfadg.com

September 5, 2013

RE: Geotechnical Investigation Report, Proposed Foundation Underpinning
Macomber Residence
44 NW Macleay Blvd
Portland, OR 97210

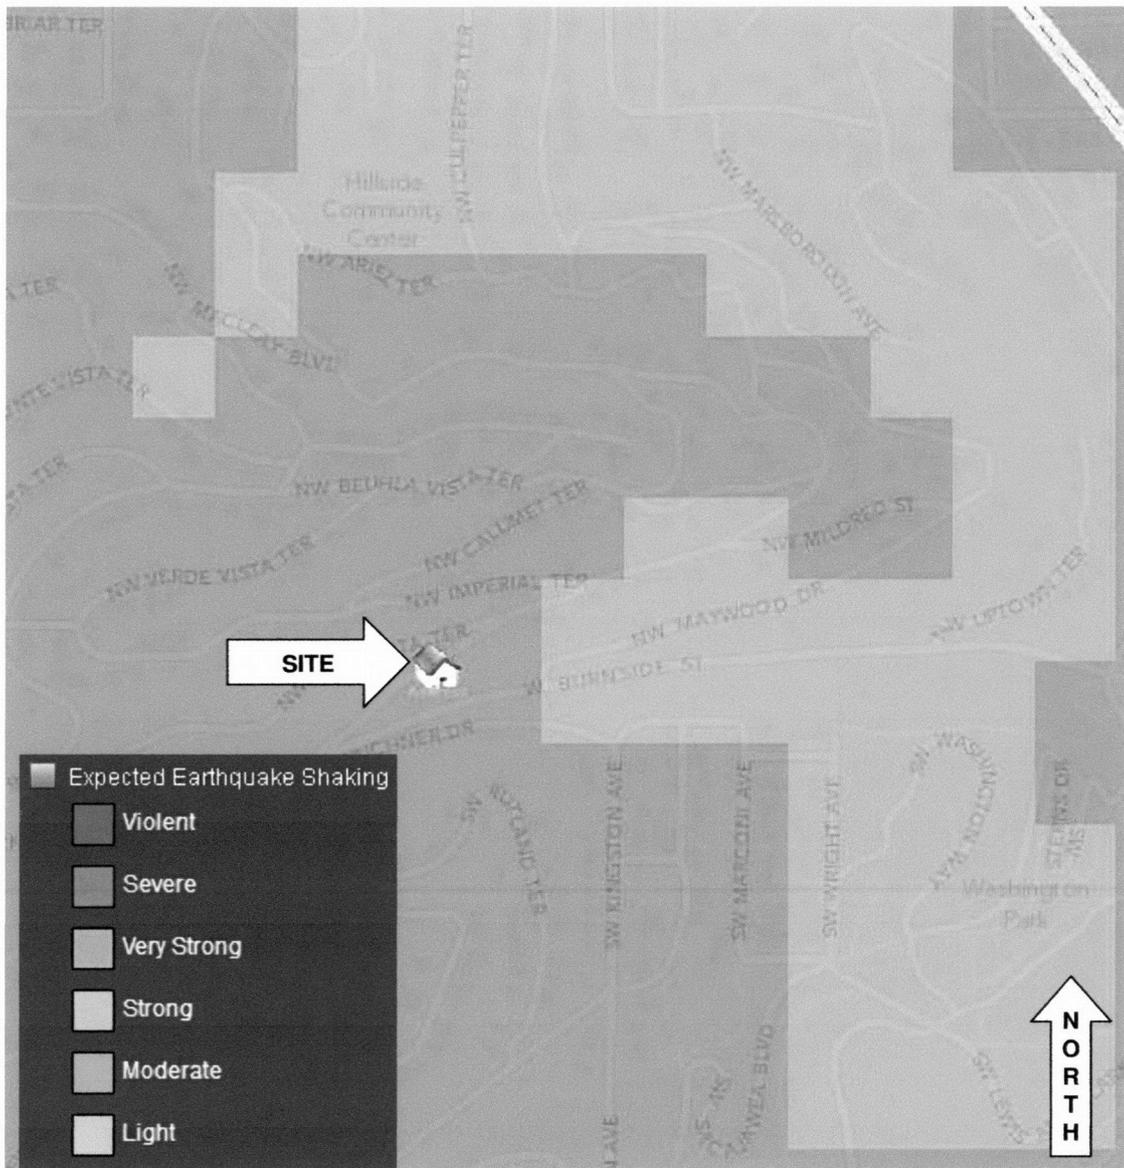
| | | FIGURE-B |

We consider the most significant geologic hazard to be the potential for moderate to strong seismic shaking that is likely to occur at the subject site. The subject site is located in the highly seismic zones in the Pacific Northwest region within the influence of several faults that are considered to be active or potentially active. An active fault is defined as a "sufficiently active and well defined fault" that has exhibited surface displacement within the Holocene time (about the last 11,000 years). A potentially active fault is defined as a fault with a history of movement within Pleistocene time (between 11,000 and 1.6 million years ago).
