Comments on Portland Building – LU 17-153413 HRM AD

5. *2013 FFA Architecture + Interiors Exterior Envelope Restoration Structure Improvements Assessment Phase 1*. FFA provided the City two repair options for the Portland Building.

FFA Architecture and Interiors was contracted by the City of Portland in September 2012 to provide a complete assessment of the existing exterior envelope condition. The project goal was to identify and quantify the scope of the ongoing problems with the exterior envelope.

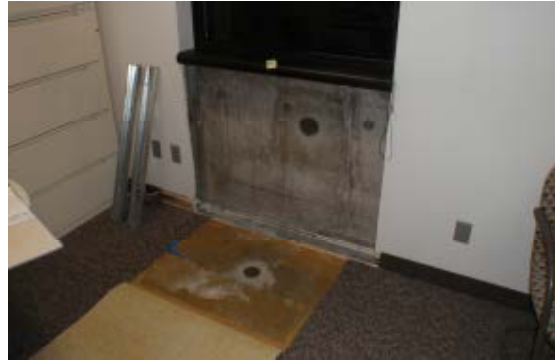
8. Test Site 11-1, 11-2 Interior finishes removed and concrete core samples taken.

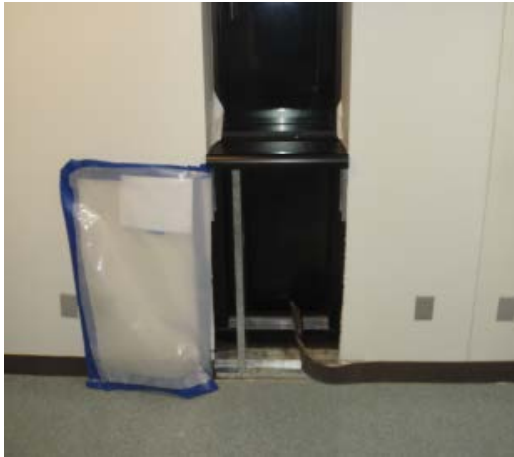
6. Test Site 4-10 Wall opened up for observation

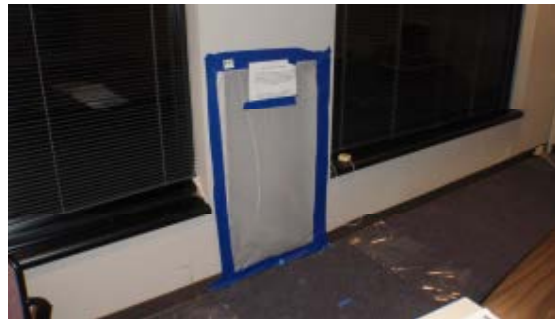
9. Test Site 15-4 wall opened for observation

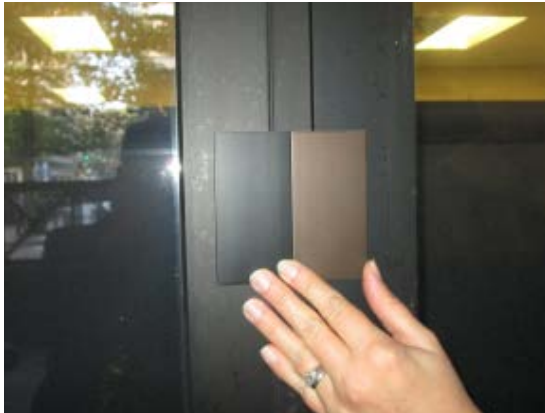
In a few of the metal panel signage areas, the team noted that the metal panels are not of the same color as the rest of the storefront assembly. The panels appear to have been replaced as some point in the past with a bronze colored panel as opposed to a black panel to match the storefront.

36. Incorrect Color Match

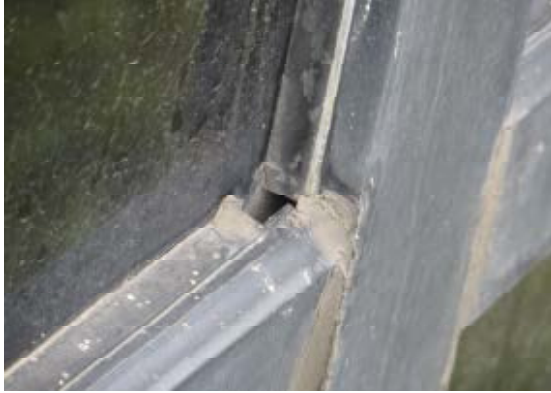
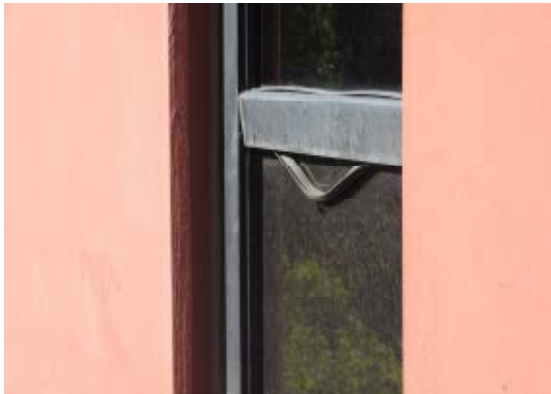
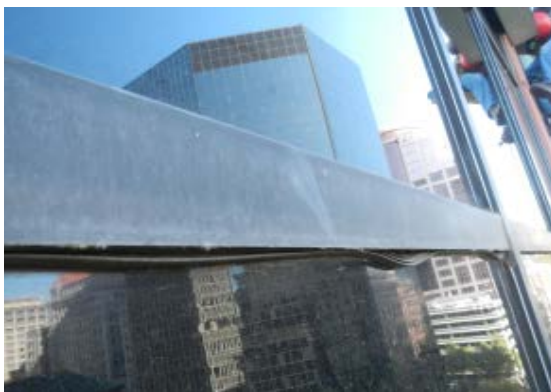
The glazing gasket failure that was observed has occurred in the form of shrinkage, cracking, and disengagement with the gasket race. This occurs with normal weathering and exposure.

39. Curtainwall Failed Glazing Gaskets

40. Curtainwall Failed Glazing Gaskets

41. Curtainwall Failed Glazing Gaskets

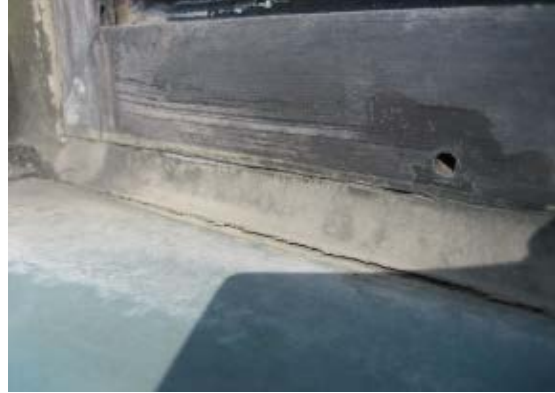
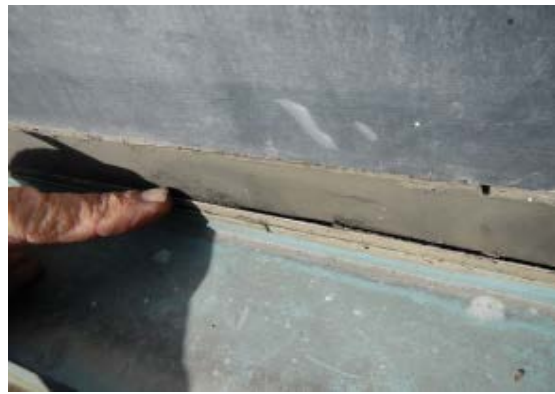
42. Curtainwall Failed Perimeter Sealant

43. Curtainwall Failed Perimeter Sealant

Adhesive failure is a condition whereby the failure mode of the sealant is typically caused by inadequate surface preparation or utilizing the incorrect sealant for the intended application. Failure occurs at the bond line between the sealant and the substrate where water and air are then allowed to enter the building.

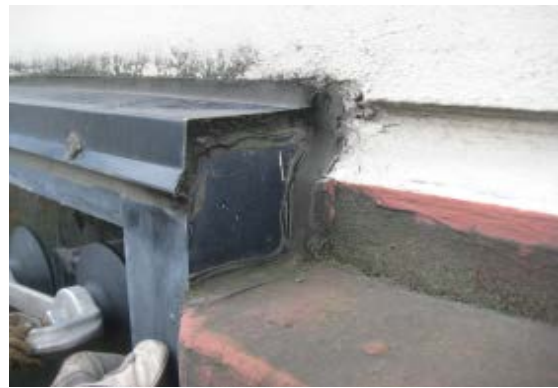
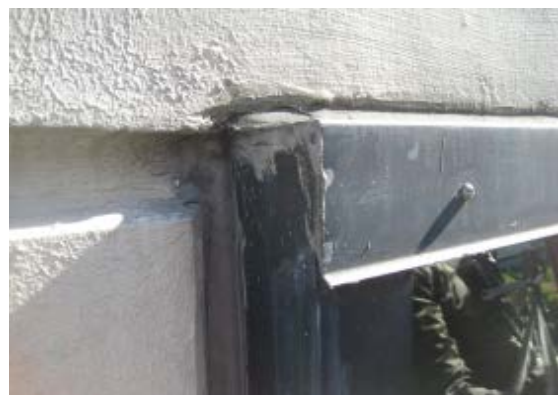
45. Curtainwall Inadequate Flashing Detailing

46. Curtainwall Inadequate Flashing Detailing

Typical failures at the sheet metal flashing areas consist of sealant failure, lap splice failures, inadequate design/installation, fastener failure and back-pitched flashing.

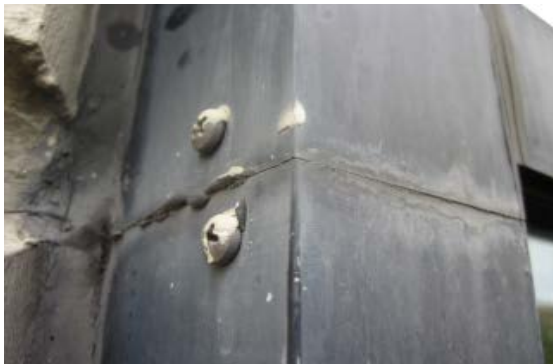
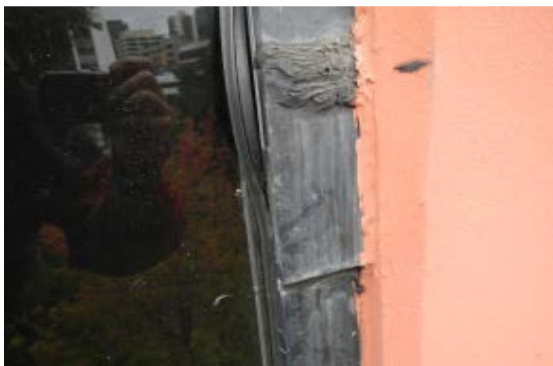
48. Curtainwall Failed Expansion Joints

49. Curtainwall Failed Expansion Joints

The expansion joints of the curtain wall assembly occur at each vertical mullion of the curtain wall system at Floors 5, 7 and 9. These joints are intended to provide a mechanism for the curtain wall assembly to accommodate thermal movement of the system as well as live load deflection of the floors to which it is anchored. The joints were installed as part of the retrofit campaign described above. The retrofit is highly dependent upon sealant and the applied splice cap to maintain a weather-tight enclosure. The sealant and the splice cap were observed to have been in a state of deterioration whereby the system does not appear to be provided adequate protection from air and water infiltration.

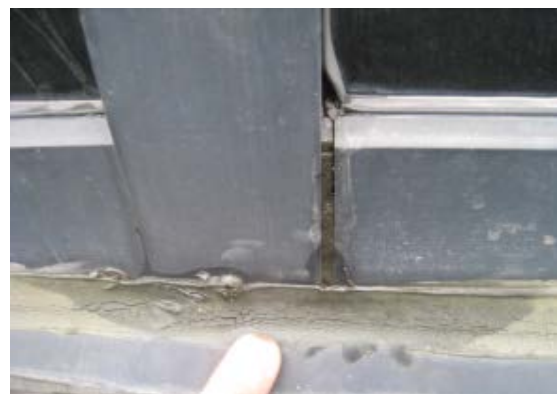
Joinery seals are the seals of the window assemblies where horizontal and vertical frame elements join together to form the frame of the window opening. At these junctures, a bead of sealant is typically run along the end of the frame member abutting the other frame member. When screwed together, the sealant forms a weather-tight seal. Omission or deterioration of the seal due to the thermal movements creates a condition where air and water can enter the assembly at a location that is not able to handle air and water.

50. Curtainwall Deteriorated Joinery Seals

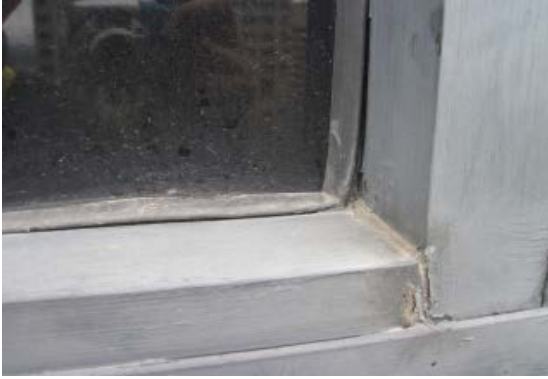
54. Ribbon Windows Failed Gaskets and Finish

Glazing gasket failure occurs in the form of shrinkage, cracking, and disengagement with the gasket race. This occurs with normal weathering and exposure.

The glazing gaskets throughout the ribbon window assemblies were found to be in generally poor condition. Recession of the gaskets is apparent in numerous locations. Additionally, glazing gaskets that became dislodged from the gasket race was noted in numerous locations throughout.

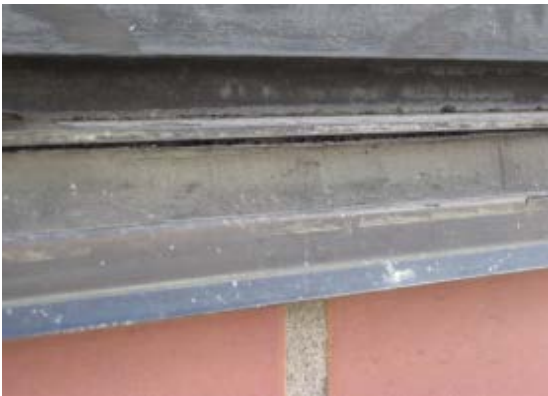
55. Ribbon Windows Failed Perimeter Sealant

Adhesive failure is a condition whereby the failure mode of the sealant is typically caused by inadequate surface preparation of utilizing the incorrect sealant for the intended application. Failure occurs at the bond line between the sealant and the substrate where water and air are then allowed to enter the building.

At the ends of the ribbon windows, failure of the sealant joint to the adjoining concrete was evident. Additionally, failure of the sealant at the ends of the head flashing allows water to bypass the perimeter sealant and migrate into the building.

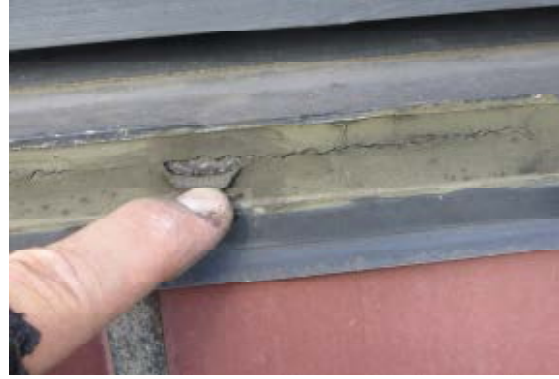
56. Ribbon Windows Failed Perimeter Sealant

Cohesive failure occurs when the sealant experienced a breakdown of the chemical properties due to exposure and starts to crack within the width of the sealant. While adhesion may still be occurring at the substrate interface, the sealant has failed due to the cracking experienced within the field of the sealant.

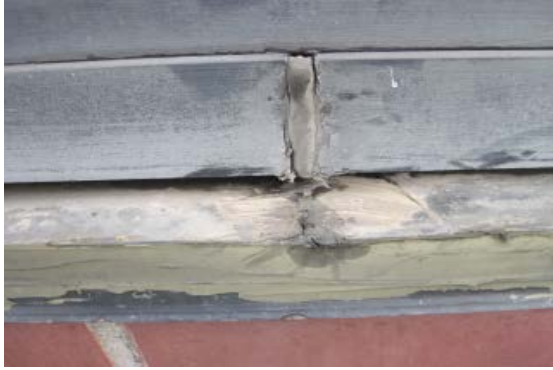
56. Ribbon Windows Failed Expansion Joint Sealant

Aluminum, like all materials, expands and contracts with changes in temperature of the material. Expansion joints were provided in the original construction by providing a 1/2" to 3/4" gap in the framing elements at approximately 10' on center. Sealant was utilized to waterproof the joint. However, over time, thermal movements of the system wear on the sealant and cause adhesive and cohesive failure similar to that noted above in "Failed Perimeter Sealant".

Nearly all of the expansion joints that are built into the ribbon window assembly are experiencing some level of deterioration. With thermal expansion and contraction of the window system, stresses are induced on the sealant that either cause adhesive failure or cohesive failure of the sealant. In a majority of the cases, failure appears in the form of adhesive failure. At that point, water can enter the system behind the perimeter

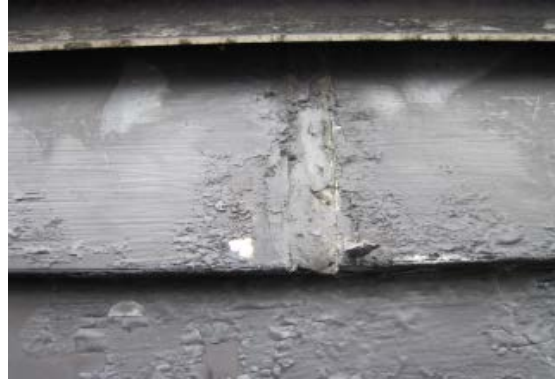
58. Ribbon Windows Deteriorated Finish

At all of the ribbon window assemblies, it appears that frames were painted with an unknown paint in an attempt to restore the finish and look of the original frames. This paint is flaking and cracking throughout. The underlying black anodized finish is exposed at the areas where the paint is flaking, revealing a weathered, chalky appearance typically caused by substandard quality of coating.

The finish of the ribbon window assemblies appears to be significantly showing age throughout the building. The past attempts at restoring/remediating the fading/chalking by painting over the frames has clearly failed over time and are no longer providing benefit to the assembly.

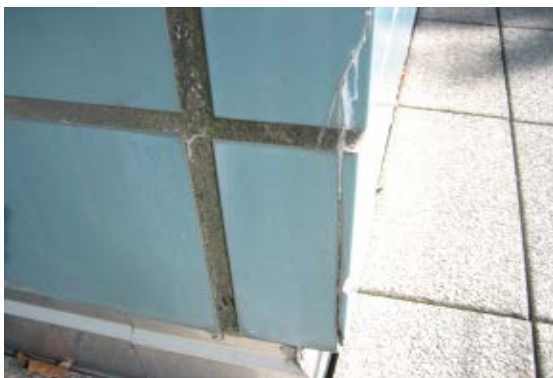
66. Ceramic Tile, Cracked, Sealant Failure

The tiles of the Portland Building are a glazed ceramic tile, wherein a smooth, impenetrable glaze is applied to the surface of a relatively porous substrate. The observed cracking of the glazed tile appears to be caused by either the freezing of moisture trapped behind the tile, corrosion of the expanded metal lath and associated anchorage directly behind the tile, or damage from maintenance operations. While rain water does not penetrate the glaze, it does penetrate the porous mortar between tiles. The glaze then acts as a barrier, preventing the moisture within the assembly from escaping. The moisture trapped against the inner surface of the glaze freezes and expands. In doing so, it exerts sufficient pressure to crack the tile.

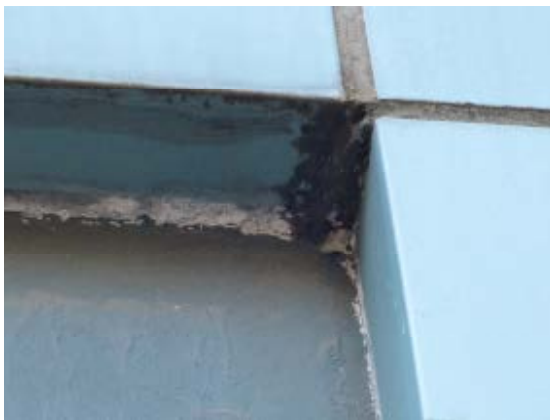
69. Ceramic Tile, Efflorescence

Efflorescence is a crystalline deposit, usually white, of water-soluble salts on the surface of the masonry and is often observed just below the point of moisture entry due to rain or condensation. Moisture within the mortar/grout joint and setting bed serves as a vehicle to carry water-soluble salts to the surface. The denser the material, such as concrete, brick, or stone, the more difficult it is for water to transport the salts. The more porous the material, such as mortar or grout, the easier it is for water to transport the salts. Upon reaching the surface of the assembly, the water evaporates, depositing the water-soluble salts. These salts present an aesthetic issue, as they mar the appearance of the tile,

and a technical issue in that they salts can deteriorate adjacent aluminum and glass assemblies.

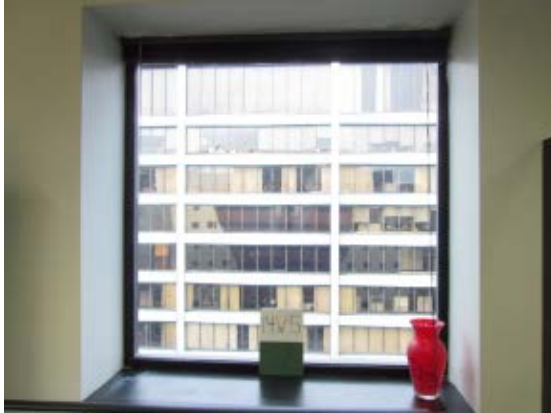
89. 14<sup>th</sup> FLOOR WEST ELEVATION

The ribbon windows installed on the 10<sup>th</sup> through 14<sup>th</sup> floors present an additional problem. These windows are set into the red ceramic tile capitol. As noted in Photo 41 the top of the tile is not flashed. Only a bead of sealant protects the top of the tile from water infiltration into the wall assembly behind. This sealant has failed and the resulting leaks have caused extensive damage to the exterior

tile installation, ribbon window assemblies and interior finishes.

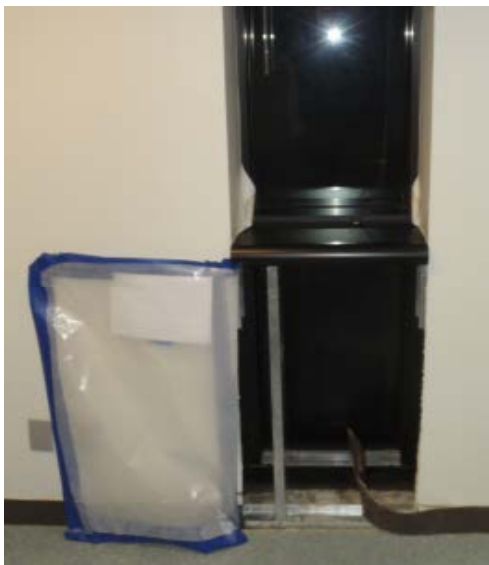
91. Test Location 4.10 (4<sup>th</sup> floor, south)

Observed extensive water damage to interior finishes, vinyl wall covering is peeling away, GWB has deteriorated. Floor has been saturated so often that carpet was removed and vinyl floor covering was installed for easy clean-up of standing water.

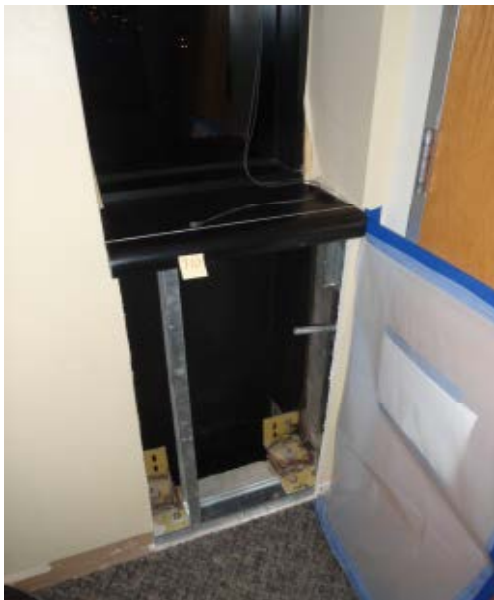
95. Test Location 7.10 (7<sup>th</sup> floor, south elevation)

Observed extensive water damage to interior finishes, vinyl wall covering is peeling away, GWB has deteriorated. Water stains were noted on curtainwall support brackets.

It was also noted that fire safing or mineral wool batt insulation normally required at exterior walls to separate one floor from the next for fire separation was not installed in this location.

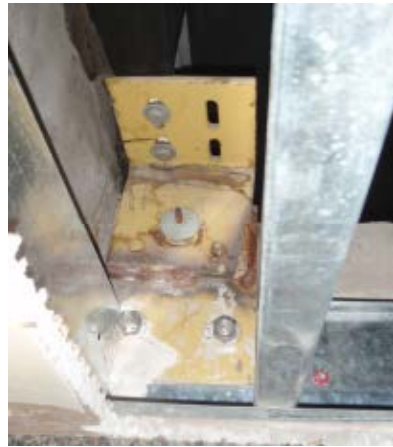
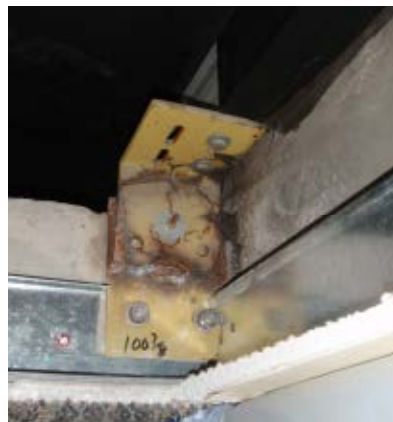
96. 7.10 Water Stains at Connection Plates

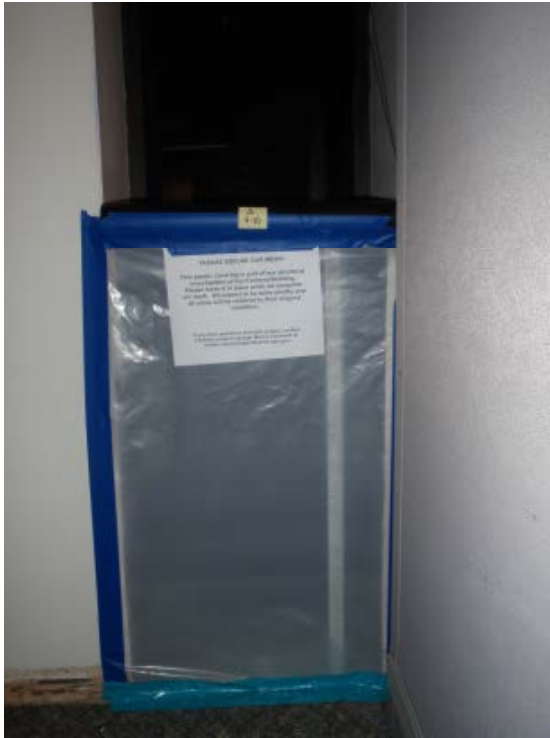
98. 9.10 (9<sup>th</sup> floor, north elevation)

Observed extensive water damage to interior finishes, vinyl wall covering is peeling away, GWB has deteriorated. Water stains were noted on curtainwall support brackets.

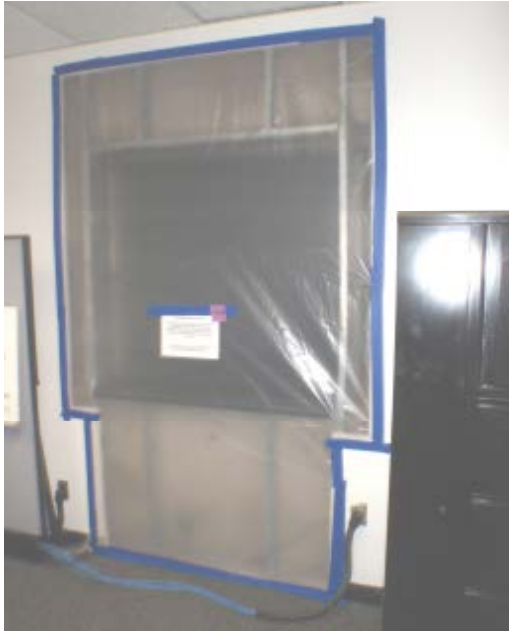
101 Test Location 14.10 (14th floor, west elevation)

Observed extensive water damage to interior finishes, vinyl wall covering is peeling away, GWB has deteriorated. Due to the amount of deterioration, it was determined to repair the head, jamb and sill installation, however, due to the failure of the exterior red ceramic tile installation, this window assembly will continue to leak.

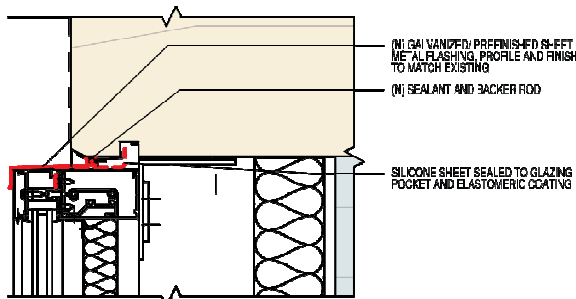
**B9 CURTAIN WALL - HEAD - OPTION B**

The curtainwall head condition at the tenth floor typically projects forward 3" +/- from the concrete above. This projection has sheet metal flashing and sealant as the water barrier. At the flashing joints the sealant has failed, water is leaking into the assembly and then the building.

- Remove existing curtainwall.
- Install new curtainwall assembly.
- Install primary seal with silicone membrane.
- Install secondary seal with sheet metal flashing and sealant.

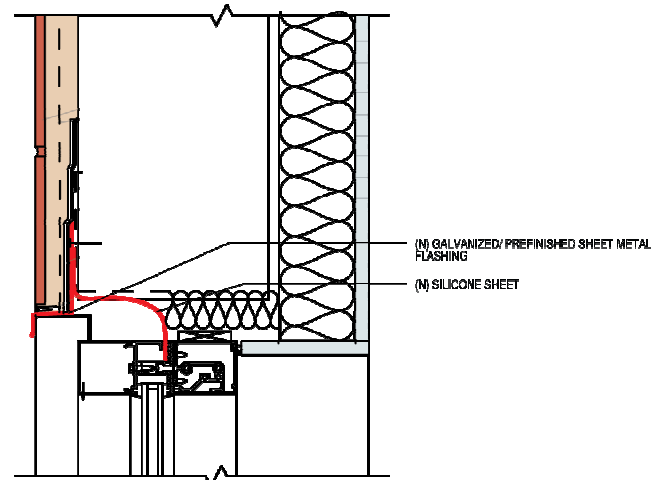
**B6** RIBBON WINDOW - HEAD (JAMB SIM.) - OPTION B

Due to the severe deterioration of the ribbon window assemblies and systemic nature of the deficiencies, remediation of these systems is not considered a viable option to arrest water infiltration in the long-term.

In order to address the observed deterioration and chronic water infiltration that have plagued the building at these assemblies, the following **dual line of defense** approach is recommended for a long-term solution:

- Remove the existing ribbon window assemblies including anchorage and associated sheet metal flashings.
- Remove two courses of tile above and below the window rough opening to allow for the installation of appropriate flashing on the face of the concrete substrate. Remove the tile, setting bed, lath and

- Apply a fluid-applied flashing atop the concrete substrate for the entire perimeter of the rough opening.
- Install a new thermally broken curtain wall system with custom snap cap to match the profile and dimensions of the existing window system. Color, finish and location to match existing.

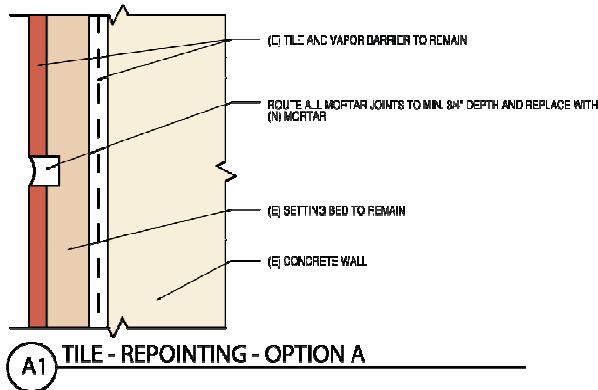
**A1** TILE - REPOINTING - OPTION A

Deteriorated Mortar Joints

- Repoint deteriorated and/or cracked joints to prevent further deterioration of the joints and excess water infiltration.
- Repointing constitutes removal of existing material within the joints (to a depth sufficient to insure adequate bond with new material).
- Replace with a tightly controlled Portland cement mortar formulation.

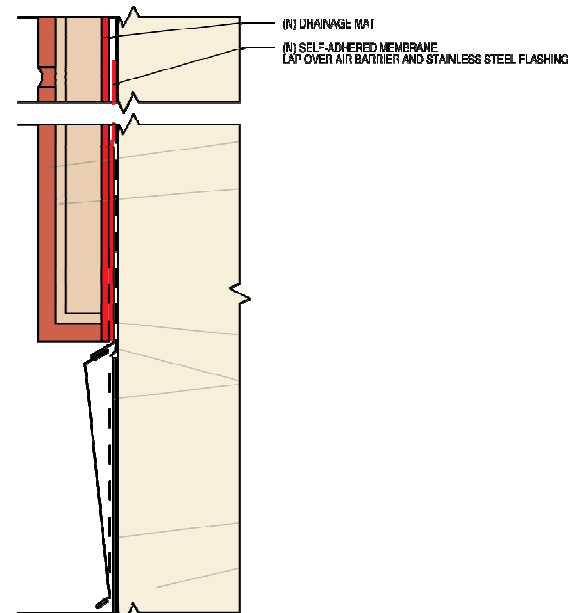
**B1** TILE TO ROOF ASSEMBLY - OPTION B

In order to address the chronic efflorescence in the long-term and properly address water infiltration issues at window perimeters, it is recommended to remove and replace the existing tile with a rain-screen type assembly that allows for a drainage plane behind the setting bed. In this scenario, we would recommend the following.

- Remove the tile, setting bed, lath and polyethylene weather-barrier down to the existing concrete substrate.
- Any removed tile that is salvageable can be reused at the owner's discretion; however past investigations have revealed that salvaging the existing tile is difficult due to the brittle nature of the tile.
- Apply a vapor permeable, fluid-applied, air barrier on the face of the concrete substrate with appropriate terminations and transitions to the windows, stucco, roofing and concrete to provide continuity of the air barrier across these transition areas.
- Install a drainage plane composed of a pre-molded drainage mat with integral lightweight breathable filter fabric.
