# NORTH AND EASTSIDE PORTLAND UNREINFORCED MASONRY BUILDING SURVEY PROJECT REPORT

Prepared for The City of Portland  
by Robert Dortignacq, Architect and Kim Lakin, Historic Preservation Consultant  
August 2013

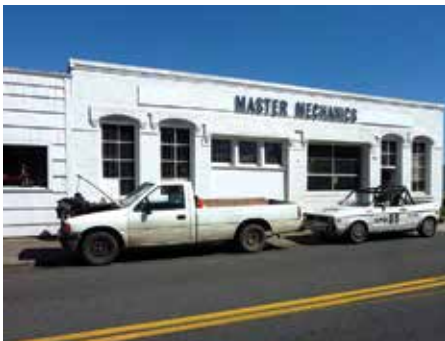
A one story solid brick automotive repair building. The structure dates to 1956 and has ornamental brick features and a heavy timbered roof structure. It is listed as URM and we concurred, however, it is of much newer construction and it may have concrete structural elements and reinforcing that cannot be determined from a brief visual survey. The style, construction and rarity may make it historically contributing.

Master Mechanics, located in the Sellwood area

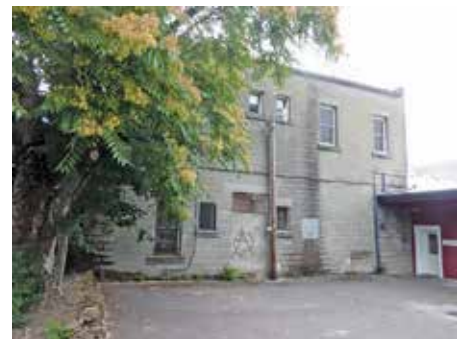
Rear view of the Griessen Building

The concrete block is in good condition and could potentially be reinforced, at least for portions of its length. Safe exiting for restaurant patrons and for residential tenants should be the first priority. Since the exits are through the front soft-story portion of the building those could be strengthened. Secondary means of exiting for the residential units might provide an alternative to reinforcement of the existing exitways. Similarly, a side exit for the restaurant might provide an adequate alternative exit. Enhancements could be phased as the neighborhood strengthens.

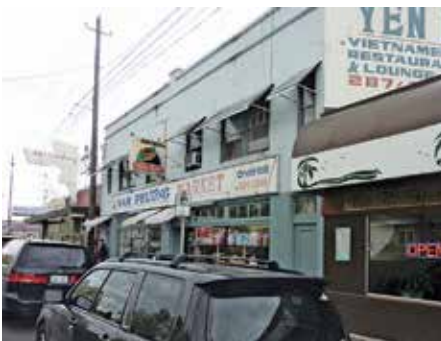
Nam Phuong Market and Building on Sandy Blvd., Study area 3

A two-story brick building that is a significant neighborhood historic landmark, but also that has significant life safety and seismic issues and is listed as a U (unsafe), which prevents use. The small irregular-shaped structure represents a most difficult economic rehabilitation example due to the complexity of seismic, structural and life safety needs, as well as a small footprint.

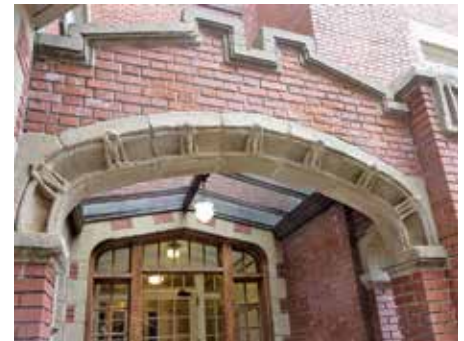
The plan configuration in a 'U' creates stress concentrations with wings responding differently than the body mass. Although the main level is raised, the foundation is concrete and provides improved support. The elevator and stair are at the intersection of the wings. The exits pass through a masonry archway.

Entry arch at Trinity Place Apartment building

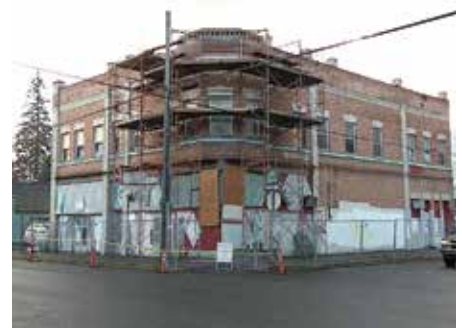
Building upgrade at 3041 N. Williams

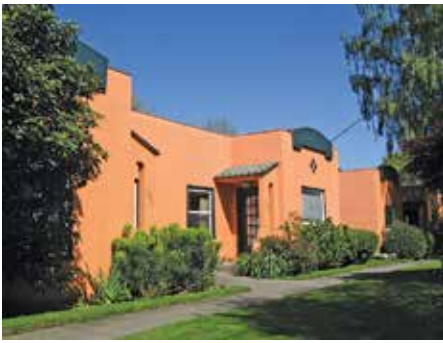
Single-story residential, stucco exterior in Kerns

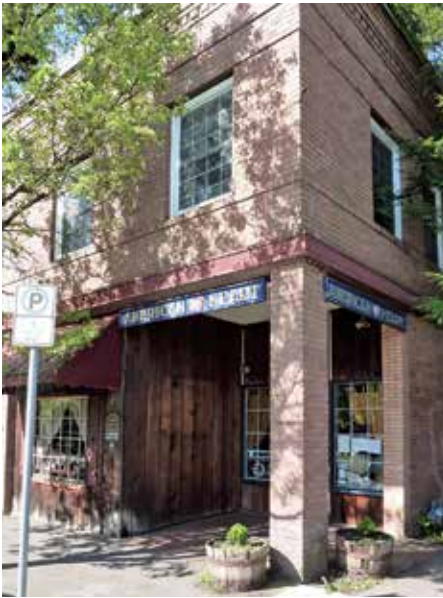
Two-story mixed-use in Sellwood
