# **City of Portland / Outfall 17 / Contaminated Sediment Source Identification**

Prepared for: Dawn Sanders/BES

Prepared by: Ali Dirks/BES

Date: June 30, 2003

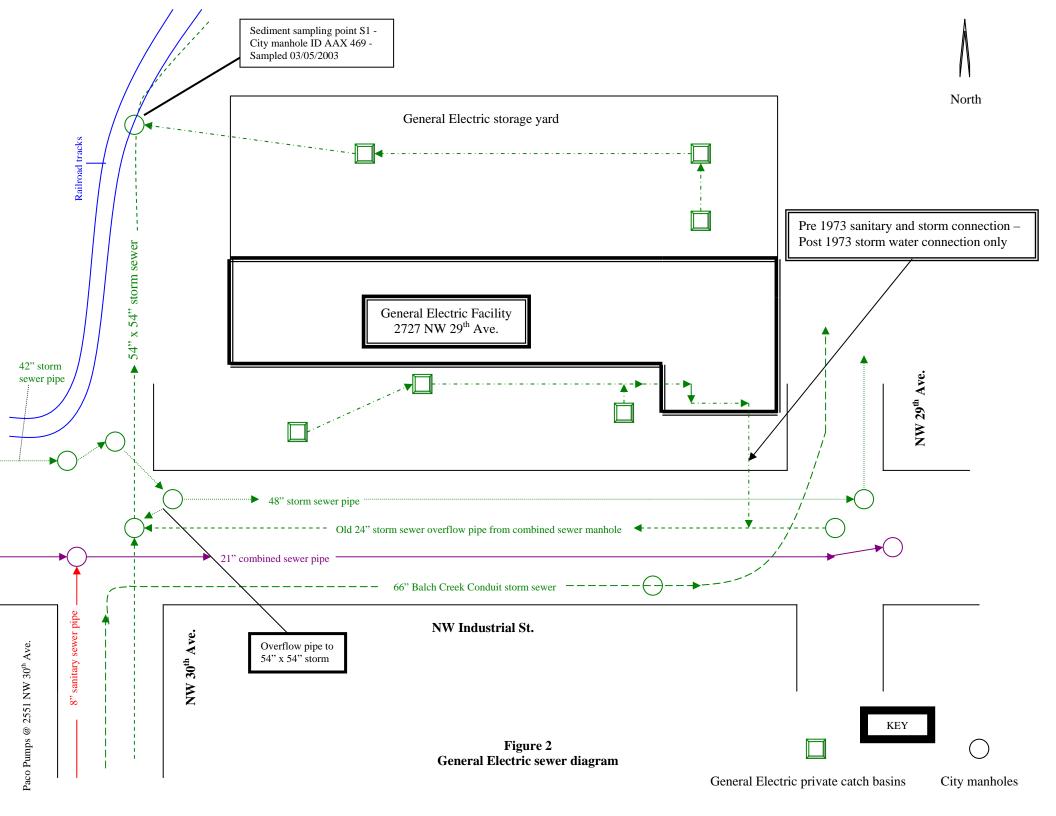
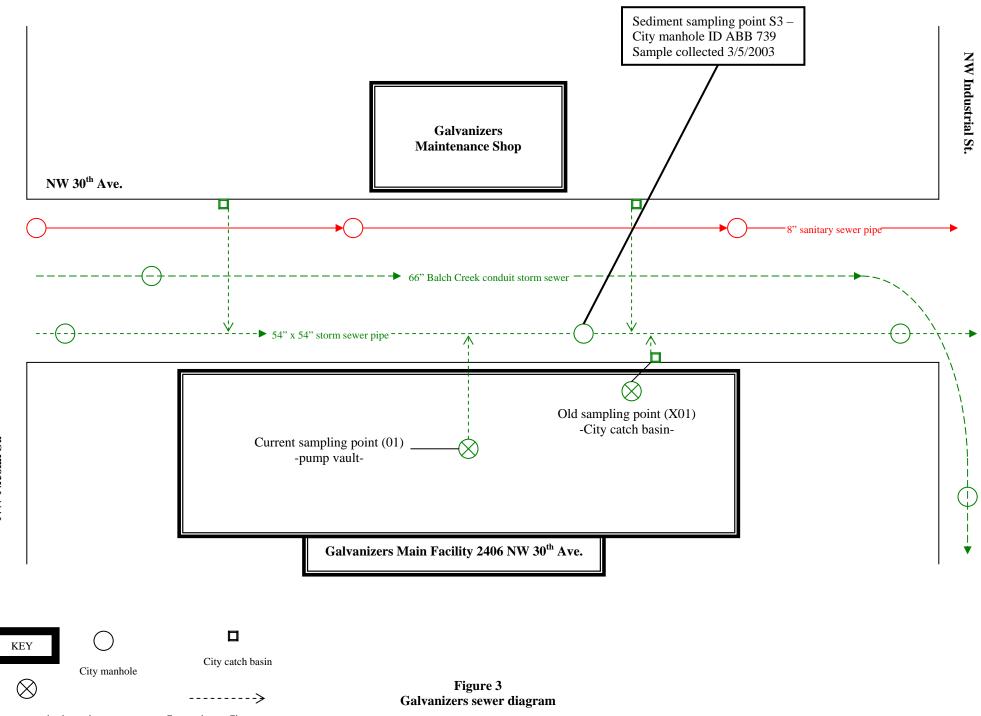
Figure 1. Location of Stormline Samples in Basin 17

Sample point one (S1) is located 450 feet north of the intersection of NW Industrial St. and NW 30<sup>th</sup> Ave (see Figure 1). S1 is a City manhole and is located on the railroad tracks. This manhole's City ID number is AAX 469. The sediment analysis indicated a high level of PCB 1260 (6,770 ug/kg).

Sample point two (S2) is located 65 feet west of the intersection of NW 29<sup>th</sup> Ave and NW 31<sup>st</sup> Ave (see Figure 1). S2 is a City manhole and is located in the middle of the street.

This manhole's City ID number is AAX 501. The sediment analysis indicated an elevated level of PCB 1260 (617 ug/kg).

Sample point three (S3) is located 580 feet north of the intersection of NW Nicolai St. and NW 30<sup>th</sup> Ave (see Figure 1). S3 is a City manhole and is located in the middle of the street. This manhole's City ID number is ABB 739. The sediment analysis indicated high levels of zinc (20,400 mg/kg), lead (531 mg/kg) and cadmium (11.1 mg/kg).
