Prepared by: **BTD/MT**
BO Letter Number: **3010523**

Engineering Addendum

Project Name: Javiena Group Fremont St Remodel (Portland) 2810523
Project Location: 5935 NE Fremont St
 Portland, Oregon 97213
Project Number: 2810523
Date: 5/10/2023

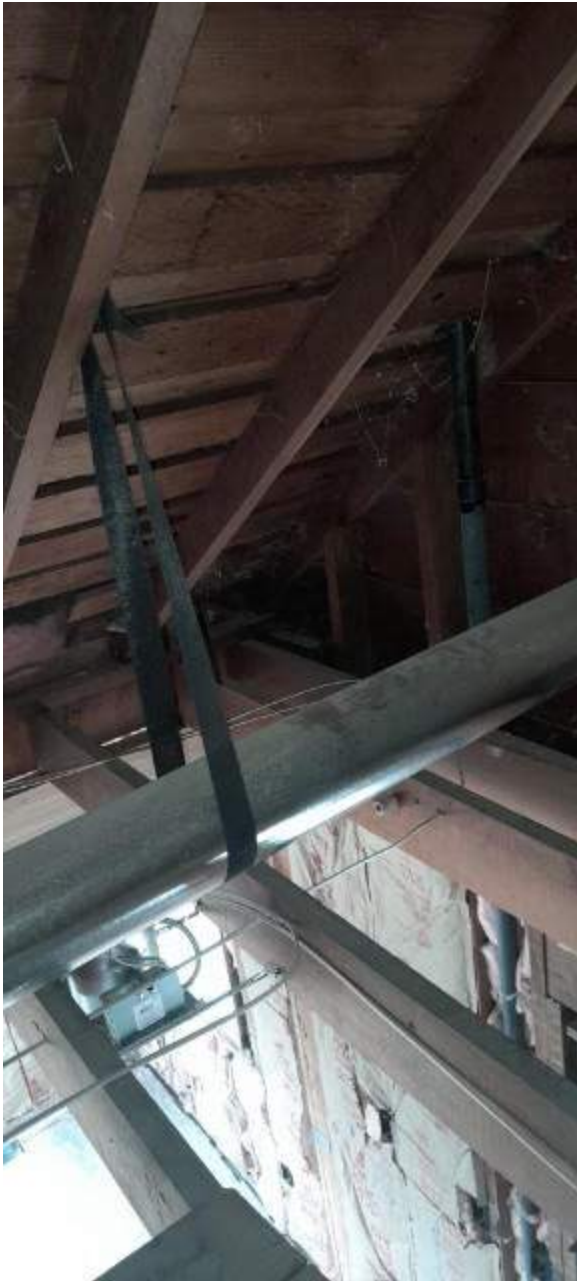
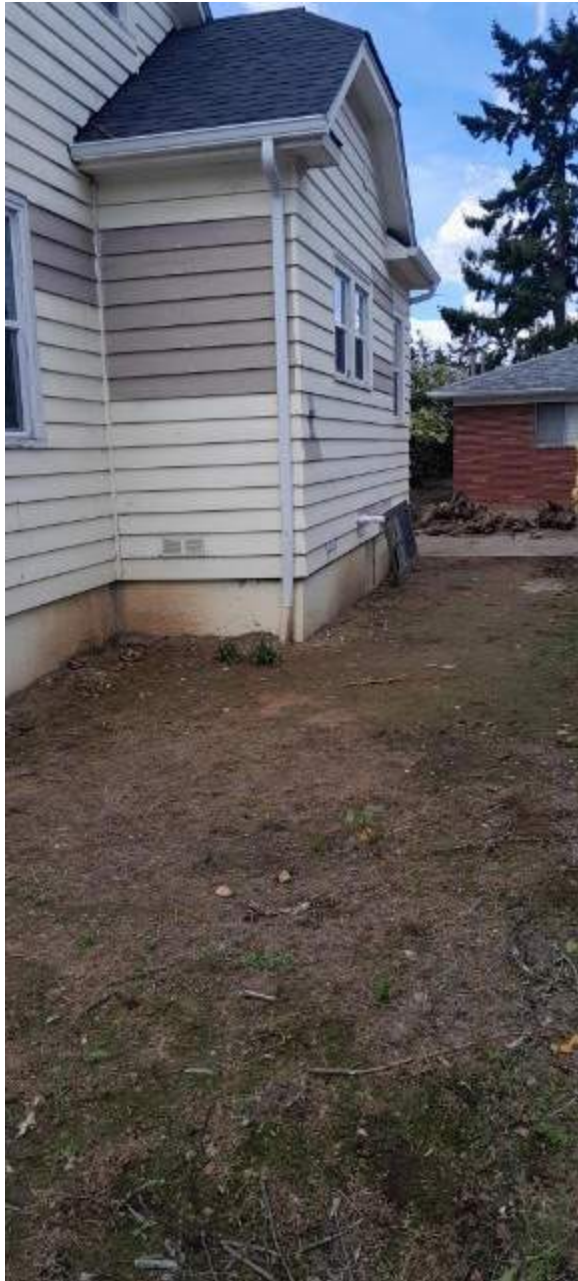
1. Plumbing hole - yes upper floor framing above kitchen
2. Plumbing hole location to load bearing wall - Leo to provide
3. Roof framing pic attached
4. Right side of house - yes popped out and sitting over a crawl space - pic attached

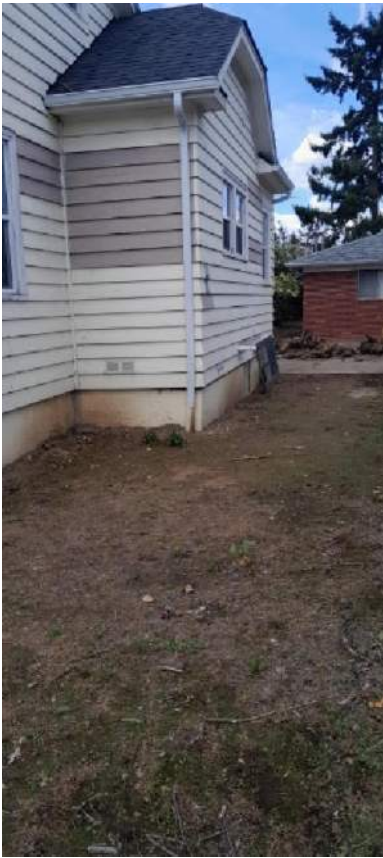
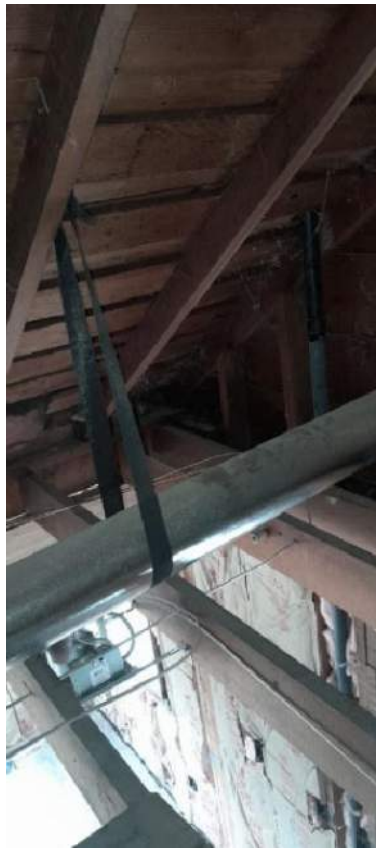
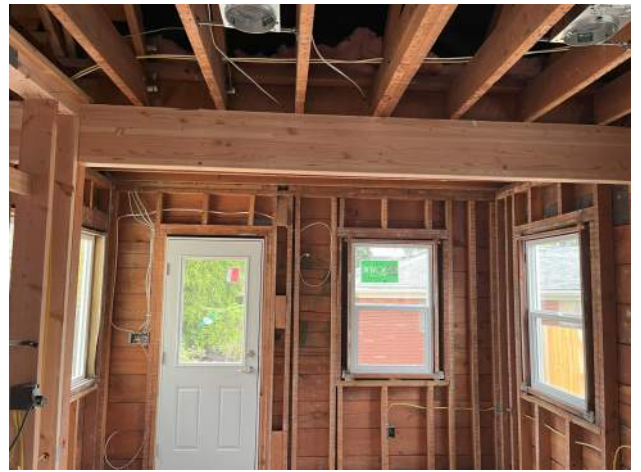
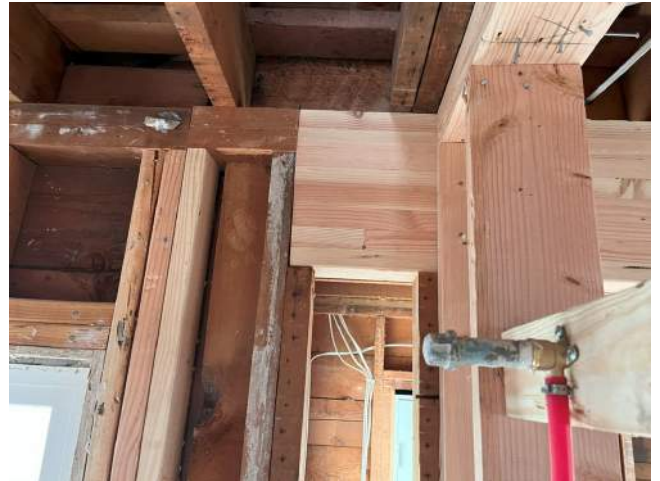
Hi Zac. Need to reinforce this joist per the inspector & wants a EOR letter with calcs. Joist is 2 x 7. Plumbing is 3". Can you have your engineer do this please? Let me know if he needs more info. It's always something.... Thx

- The joist with the drilled plumbing needs to be addressed. Attach a 30" CS14 strap to the bottom of the damaged joist, centered below the hole.
 - Alternative option: Attach a 30" long 1/4" thick steel plate to the bottom of the joist. Plate to have same width and nailing as the CS14 strap.
