Johnson Creek Restoration Projects Effectiveness Monitoring

Reporting on data collected from 1997 through 2010

DECEMBER 2012

ENVIRONMENTAL SERVICES
CITY OF PORTLAND
working for clean rivers

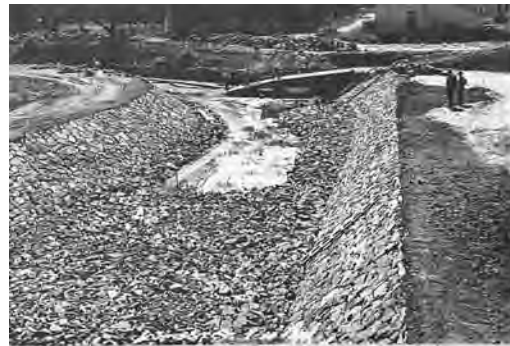
Johnson Creek provides critical habitat for coho and Chinook salmon, and steelhead trout, which are listed as threatened species under the Endangered Species Act. The creek has a history of flooding, on average, every two years. Dating back to the early 1900's various federal, state, and local agencies attempted to reduce or eliminate flooding in Johnson Creek. The most significant alteration, done in the 1930's as part of the Work Progress Administration (WPA), deepened, straightened, and armored the creek by installing large basalt rock lining along its banks and streambed. This disconnected the stream from its floodplain which previously absorbed, stored, and conveyed floodwater. The WPA work eliminated aquatic habitat such as riffles, pools, and large wood and impaired the streams ability to migrate and recruit gravels and large wood (see Photo 1).

Photo 1: From 1931 – 1935, the Federal Government widened, armored and rock-lined portions of Johnson Creek as part of the WPA, in efforts to mitigate flooding.

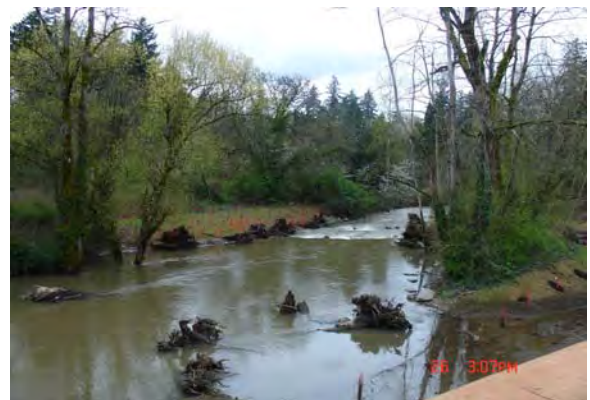
Photo 2b: Tideman Johnson Park post-restoration project. Pipe is re-buried, overflow channels were created, and large wood was placed in the channel.

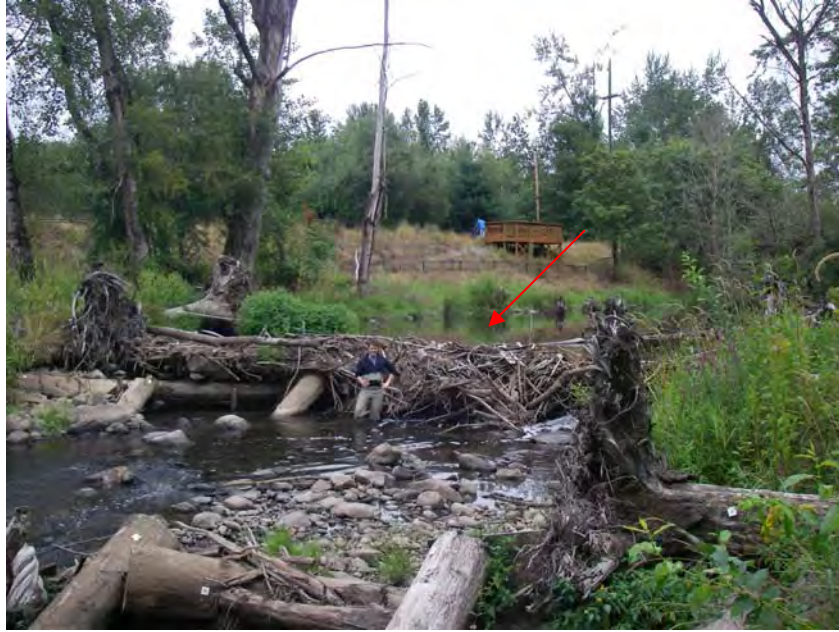
Beaver activity has been documented in this area for many decades. The newly constructed ELJ act as stout framework for recent dam construction. In 2009, two large dams were constructed within the ELJ's, along with a new beaver den. Additionally, several trees have fallen due to beaver chew. The largest dam, located at the uppermost ELJ measured over six feet tall (Photo 3).

Photo 3: BES staff standing below upper most beaver dam in Tideman Johnson Restoration Site (see arrow).

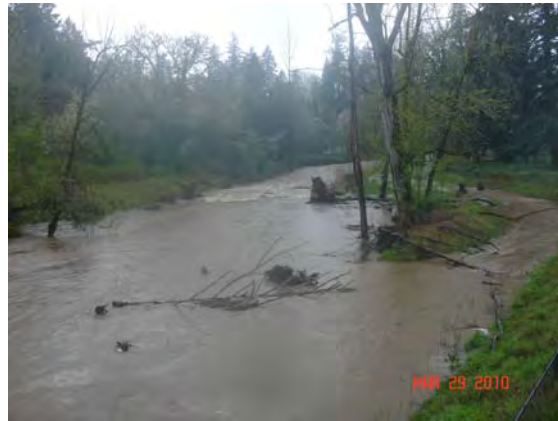
High flow monitoring is conducted annually to determine the extent of inundation during various events. Overflow channels are monitored to determine the amount of flow necessary for inundation. Two overflow channels were designed to become inundated during a 1.5-year reoccurrence interval or approximately 1200 cfs at USGS Sycamore gage. Monitoring has shown that the upper overflow channel becomes inundated during more frequent events due to large beaver dams located immediately downstream. Notably, this channel also had minimal flows during the dry season. The lower overflow channel becomes inundated during events as low as 300 cfs, providing high flow refuge during smaller events. Photo 5 shows the upper-most overflow channel during a 9-month event in March 2010.

Photo 5: Tideman Johnson - March 2010, nine-month high-flow event.

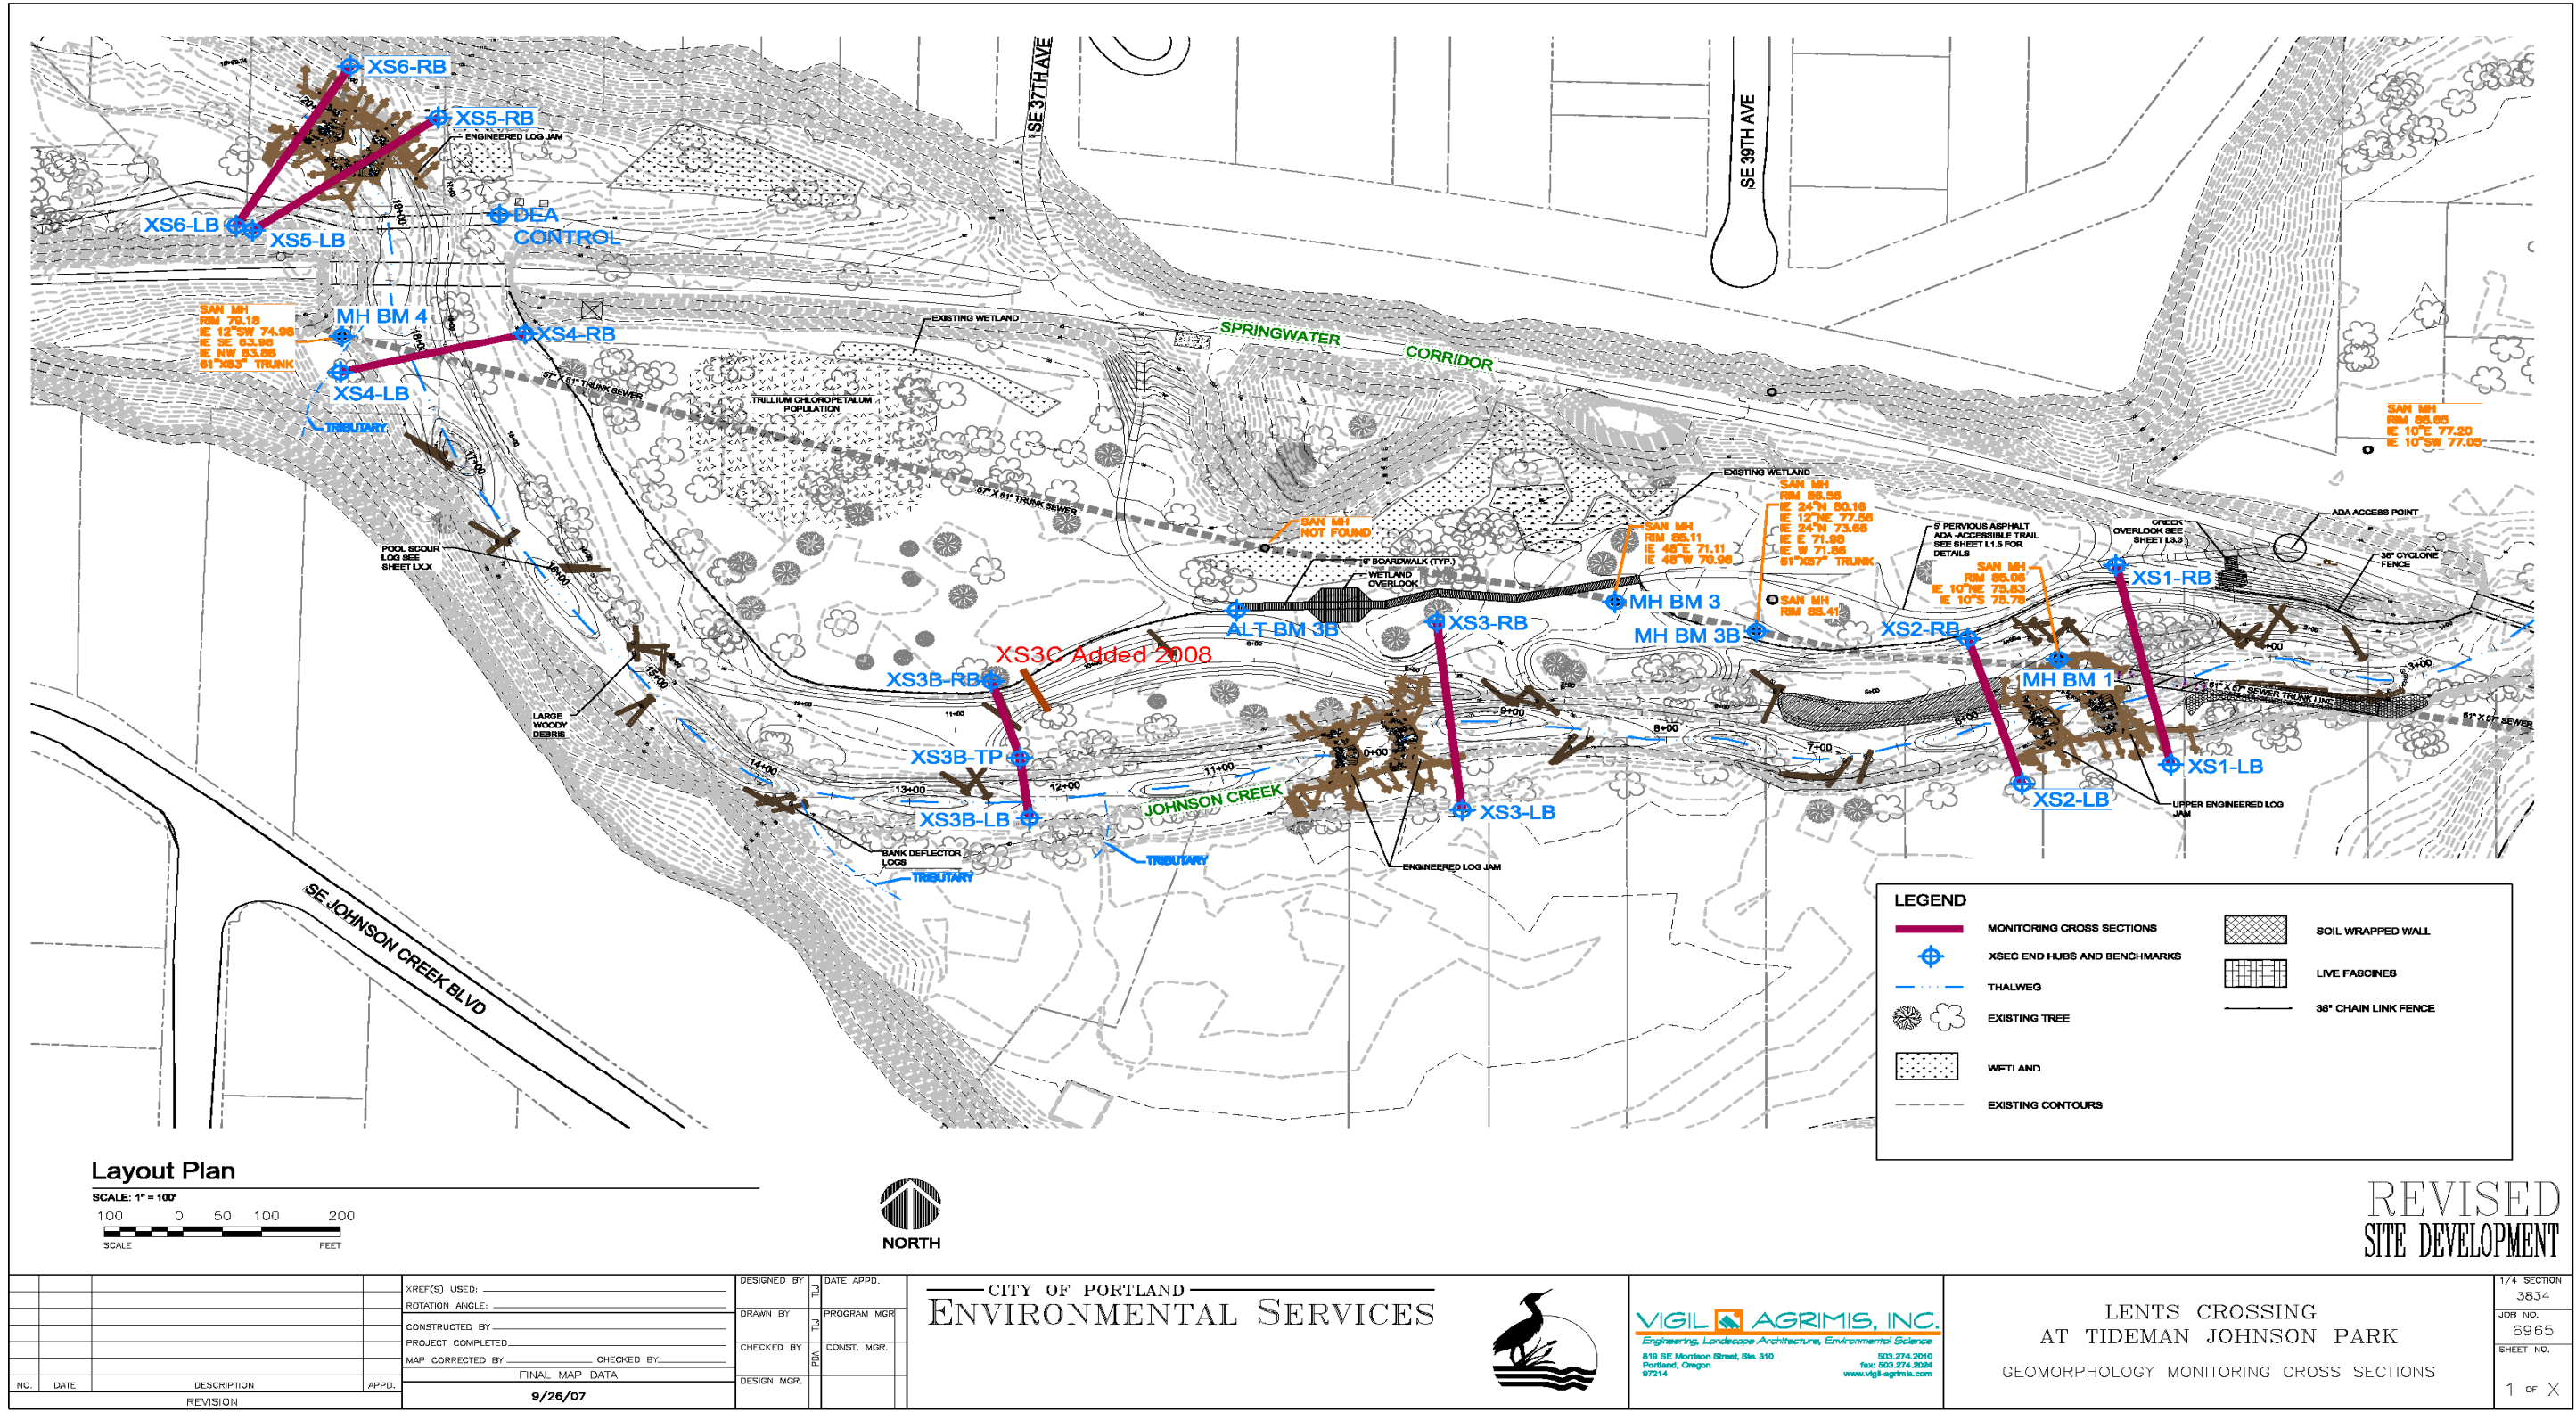
Figure 6: Tideman Johnson Cross-Sectional Survey locations

The first year of cross-sectional surveys were conducted in Summer 2007 in areas thought to be most vulnerable to scour (Figure 6). Cross-sectional survey data from 2007 to 2010 have produced valuable information revealing the extent of erosion within surveyed areas. The most significant erosion occurred in the lower overflow channel (Photo 7). Cross-section 3b captured the extent of erosion that has occurred in the overflow channel (Figure 7). To monitor the progression of the headcut within the overflow channel a survey of the longitudinal profile (Figure 8) and cross-section 3C were added to the monitoring protocol in 2008.

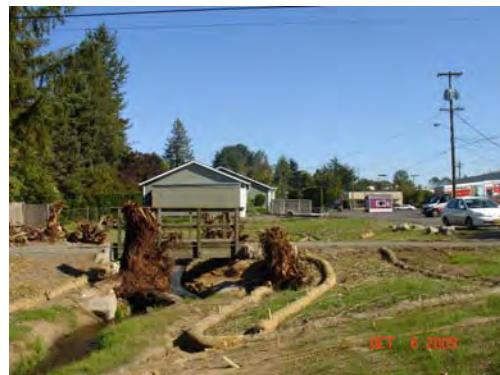
To improve opportunities for fish passage between Johnson Creek and Errol Creek, the project removed fish barriers and daylighted the section of Errol Creek that previously ran under SE 44th Ave. (Photo 9b). The confluence of Johnson Creek and Errol Creek was moved 50 feet south. The original mouth of Errol Creek remains intact and acts as a backwater channel to provide high flow refuge and flood water storage from Johnson Creek.

Photo 9b: Errol Creek post-construction. Vacating SE 44th Ave allowed Errol Creek to be daylighted and fish passage to be restored.

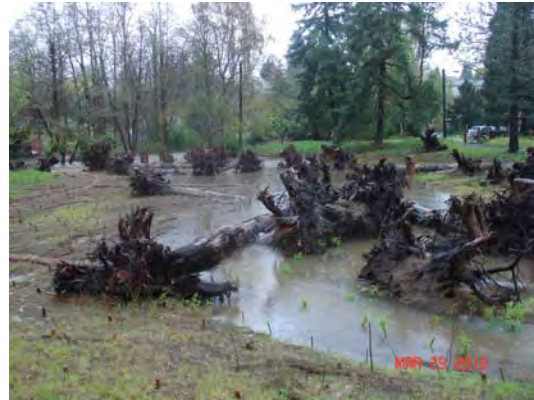
Annual high-flow monitoring revealed the channel provides valuable refuge as designed. As Johnson Creek approaches 690 cfs at the USGS Sycamore gage it backwaters into Errol Creek and its floodplain (Photo 10).

Photo 10: Johnson Creek backwaters into Errol Creek during high-flow event providing high-flow fish refuge.

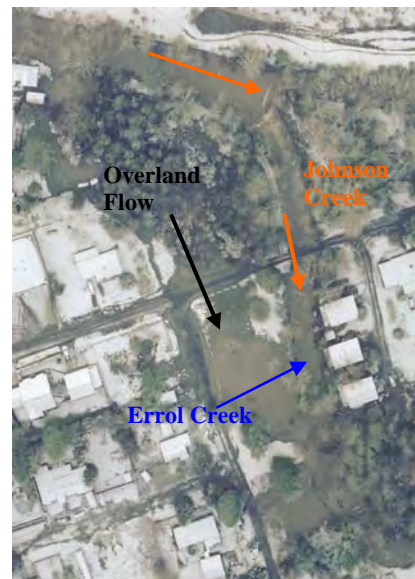
Flood storage monitoring was conducted during and after the January 2009 flood. Aerial photos and flood debris lines showed evidence that not only did Johnson Creek backwater into Errol but floodwater entered the Errol Creek floodplain by way of overland flow from upstream Johnson Creek (Photo 11).

Photo 11: Aerial of January 2009 flood. Johnson Creek accesses flood storage at Errol Confluence via backwater and overland flow.

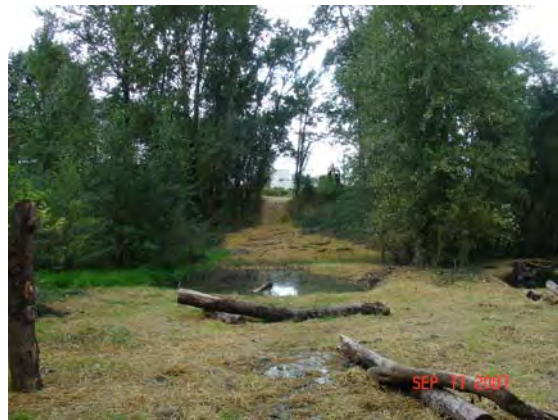
Four fish passage barriers along Errol Creek prevent anadromous fish passage into the wetland restoration area. This project removed the barrier furthest upstream, created by a private road off SE Harney Drive. The culvert was almost entirely submerged and was considered a complete barrier to juveniles and adult fish. The project removed drain tiles and 744 cubic yards of fill material on .63 acres of the site to restore 839 sq ft of wetland pond/emergent habitat and 6,276 sq ft of wetland scrub-shrub habitat. The project also restored 7,053 sq ft of riparian hardwood habitat, and 11,699 sq ft of mixed conifer/hardwood upland habitat (see before and after Photos 12a and b). Over 400 trees, 700 shrubs, 1,000 live cuttings and 25 pounds of grass and wildflower seeds were planted throughout the project.

Photo 12b: Errol Wetlands post-construction, culvert is removed and multiple ponds are created in the wetland.

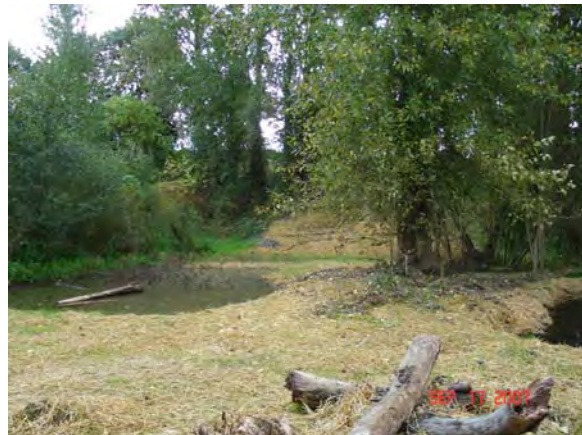
Photo 13a: Errol Wetlands in 2007, post construction, prior to revegetation. Ponds are clearly visible.

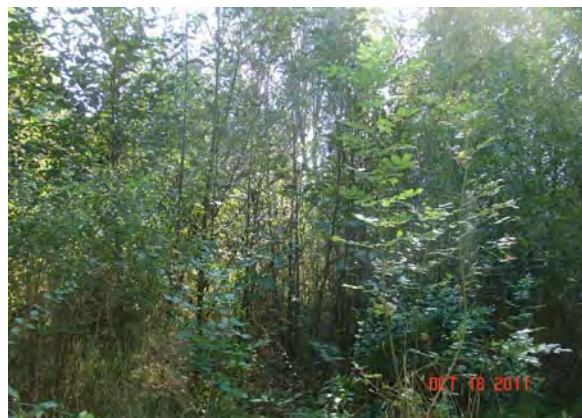
Photo 13b: Errol Wetlands in 2011, vegetation is established and blocks view of constructed ponds.

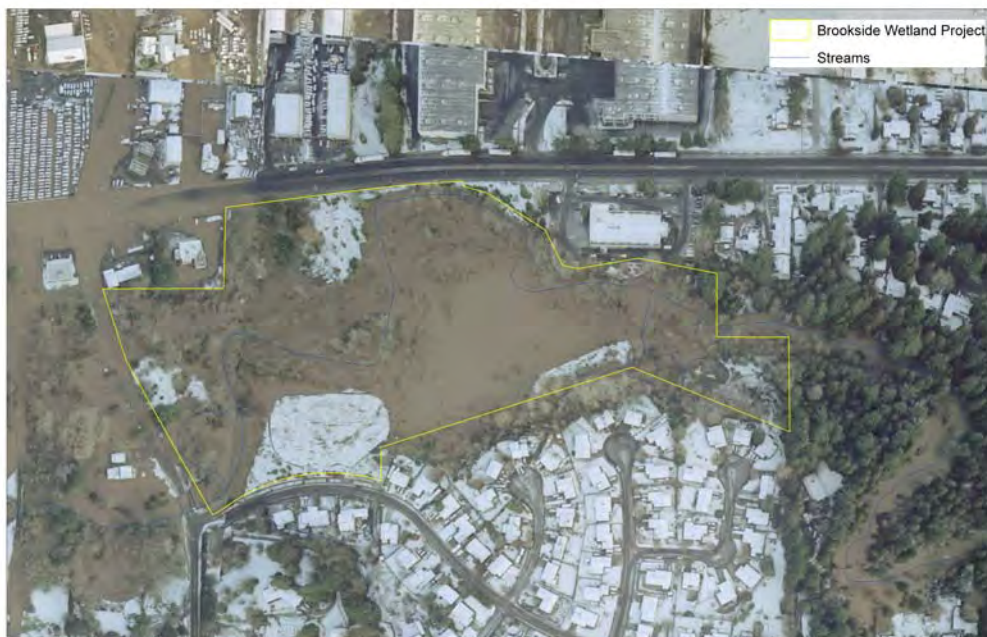
In January 2009, the site experienced a 29-year event. Aerial photos were taken during the peak of the event to show the extent of flooding (Photo 16). The photo shows that floodwater inundated the site. SE Foster Rd, adjacent streets, and private property experienced significant flooding.

Photo 16: Brookside Wetland during the peak of the January 2009 flood which filled the project to capacity.

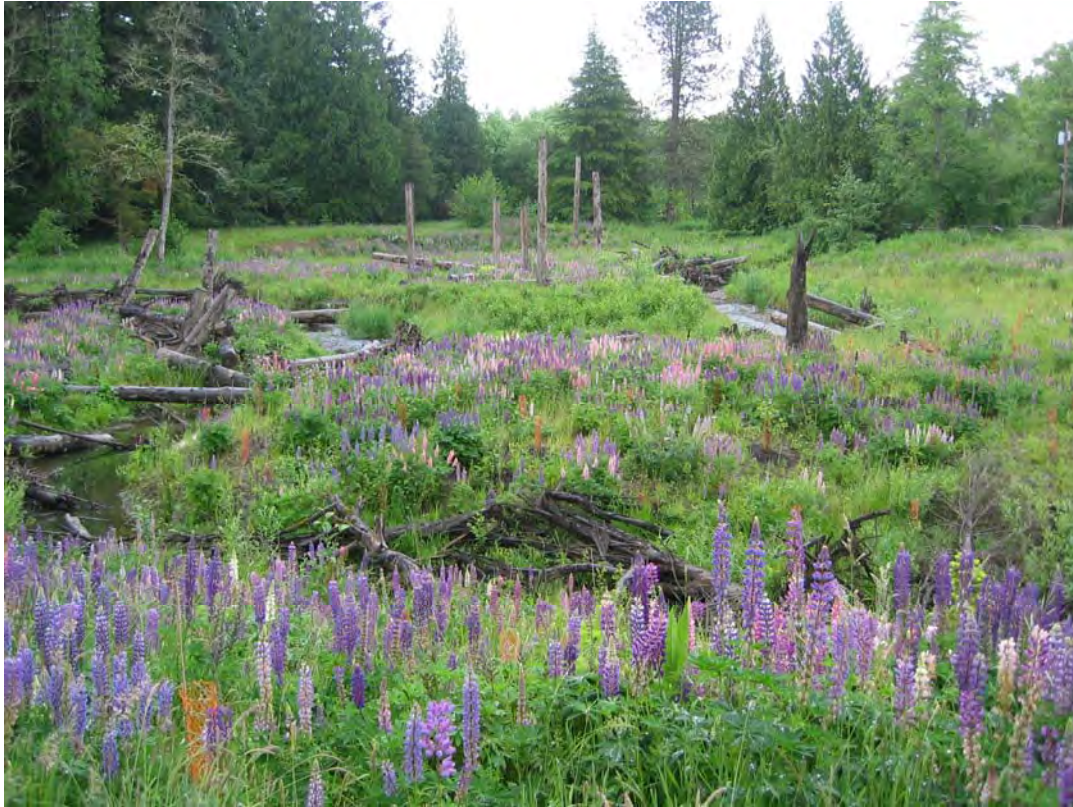
High-flow refuge habitat monitoring is performed using visual observation and photo documentation. Below are multiple photos of various flow conditions at Kelley Creek. For comparison purposes, Photo 19a shows conditions during low-flow. Stream flow is contained within the channel with a clear view of the floodplain. Photo 19b, at a slightly different angle and focal length, was taken in 2006 during a high-flow event that did not exceed the Johnson Creek banks. Photo 19c was taken in December 2007 during a two-to-three-year flood event and shows new vegetation beginning to obstruct the view of the floodplain.

Photo 19a: Kelley Creek Confluence - May 2006, low-flow conditions.

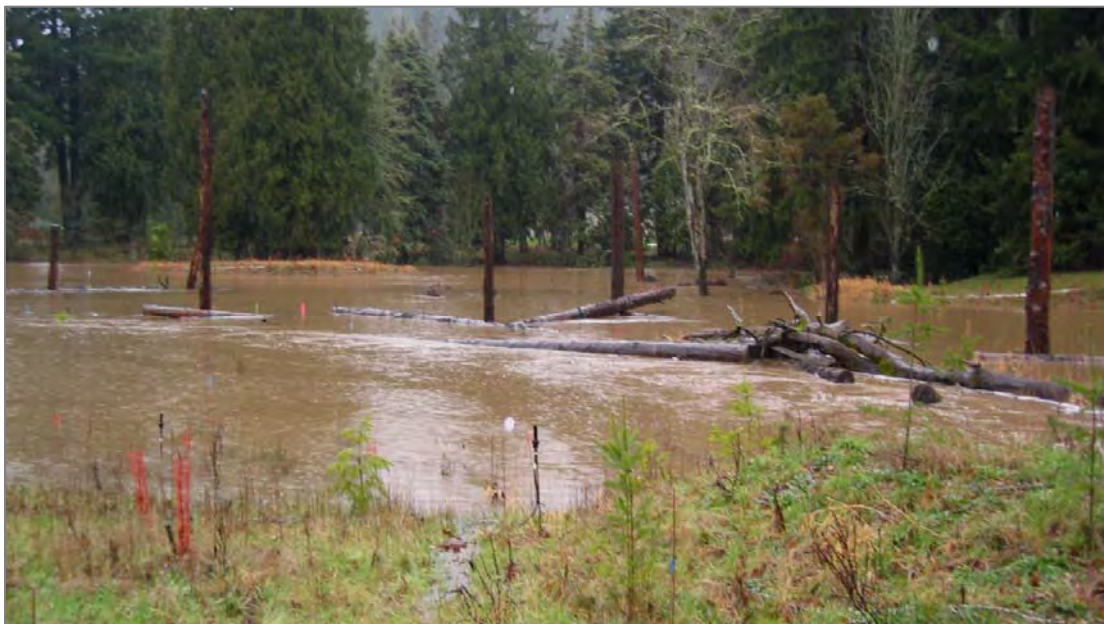
Photo 19b: Kelley Creek Confluence - January 2006, Johnson Creek was at bankfull.

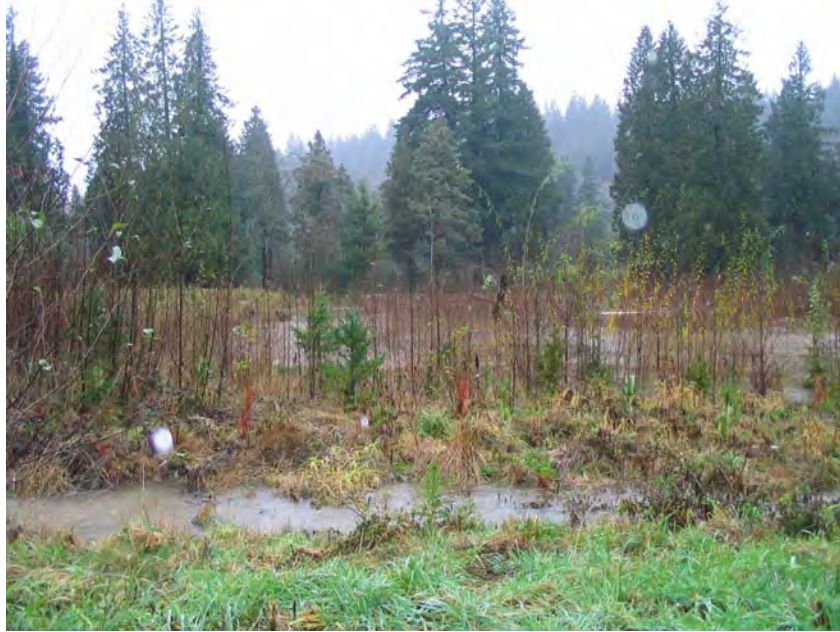
Photo 19c: Kelley Creek Confluence - December 2007, 2 to 3-year flood event for Johnson Creek.

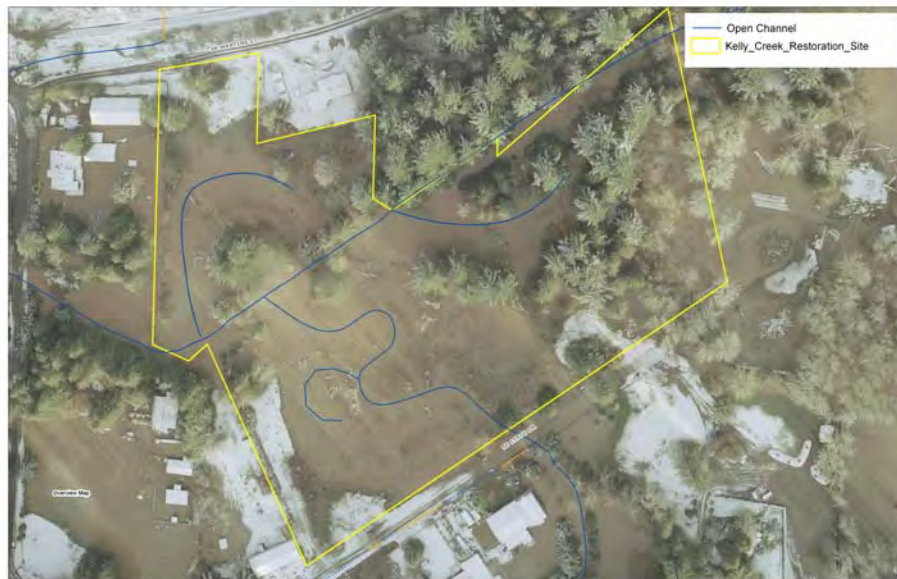
The Kelley Creek Confluence project is designed to provide flood storage for a flood event with a 10-year recurrence interval or 2,100 cfs (Figure 10). Flood storage monitoring is conducted during any over bank event. Photo 20 was taken during the peak of the January 2, 2009 flood, estimated to be a 29-year event. During each high-flow event, Johnson Creek backwatered into Kelley Creek and floodplain areas inundated, providing flood storage and off channel, low-velocity refuge for salmonids.

Photo 20: Kelley Creek Confluence - January 2009, 29-year flood.

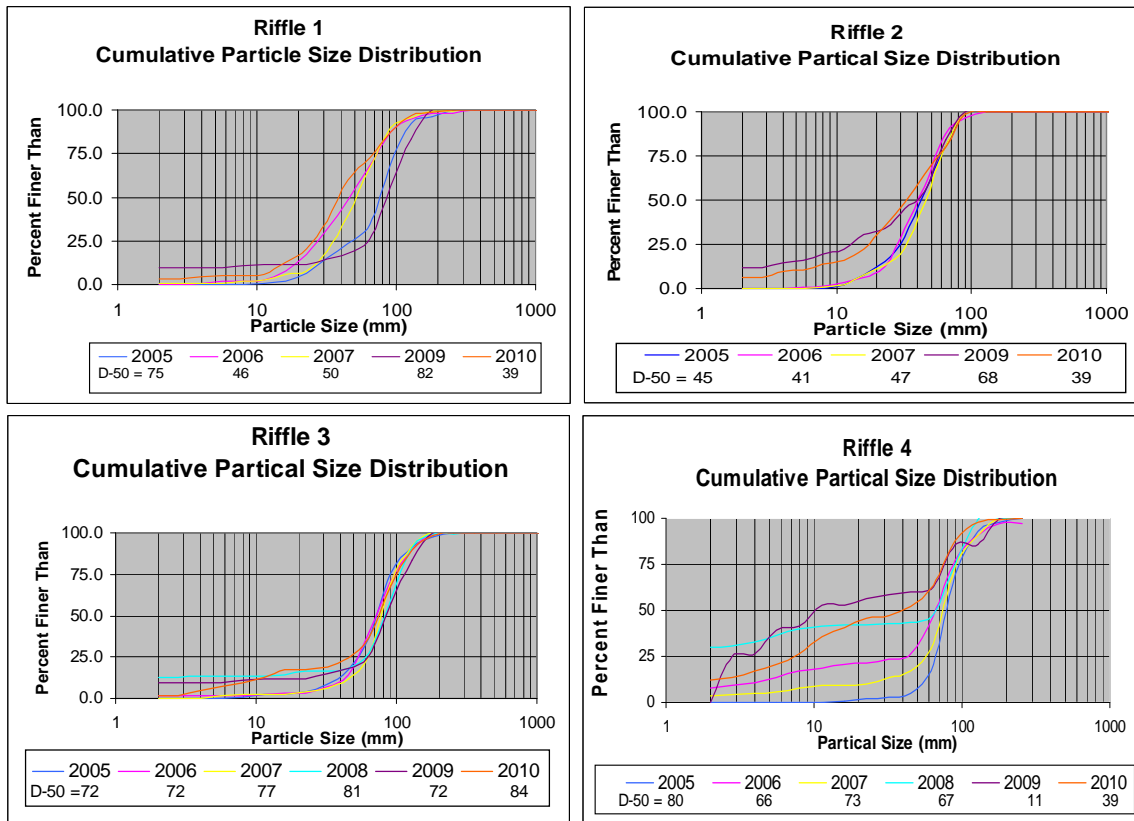
Pebble count data suggest some change in substrate composition throughout the site (Figure 12). The most significant change occurred at the lowermost riffle (Riffle 4). This riffle is at the confluence with Johnson Creek. Beaver dams, downstream on the mainstem of Johnson Creek, slow stream flows allowing sediment to drop out into the riffles. The dams will continue to be monitored to determine their effects on salmonid habitat.

Figure 12: Cumulative particle size distribution for all four riffles at the Kelley Creek Confluence Project. Riffle one starts at the top of the project near the 159th street bridge and riffle four is located just upstream of the confluence with Johnson Creek.

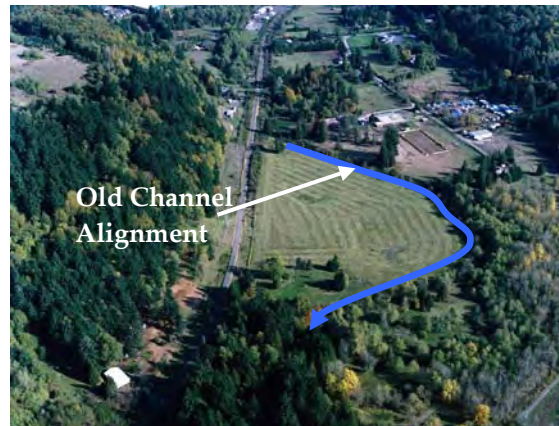
BES completed the Schweitzer Restoration Project in 2007. This 35-acre floodplain restoration project reduces localized flooding, improves water quality, and increases habitat for fish listed as threatened under the Endangered Species Act (ESA). The project created a new meandering creek channel and diverted the creek from a rock-lined, trapezoidal channel built by the WPA in the 1930's (Photo 21a).

Photo 21a: Pre-project aerial of the Schweitzer Natural Area. Johnson Creek runs along the east side of the site along the tree line.

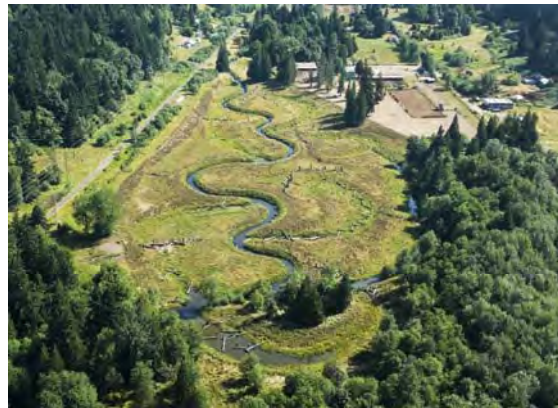
The project added about 74 acre-feet of flood storage and added backwater high-flow refuge by removing approximately 138,000 cubic yards of soil. To enhance salmonid spawning, rearing, and refuge habitat, several tons of gravel and cobble were imported in the re-meandered channel and about 500 pieces of large wood were installed within the channel and surrounding floodplain. The site was planted with over 15,000 trees, 25,000 shrubs, 7,900 wetland plants, and 890 pounds of grass and wildflower seed were planted to establish riparian, wetland, and upland vegetation (Photo 21b).

Photo 21b: The Schweitzer Natural Area. Johnson Creek now meanders through the site mimicking a more natural system. Backwater channels provide high-flow refuge.

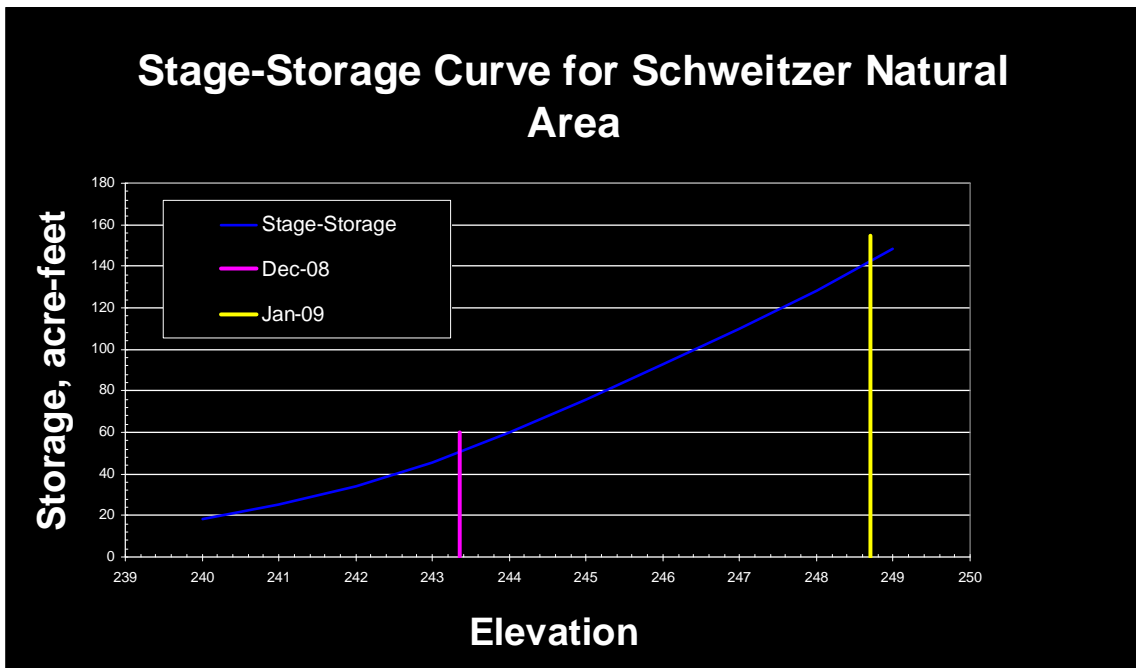
One staff gage and two crest gages were installed in a backwater channel to monitor high-flow events to determine flood storage at each event higher than 690cfs at the USGS sycamore gage. In December 2008, with the USGS Sycamore gage at 754 cfs, the floodwater at the crest gage read 3.35 ft. According to the flood stage-storage curve, created by project design engineers, this site provided approximately 50-acre ft of flood storage during this event (Figure 13). The site provided approximately 140-acre feet of flood storage during the January 2009 event. This event was calculated to have approximately a 29-year rate of return (Photo 22).

Figure 13: Flood Storage curve created for the Schweitzer Natural Area shows flood storage in acre-feet for two different high-flow events.

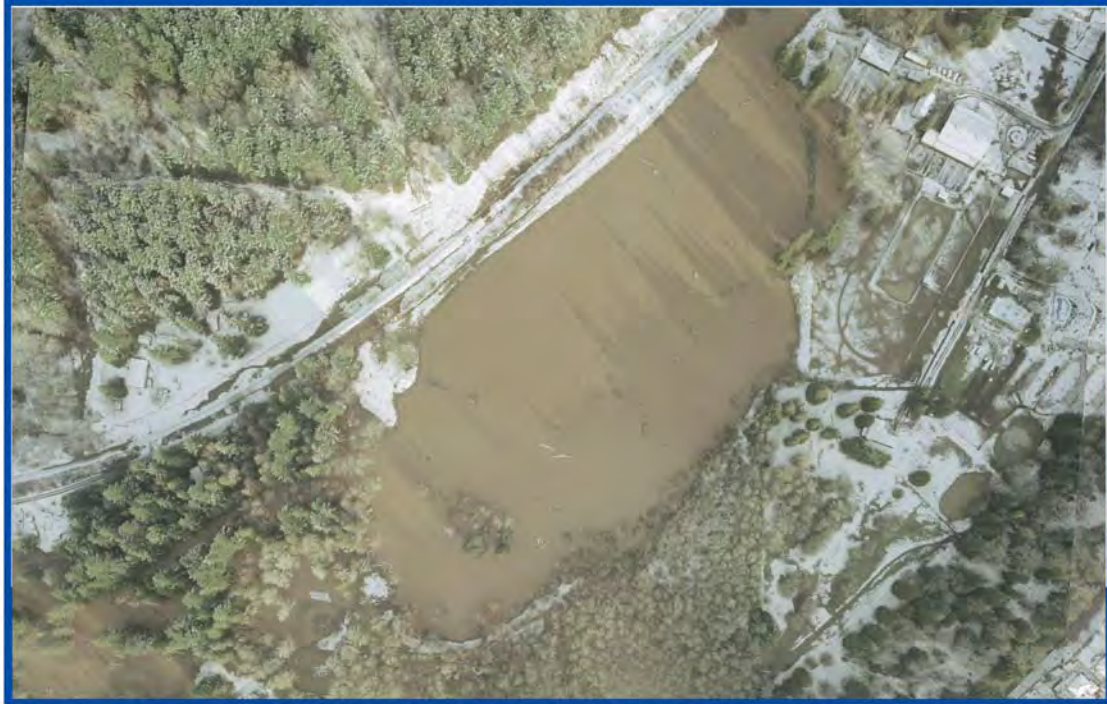
Photo 22: Aerial photo of the Schweitzer Natural Area during the January 2009 – 29-yr flood.

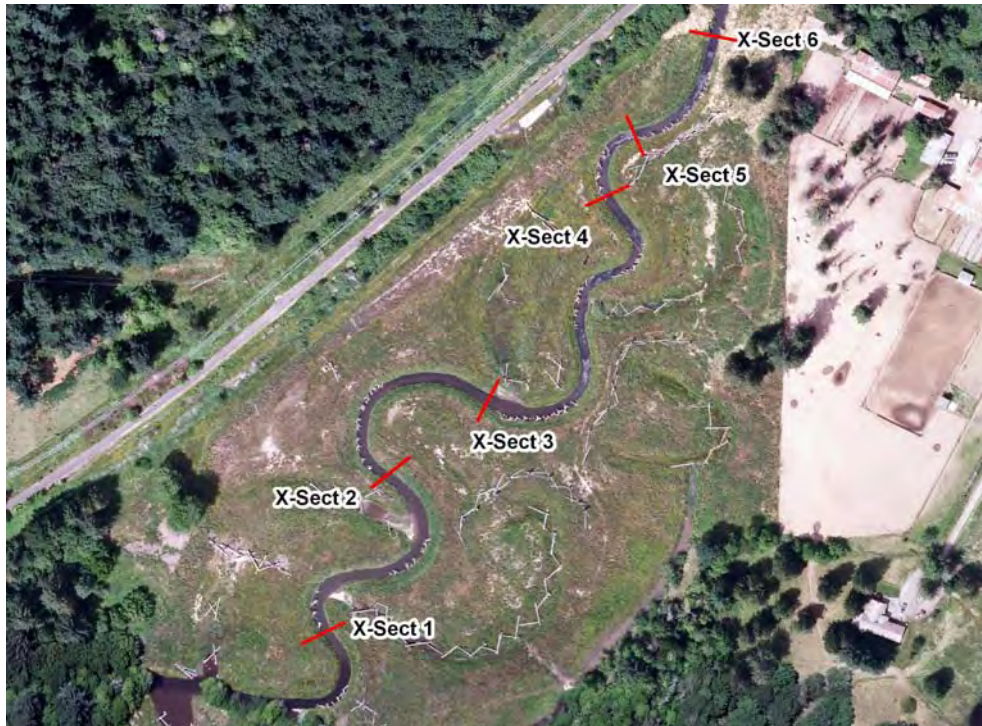
Cross-sectional surveys have been conducted annually since the project was completed in 2007 (Photo 23). Cross-sectional data shows little change within the stream channel. Some sediment deposition occurred on portions of the banks in the middle of the project area. In 2008, scouring was noted beyond the top of bank on the south side of the channel at cross-section 5. This scour is occurring around the large wood structures on the floodplain. The cross-sectional survey area was extended to include this portion of the floodplain to monitor any increase in scour. Cross-sectional data shows scour is slowly increasing. Further monitoring is necessary to determine if adaptive management measures are required (Figure 14).

Photo 23: Location of cross-sectional surveys as Schweitzer Natural Area.
