Subject: Response to City of Portland BDS Site Development Checksheet dated November 5, 2019
Prologis Development at NE 158th Avenue and NE Airport Way
Portland, Oregon
File No. 3626-071-00

FIELD REPORT

Development at NE 158th Ave & NE Airport Way

FR-26

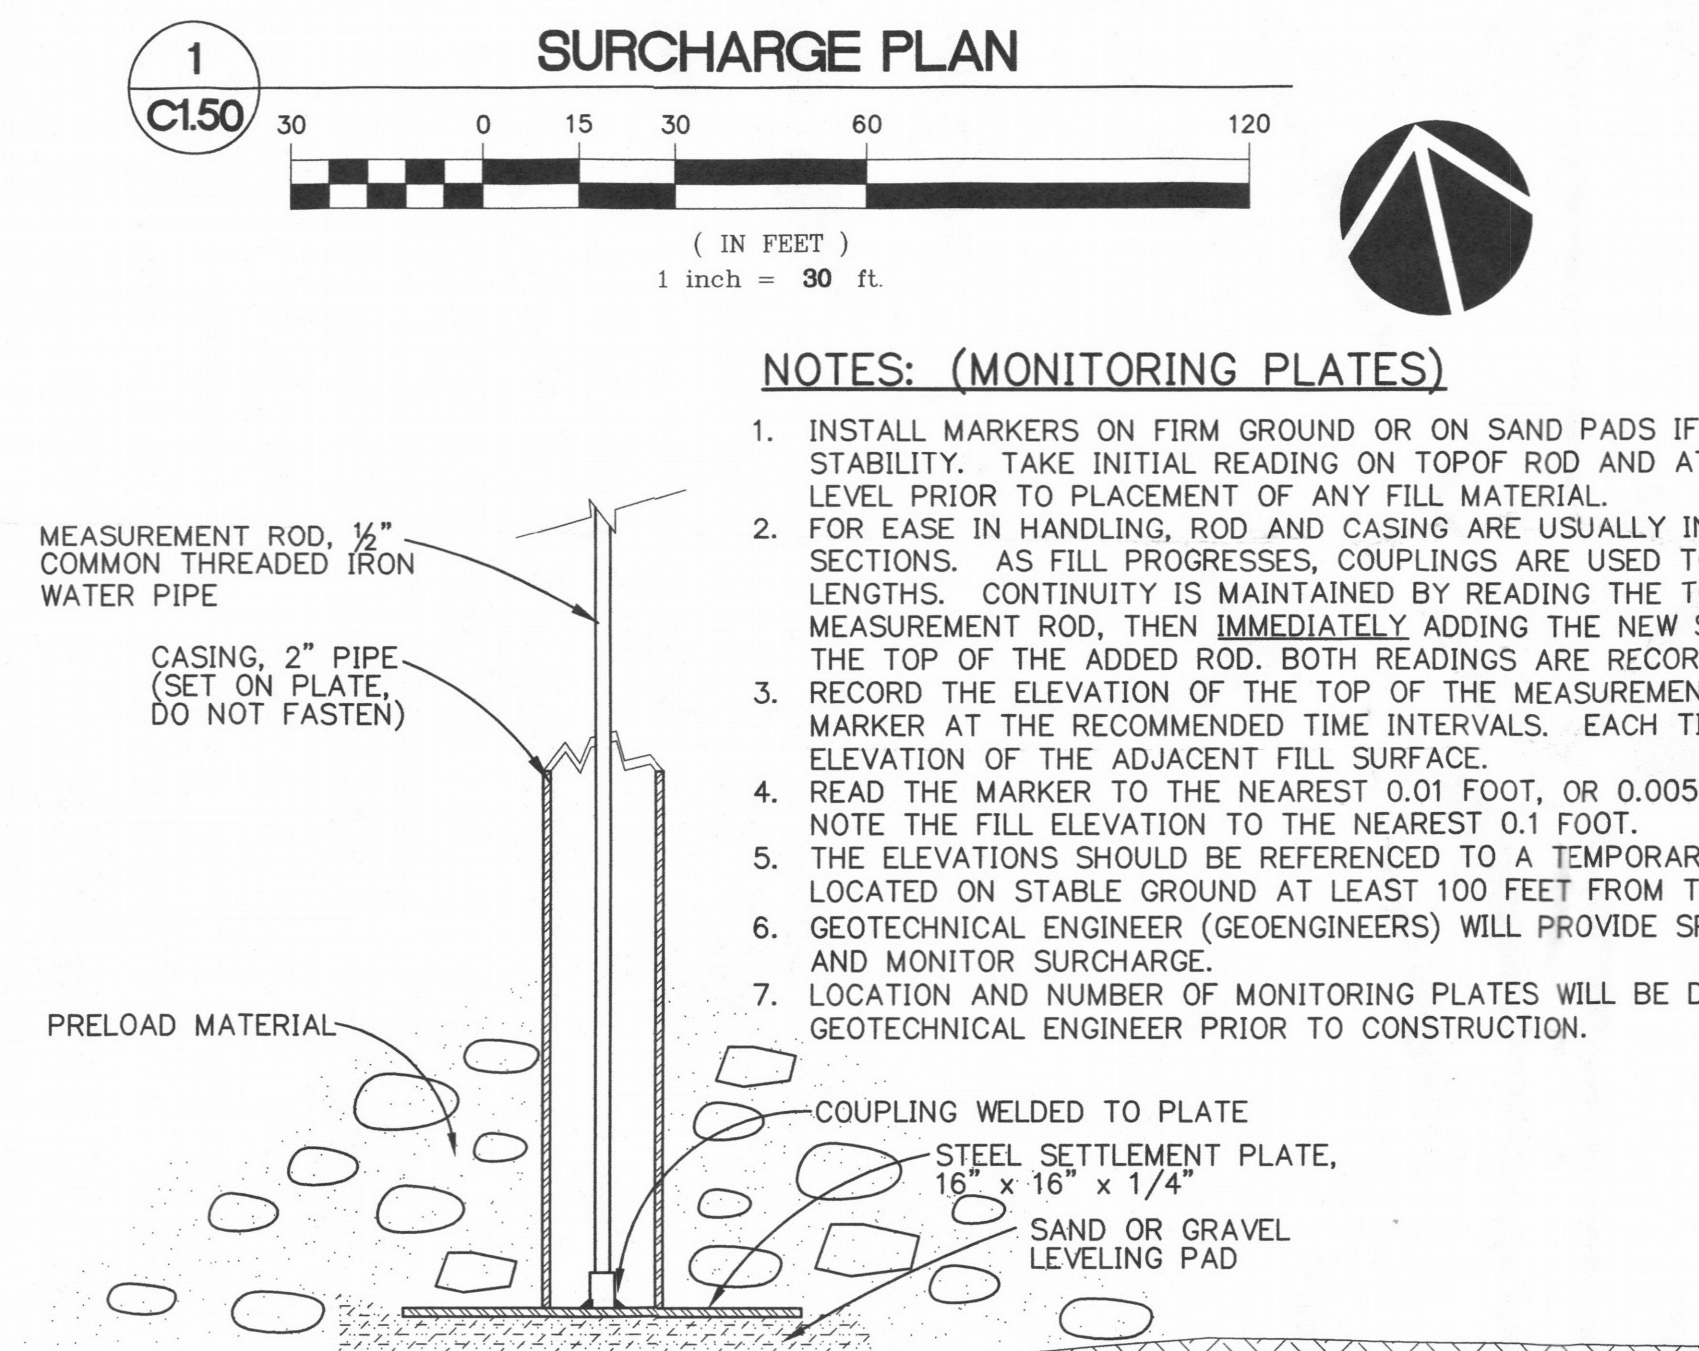
FOR REFERENCE ONLY
Figure 1
Plan check 11.8.19
PERMIT SET - 1.4.19

We understand that the proposed building at the site has been relocated approximately 16 feet west of its original location. Figure 1 presents the revised building footprint and the revised preload fill footprint constructed per our recommendations. We also completed two site visits to observe the preload fill placement within the revised building area west of the original building footprint. Our observations of the preload fill placement and evaluation are presented in the attached Field Reports 26 and 27, dated September 12 and 13, 2019, respectively. The settlement monitoring program developed and implemented for this project incorporated the revised footprint and therefore no updated preload summary letter is required.
