**Re: Emergency Declaration for a BES Sewer Repair Project**

NE 33RD AVE & NE KNOTT ST  
SEWER EMERGENCY

## E11501 NE 33<sup>rd</sup> & NE Knott Sewer Emergency Commissioner Briefing for Ordinance

| Subject: | Alternatives Evaluation and Repair Recommendations – FINAL | | |

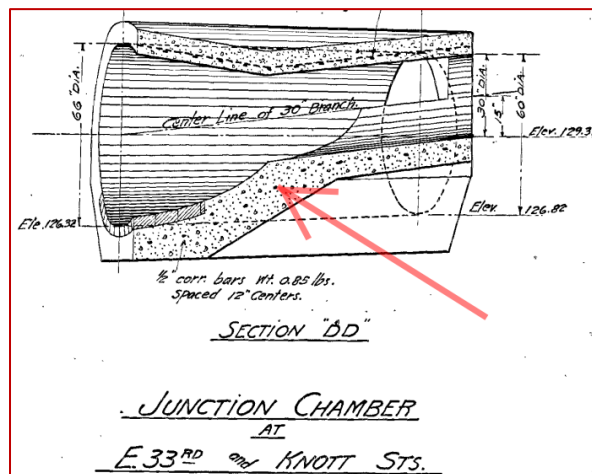
Figure 1: As-built detail from 1912

- **Existing junction chamber (AAY411):** As-built drawings dated 1912 (110 years old) showed 30" and 60" concrete pipes combining to a 66" concrete pipe. At the junction, the 30" invert is about 2.5 feet above the 66" invert, resulting in cascading flow at the base of the junction chamber (see Figure 1). The existing junction chamber is about 25-feet below ground surface.

- **CCTV inspection video:** In late May 2022, BES inspected the 30" sewer from AAY400 to the junction chamber and the 66" sewer from ABD159 to the junction chamber. The CCTV videos showed severe deterioration in the invert of the 30" sewer and at the base of the junction chamber where flow cascaded. The bricks and concrete invert appeared to be missing at both locations (see Photos 3 and 4). The first sinkhole developed directly above.

Based on the above, it is McMillen Jacobs' opinion that the root cause of the sinkholes in the middle of NE 33<sup>rd</sup> Ave at NE Knott St was the severely deteriorated invert of the junction chamber directly below. Over many years, flow from the 30" sewer dropped into the junction chamber, scouring the invert. Eventually, the invert was fully eroded and the bare soil outside the junction chamber was exposed. This allowed the fine-grained soils around the junction chamber to slowly wash into the sewer each time it rained. Soil erosion and settlement increased over time as storm water infiltration found the path of least resistance. With the second sinkhole developing about 60 feet downstream of the junction chamber, soil erosion around the outside of the existing sewer appears to have propagated both upwards and down gradient at least 60 feet from the scoured invert. It is unknown what impact, if any, that recent construction activities may have had, but suffice to say that compaction of trench backfill above the sewer exacerbated the problem and accelerated ground settlement.
