Stormwater Management Manual

Bureau of Environmental Services

Field Confirmation of Hydraulic Performance of Older Lined Green Street Facilities with the 2008 Stormwater Soil Blend

Infiltration Test Report May and June, 2017; January 2018

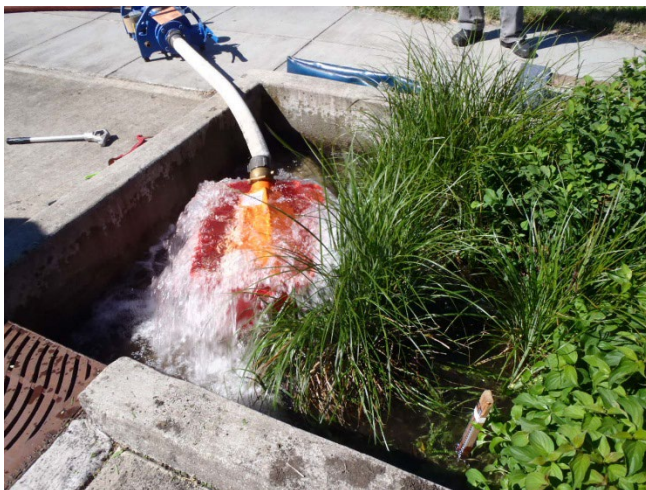
Figure 3 Diffuser in plastic recycling bin

For each drawdown test, the diffuser was placed inside the facility near the inlet in a plastic recycling bin to reduce scouring and erosion (Figure 3). Except where the available flowrate or volume of water was not adequate, the planter was filled until overflow into the bypass drain commenced. The facility on 109th
