WOODLAWN NEIGHBORHOOD DEVELOPMENT PROJECT

(PROGRAM A-5-1)

PROPERTY IDENTIFICATION

PARCEL NO. 13-2 & 3 ADDRESS 1024 N. E. Woodlawn Street

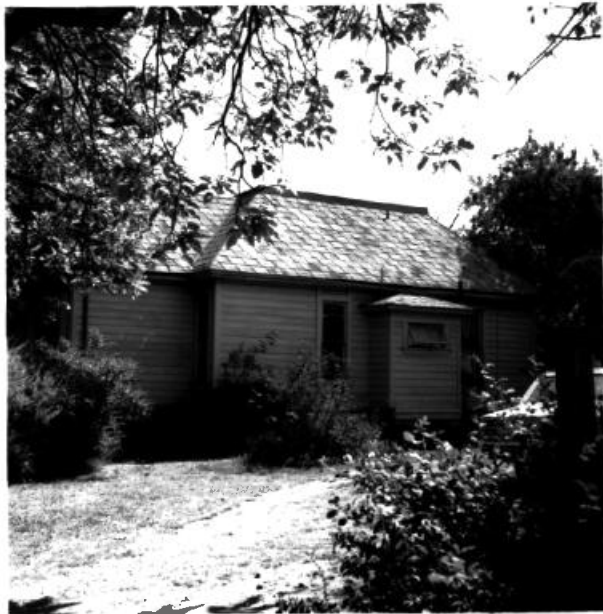
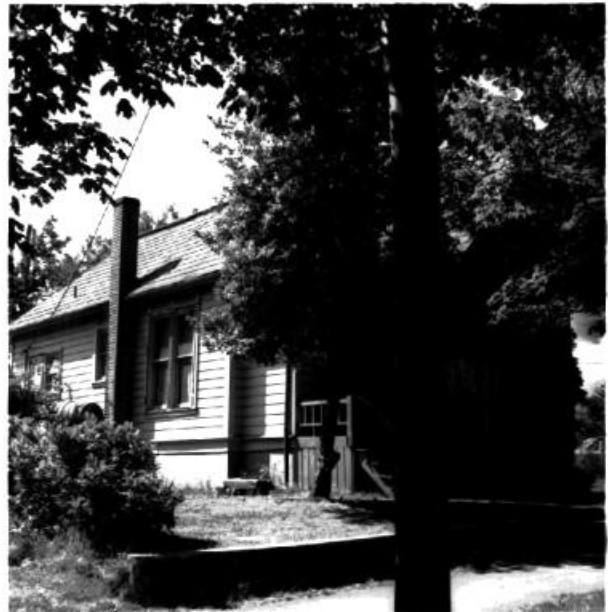
Improvements consist of a 1-story frame dwelling which was originally built in 1893 with cedar siding in fair condition; a composition roof in fair condition; gutters and downspouts in poor condition; front porch steps deteriorated; wood front porch.

The back porch is partially enclosed with plastic windows, plywood walls, fir ceilings, fir floors. The rear bedroom has the same finish; floors, walls are in poor condition. The bathroom is located between the two bedrooms and has three fixtures, linoleum floors in poor condition, a medicine chest.

The property is heated by a circulator oil heater located in the living room. There is a forced air gas fired system in the basement which is not used at this time. Access to the basement is through a porch door on the floor located in the back porch room. It has fir tread, risers, no handrail. The property has brick foundation walls, dirt floors. There is an automatic electric hot water heater; a 75% basement. There is much evidence of dry rot.
