## WASHINGTON PARK HISTORY AND SIGNIFICANCE

The work is divided into two phases: Phase A – Mount Tabor Park, and Phase B – Washington Park. This RHSR pertains only to Phase B– Washington Park Reservoirs Historic Structures, and analyzes the condition of historic features as identified in the Washington Park Reservoirs Historic District (January 15, 2004). Buildings, structures, and objects included in this analysis are:

CITY OF PORTLAND  
WATER BUREAU  
Washington Park

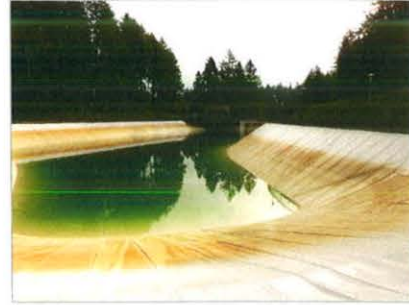
Reservoir 3 was formed by damming the drainage on the south. The resulting basin utilized a concrete lining that tied into a site wall (parapet wall) around the perimeter of the basin. A concrete stairway descends into the basin from the southeast corner by the gatehouse.

At a hydraulic grade line of 299 feet, the reservoir serves by gravity the upper portions of downtown Portland and northwest neighborhoods to approximately NW 23<sup>rd</sup> Avenue. The basin is Portland's deepest at 49 feet and is roughly 180 feet wide by 500 feet long. The construction included retrofitting of the drain tunnels. PWB is unaware of any tunnels under the reservoir, but they do know that tunnels are located on slopes adjacent to the reservoir. These systems are still in operation. The reservoir has had various waterproofing systems over time to resolve leak issues. The current flexible hypalon membrane was installed in 2003.

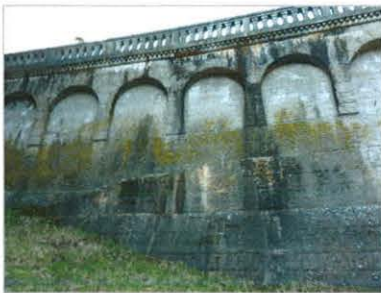
A stainless steel pipe framework descending from the dam and gatehouse walls into the reservoir is intact. The structure was installed in 2003 to allow a previously proposed reservoir cover to be pulled back for basin maintenance.

The gently radiused, 175 foot long dam has a base of approximately 40 feet that narrows at the top to provide a 10 foot wide vehicle lane, with narrow walks and guard walls on each side (discussion of these walls is included under Basin Wall Assembly). The earthen dam is concrete faced on both sides. On the dry side, the design employs a rusticated block pattern from the base upward. The top section uses the design of a blind arcade of embossed stone pattern to give the appearance of a classic viaduct. This is achieved by forming the arched structure portion (arches at 10 foot centers) and roadway walls vertically, while the lower wall continues up and into the arches maintaining its slope. The roadway asphalt is overlaid on portions of the original 4-foot wide sidewalks. A portion of the walks are visible at the east end near the gate house.

There is a painted steel valve platform located west of the gatehouse on the reservoir side of the dam. It is a non-historic fabrication that has replaced the original at this location.

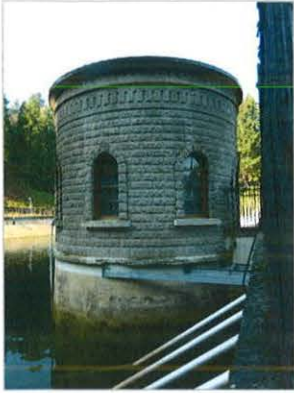
Constructed in 1894, the building is a symmetrically composed, poured in place concrete structure, circular in plan, measuring close to 25 feet in diameter. The exterior design and finish of the building are similar to the gatehouse of Reservoir 3. The exterior was formed with a rusticated block pattern with projecting water table, top banding and simplified cornice detailing. The parapet has a metal covered coping that slopes gently to the exterior (6" slope over 28"). The interior finish which shows its 6-inch board form pattern is smooth and painted. Door and window openings are round arched and have projecting quoined surrounds. The lower water facing exterior below the water table line (floor line projection) is unpatterned and coated with cement plaster. The concrete floor deck is finished with a smooth troweled topping slab and is without other finishes. There are multiple Ransome floor lights and their patent marks.

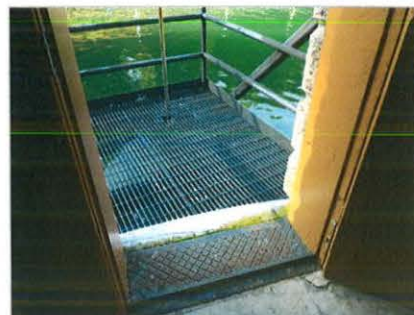
## Doors

There is a single entry with inswinging paired doors at the top of three exterior concrete steps on the east side. The doors are flush steel 1987 replacements with a hollow steel frame. The original wood jambs have been cut off at the transom line. The arched transom and fan light remain as does the cast iron sill. Similar to Gatehouse 3, the transom has an exterior plexiglass storm window. The reservoir side door is a single wood 4 panel stile and rail painted door (historic, but not original) with original wood frame and no transom. It has black finished mortise latch, replacement hinges, and the original cast iron threshold.

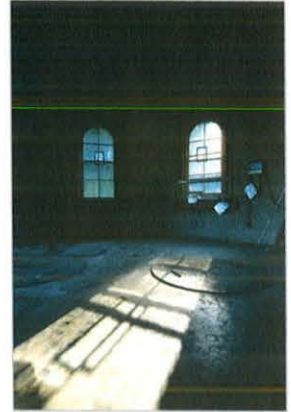
## Interior Space

The interior retains most of the original wheeled valves, water level measurement and mechanical equipment that is intact and operable, though mostly no longer used due to replacement equipment. In addition, there is new security equipment. The overhead trolley is intact. An iron stairway descends clockwise along the west curved wall to the lower level. The treads have been overlaid with expanded metal or straight bars for better traction, but otherwise the assembly is in original condition. It is enclosed with an iron pipe railing. The stairway is similar to the stairway at Gatehouse 3.
