# BORA

LINCOLN HIGH SCHOOL MODERNIZATION  
DESIGN ADVISE REQUEST  
JULY 26, 2018

PROJECT OVERVIEW  
PUBLIC ENGAGEMENT PROCESS  
PROGRAM  
SITE  
EVALUATION CRITERIA  
OPTIONS CONSIDERED  
PROPOSED DIRECTION

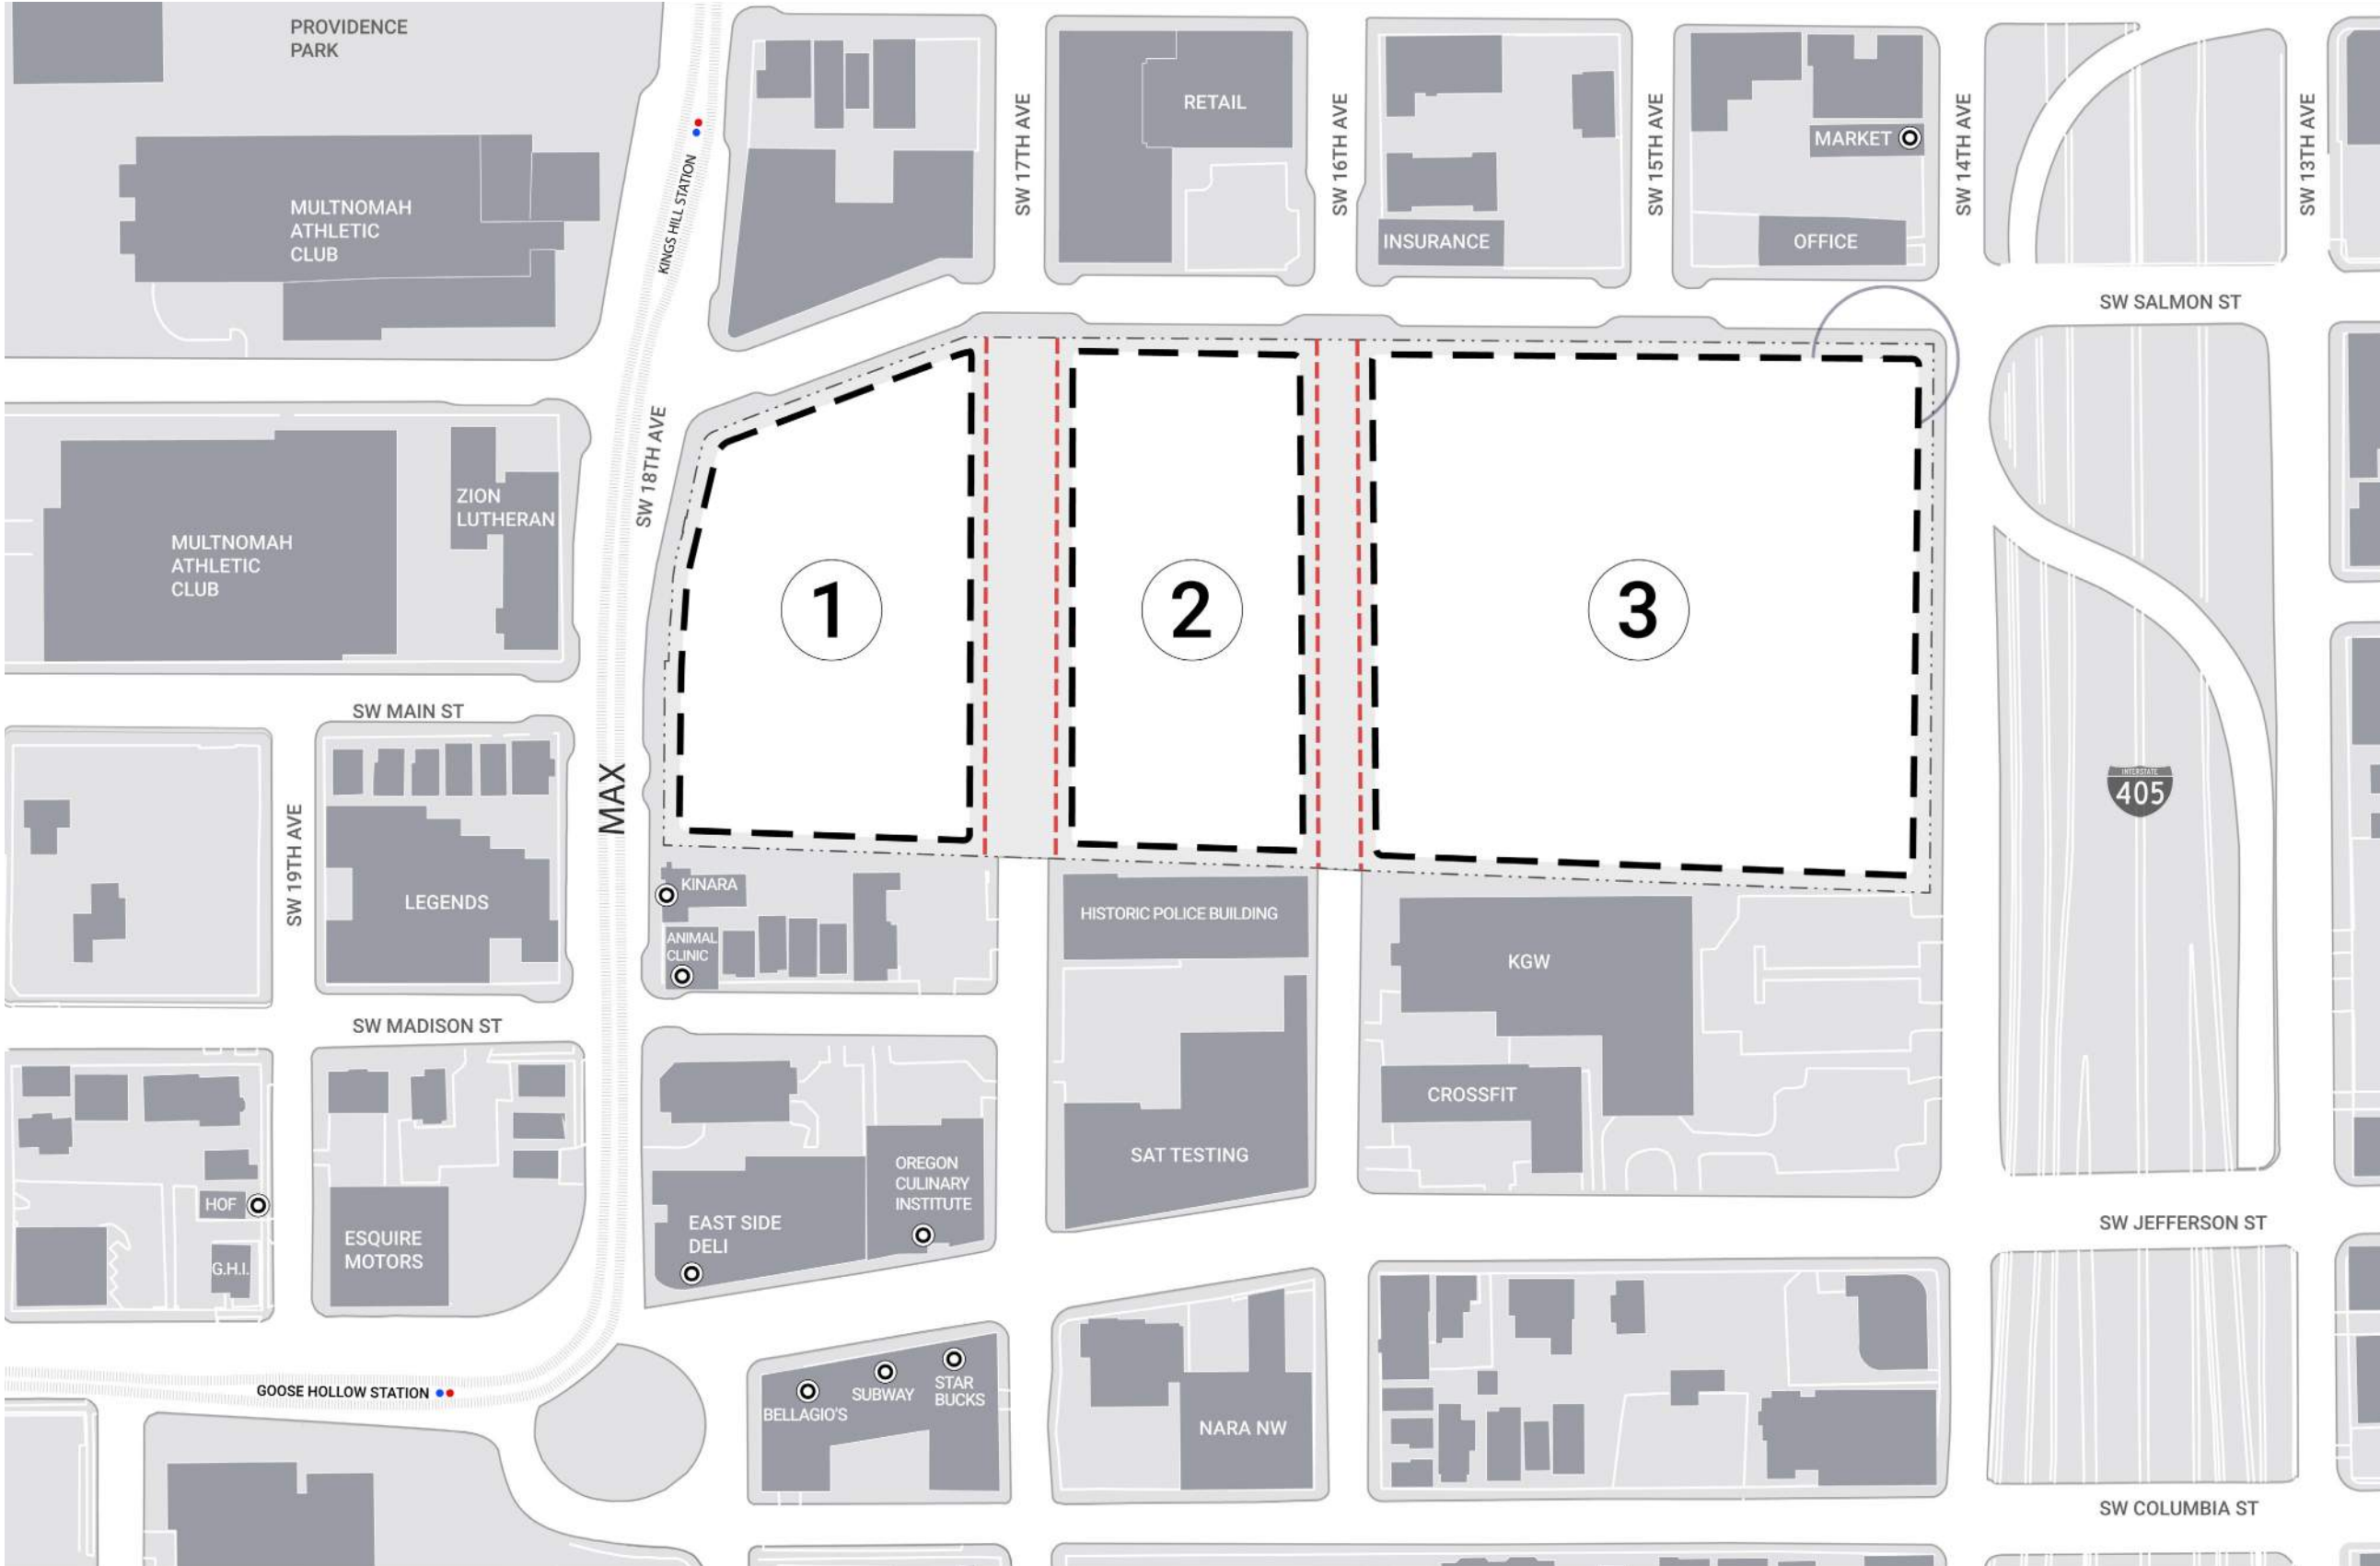
BUILDING LOCATION OPTIONS  
LINCOLN HIGH SCHOOL MODERNIZATION

BUILDING LOCATION CRITERIA	1	2	3
Allows Continuous Operation of Lincoln High School	✓	✓	X
Allows Space for Track & Field	✓	X	✓
Accommodates Building Program	✓	✓	✓
Accommodates Pedestrian Connectivity Through Site	✓	✓	✓

Option 1 is the only option that allows for continuous Lincoln High School operations during construction and accommodates the required Track & Field.

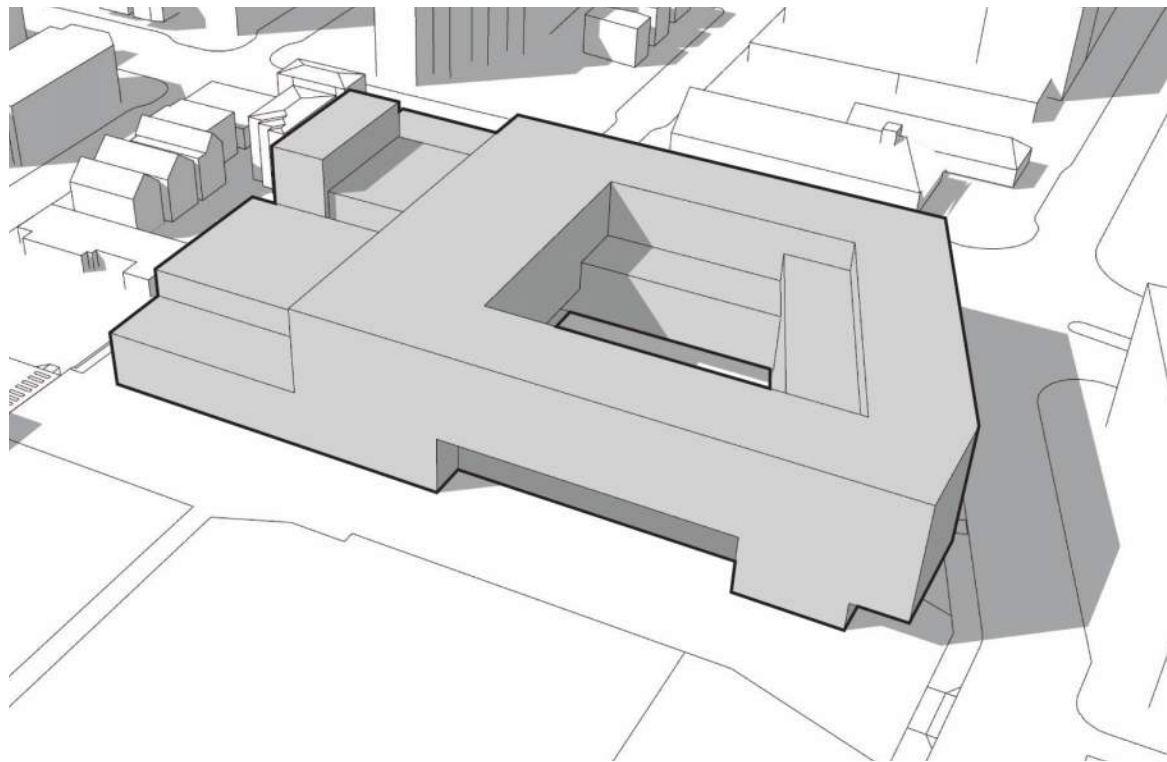
HORIZONTAL ORGANIZATION

ORGANIZATION CRITERIA	HORIZONTAL	VERTICAL
Accommodates Building Program	✓	✓
Minimizes Structural Transfers	X	✓
Minimizes Acoustical Transfers	X	✓
Provides Varied Massing and Profile	X	✓
Provides Daylight and Views to all Program Spaces	✓-	✓

- Horizontal Option requires placement of short span structure over long span assembly spaces = \$\$\$
- Horizontal Option requires costly acoustical isolation of assembly spaces
- Vertical option provides more varied building profile, Horizontal Option is more monolithic
- Horizontal Option will limit daylight and views to some program

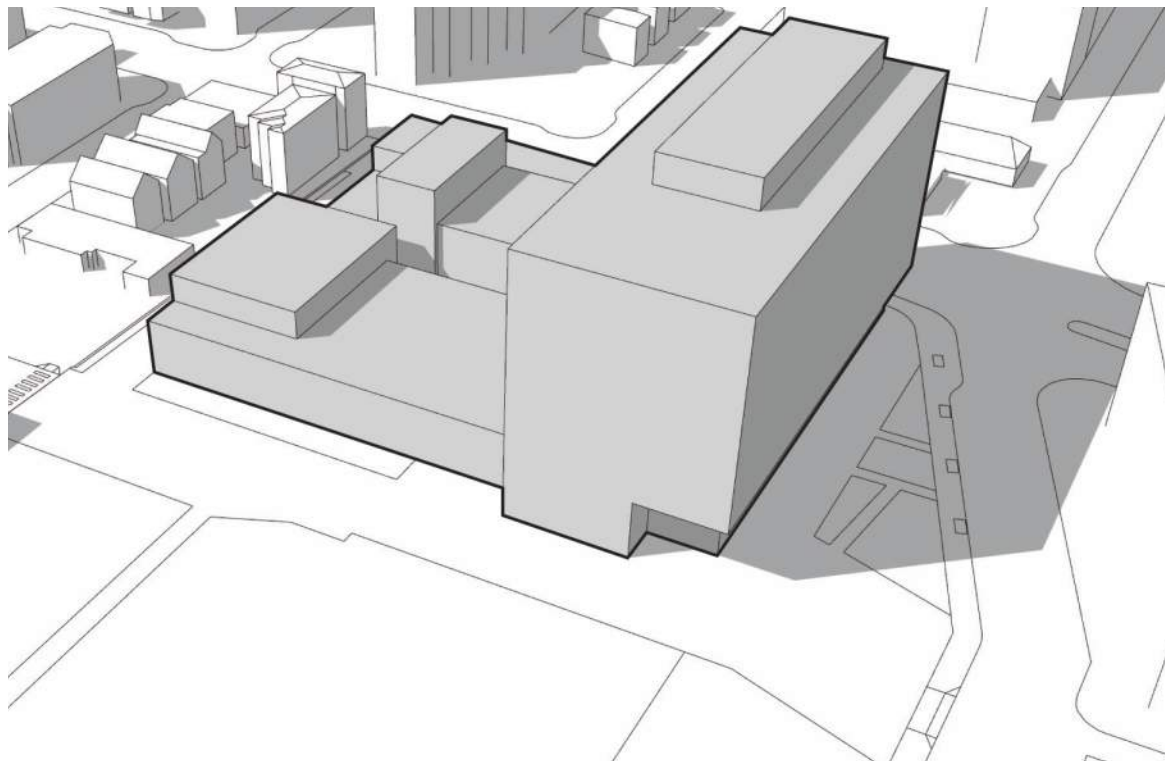
VERTICAL ORGANIZATION

Vertical Option Preferred

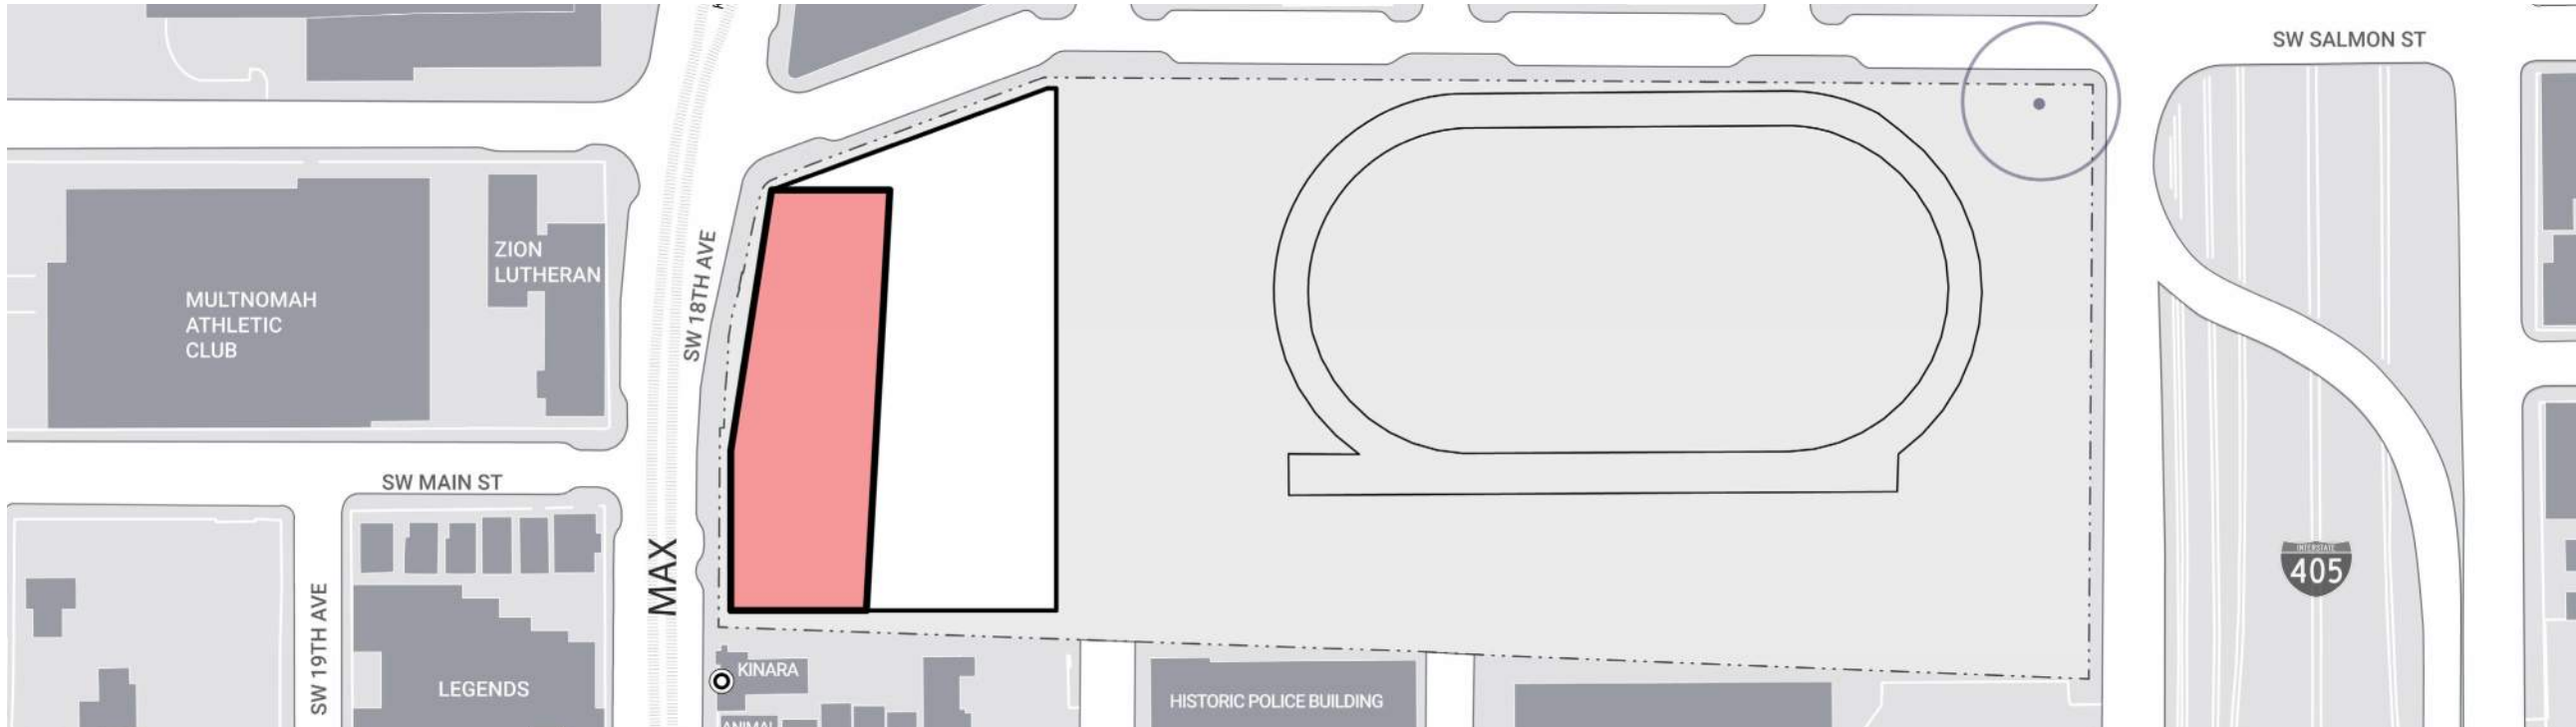
EAST/WEST FACING

VERTICAL BAR ORIENTATION CRITERIA	EAST/WEST	NORTH/SOUTH
Minimizes Glare in Instructional Spaces	X	✓
Minimum Heat Gain in Instructional Spaces	X	✓
Minimum Energy Use	X	✓
Minimum View Impact	X	✓

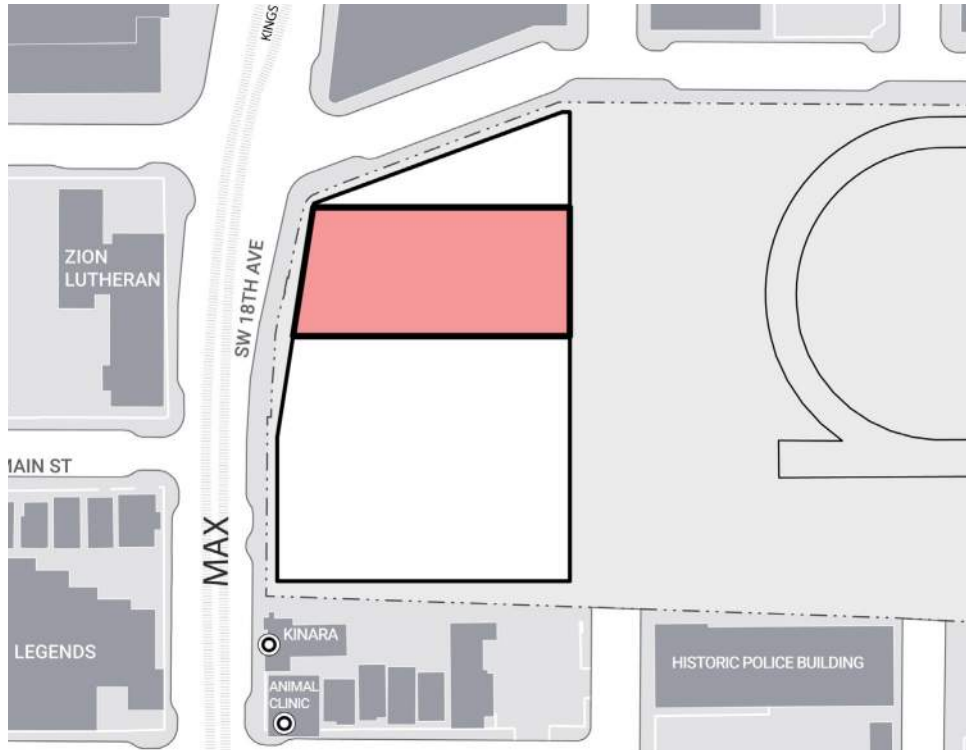
1. PERPENDICULAR TO 17th

VERTICAL BAR LOCATION CRITERIA	1	2	3	4
Accommodates Building Program	✓	✓	✓	✓
Minimizes Structural Transfers over Assembly Spaces	✓	✓	X	✓
Maximizes Adjacency of Program to Main Entry	✓	✓	X	X
Defines Street Edge/Public Realm	✓-	✓	✓	✓
Maximizes Public Uses on Ground Floor / Active Uses	X <sup>A</sup>	✓	✓-	✓-
Maximizes PPS Operational Efficiencies	X <sup>B</sup>	✓	✓-	✓-

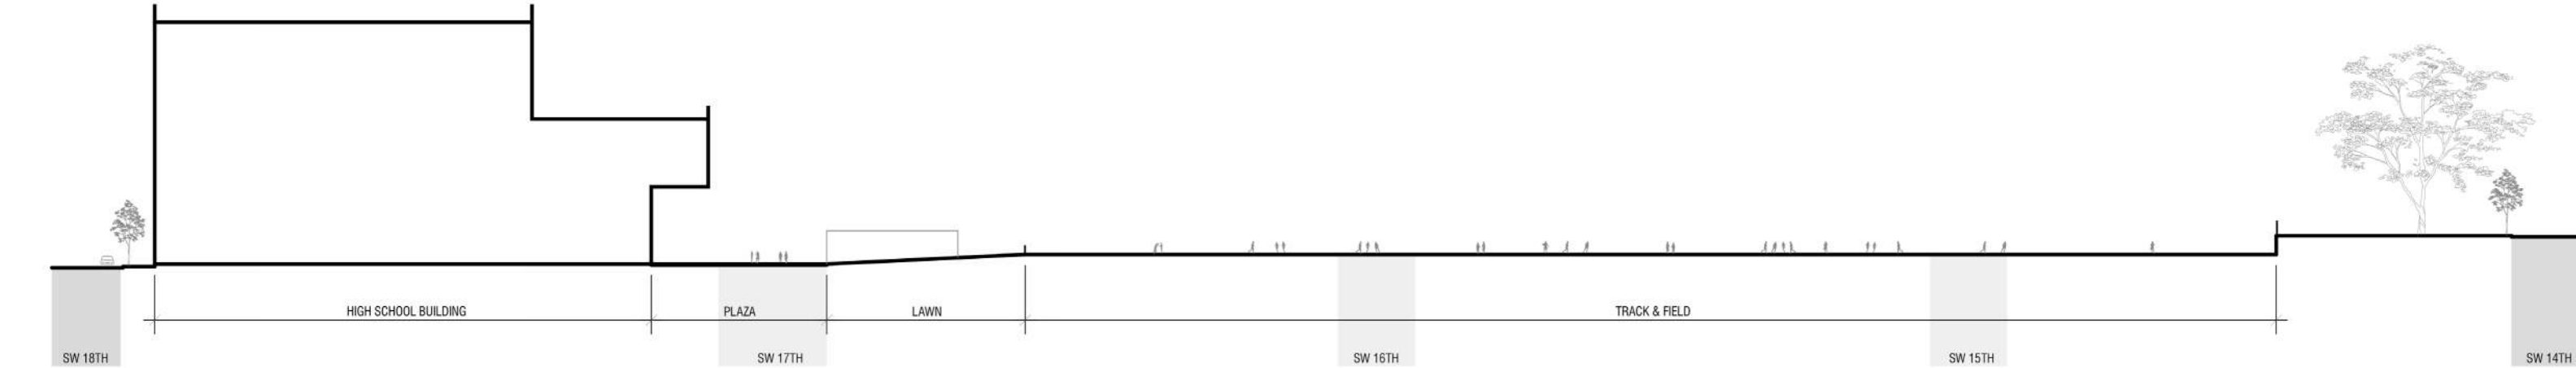
1

NEIGHBORHOOD CONNECTIVITY - SITE SECTIONS  
LINCOLN HIGH SCHOOL MODERNIZATION

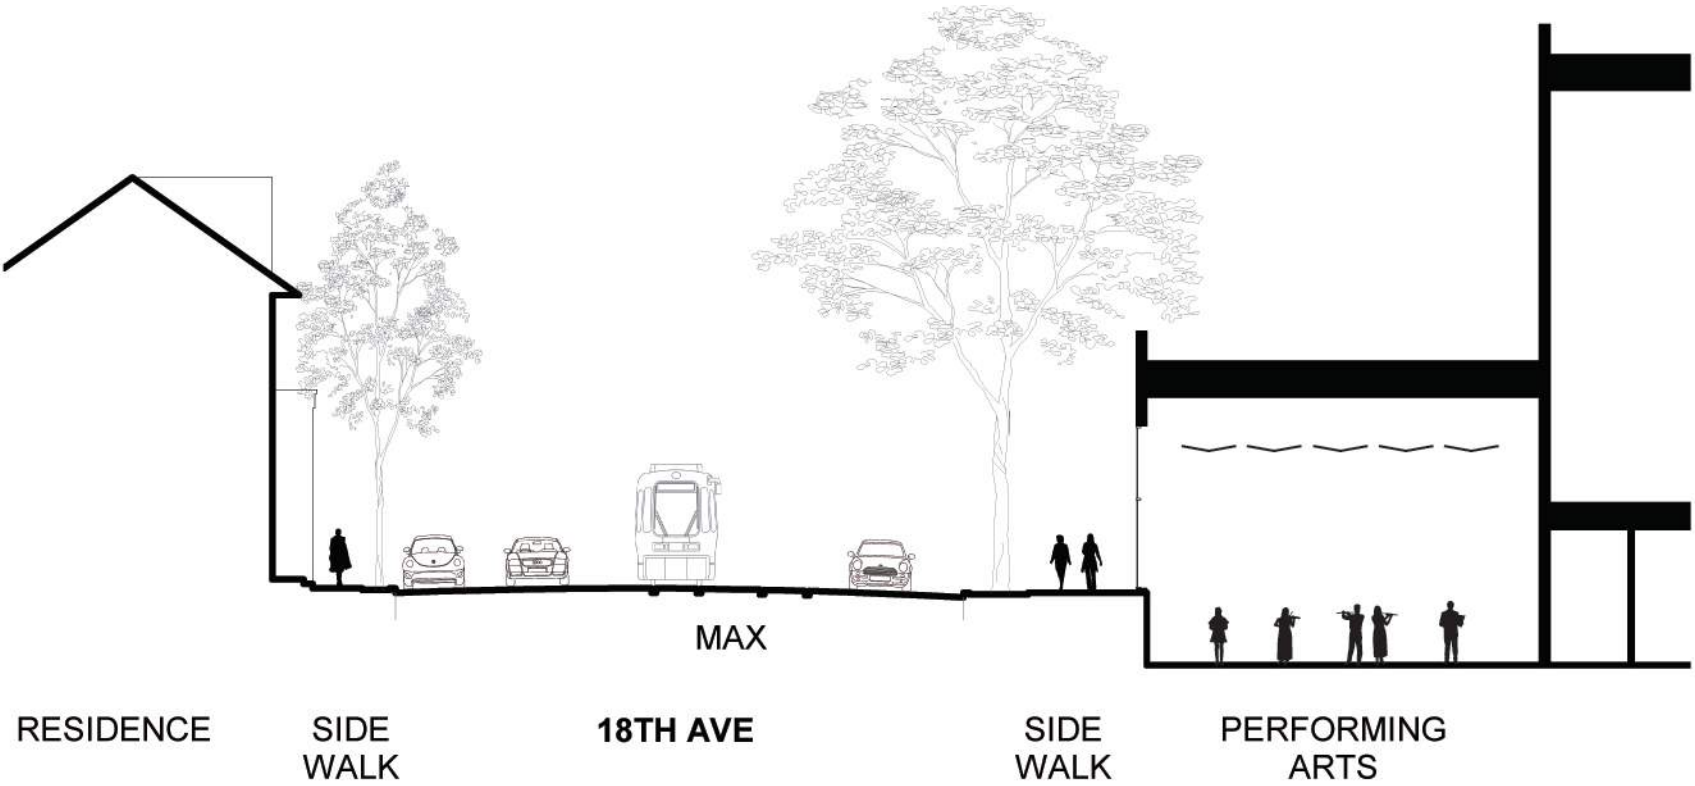
ACTIVE GROUND FLOOR - GRADE RELATIONSHIPS  
LINCOLN HIGH SCHOOL MODERNIZATION

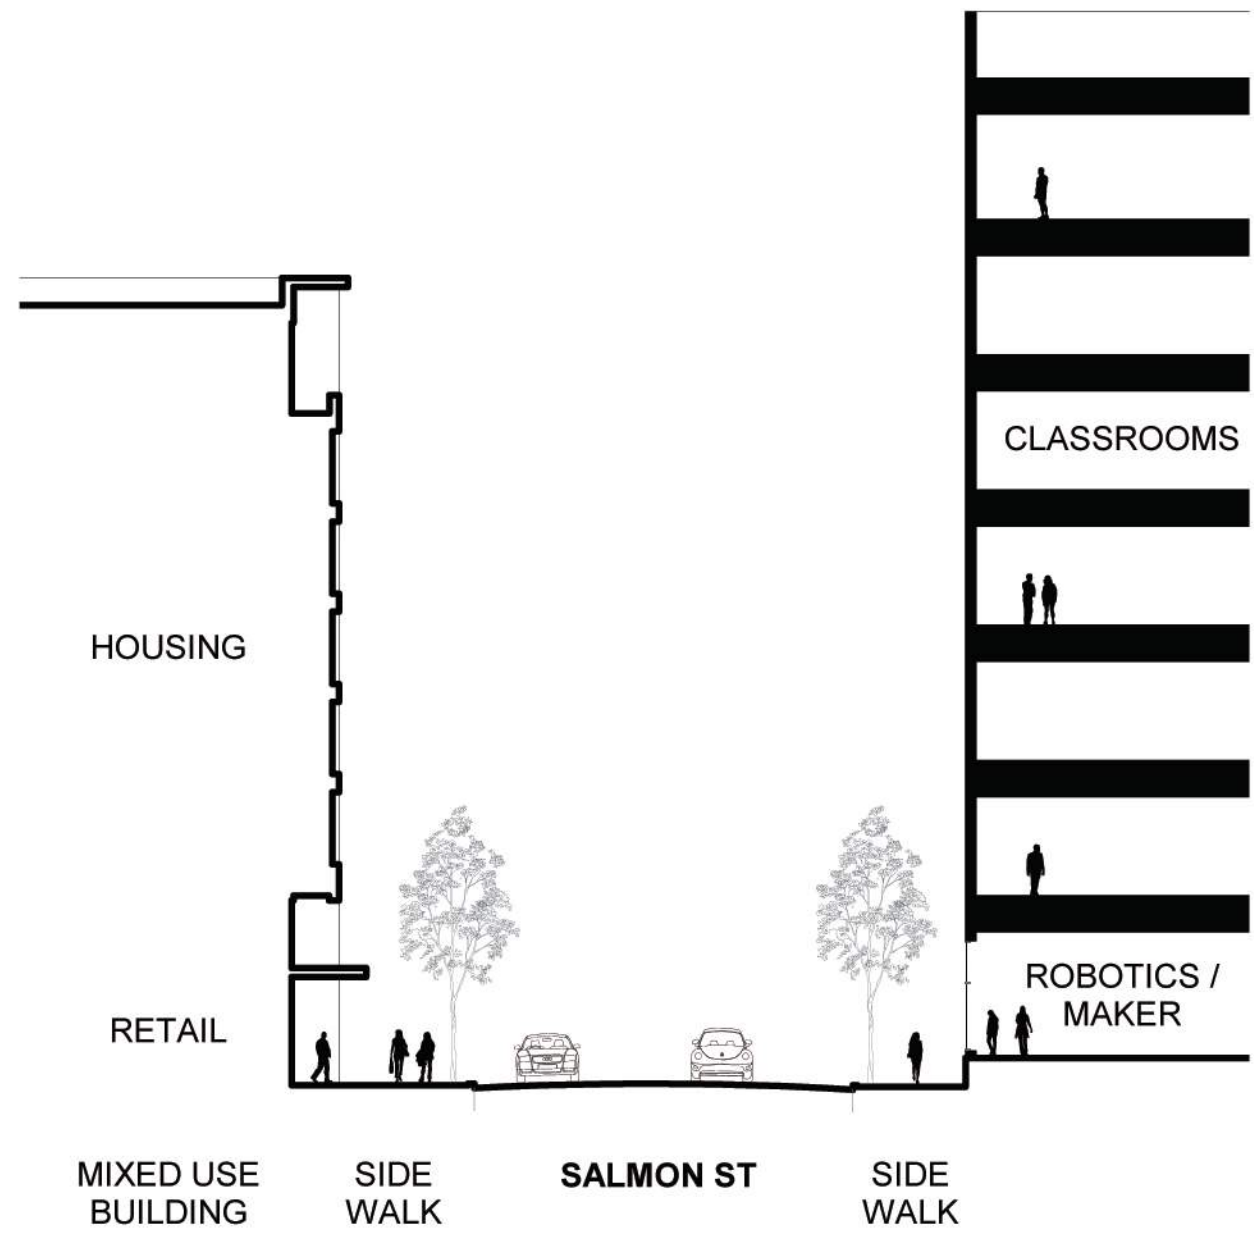
ACTIVE GROUND FLOOR - GRADE RELATIONSHIPS  
LINCOLN HIGH SCHOOL MODERNIZATION
