MASON EHRMAN BUILDING

MASON EHRMAN BUILDING ANNEX

ANALYSIS

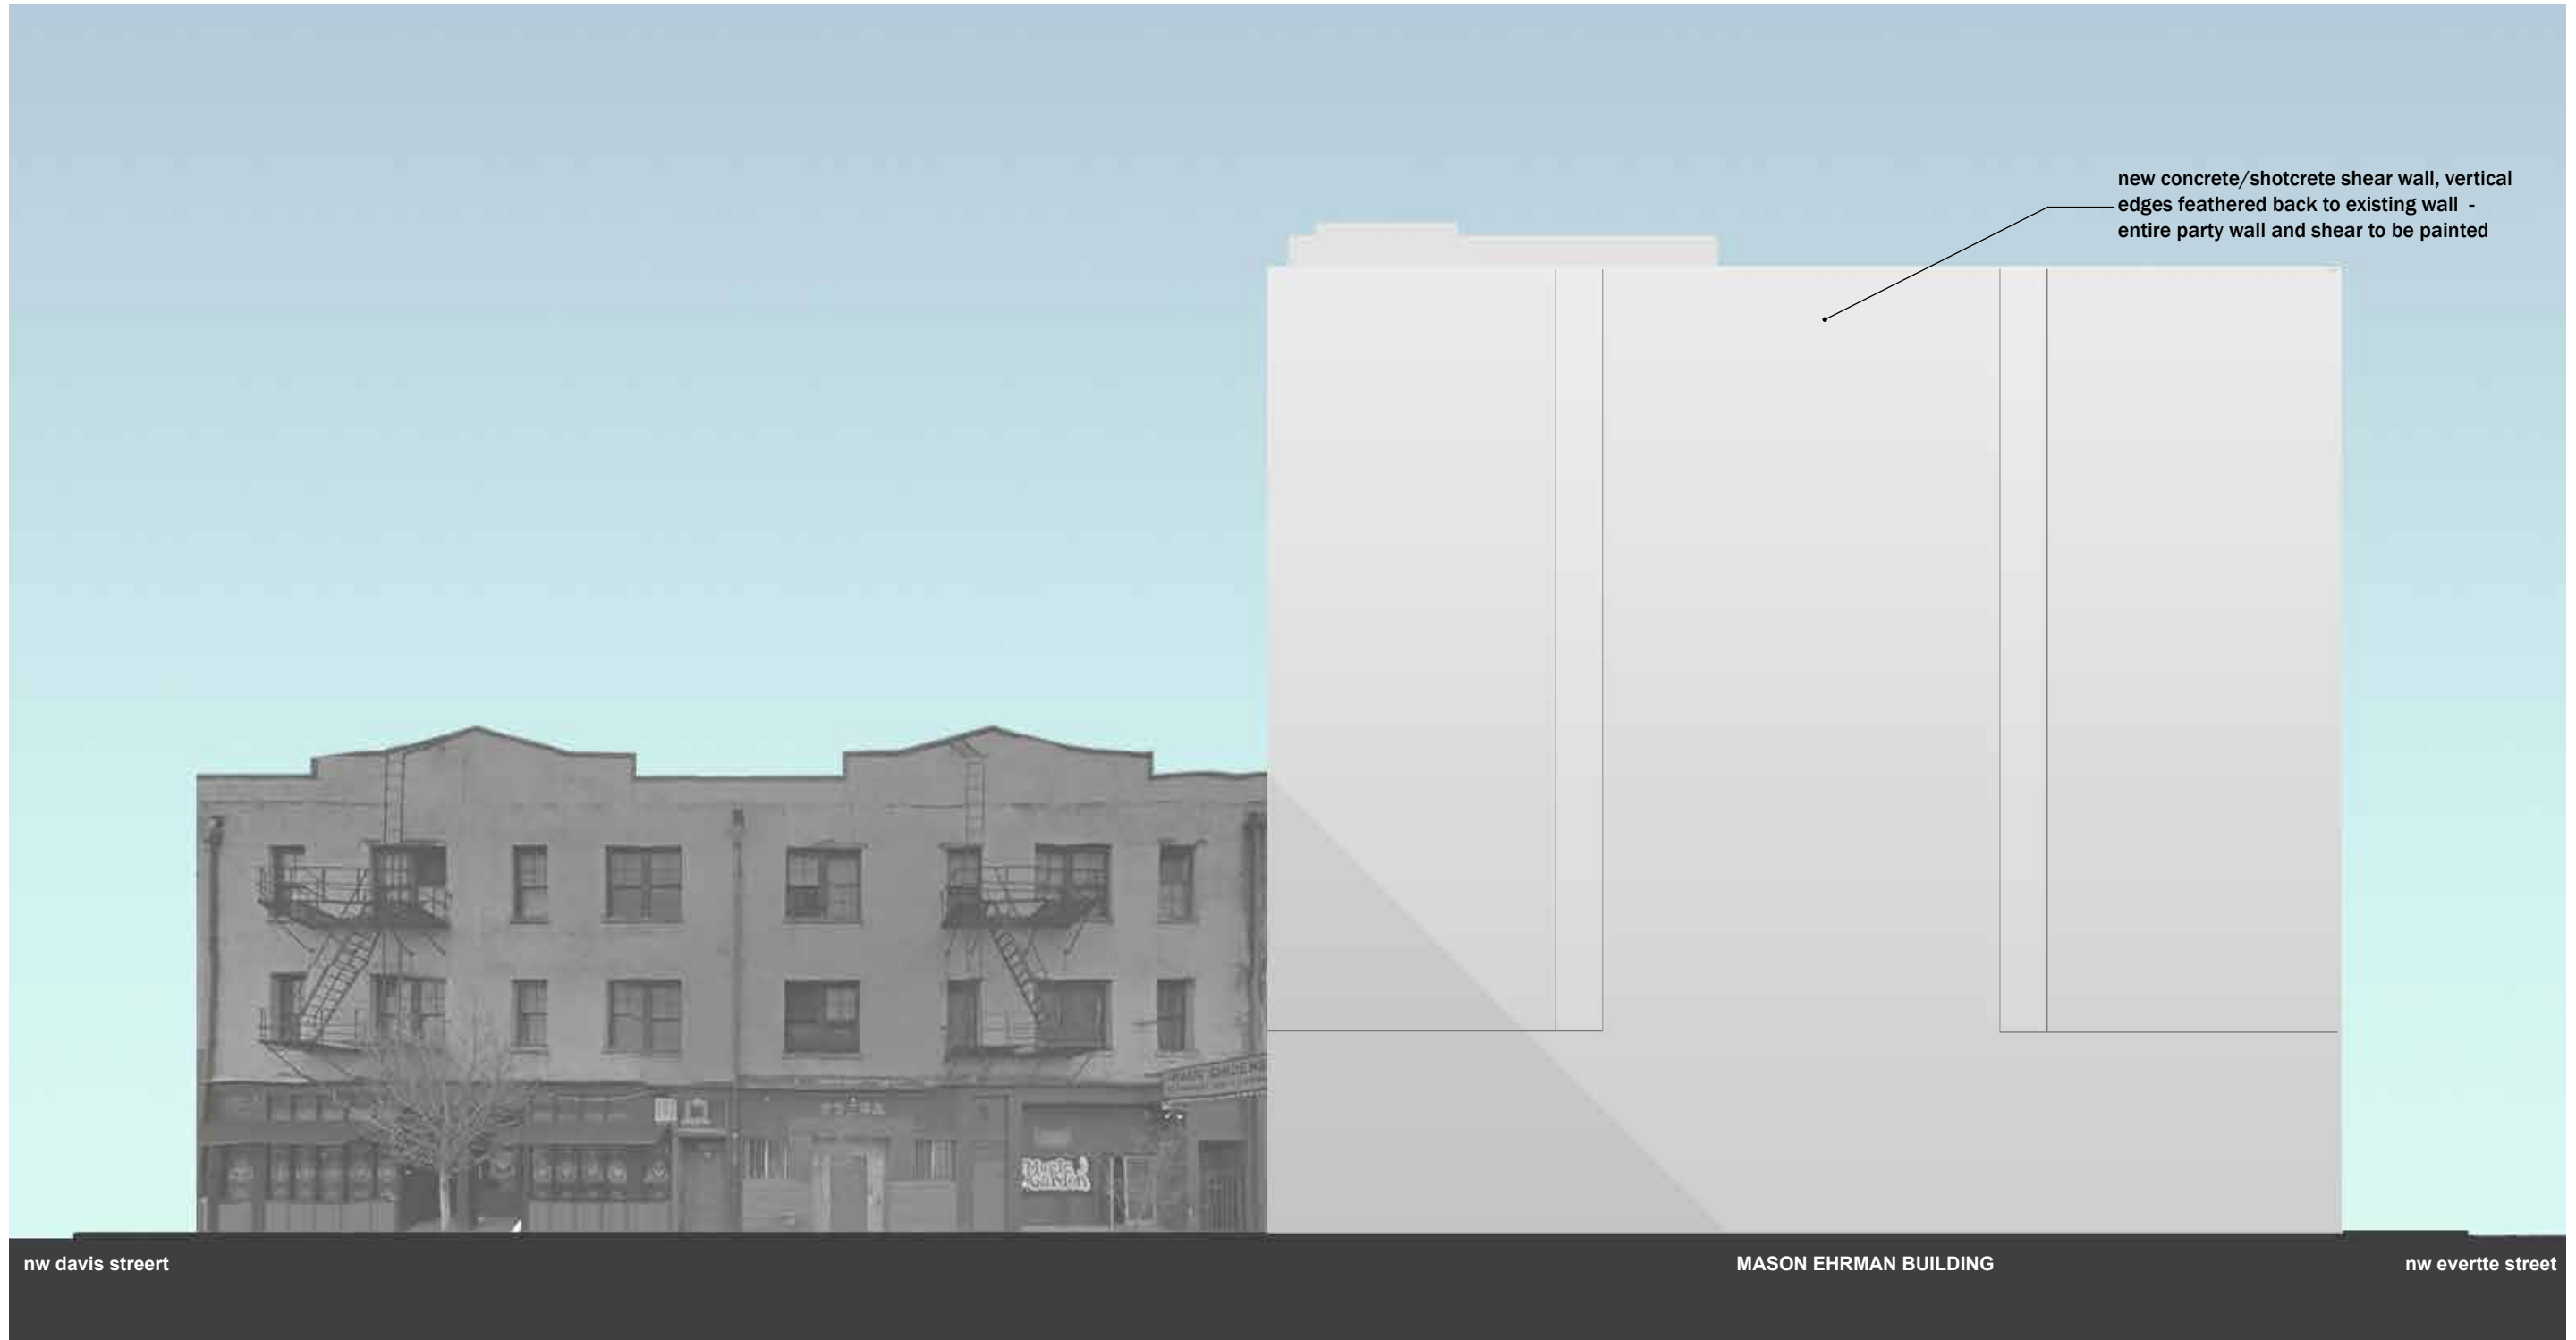
new concrete/shotcrete shear wall, vertical edges feathered back to existing wall - entire party wall and shear to be painted

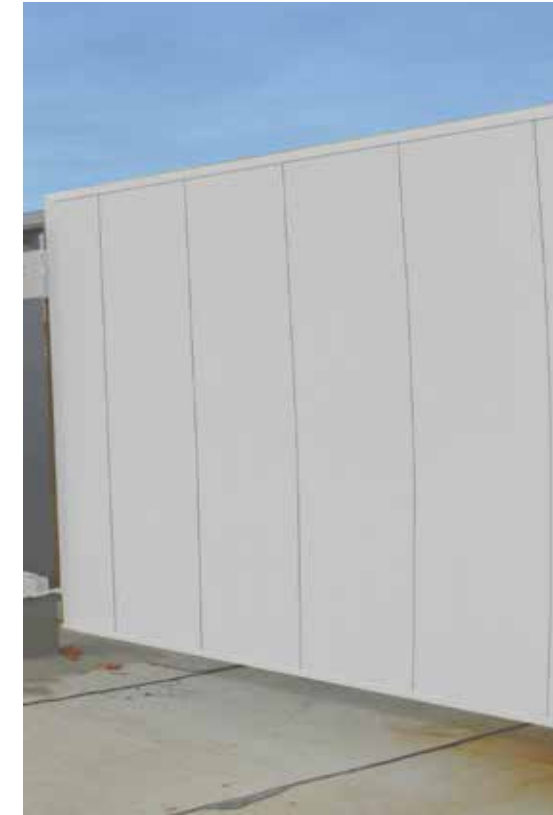
vertical seam metal panel mech screen

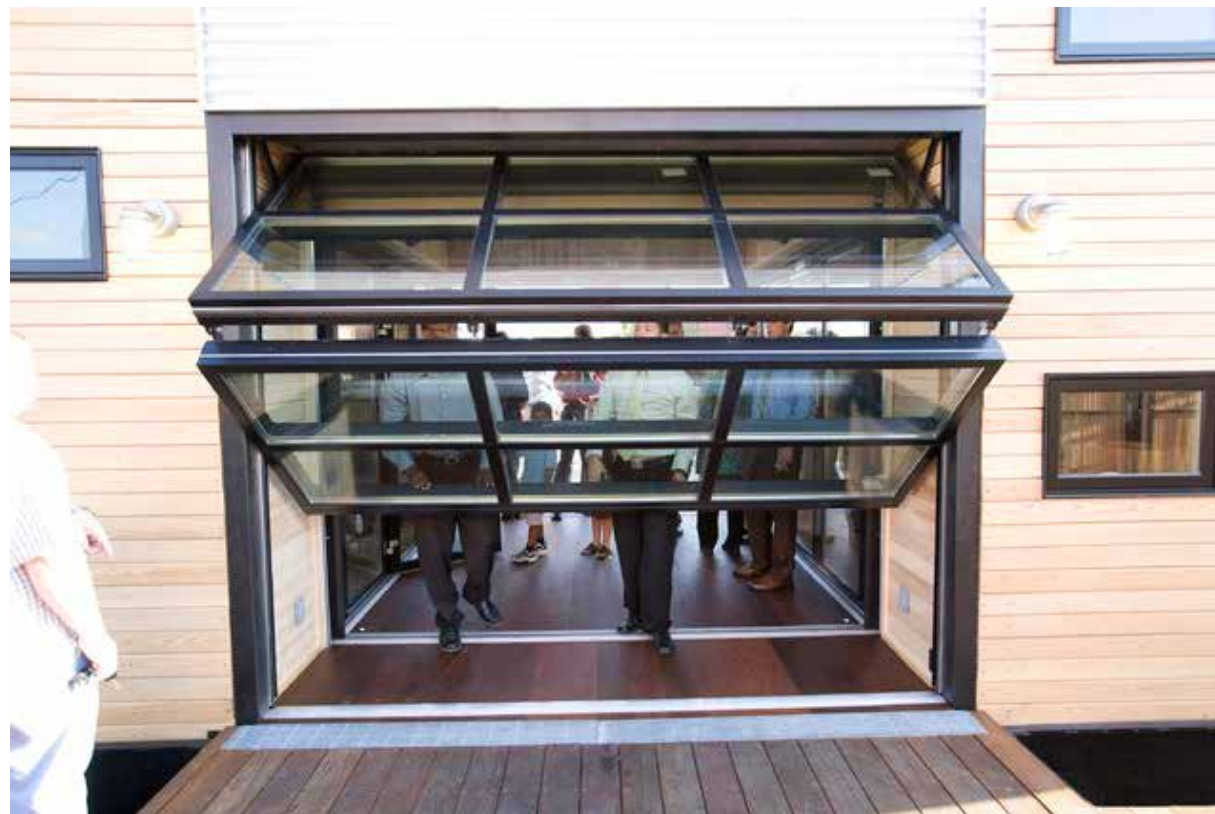
metal garage doors - fold up mechanism

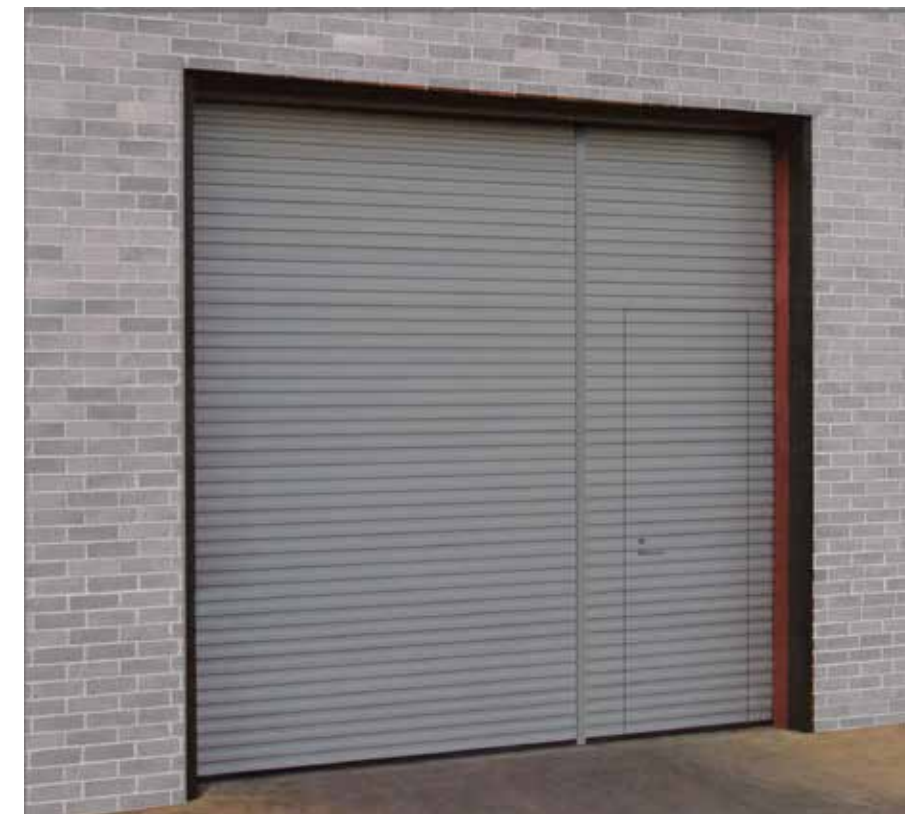
metal rollup garage door with concealed man door

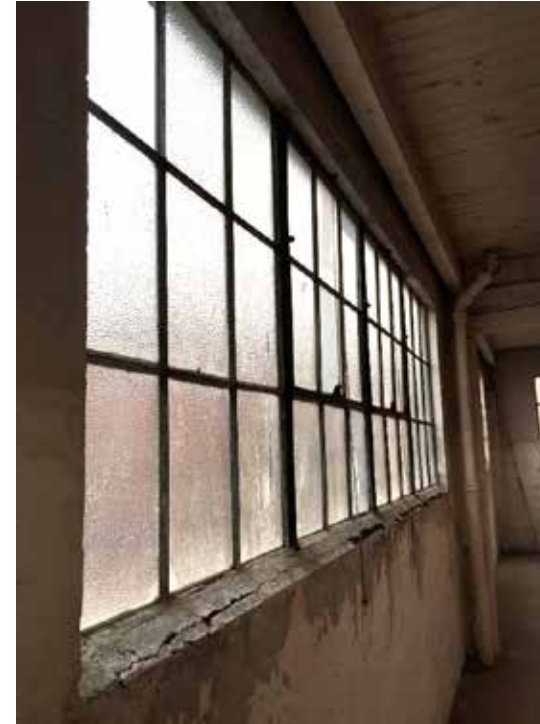
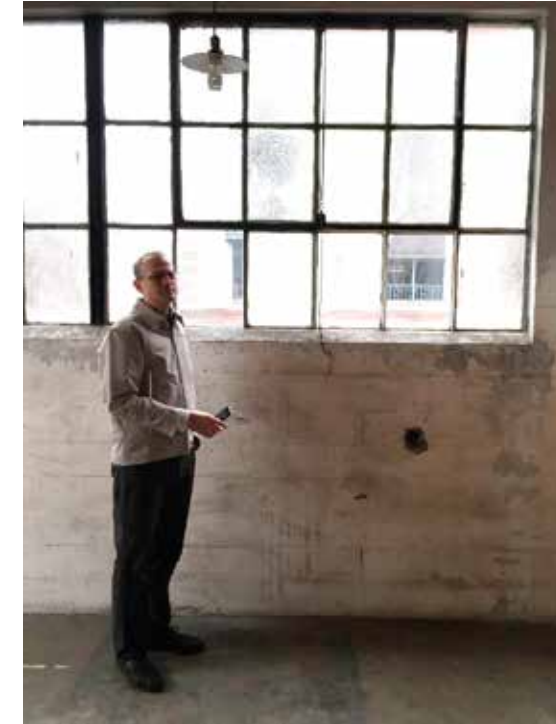
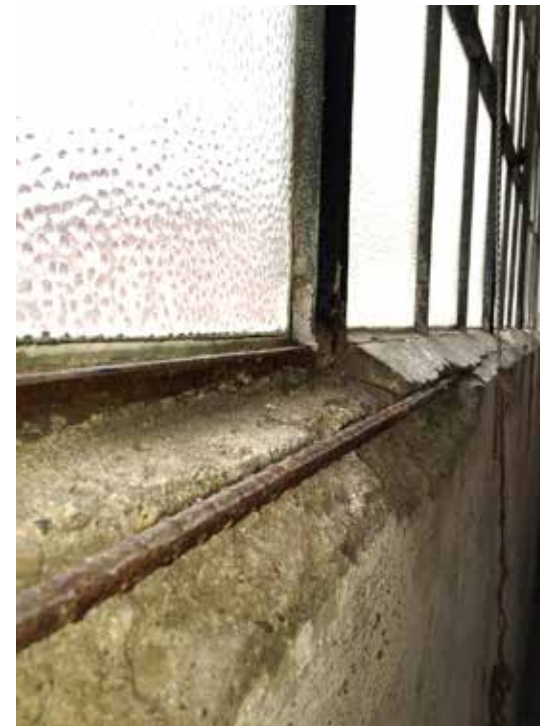
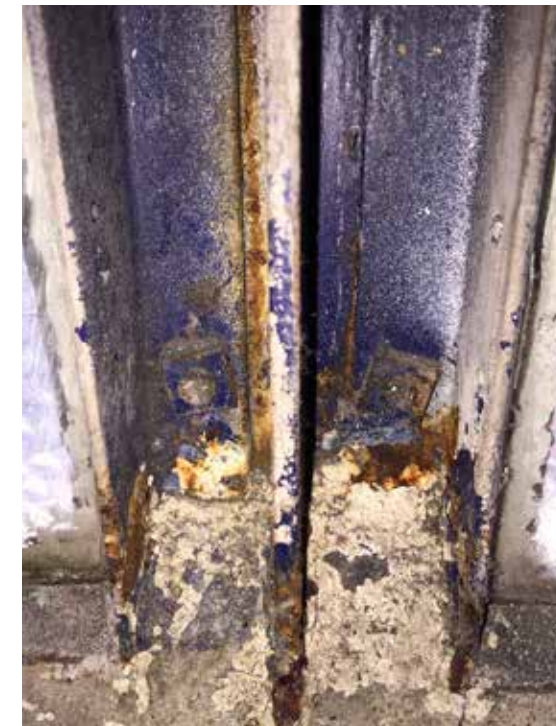
images of existing second floor windows

The existing steel-framed windows are not thermally broken and are a single pane with a variety of types of vision-obscuring glass. While appropriate for semi-conditioned storage space when they were in decent condition, the windows pose multiple issues for the new use: significant energy loss, thermal discomfort for the occupant, and moisture management due to increased condensation. The windows frames and glass are in poor condition and would require significant reconstruction including the replacement of all the glass and glazing compound. The frames need to be stripped to remove rust, damaged paint (likely to contain lead), and glazing, and require refinishing prior to the installation of new glass. Because reconstruction of the existing windows would provide minimal performance improvement, it is unlikely to be cost effective.

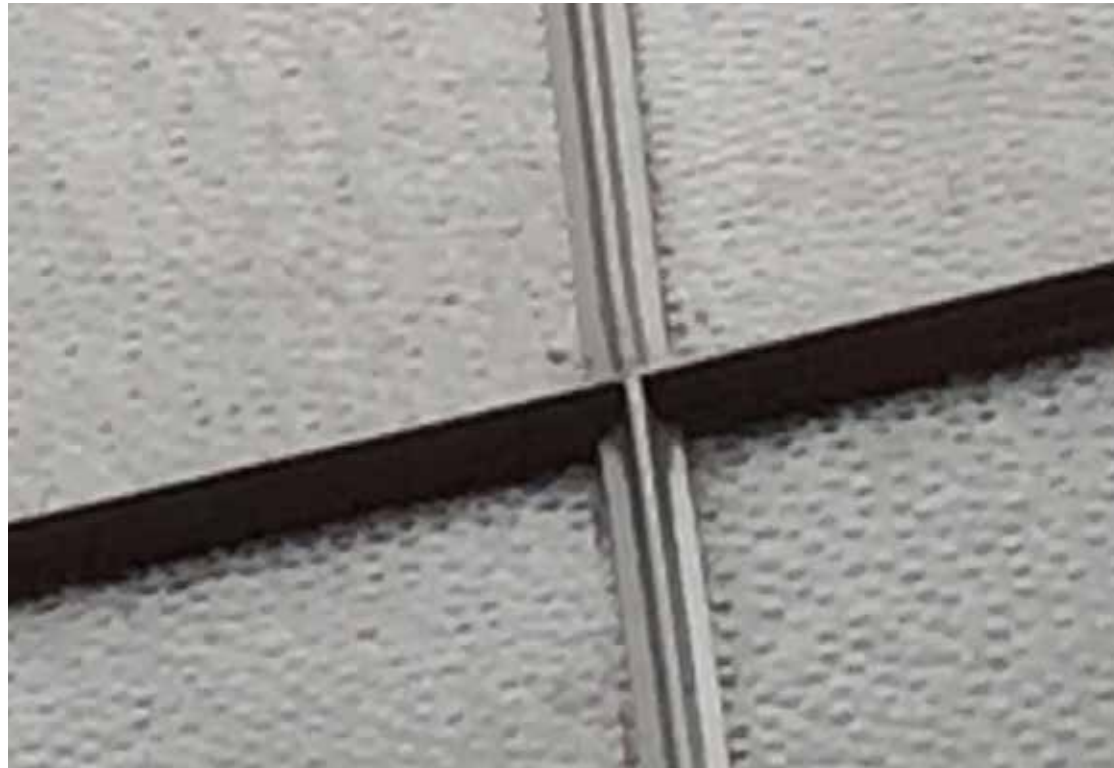
existing steel window mullion

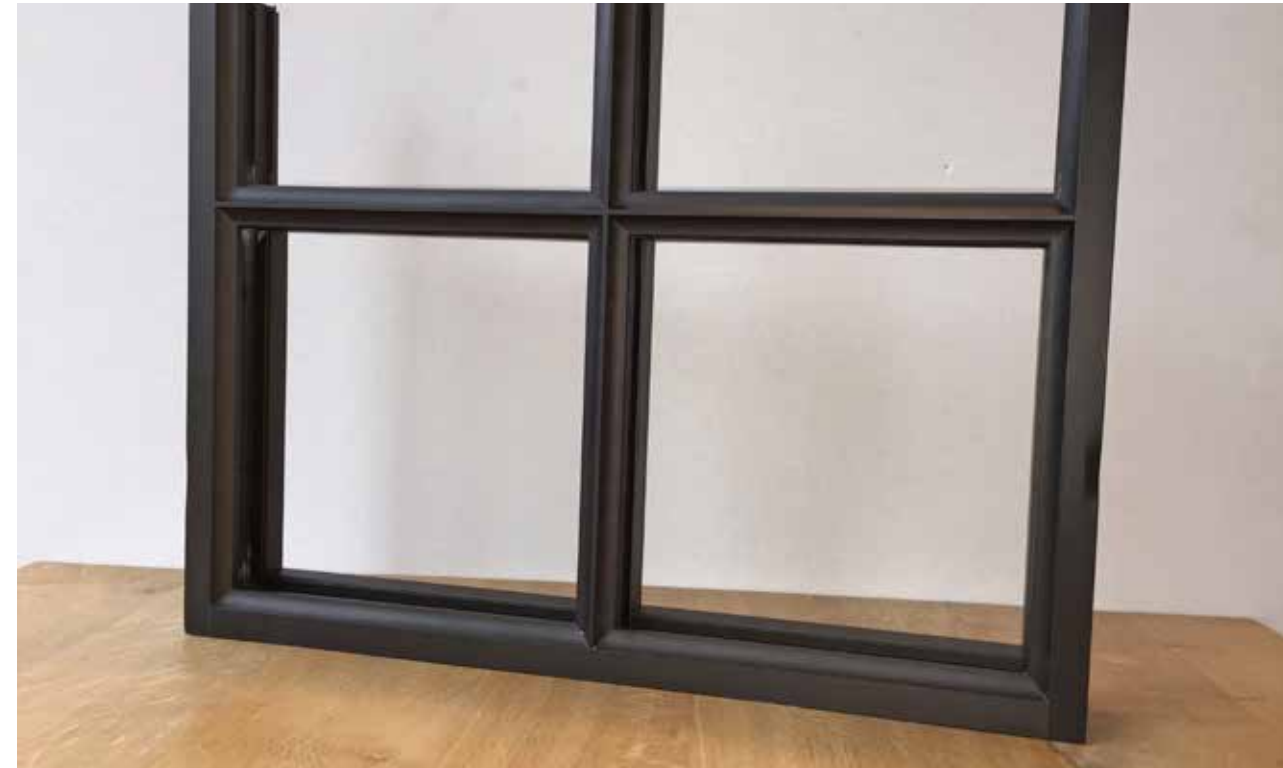
replacement window image

The design team recommends a complete replacement of the windows with steel or aluminum replica frames with insulating glass. From the exterior, the replacements would match the profile and pattern of the existing windows including the narrow sightlines. Replacement windows will improve energy efficiency, thermal comfort, and minimize moisture management concerns. Clear insulating low-e glass which complement the historic windows but provide significantly improved performance are recommended.

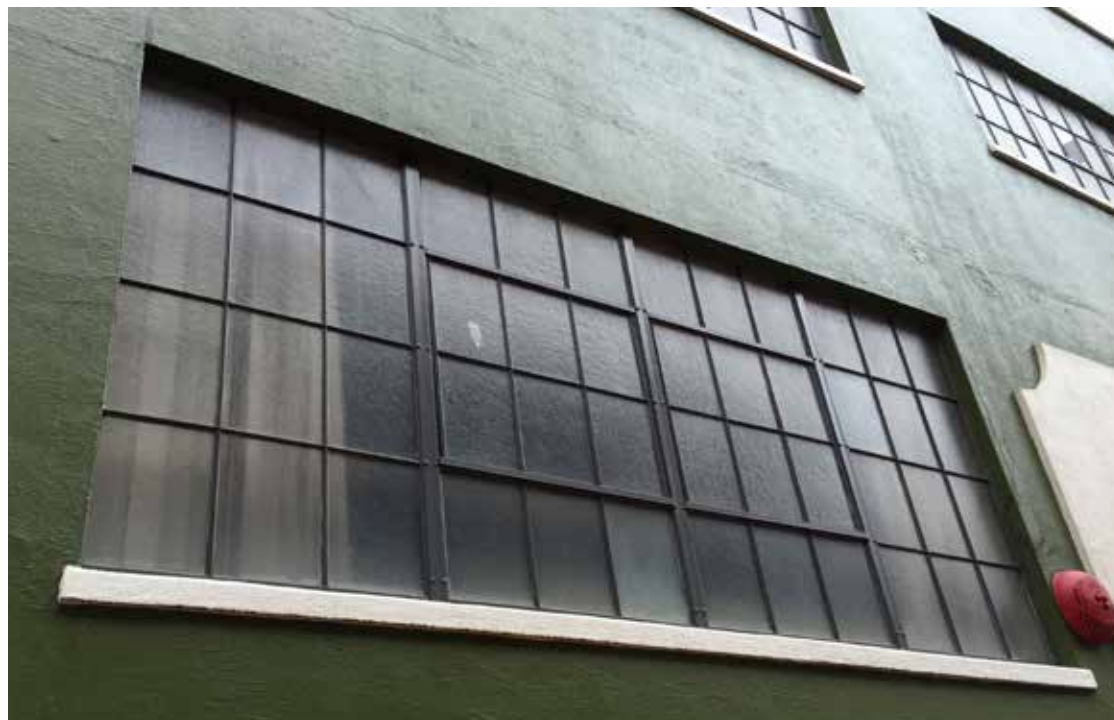
existing steel window

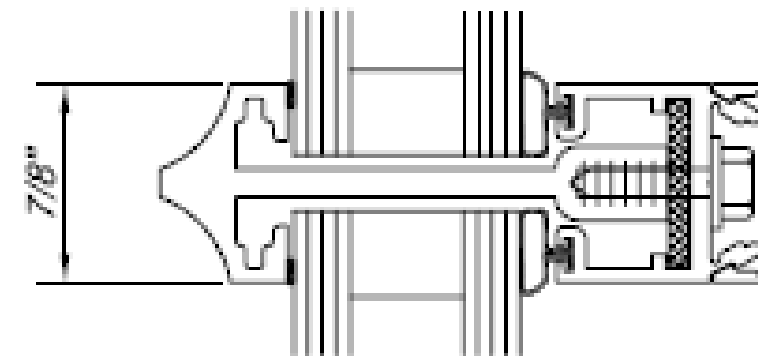
replacement aluminium window mullion section
