Earth
Engineers,
Inc.

**Subject: Limited Geotechnical Recommendations for New Fence Wall
Portland Industrial Services
1033 Southeast Woodstock Boulevard
Portland, Multnomah County, Oregon
City of Portland Application # 21-096435-000-00-CO
EEI Report No. 21-248-1-R1**

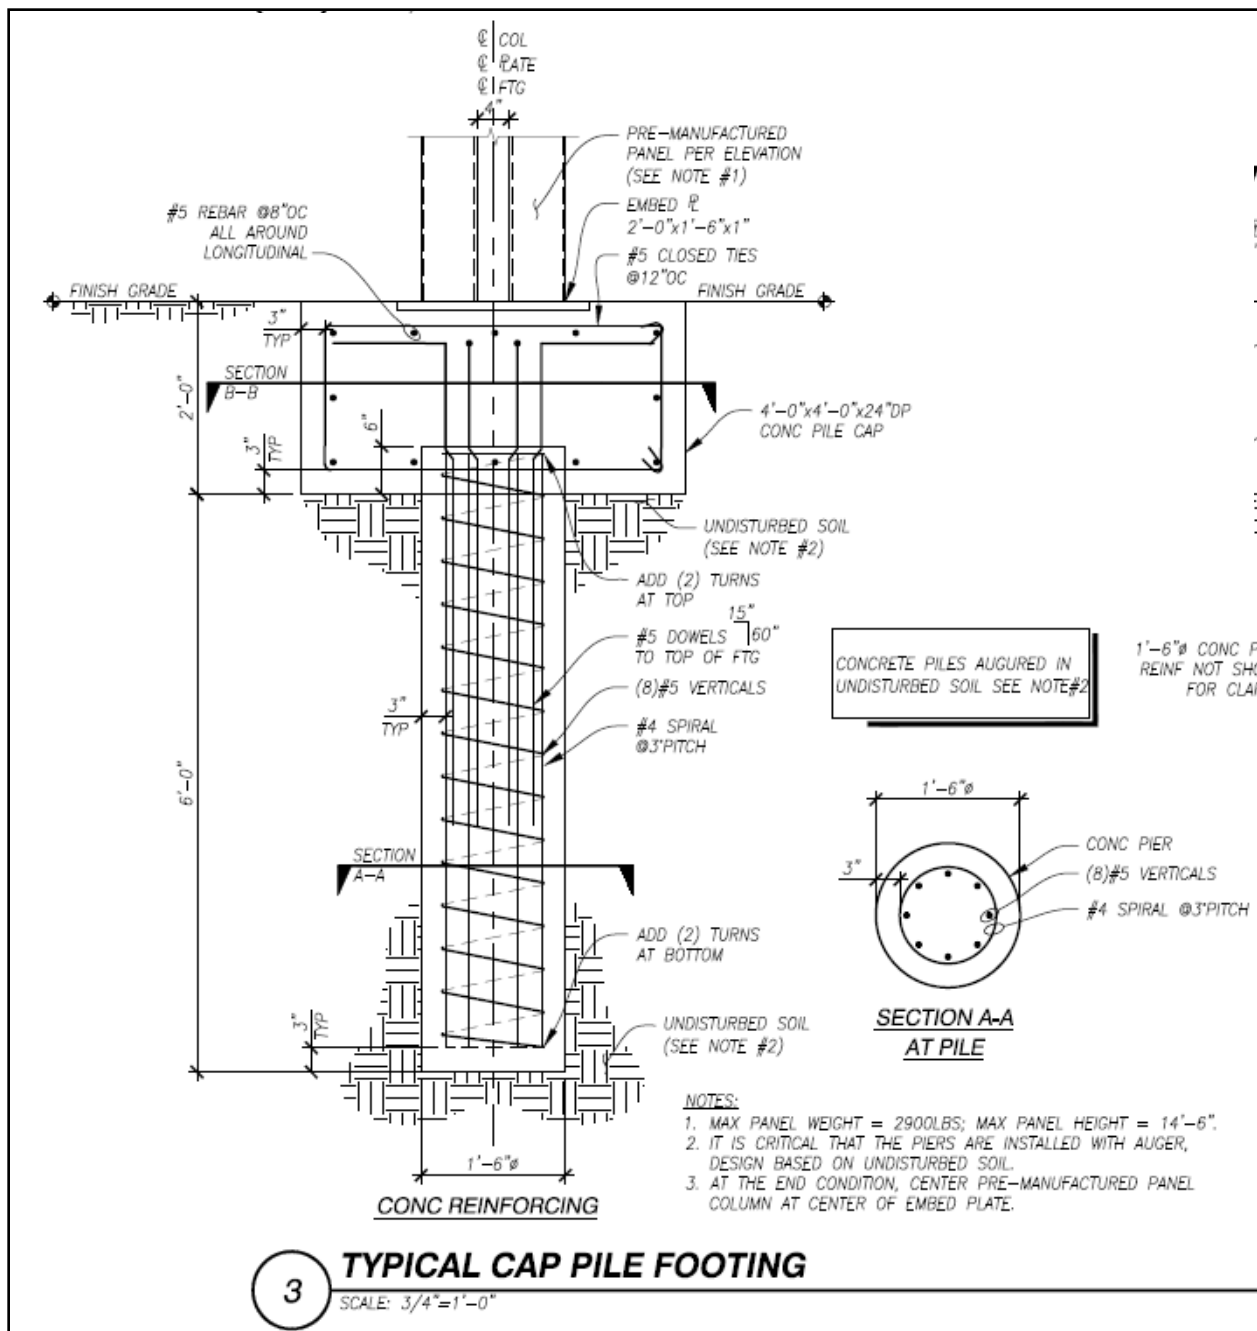
Figure 2: Site plan showing the location of the proposed fence wall (base drawing source: S2 by M-Group).

Briefly, we understand that you plan to construct a new fence wall to replace an existing chain link fence. The fence wall has been designed by Massaad Engineering Group (M-Group), reference their drawings titled "Fence Wall, 10033 SE Woodstock Blvd, Portland, OR 97206," sheets S1 and S2, dated 9/21/21. The drawings show that the fence wall will be supported by 18-inch diameter reinforced concrete drilled piers that will be embedded 8 feet below finish grade, or 6 feet below the bottom of the pile caps. The drawings note that the drilled piers have been designed based on the following assumed parameters:
