# Impacts of Fuel Releases from the CEI Hub Due to a Cascadia Subduction Zone Earthquake

EXECUTIVE SUMMARY

The purpose of this study is to identify the magnitude and extent of potential fossil fuel releases at the CEI Hub from a CSZ earthquake and to evaluate the resulting damages. ECONorthwest, Salus Resilience, and Enduring Econometrics prepared this report for the City of Portland and Multnomah County. For more information about this report, contact: Laura Marshall, Project Manager at marshall@econw.com.

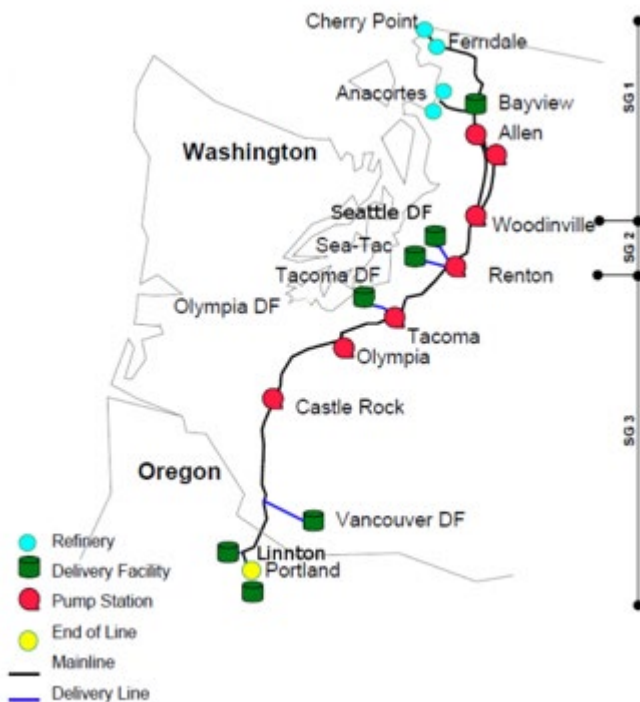
Figure 2. Olympic Pipeline Map

The CEI Hub is supplied by the Olympic Pipeline which connects as far north as Bellingham, Washington and transports gasoline, diesel, and jet fuel in pipes between 12 to 20 inches in diameter (Figure 2).<sup>20</sup> There are also other pipelines connecting to the CEI Hub for fuels, including the Kinder Morgan pipeline that links petroleum terminals in the Portland region, including to the Portland International Airport. Like tanks, pipelines are also subject to potential failure due to seismic risks. For the Olympic Pipeline, breaks could occur north of the CEI Hub. Pipeline contents and the resulting risk of release vary by day. Since the material is ultimately stored in tanks at the CEI Hub, the effect of pipeline releases is partially accounted for in the tank capacity. Given these uncertainties, this analysis does consider the effects of a pipeline rupture at the CEI Hub, but focuses solely on tank capacity.

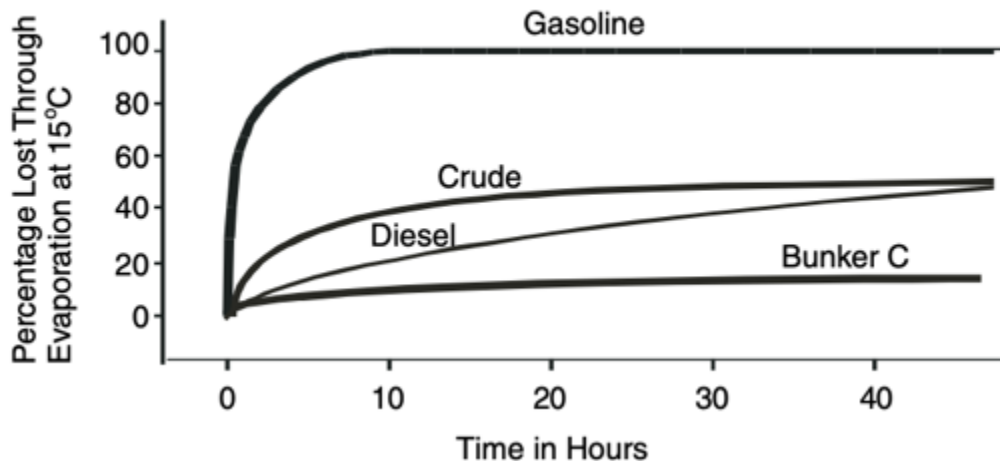
Figure 3. Evaporation Rates of Different Types of Oils

heavy oils will lose only 10 percent of their volume in the first few days following a spill (Figure 3).<sup>35</sup>

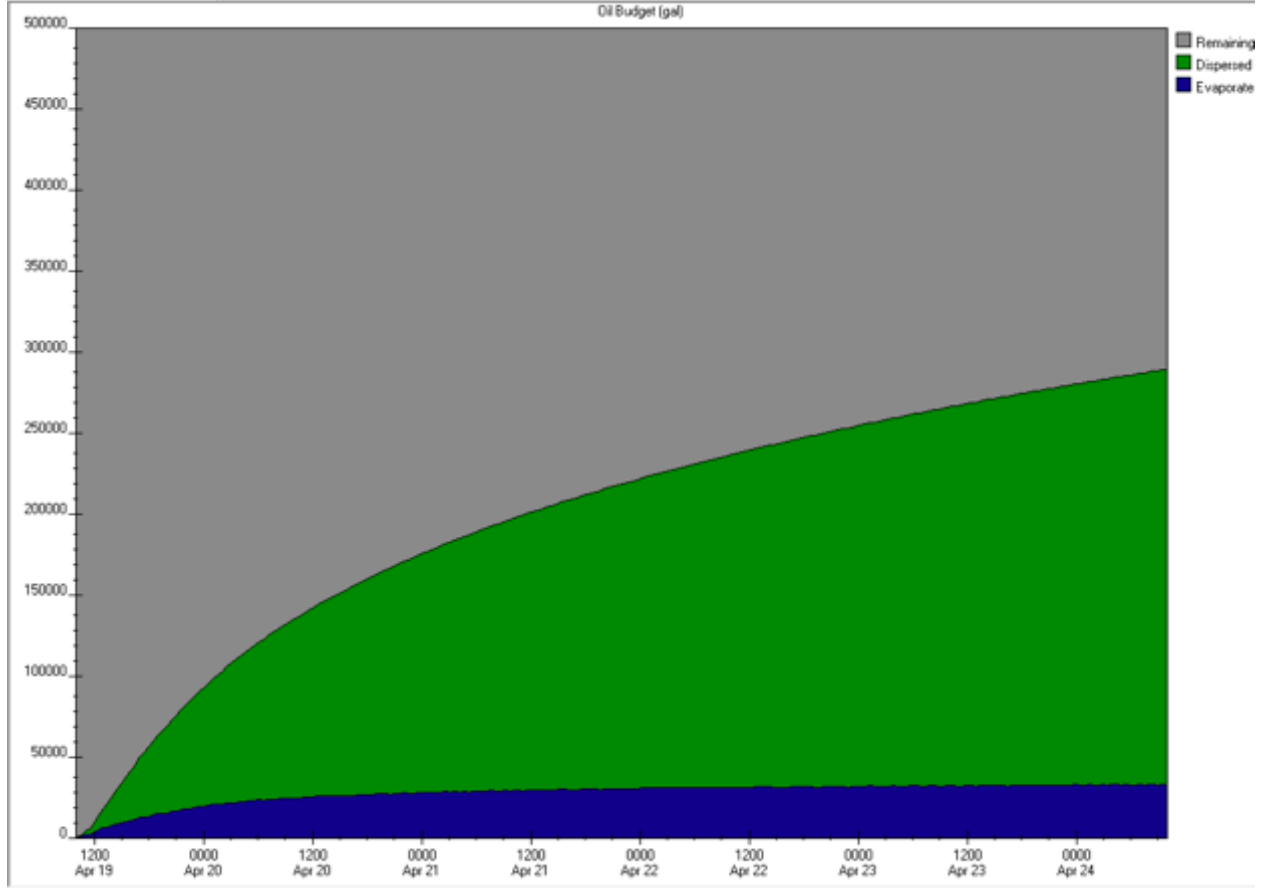
Figure 4. Weathering of Heavy Oil (Bunker), NOAA ADIOS Model Results

Weathering can be modeled using NOAA’s Automated Data Inquiry for Oil Spills (ADIOS) that uses location- and material-specific parameters to model the results of oil releases into water environments.<sup>36</sup> For a heavy oil, like bunker, a large percentage of the oil will remain even weeks later (Figure 4). In contrast, a light oil, like gasoline, will fully disperse or evaporate within 1 or 2 days (Figure 5).

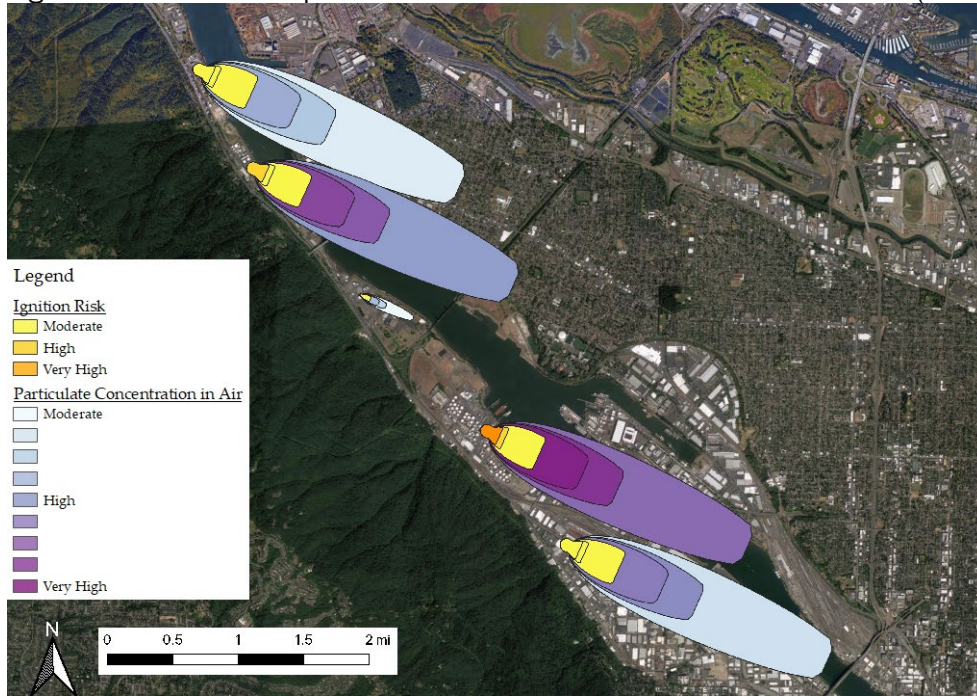
Figure 10: One-Hour Dispersion of Gasoline Chemicals from CEI Fuel Hub (NNW Wind Direction)

Figures 11 and 12 show a map of the projected area of toxic vapor risk under two prevailing wind conditions for the area surrounding the CEI Hub<sup>109</sup>. Dark shaded areas are likely to exceed or greatly exceed the OSHA 8-hour time-weighted average limits for gasoline particulate exposure. The yellow zones immediately surrounding each tank area represent the zones at risk of a fire ignition. Depending on the severity, location

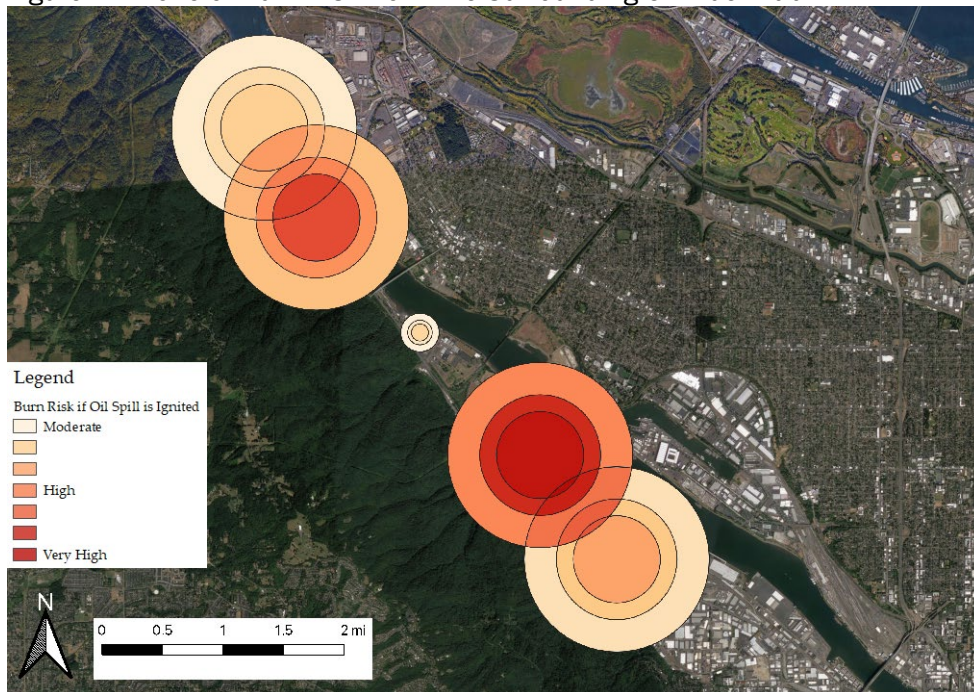
Figure 12: Zone of Burn Risk from Fire Surrounding CEI Fuel Hub

and spread of the spill, the concentration of hazardous gasoline vapor may extend beyond these regions. Figure 13 shows the levels of risk of mild to severe burns. The highest zone of risk from a burning gas fire represents a high probability of death within 60 seconds of exposure.

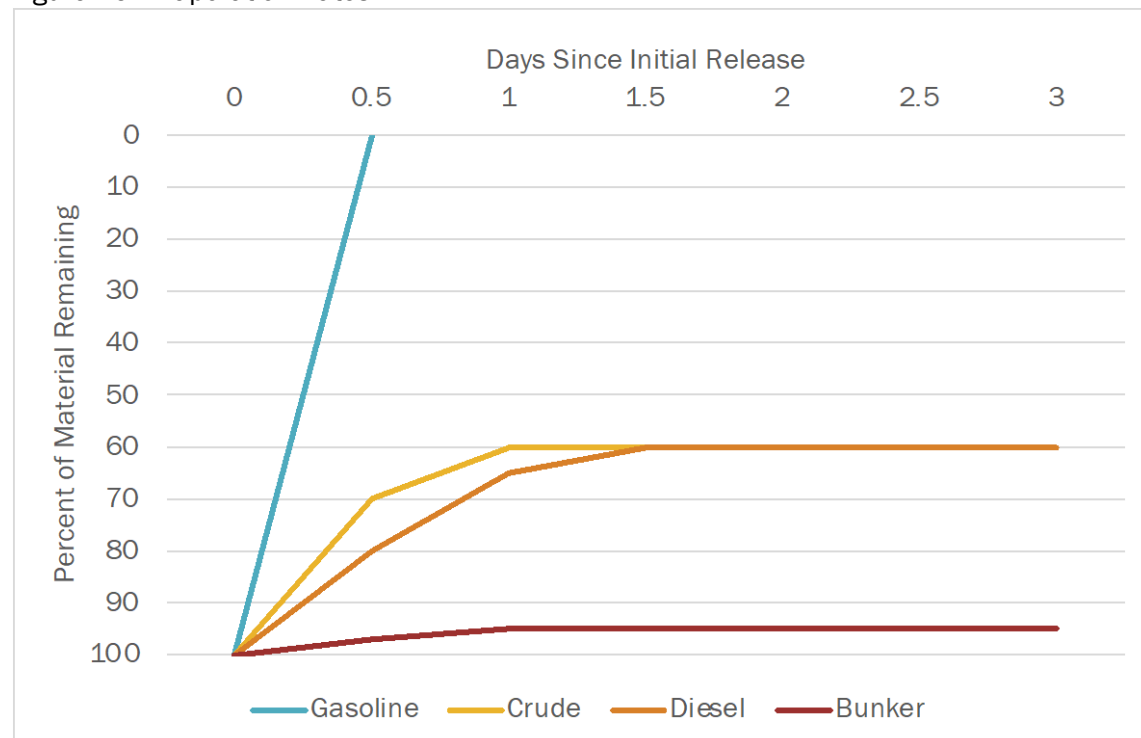
Figure 16. Evaporation Rates

As discussed in section 4.2, not all the materials released from the CEI Hub will remain in the water for the length of time it would take to reach the Pacific Ocean. After 10 hours, almost of all the gasoline, ethanol, and aviation fuel will have evaporated into the air, particularly during hotter days when evaporation rates are higher and more sunlight and microbes can break down the chemicals.<sup>122</sup> Diesel and crude oil will evaporate in part, but up to 60 percent could be remaining when the materials reach the Pacific Ocean.<sup>123</sup> Because these light fuels float on top of the water they will largely flow with the river. Heavier oils like asphalt and bunker crude oil will sink in the water and largely remain in any environment that they come in contact with on riverbeds and shorelines. Despite sinking, heavier oils will continue to be transported by the water velocity, although at a slower rate than non-sinking lighter oils that remain on the water surface. Figure 13 models sample evaporation rates for gasoline, crude, diesel, and bunker fuels over time for the first three days.

Applying the evaporation rates described previously to the materials that could be potentially released at the CEI Hub results in the finding that after three days between 20.9 million and 42.3 million gallons of diesel, medium, and heavy oils could be remain in the water (excluding additives and unknown materials). Because most evaporation occurs early, in the low flow scenario in the summer these levels of materials are likely to remain about as high for the remaining days and be transported to the Pacific Ocean. This level of contamination is likely to result in significant mortality among aquatic species throughout the lower Willamette and Columbia Rivers. Mortality and impacts to sensitive species will be particularly pronounced if the spill occurs during the salmon spawning seasons in the late spring to early fall.

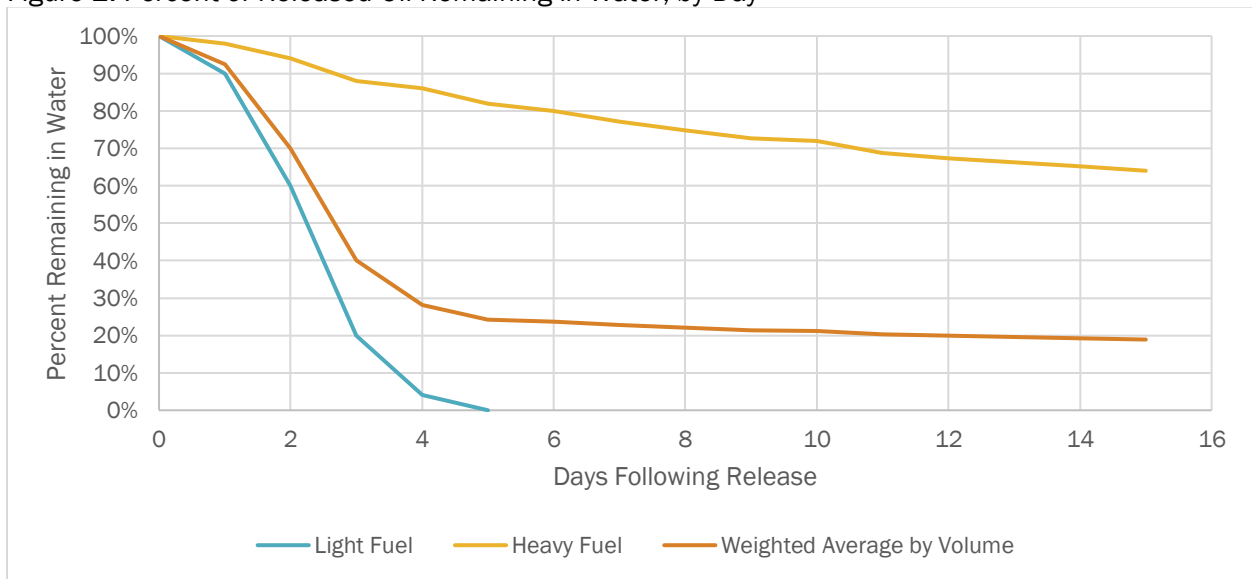
Figure 2. Percent of Released Oil Remaining in Water, by Day

As described in Section 1-4.2 of Chapter 1 of this report, oil released as a result of a failure at the CEI Hub will undergo both weathering and transport in the days following the spill. The degree of weathering – through dispersion or evaporation – is dependent on the type of oil, with lighter, more volatile fuels disappearing from the Willamette and Columbia Rivers more quickly than heavier fuels. While lighter fuels are more detrimental to air quality impacts, they are relatively less harmful in an aquatic environment. Figure 2 shows the percent of the oil that is expected to remain in the waters of the Willamette and Columbia Rivers, by day, following the release.

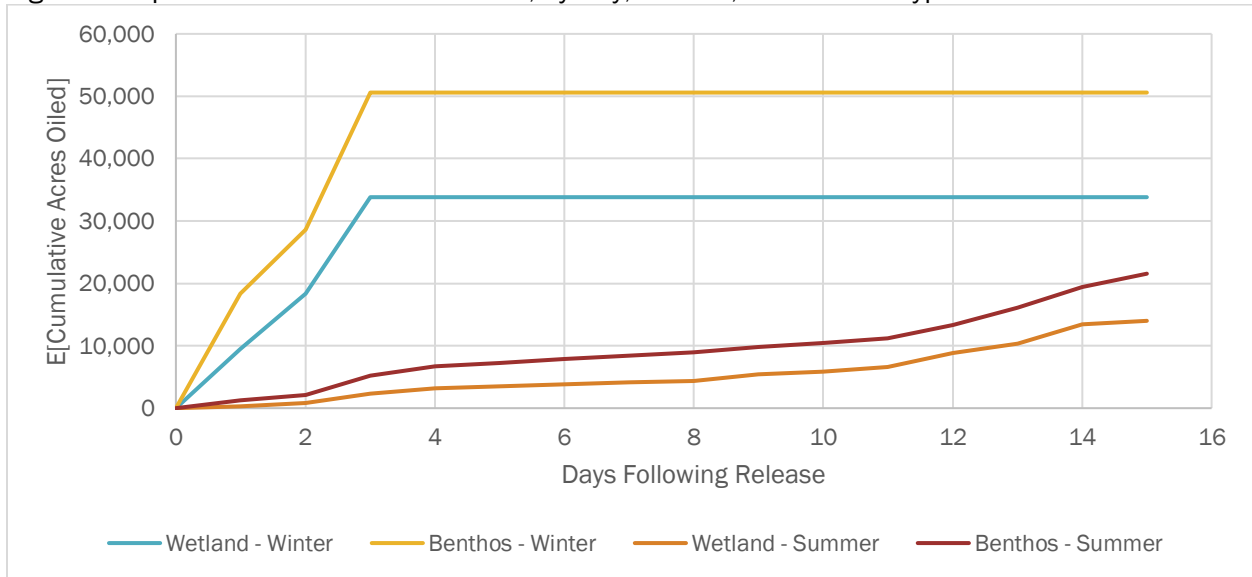
Figure 3. Expected Cumulative Acres Oiled, by Day, Season, and Habitat Type

habitats further downstream before natural weathering of the released oil can occur. The comparative acres oiled by day following the release by habitat type are displayed in Figure 3. Due to the higher river flows, a release from the CEI Hub in winter will lead to a larger expected number of acres of habitat oiled compared to a release in summer.

The degree of oiling of these habitats is dependent on the fate and transport of the oil on the rivers, which, as described earlier, is dependent on the mix of oil released and the seasonal velocity of the rivers. In winter, higher river velocity will cause a larger density of oil to reach

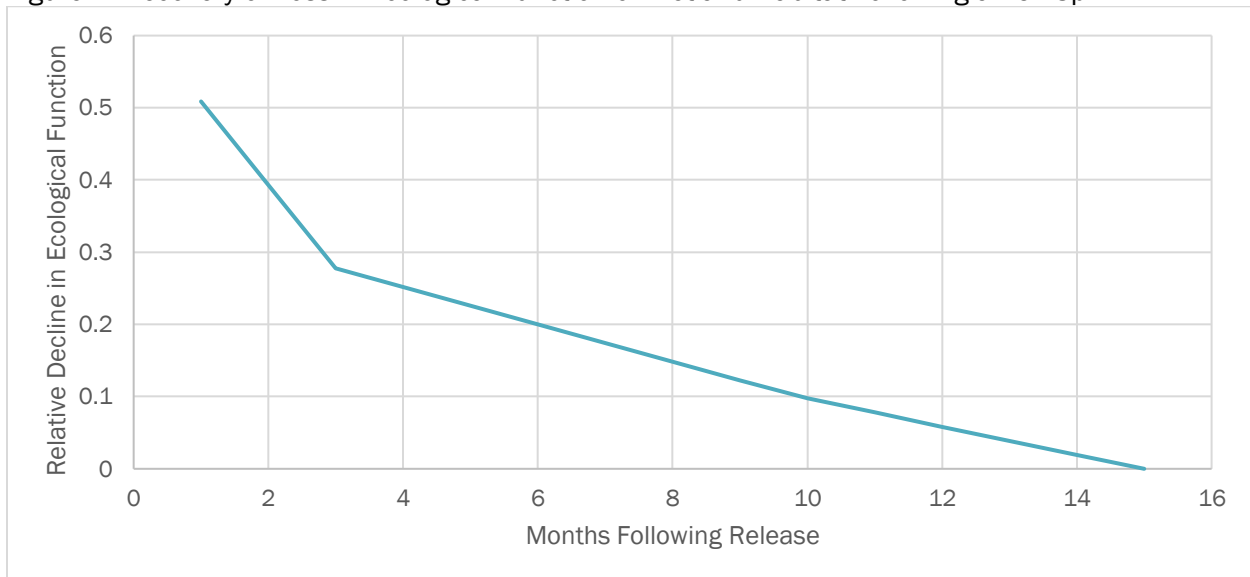
Figure 4. Recovery of Loss in Ecological Function of Wetland Habitat Following an Oil Spill

After the oil accumulates in wetlands and along the river bottom, it causes both a physical injury and chemical injury to the ecological function of those habitats. Fortunately, these impairments are not permanent, and evaluations following other oil spills in estuarine environments found that the decline in function following an oil spill tends to resolve approximately 15 months following the release. While the initial injury can be profound (exceeding a 50 percent decline in ecological function) in the first months after a spill, as the oil weathers and moves around in a dynamic riverine environment, the initial injury slowly dissipates, and the habitats recover to a point where they eventually reach baseline conditions, as shown in Figure 4.<sup>52</sup> These effects can be exacerbated or mitigated by the initial baseline function of the habitat and other co-occurring anthropogenic stressors or cleanup activity.

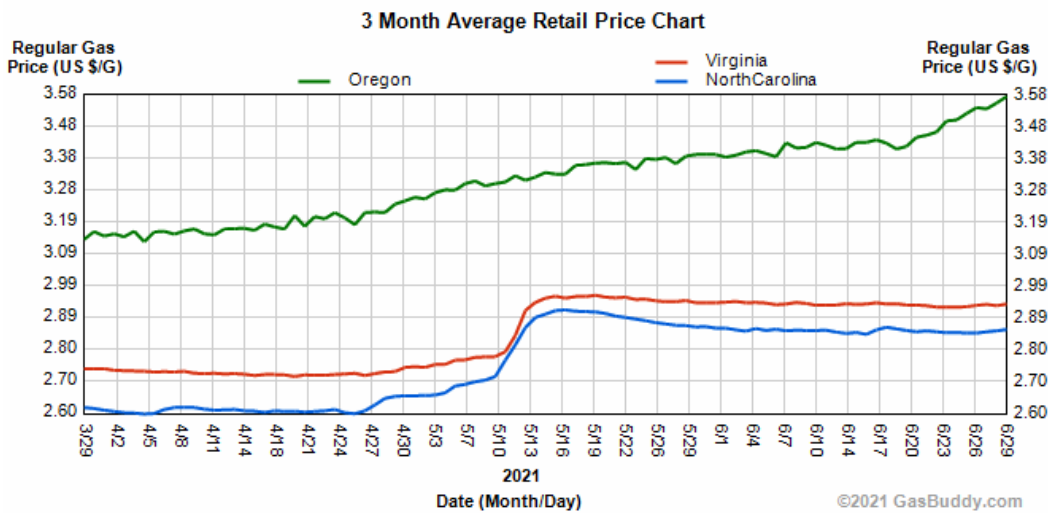
Figure 5: Retail Gasoline Prices in VA, NC, and OR: April to June 2021

Many East Coast states experienced acute price jumps in gasoline in the week or and week following the Colonial Pipeline service outage. Figure 5 shows data from Gas Buddy, a fuel price tracking app that publishes daily price data at the state- and metro-level for retail gasoline. Prices in Virginia and North Carolina jumped by about 7.5 percent, or 20 cents per gallon, between May 7, when the shutoff began, and May 16, when prices peaked following the shortage.<sup>85</sup> Oregon prices, which were unaffected by the shortage, are shown for reference.

The gulf coast states of Mississippi, Alabama and Georgia have a low, medium, and high level of reliance on the pipeline, respectively, and each experienced different gas price effects (Table 22). As shown in Figure 5, the higher reliance on the pipeline for gasoline supply was associated with a greater rise in gas prices. Although other factors may have contributed to this relationship, it suggests that states with a greater diversification of fuel supply sources may

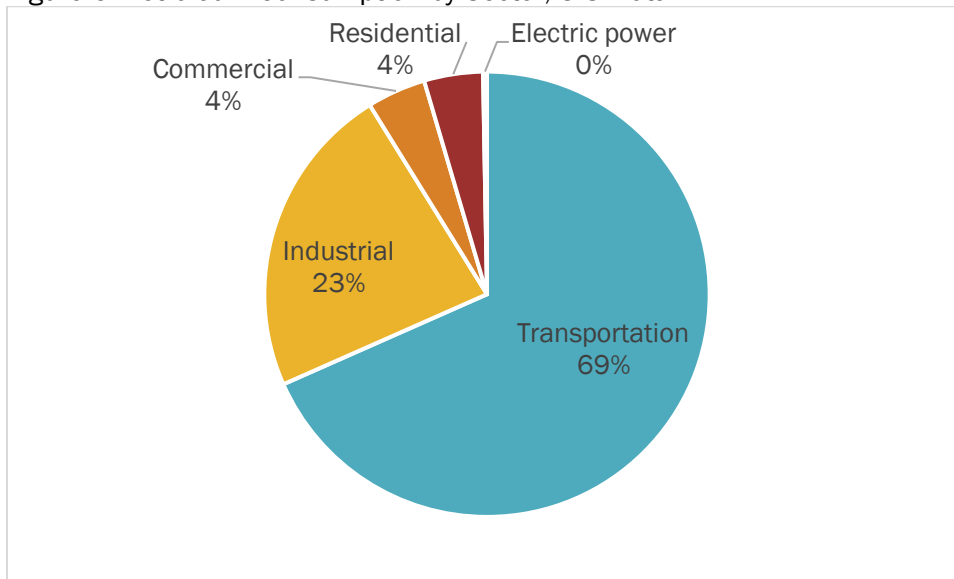
Figure 6. Petroleum Consumption by Sector, U.S. Total

The direct effect of lost fuel supply would mean fuel-dependent businesses would likely face a temporary halt in operations until a replacement fuel source became widely available. Based on data collected by the Energy Information Administration, the transportation sector is the largest consumer of petroleum fuel (24 quadrillion btu annually in the U.S.), compared to about 8 quadrillion btu by the industrial sector and less than 2 btu for the commercial and residential sectors (Figure 6).

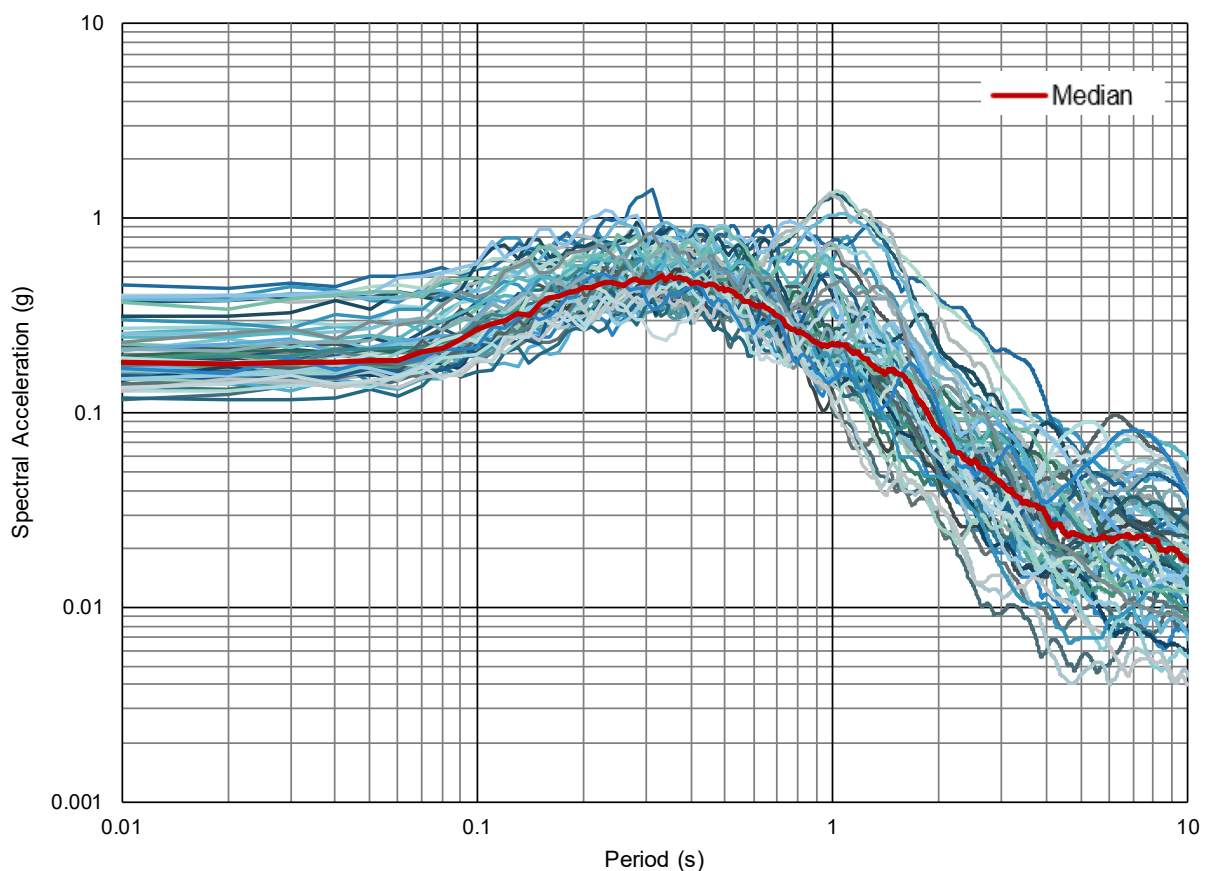
Figure 4.1 CSZ Ground Motion Components (Frankel et al. 2019)

For this study, the ground motions were selected for the model grid point nearest 45.57 degrees N, -122.76 degrees E, the closest model grid point to the project study area. The synthetic ground motions are two-component (north-south and east-west) synthetic acceleration time histories for a stiff soil condition. The soil condition used at the ground surface in the Frankel et al. (2019) model is a site with time averaged shear wave velocity in the top 100 feet (30 meters) of approximately 2,000 feet per second (600 meters per second). Figure 4.1 below shows the response spectrum for the 60 acceleration time series selected from the Frankel et al. (2019) model in blue with the median in red.

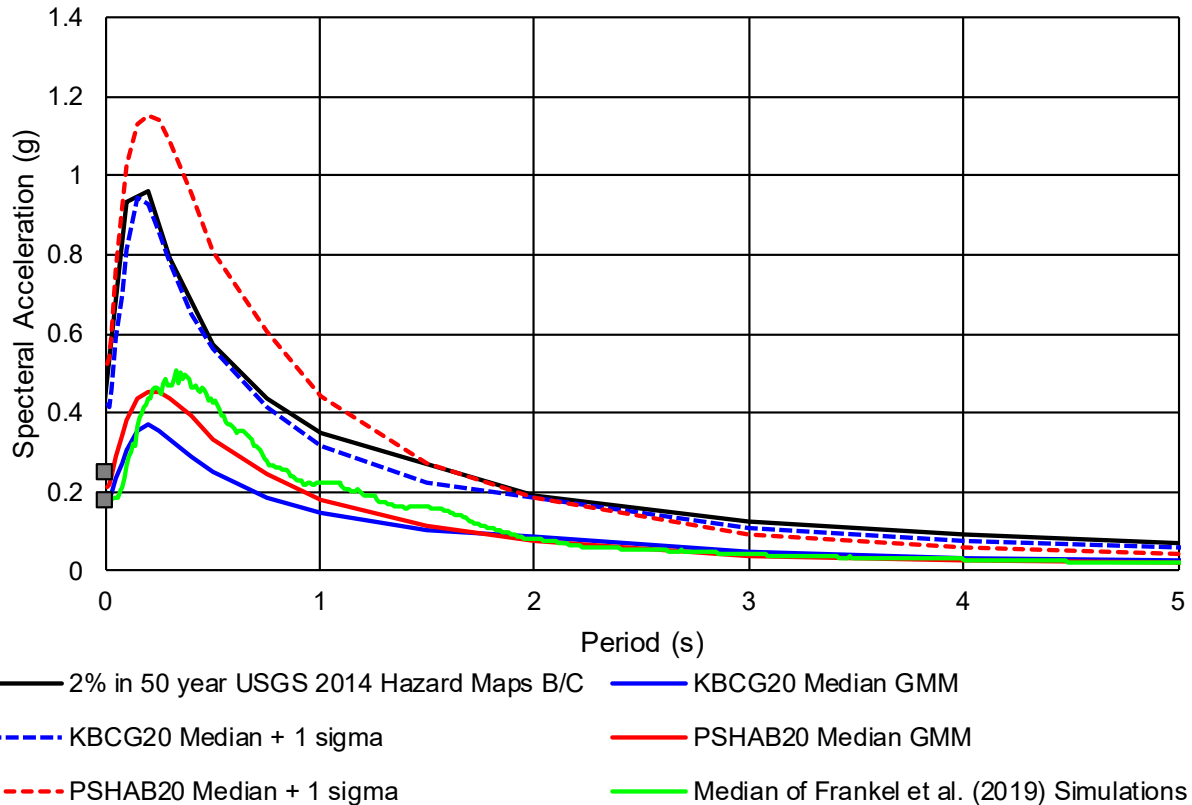
Figure 4.2 CSZ Spectral Response

In engineering design, the ground motions due to seismic shaking are commonly transformed to a spectral acceleration response spectrum that can be used to model how an earthquake is experienced by a building/structure. Spectral acceleration values for the available calculation methods are shown on Figure 4.2 below for a stiff soil or rock-like Site Class B/C condition. The black line represents a probabilistic geometric mean spectrum from the 2014 USGS hazard maps commonly used in IBC design for new construction. This probabilistic curve includes the effects of both subduction events and shallow crustal events, represents the hazard of a 2 percent probability of exceedance in 50 years (equivalent to a 2,475-year return period), and is shown for comparison only. The red and blue lines are computed from the PSHAB20 and KBCG20 GMMs, respectively, with the solid lines representing the median and dashed lines representing the 84th-percentile ground motion (median plus one standard deviation,  $\sigma$ ). The PSHAB20 and KBCG20 GMMs were computed using the earthquake characteristics shown in Table 4.1 below. The green line is the median of the Frankel et al. (2019) simulations. The gray points are the surface intensity values from the DOGAMI (2018) report decreased by a factor of 1.2 to remove the effects of soft soil amplification and approximate a stiff soil or rock-like condition similar to the condition used for the other lines plotted on the figure. The 1.2 factor is consistent with the NEHRP amplification ratio between the site class used in the DOGAMI (2018) map near the project site (Class D, representative of the surface soil condition) and the site class used in this study for the Frankel et al. (2018) simulations and NGA-Sub GMMs (Class C, representative of a stiff soil or soft rock condition).

Figure 4.2 indicates that the level of ground motion shaking shown in the DOGAMI hazard maps is similar to the intensity estimated from the most recent ground motion models for a CSZ rupture. However, the uncertainty range of the GMMs indicates that an 84th percentile event represents a significantly higher level of ground motion shaking than the median earthquake event; specifically, the peak ground acceleration (equivalent to the spectral response at a period of zero seconds) is approximately 100 percent higher for the 84th percentile event than the median event.

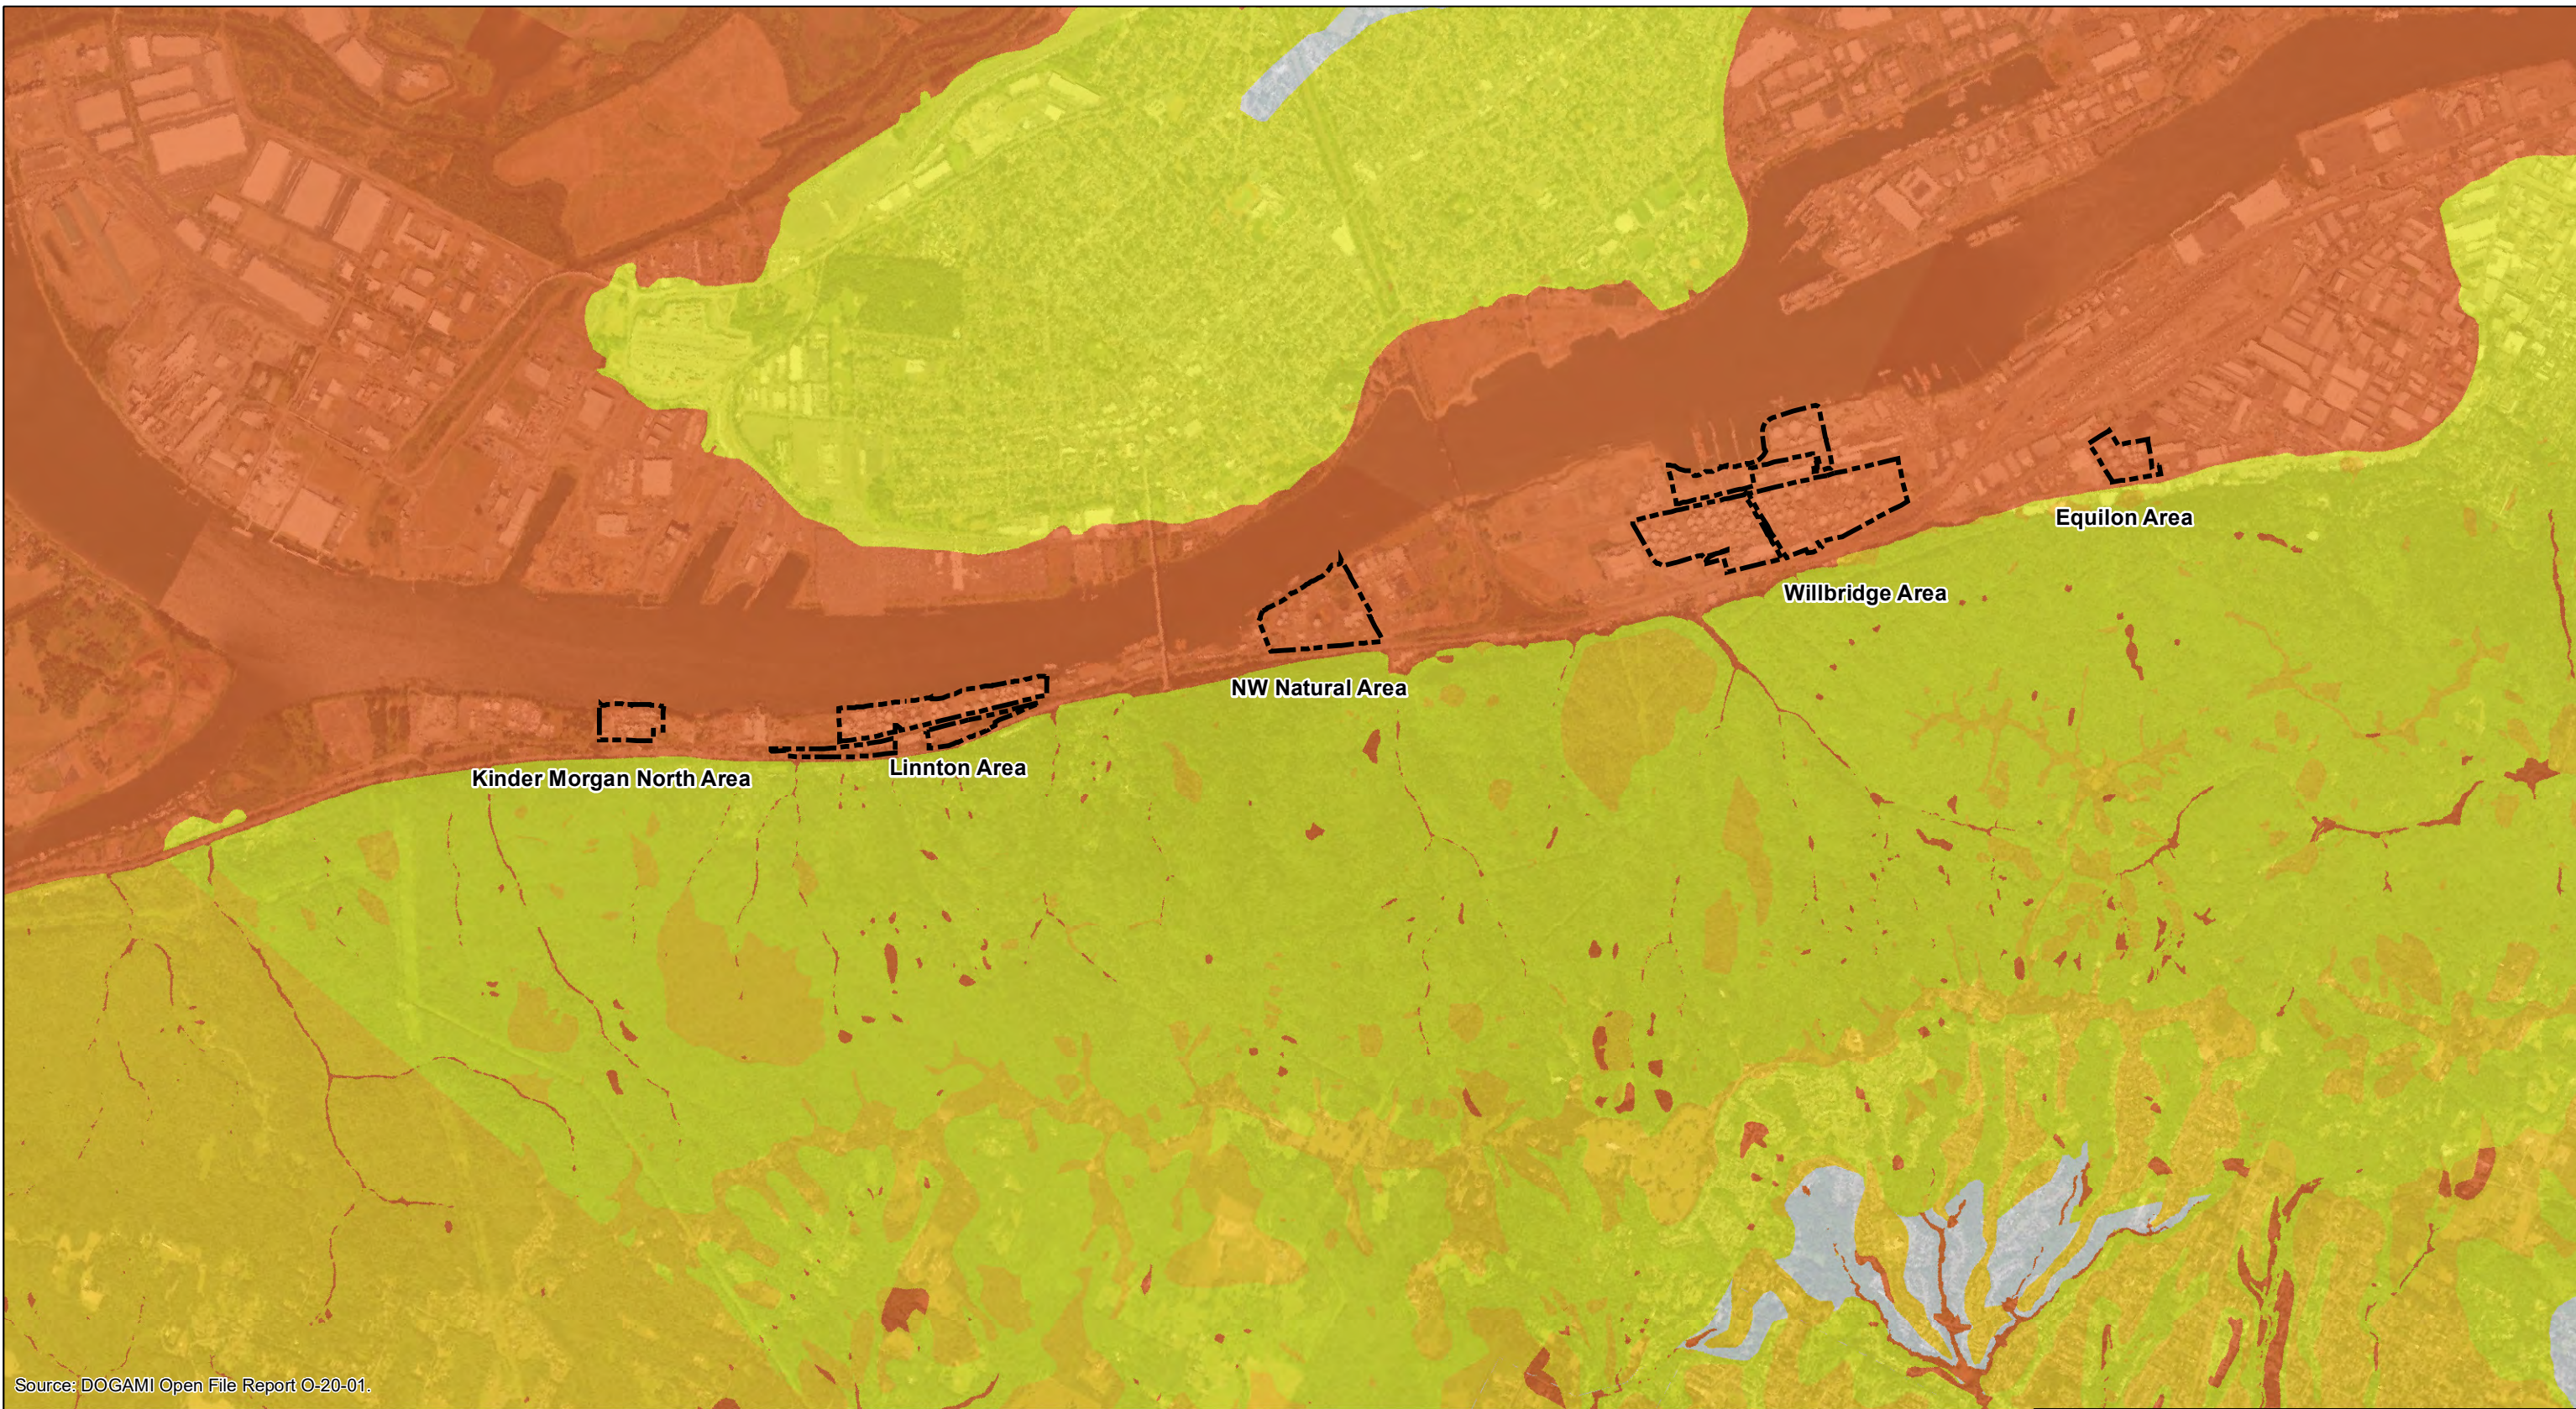
Source: DOGAMI Open File Report O-20-01.

- None
- Low (0 – 10 cm; 0 – 4 inches)
- Moderate (10 – 30 cm; 4 – 12 inches)
- High (30 – 100 cm; 12 – 39 inches)
- Very High (100 – 1180 cm; 39 – 173 inches)

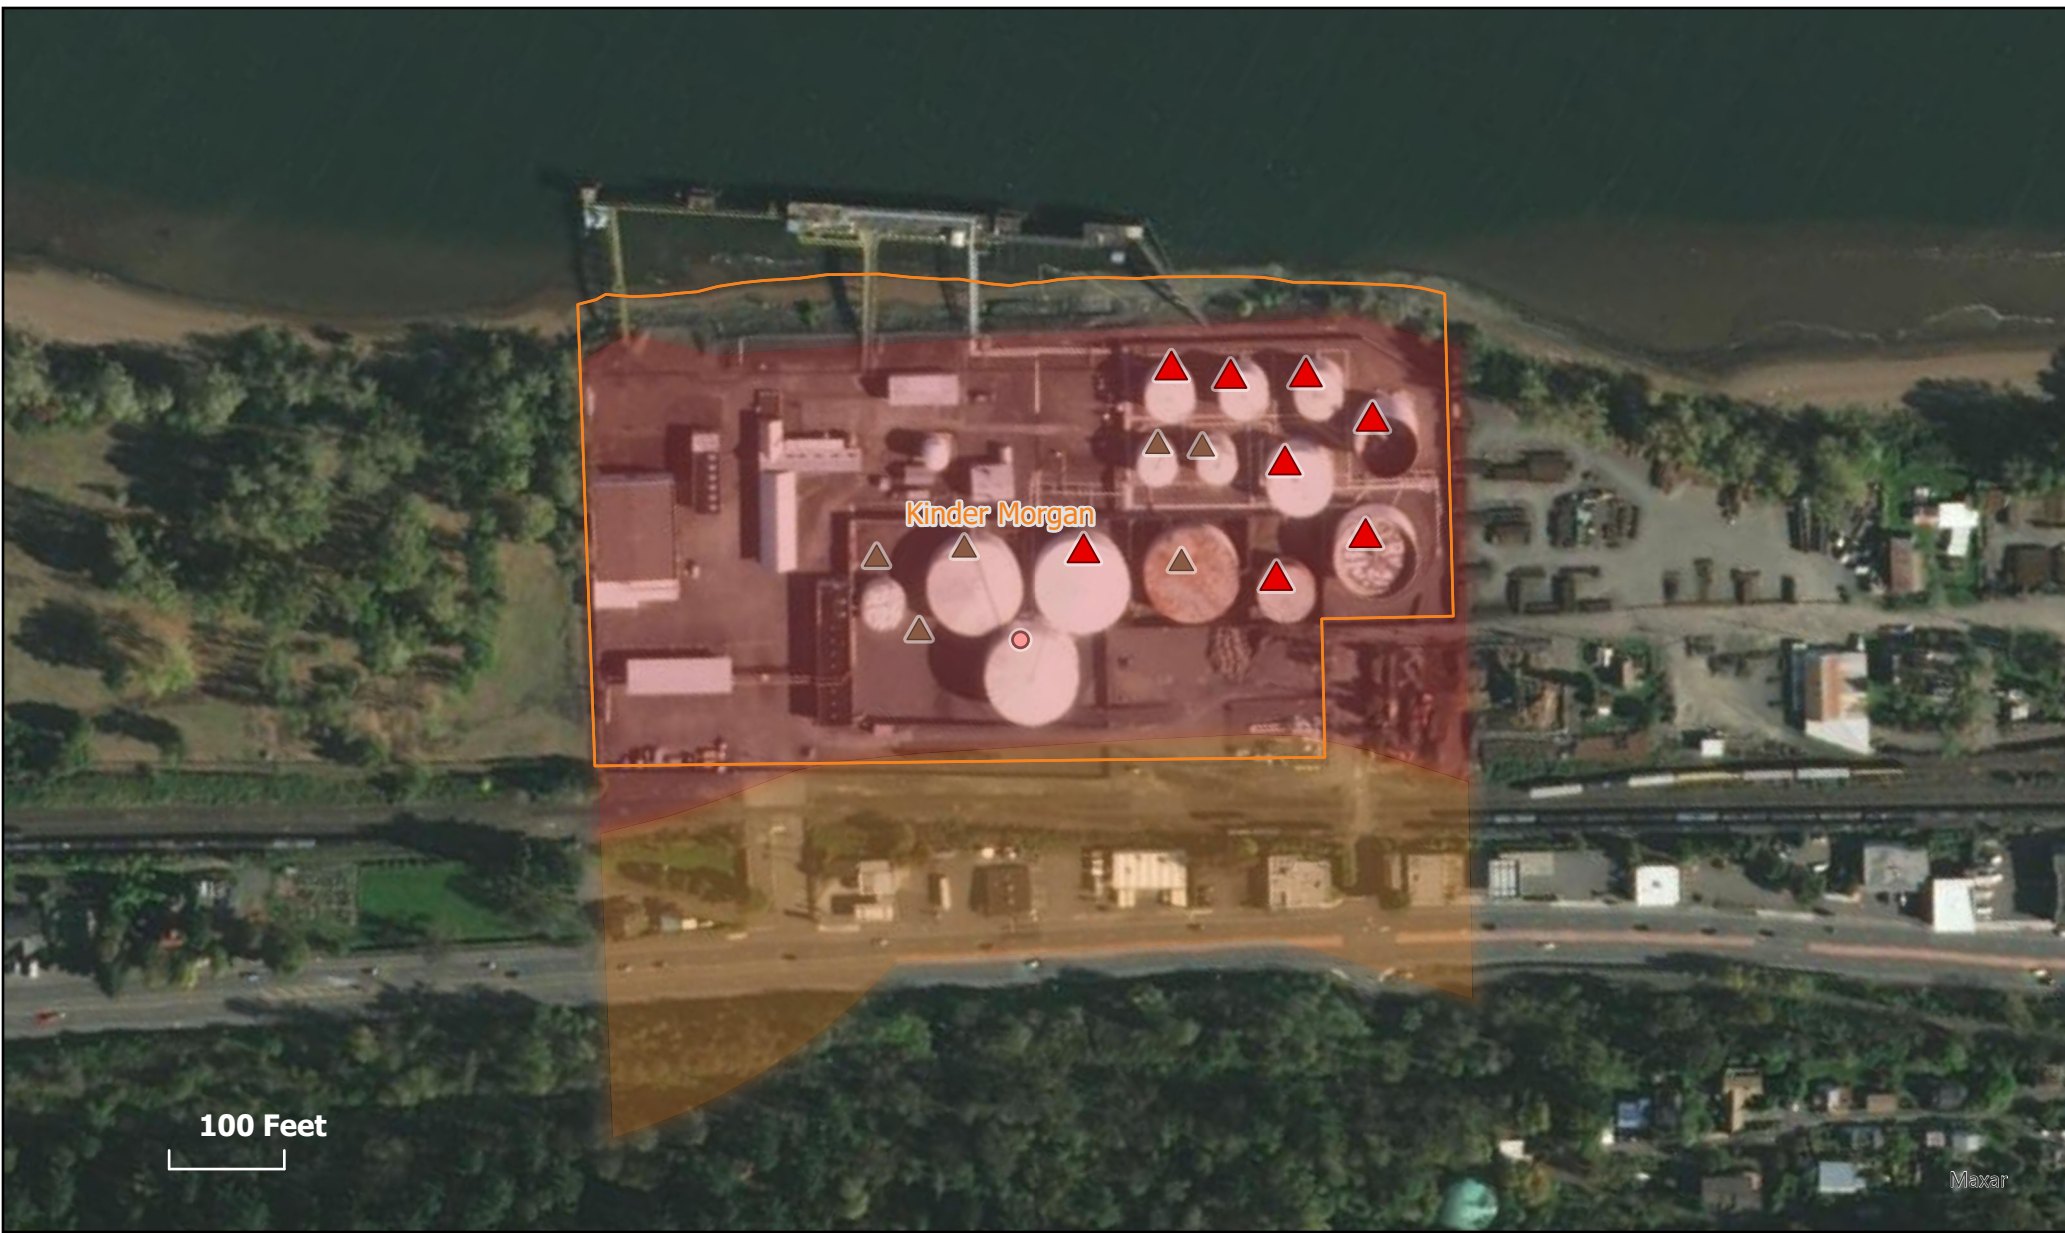
**FIGURE 2A**  
**KINDER MORGAN NORTH**

**Tank Release**

- ▲ Flammable and Hazardous
- ▲ Empty or Out of Service

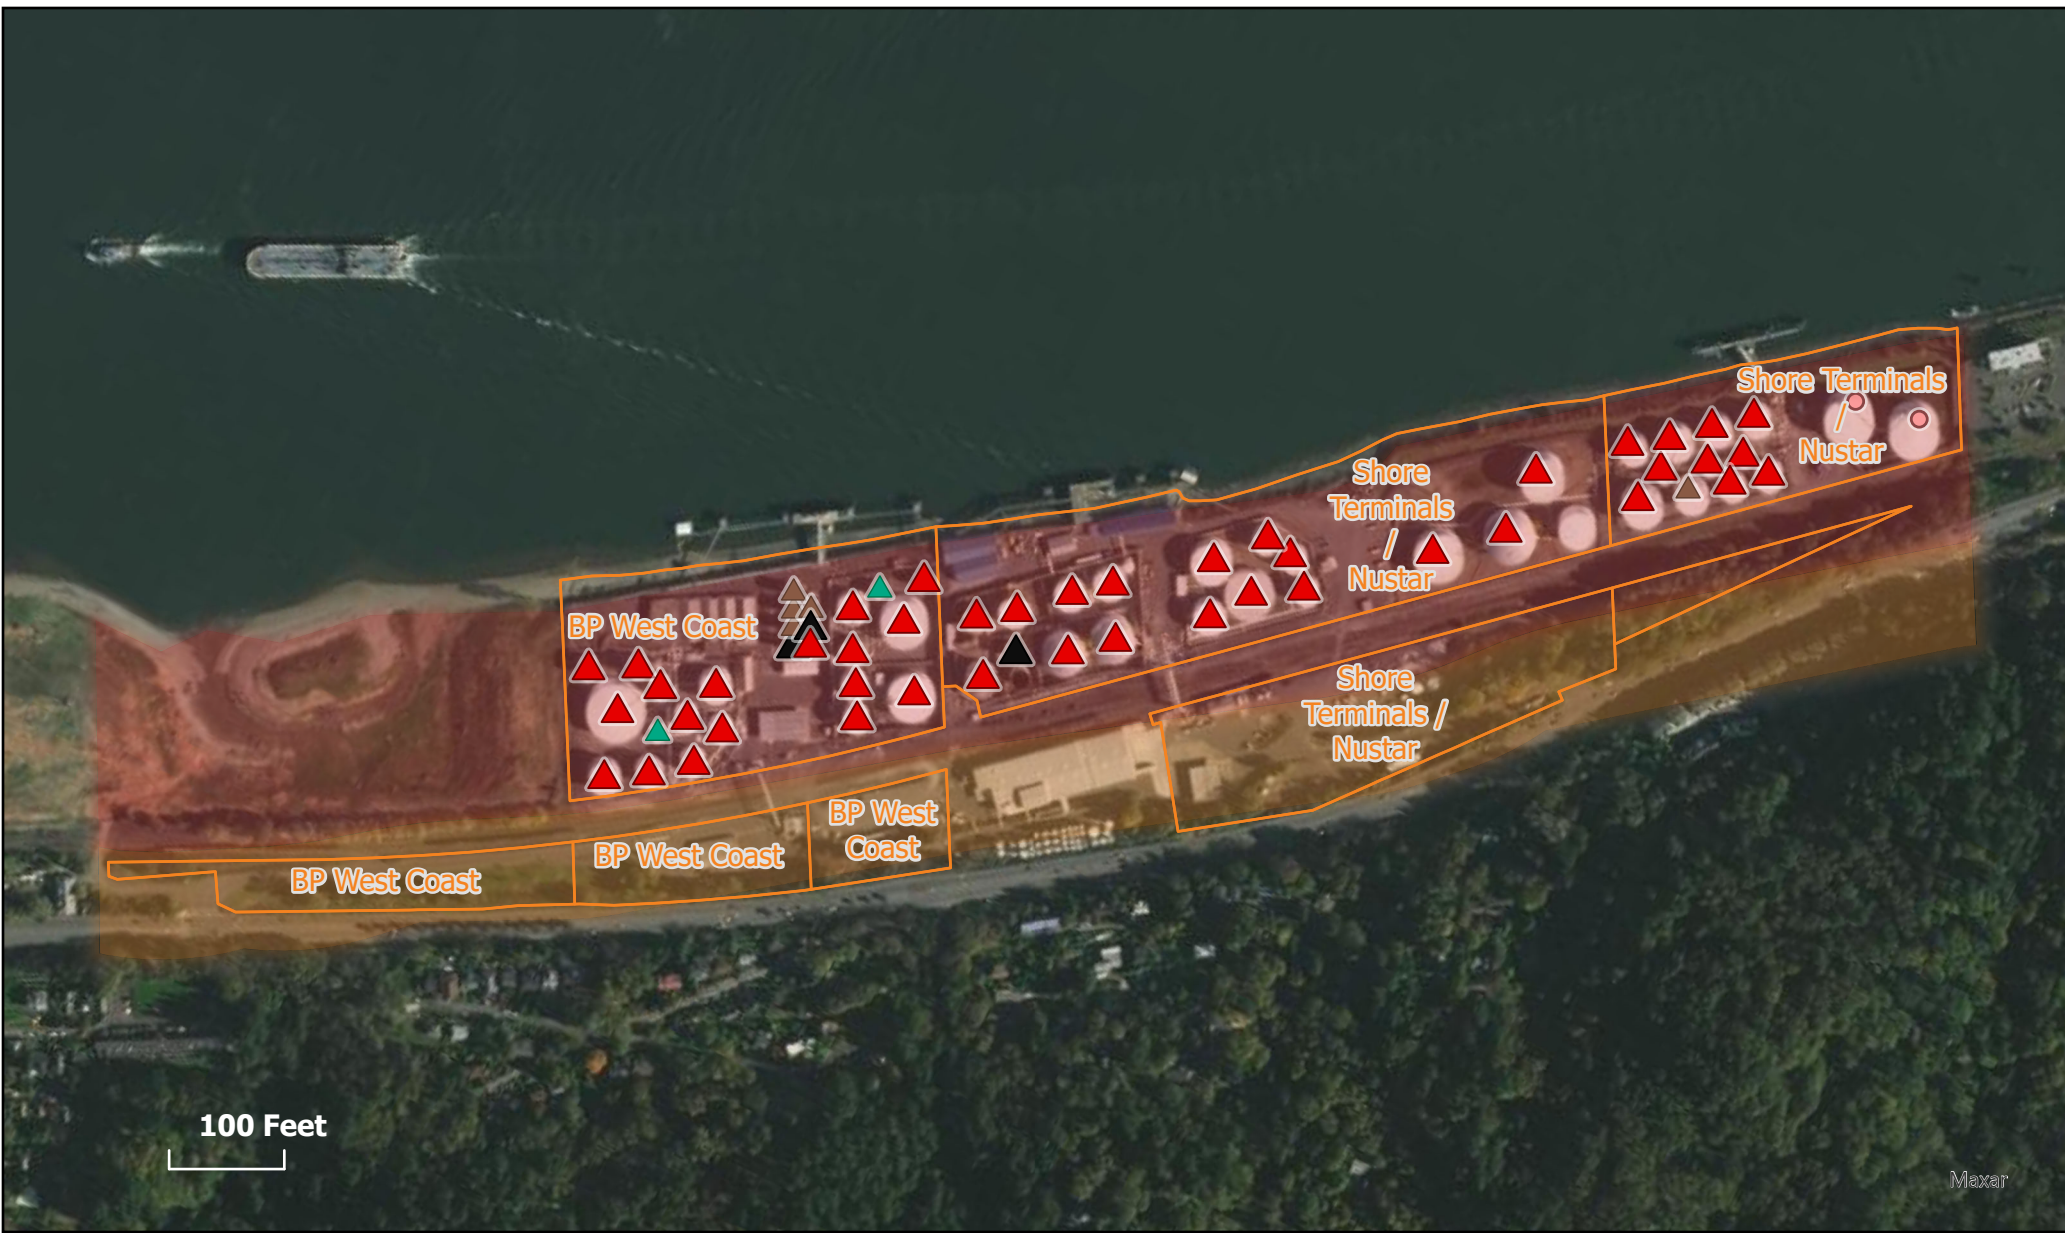
**FIGURE 2B  
LINNTON**

### Tank Release

- ▲ Flammable and Hazardous
- ▲ No Data
- ▲ Empty or Out of Service
- ▲ Tank Failure, not Flammable and not Hazardous
